TY MAWR PORTHGAIN

ARCHAEOLOGICAL ASSESSMENT MAY 1992

AN ARCHAEOLOGICAL ASSESSMENT WITHIN THE OLD BRICKWORKS BUILDING KNOWN AS TY MAWR, PORTHGAIN, DYFED, MAY 1992

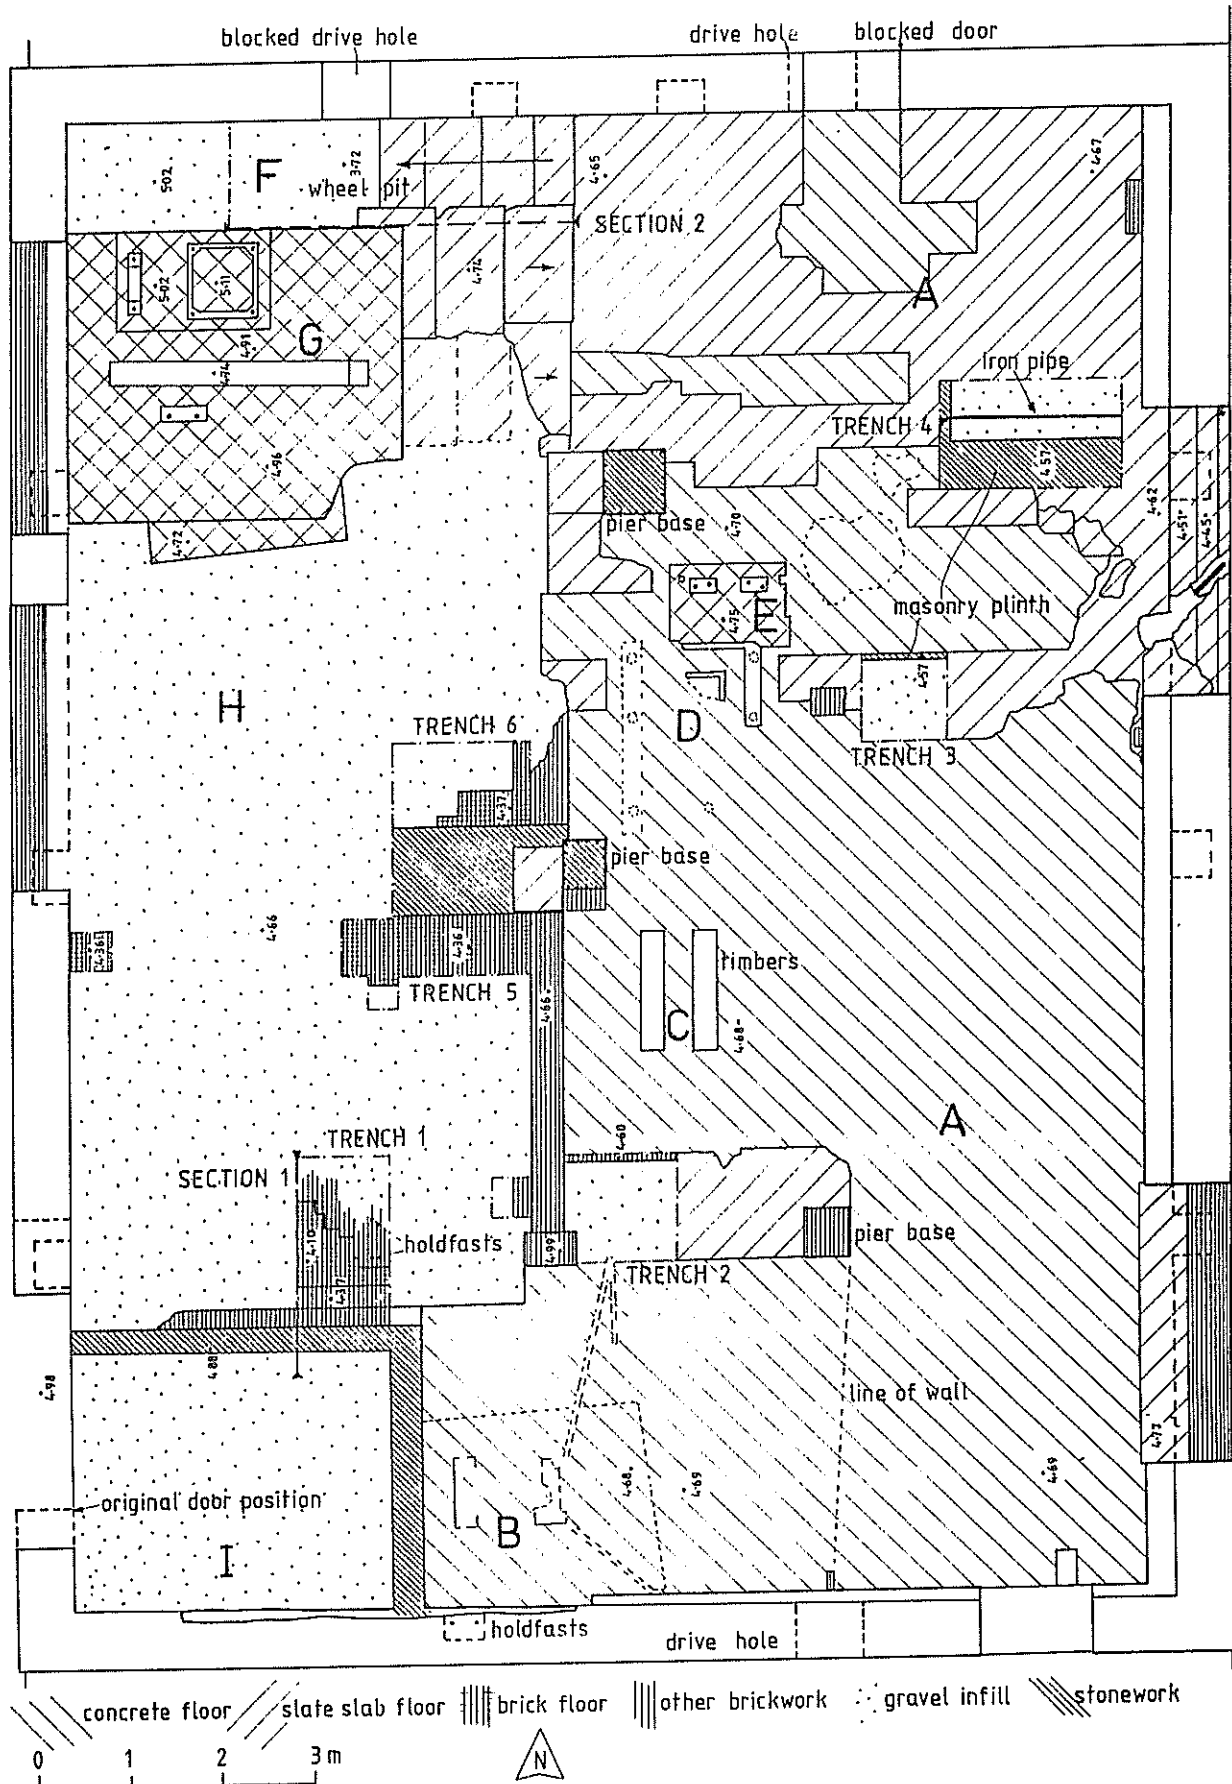
Fig. 1 Plan of latest floor surfaces

This was a complex surface, composed of many different materials and comprising several elements. For ease of description it has been divided into several elements - see Fig. 1 for their location. Some features are only shown on the plan and not described as their function is clear.

A) The whole of the eastern side of the building was taken up by a concrete and slate slab floor. It would appear that the concrete was a replacement for the slate; the slabs having been lifted and concrete laid in their place.

B) A machine base measuring 1.2 m by 0.75 m sat on the concrete floor on the southern side of the building. The machine may have been surrounded by a partition. Iron pipes in channels cut into the floor led to this machine. A holdfast set in the adjacent wall may have been associated with this machine.

C) A machine base represented by two timber sill beams 1.35 m long set 0.6 m apart between their centres.

D) A machine base >2.1 m in length and 1.4 m wide represented by iron staining on the concrete floor.

E) A machine base with two sets of holdfasts set on a low concrete plinth 1.25 m by 0.8 m.

F) Wheelpit. This stone and slate-lined pit was partly emptied of its soil and crushed stone fill (see Fig. 4, Section 2). A blocked opening at floor height in the wall adjacent to this feature leads into the boiler/engine house suggesting that the pit accommodated a flywheel or large pulleys for belt drives. The pit was later modified and narrowed by the addition of brickwork. It is possible that the engine house became redundant and was replaced by an internal combustion motor sitting on the concrete plinth, G, to the south.

G) Concrete plinth built over the blocking brickwork of the pit F. A machine base 1.7 m by 1.1 m and other machine holdfasts sit on the concrete. A resident of the village remembers a compressor on this plinth. An earlier, smaller concrete plinth protrudes from the southern side of the main plinth.

H) Infill of crushed stone and gravel, contemporaneous with the partial blocking of the two doors on the western side of the building. It is assumed that the floor surface over this infilling was at a higher level and has now been lost. The infill covered sunken brick floors and walls (revealed in trenches 1, 5 and 6). These brick floors and walls appear to have formed at least three storage tanks (see Fig 2), the bases of which were between 0.25 m and 0.6m below the concrete-slate floor to the south. The infilling may have taken place at the same time as the modification to the pit F. Some of the brickwork of the tanks had been robbed prior to infilling.

I) Infill within a brick and stone wall. This was not examined but may have been another storage tank, similar to those described above. The surrounding stone wall was contemporaneous with the external walls of the building.

- 1) The surfaces revealed in the archaeological assessment should be preserved in situ beneath the proposed new floors. Some form of impermeable membrane could be employed to protect and demarcate the existing surfaces. It is recognised that loss of part of the original floor area will occur, particularly in the north-west corner of the building where the concrete plinth is some 0.3m higher than the average levels.

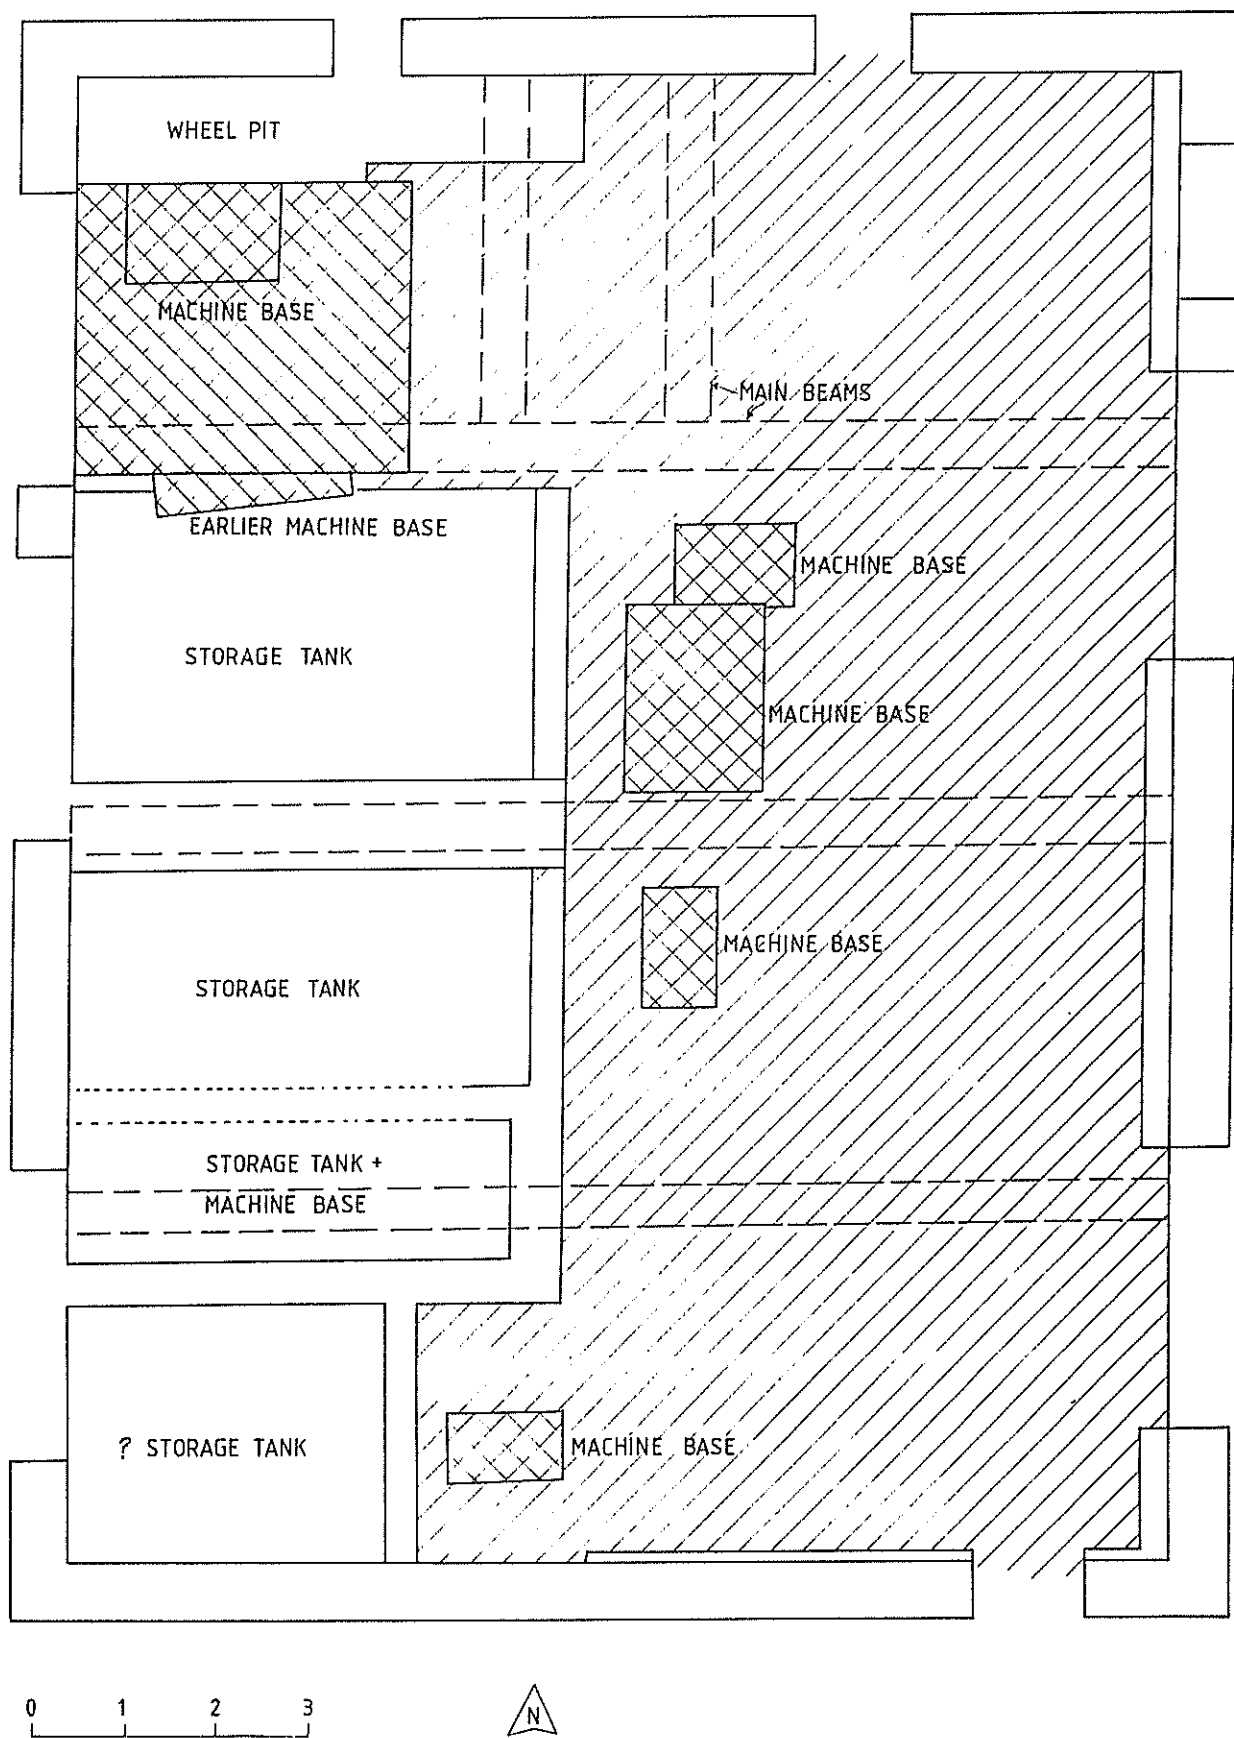
Fig. 2 Interpretative plan of latest floor surfaces

Ty Mawr is a two storey, stone-built structure with internal dimensions 16 m by 11.6 m. The walls are 0.6 m thick. Two of the three 3 m wide doorways on the western side of the building have been partially blocked and turned into window openings. The third has been slightly moved from its original position and heightened. The external ground surface to the west of the building is now considerably higher than the original floor surfaces within the building. One of the two 3 m wide doorways on the east side has been turned into a window opening. There are steps down to the outside in these doorways. There are two windows in the east wall (not shown on the plans). Three large joists ran across the building 2.9 m above the ground floor surface and two ran from the north end wall to the northernmost of these (Fig 2, main beams).

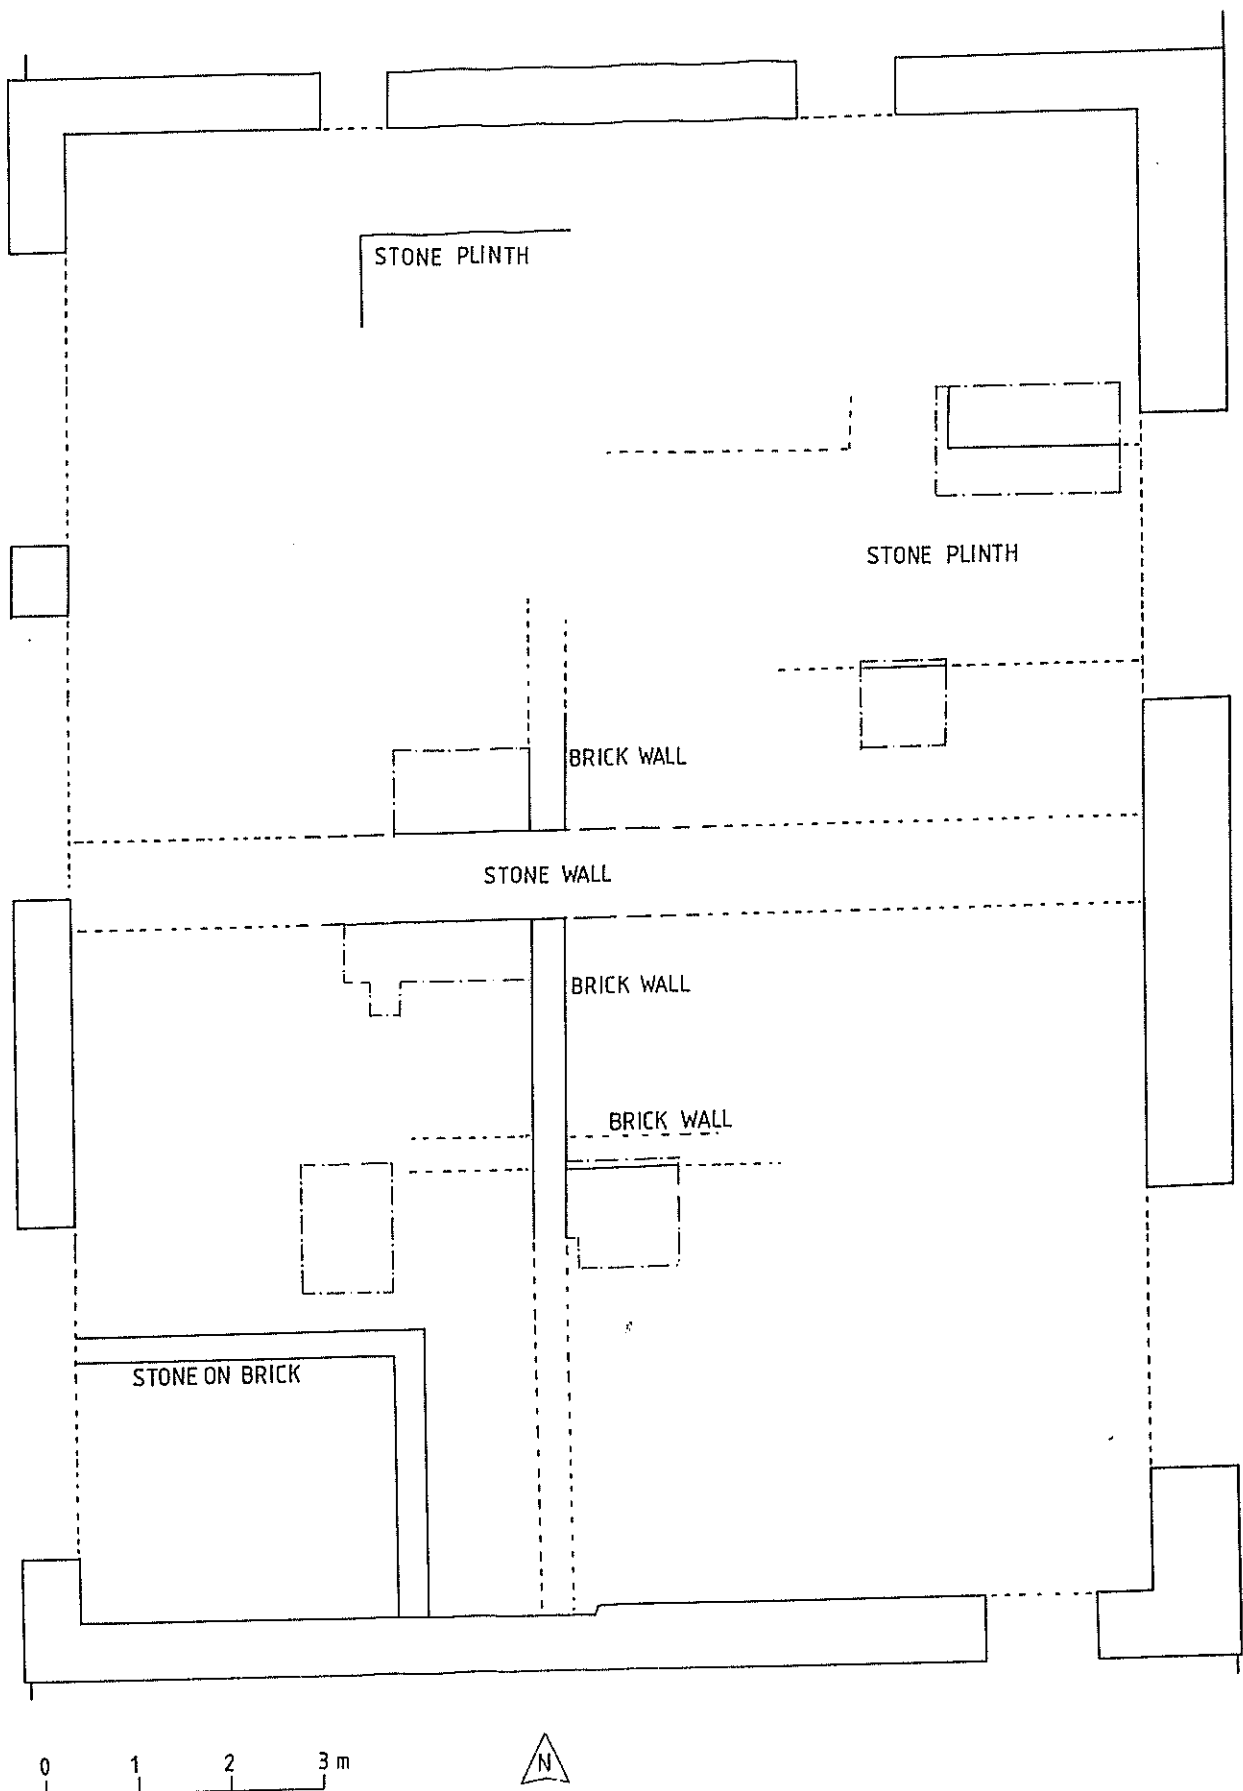
Fig. 3 Sub-floor walls

The building had one major phase of use, though it had undergone modifications; some of these were quite extensive. It is clear from the limited area of the excavations that sub-floor walls and foundations had been designed as an integral part of the structure; these are shown on Fig. 3. The purpose of some of these sub-floor features is unclear.

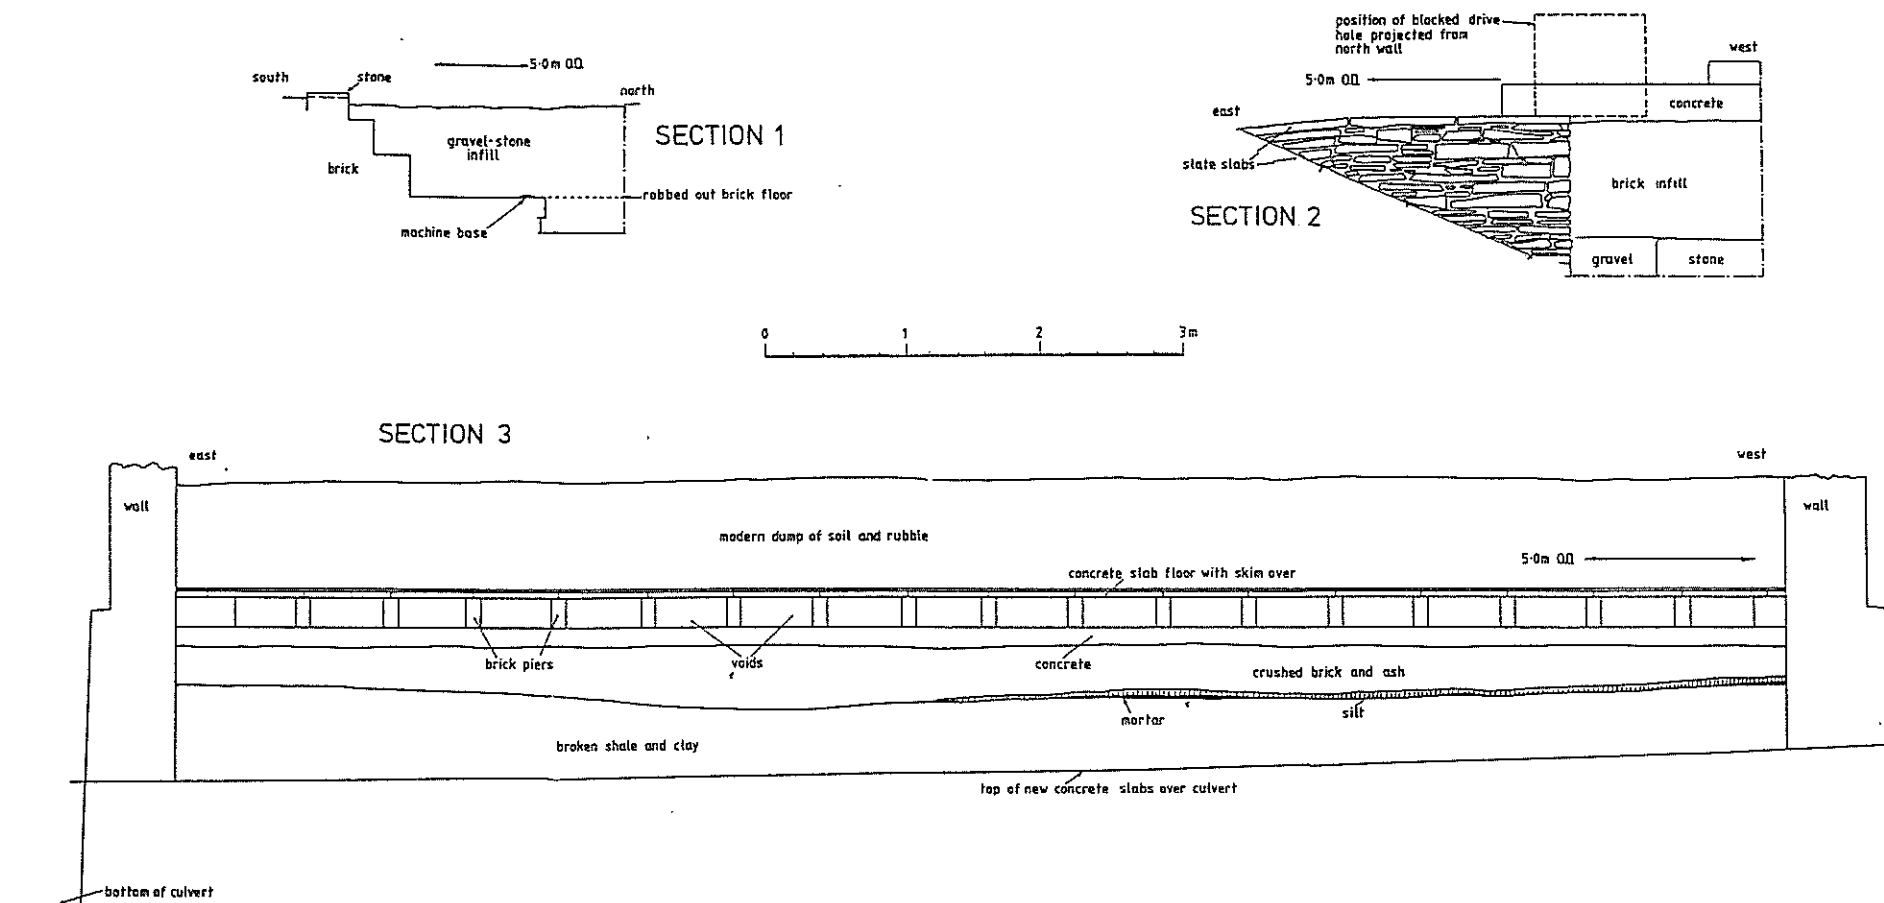
Fig. 4 Sections

Trench 1. Dug in the area of infilling H (Fig. 4, Section 1). The partially robbed brick floor was 0.6 m below the concrete-slate floor and at a lower level than those revealed in Trenches 5 and 6. Two machine holdfasts protruded through the brick floor.

Against the south wall of Ty Mawr, the trench cut through the remains of the drying sheds, clearly exposing the floor construction with its brick piers and air channels (Fig 4, section 3). Again, it is plain that the archaeological remains of the sheds are well-preserved.
