TIR GOFAL MANAGEMENT PLAN: HERITAGE MANAGEMENT INFORMATION

Prepared for:
Brynbanc Farm
W/13/4476

Report No. 2004/79
Project No. 49846

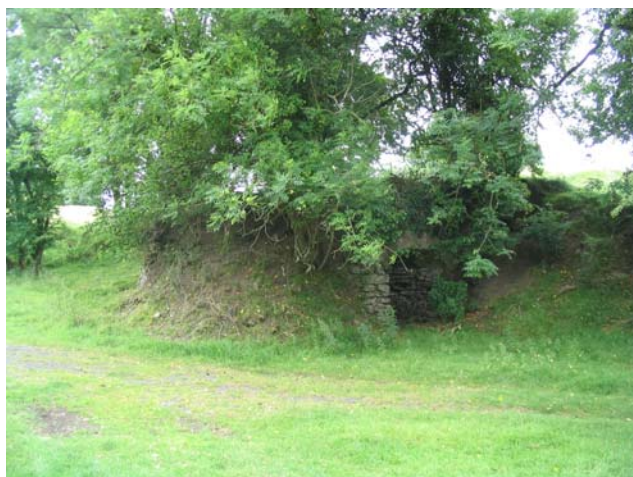
A well preserved lime kiln in the west of the large quarry complex (PRN 19363) to the south of Brynbanc farmstead. It first appears on the 1889, 25 inches to 1 mile Ordnance Survey map, together with a neighbouring kiln (PRN 51192) to the north (now destroyed). It is of the 3/4 circle draw kiln type, and set into a steep natural earth bank with charging platform to the rear. A c.10m diameter earth and stone kiln wall encloses the 6m diameter kiln pot. Opposing drawing arches (with poking holes and kiln eyes still visible) are situated in the north and south. The kiln is intact and relatively stable, although the roof of the northern arch has slumped slightly. No specific management threats were identified. Mature hawthorn trees are growing around the surface of the structure. These appear stable but pose a risk in the long term by windthrow. The kiln pot is infilled with domestic rubbish. This is also spread around the surface, detracting from the kilns original appearance and masking the natural profile of the pot.

Looking east towards the lime kiln at Brynbanc quarries.

The aim is to enhance the visibility of the kiln without compromising stability. All debris to be cleared from the surface of the structure. Some of the debris inside the pot to be removed to restore the original profile. Care should be taken not to damage the kiln structure during these works. Following removal, remaining debris should be covered by a thin layer of inert material (soil or sand).

The trees around the surface of the structure are mostly stable but risk damage by windthrow in future. Options include:

- Monitoring of existing trees. Trees growing out of the kiln walls to be removed. Unstable specimens to be cut off at the roots before being allowed to fall naturally (in order to prevent damage by falling trees and uprooting).
- Removal of all trees growing on/ around the structure. Trees to be cut off at root level. Care taken not to damage the kiln structure during felling. Future tree/ scrub growth to be cut back and spot treated to prevent re-growth. Establish a follow up programme of regular grazing by sheep to establish stable grass sward, re-seeding if necessary.

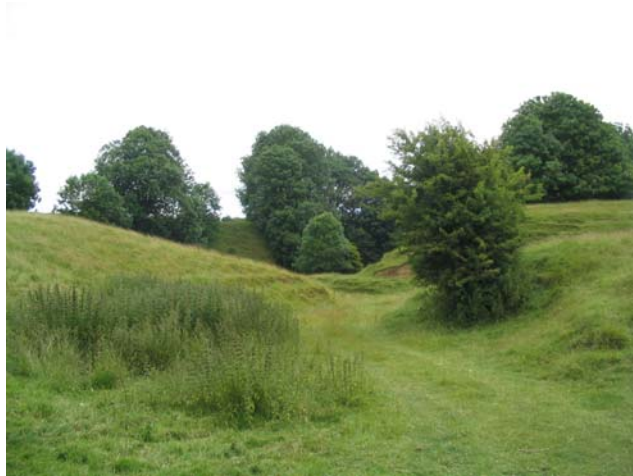
**BRYN BANK
QUARRIES** ([19363](#))

A substantial limestone quarry, covering at least 1.5 acres, to the south of Brynbanc farmstead. It first appears on the 1889, 25 inches to 1 mile Ordnance Survey map (c.90m west of quarry PRN 51190) and is named "Bryn-banc quarries". It marked as disused by the time of the 1907 edition. It includes spoil tips and a quarry trackway with two limekilns (PRNs 51192, 51193), the latter now destroyed situated, to the west. As such it forms part of a rare complete industrial lime processing complex. The site lies within a pasture field. Trees are established on some of the steeper slopes.

Brynbanc quarries, viewed from the west.

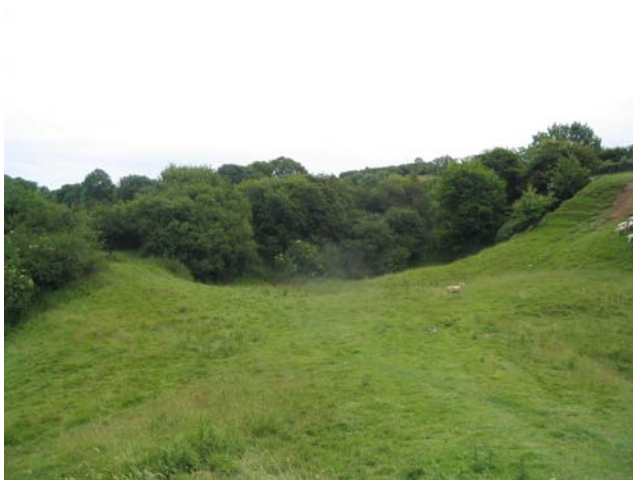
**BRYN BANK
QUARRIES** ([51190](#))

A quarry first marked on the 1889, 25 inches to 1 mile Ordnance Survey map some 90m to the east of quarry (PRN 19363). Both are identified as Brynbanc quarries at this time. It is now abandoned, work having ceased in the early years of the twentieth century. Pasture now covers much of the site with trees on some of the steeper slopes.

Inside the quarry, looking south east.

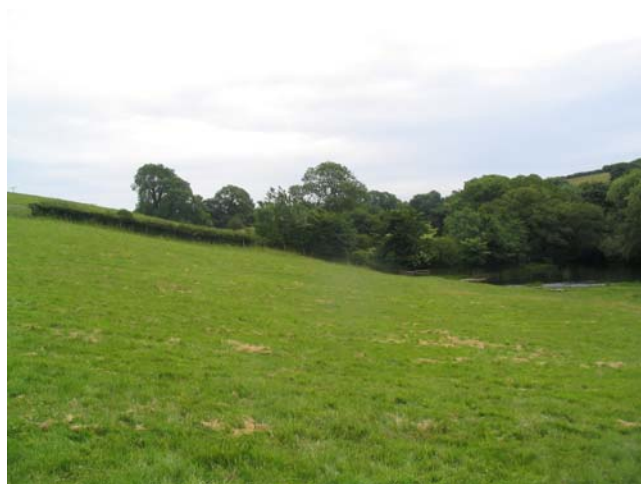
[\(51195\)](#)

On the tithe map, in this position, there is an enclosure containing two buildings. Although these appear on the map, the enclosure is named "pasture" on the apportionment implying that the buildings had been abandoned by this point. No obvious surface traces of any buildings survive today, a pond has recently been created to the south. The site was under pasture at the time of the farm visit.

Looking west towards the former cottage site
