CASTLEMARTIN ARMY TRAINING ESTATE PEMBROKESHIRE

CONDITION SURVEY

Report No. 2004/39
Report Prepared for:
WESSEX ARCHAEOLOGY

MARCH 2004

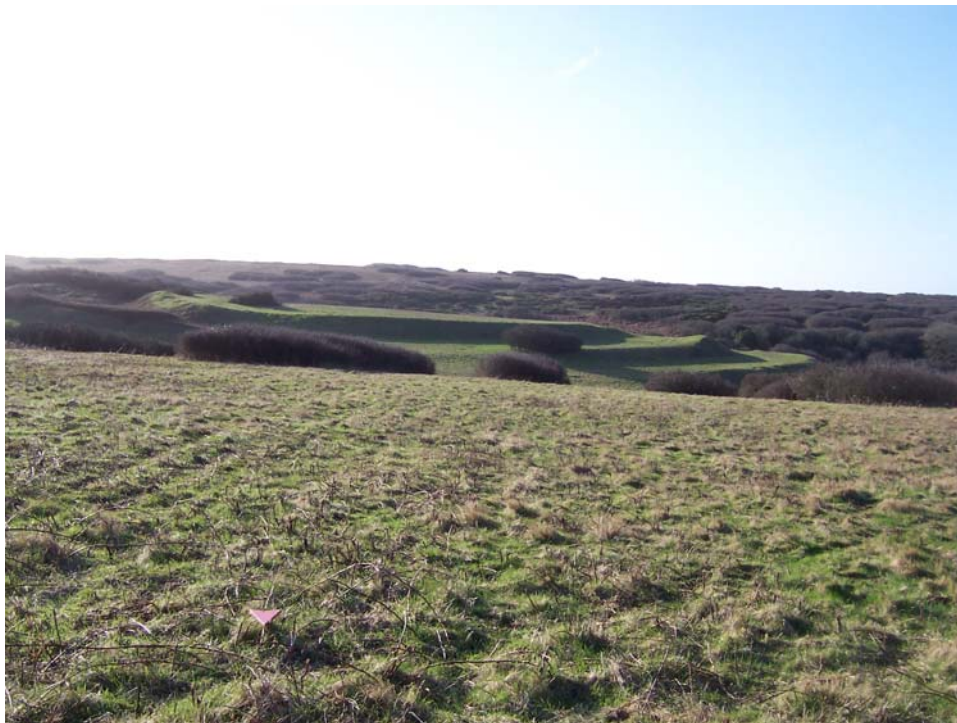
Plate 1: Bulliber Iron Age Hillfort (PRN 549). On-going scrub clearance is uncovering the eastern defences. The partially cleared eastern bank is visible on the left hand side of the photograph.

4.1.3 The clearance works on Bulliber Hill Fort (PRN 549 – see Plate 1) should continue and the infantry target close to the base of the bank on the north side could be moved further from the monument

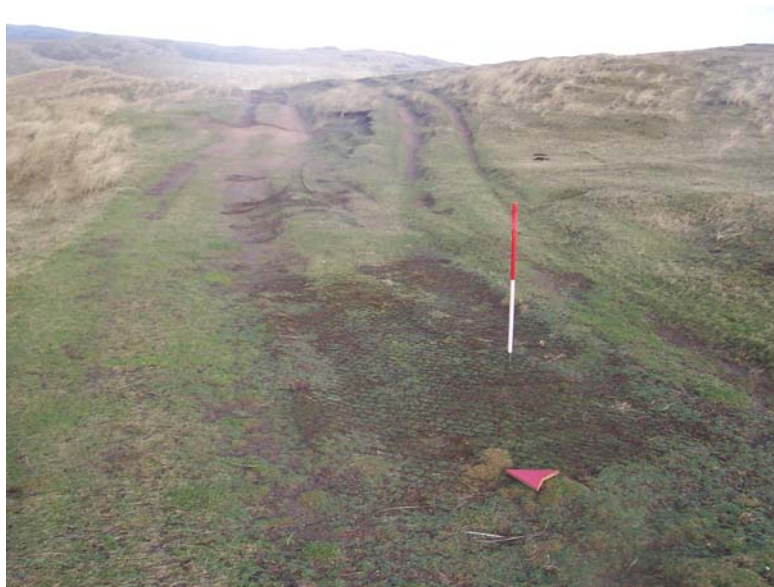
Plate 2: A length of military meshed steel track (PRN 28790). The track survives only in short lengths and is in poor condition overall.

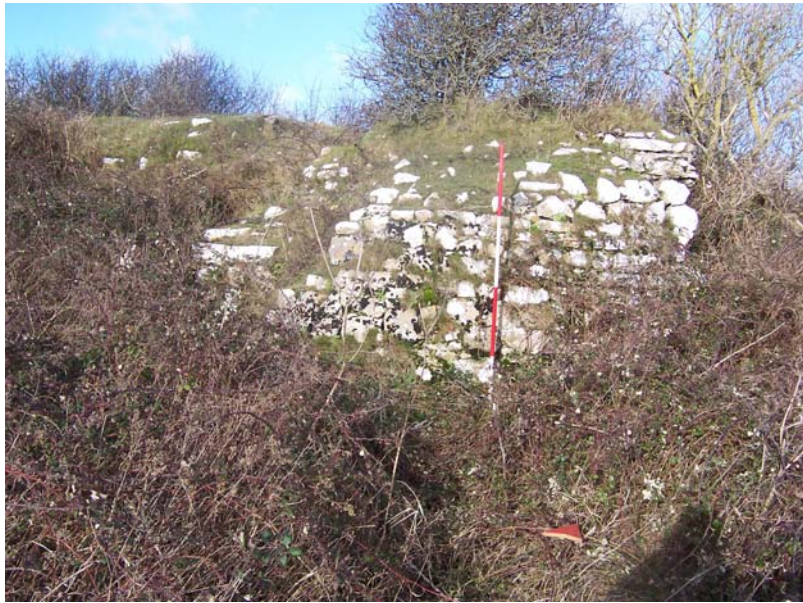
3.2.2 natural processes are having a significant impact on many sites, with scrub encroachment and erosion perhaps the two biggest problems, although structural collapse on the many surviving buildings across the range is also a concern. Scrub encroachment is beginning to obscure many sites, and the development of the vegetation will have long-term implications for sites with standing structures and earthworks (Plate 3).

Plate 3: Scrub encroachment on and around Slade Limekiln (PRN 26300). This is typical of many of the sites with standing remains.

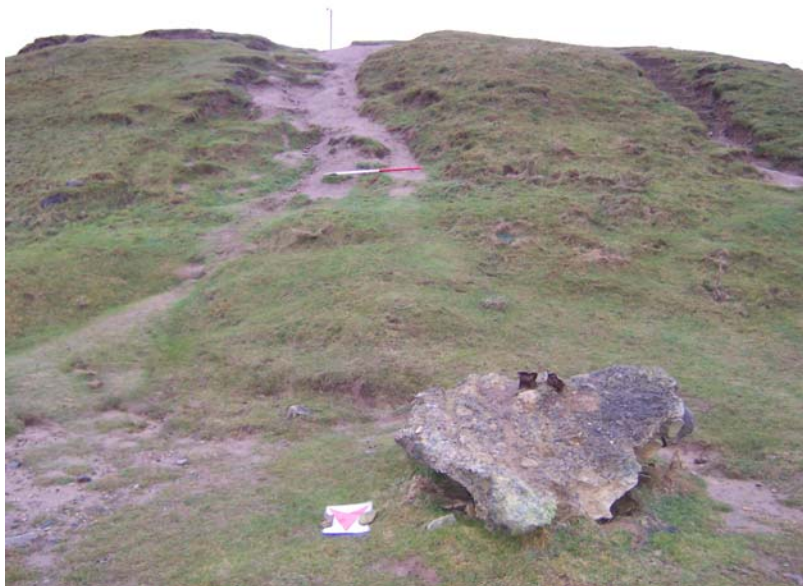
3.2.3 Erosion is a problem on some sites, particularly those close to the coastline, where visitors to the Pembrokeshire Coast Path, wind and cliff erosion are all factors affecting the condition of some sites.

Plate 4: Visitor erosion is having a significant impact on the protective earth mound of the St. Govan's Head Observation Post (PRN 33454), despite the provision of purpose built steps (on the right). This mound is also suffering from severe wind erosion and burrowing animals.

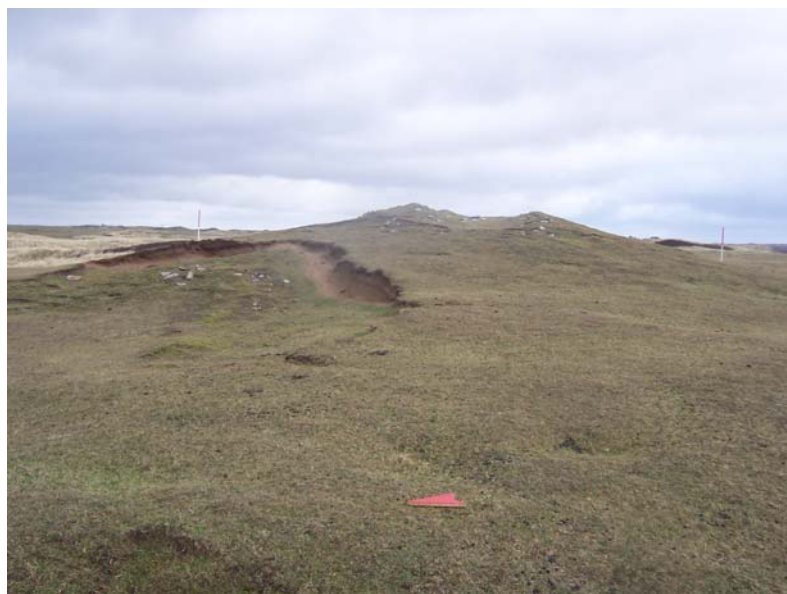
3.3.2 There are some specific concerns including the scheduled Bronze Age round barrow, Crow Back (PRN 536), which is suffering from erosion on its northwest - seaward side (Plate 3). The erosion is active and mitigatory measures are required.

Plate 5: Crow Back Tumulus (PRN 536) showing the active erosion on its west side.

4.1.2 Crow Back Tumulus (PRN 536 – see Plate 3), is suffering severe erosion on its west side. Cadw should be consulted to devise the most appropriate strategy for consolidation, if not reinstatement, of the monument.

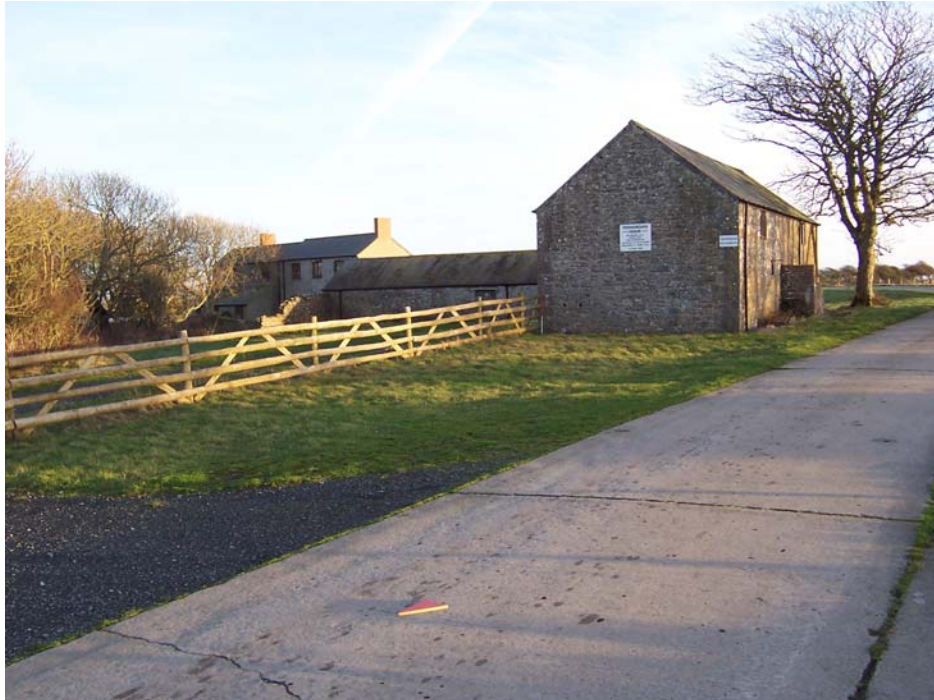
Plate 6: Tenorgan Farm (PRN 464043) is a good example of a site where the condition and stability have been improved for military purposes. The abandoned farmstead has been renovated and recently opened as a 'stone tent'.

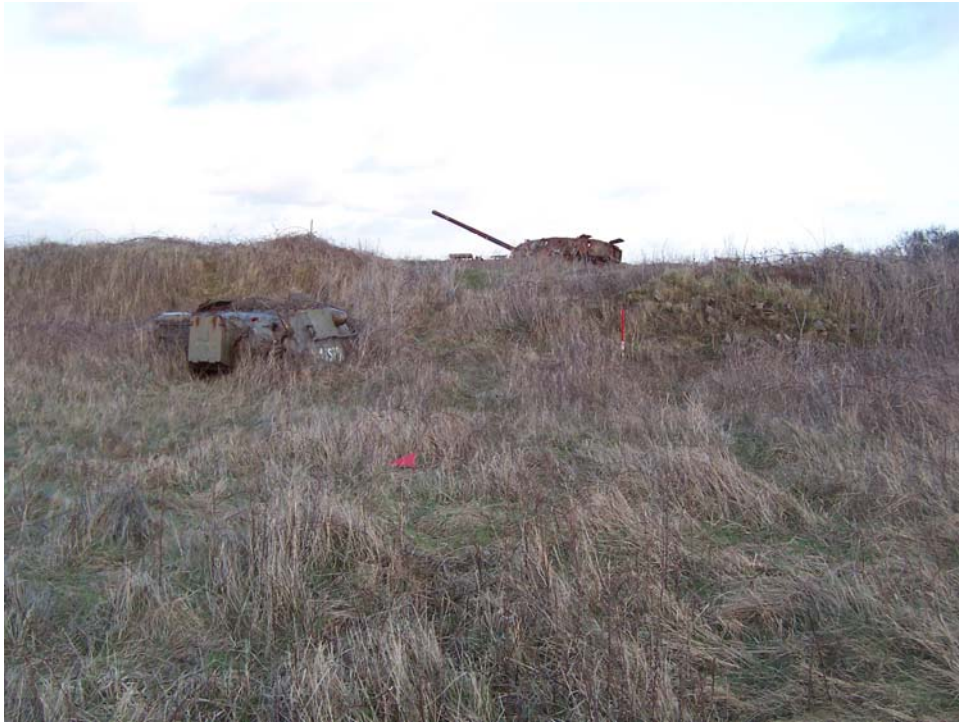
Plate 7: Disused blockhouse (PRN 28780) with target tanks placed on its protective earth mound. The blockhouse has been virtually destroyed.

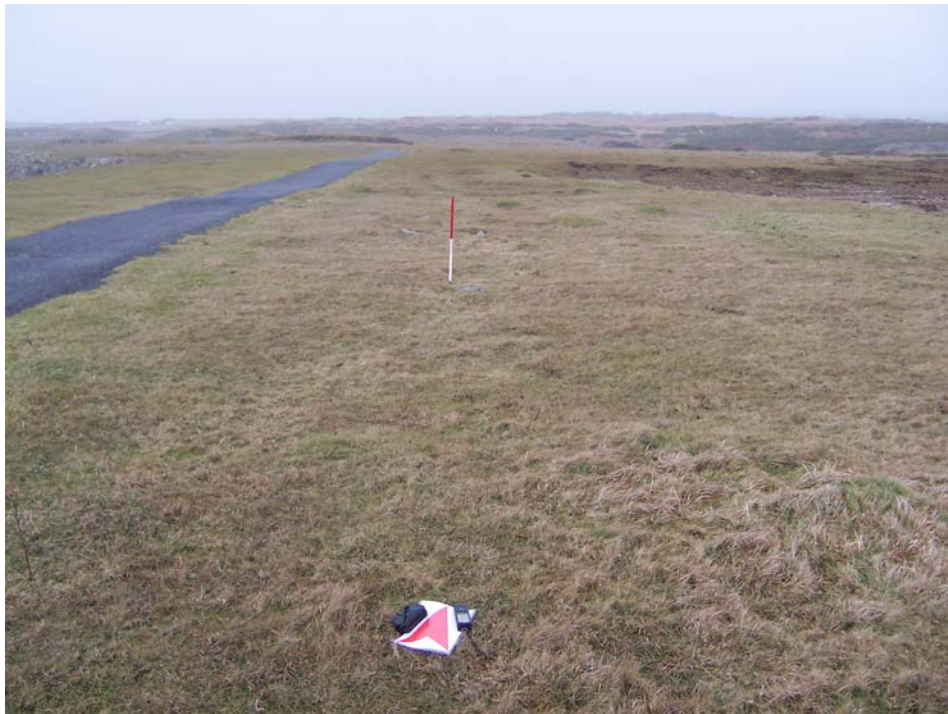
Plate 8: A typical findspot, on St. Govan's Head. This site was the reported findspot of Mesolithic flint blades, flakes and a microlith. The path on the left leads to the St. Govan's Head Observation Post (PRN 33454 – see Plate 4 above) and is used by thousands of visitors each year. This and similar sites along the coast path are vulnerable to the casual recovery of flints.
