TIR GOFAL MANAGEMENT PLAN: HERITAGE MANAGEMENT INFORMATION (HE2)

Prepared for: Tireglwys Farm

Tir Gofal Reference No: W/12/4368

**Helen Milne
Cambria Archaeology**

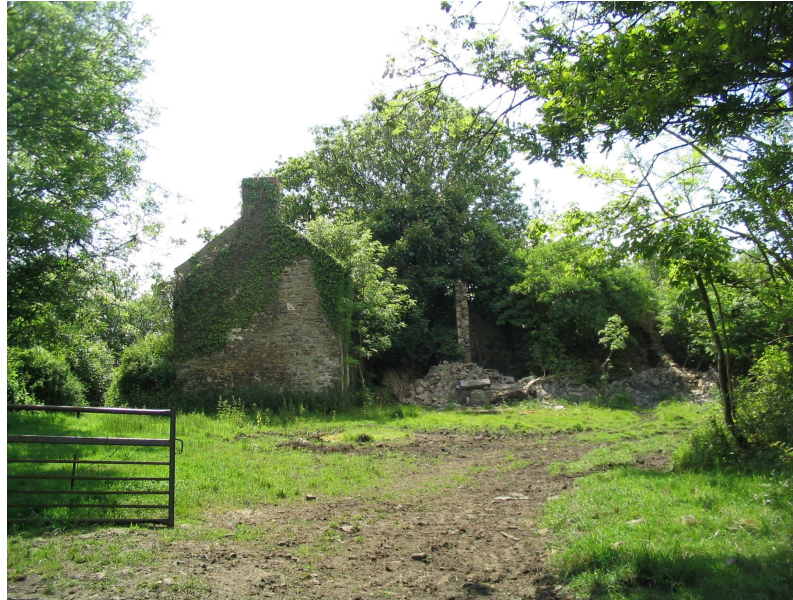
Gwern-Y-Cwm farmstead is first shown on the Ordnance Survey Old Series of 1830 (sheet XXXVII). It also appears on the parish tithe map, and later historic maps demonstrate that during the nineteenth century it was larger and more prominent than Tireglwys farm. Gwern-Y-Cwm farmstead is now in ruins, and the farmer said that it has been abandoned for at least 30 years. The site is heavily overgrown with vegetation including ivy and numerous mature trees, which are causing structural damage. Access was not gained internally due to loose overhanging masonry. The complex consists of a two storey dwelling with associated barn range to the rear (west), whilst to the north, a detached range of smaller stall buildings runs parallel with the main barn range. The whole complex is surrounded by a substantial and well-established stone-walled enclosure. A pond and sluice (PRN 51026) were added to the north, just outside the enclosure between 1879 and 1907. The house itself is built of rubble stone with a slate roof, and the proportions suggest that it is of traditional 3-bay type with central door, although, at the time of the site visit, the front elevation was so overgrown with vegetation that it was difficult to be certain. There is a lower, two-storey out-shut to the rear (west) with a cat-slide roof which extends down from the level of the main roof. The south gable end of the house has a cement render on it, and the west wall (back wall of the outshut) is bare stone with a number of window openings with stone lintels. Some of the jambs have been repaired with bricks. There are several areas of repair on both the farmhouse and the barn range. The barn range is aligned east-west and runs from the back (west side) of the farmhouse, but is not joined to it. The main body of the building has two storeys, and is constructed of rubble stone. It is now roofless, and the second storey has fallen away. Some repairs have been made using modern materials such as concrete breeze blocks, suggesting that the buildings had been in use for some purpose until quite recently. The exact nature of this building is not easy to define, as a substantial portion of the north side (front) of the range is now missing. At the west gable-end there is a lean-to, which lies transversely across the barn range. This has seen considerable modification, firstly for use as a garage - it has an iron girder forming the lintel over a widened entrance to a pre-existing stone building. After this it seems it was re-converted for agricultural use, when a red brick partition was erected

within the shed, which appears to be a stall. There are also breezeblock repairs to the rear (south) end of this building. The mortar that has been used in parts of the lean-to is very black, which may indicate that some construction was done whilst the local coalmines were functioning. The building opposite and parallel with the barn described above consists of a stone-wall of single storey height, which forms the rear of a lean-to shelter, roofed with corrugated iron and supported by timber frames. This shelter still houses two pieces of vintage farm machinery: one Massey Ferguson seed drill, and one wooden threshing machine. The entire farmstead is now very overgrown with vegetation, and in a poor state of repair. The range of buildings to the rear of the farmhouse has been used as a quarry for stone in the recent past, and it appears that some of this stone has been used to consolidate trackways. *Visited 25/05/2004 (HGM)*

The northern gable end of Gwern-Y-Cwm farmstead (51022), showing the range of collapsed outbuildings to the rear (right hand side of the picture), and encroaching vegetation.

The management priority for this farmstead is to preserve the remains in a stable and visible condition. Further removal of hardcore from the site should not occur. Excessive vegetation should be removed where it is practical and safe to do so.

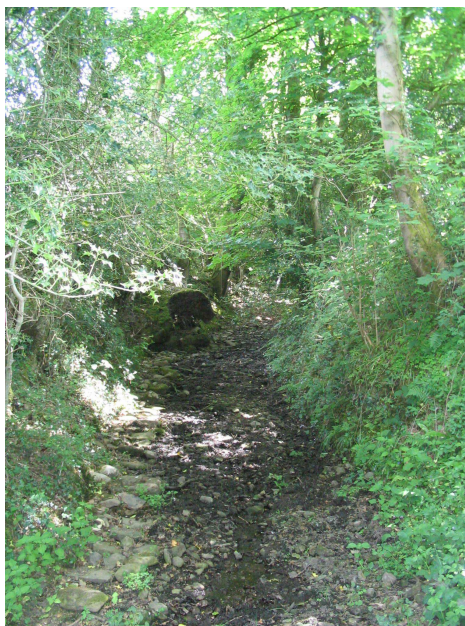
This trackway leads from the river Marlais up to the abandoned farmstead (PRN51,022). A branch also leads off to the north-east. It is bounded by high hedge-banks, and parts of it have been eroded to form a sunken lane, suggesting that the track is well established. The southern end next to the farmstead has become waterlogged, and the whole of the track is becoming very overgrown with small trees and other vegetation. The hedge banks have also become grown out. The trackway is becoming obscured by shrubs, and will eventually be lost as an historic landscape feature if measures are not taken to control vegetation. Visited 25/05/2004 (HGM)

View up trackway linking the Marlais with Gwern-Y-Cwm farmstead

Ideally any vegetation that is springing up on the trackway itself should be cleared, and hedge boundaries should be restored, in order to preserve this as a feature of the historic landscape.

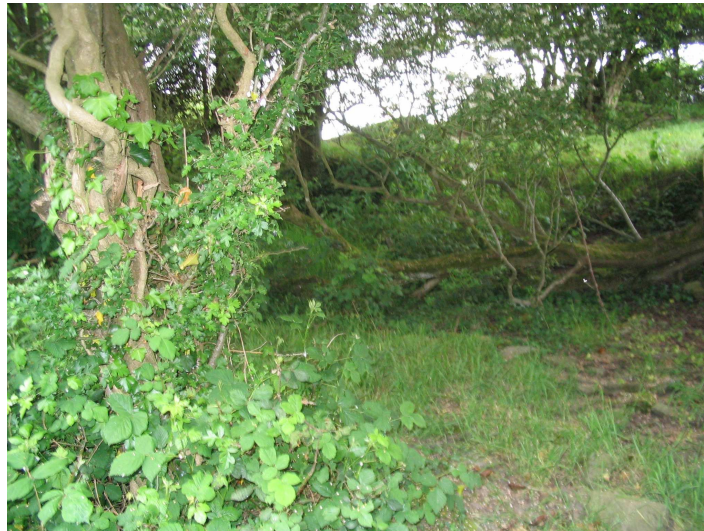
A cottage is marked, but not named on the parish tithe map within a small square enclosure. It is marked on the first edition OS map, but not named, and by the time of the second edition OS map it is not marked at all, suggesting it had been deserted by this time. On the ground, the location of the cottage is now just identifiable as a small overgrown depression, with a concentration of rubble stone around the edges of the patch. The remains are not substantial, but care should be taken to ensure that they do not deteriorate further. *Visited 25/05/2004 (HGM)*

Site of cottage 51038 looking north-west.

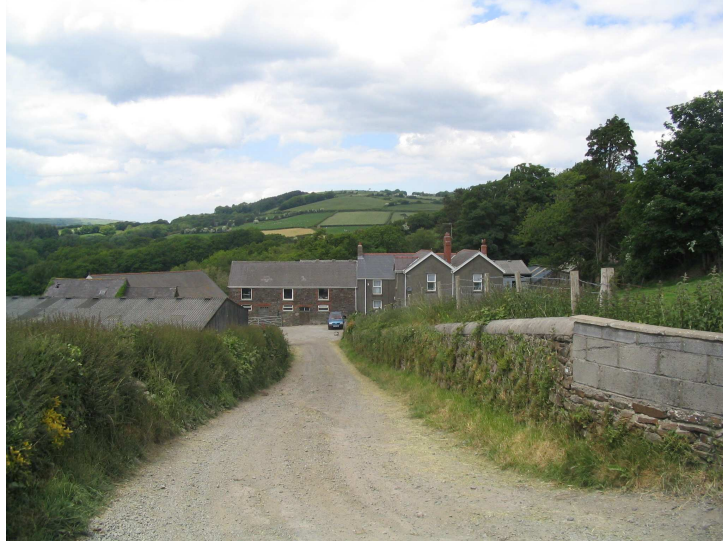
Tireglwys farmstead occupies an elevated position on the south-facing slope which runs down to Afon Morlais. The first known historical record of the farm is the Old Series Ordnance Survey (OS) map of 1830 (sheet XXXVII), where the farm is marked as a single building. In its' current form it incorporates farmhouse and attached stable, also a former threshing barn and cart shed, and numerous modern agricultural buildings. On the first edition OS map it appears as a single building, in the same position as the present farmhouse and stable. whilst by the time of the second edition OS map. the buildings identified as a

threshing barn and cartshed (see below) are marked. Since this time the farmhouse itself has been extended, and some modern agricultural sheds added. The farmstead is variously referred to as 'Tireglwys' and 'Tyreglwys'. The earliest rendering of the name on historic map sources is 'Tireglwys', and this seems to be the more common form. This version implies that the farm occupies land, which formerly belonged to the church. The alternative 'Tyreglwys' (abbreviation of 'Ty'r Eglwys'), would imply that the house itself belonged to a church, which seems less likely. *Visited 25/05/2004 (HGM)*

View of Tireglwys farmstead looking north.

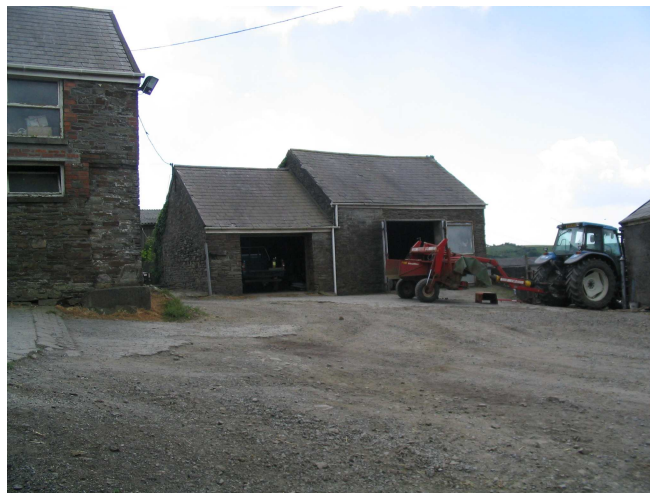
This barn range is orientated east/ west (the same line as the farmhouse and attached stable - see below), but lies separately, to the south-west of the main buildings. It has two sections, and is built of rubble stone with a slate roof. It appears on the second edition OS map of 1907, but not on the first edition of 1879, so must have been built between these dates. The more westerly section appears to have been a threshing barn. It is tall with a wide entranceway on the north elevation, the south elevation was not seen. The shape and height of the structure suggests that it was originally designed as a threshing barn, and has been modified more recently to allow the insertion of a concrete lintel, and modern doors to be hung. To the east is a lower section which looks to have been built at the same time (as a piece with the threshing barn). It is likely to have been built as a cart shed, and the wide entranceway, which still allows for the ingress of a vehicle, may be original, as it shows very little sign of modification. Both buildings are in a reasonable state of repair, and are still in regular use as storage for modern agricultural machinery. There are some areas of damage to the slate roof, and these areas should be repaired before they are allowed to deteriorate any further. *Visited* 25/05/2004 (HGM)

Northern elevation of threshing barn and cart shed (51024)

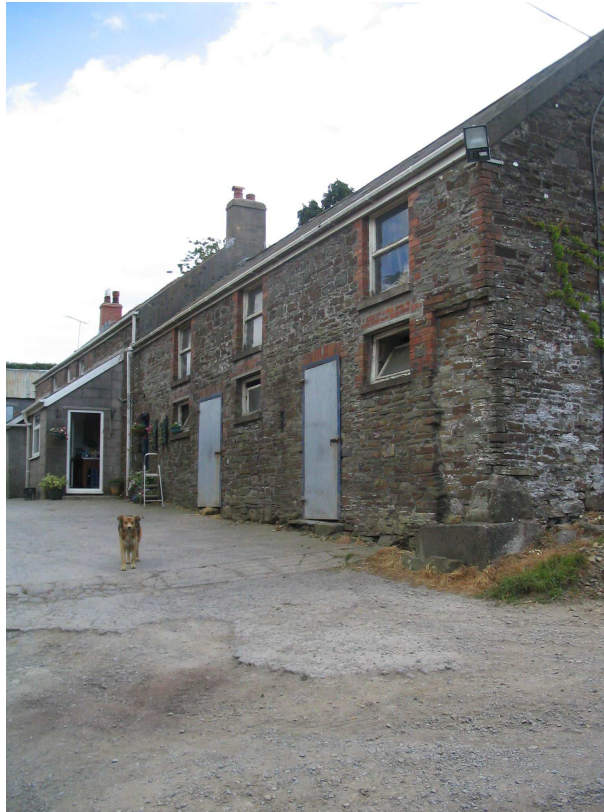
The farmhouse and attached stable range form a single row, which is aligned east to west. The house occupies the eastern end of the range, and the barn is slightly lower, in line with the earlier portion of the house (which has had a double-pile extension added to south elevation since 1907). Historic map evidence suggests that this group of buildings formed the earliest part of the farmstead, although it has been substantially modified over the years. There have been several phases in the more recent development of this farmstead. Most of the house has been cement rendered, making identification of original features problematic. However, the rear (north side) of the house is free of cement render, and suggests that the original was of standard traditional three-bay construction, and also shows that there has been some patching/ modification of this building using red brick. The barn range is joined to the west of the house, and lies in line with, but slightly lower than the original house. The barn range has had brick jambs and lintels inserted into a pre-existing stone building, and the most recent formation of doors and windows is consistent with it having been used as a stable. It is not clear when this modification took place, or whether the position of the window and door openings are original. Both the north and south elevations of the barn have had brick inserts. On the north side bricks have been used to repair and patch various areas. In another more recent phase, the doorways on the south side ground floor of the barn have been infilled using a variety of materials including breeze blocks and bricks. The barn is currently in use for storage and appears to be in a reasonable condition. *Visited 25/05/2004 (HGM)*

North elevation of farmhouse and barn (51025), showing brick insertions.

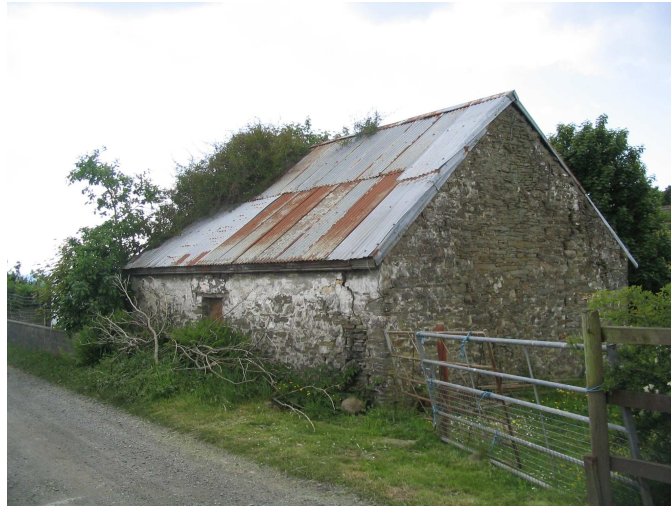
It is not clear whether this building belongs to the farmer. The tithe map of 1843 shows a cottage against the roadside. It is marked on both first and second edition OS maps, and on the second edition it is named 'Ty Crwn' ('Crwn' implies 'fat'; 'stocky', which may refer to the shape and size of the building). This site is still upstanding, and is largely intact, but has been modified. Garage doors have been added to southerly gable end - and it appears to be in use currently for storage. The north gable end wall is intact. It is constructed of rubble-stone, and is roofed with corrugated iron. East and west elevations are low walls, with a single low door on the east (road) side, with wooden lintel above. An important survival of a road-side cottage, which may contain original features. The building was not accessible at the time of the site visit. *Visited* 25/05/2004 (HGM)

Former road-side cottage (51036), now in use as garage/ storage.
