**TIR GOFAL MANAGEMENT PLAN:  
HERITAGE MANAGEMENT INFORMATION  
(Call Out)**

**Prepared for:  
Tyreglwys**

**Tir Gofal Reference No: 4368**

**Report Number: 2007-46  
Project Record Number: 50493**

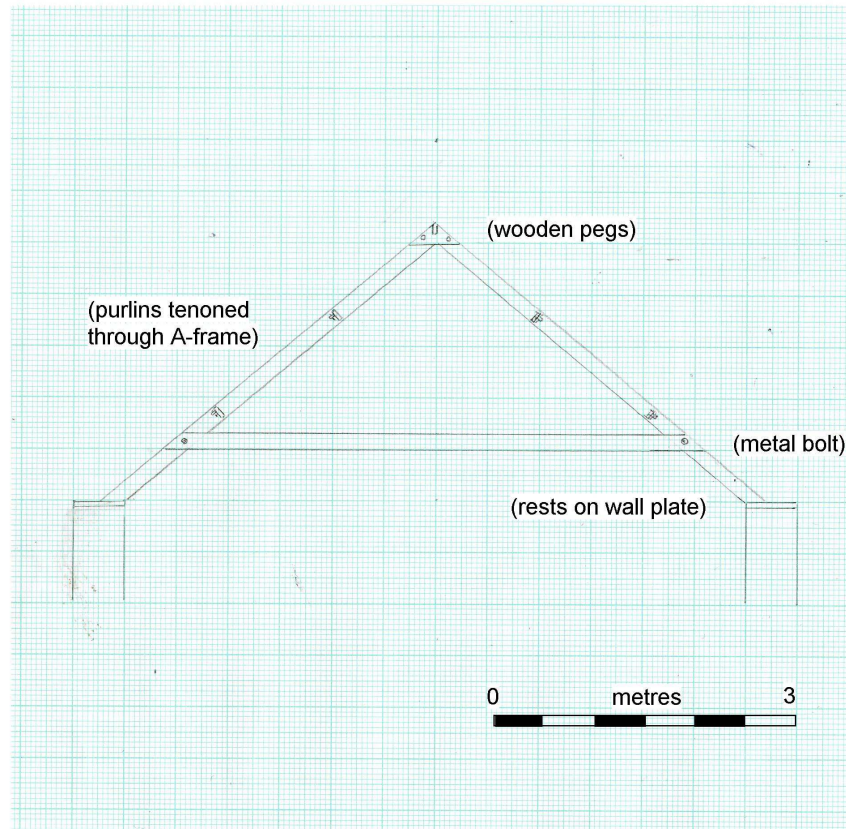
## ROOF DETAIL (CART HOUSE)

- The carhouse part of the range is in fair condition. Some of the slates have slipped on the rear roof pitch. The rear wall is obscured by climbing vegetation.
- The barn is in a deteriorated state. The rear pitch of the roof is letting in water where roof timbers are in a deteriorated state and there are patches of missing slates. The rear wall and lower pine end are obscured by climbing vegetation but some “bulging out” is clearly visible with vertical cracks beginning to appear. These are most dramatic against the rear wall where they are up to 0.1 metres wide at their widest point.
- The cracking appears to be a direct result of subsidence at the lower (west) end of the building. The building continues to deteriorate and the owners are concerned about the threat of collapse, which poses a health and safety risk to them and their livestock.

- Seek specialist advice from suitably qualified builders or structural surveyors about the works and costs required to stabilise and repair the building. It is general practice within Tir Gofal that at least two quotes should be obtained.
- It is recommended that this advice should consider various options for repair, including complete like-for-like replacement using traditional materials and techniques, as well as options which are based on compromise between traditional and non-traditional materials.
