### TIR GOFAL MANAGEMENT PLAN: HERITAGE MANAGEMENT INFORMATION (Call Out)

Prepared for: Ty newydd Tir Gofal Reference No: W/11/005976

Project Record Number: 50502 Report Number: 2009/42

# **Call Out Visit**

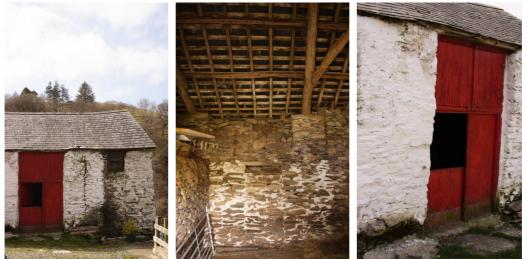
*Entrance to the threshing barn (left), interior, showing blocked doorway in rear wall (centre) and wall set mounting block (right, bottom left of photograph)*

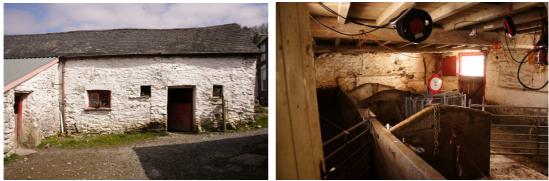
Façade (left) and interior (right) of the cow shed

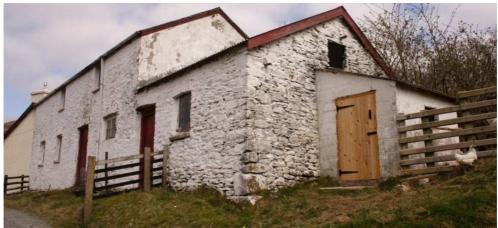
Façade of cart shed, stable, single-storey extension and modern hen house.
