TIR GOFAL MANAGEMENT PLAN: HERITAGE MANAGEMENT INFORMATION CALL OUT REPORT

Prepared for: **Monachty-bach**

Tir Gofal Reference No W/11/4513

Report No. 2005/42 Project No. 50521

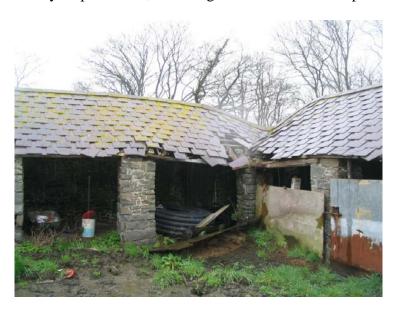
An L-plan stone built cattle shelter with a pitched slate roof at Monachty-bach. It is open fronted and forms two sides of a square fold yard. Square stone piers at two and a half metre intervals support the roof and there is an attached cart shed in the yard-facing gable end. A *tô brat* slating pattern with intervals left between slates adds to the interest of the building. This characteristic is now becoming increasingly rare in the region.

The shelter shed is derelict and falling into disrepair. The roof is collapsed at the corner where the two ranges meet and there is some decay in the roof timbers. There is also some localised masonry displacement, including in some of the stone piers.

The restoration and maintenance of this building should be considered a priority. It is an important element of the mid-late nineteenth century farmstead group and gains further status as a distinctive and unusual building in its own right.

- Repairs should be based on an ethos of repair over replacement as far as is practicably possible in order to preserve the historic character of the building.
- Care should be taken to re-use the maximum number of old slates possible. New slates should, ideally match the type, colour, texture, size and thickness of the existing ones. New slates can be mixed with old ones across the roof or reserved for less prominent slopes. In particular the unusual existing slating pattern should be replicated.

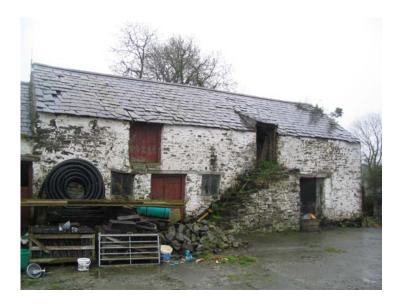
Monachty-bach 53422	Post Medieval Combination	SN50276245	В	
	Farm Building

The range probably dates to the later nineteenth century although map evidence suggests that there was probably an earlier building on the same site. It is now falling into disrepair with many displaced and missing slates and timber decay in the roof and floor joists. Sections of the rear wall are unstable and in varying stages of collapse. There is some vegetation around the lower end of the building.

The restoration and maintenance of this building should be considered a priority. It is a central element of the historic farmstead plan and its ongoing deterioration would be to the detriment of the group as a whole. It is not a particularly unusual building but is historically interesting and retains many of its original features. In addition to the Generic Management Prescriptions listed above the following is emphasised.

- Repairs should be based on an ethos of repair over replacement as far as is practicably possible in order to preserve the historic character of the building.
- Care should be taken to re-use the maximum number of old slates possible. New slates should, ideally match the type, colour, texture, size and thickness of the existing ones. New slates can be mixed with old ones across the roof or reserved for less prominent slopes.
- The collapsing rear wall is a safety concern. If this part of the building is not repaired, it will be possible to remove unstable sections taking care to retain as much of the intact historic fabric as possible.

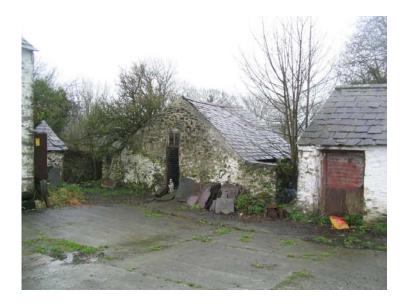
Monachty-bach 53423	Post Medieval Pigsty	SN50266243	В

Map evidence suggests a late nineteenth century date. The building is now falling into disrepair with some displaced slates, decay in the roof trusses and unstable walls.

It is hoped that the buildings will be restored (Generic Management Prescriptions) but if this cannot be achieved the management aim should be to slow down the deterioration of the building.

• Cut back any vegetation or young trees growing on or near the walls leaving the roots *in situ*. This will prevent displacement of masonry by uprooting or collapse.

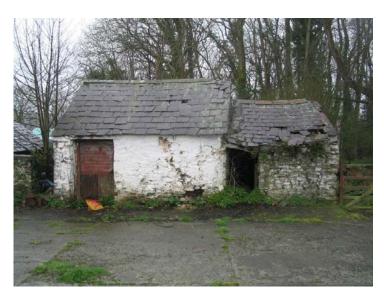
A small stone built shed and annex under a slate roof.

Map evidence suggests a later nineteenth century date. The building is now derelict with displaced and missing slates, decay in the roof trusses and unstable walls.

It is hoped that it will be restored (Generic Management Prescriptions) but if this cannot be achieved the management aim should be to slow down the deterioration of the building.

• Cut back any vegetation or young trees growing on or near the walls leaving the roots *in situ*. This will prevent displacement of masonry by uprooting or collapse.
