**TIR GOFAL MANAGEMENT PLAN:  
HERITAGE MANAGEMENT INFORMATION  
(Call Out)  
Prepared for: Crug y Deri**

**Tir Gofal Reference No: W/13/4830**

**Report Number: 2005-35  
Project Record Number: 50549**

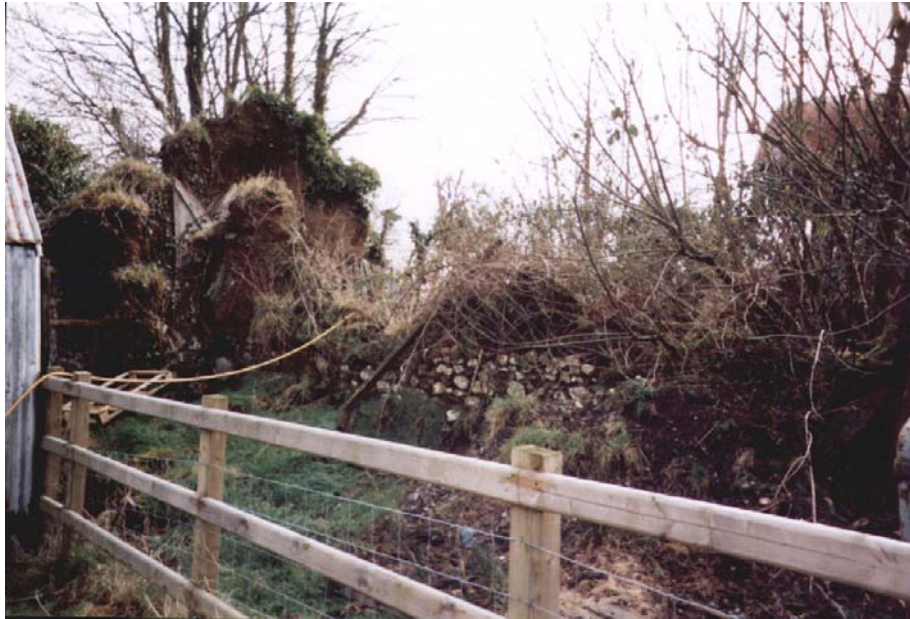
**View of the barn, looking south-east, showing north elevation and east gable-end.**

The walls, both stone and clom, are very overgrown with ivy, and have quite mature saplings growing out of them in various places.

The roof of the barn has collapsed and there was no sign of any roofing material, such as fallen slates, although there may be slate buried in the low berm, which runs up to the base of the walls. What remains of the barn is currently being used to store palettes and other timber. Although no roof timbers survive in-situ, material piled inside the walls may include former structural timbers. At the time of the callout visit this material made it impossible to establish the internal arrangement of the barn, apart from one internal dividing wall made of clom, which was just visible. Neither was it possible to establish the type and condition of flooring.

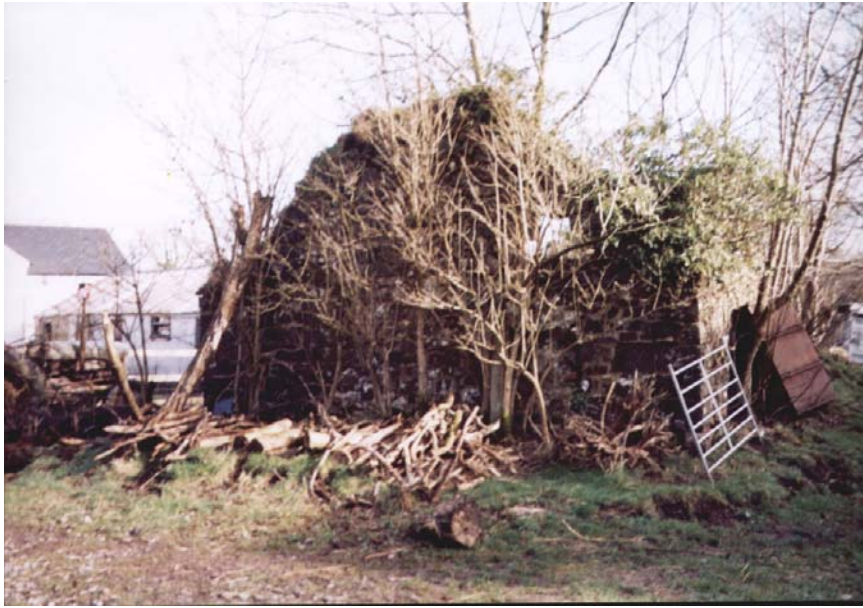
The walls on the north and south sides do not stand to their original height. Structural evidence suggests however, that both eastern and western gable ends are close to their original height. The western gable end is built of dressed, slightly squared stone. It is un-rendered, and pointed with lime mortar. The pointing to the upper courses has been washed out, (the location of this deterioration suggests that it has occurred since the collapse of the roof). A doorway in the southern side of this elevation (c. 80cm wide) has been blocked off with stone infill.

**Western stone-built gable end**

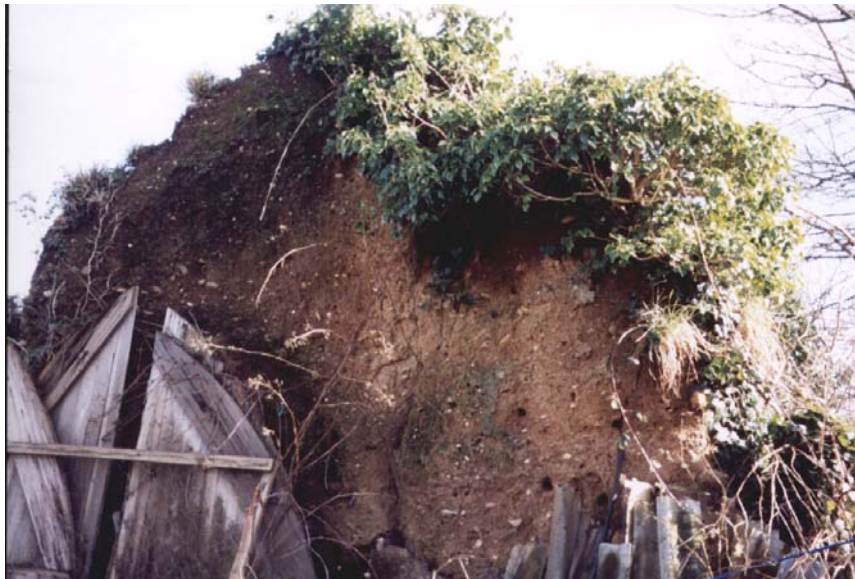
The eastern gable end is constructed entirely of clom. Both the external and internal faces of this wall have suffered heavy erosion, but despite this the gable end has survived to a considerable height. This is due in part to its having been supported by a dense and mature growth of ivy, which has served to bind the earth and therefore delay collapse. However, this gable end has become very fragile and will collapse soon.

**Eastern clom-built gable end**

Earth walled buildings are very susceptible to damage from water penetration. The elements of the barn at Crug Y Deri that are made of clom have deteriorated more rapidly than the parts built of stone, and are beyond repair. If restoration were undertaken, the clom elements would need to be taken down and completely re-built.

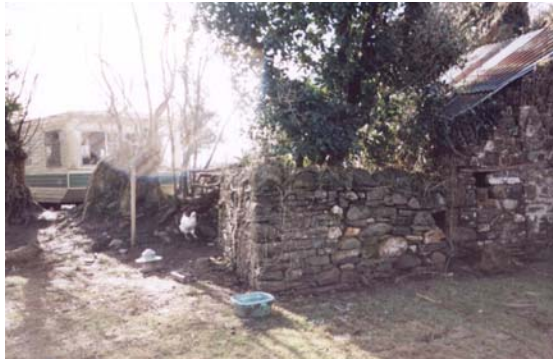
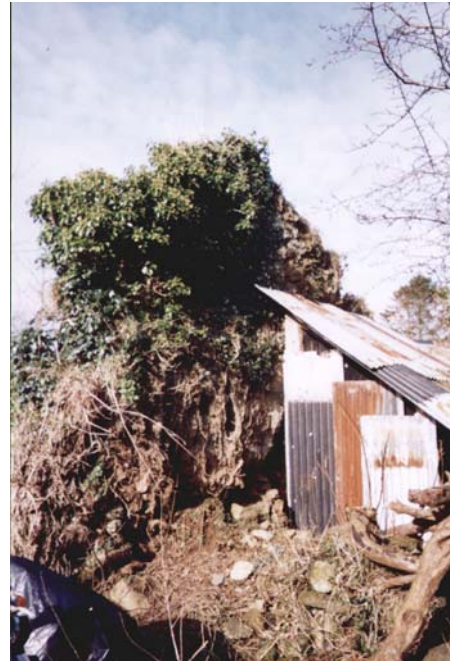
A pigsty with adjoining pen is built up against the external face of the east gable end. It appears originally to have been entirely constructed of stone, but is now roofed with corrugated tin, and the southern part is also protected with corrugated tin. The structure is currently being used to house chickens. The southern stone wall of the pen has collapsed, but the northern wall survives. The northern elevation of the pen has a low former entranceway, with wooden supporting lintel. This entrance has been blocked with stone infill.

**Two views of the pigsty on the eastern gable end, looking south-west (above) and looking north-west (right).**
