## TIR GOFAL MANAGEMENT PLAN: HERITAGE MANAGEMENT INFORMATION (HE2)

Prepared for: Garness Mill Farm

Tir Gofal Reference No W/13/4787

Report No. 2004/103 Project Record No. 50563

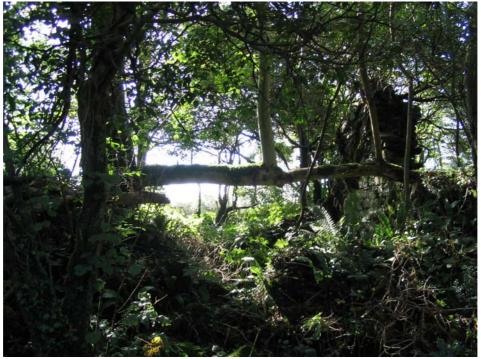
The ruinous farmstead of Perlin Hill lies within woodland at Garness Mill Farm

Perlin Hill farmstead lies within dense woodland and scrub. Falling branches and trees are accelerating the decay of the masonry remains.

The site of Perlin Hill farmstead would benefit from some sensitive woodland management. Those trees and saplings which have become established within, or in close proximity to, the masonry remains of the farmhouse or enclosure walls should be cut back above the roots. The roots may be spot treated to prevent regrowth. Any timber extraction should be carried out with great care not to cause any further damage to the masonry remains.

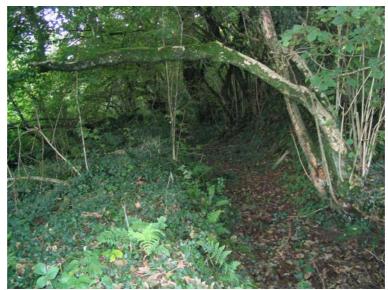
The mill leat is clearly shown on both 1st and 2nd edition Ordnance Survey maps of 1890 and 1907. The course of the mill leat follows the contour at the bottom of the valley side. It is traceable along its entire length within the farm holding, except at the point where it enters the mill building itself, where earthmoving has interrupted its course, it is not clear if the water was supplied by a channel into the building or by a wooden launder. Some of the leat is very overgrown and difficult to gain access to.

The course of the mill leat is clearly visible running through the farm holding.

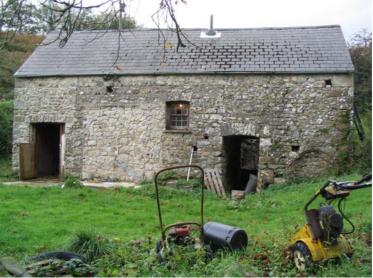
The mill building survives intact although modified and the milling machinery has been removed.

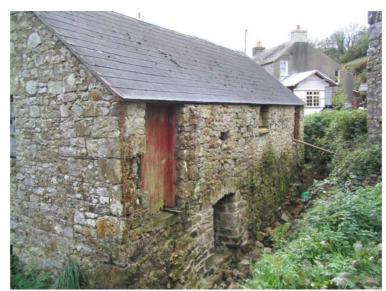
Of primary importance is the consolidation of the mill building and the adjacent corn drying building, whose stability maybe threatened by the recent digging of a large trench between the two buildings. It maybe necessary to seek professional structural advice on this issue.

A large trench at the rear of the mill building has recently been excavated, and it is of some concern that this may threaten the stability of the building.

It is a priority that the trench against the northwest wall of the mill building is filled back in. This is a matter of some concern, not only effecting the stability of the mill building, but also the corn drying building behind it to the northwest. It appears that the buildings are built, not on bedrock, but on clay which is liable to shrink if it is allowed to dry out and this may destabilise the adjacent buildings.

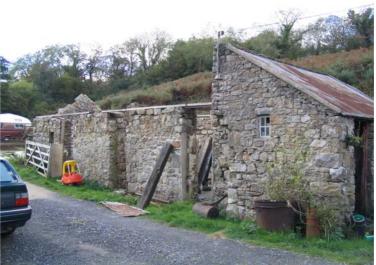
In addition the cow shed (PRN 51858) may also require specialist structural advice on the replacement of the roof structure and slates; one of the supporting walls may require strengthening in order to be able to carry the weight of the roof.

To the south of the farmhouse is a low one storey building, now without a roof. At the north end is a tall leanto against the gable wall. The building has been quite substantially modified although two of the original doorways survive on the eastern wall and an earlier cartshed entrance, now infilled, can be traced at the southern end. The building is currently being repaired and a roof is being replaced as part of the Tir Gofal Scheme. There is some concern regarding the front (east) wall, of the cow shed, which is bowing outwards.

The former cow shed is currently subject to some rebuilding and it is hoped that the roof will be replaced through the Tir Gofal scheme.

It is recommended that specialist advice is sought to establish whether the front (east) wall is stable and will support the roof structure.

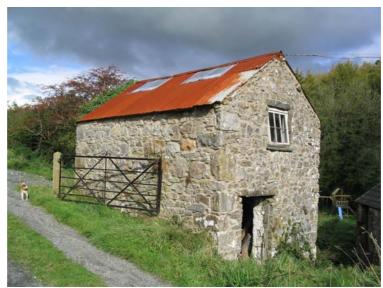
Northwest of the mill building is small rectangular building which lies further up the natural bank. It is constructed in a rubble stone, with a pitched roof currently covered with corrugated iron. It is a two storey building, the ground floor is accessed from the south gable wall and the upper floor is accessed by external stone steps at the north gable wall. It seems likely that this small building was a corn drying kiln, however there is little evidence inside the building to support this assumption. The building appears to be in a reasonably stable condition at present, however there is ivy encroaching on the north gable end which may damage the building in the future.

The building to the north of the mill building is thought to be a former corn drying kiln, however little internal evidence was observed to confirm this and it is currently used for storage.

The ivy encroaching over the building should be cut at ground level and the roots may be treated to prevent regrowth.

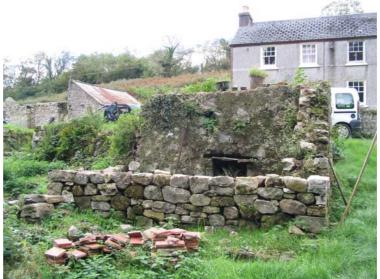
A ruined pigsty within the farmstead and the 19<sup>th</sup> century farmhouse beyond.
