# **NEW QUAY SLIPWAY CEREDIGION**

## **A WATCHING BRIEF**

Report No. 2004/51

**ARCHAEOLOGICAL WATCHING BRIEF,  
APRIL 2004**

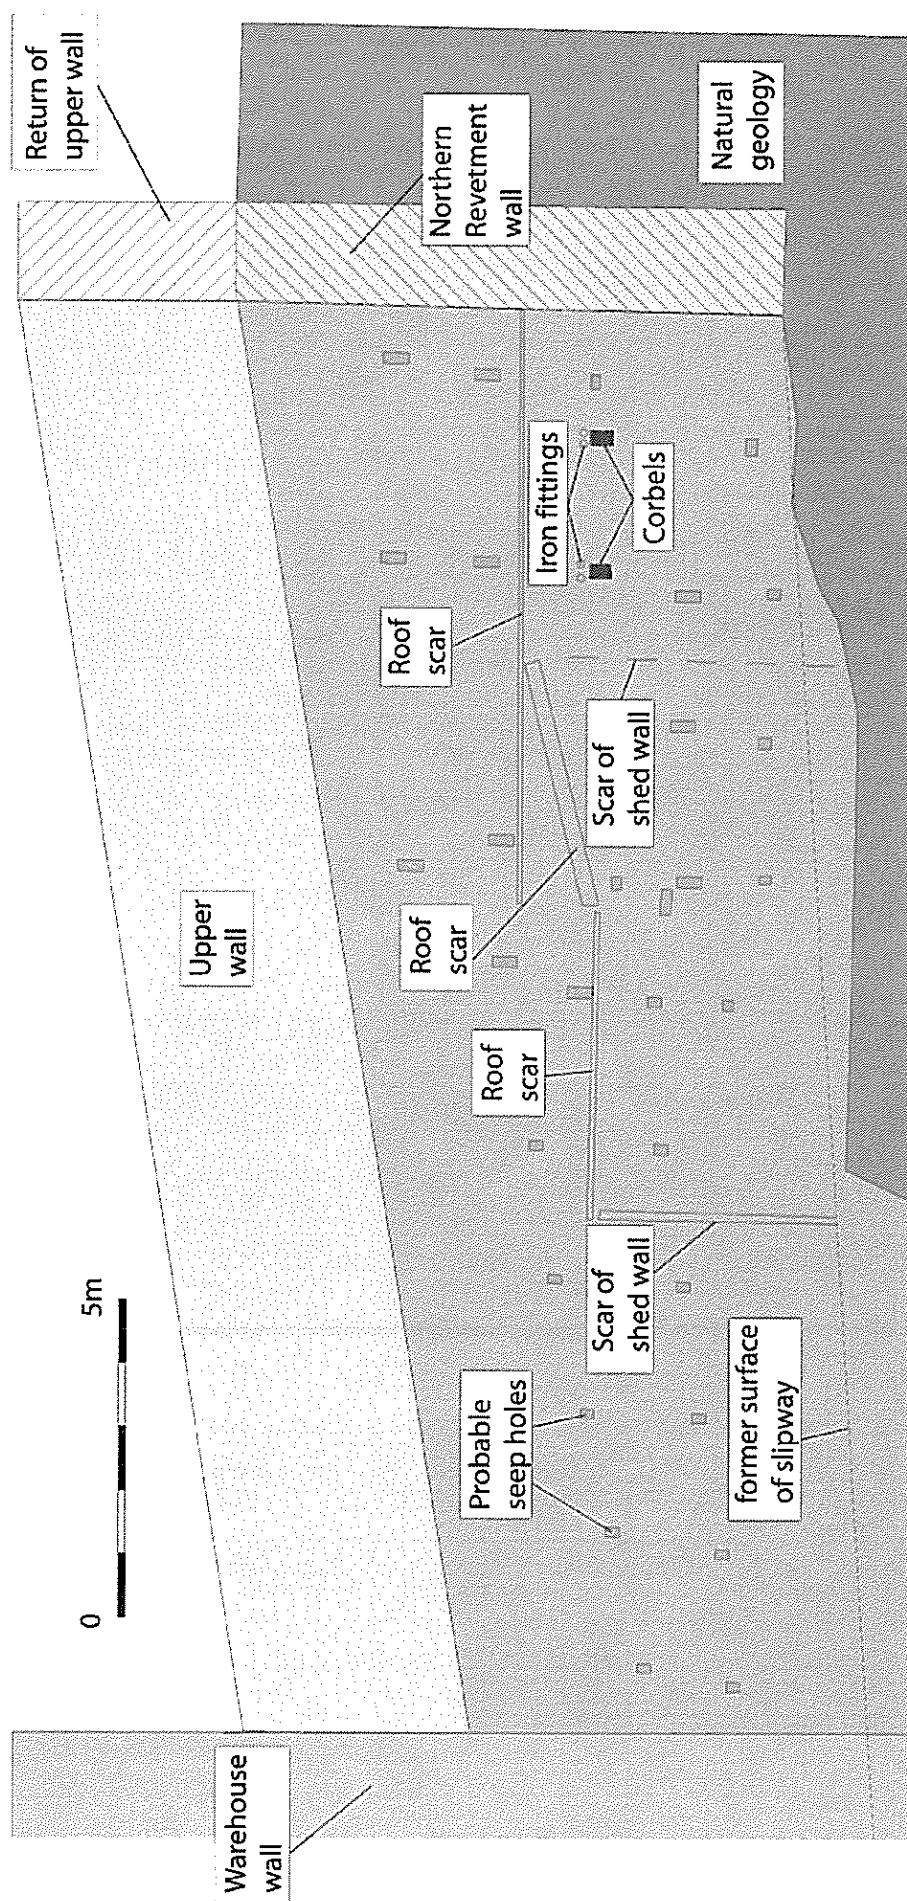
The elevation drawing of this wall (Figure 2) was measured horizontally, but since they could not be measured, vertical measurements are approximate. The positions of the various features in the wall that could not be reached are also approximate.

**Figure 2:** Elevation of the west revetment wall, to the north of the warehouse. NB. Horizontal distances measured, but vertical distances above roof scars are estimated. The locations of the seep holes are not exact. The width of walls in section are not known.

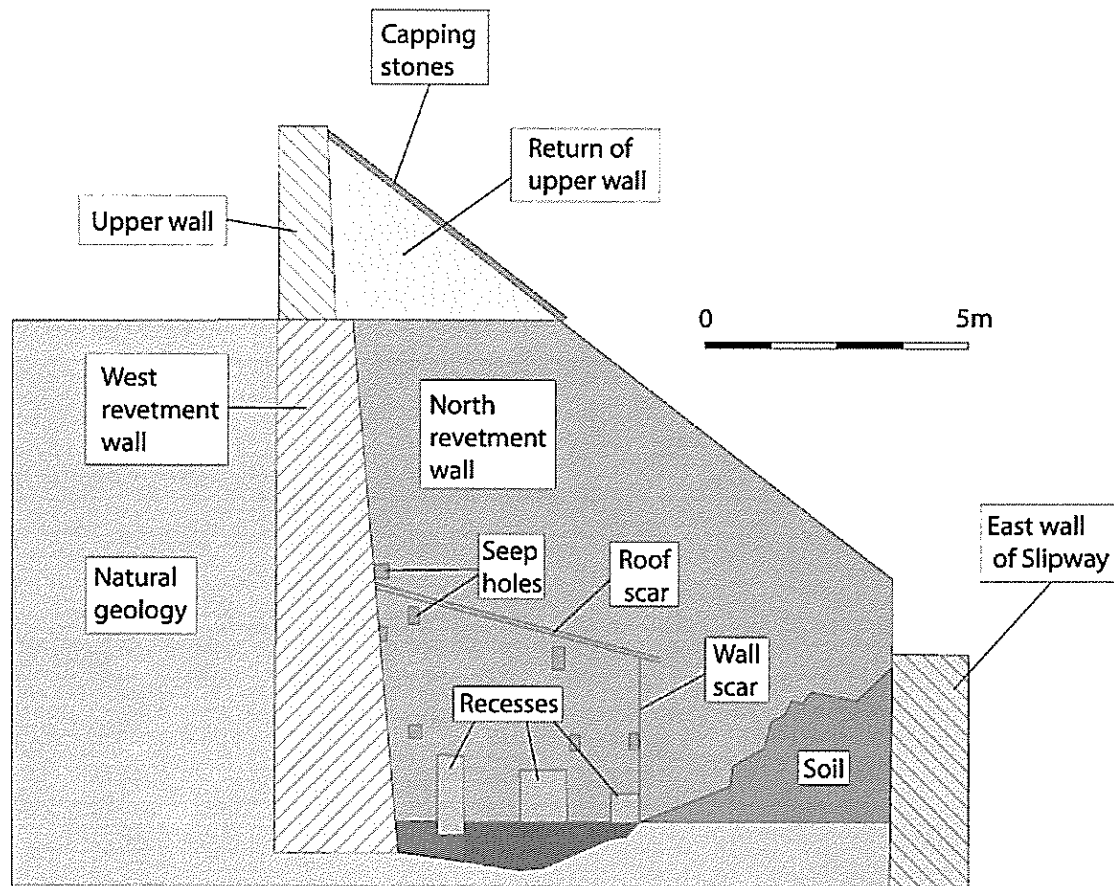
The northern revetment wall butts up against the southern wall, and is cut into the slope. It is built upon bedrock. The top portion of the wall was obscured by ivy but appears originally to have been capped with flat stones and to have sloped downwards to the east to meet the east wall of the slipway. The wall contains a few irregularly positioned rectangular niches. Some of these are probably seep holes but others may have held roof beams associated with the winch shed. The roof and wall scars of a fisherman's shed are also visible. The main features of interest are three differently sized rectangular niches set into the wall at ground level. The left hand niche appeared to continue upwards within the fabric of the wall, while the other two niches appeared not to. The functions of these features are uncertain. The relationship between these features and linear 'troughs' in the footings for the winch mechanism is also uncertain (see below).

**Figure 3:** Elevation of the northern revetment wall. NB. Horizontal distances are measured, but vertical distances are estimated. The width of walls in section are not known

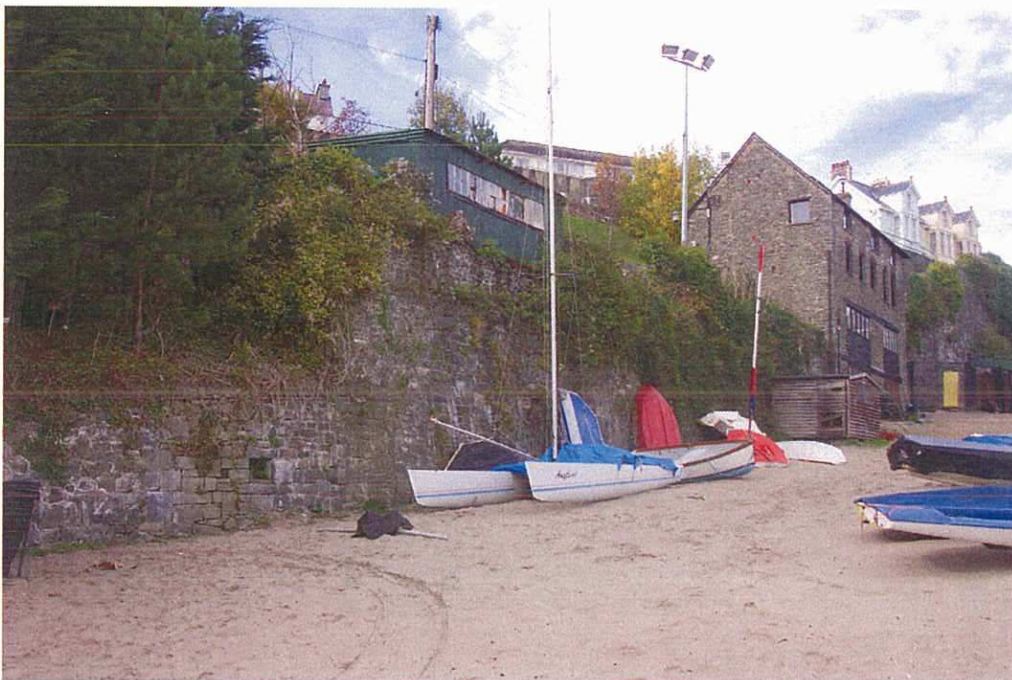
To the south of the steps, the revetment wall, which slopes downwards to the south, is constructed from rough dressed rubble masonry. The main features are numerous, apparently irregularly placed, square or rectangular seep holes. Towards the southern end is a vertical joint of uncertain significance. Two larger openings, similar to those on the eastern wall of the slipway, but without the chains, were observed in this section of wall (one of these is visible in photo 2). Other such openings may exist but were obscured by ivy. A property boundary wall of rough rubble masonry is built above the revetment wall.

**Photo 2:** The southern end of the slipway. The new fishermen's sheds were constructed north of the red boat. Note the large square opening in the wall to the left of the boats.

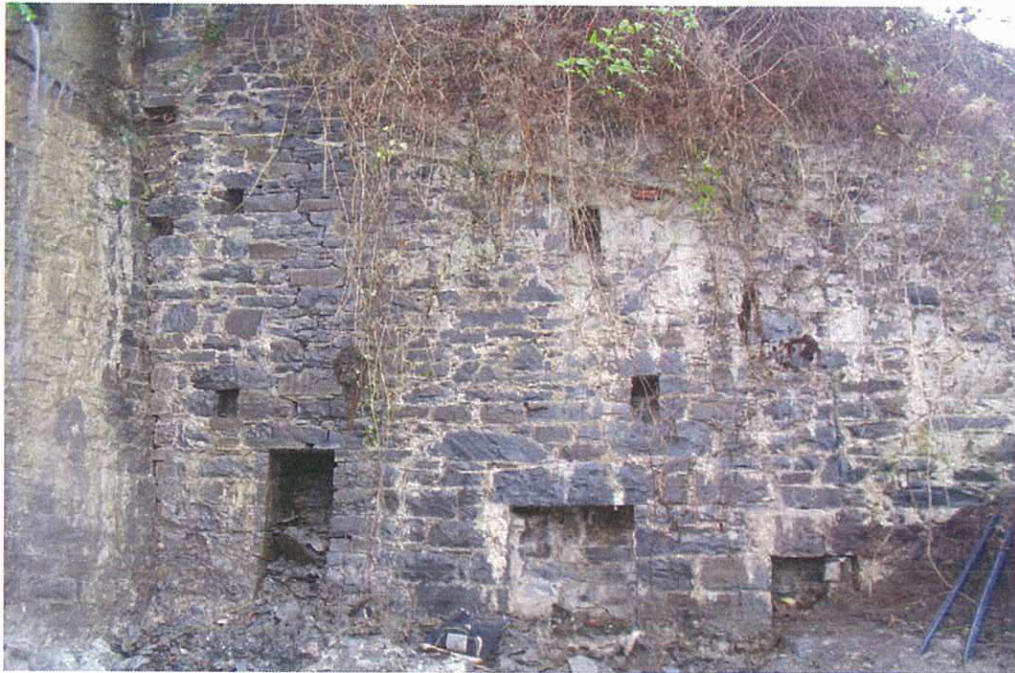
**Photo 3:** The north revetment wall of slipway showing the various features in the wall and the roof line scar.

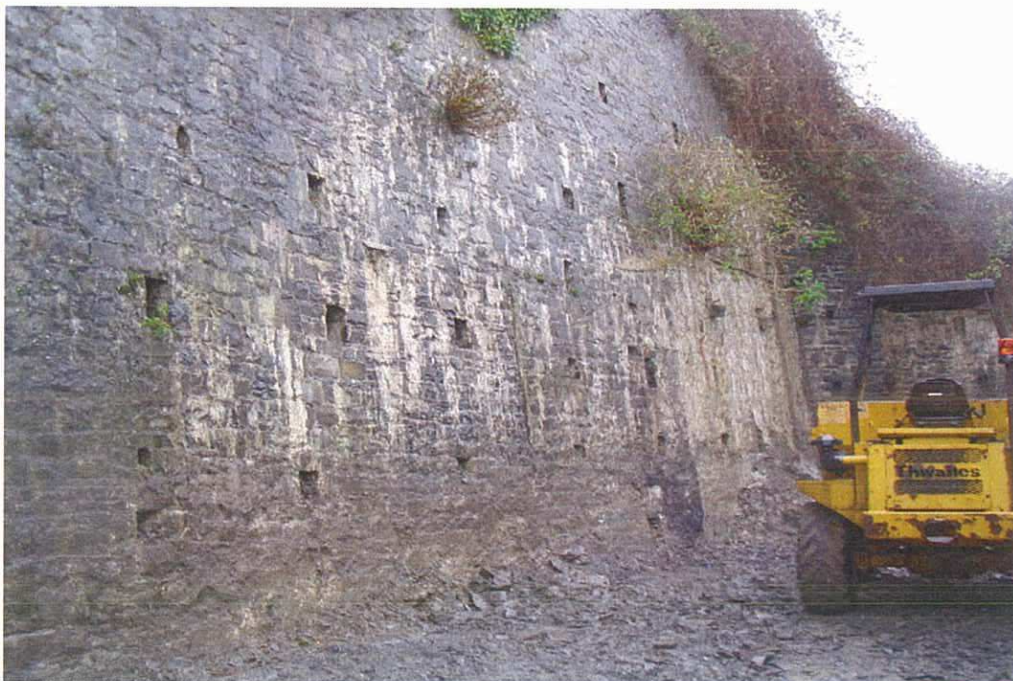
To the north of the warehouse the revetment wall increases in height to the north, and is again topped with a secondary wall of rougher build, largely obscured by ivy growth. Again there are numerous square and rectangular openings in the masonry (Photo 4), but these are more regularly spaced than those to the south, and some may be directly associated with the Patent Slipway structure, rather than simply being seep holes. In addition there are several mortar scars indicating the position of roof lines. While some of these scars may be the remnants of the fishermen's sheds, others are probably associated with a shed situated at the top end of the slipway, which is depicted in the early photographs (Plates 1 and 2), and which presumably housed the winching mechanism. The two corbels that project from the wall face are also presumably associated with this shed (Photo 5).

**Photo 4:** The west revetment wall of the slipway showing seep holes and other features north of the warehouse.

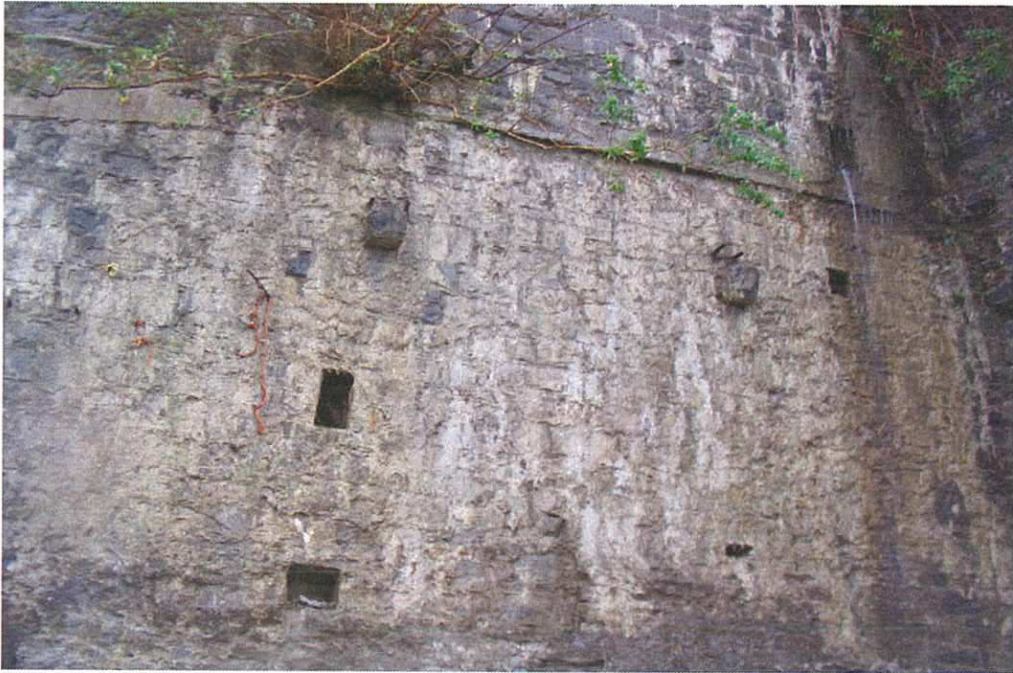
**Photo 5:** North end of the western revetment wall showing corbels, roof scar and other openings.

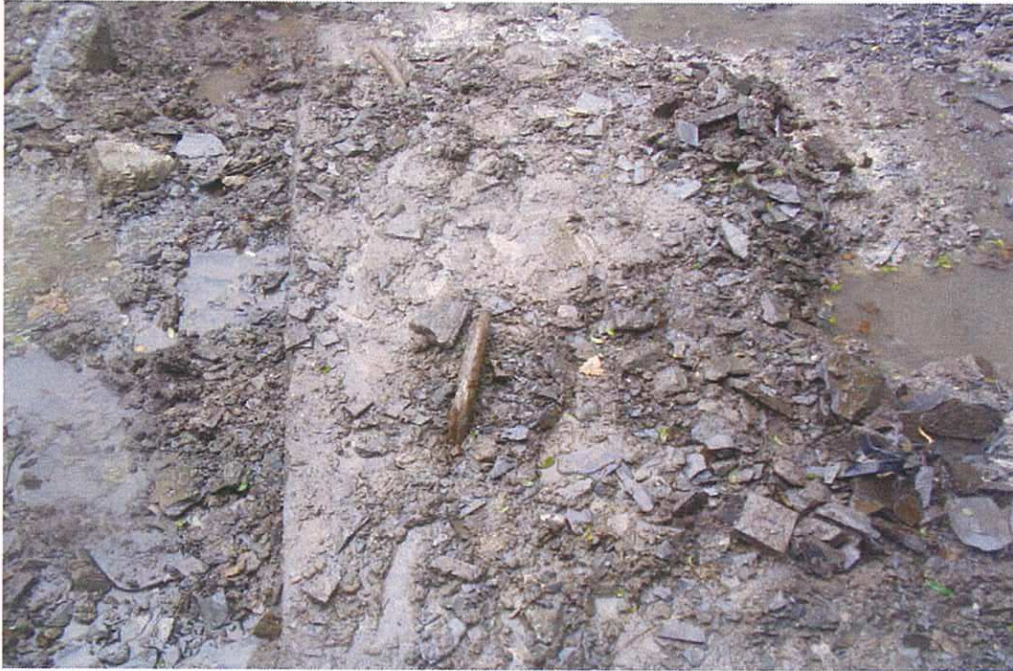
between them (Photos 6 and 7). The purpose of these features is uncertain but they are presumed to be the remains of solid foundations for the winch mechanism. The remains of iron holding bolts for anchoring the winch were noted (Photo 7). A subsequent visit to the site suggested that additional groundworks had been undertaken since the previously revealed features could not be identified. It is hoped that an opportunity for more detailed recording of this area will be possible when the retaining wall is rebuilt.

**Photo 7:** Probable holding bolt for rail or winch mechanism.

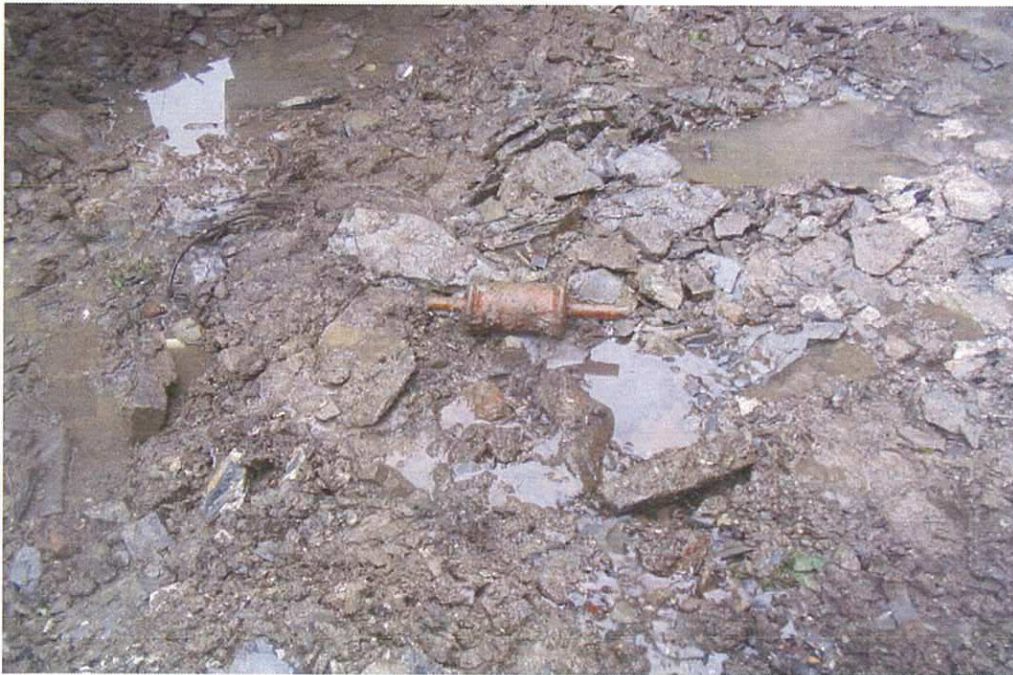
**Photo 8:** Iron fixture presumably associated with the winch mechanism.

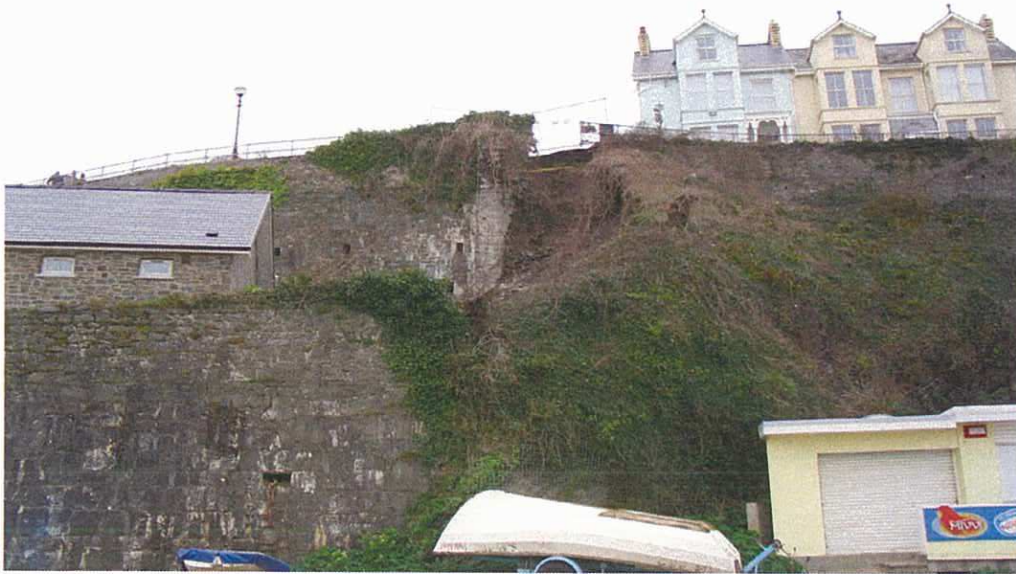
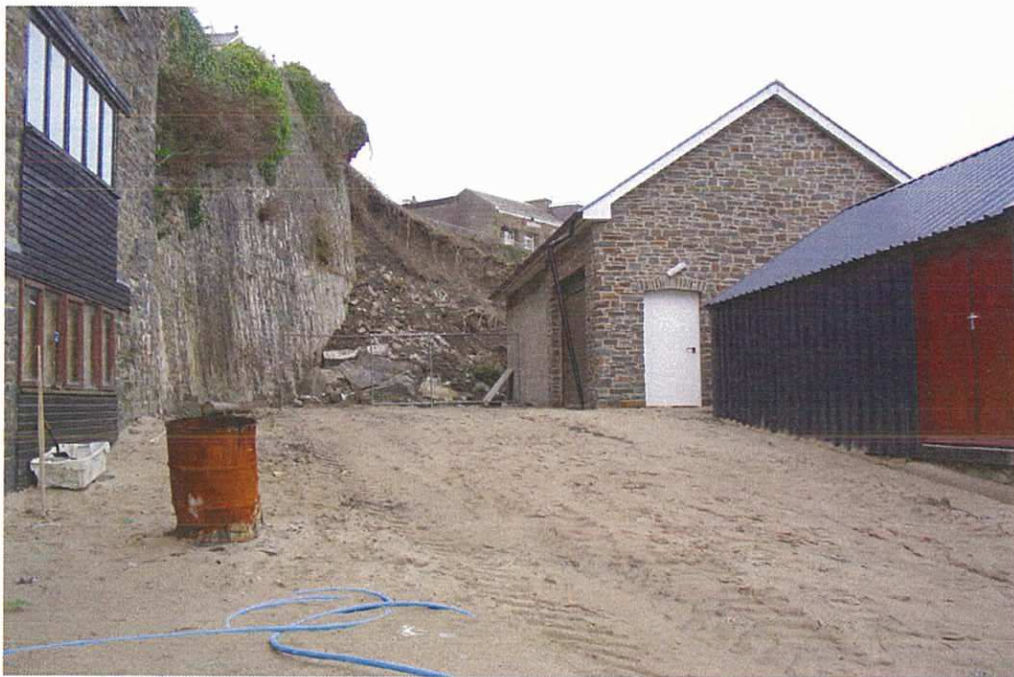
During the winter of 2003/4 the northern retaining wall of the slipway collapsed (Photos 9 and 10). This section of wall was not included in the slipway listing, but was nevertheless an integral part of the slipway complex. Within the fabric of the wall were several features relating to the function of the slipway and associated structures. At present it is unclear how much, if any, of this wall remains standing. Before the collapse, a sketch elevation of the wall was made. Horizontal distances were measured while vertical distances were estimated. It is hoped that this record, coupled with photographic evidence and detailed recording of any surviving remains of the wall will be sufficient to reconstruct the main features of the wall, were that required.

**Photo 9:** North end of the slipway after collapse of the north revetment wall.

**Photo 10:** North end of slipway after collapse of northern revetment

The collapse of the northern retaining wall has further compromised the integrity of the surviving parts of the slipway. It is strongly recommended that there is an adequate level of archaeological input into any future aspects of the development. It is further recommended that the clearing of the collapse debris and any further groundworks are carried out under direct archaeological supervision and that there is detailed recording of the surviving remains. This will hopefully enable sufficient information to be recovered from the remains to inform whatever action is taken to remedy the collapse of the revetment wall and the damage done to the setting of the surviving parts of the slipway.
