**THE PATENT SLIPWAY
NEW QUAY
CEREDIGION**

**WATCHING BRIEF JUNE 2004
INTERIM REPORT**

RHIF YR ADRODDIAD / REPORT NO. 2004/72
RHIF Y PROSIECT / PROJECT RECORD NO. 51399

**THE PATENT SLIPWAY, NEW QUAY,
CEREDIGION**

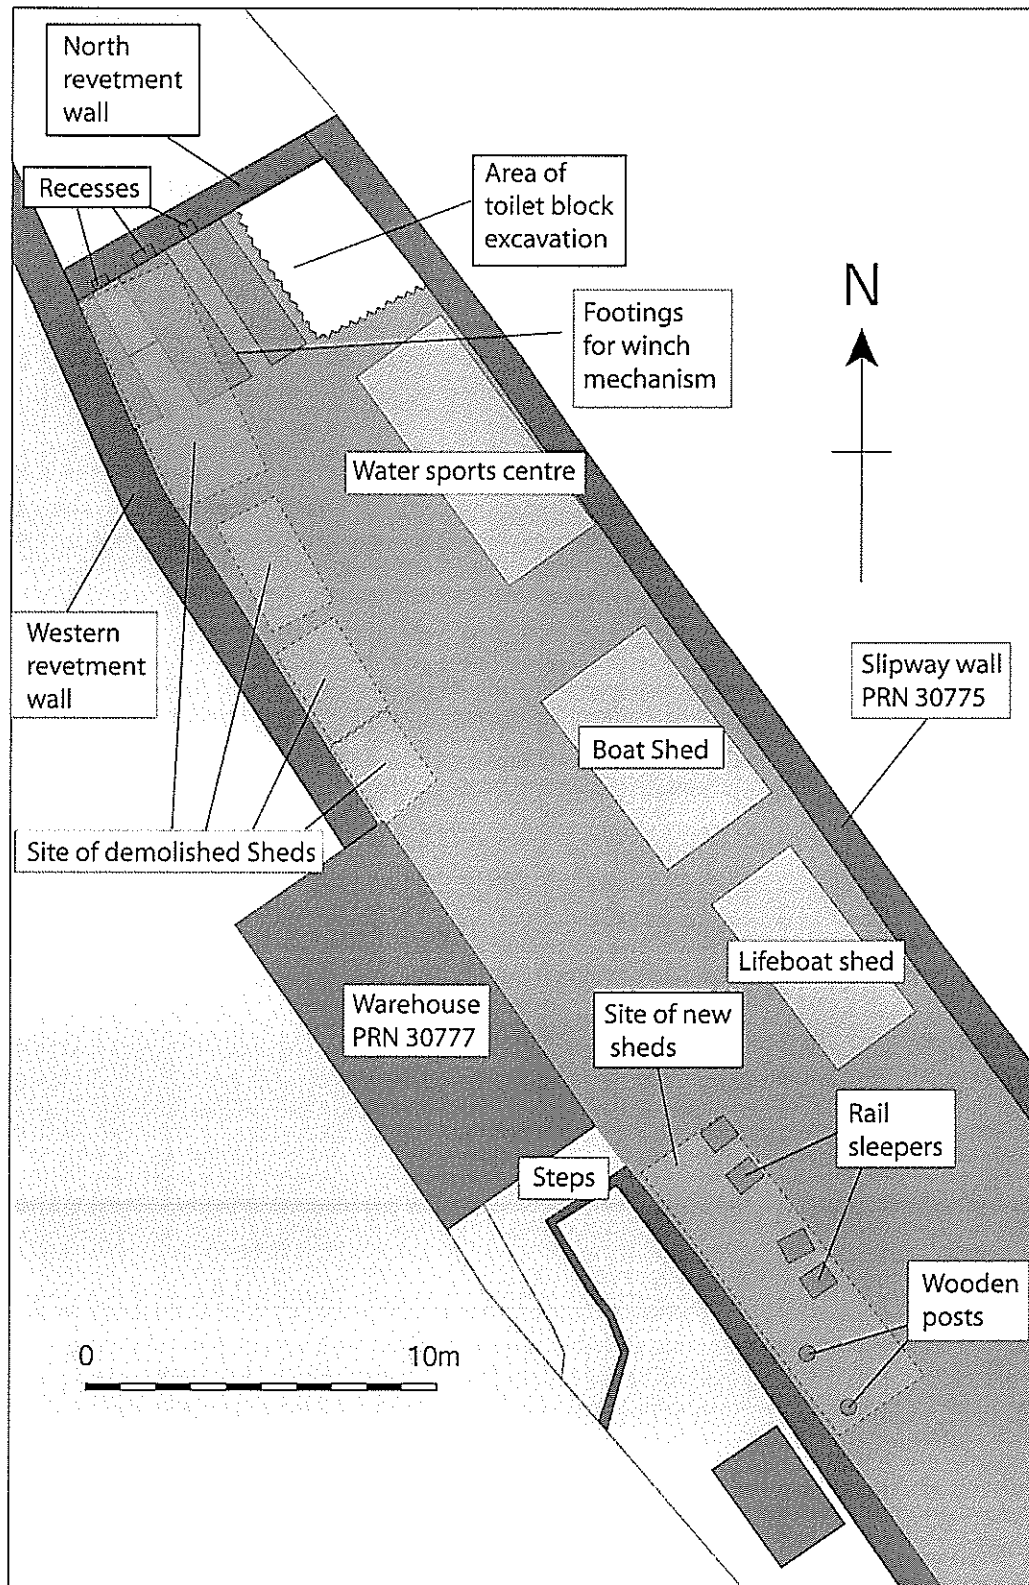
The footings for the winch mechanism appear to have been removed during the works immediately prior to the collapse of the north wall. The excavation for the toilet block (figure 1) cutting deep into the bedrock (photo 4) will have probably destroyed all archaeological remains in that area. The wall collapse may have been due to, or caused, shifting of the bedrock shelf onto which the wall was constructed. The whole of the north wall had either collapsed or shifted. The only possible *in situ* remains is the stub of the north wall bonded into the east inner side of the east slipway wall.

Figure 1: Plan of New Quay slipway showing locations of features associated with the Patent Slipway revealed during the recent groundworks. NB. Locations and dimensions not exact (after Schlee 2004).

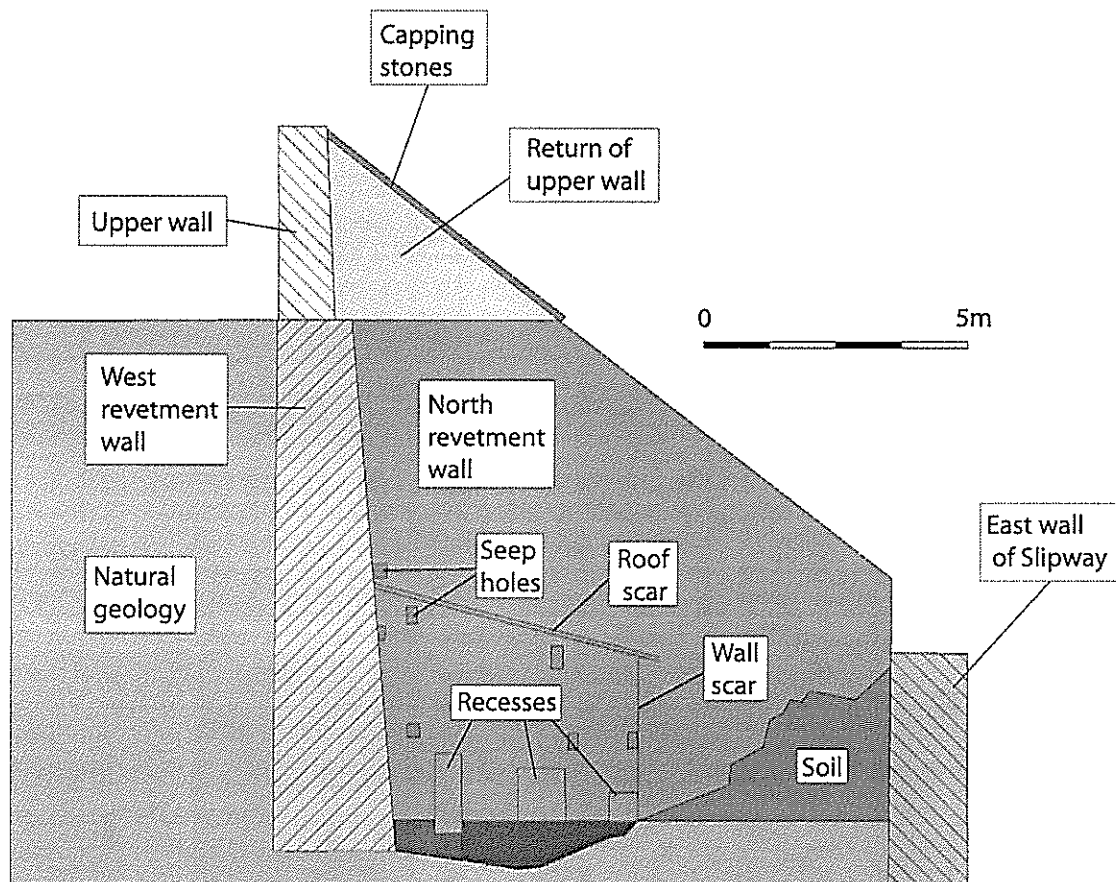
Figure 2: Elevation of the northern revetment wall. NB. Horizontal distances are measured, but vertical distances are estimated. The width of walls in section are not known (from Schlee 2004)

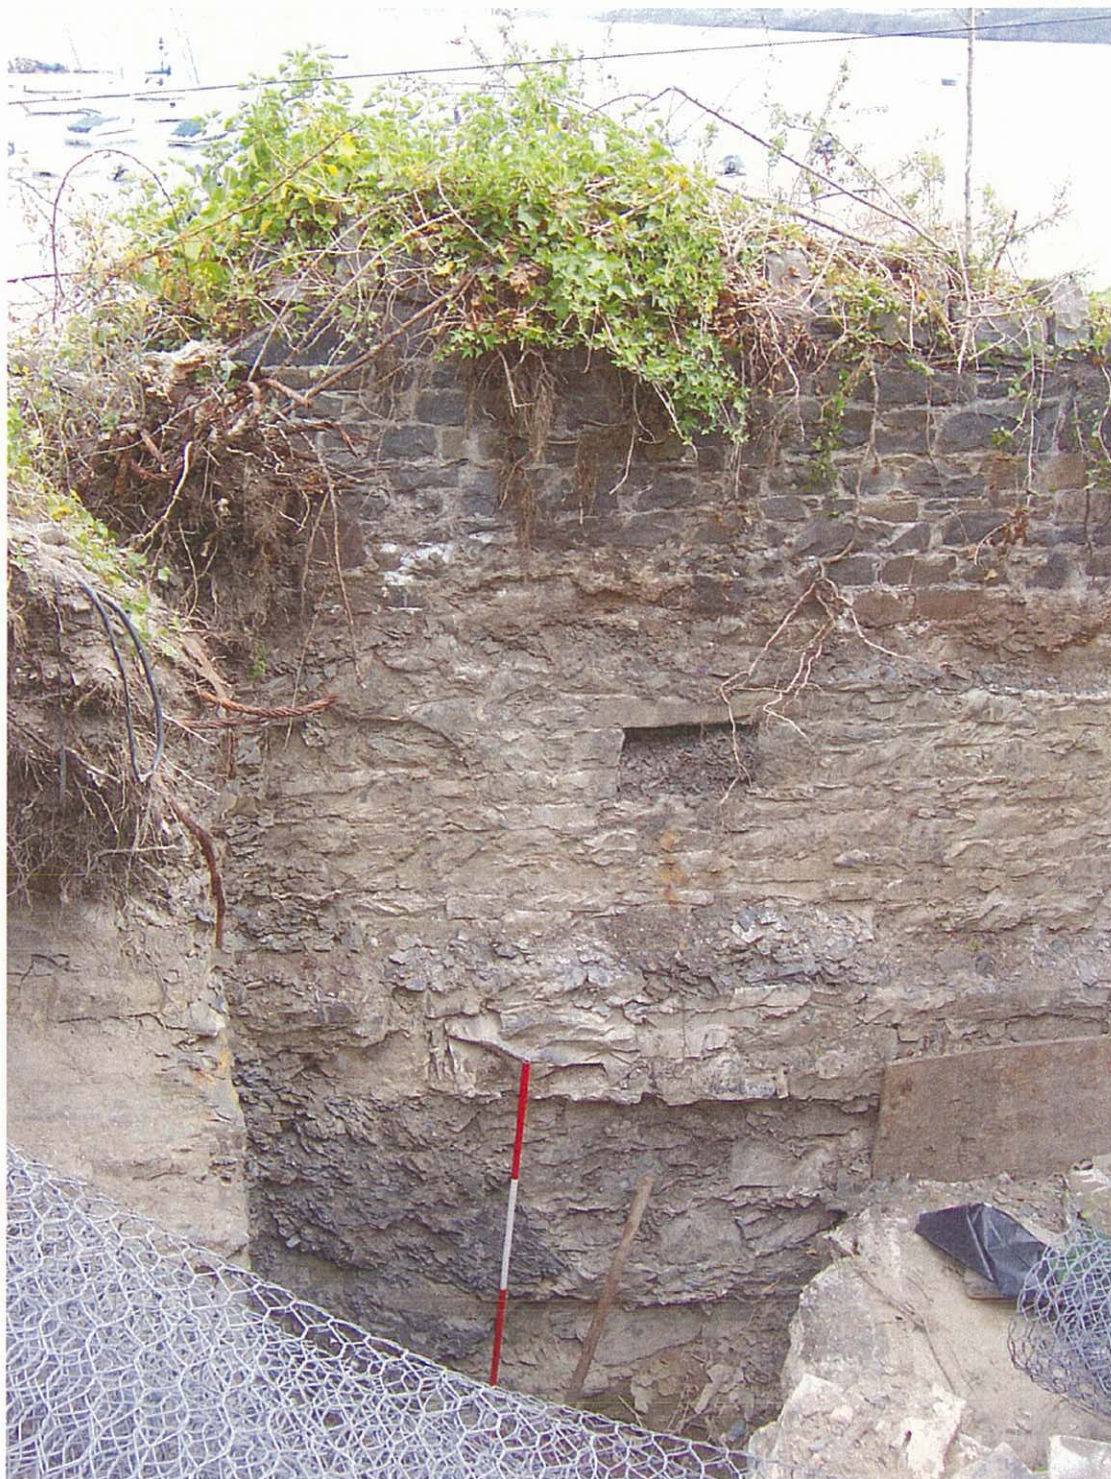
Photo 1: Part of hole excavated for toilet block. View NE. Scale 1.5m. The north wall was to the left, the east wall PRN 30775 is behind the scale.

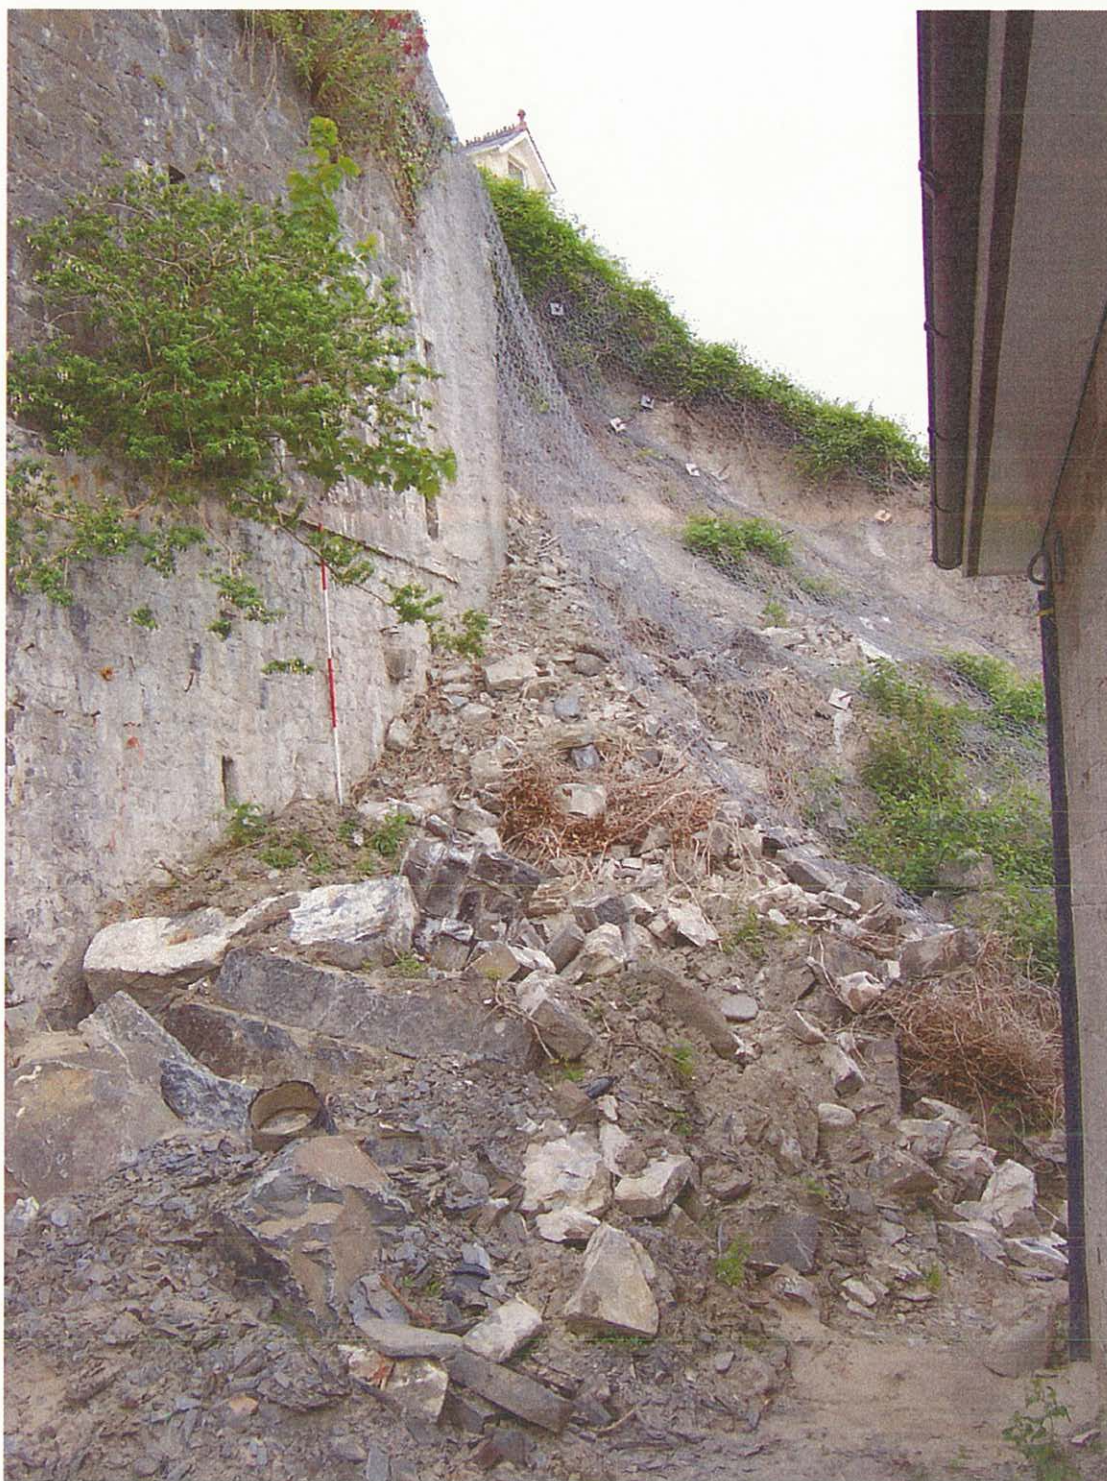
The north wall collapsed overnight during the winter of 2003/4. This occurred during work that had entailed digging into the bedrock, with a large jackhammer on a mechanical digger, immediately in front of the wall. A deep section, over 2m below the surface of the slipway, had been excavated in front of the eastern end of the north wall (photo 1) for a proposed toilet block (figure 1). No archaeological monitoring or recording was undertaken during these groundworks. The upper part of the collapse had been consolidated by pinning and covering in wire mesh (photos 2-3).

Photo 2: Collapse. View NE. Scale 2m

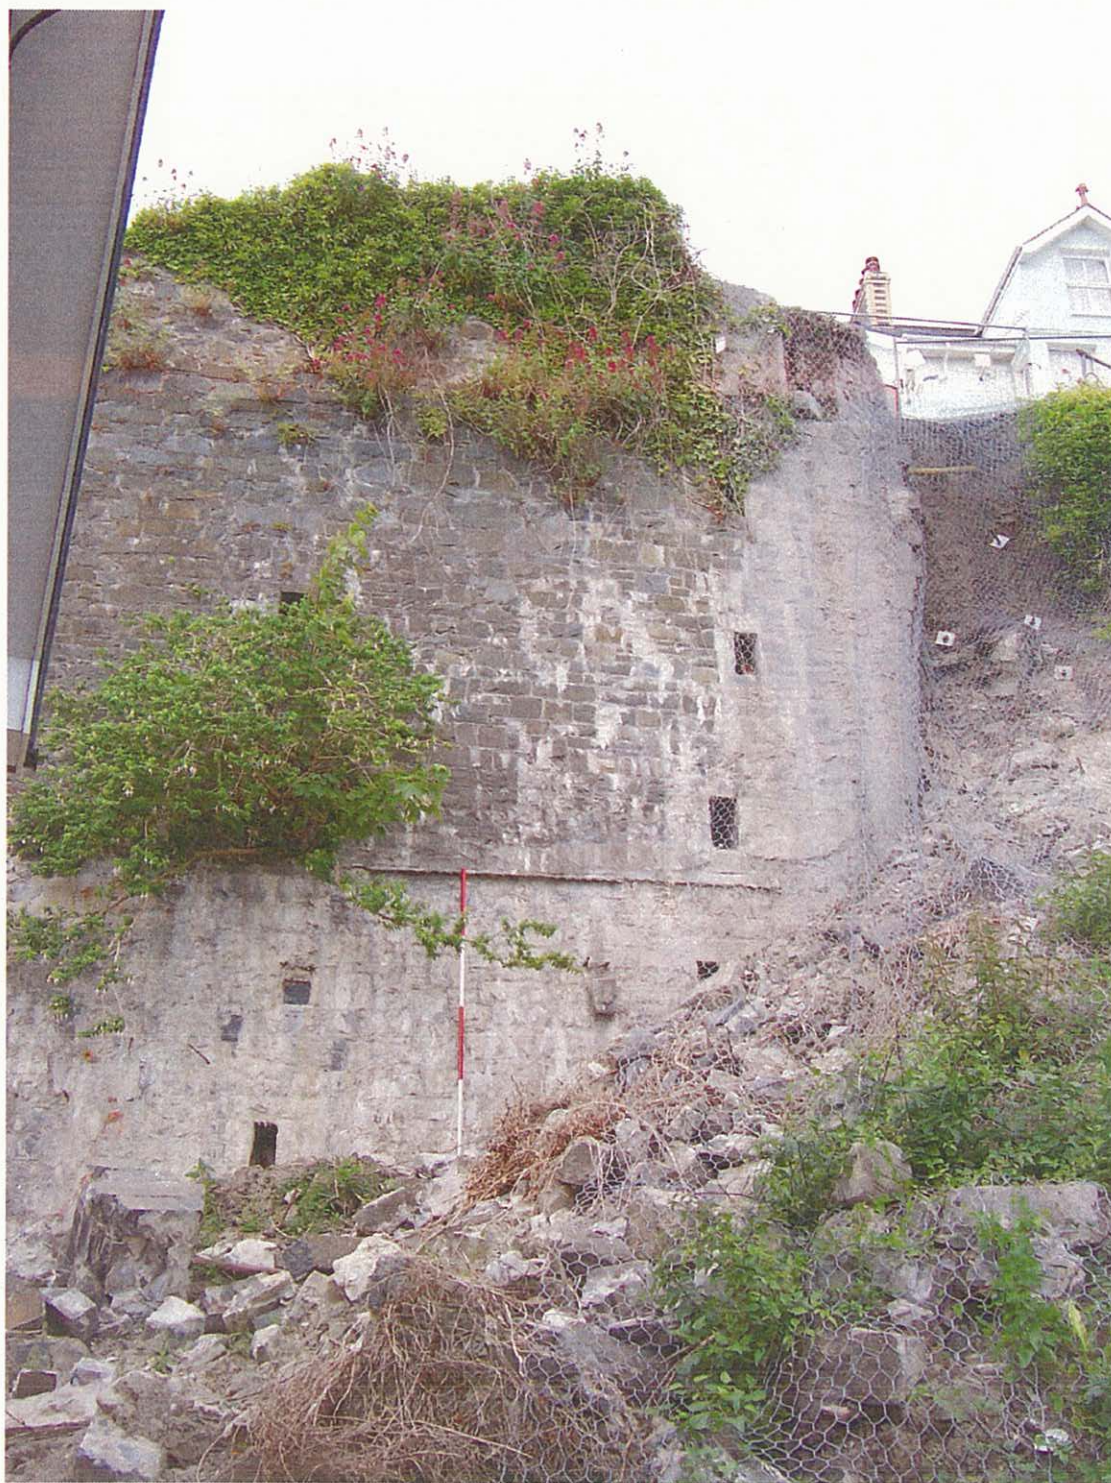
Photo 3: Collapse. View W. Scale 2m

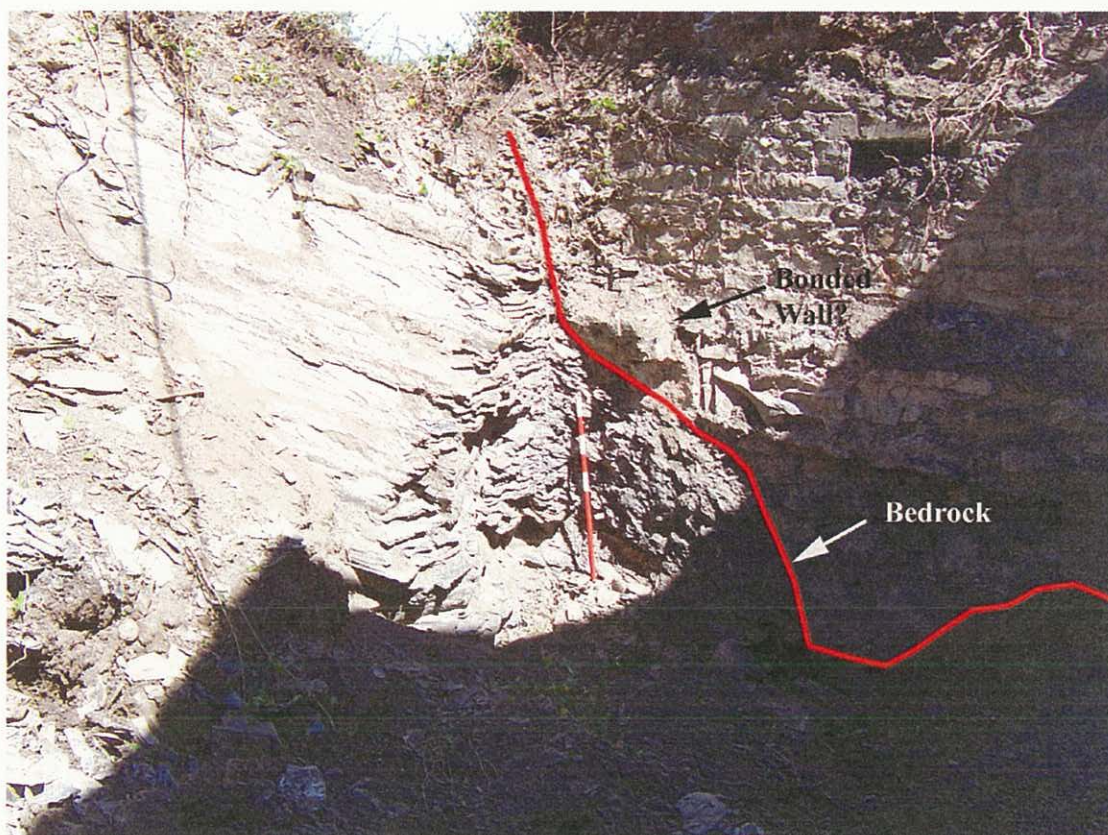
The wall appeared to have been constructed by cutting into the base of the shaley bedrock and then material, including artefacts of late post-medieval to modern date, being deposited behind the wall. This wall appears to have been bonded or keyed, partly at least, with the eastern wall (photo 4), although it was only butted against the tall retaining wall to the west.

Photo 4: In hole for toilet block, stub of north wall bonded to eastern? View N. Scale 1m

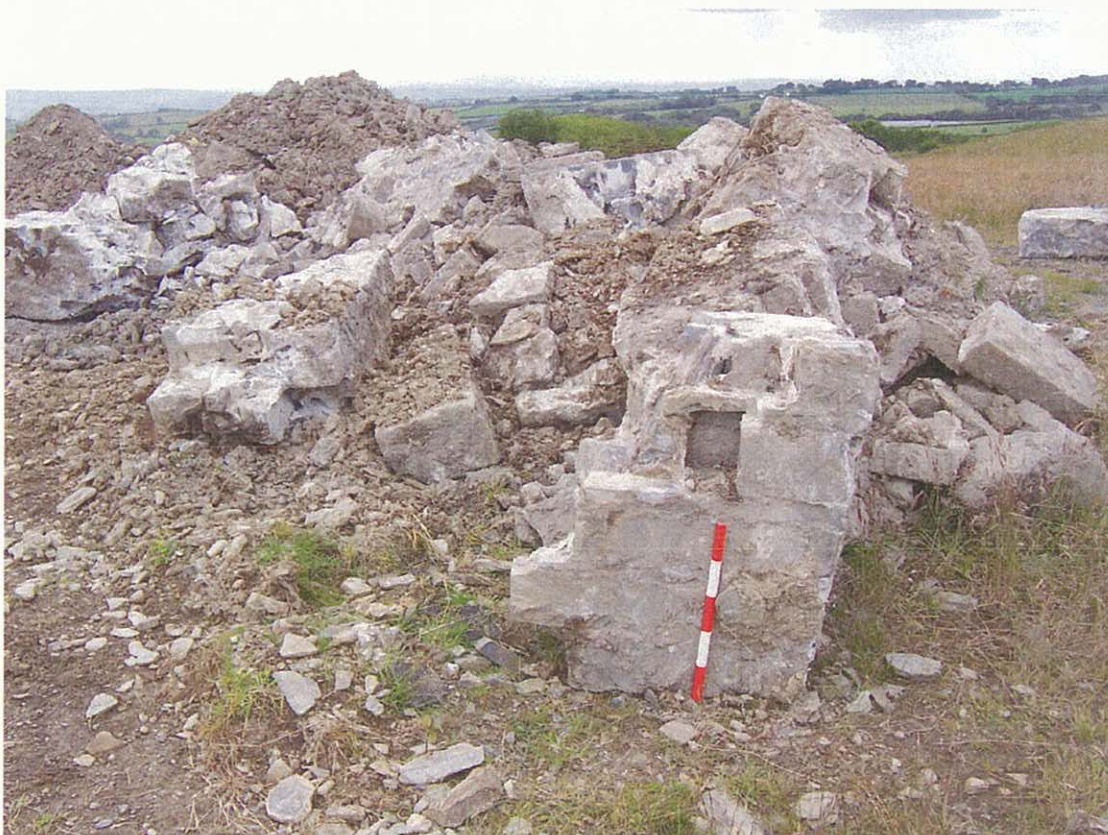
Photo 5: Masonry from collapse, original socket for timber. Scale 0.5m

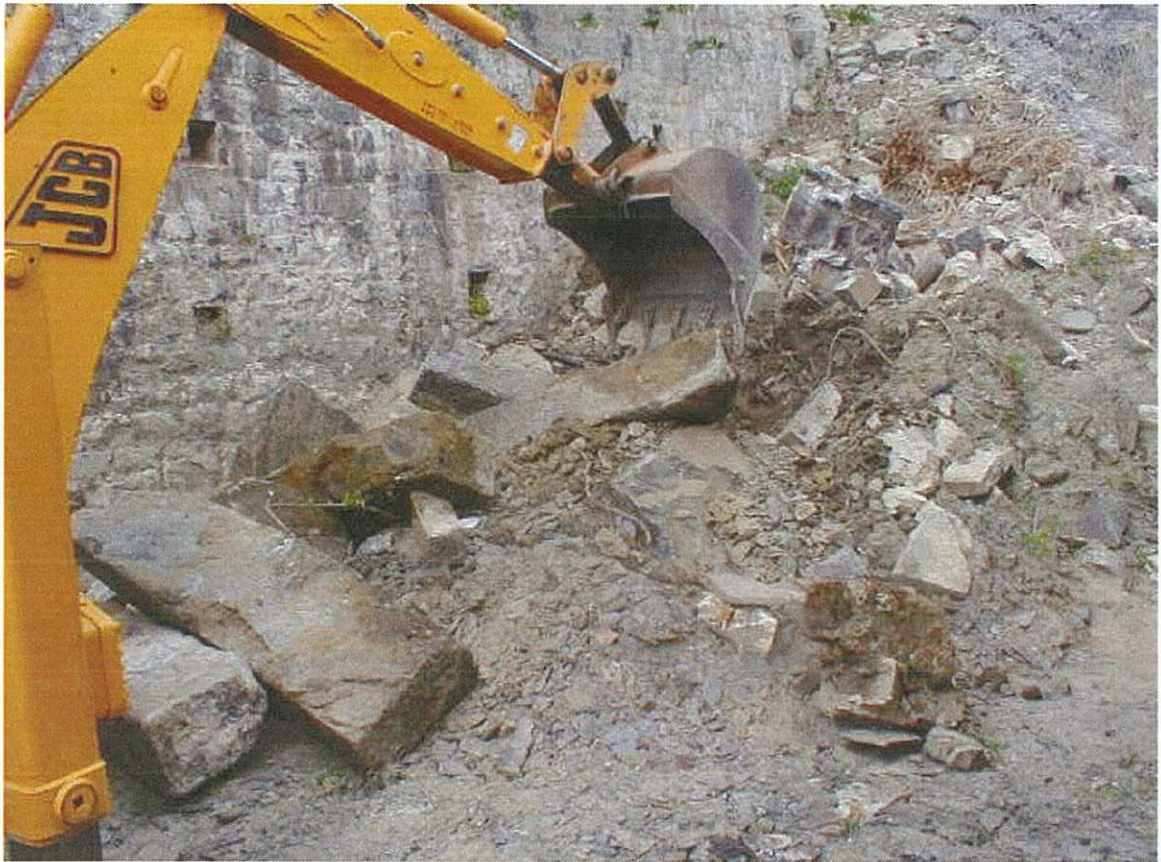
Photo 6: Massive stones being moved. © Andrew Hale

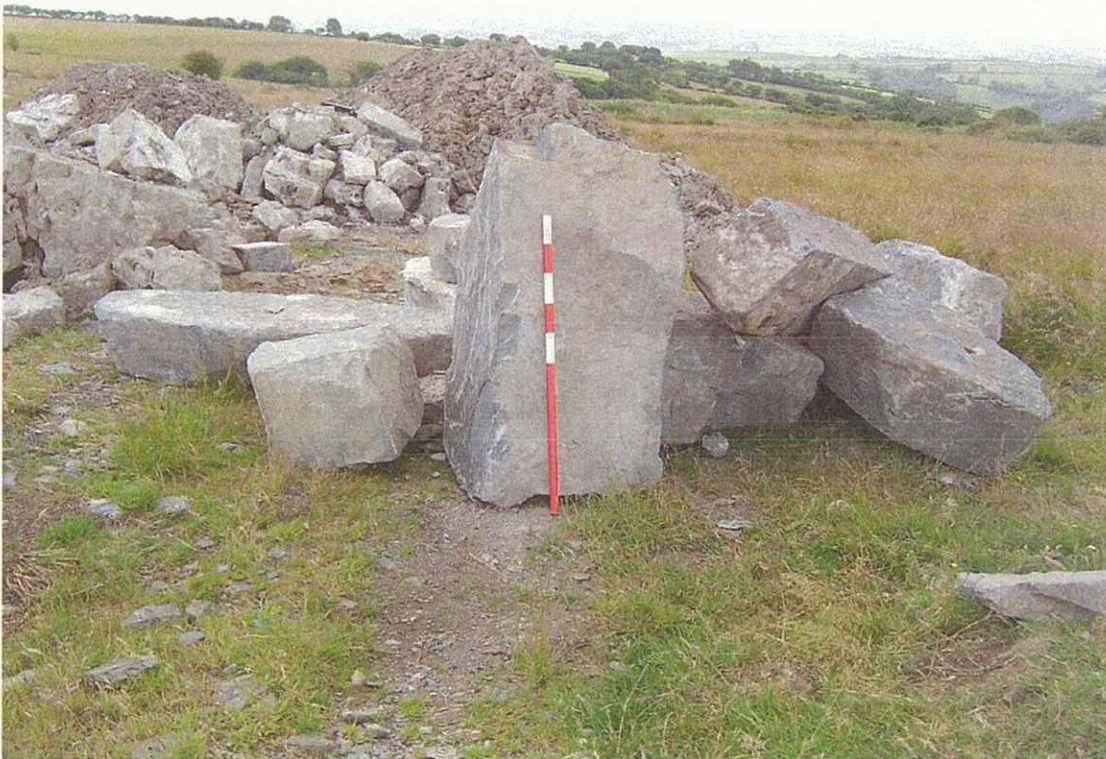
Photo 7: Massive stones now at depot. Scale 1m

The massive stones were separated from the collapsed material, as were the masonry lumps. These have been deposited at the local council depot so that there is the option of using most of the stonework in the rebuild.

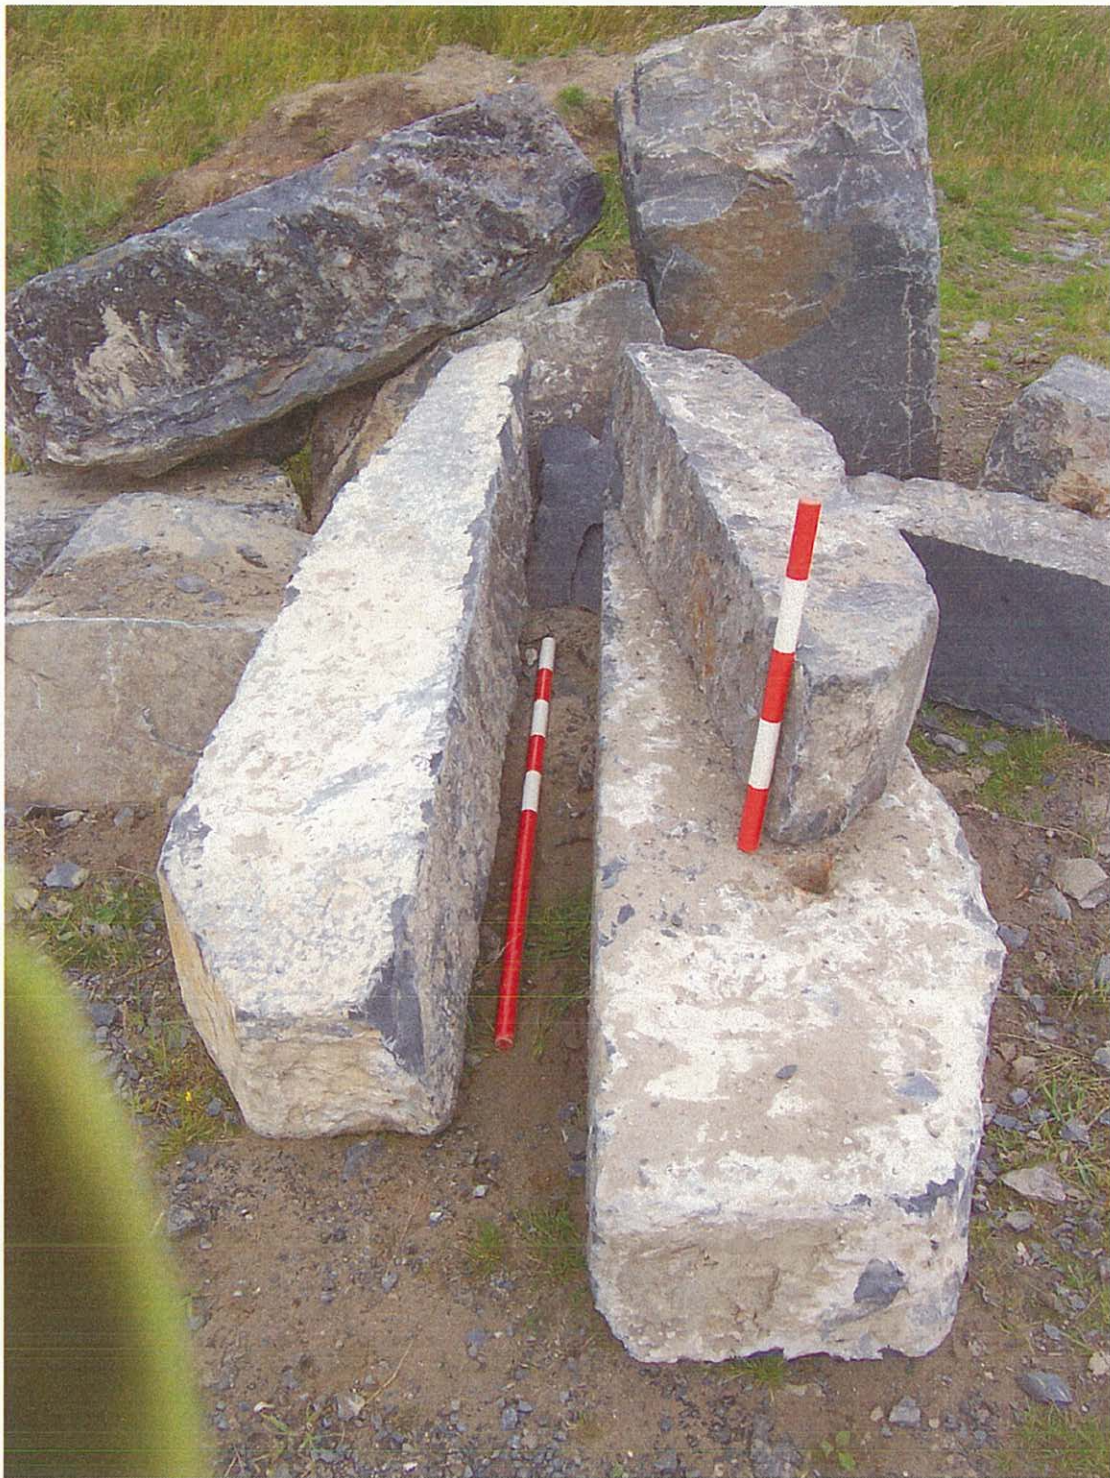
Photo 8: Massive stones now at depot

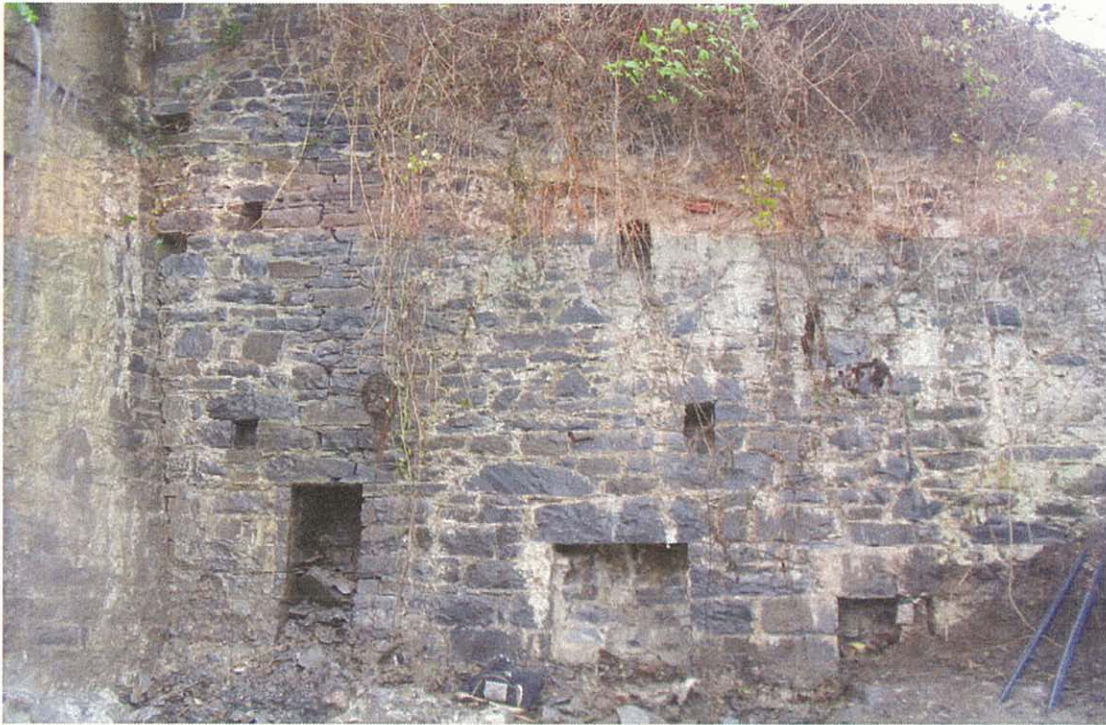
Photo 9: The north revetment wall of slipway showing the various features in the wall and the roof line scar. View NW

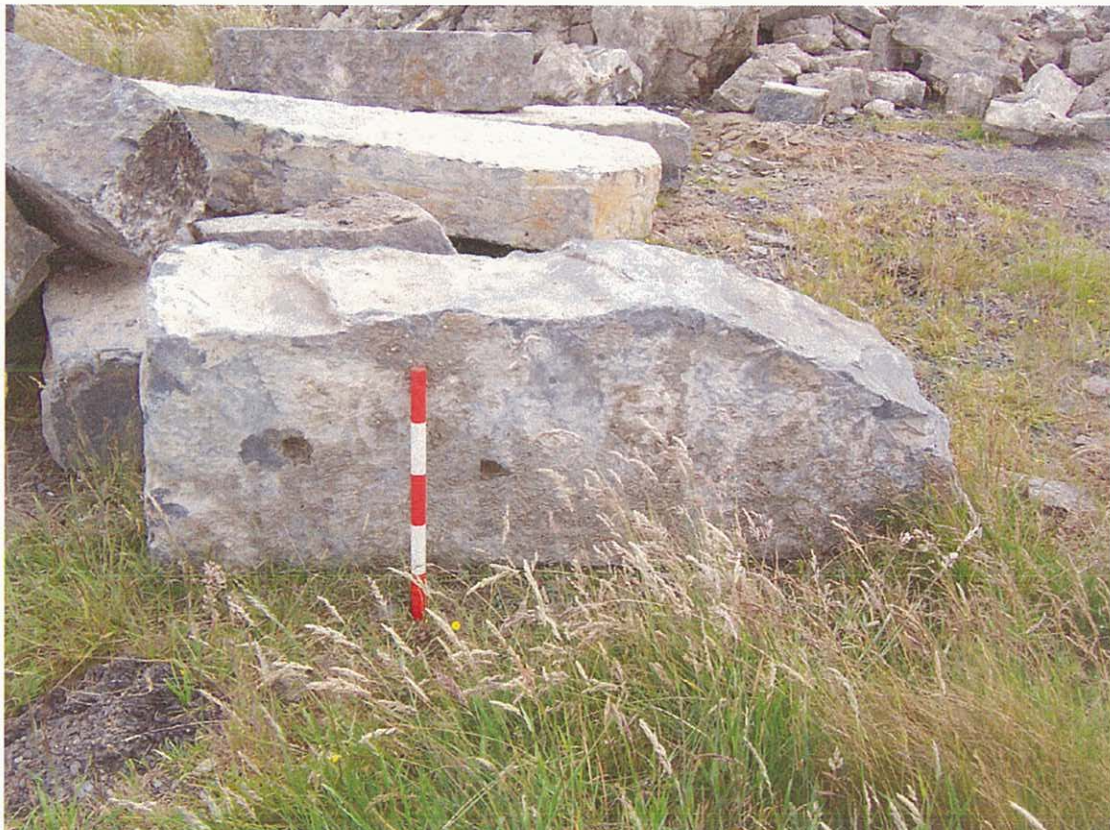
The masonry was all cement- and lime-mortared, with significant flecks of lime. Various inspections of the mortared material were made and it was all very consistent, indicating that this northern wall was all of one build. At least two holes for the ends of timber were seen in the collapsed masonry. These also appeared to be part of the primary construction (photo 5). These holes may have been those for the roof supports for the winching house but their original locations are uncertain due to the collapse. The wall was between 620mm to 680mm wide with the probability that the slightly thinner walling is from the upper part. A number of massive stones were separated from the collapsed masonry (photos 6, 7 and 8). Three of these stones will have come from the lintels of the three recesses near the base of the wall (photo 9 and figure 2), but it is obvious that there were a number of other massive stones in the wall face. Several of these massive stones had c. 50mm diameter holes bored through them. One stone had two holes, but only one of which (on the left of photo 10) was bored through.

Photo 10: Massive stone with two bored holes, only the left goes through stone. Stones now at depot
