RHIF YR ADRODDIAD / REPORT NO. 2005/2  
RHIF Y PROSIECT / PROJECT RECORD NO. 53031

## BUILDING RECORDING AT FLIMSTON FARMHOUSE CASTLEMARTIN RANGE, PEMBROKESHIRE DECEMBER 2004

Duncan Schlee

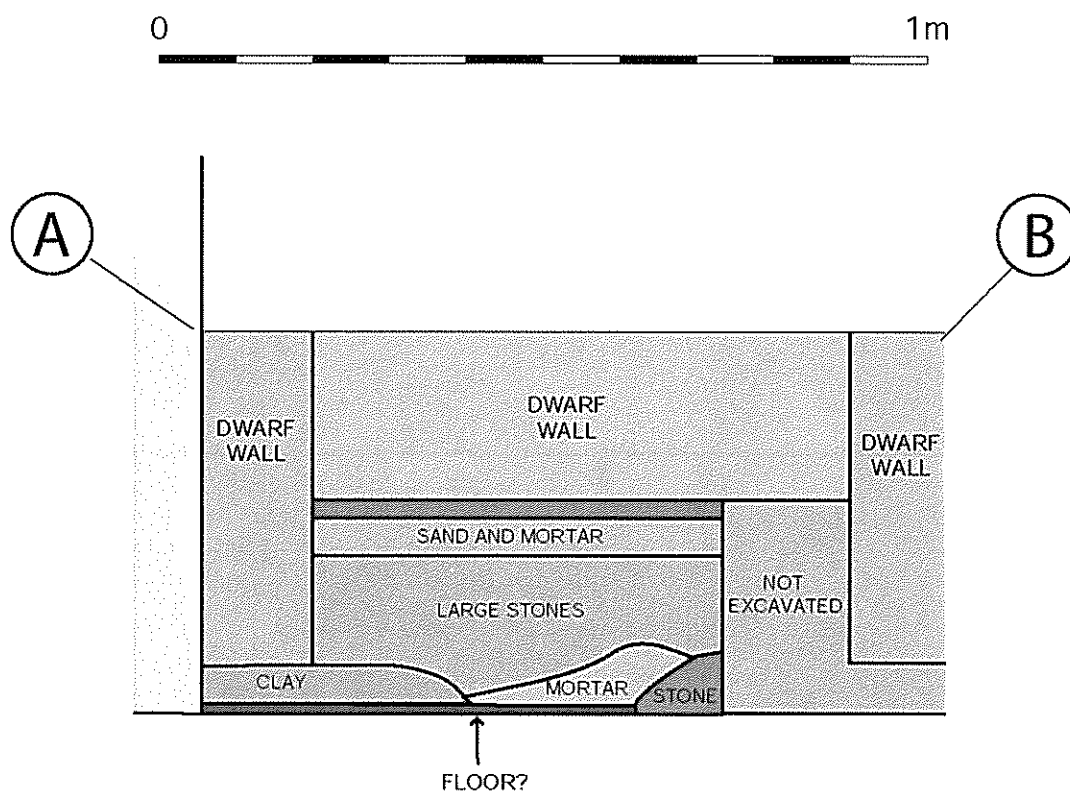
**Figure 2:** Schematic section drawing showing excavated deposits

### 3.4 Footings excavation (figure 2)

The excavation of a small trench 0.50m long, 0.40m wide and 0.50m deep, for a concrete footing for a prop against the north wall of the building, revealed a sequence of deposits (figure 2). These are difficult to interpret due to the restricted size of the hole and its location (figure 1). Dwarf walls, capped with slate and built against the earlier masonry to support later plank floors, made it difficult to ascertain the stratigraphic relationships between the deposits and the masonry. The most significant deposit was at the bottom of the excavation where a clay layer containing plentiful charcoal fragments was encountered (see photo 6). This deposit may represent the floor level of the original building, although further excavation would be required to confirm this.

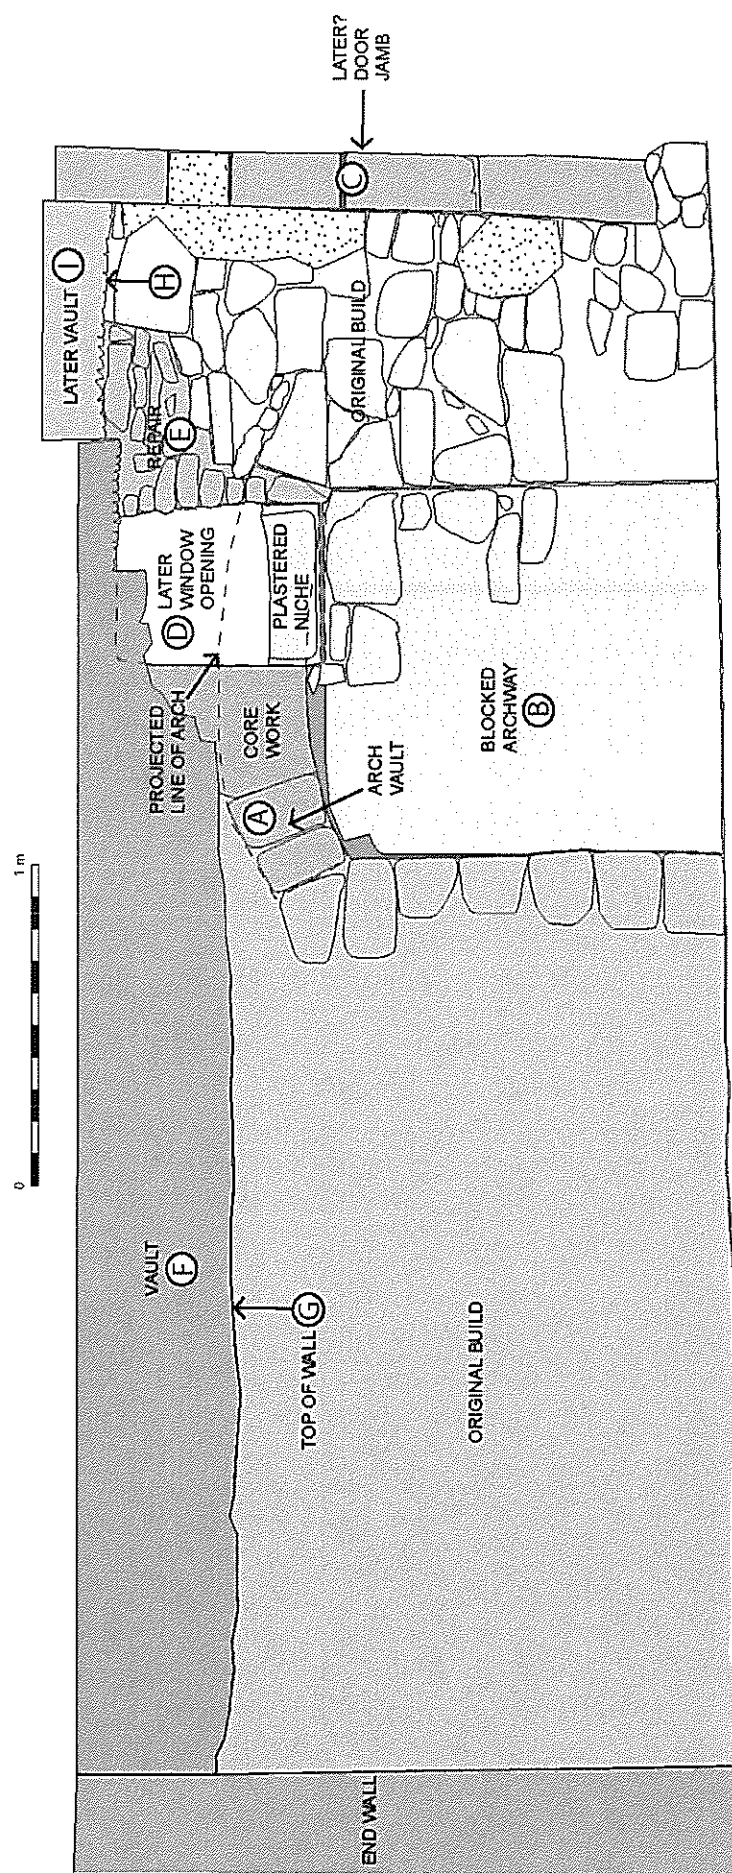
**Figure 3:** West facing internal elevation of undercroft wall

#### 3.1 The internal elevation (figure 3)

The wall is constructed from random coursed limestone rubble. Much of the wall face is covered in mortar and multiple layers of limewash which may to some extent mask additional features in the fabric of the wall. The main feature is a blocked up (A) arched opening (B) (see photo 1). This archway runs right through the wall, suggesting it may have been a doorway associated with an earlier (lower) floor level. It may have been blocked when the floor level was raised. The existing doorway (C) may also have been constructed at this time.

At some time after, a niche or window light (D) 0.50m wide, 0.65m high, was knocked through the wall, removing some of the arch stones in the process (see photo 2). The springing points of the arch are however, still discernable. The creation of this opening also necessitated the removal of some of the stone vaulting in the vicinity. The sides of the opening were constructed at this time using smaller stones (E).

For the majority of its length, the vault (F) is sprung from the line (G) indicated to the left of the blocked arch. To the right of (A) however, the vault (I) is sprung from a higher point (H) and is of noticeably different construction. This may suggest that this part of the vault (and the wall) was rebuilt at a higher level when doorway (C) was constructed, for ease of access.

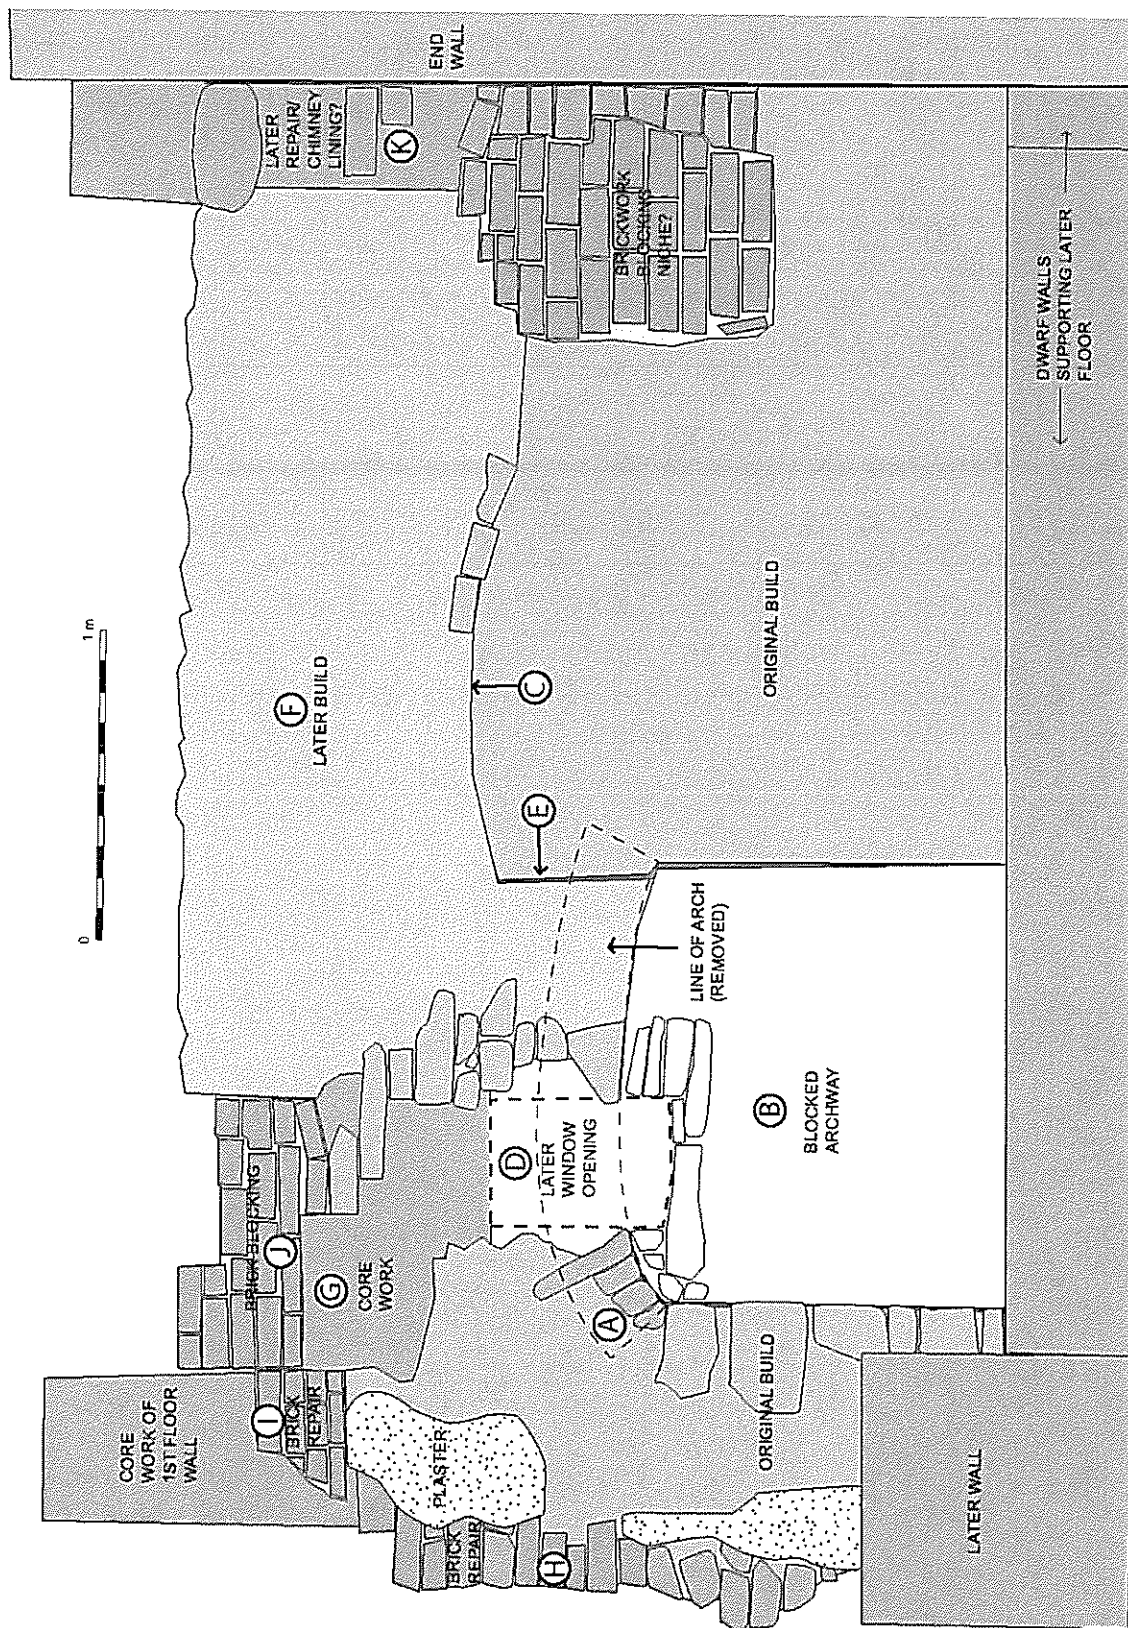
**Figure 4:** East facing external elevation of undercroft wall

#### 3.2 The external elevation (figure 4)

This exterior elevation is more complex than the interior. The arched opening (A) and its blocking (B) are visible as vertical joints. The springers for the arch are still discernable but the majority of the arch stones have been lost in subsequent rebuilding events. The masonry on either side of the arch appears to be original as high as point (C) on the right hand side. Traces of limewash adhere to the wall face. The extent of original masonry to the left is less certain due to subsequent alterations.

The masonry above (C) is of a different build (F), with no traces of limewash. This build also appears to have removed the majority of arch (A). The straight joint (E) above the right hand side of the arched opening is of uncertain origin and may or may not be significant.

The creation of window opening (D) has further destroyed evidence of arch (A) and subsequent collapse has caused core work of the wall to be revealed (G). To the left of the arch, the wall appears to have been truncated and repaired at least once (H and I) with brick and stone. Brickwork (J) may block a doorway or window (see photo 5).

At the right hand end, masonry (K) is of different build and materials to (C) and (F). It also seems to be associated with brickwork patch (L). Traces of plaster around the edge of (L) suggest the bricks are blocking a niche or opening (of which there is no trace on the other side of the wall). It is thought that this may be a blocked up bread oven and that (K) is a chimney lining, the rest of the fireplace and chimney having been demolished in subsequent building phases (see photo 4).

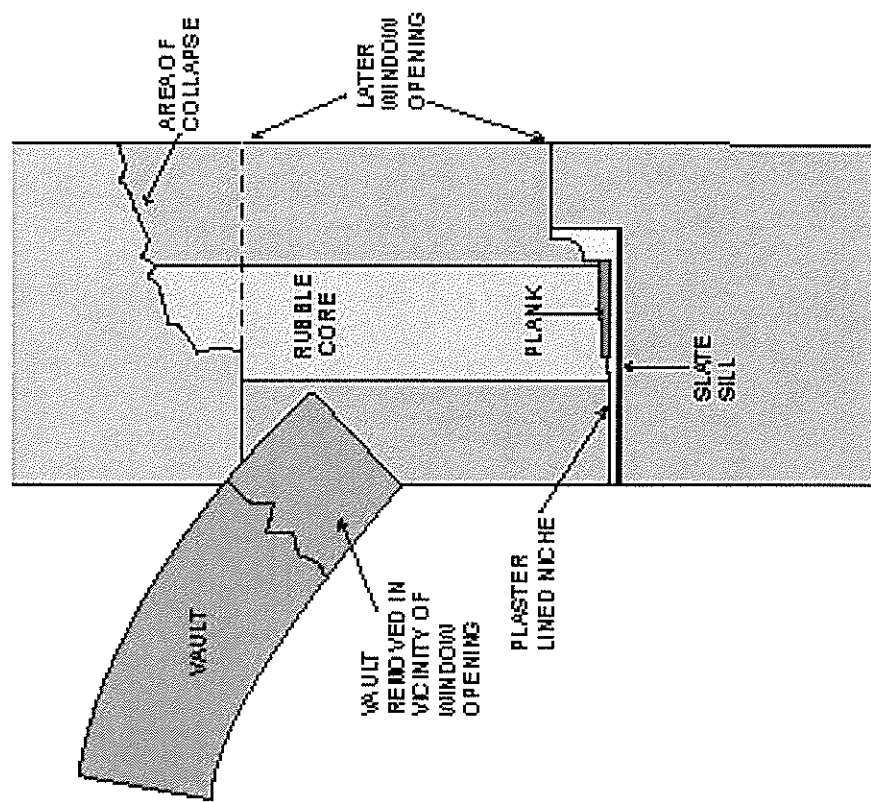
**Figure 5:** Schematic cross section through wall  
 In location of 'window' feature (facing north)

### 3.3 The window opening (figures 5 and 6)

The rectangular opening is an interesting modification, but its original character is uncertain. On the whole it is thought most likely to have been a window light. Its construction required the removal of parts of the arch, blocking and the vault. This has been the initial cause of subsequent collapse of the masonry surrounding the opening. The original feature may however, have been less of a botch job than it appears now. The base of the opening is lined with a piece of slate, but little if any of the other facets survive undamaged. Above the slate are the remains of a layer of plaster that originally may have lined the whole window opening (see photo 3). There is an impression in the surface of the plaster that appears to have held a plank of wood that was found in the opening during cleaning. This butts up against a sill that may have supported a window frame.

It is recommended that the currently damaged probable window opening is reconstructed as a window from the surviving structural evidence. It is important to ensure that the sequence of repairs alterations and additions that have been made to the surviving masonry over the years remains 'readable' after the current repairs have been made. It is recommended that no additional reconstruction or re-pointing of masonry is undertaken until full archaeological building recording and phasing of the structure has been undertaken. Some excavation might be useful in order to clarify details of construction that are now masked or buried.

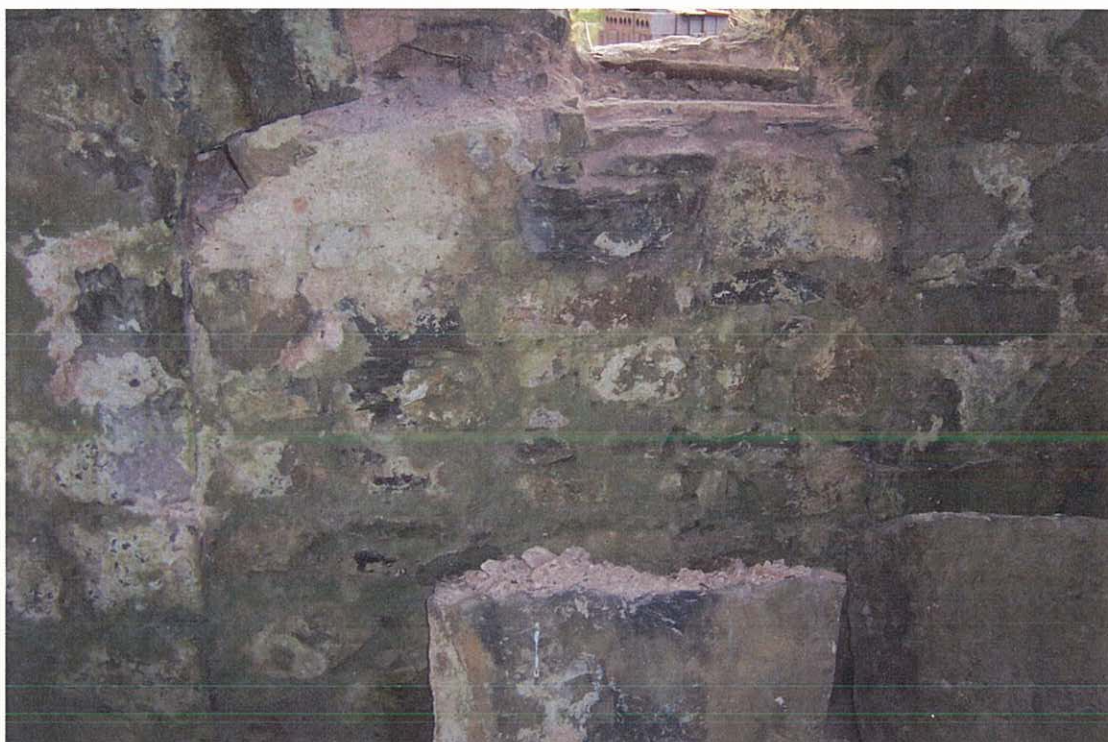
**Photo 1:** Blocked archway in interior face of undercroft wall

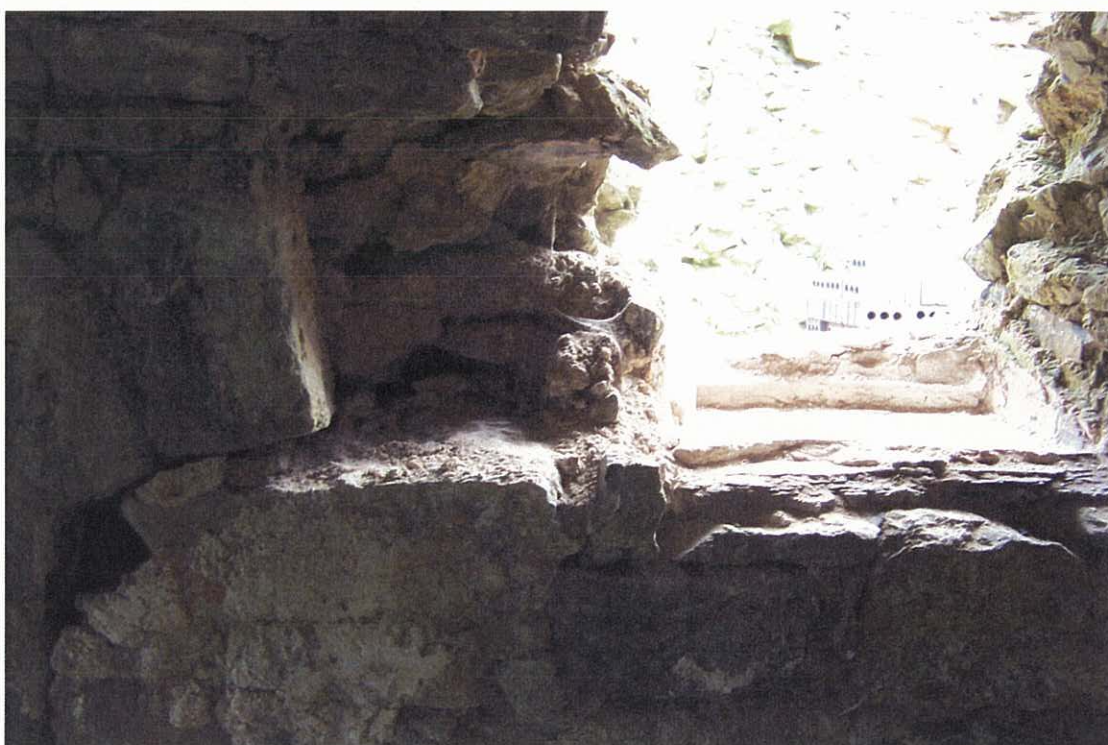
**Photo 2:** Photo showing 'window' opening cutting through arch (looking east)

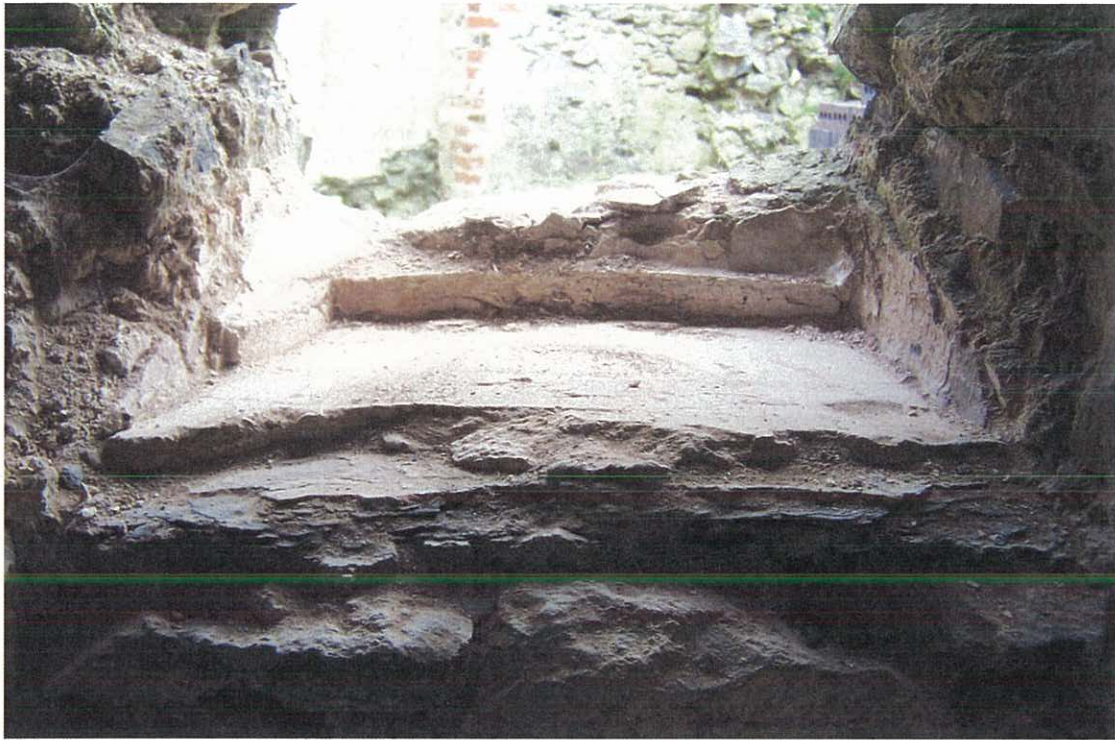
**Photo 3:** Detail showing plaster lining of 'window' (looking east)

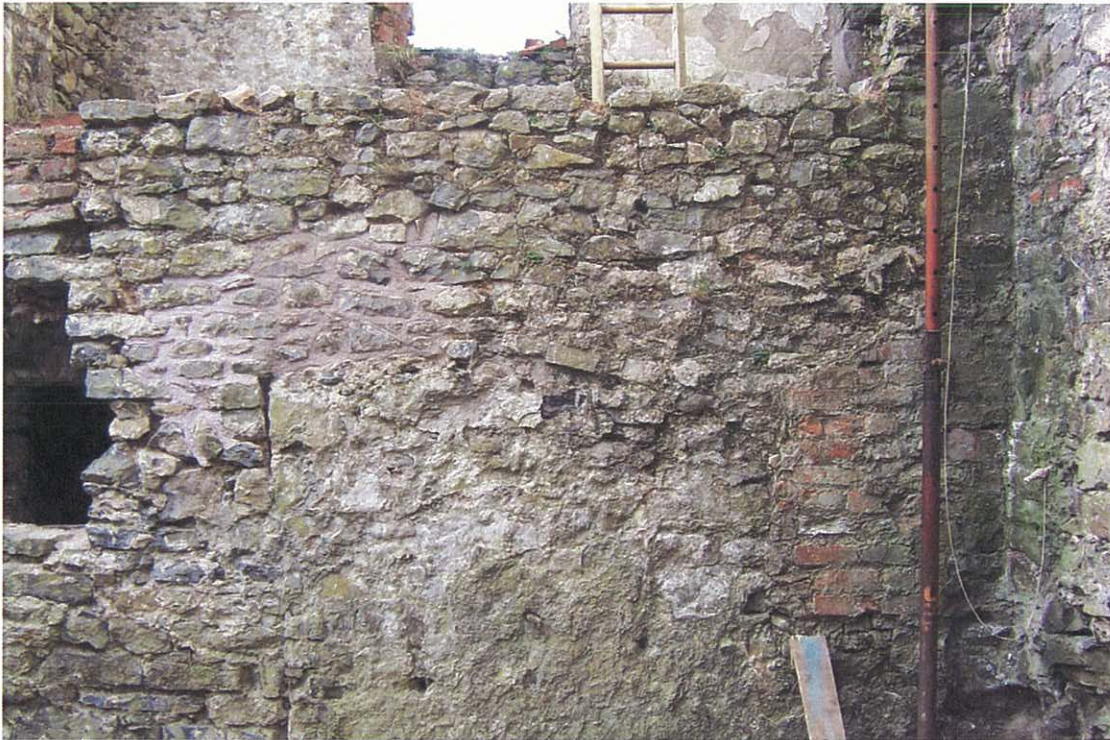
**Photo 4:** Shot of east facing elevation of undercroft wall showing various masonry builds

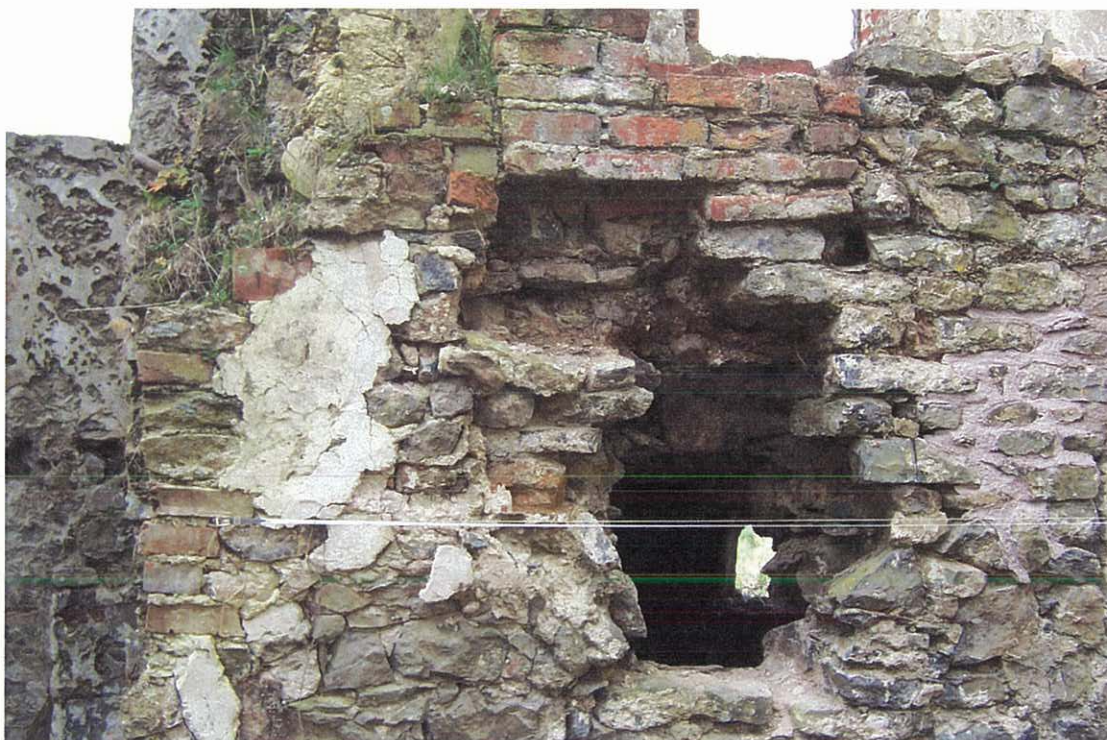
**Photo 5:** Detail of masonry in exterior face of undercroft wall in the vicinity of the 'window' opening

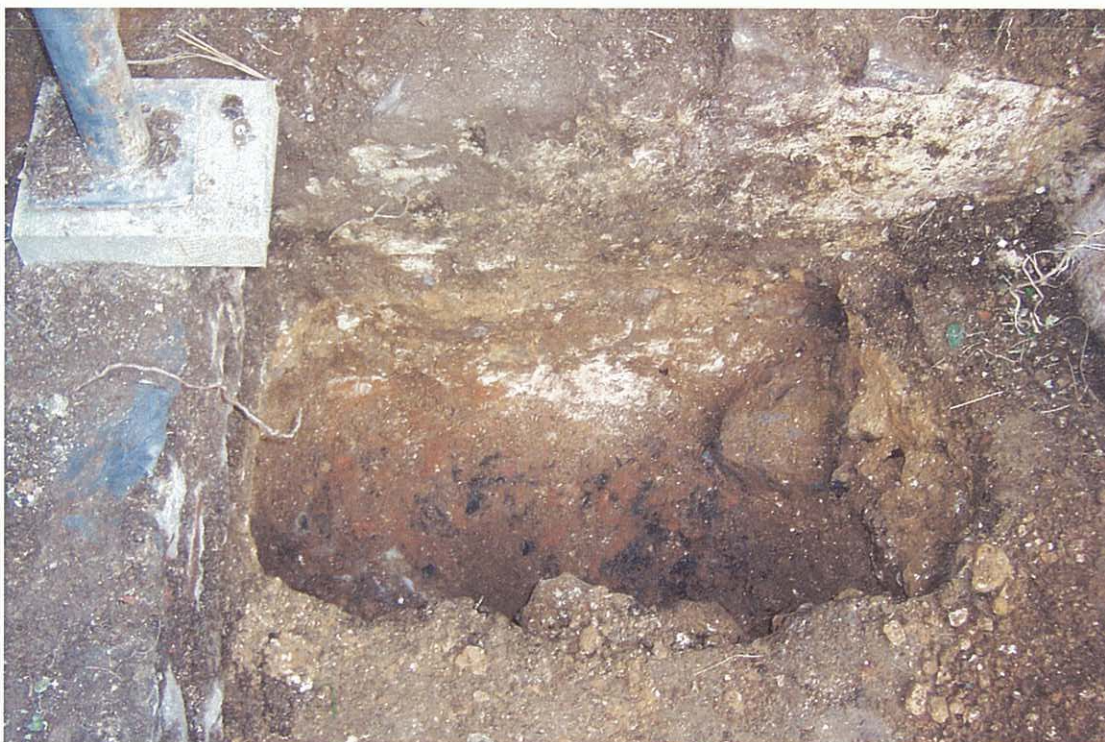
**Photo 6:** Shot of charcoal and clay 'floor' in foundation cut (looking north)
