TIR GOFAL MANAGEMENT PLAN: HERITAGE MANAGEMENT INFORMATION (HE2)

Prepared for: Ciliau Uchaf

Tir Gofal Reference No W/11/5387

ACA Report No. 2006/15 Project Record No. 53747

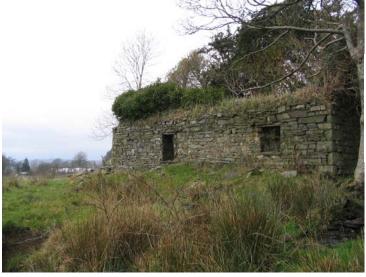
A cottage first marked on the 1st edition Ordnance Survey map of 1889. The site is now ruinous, although three walls stand to close to their original height. Much of the western gable wall has gone, as has the roof and any internal features. The building measures roughly 10m by 5m, aligned ENE-WSW, rubble built bonded with clay, with indications of a former corrugated iron roof. A fireplace remains in the eastern gable wall, two windows face south and the doorway appears to have been in the western gable wall. Ivy covers the top of the remaining gable wall and trees grow along the northern edge of the building. *Visited* 13/02/2006 (PP)

NW facing shot of the remains of Blaen-waun cottage.

The aim of the management for this site should be to ensure the survival of the remains of this cottage site. Cottages such as this were a common feature in this area during the 18th and 19th century but many have since been removed during agricultural improvement making it important to retain upstanding remains such as this. The masonry generally appears to be in a relatively stable condition, however trees grow behind the northern wall with overhanging branches threatening the stability of the wall and ivy has established itself along the tops of most walls.

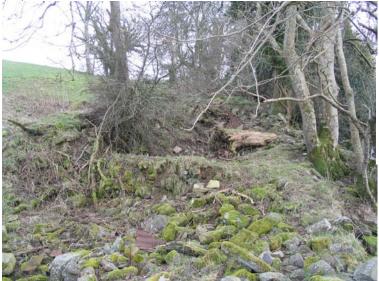
A small farmstead complex marked on the old series Ordnance Survey map of 1834, although Wmffre (2004) records the name from 1760 onwards. The site is still marked on the 1st (1889) and 2nd (1905) edition Ordnance Survey maps but it had been abandoned by the time of the 1964 map. The site now consists of the tumbled stone remains of several buildings arranged along the streamside. Much of the site is currently grass covered, with trees grow along the streamside within the former farmstead complex. *Visited* 13/02/2006 (PP)

SSE facing shot of the tumbled remains of building walls within Parc-y-bedw farmstead.

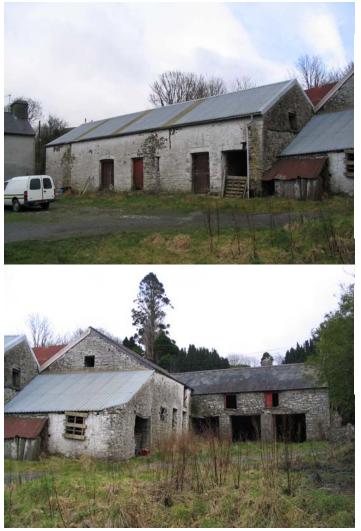
The cow barn/stable range is still in low level use but the remaining buildings no longer appear to be in use. These buildings are generally in a good condition although many of the wooden lintels are deteriorating threatening the stability of the walls above. *Visited* 13/02/2006 (PP)

ENE facing shot of the cow barn/stable range.

E facing shot of the later cartshed range (facing the camera) and the earlier stable range with attached leanto (on the left of the photo).

The aim of the management of this site is the preservation and maintenance of the traditional farm buildings to maintain the historic character of the farmstead (PRN 54657) as a whole. Wooden lintels are visibly deteriorating which threatens the stability of the walls above, most notable on the cartshed range.

• Wooden lintels may have to be repaired to ensure the stability of the walls.

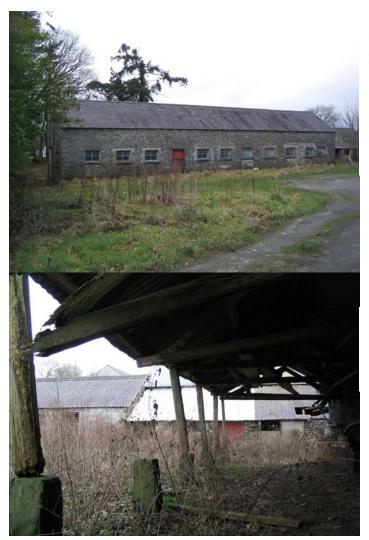
This range of farm buildings no longer appears to be in use and is in varying states of deterioration, described in more detail in the specific management recommendations. *Visited* 13/02/2006 (PP)

WNW facing shot of the front of the lofted barn.

E facing shot looking out from the interior of the open fronted farm building.

The aim of the management of this site is the preservation and maintenance of the traditional farm buildings to maintain the historic character of the farmstead (PRN 54657) as a whole. The buildings no longer appear to be in use. The main lofted barn appears to be in a relatively good and stable condition, however the stalls along its western side are in varying states of decay with some tumbled masonry and damaged and deteriorating roofs, especially the slate roof. The roof of the open fronted building is also deteriorating and appears to be on the verge of collapse. Tree branches and scrub also grow over the roof putting extra pressure on the structure. Trees and scrub grow on and around the pigsty damaging the roof structure and threatening the structural integrity of the walls. The stone walled yard and small farmyard are covered in light scrub.

- Scrub should be cleared from the small yard and dead material removed.
- Tumbled and damaged masonry on the stalls along the western side of the large lofted barn should be repaired and consolidated using appropriate materials and techniques.

- The damaged and deteriorating roofs of the stalls should also be repaired, preferably in slate as this appears to have been the traditional roofing material on these stalls.

- Scrub and tree branches that are damaging the roof of the open fronted building should be cut back and removed to relieve the pressure on the roof.
- The roof structure of the open fronted barn should be repaired or replaced using appropriate materials and techniques. The current corrugated iron roofing should be seen as the traditional roofing material for this barn.

- Scrub and trees growing on and around the pigsty damaging the roof and threatening the stability of the walls should be cut back.
- The damaged section of roofing on the pigsty should be repaired using appropriate materials and techniques to ensure the building remains weatherproof.

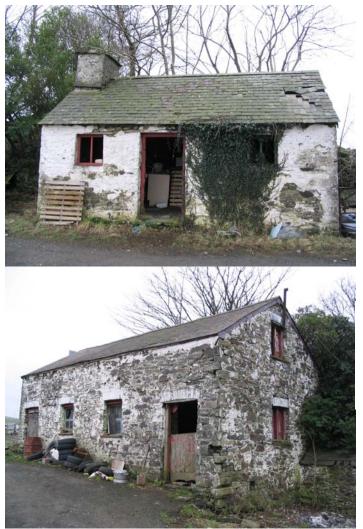
A working farmstead complex marked on the old series Ordnance Survey map of 1834. The complex consists of a mix of scattered traditional and modern farm buildings. A row of small stone built and slate-roofed farm buildings line the north side of the current main trackway into the farmstead. The first building includes a cobbled floor and chimney stack in its gable wall suggesting its use as a former cottage. The remaining small barns are separated with small stone walled yards. Attached to the south-eastern corner of this row is a stone built former stable block with brick dressing and a slate roof. This forms the western side of a yard in front (to the south) of the farmhouse. The southern side of the yard is formed by a stone-built, slate-roofed cartshed and barn, now surrounded by modern farm buildings. To the northeast of the farmhouse lie two barns, both now with semi-circular corrugated iron roofs. The easternmost is brick built, the westernmost stone built although with brick added presumably when the rounded roof was put on. The farmstead is still in use. Traditional buildings are generally still in use and in a relatively good condition although loose slates and stonework has been noted on some of the buildings. *Visited* 13/02/2006 (PP)

S facing of the small farm building and possible former cottage at Ciliau Uchaf.

SW facing shot of the former stable block at Ciliau Uchaf.

The aim of the management for this site should be to ensure the survival of the traditional buildings and maintain the historic character of the complex of traditional farm buildings as a whole. Loose slates have been noted on the row of small farm buildings with overhanging trees growing along a bank to the rear. Stonework has also fallen away from the corner of the easternmost building. Loose slates have also been noted on the cartshed/barn and loose stonework on the stone barn to the northeast of the farmhouse.

- Tree branches that overhang the row of small farm buildings along the northern side of the trackway into the farmstead should be cut back as these are causing damage to the roofs and threatening further damage.
- Missing and loose slates should be replaced on the row of small farm buildings.
- Loose masonry on the corner of the eastern building in this row of small farm buildings should be consolidated to prevent further deterioration.
- Loose and missing slates on the roof of the cartshed/barn should be replaced.
- Loose and tumbled masonry around one of the entrances to the stone built barn to the northeast of the farmhouse should be repaired and consolidated to ensure this is not putting undue pressure on the rest of the building structure.
