WATCHING BRIEF AT ST PETERS CHURCH, HASGUARD

RHIF YR ADRODDIAD / REPORT NO. 2005/18
RHIF Y PROSIECT / PROJECT RECORD NO. 53870

Watching Brief at Hasgurd Church

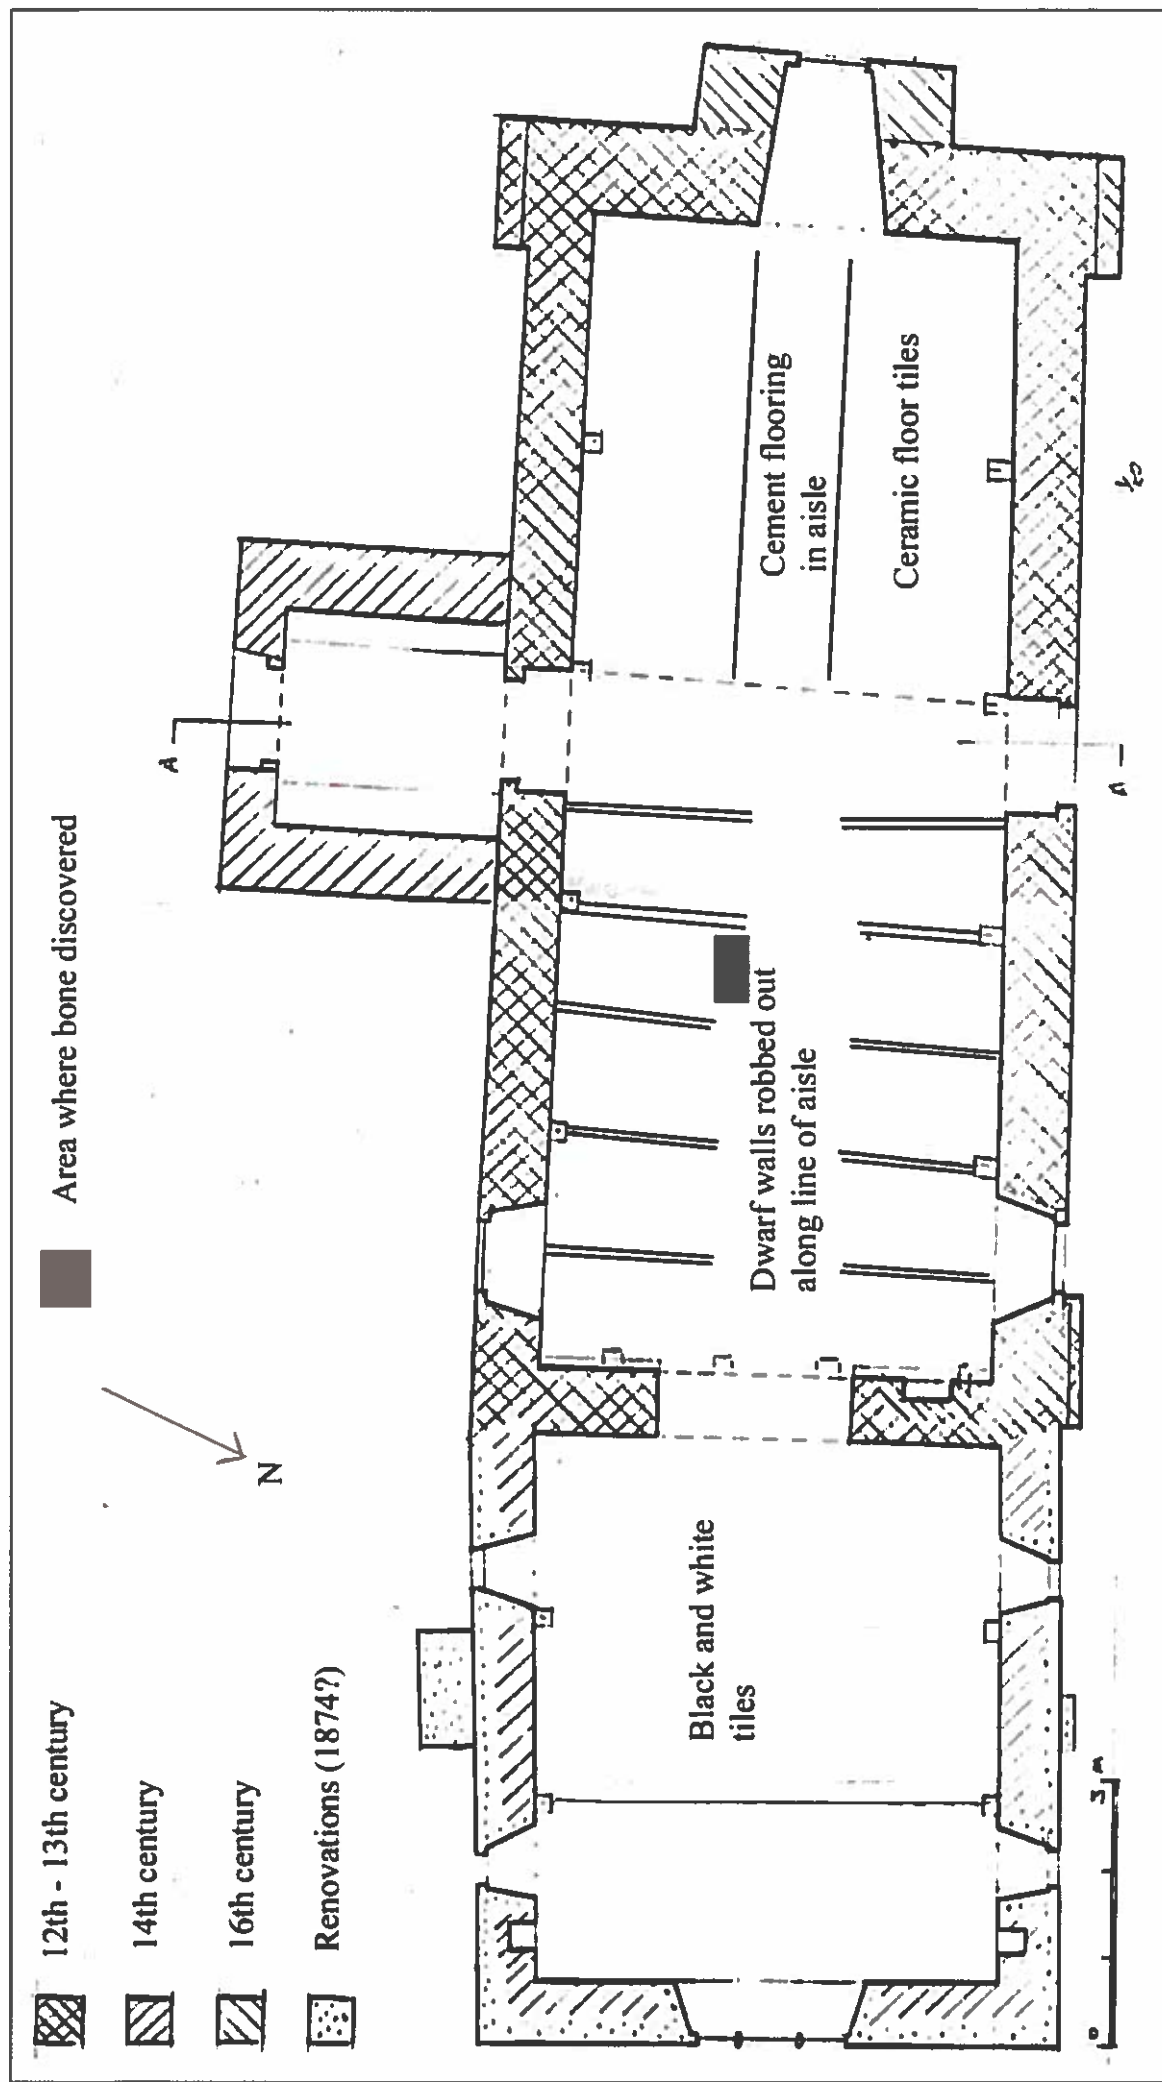
Figure 1: Plan of St Peters Church, Hasguard. After Parkinson, 1988 with additional annotations and information.

See plan in figure 1.

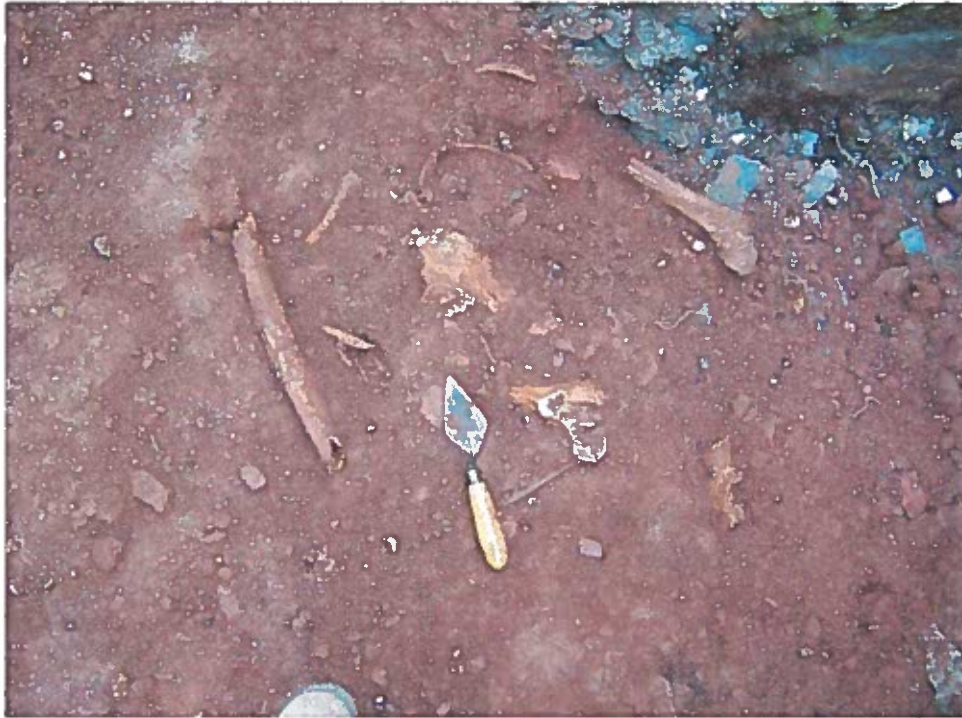
Slight traces of a plaster floor were noted along the length of the aisle, but only small patches of it survived. In one location, work accidentally went below the layer of modern debris. In this area of disturbance, human bone was noted. The bone appeared to be very densely packed, and was immediately underneath the plaster floor layer.

All of the bone appeared to be adult. Part of a pelvis, a collarbone, two ribs, and several long-bones were all noted. A high proportion of the bone had been broken in the past, with one of the long bones snapped in two. The bones were not an articulated burial, but appeared to be very 'jumbled', overlying each other, and embedded at angles into the ground. The bone was re-buried on site.

Figure 2 (above): Densely packed human bone close to the surface and immediately underneath the traces of a plaster floor. The bone was re-buried on site.

A final phase of work appears to post-date this Victorian renovation, when the floorboards seem to have been removed from the aisle and replaced with a plaster floor. It also appears that earth was piled up along the length of the aisle, to provide a solid 'foundation' for the aisle and to raise it up to approximately correspond with the floor-levels either side of it. This must have involved considerable disturbance to ground inside the church, probably explaining the 'jumbled' nature of the human remains which were observed.

There should be no ground disturbance inside the church building. Any disturbance will inevitably come down onto the archaeological layers and involve excavation of human remains.

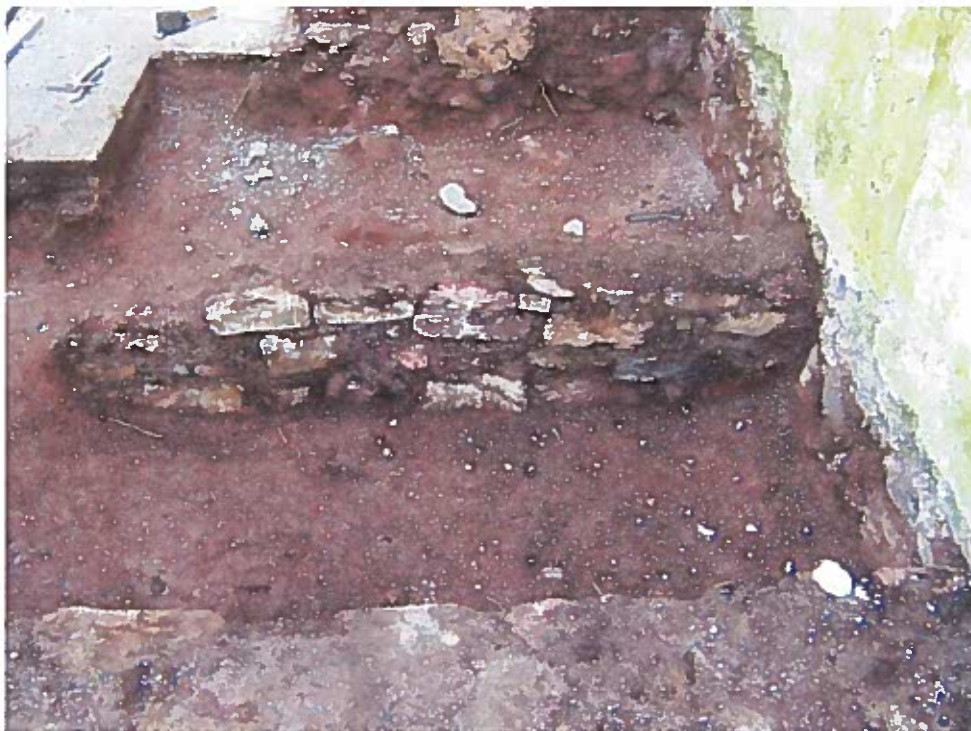
During the works, several details of the building's construction were noted. The dwarf walls only butt loosely against the exterior walls, confirming that they were a later addition. The walls do not run all the way across the building, but appear to have been robbed out in the middle, making space for the aisle to run through. The ends of the walls are not neatly finished, but have been roughly removed – perhaps to allow new flooring to be laid in the aisle? This would coincide with the situation at the west end of the church, where the aisle is floored in cement and is slightly lower than the surrounding floor.

Figure 3 (below): Dwarf wall at the east end of the nave. These walls are roughly built, and butt up against the exterior walls of the church. The gaps between them were filled with modern debris from the removal of the roof and from the building standing empty. The walls are not finished neatly, but appear to have robbed out where the aisle passes through (left of picture).

Another phase of flooring is represented by the insertion of the dwarf walls for carrying floorboards. These roughly built walls butt up against the exterior walls. If, as suggested, the medieval ground level was close to today's level, then there must have been considerable disturbance to it when the flooring was put in. This work is likely to have taken place during the 1874 renovations – the insertion of floors like this was common across the county as the era of Victorian church restorations got underway and the 'package' of pulpit, lectern and pews was delivered to countless parish churches. The black and white tiling in the chancel may well also date from this time.
