## **TIR GOFAL MANAGEMENT PLAN: HERITAGE MANAGEMENT INFORMATION (HE2)**

**Prepared for:  
Cilgynydd**

**Tir Gofal Reference No  
W/13/5799**

**ACA Report No. 2005/123  
Project Record No. 54183**

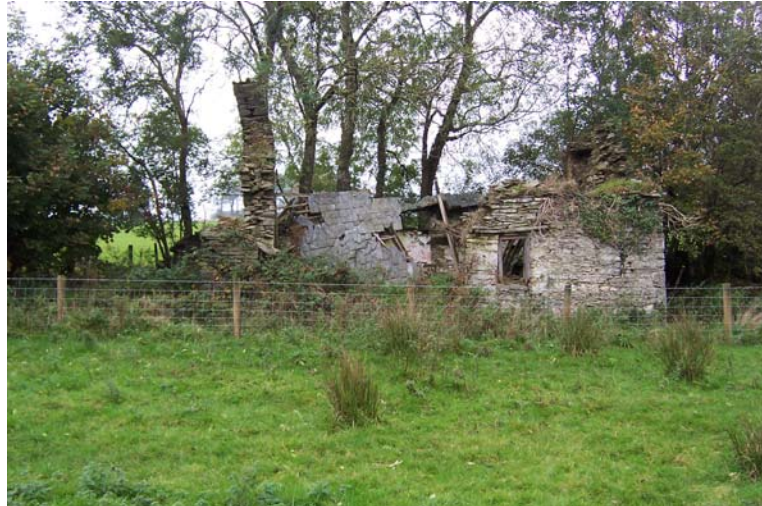
<b>HIN CILGINYDD CILGYNYDD ISAF</b> <a href="#">(22275)</a>	<b>Post Medieval cottage?</b>	<b>SN18262332</b>	<b>B</b>		<b>Generic</b>
<p>A ruinous single storey cottage and outhouse of probable pre-mid nineteenth century date. It is stone built with clay bonded walls and a slate roof. There are at least two rooms downstairs with a passage in between and a loft over the whole floor space. Internally the walls retain traces of yellow, orange and red colourwash. Adjoining the cottage to the north are the wall bases of an outhouse, accessed from the outside and with no internal entry to the dwelling. The building has been derelict for a number of years and is in the process of collapse. It is fenced out and the whole site is becoming overgrown.</p> <p>The tithe map of c.1843 identifies a cottage and garden which may be consistent with the above and an early nineteenth or earlier date is therefore possible. It is a type of dwelling which was one common in the region but of which few unaltered examples now survive.</p>

The ruinous cottage of Cilgynydd Isaf.

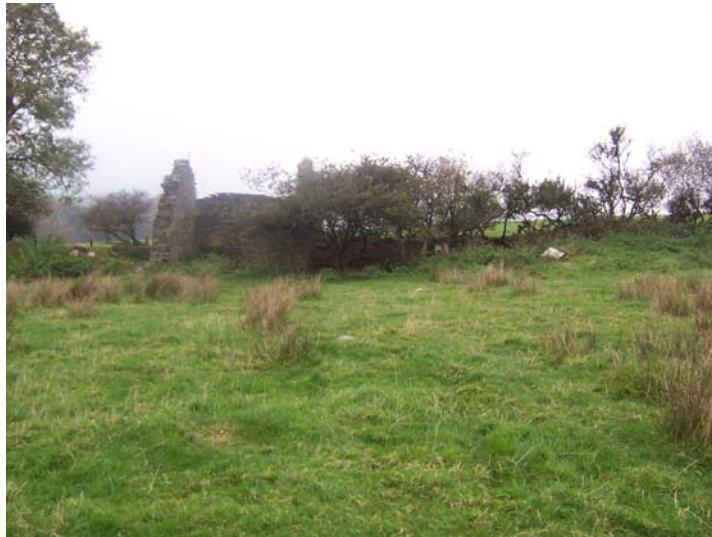
The site of a minor farmstead, long abandoned and now levelled with the roofless walls of only one lofted outbuilding remaining. Llwyn Coch is identified on the 25" Ordnance Survey 1st edition map as a modest small holding comprising four small buildings in a U-plan.

No traces of the other buildings remain other than a random scatter of stones. The site is in a pasture field.

The site of the former small holding of Llwyn Coch, later Llwyn y Gog seen from the west.

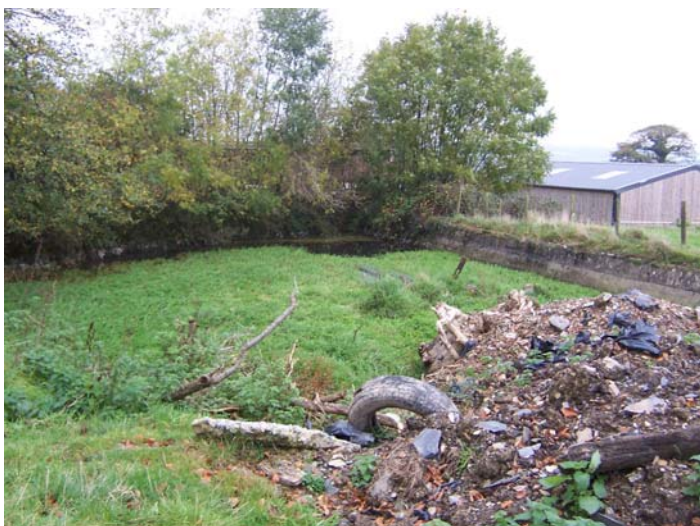
The pond still holds water but is becoming choked by marshy vegetation. There is some general farm debris dumped on the east side.

The pond still holds water but is becoming choked by marsh vegetation.

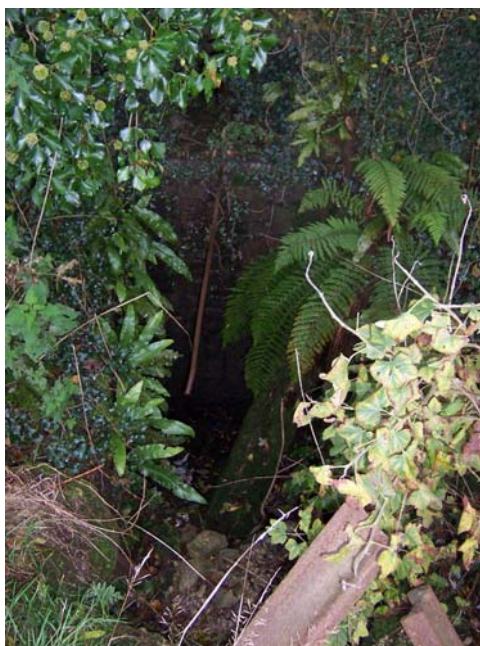
The pit is relatively stable. Low growing scrubby vegetation surrounds the site.

The pit is relatively stable but is now obscured by vegetation.

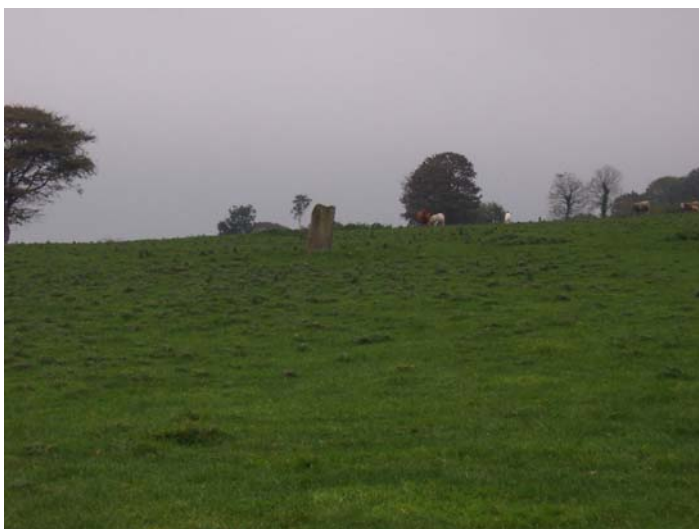
A large upright stone in a pasture field said to be a former gatepost put there by the previous owner as a rubbing stone for cattle.

View of the cattle rubbing stone from the west.

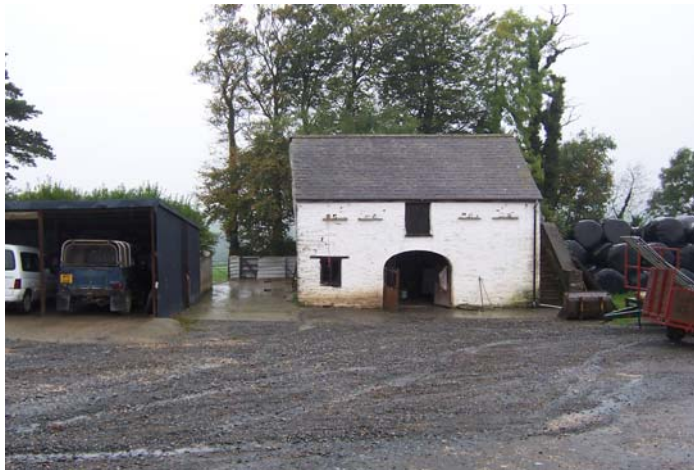
This building is thought to date to the early nineteenth century. It is well maintained and in a weatherproof condition.

The front (east facing elevation) of the cart shed.

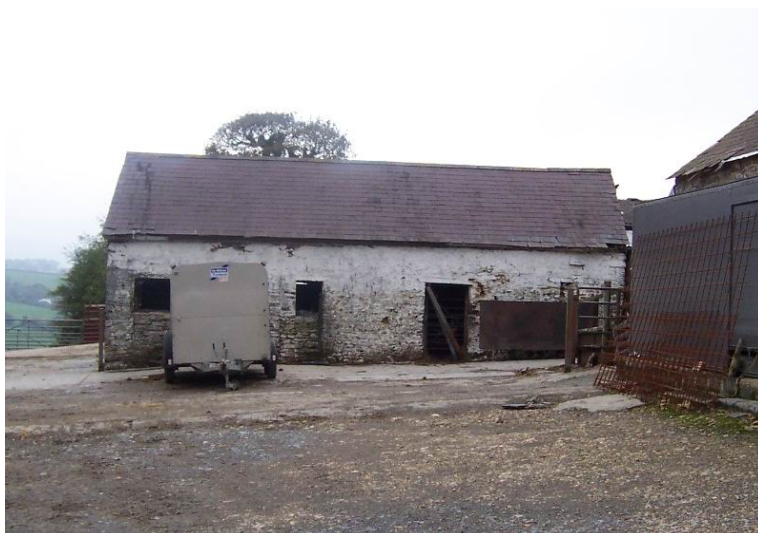
The building probably dates to the early nineteenth century or before. It is in a reasonable condition but part of the outshut to the rear has been dismantled. There are some loose slates above.

The front (south) facing elevation of the cow shed.

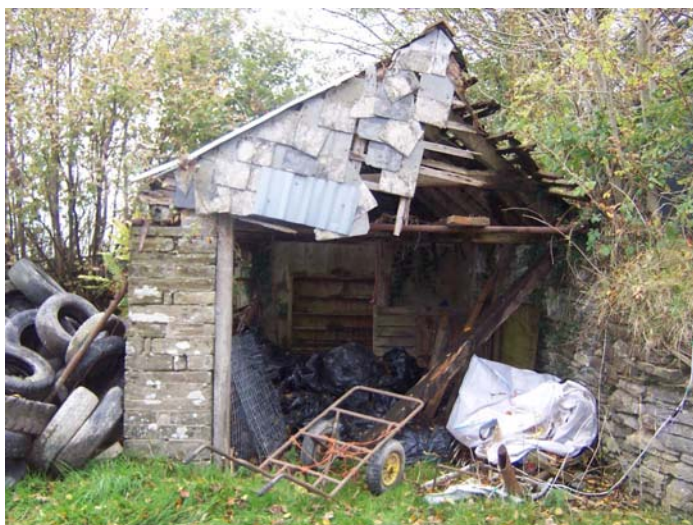
The building appears on the 25" Ordnance Survey 1st edition map of 1889. It is now dilapidated and ruinous.

The front (west facing) elevation of the shed.
