HAFOD: PROPOSED FELLING ARCHAEOLOGICAL RECOMMENDATIONS

November 1997

**Report commissioned by: Forest Enterprise
Report by: K Murphy BA MIFA**

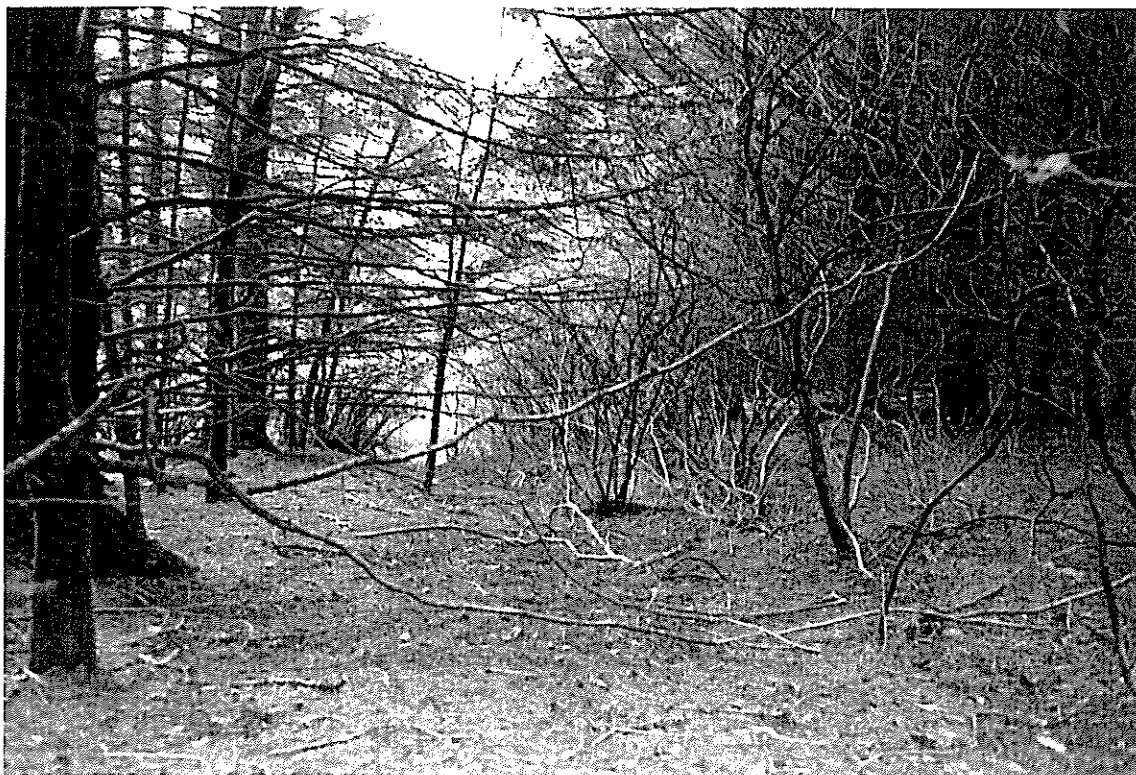
Photo 1.

32971. Path (*Photo 1. Showing path running to the south out of the coupe*). This is traceable as a clear earthwork hollow-way to the south of the coupe, but is not readily detectable in the coupe on the higher slopes, though it is depicted on the Ordnance Survey 1:2500 1st Edition map in this area. There are linear earthwork hollows following the line of the path in the coupe, but these seem to be the result of former extraction/felling processes.

Value: 3.

Recommendations: None.

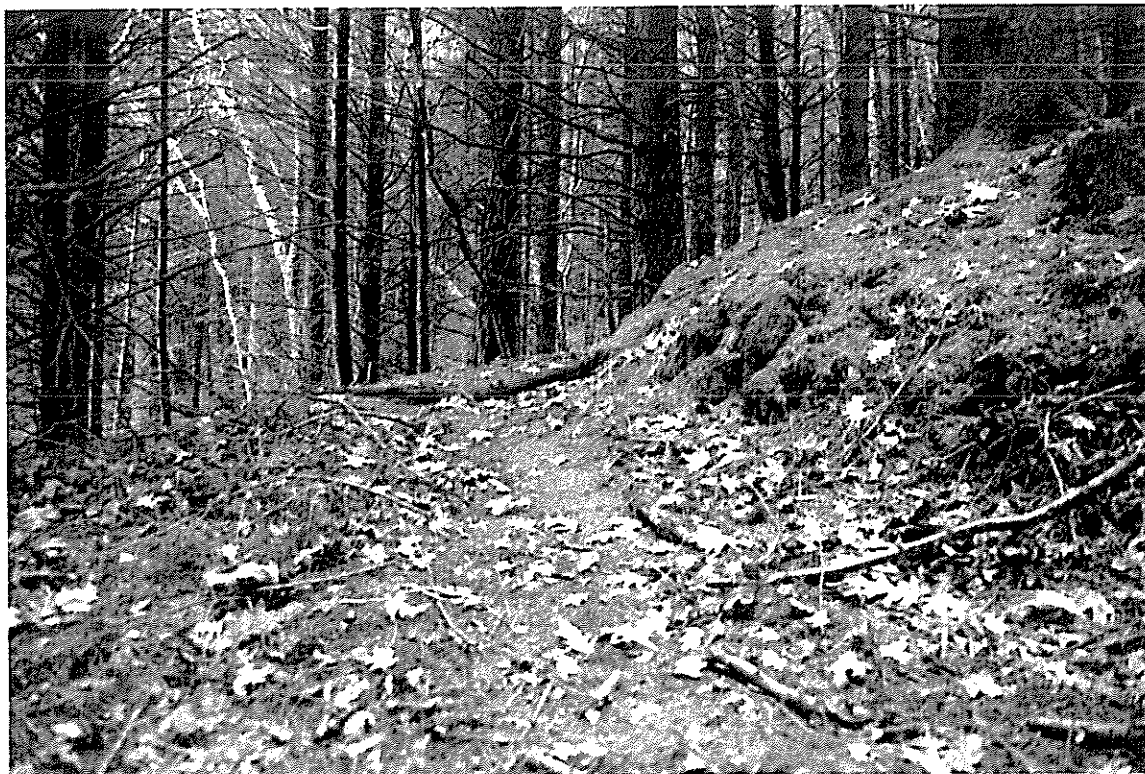
Photo 2.

33079. Path (*Photo 2. At A showing the path round a spur. Photo 3. The path on a terrace to the east of A*). This path runs gently up-slope from north-east to south-west. Its course is shown on the Ordnance Survey 1:2500 1st Edition map. There is no surface evidence for this path for much of its course across the coupe, but towards the south-west (to the east of A) it runs on a distinct earthwork terrace c.2m wide. At A, immediately to the east of a dry stream-bed, the path rounds a spur on clearly created terrace before descending to the former stream. There is no evidence for a bridge. This method of terracing is indicative of the work of Thomas Johnes, and it is possible that this is a previously unrecorded example of one of his picturesque paths.

Value 3.

Recommendations: Care should be taken to protect this path where it is visible on the ground as a terrace (at A and for c.50m to the east of A) from damage. These terraces are generally quite robust, but their outer lips are susceptible to damage, particularly if logs are dragged across them.

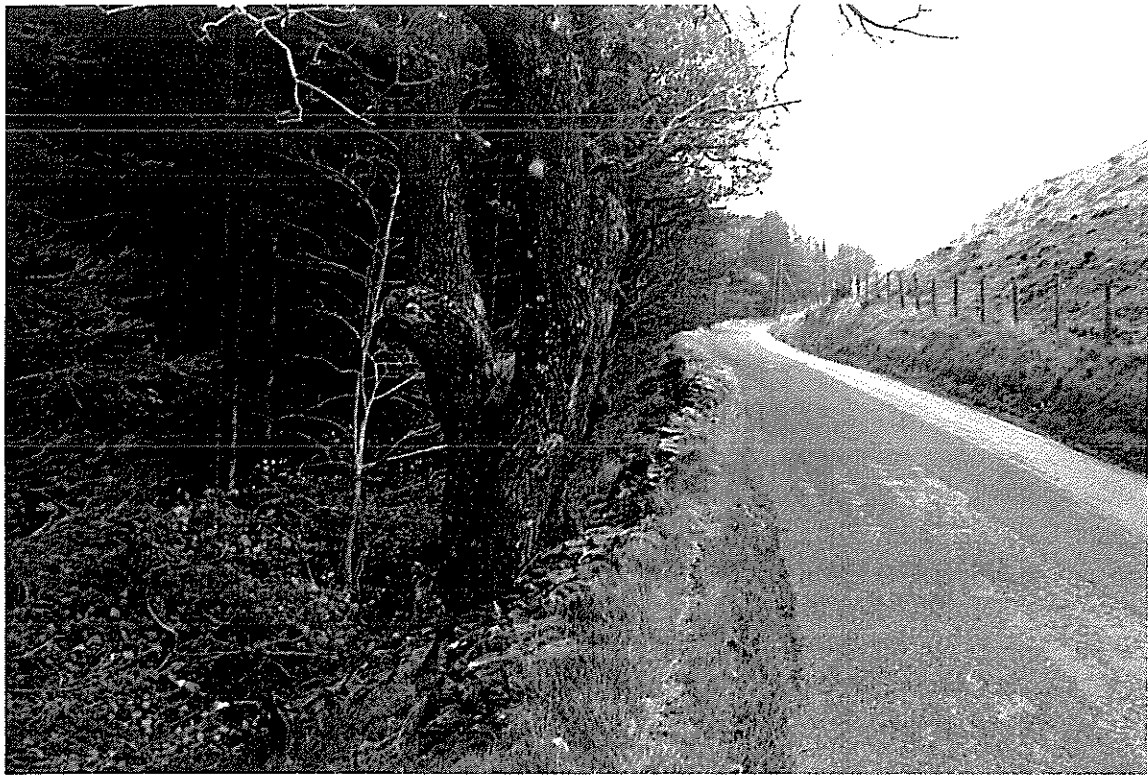
Photo 4.

33617. Wall (*Photo 4*). Dry-stone wall alongside public road. The wall is now in poor condition, mainly collapsed but not breached, and standing to a maximum of 0.8m high. Broadleaf trees have been planted at regular intervals alongside this wall; some of these are still in evidence. Probably built by Thomas Johnes.

Value: 3

Recommendations: Given its location it is unlikely that this wall will be affected by felling, but care should be taken not to cause further damage.

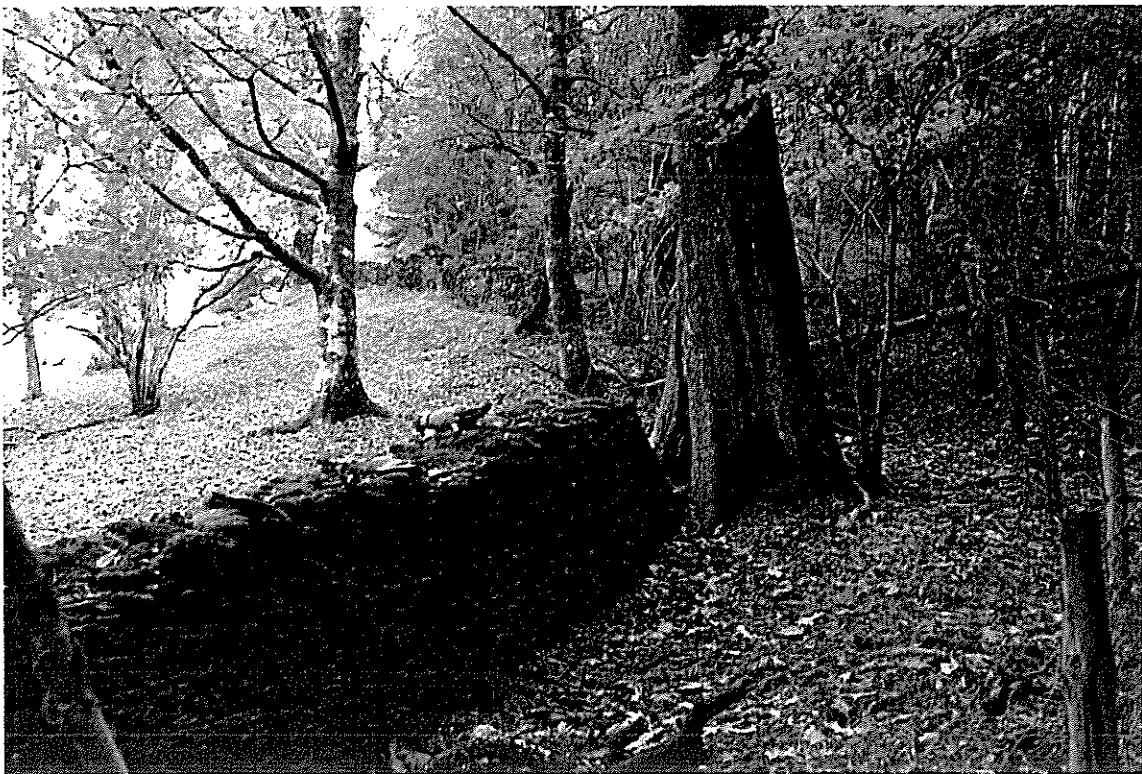
Photo 5.

33548. Wall (*Photo 5*). Dry-stone wall on the boundary of the coupe. In fair condition, standing up to 1.2m high with cap-stones surviving, though breached in several places. Should not be affected by felling.

Value: 3

Recommendations: None

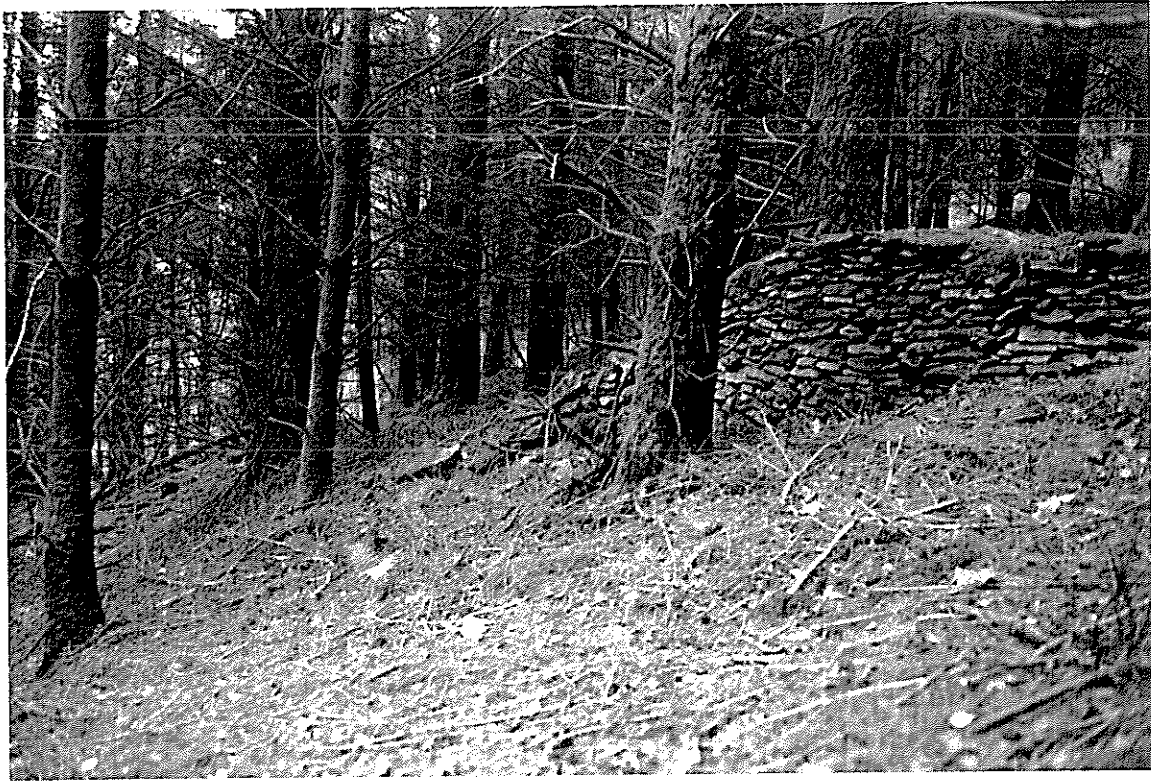
Photo 6.

33549. Wall (*Photo 6. Wall, looking west showing beginning of breach at B*). Dry-stone wall built on a steep slope. The wall is in very poor condition, mostly collapsed and breached in several areas. Where breached it is represented by a spread of rubble. There is a large breach in this wall at B.

Value: 3

Recommendations: As this wall is in poor condition, it is unlikely that the felling programme will greatly affect it. However, so as to cause as little damage as possible, any access across this wall should be via the large breach already created at B.

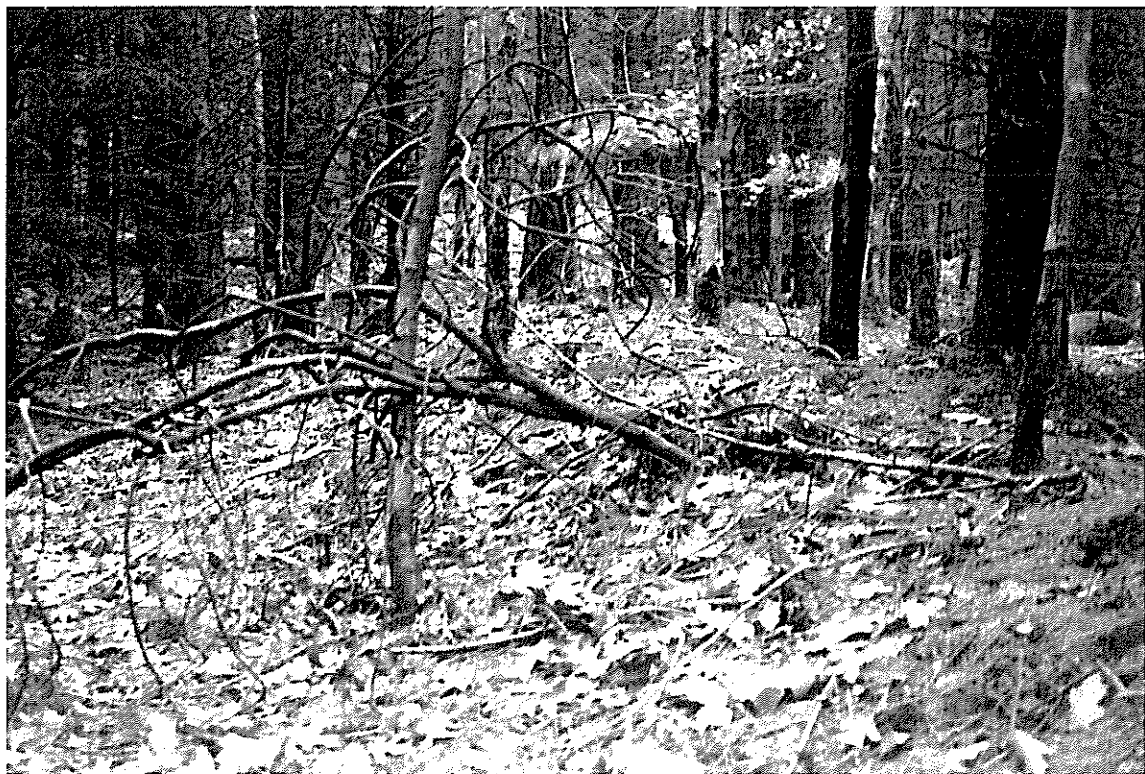
Photo 7.

33555. Bank (*Photo 7*). Earth-built boundary bank, c.3m wide, 0.5m high, with a rounded profile. There are now breaches in the bank. Conifers have been planted on it.

Value: 3

Recommendations: Machinery and extracted timber should be taken over this bank via a single access point. It may not be necessary to create a breach in the bank, but if this is necessary it should be as narrow as possible.

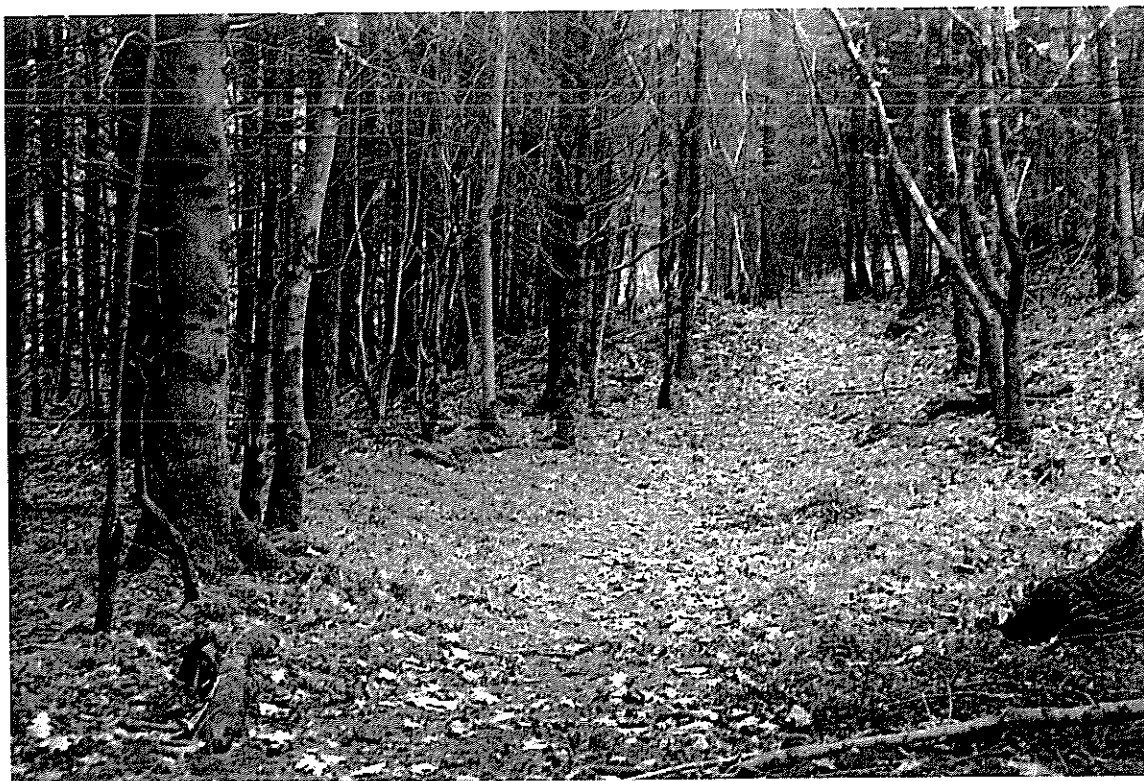
Photo 8.

32946. The Nant Ffin track (*Photo 8. Track looking east with wall 32947 to south*). To the east of the coupe this track runs on a clear terrace cut into the hillside. The levelled ground within the coupe makes its exact course less obvious, but its line is quite clear.

32947. Wall (*Photo 8. The wall is to the south, left, of the track and is indicated by a low vegetation-covered rubble bank*). A ruined dry-stone wall. Mostly represented by a low rubble bank with hardly any upstanding masonry. There is a breach/low point in the rubble bank at A adjacent to a small stream. This may have been a route used for extraction in the past. The wall encloses a roughly rectangular area which may have been a garden.

Recommendations: Because the level course of the track within the coupe, the potential for damage is slight. The track is an important element in the Hafod landscape, and conservation proposals should be formulated to ensure that no damage occurs.

Recommendations: Action should be taken to avoid further damage to the wall. The breach at A should be used as the access point across this wall. No new breaches should be made.

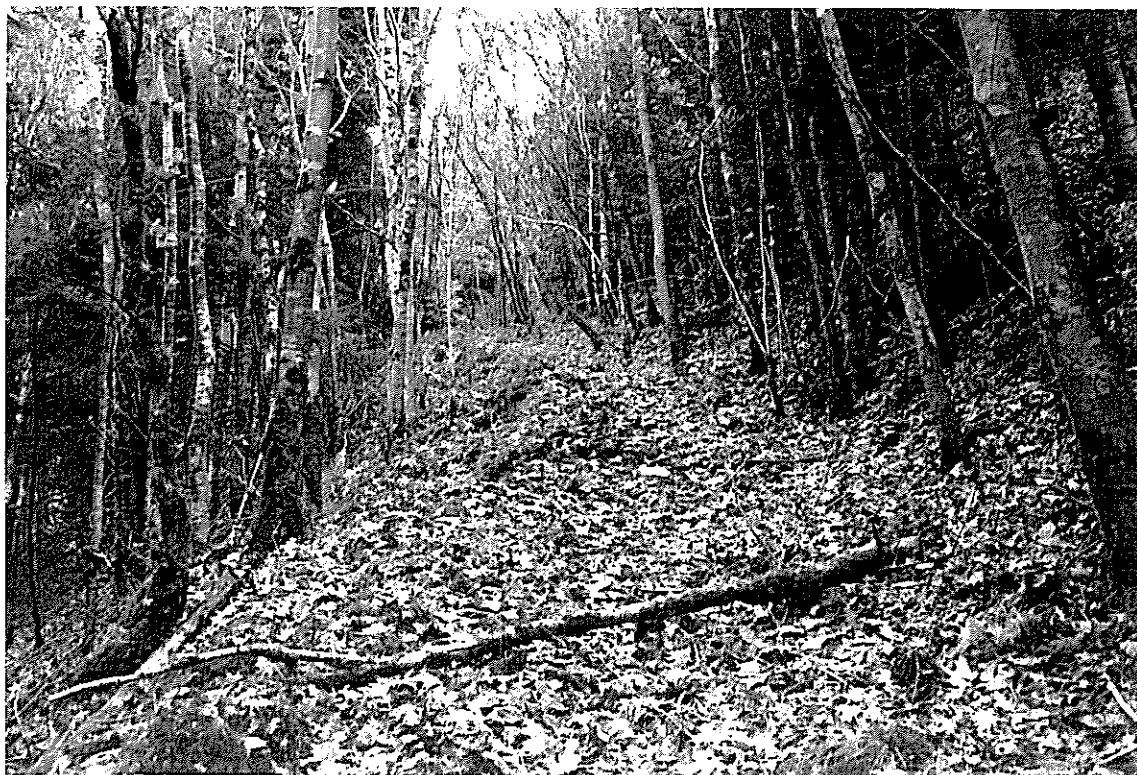
Photo 9.

32958. Path/track (*Photo 9*). This track runs diagonally up a steep slope on a c.3m wide terrace. The terrace is revetted on the down-slope side by dry-stone walling. Surface disturbance at the lower end suggests that this track may have been used for extraction in the past.

Value: 3

Recommendations: This track should not be used for extraction purposes. Care must be taken not to damage the vulnerable outer lip of the terrace during felling and extraction.

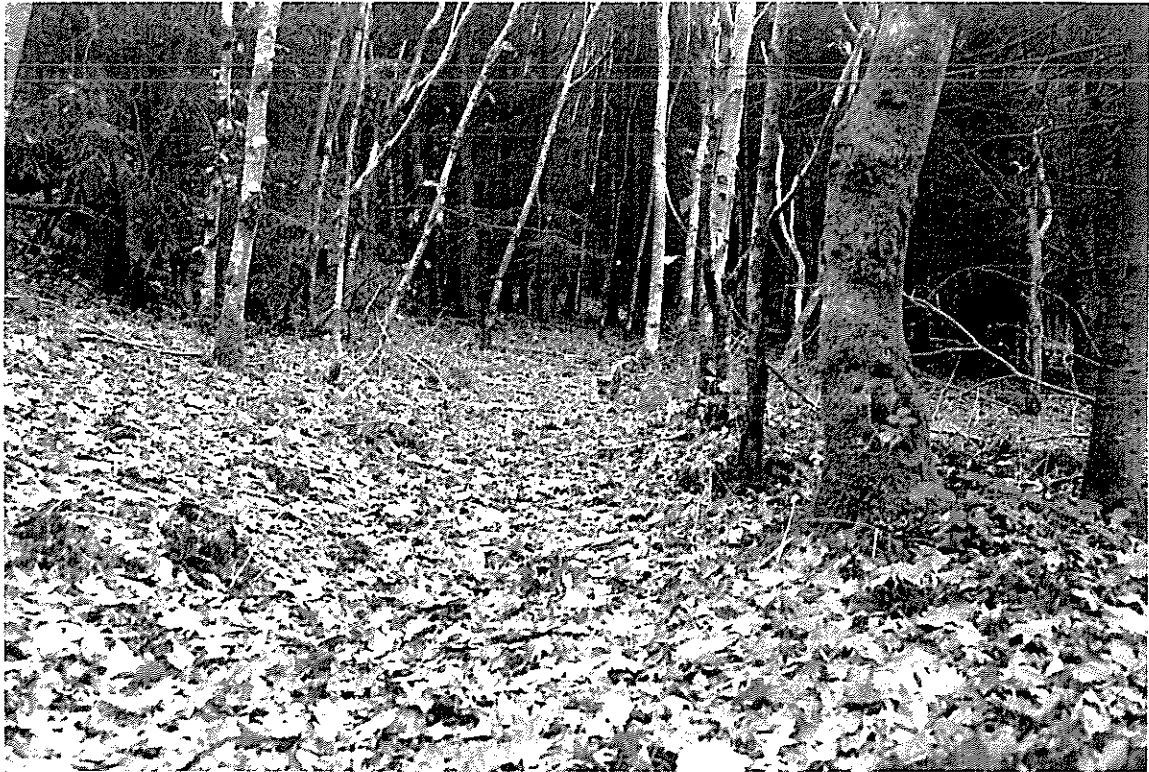
Photo 10.

32959. Path (*Photo 10. Slight earthwork of the path looking south-west as it enters the coupe*). Shown on the Ordnance Survey 1:2500 1st Edition map as running across the coupe, this path is now only traceable towards the north-east corner of the area (B to B). Here it exists as a linear hollow some 2m wide and 0.3m deep with a low bank

to the west. As it runs towards the centre of the coupe this linear earthwork is lost amongst ruts and hollows caused by extraction. It seems likely that the course of the path in this central area is followed by an extraction track.

Recommendations: The surviving earthwork section of this path should be protected from further damage during felling and extraction.

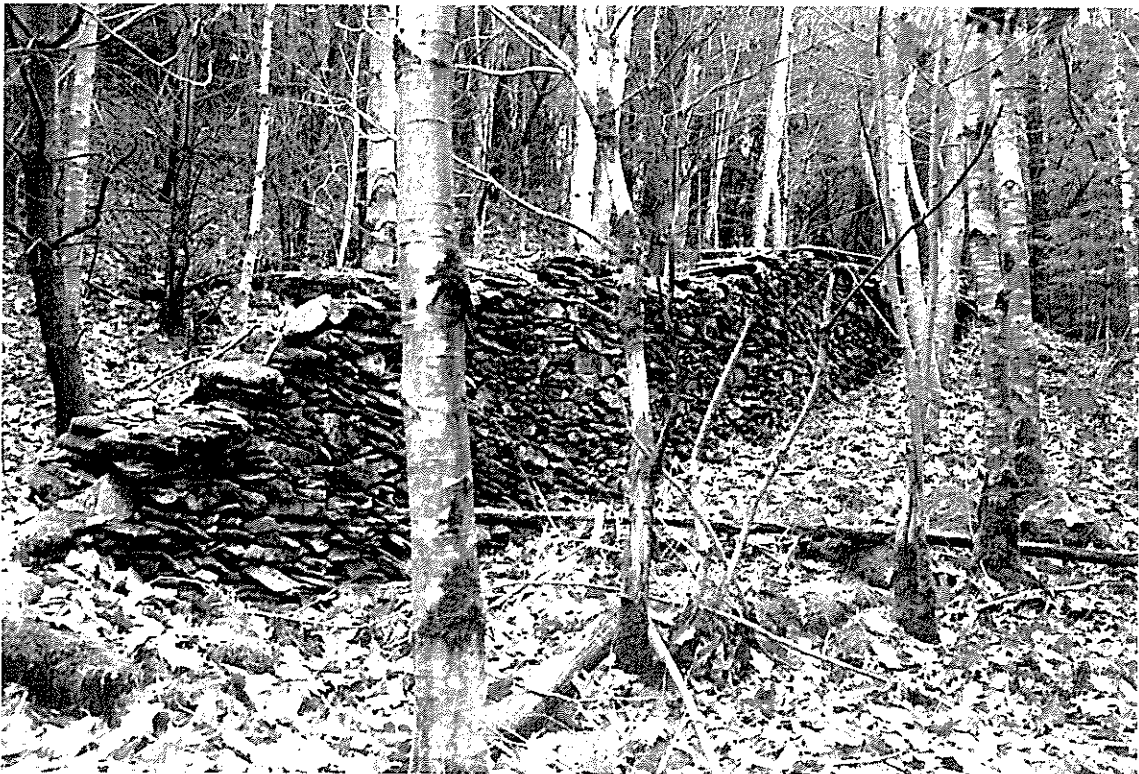
Photo 11.

33547. Wall (*Photo 11*). A well-built dry-stone wall which survives to its full height complete with capping stones in several lengths, but in general it is beginning to collapse and stands to less than 1m high. At B it has been breached for access. To the south-west of B it has been mostly destroyed or buried beneath a forestry drive.

Value: 3

Recommendations: Access across/through this wall should be via the already created breach at B. Creating further breaches in the wall should be avoided, but if necessary these should be made where the wall in its most collapsed state.

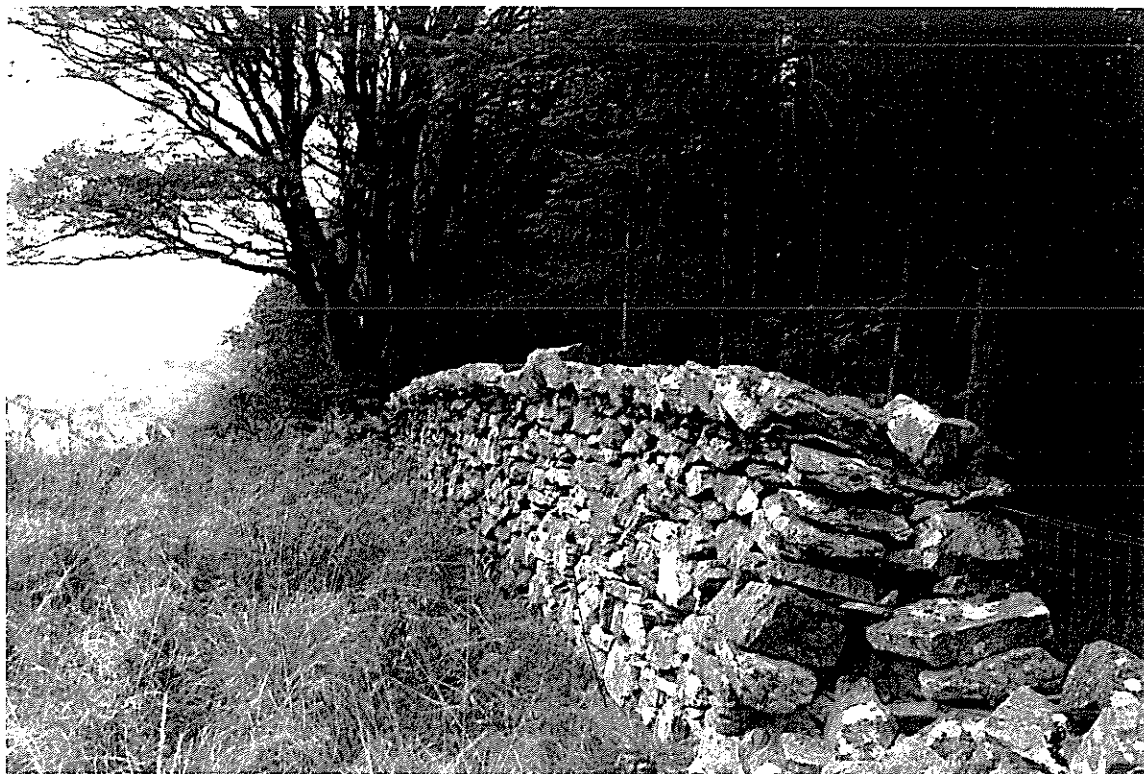
Photo. 12

33563. Wall (*Photo 12*). A long dry-stone boundary wall with broad-leaf trees planted at regular intervals alongside. The wall is in good condition and survives to full height with intact cap-stones. There are a few short stretches of partial collapse. This wall was built by Thomas Johnes. It is the best surviving of his estate walling at Hafod.

Value: 3

Recommendations: This boundary is an important element in the Hafod landscape. It should not be damaged.

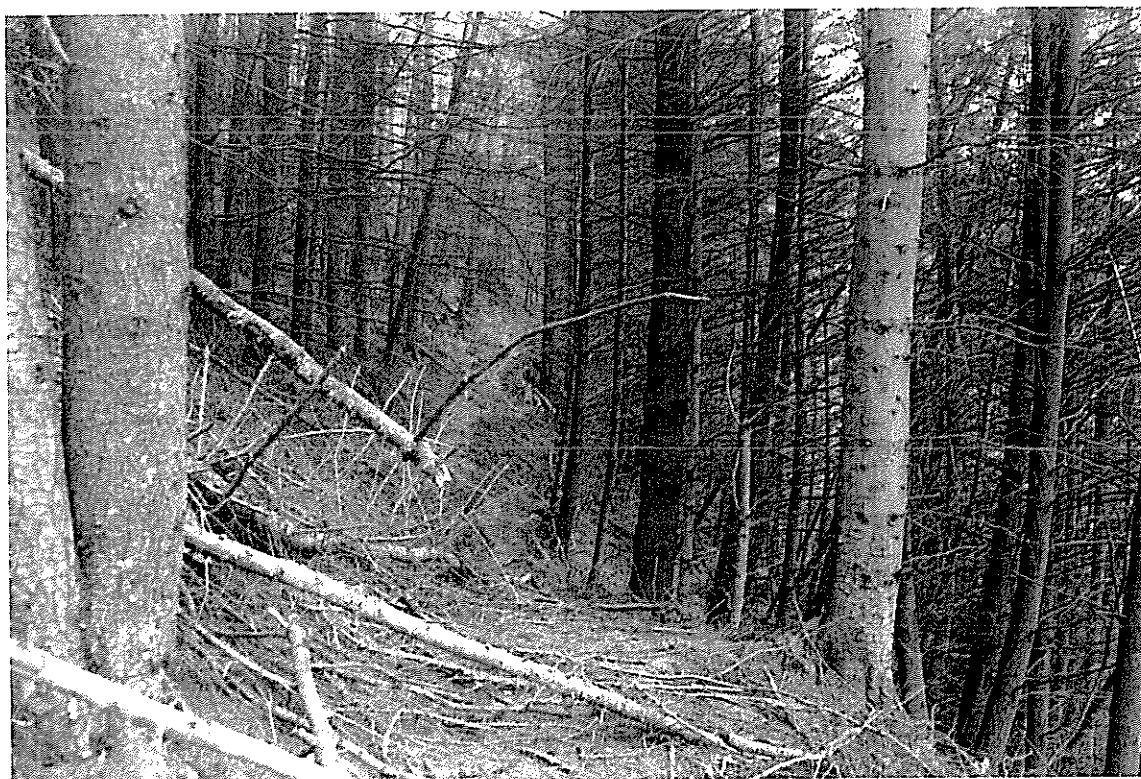
Photo 13

33008. Gentleman's Walk (*Photo 13. The terrace of the walk looking west*). The Gentleman's Walk which crosses this coupe from east to west is located on a distinct linear terrace some 2m wide mid-way up a very steep slope. This walk is an important element in the Hafod landscape. It must not be damaged.

Value: 2

Recommendations: It is vital that this feature is not damaged. The most vulnerable part is the outer lip of the terrace on which the walk is located. Damage can occur here if logs are dragged up or down the slope. It is therefore recommended that a single route across the terrace for log extraction is selected. The terrace on this route can then be protected by positioning logs along the line of the walk, over which the extracted logs are dragged.

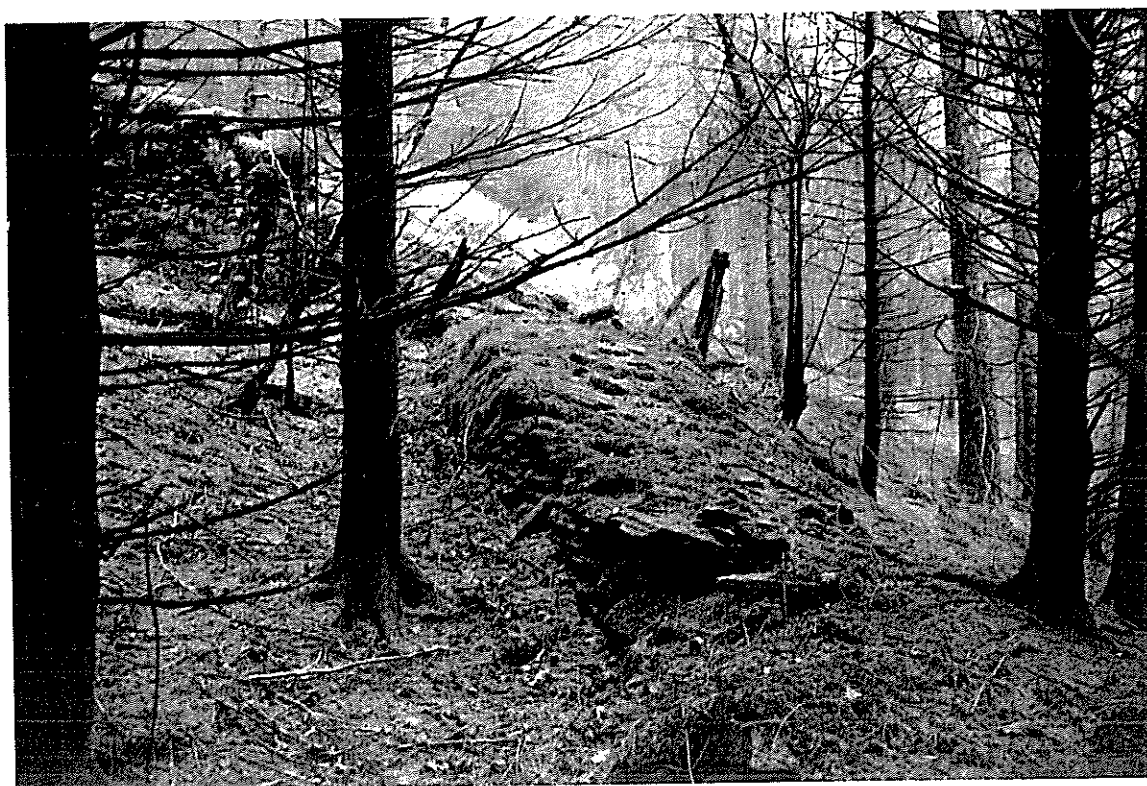
Photo 14

33563. Wall (*Photo 14*). This is a continuation of the boundary wall present in coupe 14435. Here the wall is moss-covered and is beginning to collapse. Nevertheless, it stands up to 1m high. There are no major breaches in it.

Value: 3

Recommendations: Damage to this wall should be avoided. Any breach through this wall - should it be found necessary to create on for extraction - should be narrow, and should be restored following the felling programme.

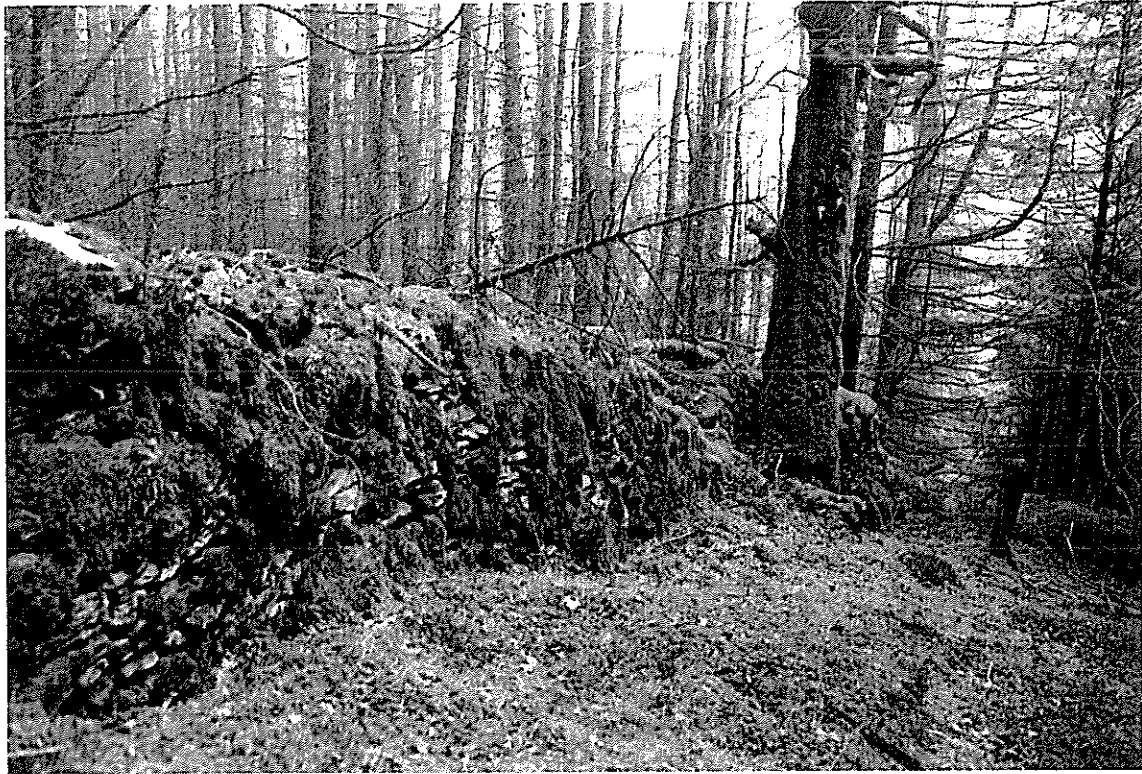
Photo 15.

33570. Wall (*Photo 15*). This wall is generally in good condition and stands to its full height with cap-stones. It has been breached by a track just outside the coupe to the south. There is no reason why this wall should be damaged by felling operations.

Value: 3

Recommendations: Care should be taken not to damage this wall.

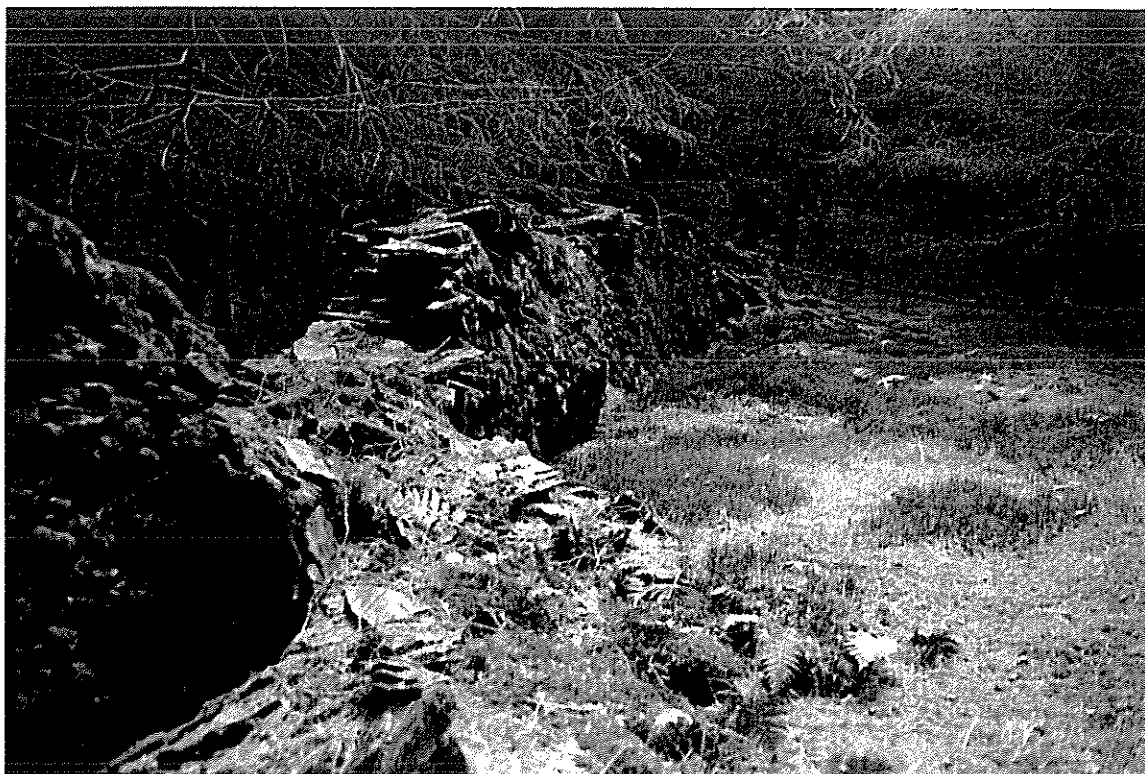
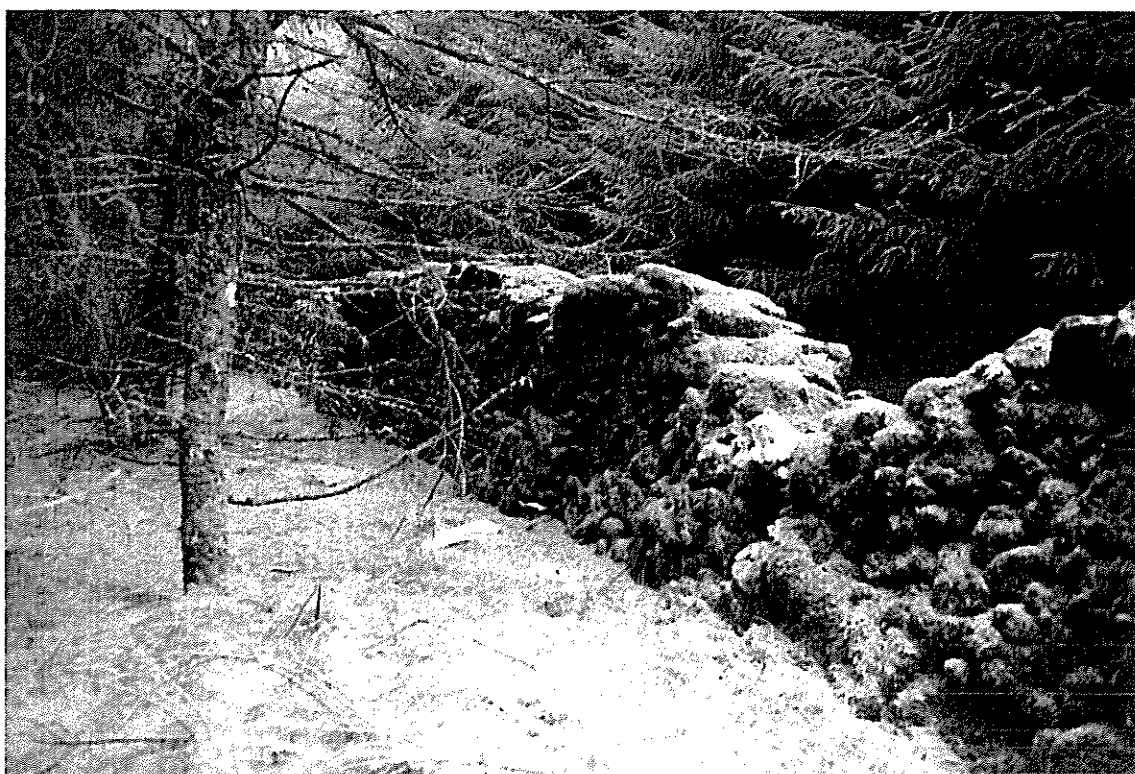
33573. Wall (*Photos 16, 17*). A good example of a dry-stone wall, probably built by Thomas Johnes. It stands to its full height with cap-stones set at 45 degrees. Collapse of this wall is not severe and does not detract from its overall character. There are no breaches in the wall. At its eastern end, at the boundary of the coupe, this wall has been truncated by a forestry drive.

Value: 3

Recommendations: This is one of the best examples of a late 18th-century or early 19th-century wall on the Hafod estate. Damage to it should be avoided. Any breach (or breaches) created through this wall for extraction purposes should be narrow, and should be restored subsequent to the felling programme.

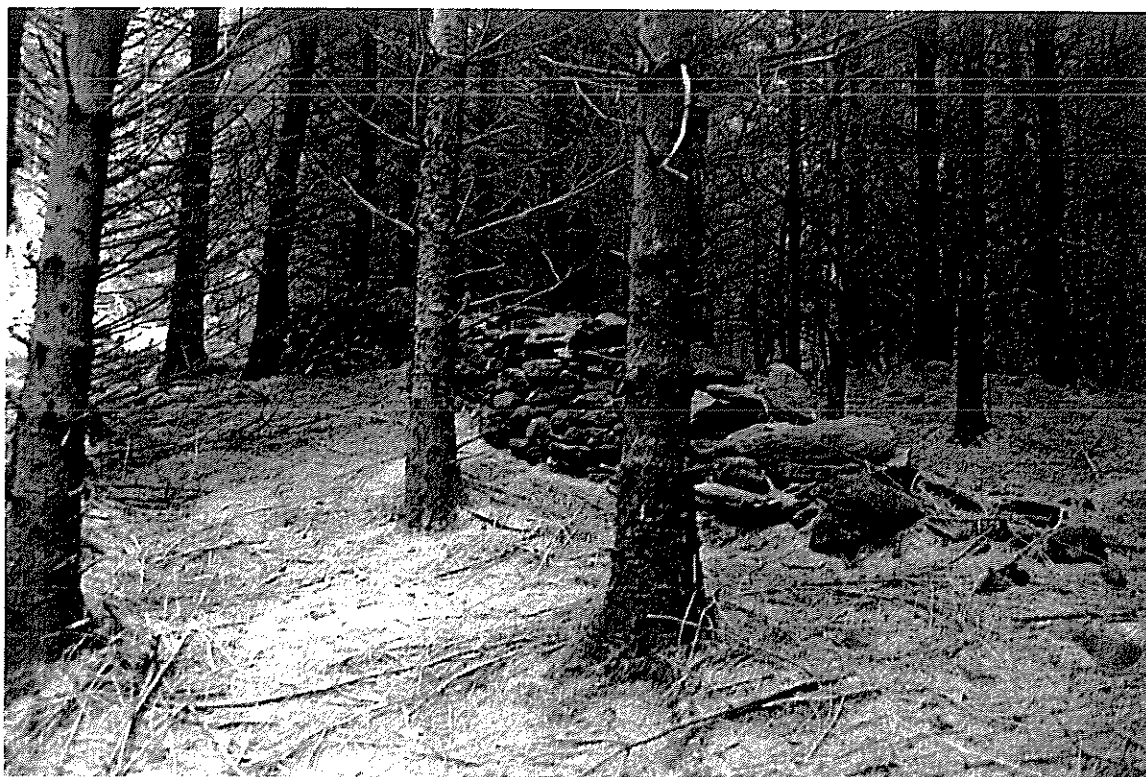
Photo 18.

33574. Wall (*Photo 18*). This dry-stone wall has suffered collapse and has been breached in several places. Nevertheless, there are stretches where it survives to its full height with cap-stones present. The severest area of damage is at its north-east end, where it meets wall 33573 (above).

Value: 3

Recommendations: it is recommended that further damage to this wall is avoided. The current breaches in the wall should be used for access and no new breaches created.

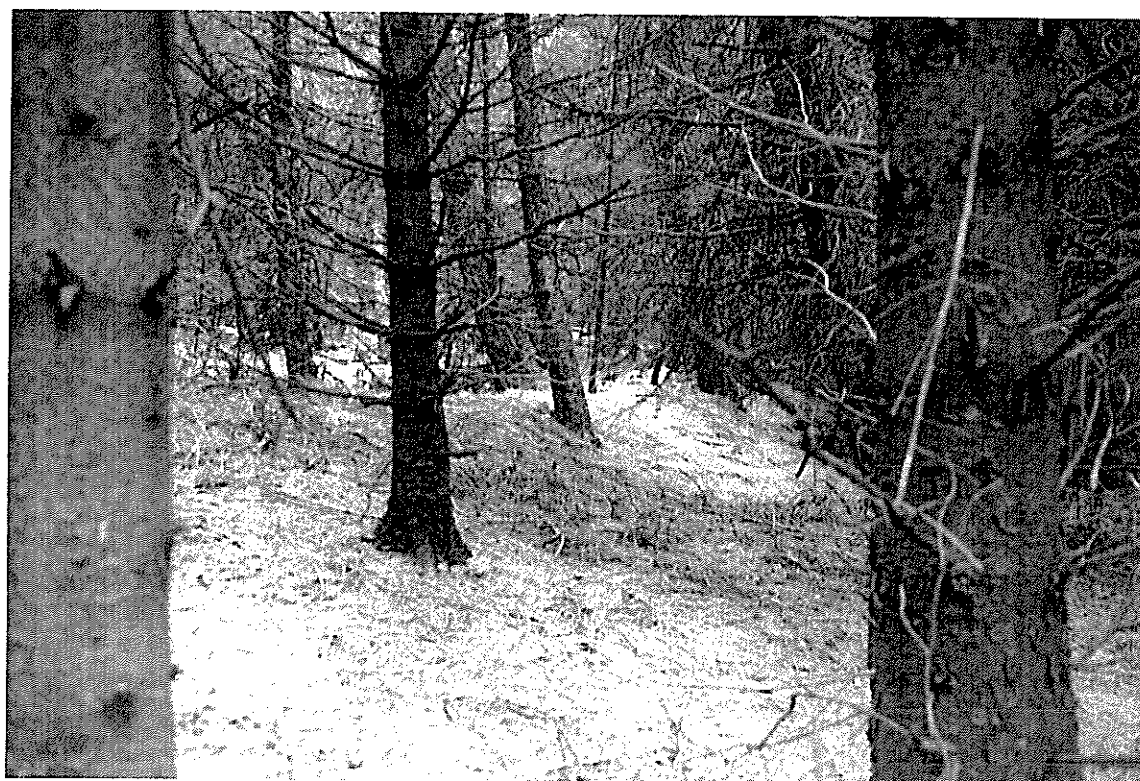
Photo 19.

35417. Boundary bank (*Photo 19*). This earth-built and stone boundary bank stands to 0.6m high and is up to 3m wide with a spread, rounded profile. Trees have been planted over this boundary, and it has been further damaged by drainage gullies and machine ruts. Its course is difficult to trace towards the centre of the coupe.

Value: 3

Recommendations: Even though damaged, action should be taken to ensure that this boundary does not suffer further degradation. For extraction purposes, one or two crossing points over this boundary should be identified; this should ensure that the remainder of the bank survives in its present condition.

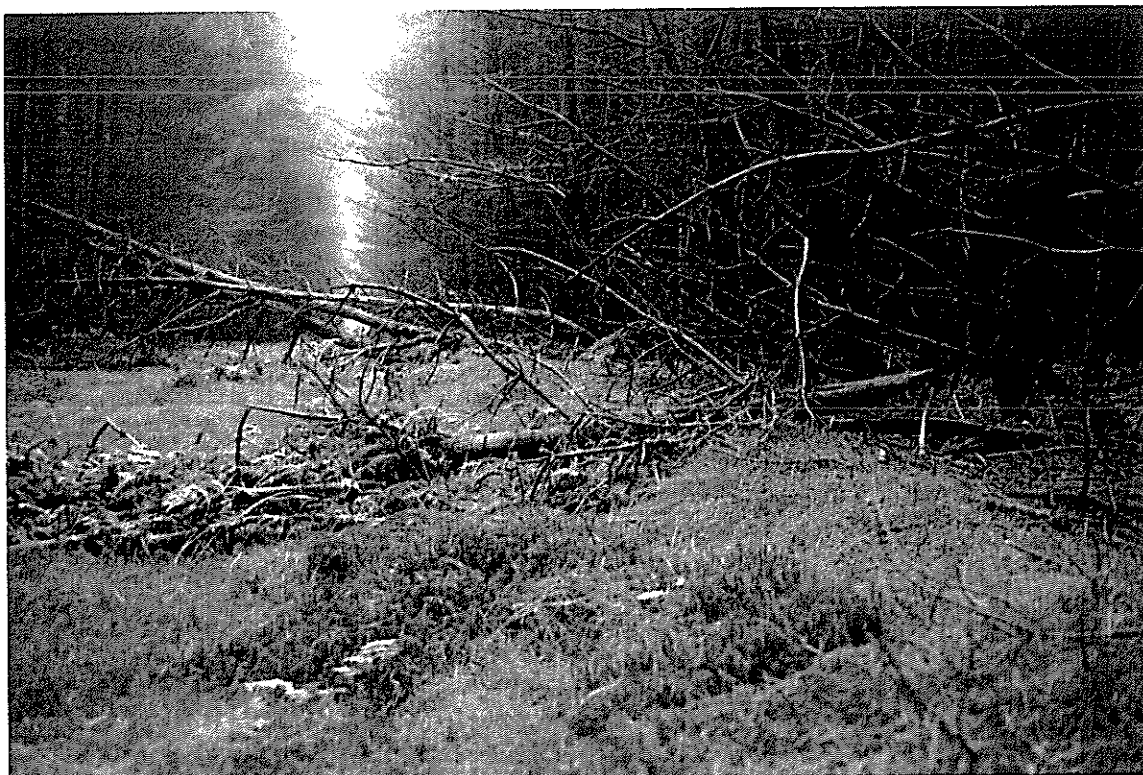
Photo 20.

35418. Boundary bank (*Photo 20*). Earth-built with some stone. 0.5m high, 2m wide, with a rounded spread, rounded profile. This boundary lies outside the coupe and should not be damaged by felling.

Value: 3

Recommendations: None
