OLD PRIORY ROAD ALLOTMENTS

ARCHAEOLOGICAL WATCHING BRIEF

REPORT NO. 2005/85
PROJECT RECORD NO. 54891

July 2005

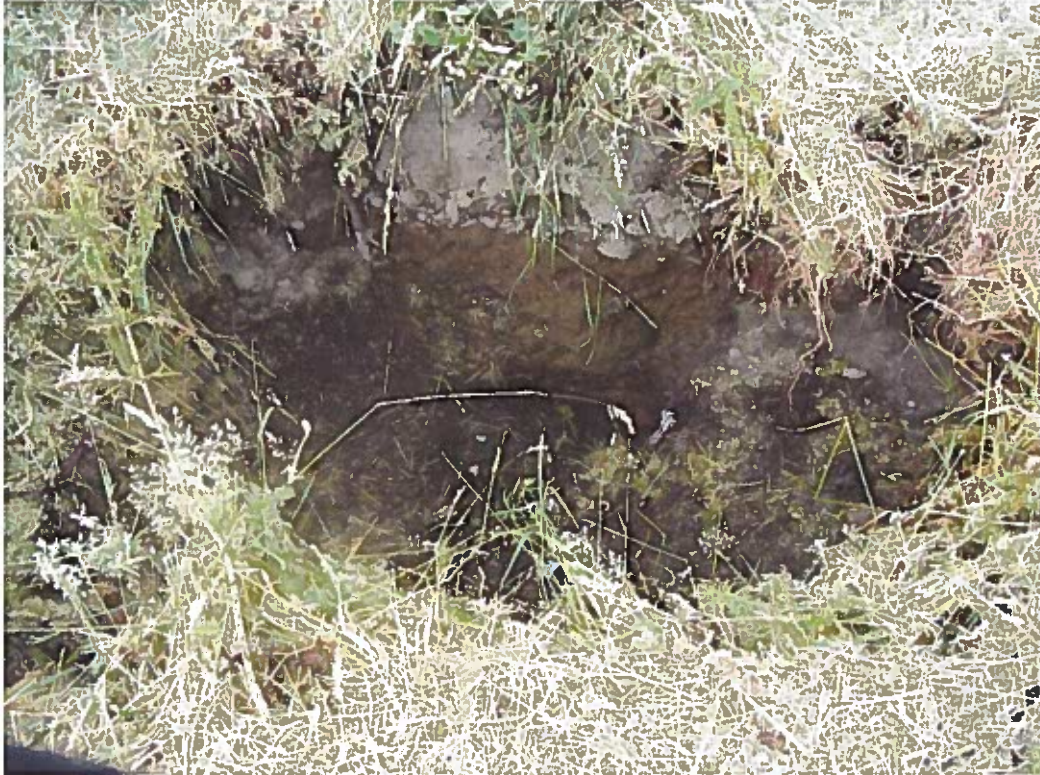
The initial collapse was identified in early July and it resulted in a hole c.1.5m x 1m x 1.5m deep. This exposed a soil profile consisting of c.40cm of loamy topsoil overlying light brown silty clay (Plate 1).

Plate 1: The hole caused by the initial collapse showing the topsoil and subsoil.

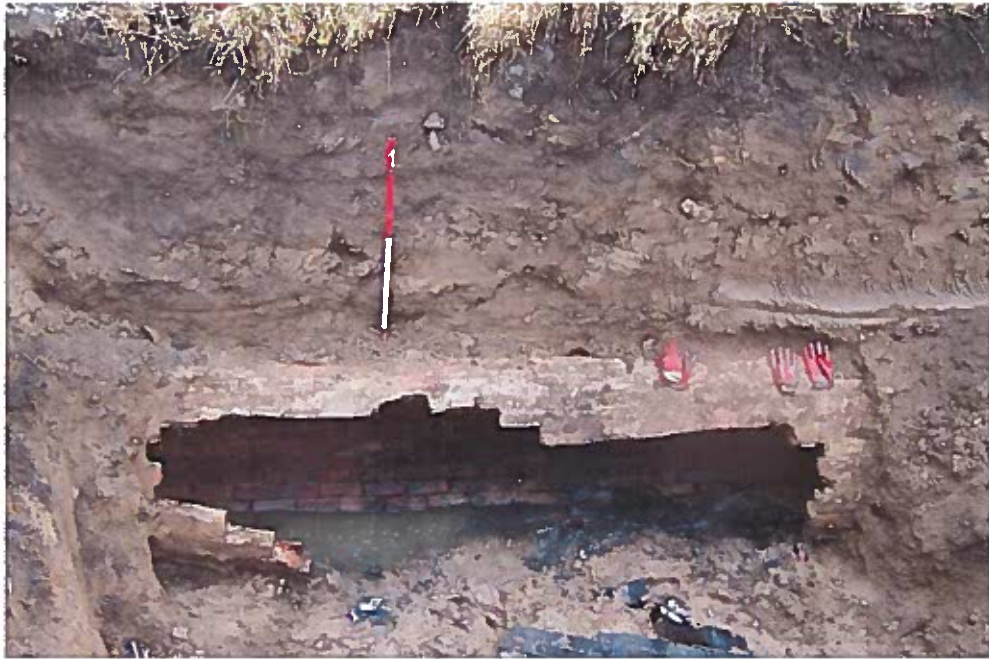
The northeast side of the trench revealed that the topsoil was of an average 40cm thick, although it increased to c.1m at the northwest end, where it appeared to fill a hollow in the clay. The underlying light brown silty clay extended down to the top of the arched culvert (Plate 2).

It was felt that the interface between the topsoil and subsoil would be the likely level at which deposits or features associated with the priory would be encountered. However, the recorded profile was directly above the culvert and, therefore, it must have been formed after the culvert was constructed and it was probably re-deposited during the backfilling of the original construction trench (see Plate 2).

Plate 2: The collapsed section of the culvert and overlying stratigraphy.

The culvert measured c.1m diameter and was constructed from red brick using a stretcher bond (see Plate 2). The base of the sewer was not investigated so it is not certain if it has a flat base or whether the culvert is completely circular.

The condition of the culvert in this area is of some concern, as it has apparently collapsed in the past (Zoë Bevans pers comm.). The previous collapse may be evidenced by the topsoil filled hollow visible in the northeast section (see Plate 2). It could be that the fabric of the culvert is degrading to a point where it may cause structural problems elsewhere.
