BUILDING RECORDING AT ALLT DDU, PONT LLANIO, TREGARON

Paratowyd gan Archaeoleg Cambria
Ar gyfer Mr K Price, Pentre Farm, Llanfair
Prepared by Cambria Archaeology
For Mr K Price, Pentre Farm, Llanfair

RHIF YR ADRODDIAD / REPORT NO. 2005/103
RHIF Y PROSIECT / PROJECT RECORD NO. 55177

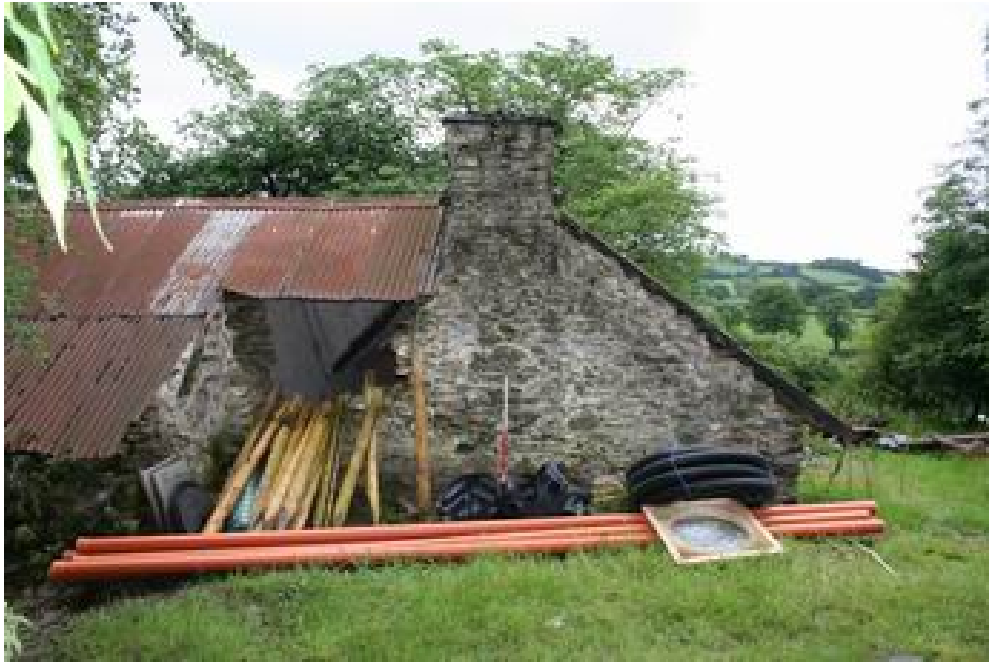
Photo 1: The upper (north facing) end of the dwelling.

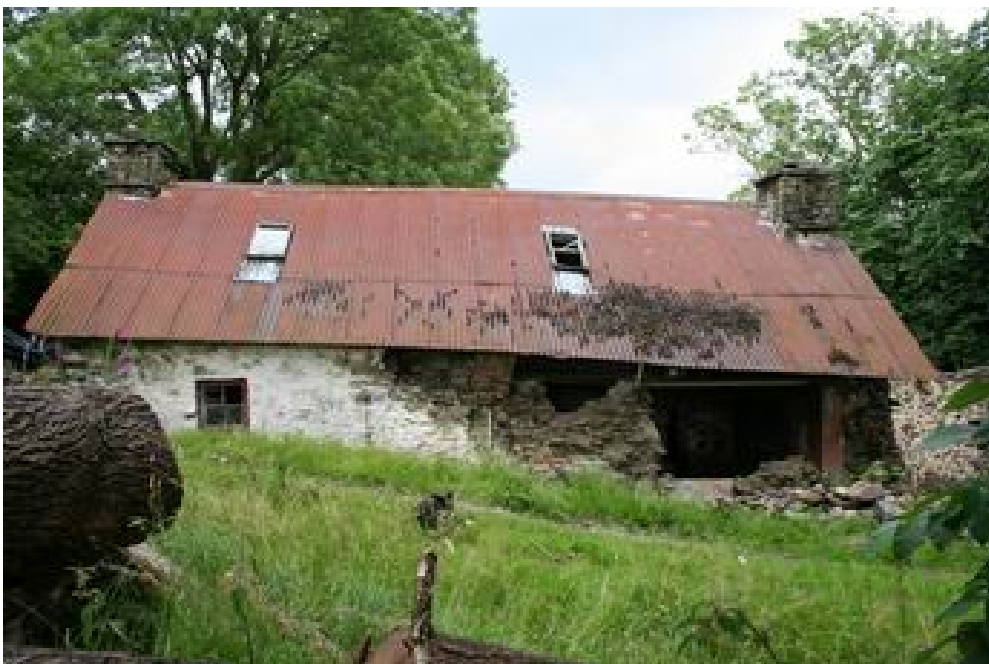
Photo 2: The rear (west facing) elevation of the dwelling.

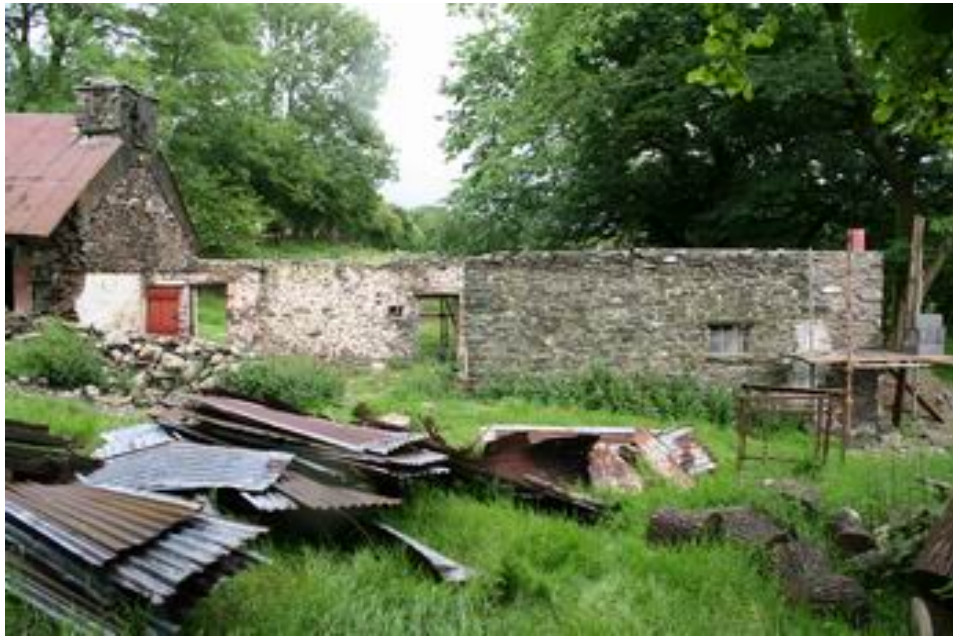
Photo 3: The rear (west facing) elevation of the downhouse.

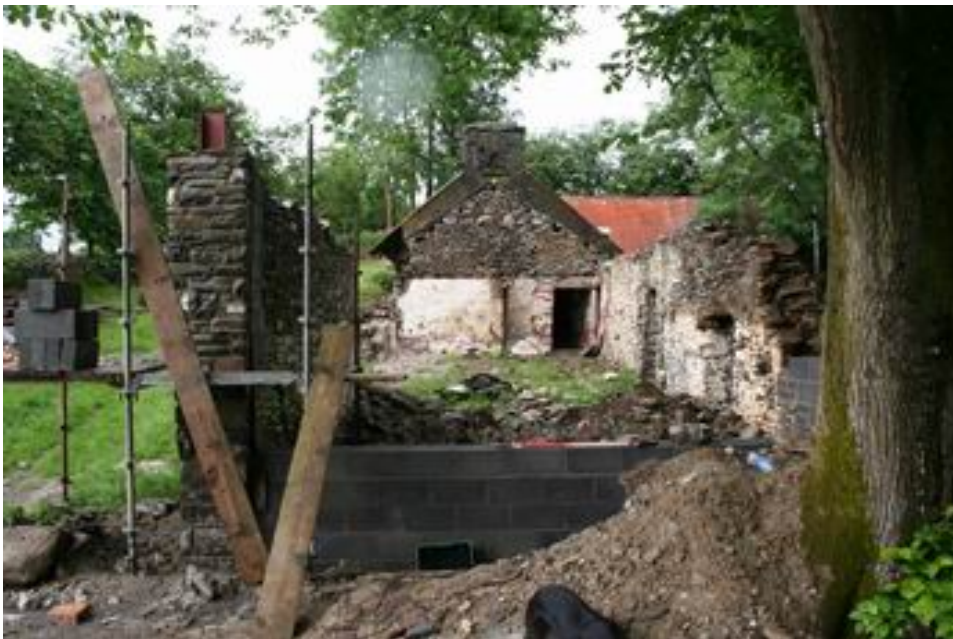
Photo 4: The lower (south facing) elevation of the downhouse.

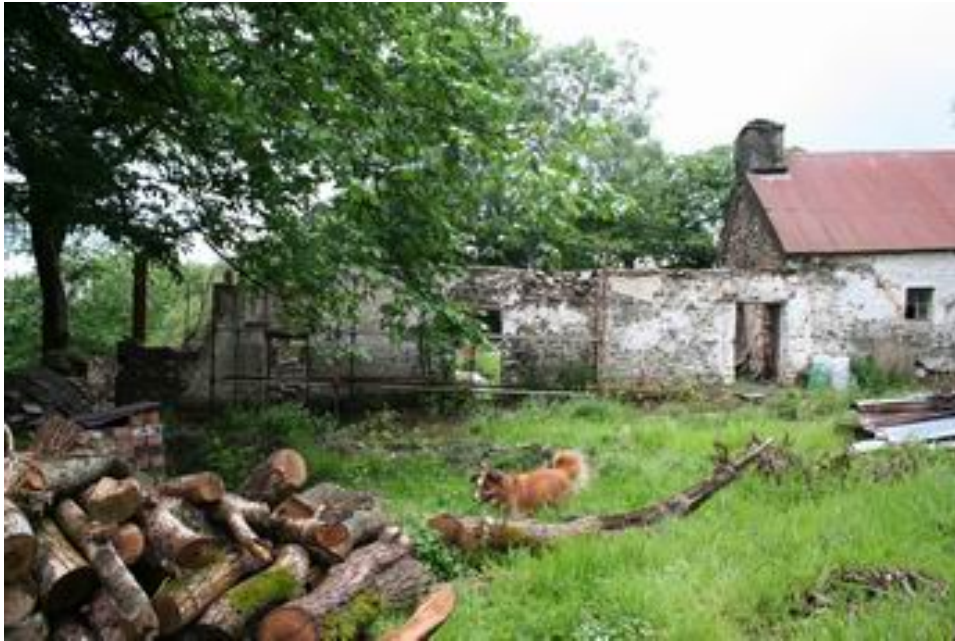
Photo 5: The front (east facing) elevation of the downhouse.

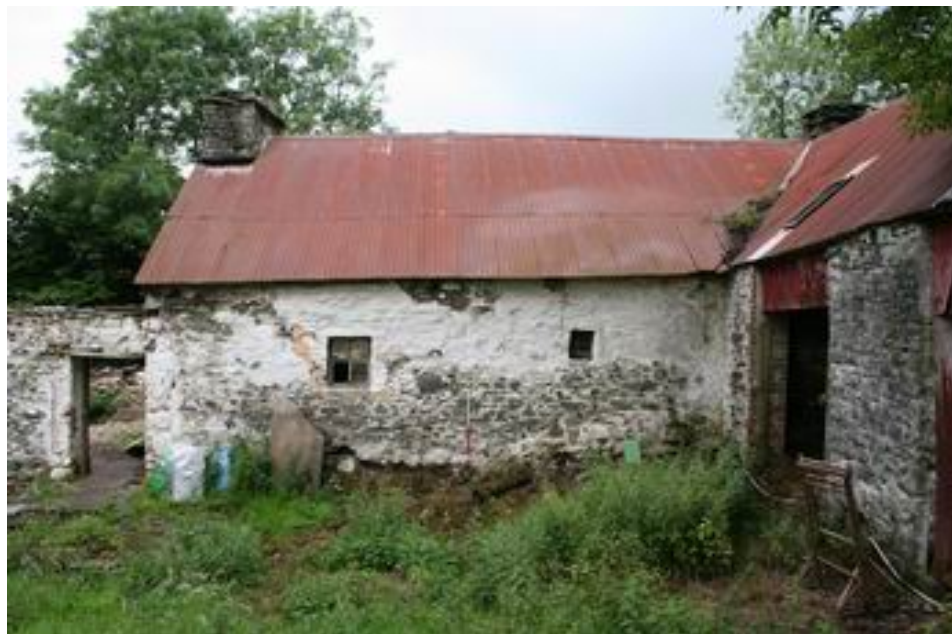
Photo 6: The front (east facing) elevation of the dwelling.

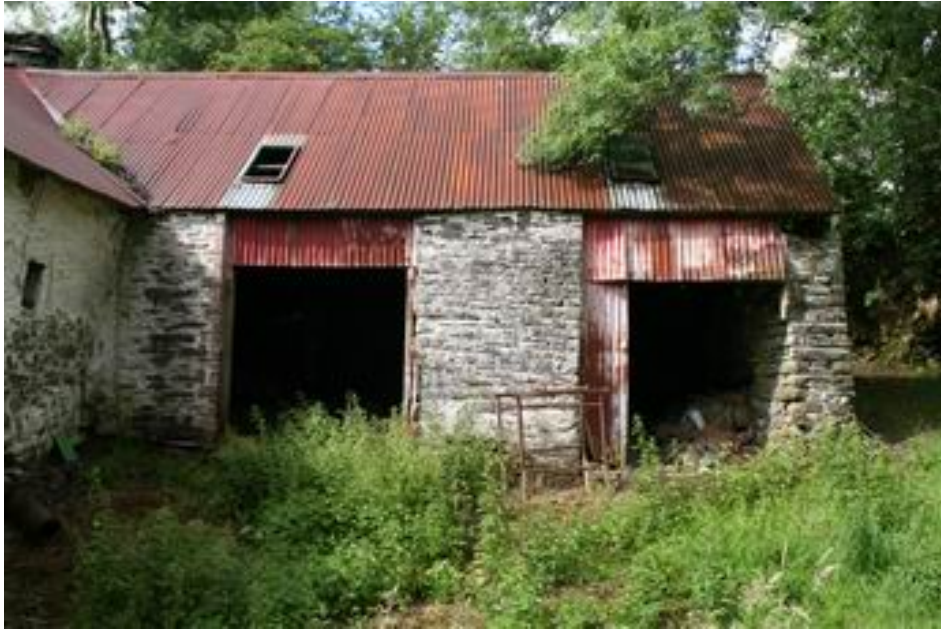
Photo 7: The front (south facing) elevation of the outbuilding.

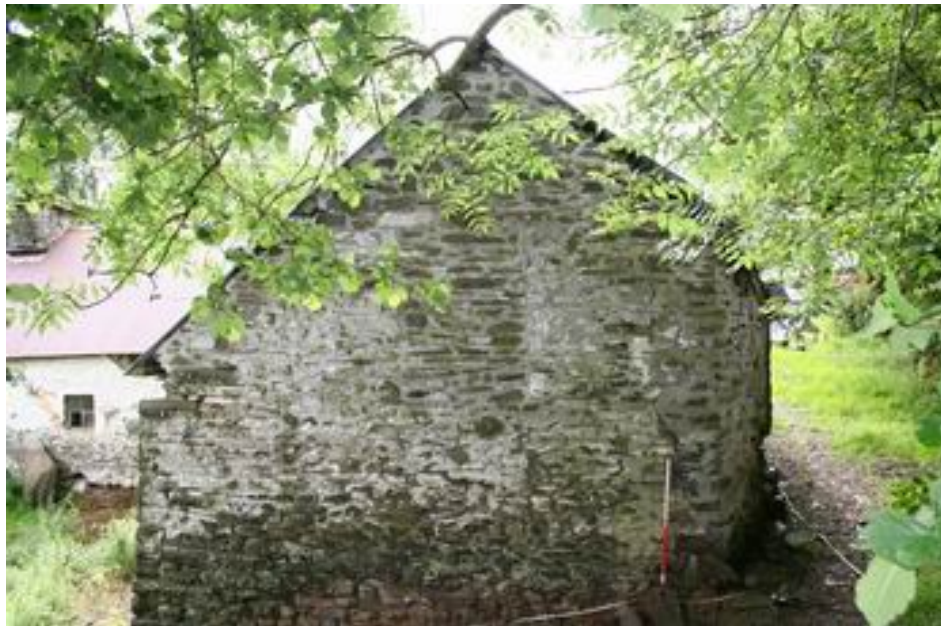
Against the transverse wall in the neighbouring room is a feed rack. Wall sockets represent a former hayloft above and there is blocked loading door in the east pine end.

Photo 8: The east facing elevation of the outbuilding. Note the blocked in loading door.

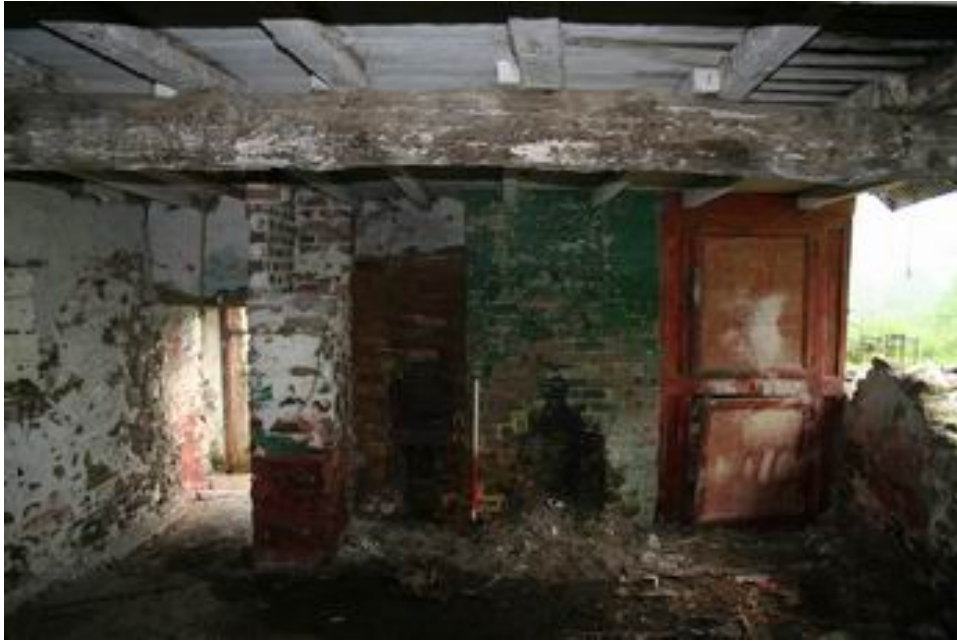
The first room from the entrance with its large fireplace was the main living room. The fireplace is paved with stone flags at floor level but does not otherwise retain any original features: it is presently infilled with a built in range and dry cupboard of the early 20th century and the lintel has been removed. This room is lit by two small windows in the east wall. A straight joint in the semi-collapsed west wall may have been another small window.

Photo 9: The dwelling interior looking south towards the main fireplace.

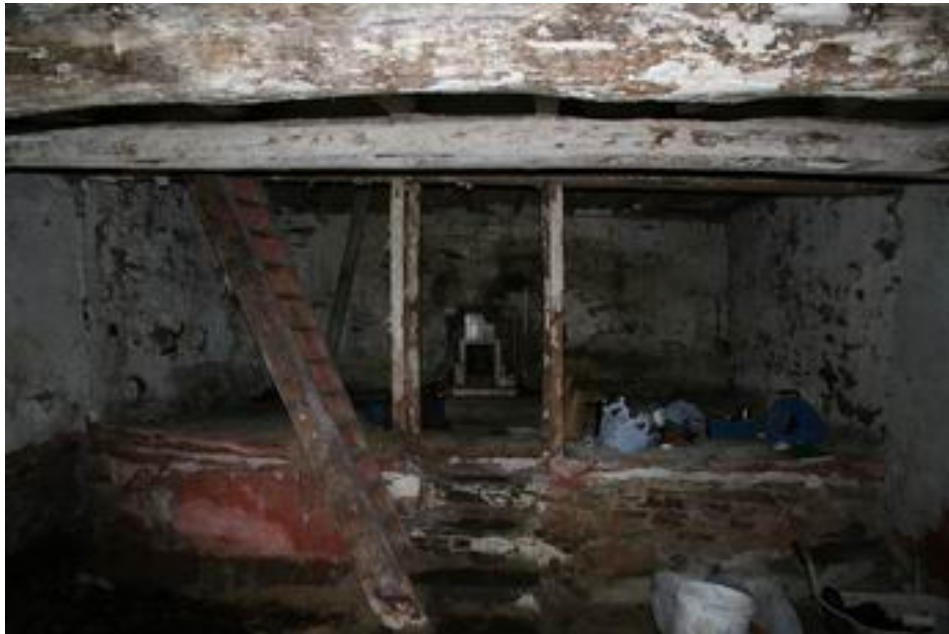
Photo 10: The dwelling interior looking north.

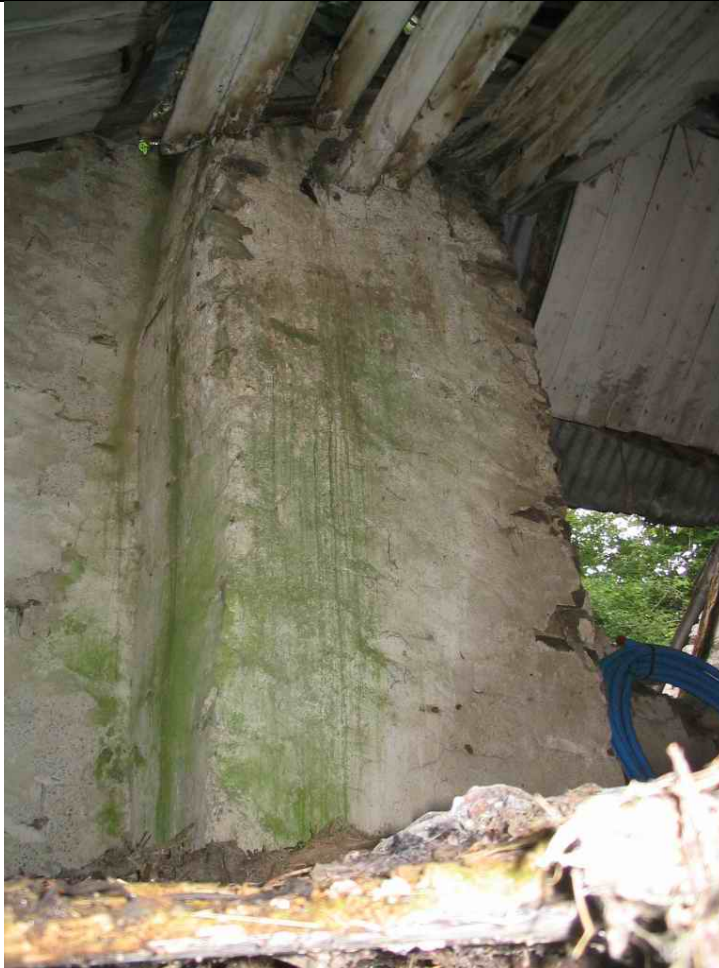
Photo 11: Loft interior looking north to flue of secondary fireplace.

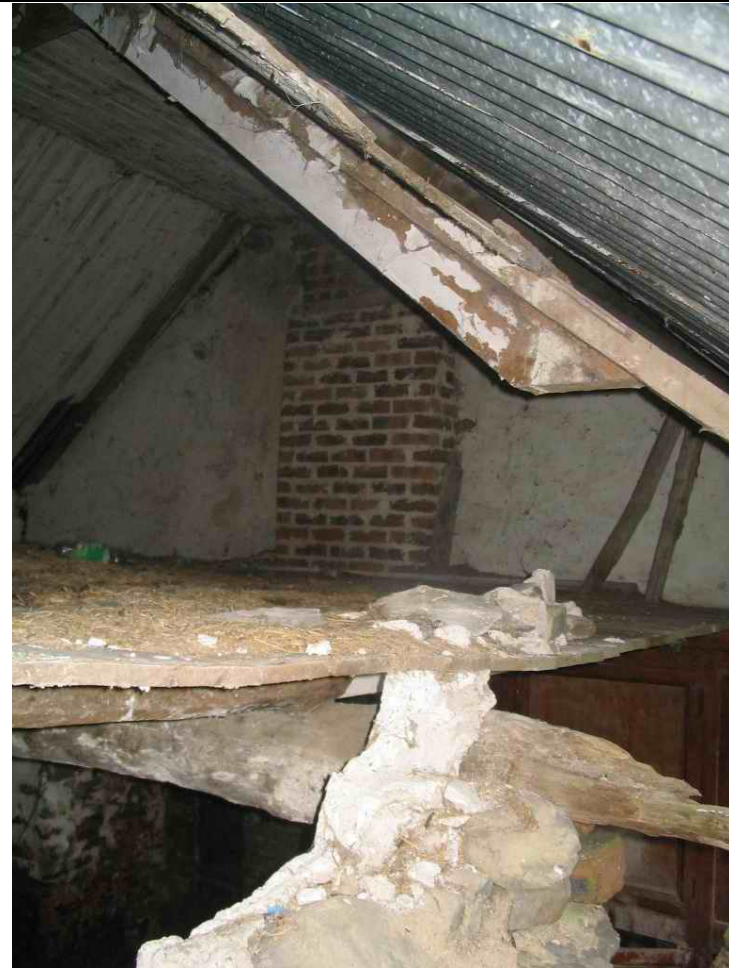
The dwelling end represents the earliest phase. It is of local rubble construction, clay mortar bonded with walls some 0.6m thick. The east (front) wall had been coloured yellow but the entire building was later whitewashed. The roof (now under corrugated tin) was formerly thatched. There are two fireplaces, the main one being situated in the transverse wall in the centre of the range. They are both constructed of stone with large stacks. The flue of the main fireplace was latterly replaced with brick.

Photo 12: Loft interior looking south to replacement flue of main fireplace.

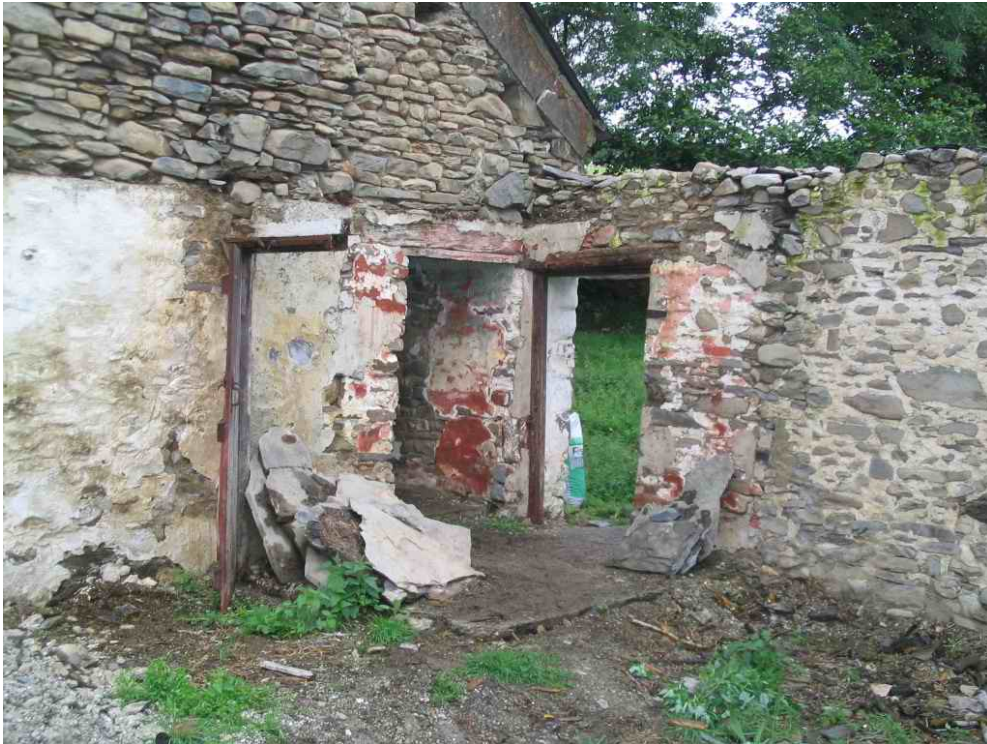
Between the dwelling end and downhouse are the brick wall bases of two small rooms; a small store and a lobby between the outside entrance and the living room doorway. Whether this respects an original arrangement or not cannot be stated with certainty. The store room has several successive layers of whitewash and the lobby is coloured red. Sawn off joists in profile in the wall above identify a former loft.

Photo 13: The downhouse interior – the store room and lobby.

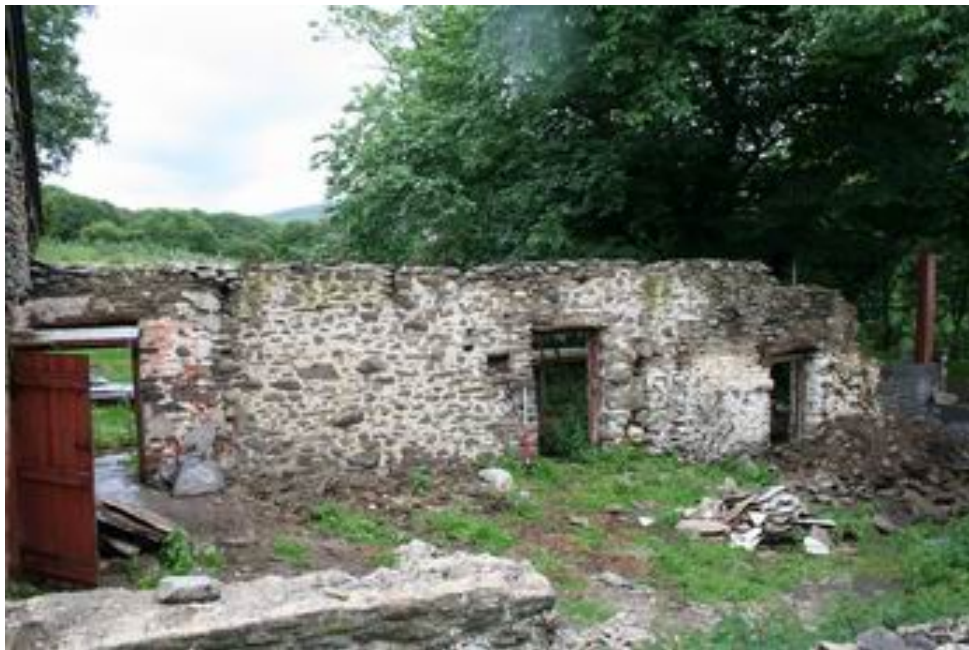
Photo 14: General view of downhouse interior looking south-east.

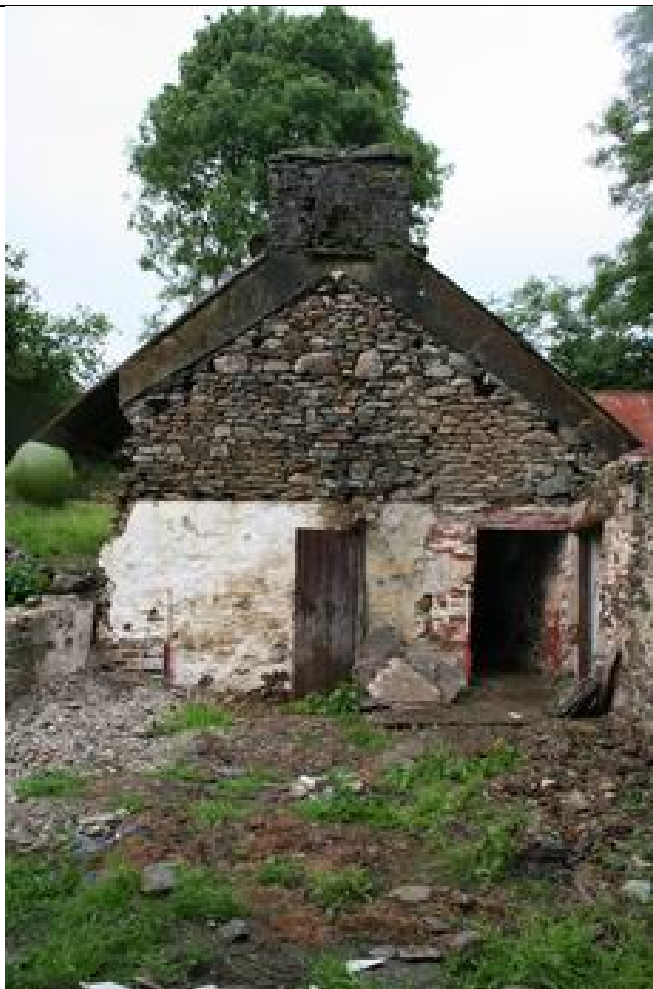
Photo 15: The downhouse interior looking north.

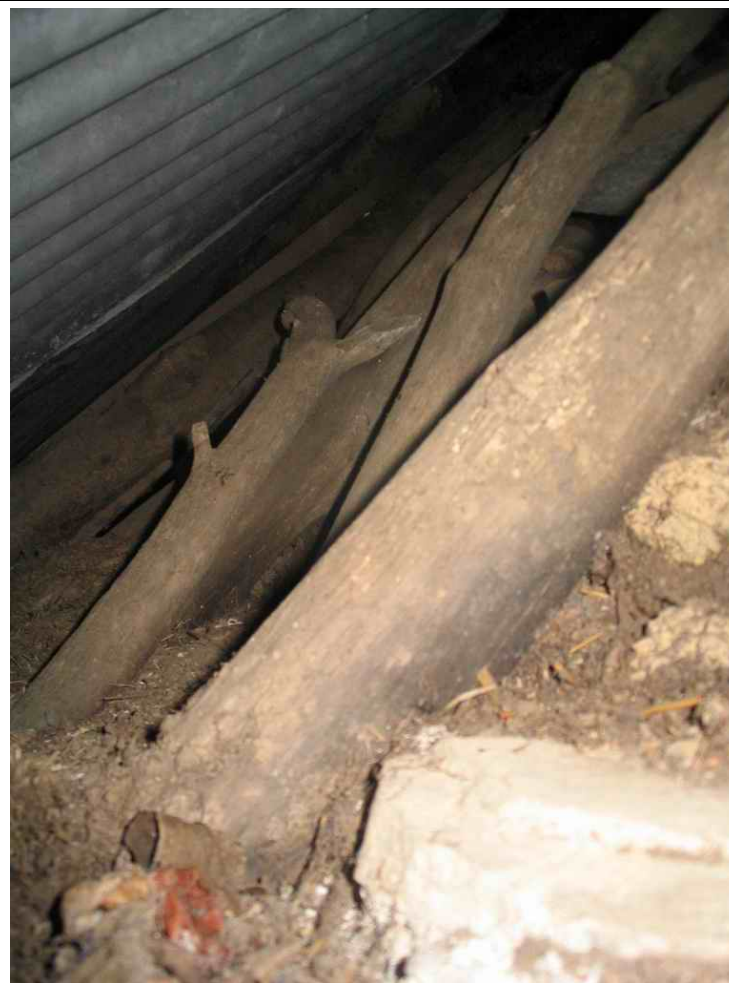
The present roof consists of insubstantial A-frame trusses and corrugated tin. No slots for cruck trusses were identified and it may be that the original roof used collar beam trusses. Remnant thatch consisting of rough branches laid close together and wooden spars pushed into turf clods and straw, was found beneath the eaves at the north gable end.

Photo 16: Rough branches and thatch beneath the eaves at the north gable end.

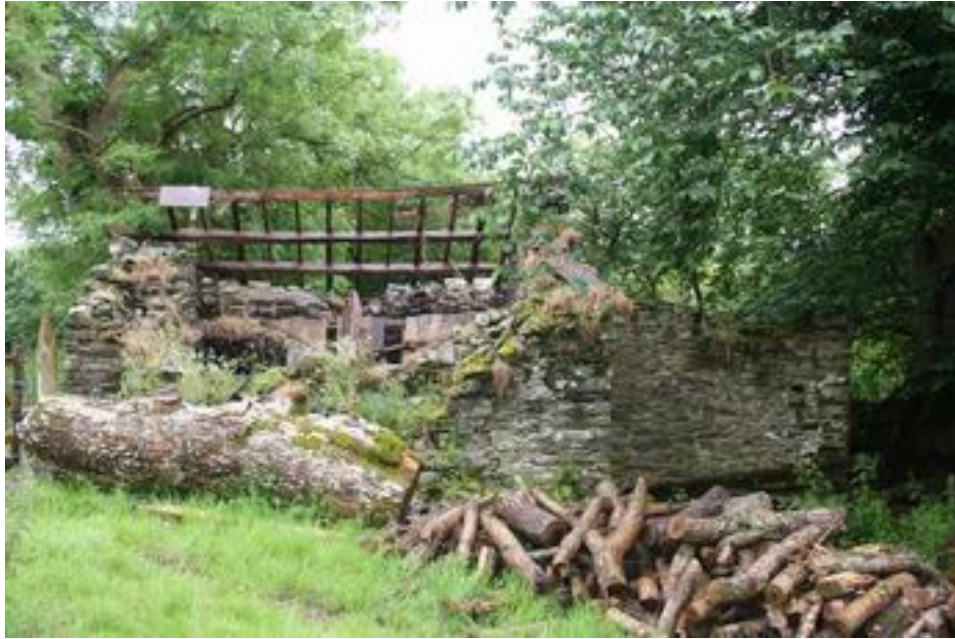
To the southeast of the longhouse is a small outbuilding consisting of a lofted cow house and lean-to pigsty. No record of this building was specified as part of the brief but because of its derelict condition a photographic record of the exterior was made and is included in this report.

Photo 17: The north facing elevation of the ruinous cow house.

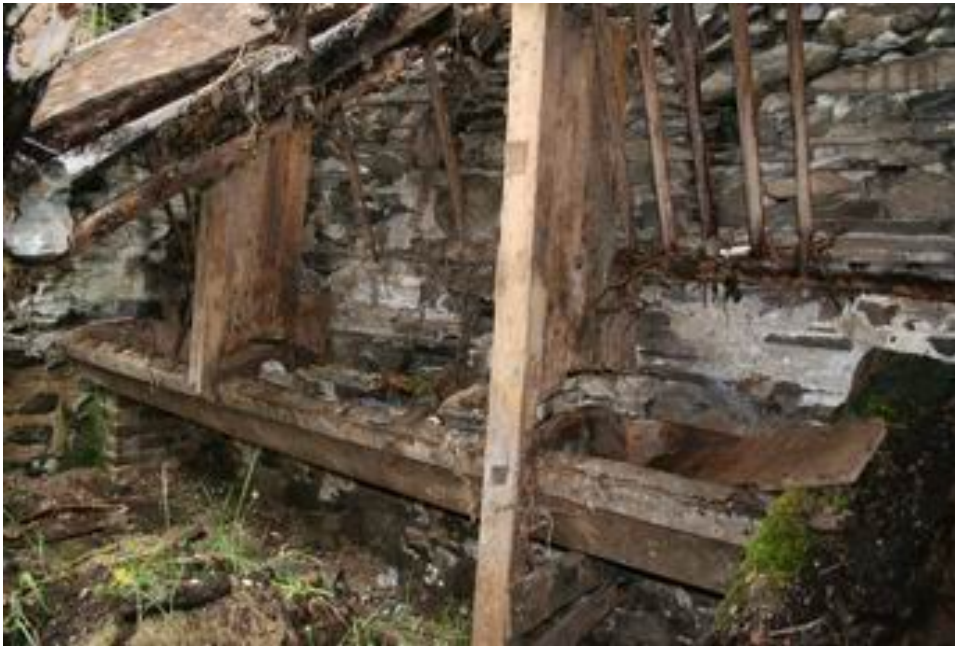
Photo 18: Cow house interior detail.
