FENTON HOME FARM, CRUNDALE, HAVERFORDWEST, PEMBROKESHIRE

**BUILDING RECORDING,
OCTOBER 2005**

RHIF YR ADRODDIAD / REPORT NO. 2005/120
RHIF Y PROSIECT / PROJECT RECORD NO. 55439

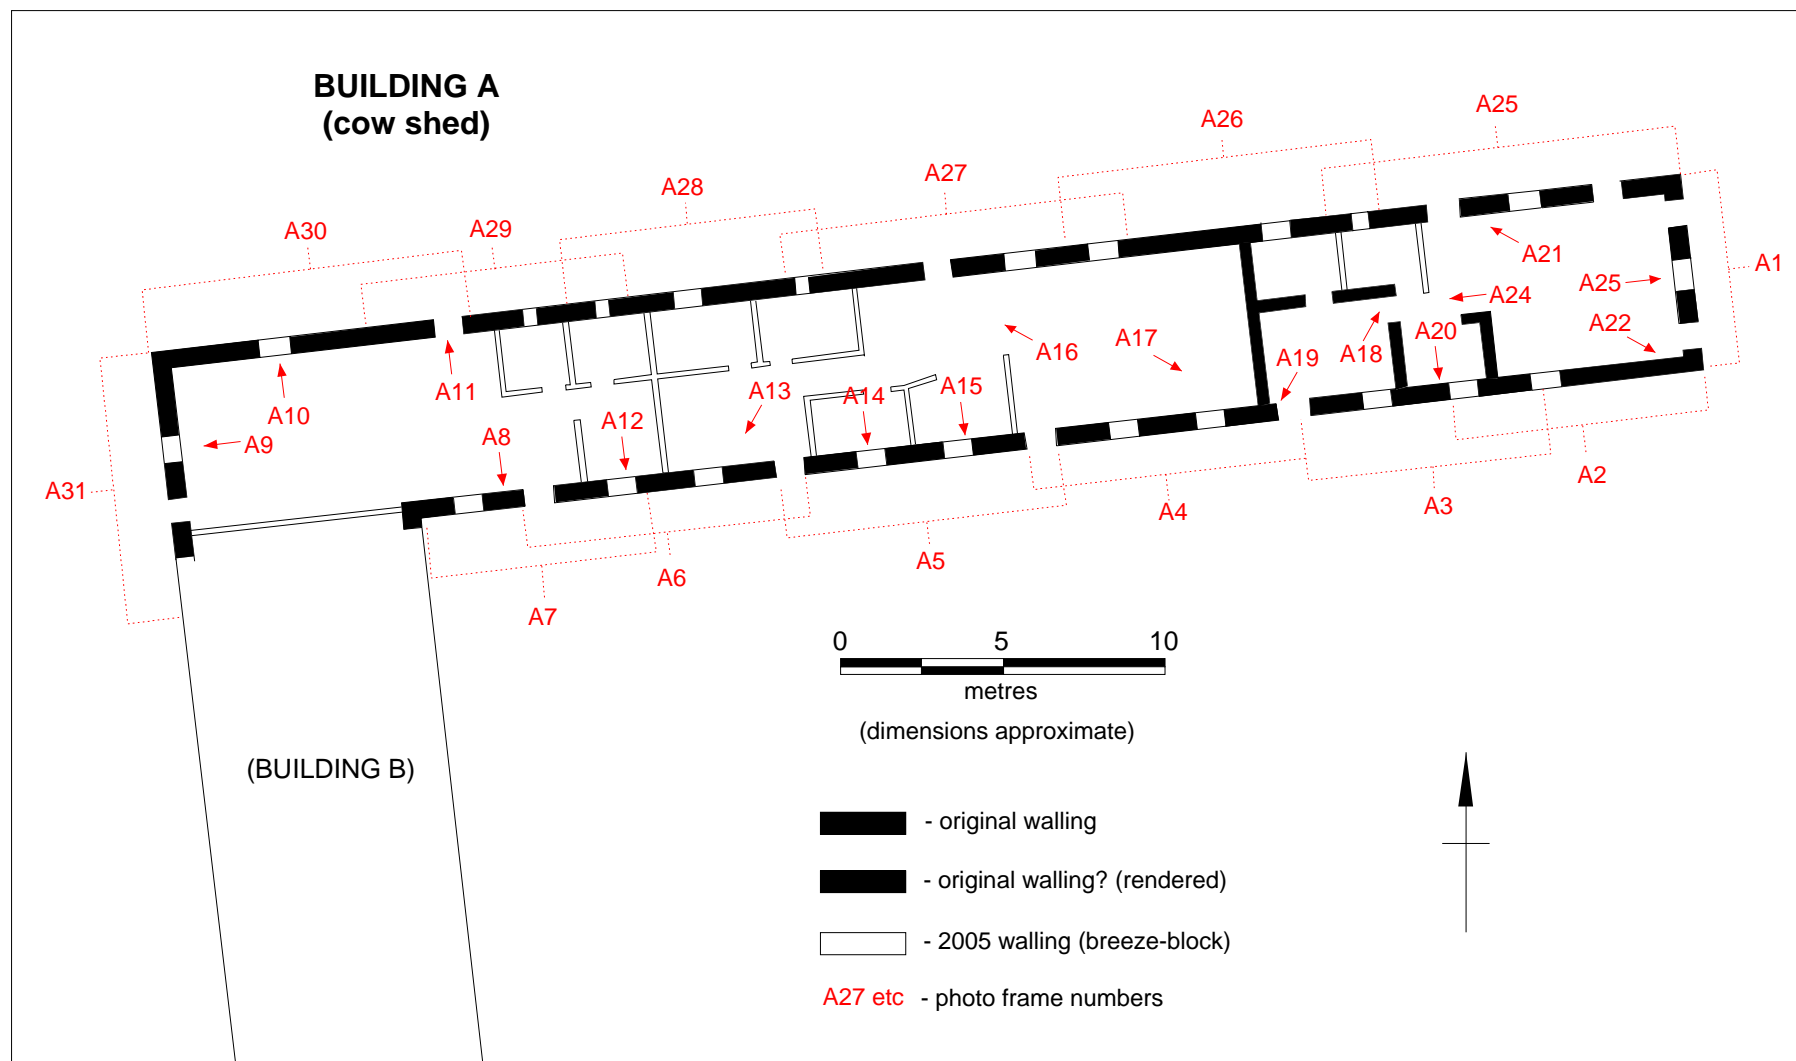
Fig. 4 - Building A

The buildings were already under conversion when the site was visited, with new roofs and concrete-screed floors, while the wall-tops had been raised to form level wall-plates in breeze-block. Most internal features had been lost, a number of internal partitions, in breeze-block, having been inserted, while much of the internal wall surface had been roughcast. Nevertheless, most of the original window- and door-openings survived and formed a regular rhythm, particular on the south side of Building A. They define six bays, each with a doorway and two windows to the south (towards the yard), except the eastern- and westernmost bays which feature entries in the end walls. A number of the north wall windows have been rebuilt, or are new, smaller insertions following the style of the original, in slightly harder, bluer bullnose brick. The two doorways and window in this wall are original, and it may be that they relate to a double feeding-passage system along the side walls, with the stalls between them. The pigeon holes above these openings, high up in the gable, are *de novo* introductions from 2005 and imitate original features seen elsewhere on the farm. The doorway and window in the west gable wall were (re)built in 2005, and the gable above rebuilt in breeze-block. This westernmost bay may have been a feed-preparation area.

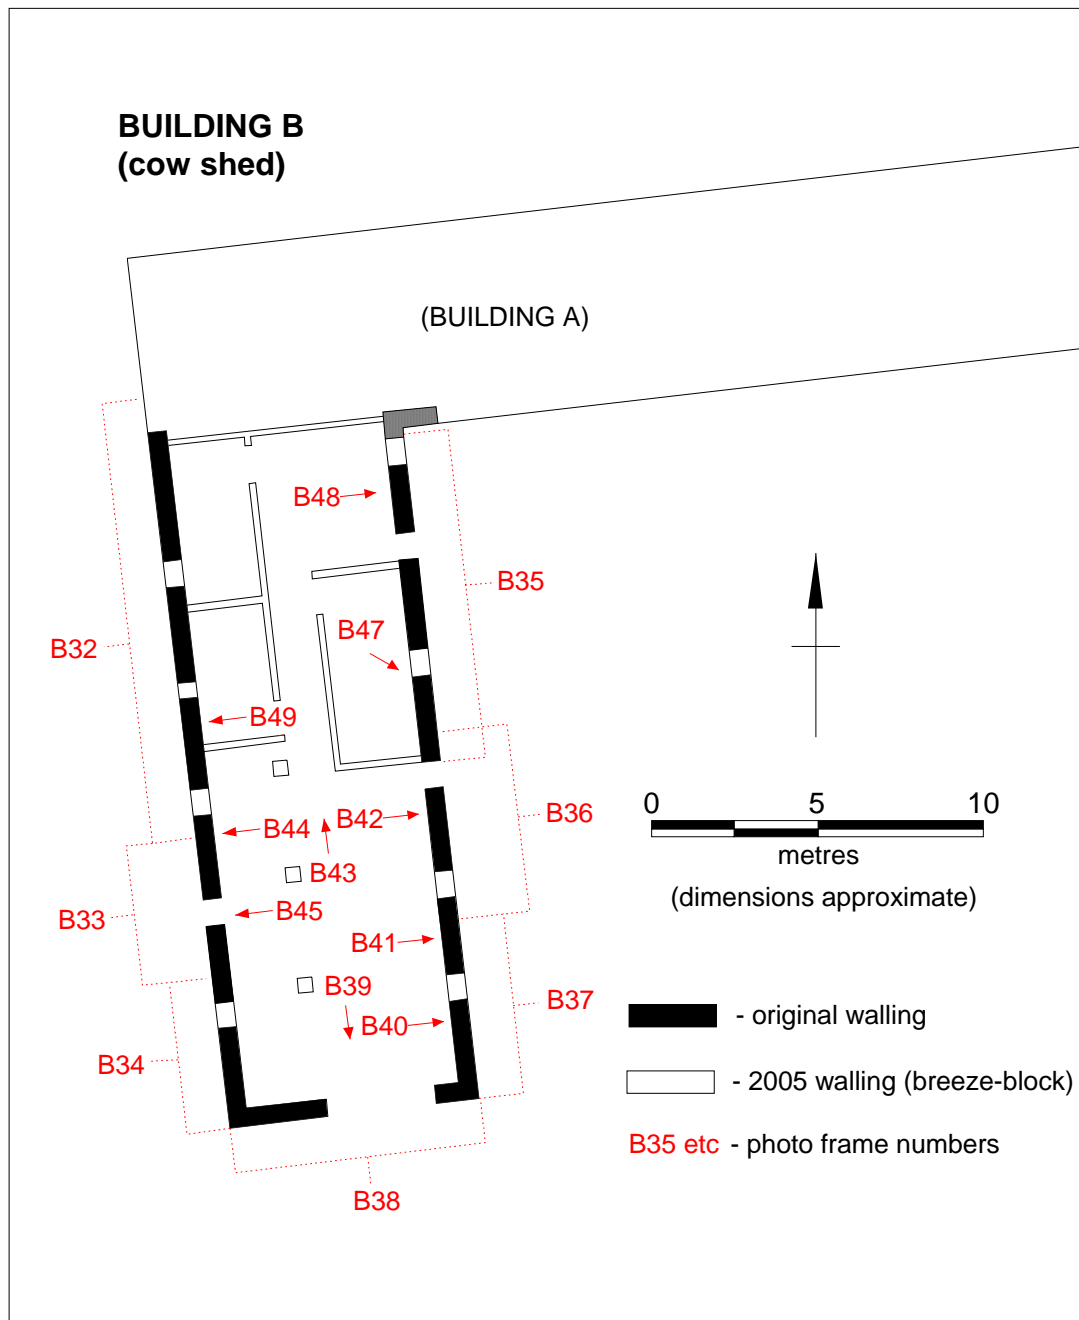
Fig.5 - Building B

Building B comprised three bays, again defined by four windows and two doorways in the east wall, towards the yard, and four windows and a doorway to the west; not all windows here may be original. There is a wide entry in the south, end wall which is probably original, but has been rebuilt; the gable above has been rebuilt in breeze-block during 2005.

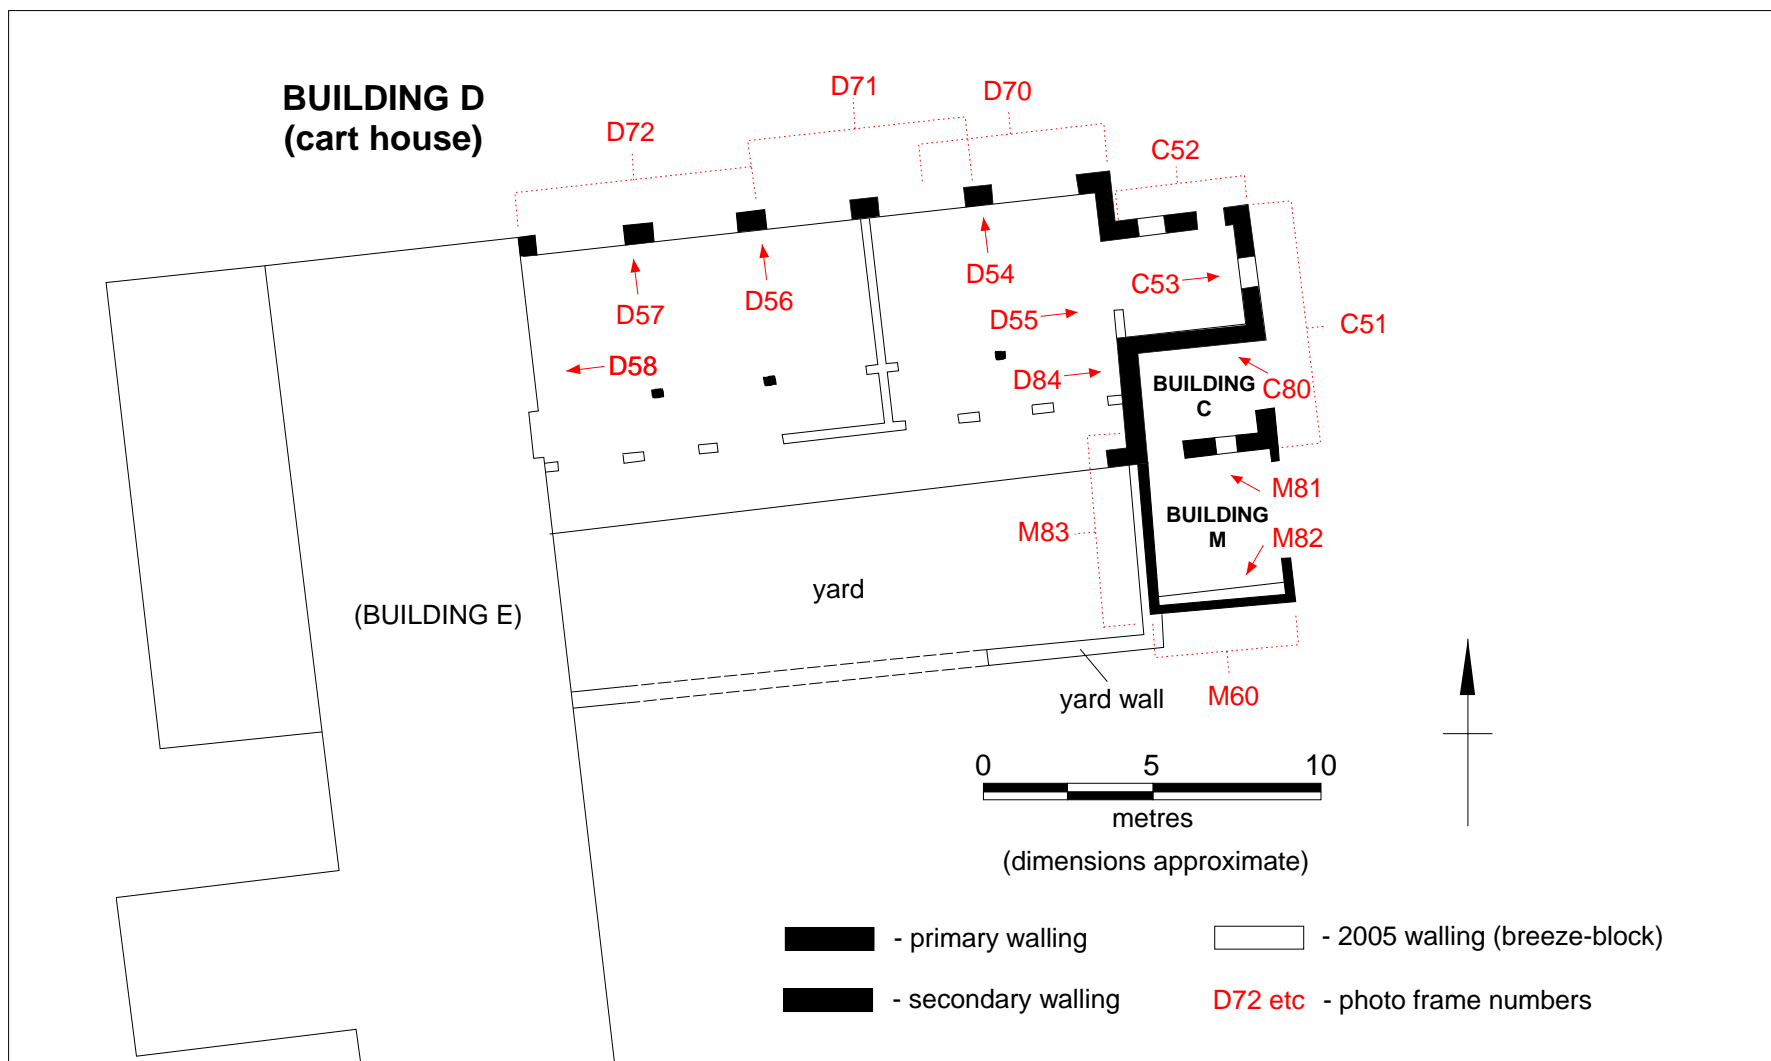
Fig. 6 - Buildings C, D and M

Building D has been much altered, both during 2005, and earlier. Its south wall had entirely gone, having been removed sometime prior to 2005 and replaced by an open side, the roof eaves being supported on an iron joist (now gone). By October 2005, a number of breeze-block partitions and pillars had been built, replicating the spatial division of the building. The roof, formerly gabled, had been taken off and the floor covered with a concrete screed.

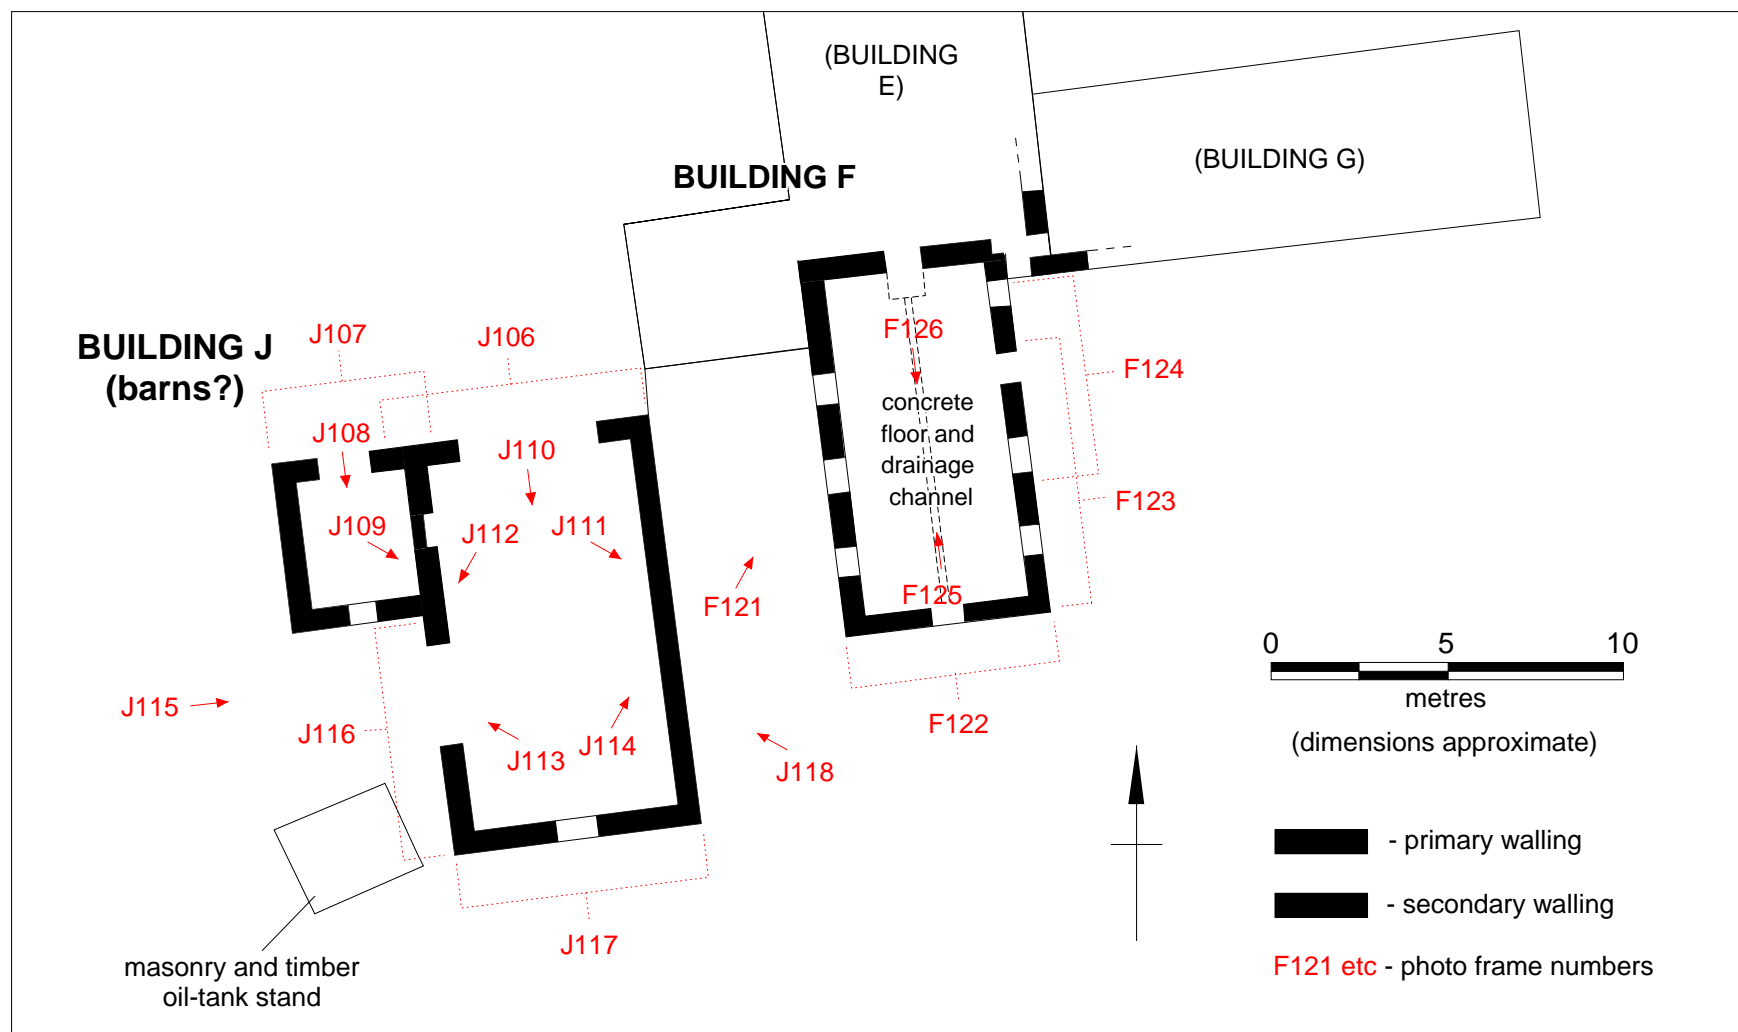
Fig. 8 - Buildings F and J

Both buildings may have been barns. They had not been affected by the 2005 development, and were in fair condition, but under a heavy growth of ivy.

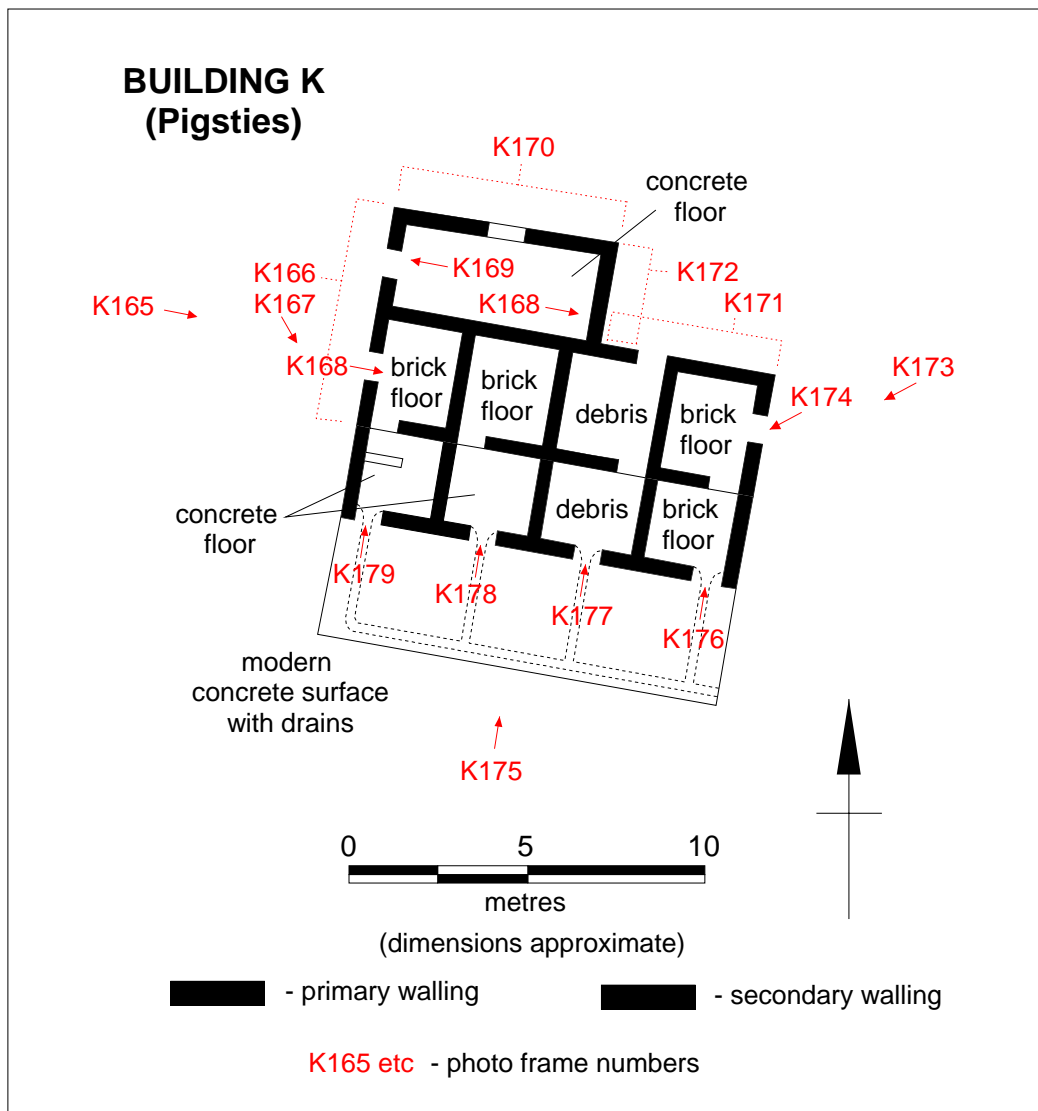
Fig. 10 - Building K

The building had not been affected by the 2005 development, and was ruinous, roofless and partly obscured by heavy vegetation growth.

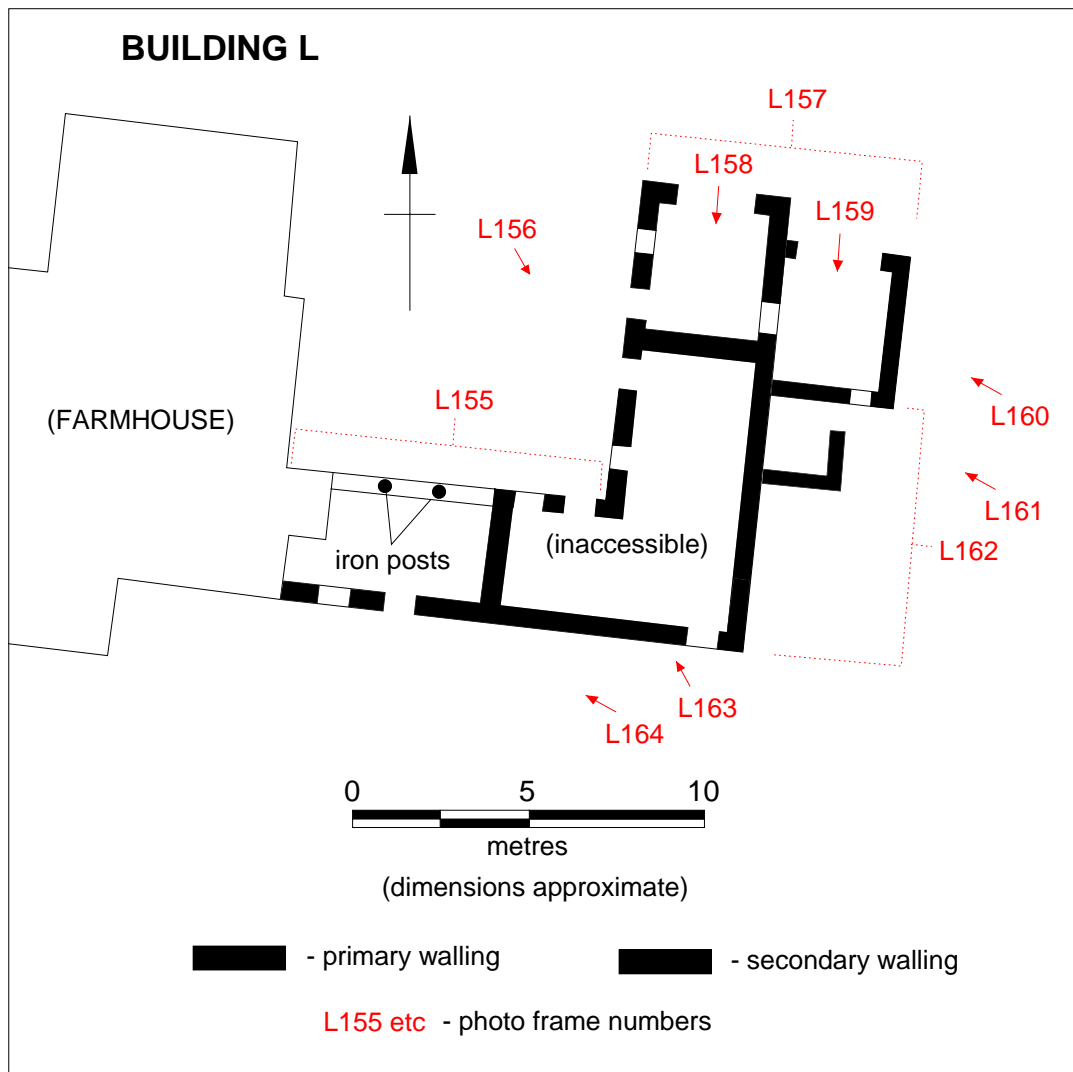
Fig. 11 - Building L

Building I had not been affected by the 2005 development, and was largely in good condition. A small 'shed' lies in the angle between the east wall of the building and the annexe; it is ruinous but appears to be secondary. Nevertheless it is shown on the 1889 Ordnance Survey map.
