# **FLOOD ALLEVIATION WORKS AT MONKTON BRIDGE, PEMBROKE A WATCHING BRIEF**

May 2006

**ARCHAEOLEG CAMBRIA ARCHAEOLOGY**  
RHIF Y PROSIECT / PROJECT RECORD NO. 56897  
RHIF YR ADRODDIAD / REPORT NO. 2006/62

Gan / By  
**Duncan Schlee**

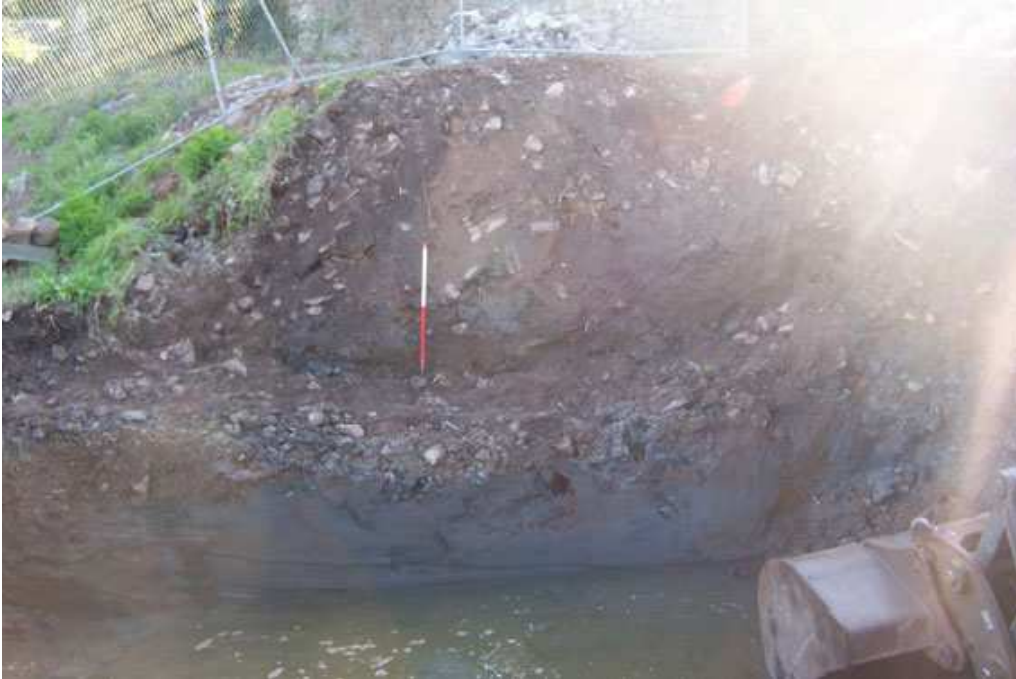
To the west of bridge wall (O), the exposed deposits consisted of modern made-ground overlying water-lain silty and gravely deposits (Q and P). These layers were deposited against the west wall of the bridge by tidal deposition (after the construction of the bridge, but before the water levels in Monkton Pill were artificially controlled to their current level well below the high tide).

**Photo 1:** Deposits to west of the bridge

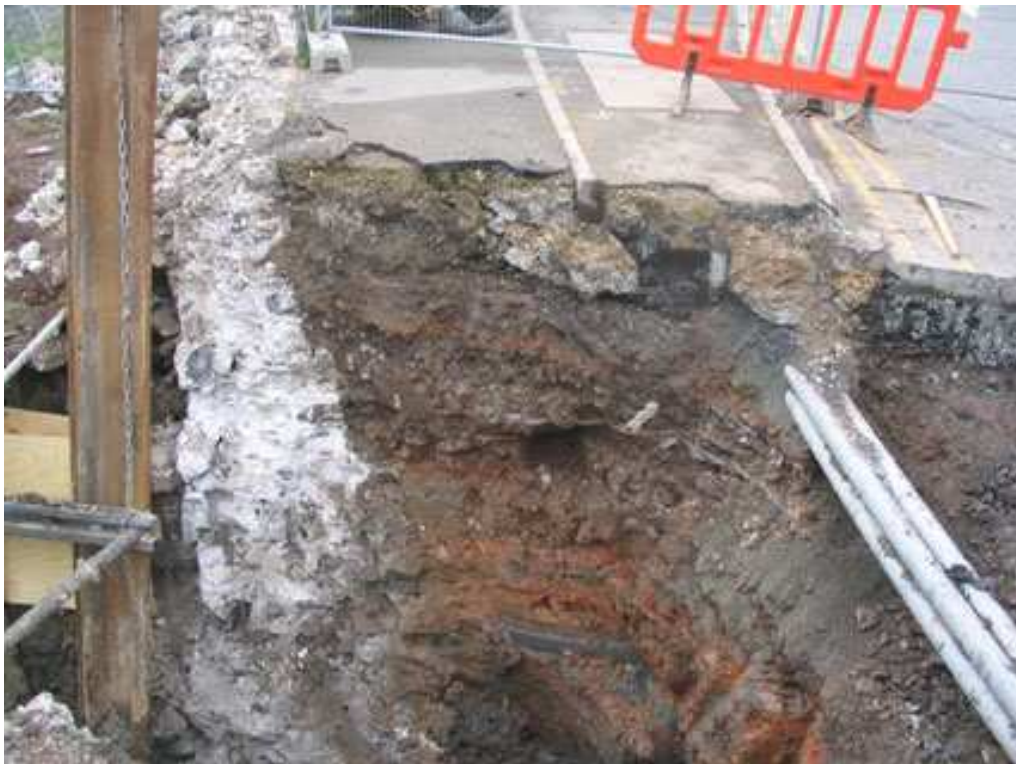
The west wall of the bridge was cut through and revealed in section (photo 2). Above ground the wall was 1.0m high and 0.70m wide at ground level. Below the ground surface, the wall was found to be of good stone rubble construction, roughly faced on its western side and almost vertical except for a step out at the level of the construction cut, to a total depth of 4.0m from the current pavement level. The east side of the wall was un-faced and stepped out at two points as it descended. The first step at the level of the earlier road surface (E), the second at the base of the road make-up deposits (D). At its base, the wall was 1.6m thick.

The construction, mortar type and general appearance of the west wall of the bridge did not suggest that it contained more than one phase of construction. No repairs were apparent and in this location at least, there was no evidence to suggest that the wall had medieval origins. Although the east wall was not observed in section, it is assumed to be contemporary with the west wall and not to be of medieval origin.

**Photo 2:** Section through wall, road and backfill deposits

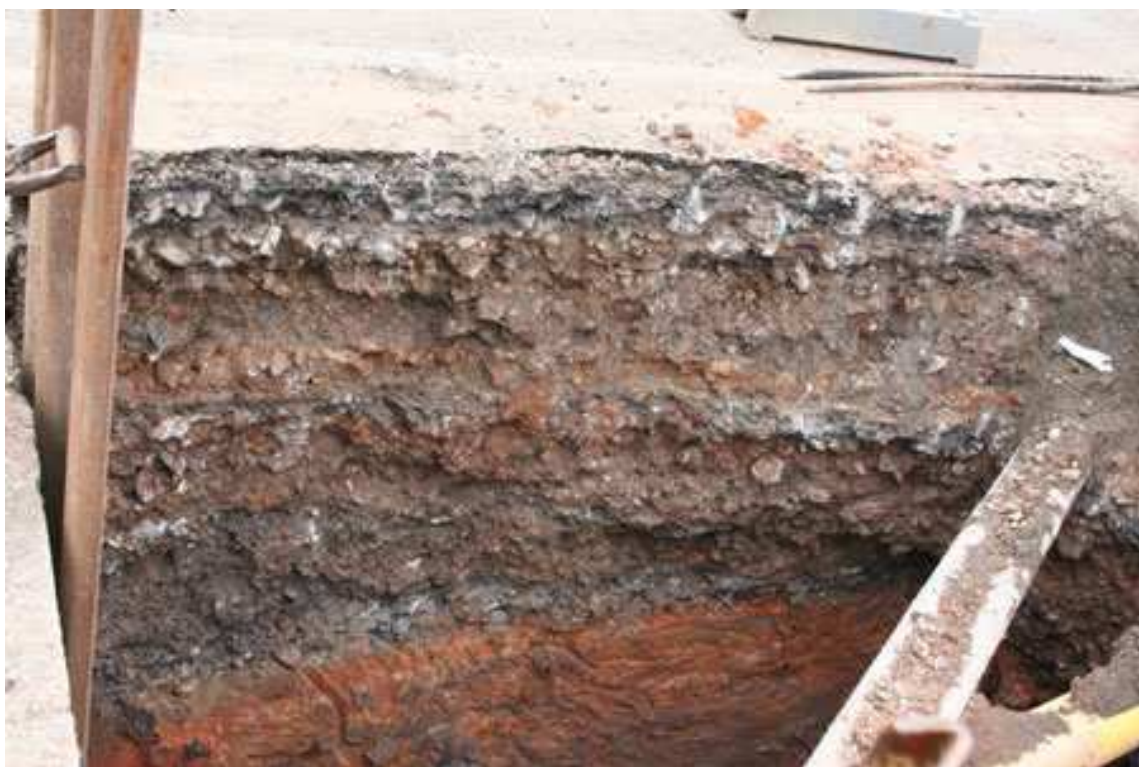
Above the backfill deposits (A, B, and C) are a series of road make-up layers consisting of laminations of stone and chippings in a different soil matrices (D) topped by a surface of highly compacted road-stone (E). This group of deposits

The earlier road surface was overlain by another deposit of road make-up (F) up to 0.40m thick, upon which was constructed the modern tarmac road surface (G), up to 0.25m thick. These deposits were also truncated by numerous service trenches (R).

**Photo 3:** Detail of road deposits

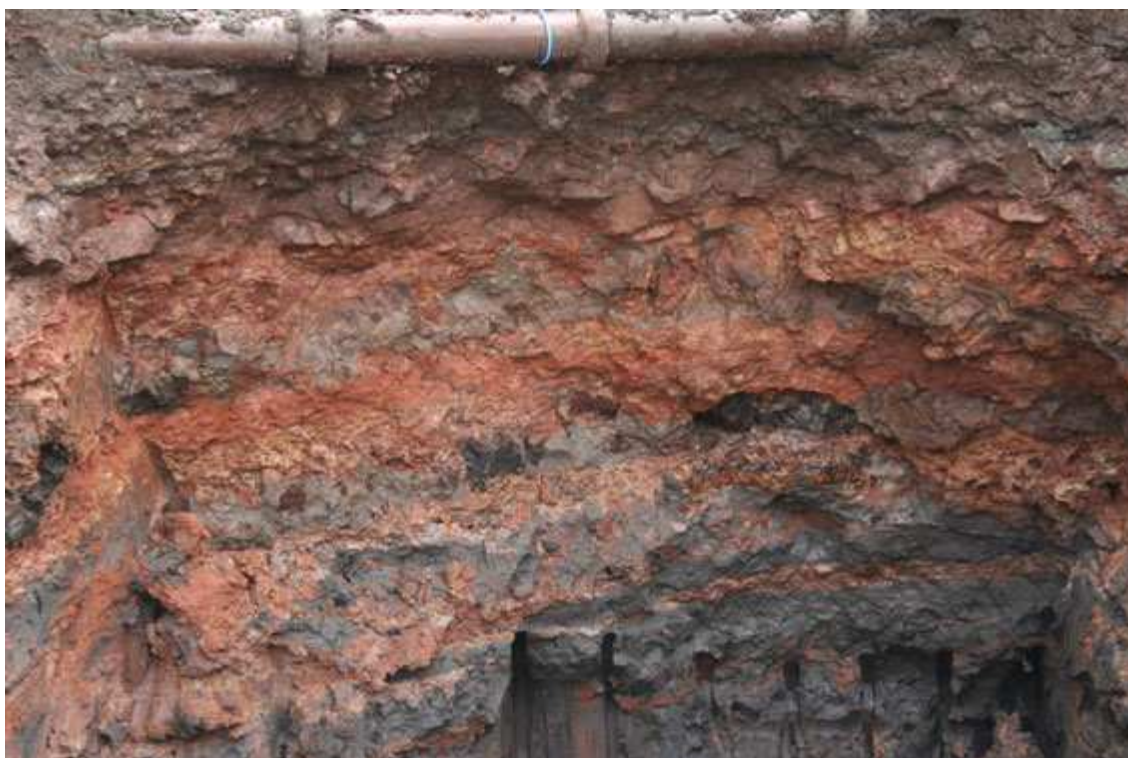
Deposit (B) is overlain by a markedly different deposit (C), which is generally orange in colour, up to 0.70m thick and contains several laminations (see photo 4). Although different in colour, and more mixed, this deposit may in fact be similar material to the grey silty clay but in an oxidised, ferrous-rich form. It is assumed that both these backfill deposits are derived from the material removed from the construction cut for the bridge.

**Photo 4:** Detail of redeposited orange silty clay deposits

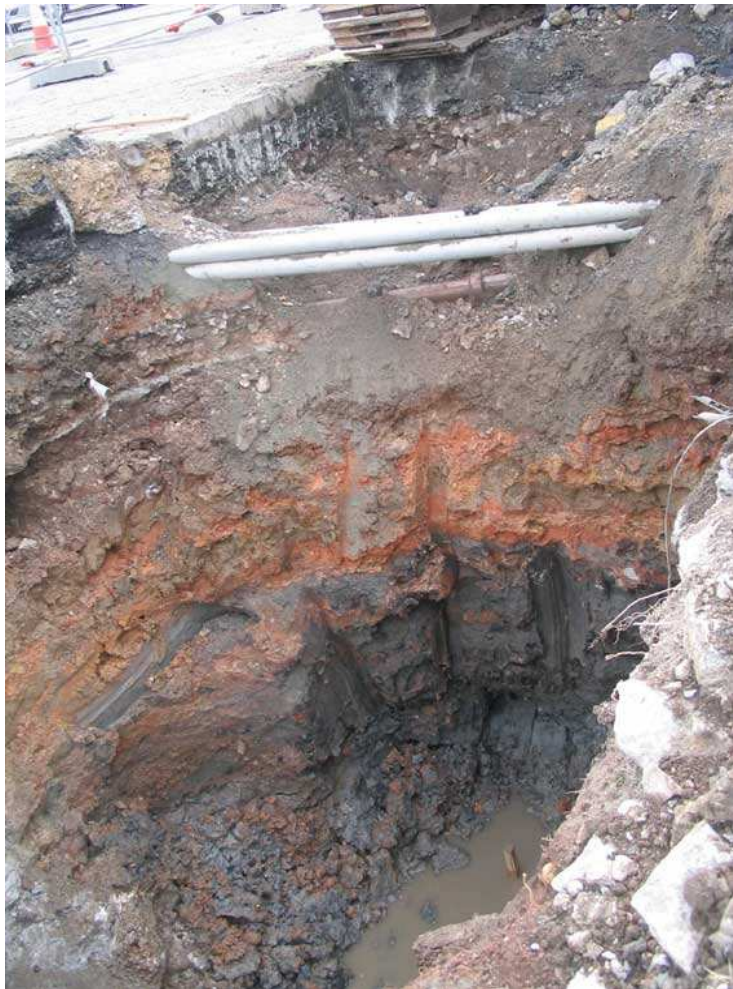
Above the stoney layer was a deposit of grey silty clay (B) containing occasional stones and fragments of waterlogged wood. This layer was a maximum of 1.30m thick, and towards its upper limit was mixed with several laminations of material from the layer above (see photo 5). The grey deposits have been interpreted as re-deposited natural silts and clays. No dating evidence was recovered from any of these deposits.

**Photo 5:** The complete sequence of backfill deposits

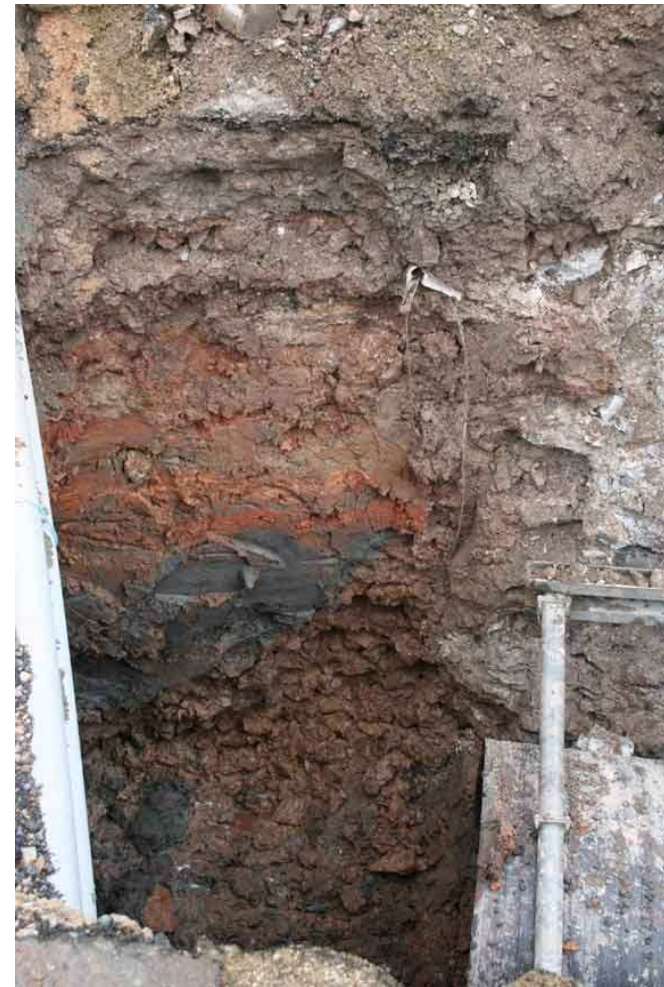
The lowest backfill deposit between the two bridge walls was a mixture of stone, sand, silt and grey clay (A) which lay against the inside face of the west wall. This was more clearly demonstrated by an isolated deposit of stone rubble in the southern side of the construction trench (see photo 6). A similar relationship is assumed for the east side of the bridge although the opportunity to record this during the trench excavation was missed.

**Photo 6:** Detail showing rubble at base of wall and Sealed by backfill deposits

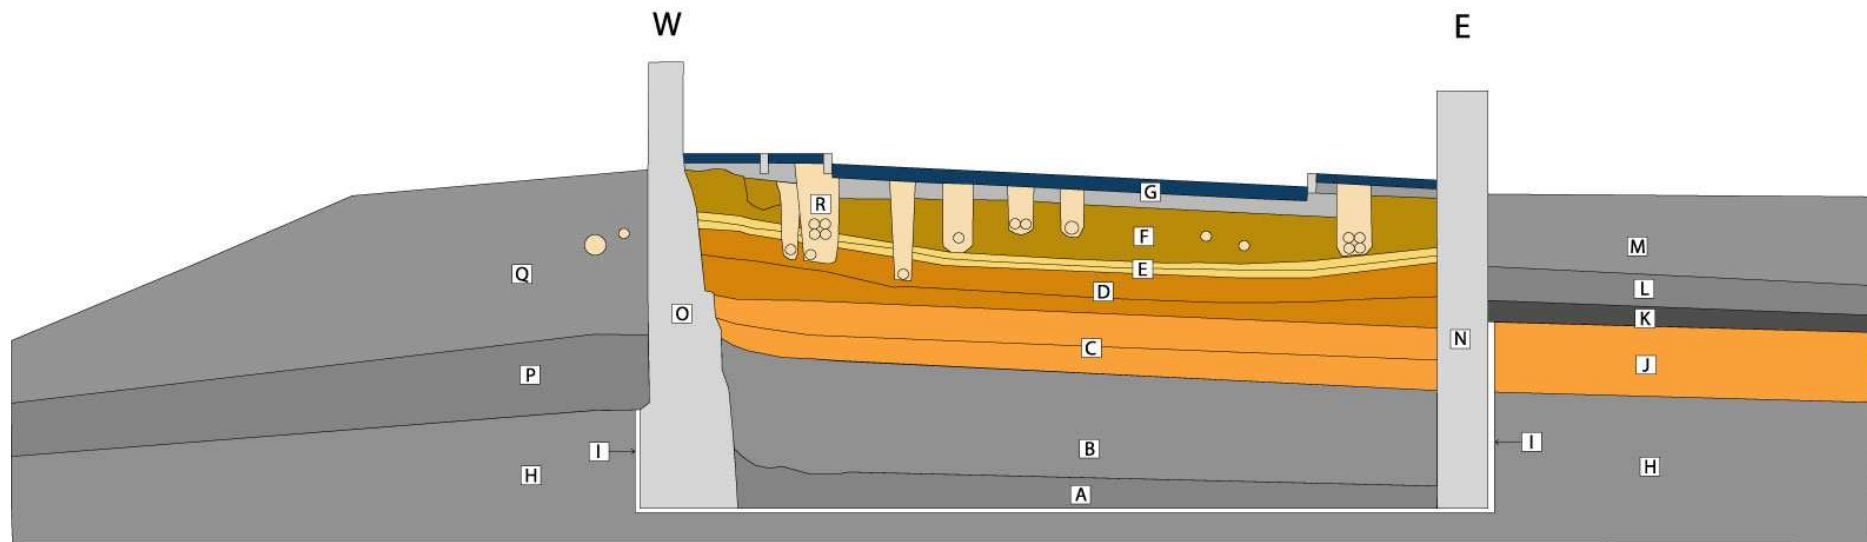
**Figure 1:** schematic section through Monkton Bridge

The construction trench for the new pipe was cut to a depth of approximately 4.0m below the present road surface. This coincided with the base of the bridge walls (O and N). The cross section across the bridge demonstrated that the bridge walls did not have individual construction cuts. Instead there was a single cut for the whole width of the bridge. The walls were constructed as free-standing structures, with only the lower portions of the exterior wall-faces built against the construction cut (I). As a result, the base of the bridge walls and the base of the construction cut are below the upper level of the surrounding natural deposits (H, and J). The interior area between the two bridge walls was then backfilled with a series of laminated clay and silt deposits up to the same level as the surrounding natural deposits. The water-lain deposits (H) continued below the depth of the machine-excavated trench to an unknown depth.
