CROFTUFTY SOLVA

STANDING BUILDING RECORDING

Project Record No. 8885

MARCH 1996

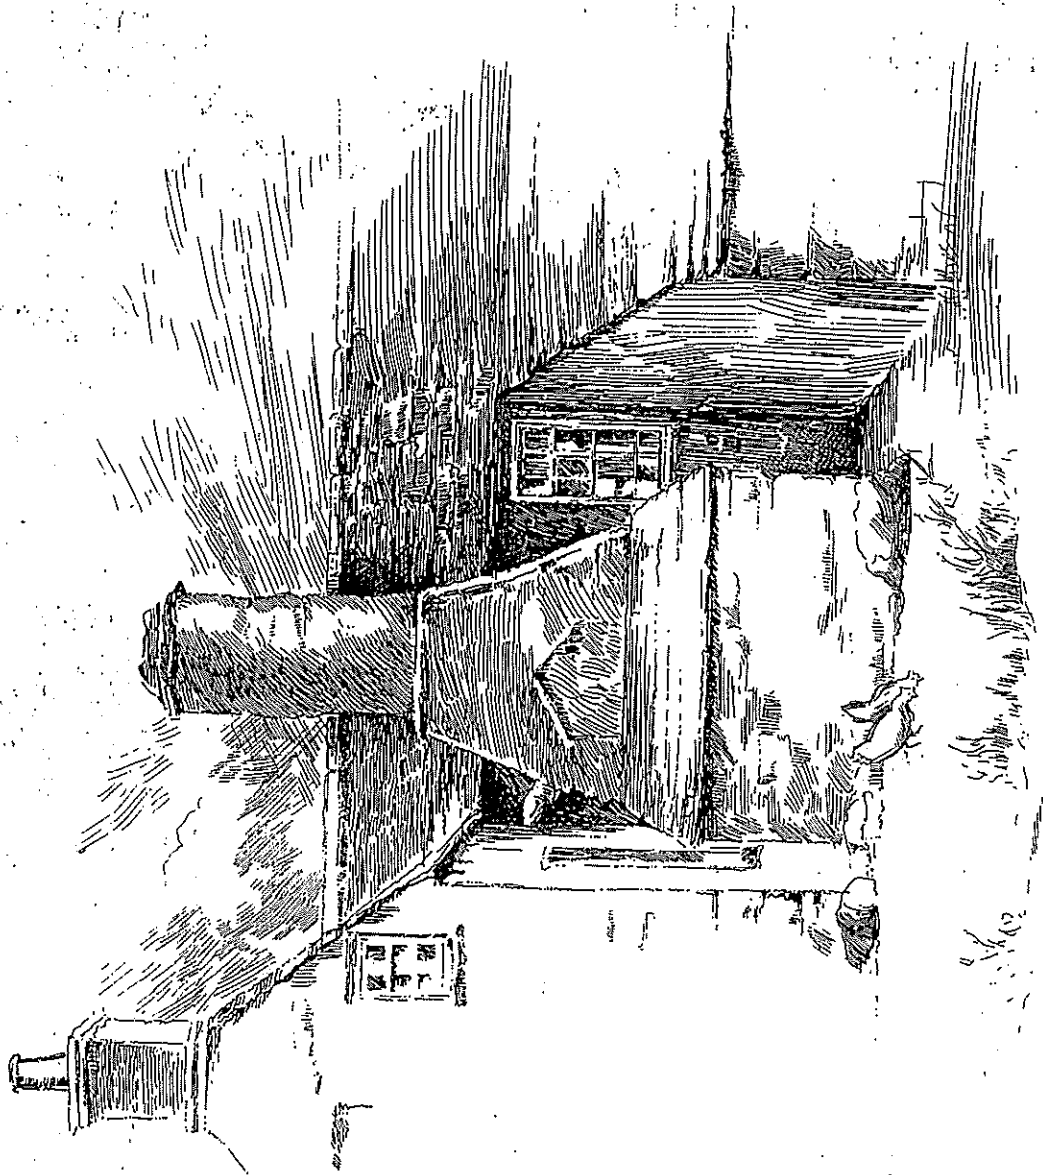
Figure 2

The lateral fireplace with a round upper chimney stack (figure 2), often referred to as 'Flemish style' (Barnwell 1862), may date from the early post-medieval period, if not before (Allen 1902, Smith 1988). It has been suggested that this style of chimney stack may be derived from high status medieval buildings, such as those that survive at the Bishop's Palace in St. David's and Flimston, near Castlemartin. This stack, however, is shorter and conical, and may well be post-medieval, and therefore have no direct link to high-status medieval buildings (pers comm., A J Parkinson of RCAHMW 1994).

The farmhouse building, being described as in a ruinous state, became a Scheduled Ancient Monument in 1978. In a report of a visit in 1986 by the local Field Monument Warden, specific mention is made of the hold that vegetation had taken on the site; however, no action was taken and the upper part of the chimney stack subsequently collapsed.

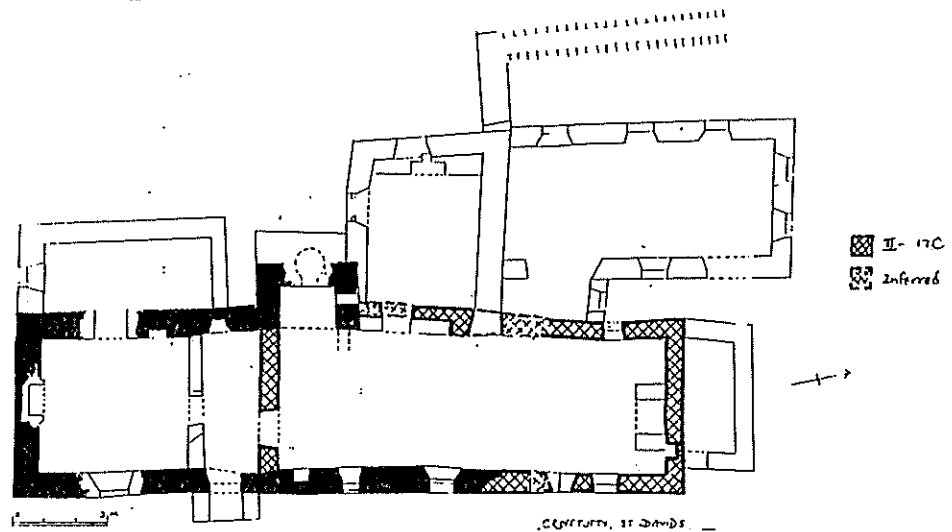
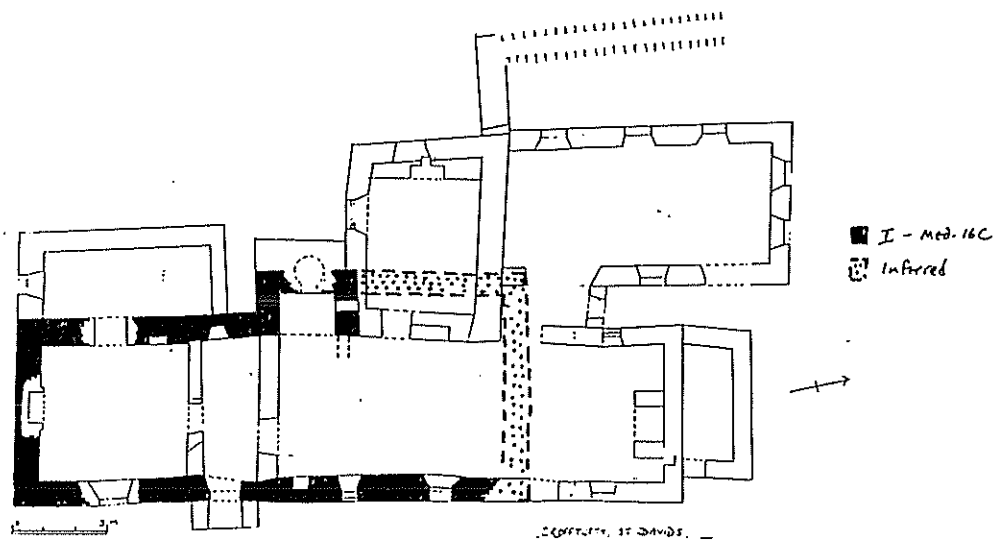
Figure 3

This 1993 evaluation concluded that the sequence of this building would be unlikely to be resolved below ground, due to the lack of stratified deposits either within or against the outside of the farmhouse. However, there were considered to be two areas where excavation might prove to be beneficial: within the central west extension to see if there was any evidence of the line of the postulated wall running from the back of the fireplace (figure 3); the other would be just inside the building to the south of the northern doorway to see if there were any traces of an original shorter north end to the farmhouse (figure 3).

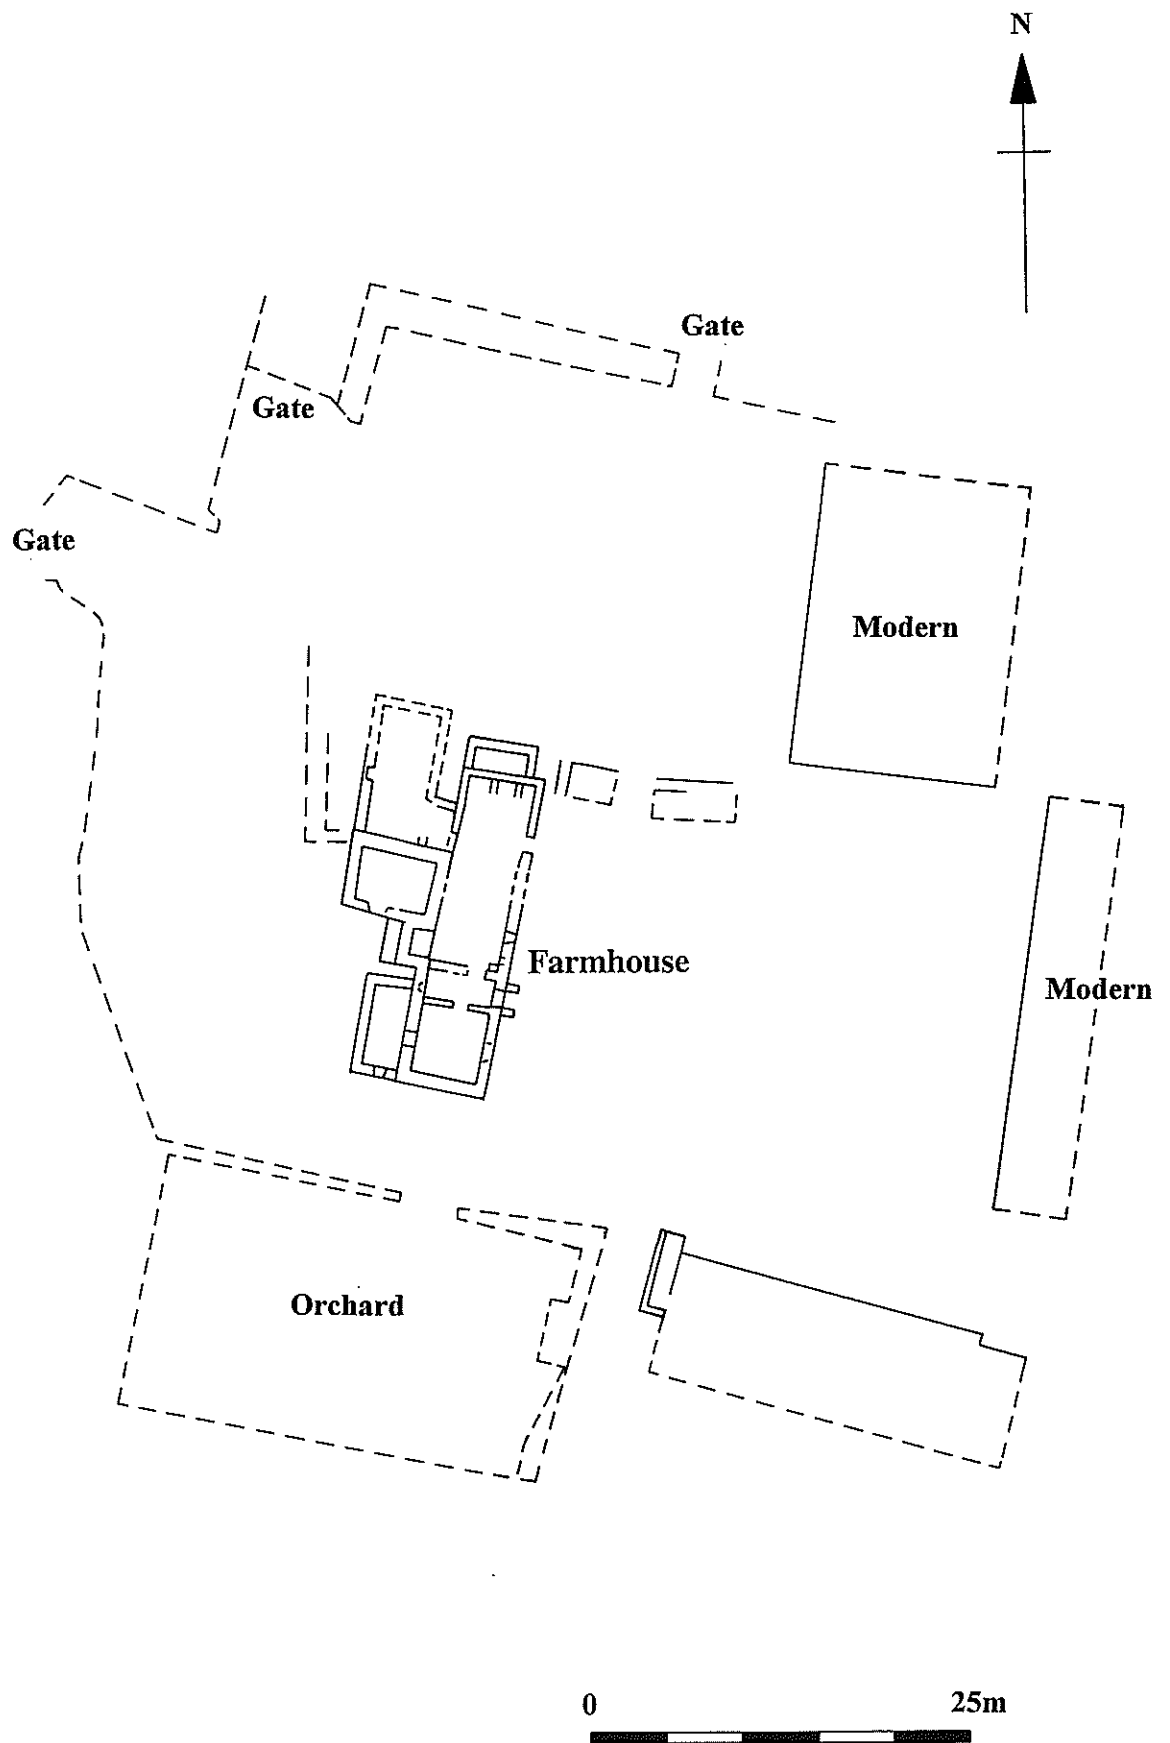
Figure 6

The remains of the farmhouse are within a sub-square/rectangular enclosure, now with modern buildings on its eastern side (figure 6). The original hedge bank on the eastern side has been removed.

In the western part of the south side of the compound there is an orchard (figure 6), now very overgrown, enclosed by Pembrokeshire style hedge banks; within this there was probably a pigsty. The original entrance to this orchard is in the middle of its northern side, and no other entrances are visible. Directly to the east of the orchard is a substantially intact outbuilding, which has now been almost completely renovated into a dwelling. The remains of stone steps up to the first floor are intact and are on the western (orchard) side of the building (figure 6).

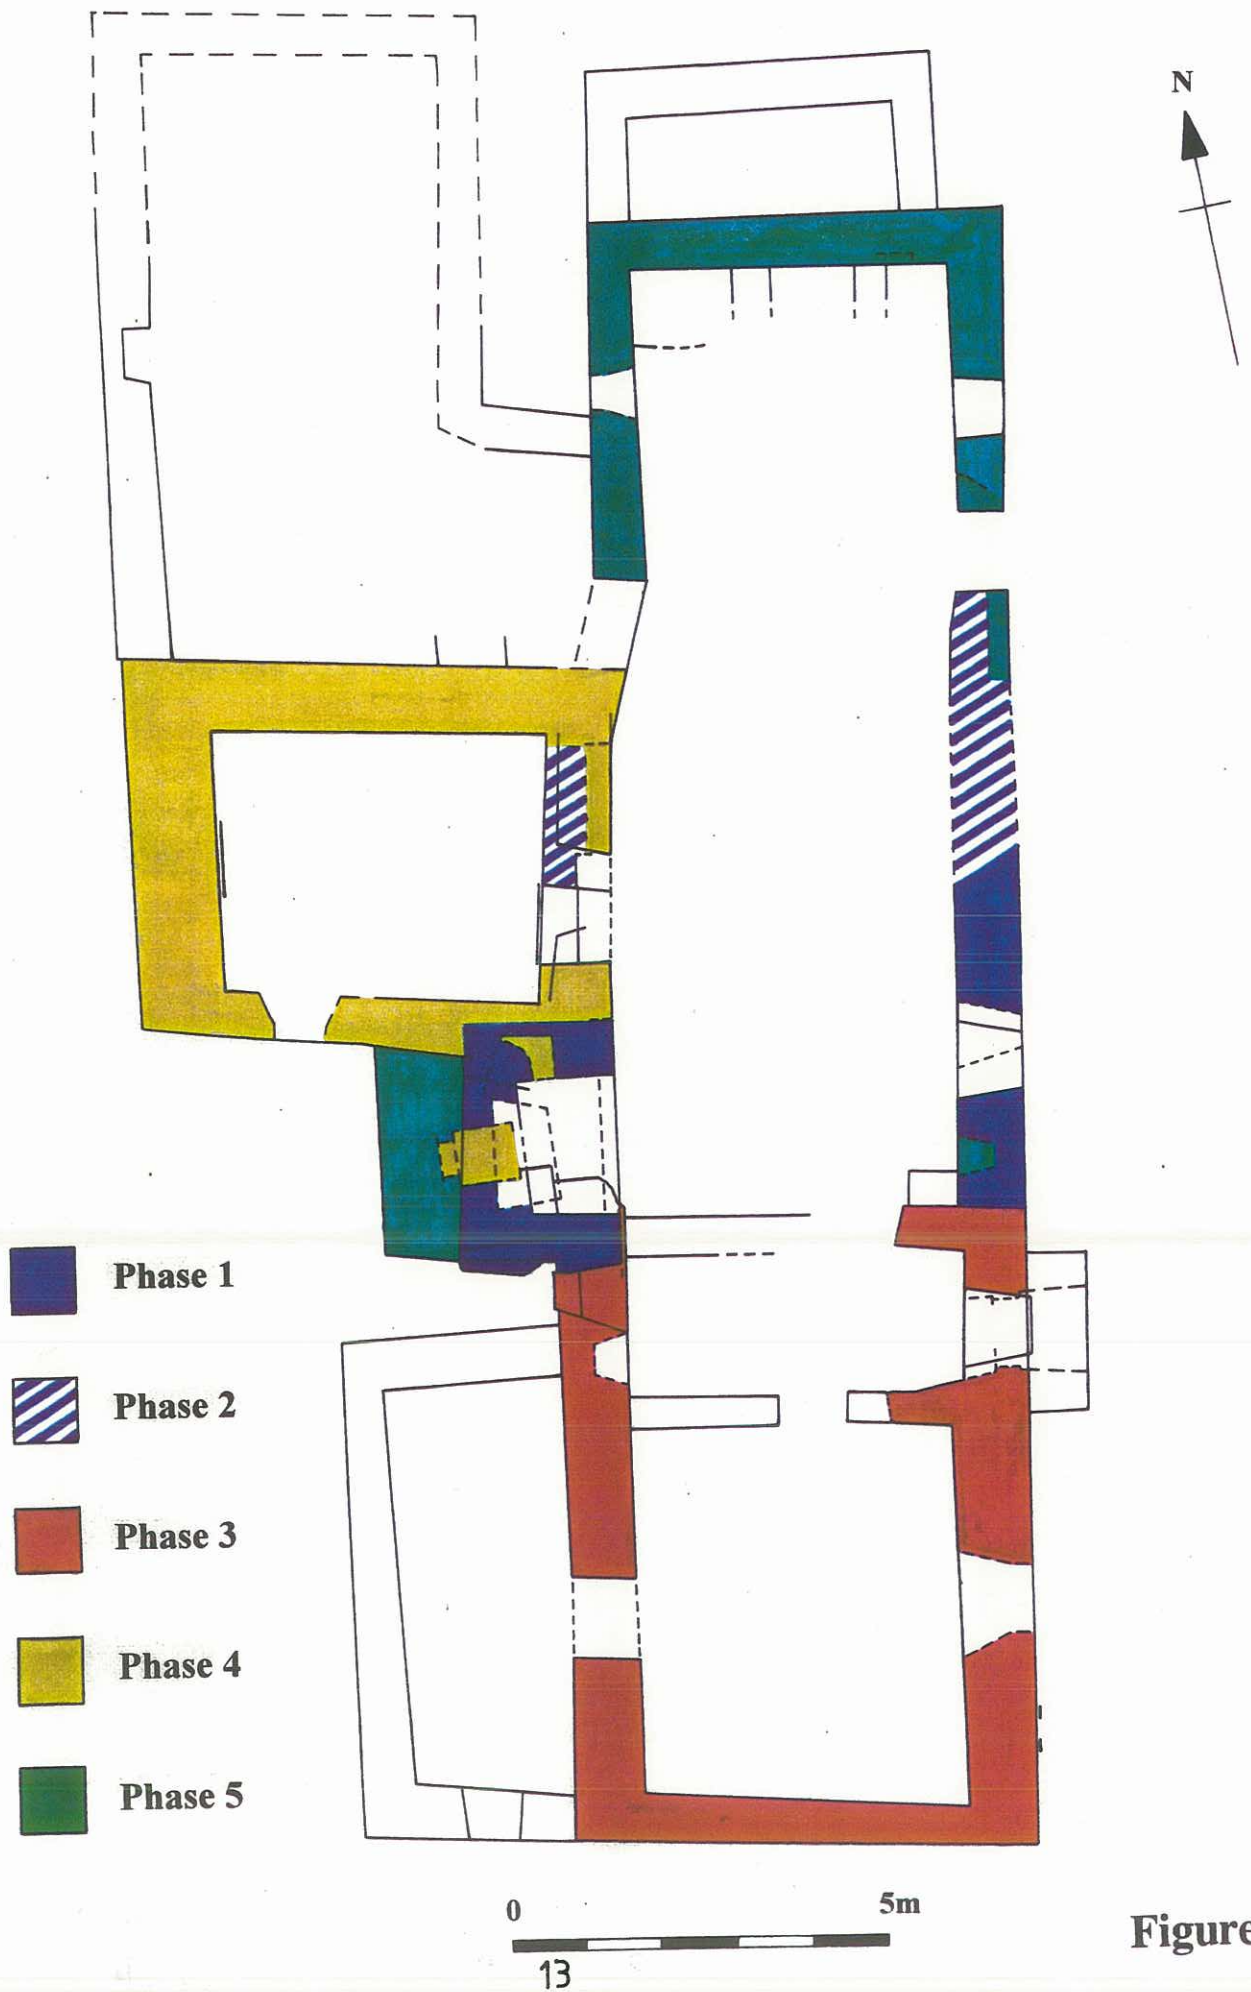
Figure 7

The interior walls opposite the main door, and on either side of the stairs were later than the rebuild of the main wall (figure 7), but had been partly keyed in. On the southern interior wall, main wall plaster could be seen in the butt joint.

On the north side of the door into the western section there was an earlier face, approximately half the width of the wall (figure 7); this inner face is just visible in the main elevation drawing (figure 10). The face was plastered and continued 500mm to the north before turning to the east, but not running so far as the later interior face (figure 7). This earlier build indicated that there was a doorway in this position previously. This part of the structure could be contemporary with the fireplace and chimney, if the doorway was set back on its southern side, as was the case on the northern side.

The structural evidence indicated that little of the remaining structure was original or early (figure 7). Whether there was originally a through passage with a back door opposite the front door, as on some houses of this type, could not be ascertained, due to this section of the back wall being a rebuild.

From the structural evidence it can be seen that only the fireplace, chimney and probably most of the lower front wall opposite are of any antiquity (figure 7); most likely early post-medieval. Very little of the farmhouse is original. There may be some original structure within the wall to the north of the chimney, but this cannot be proved and could be second phase. Probably all of the walls south of the chimney and main front door have been rebuilt, possibly on the position of earlier walls. The rest of the structure is likely to be eighteenth century or later, along with some later windows and doorways.

Further observation and a very limited watching brief during renovation are considered advisable.

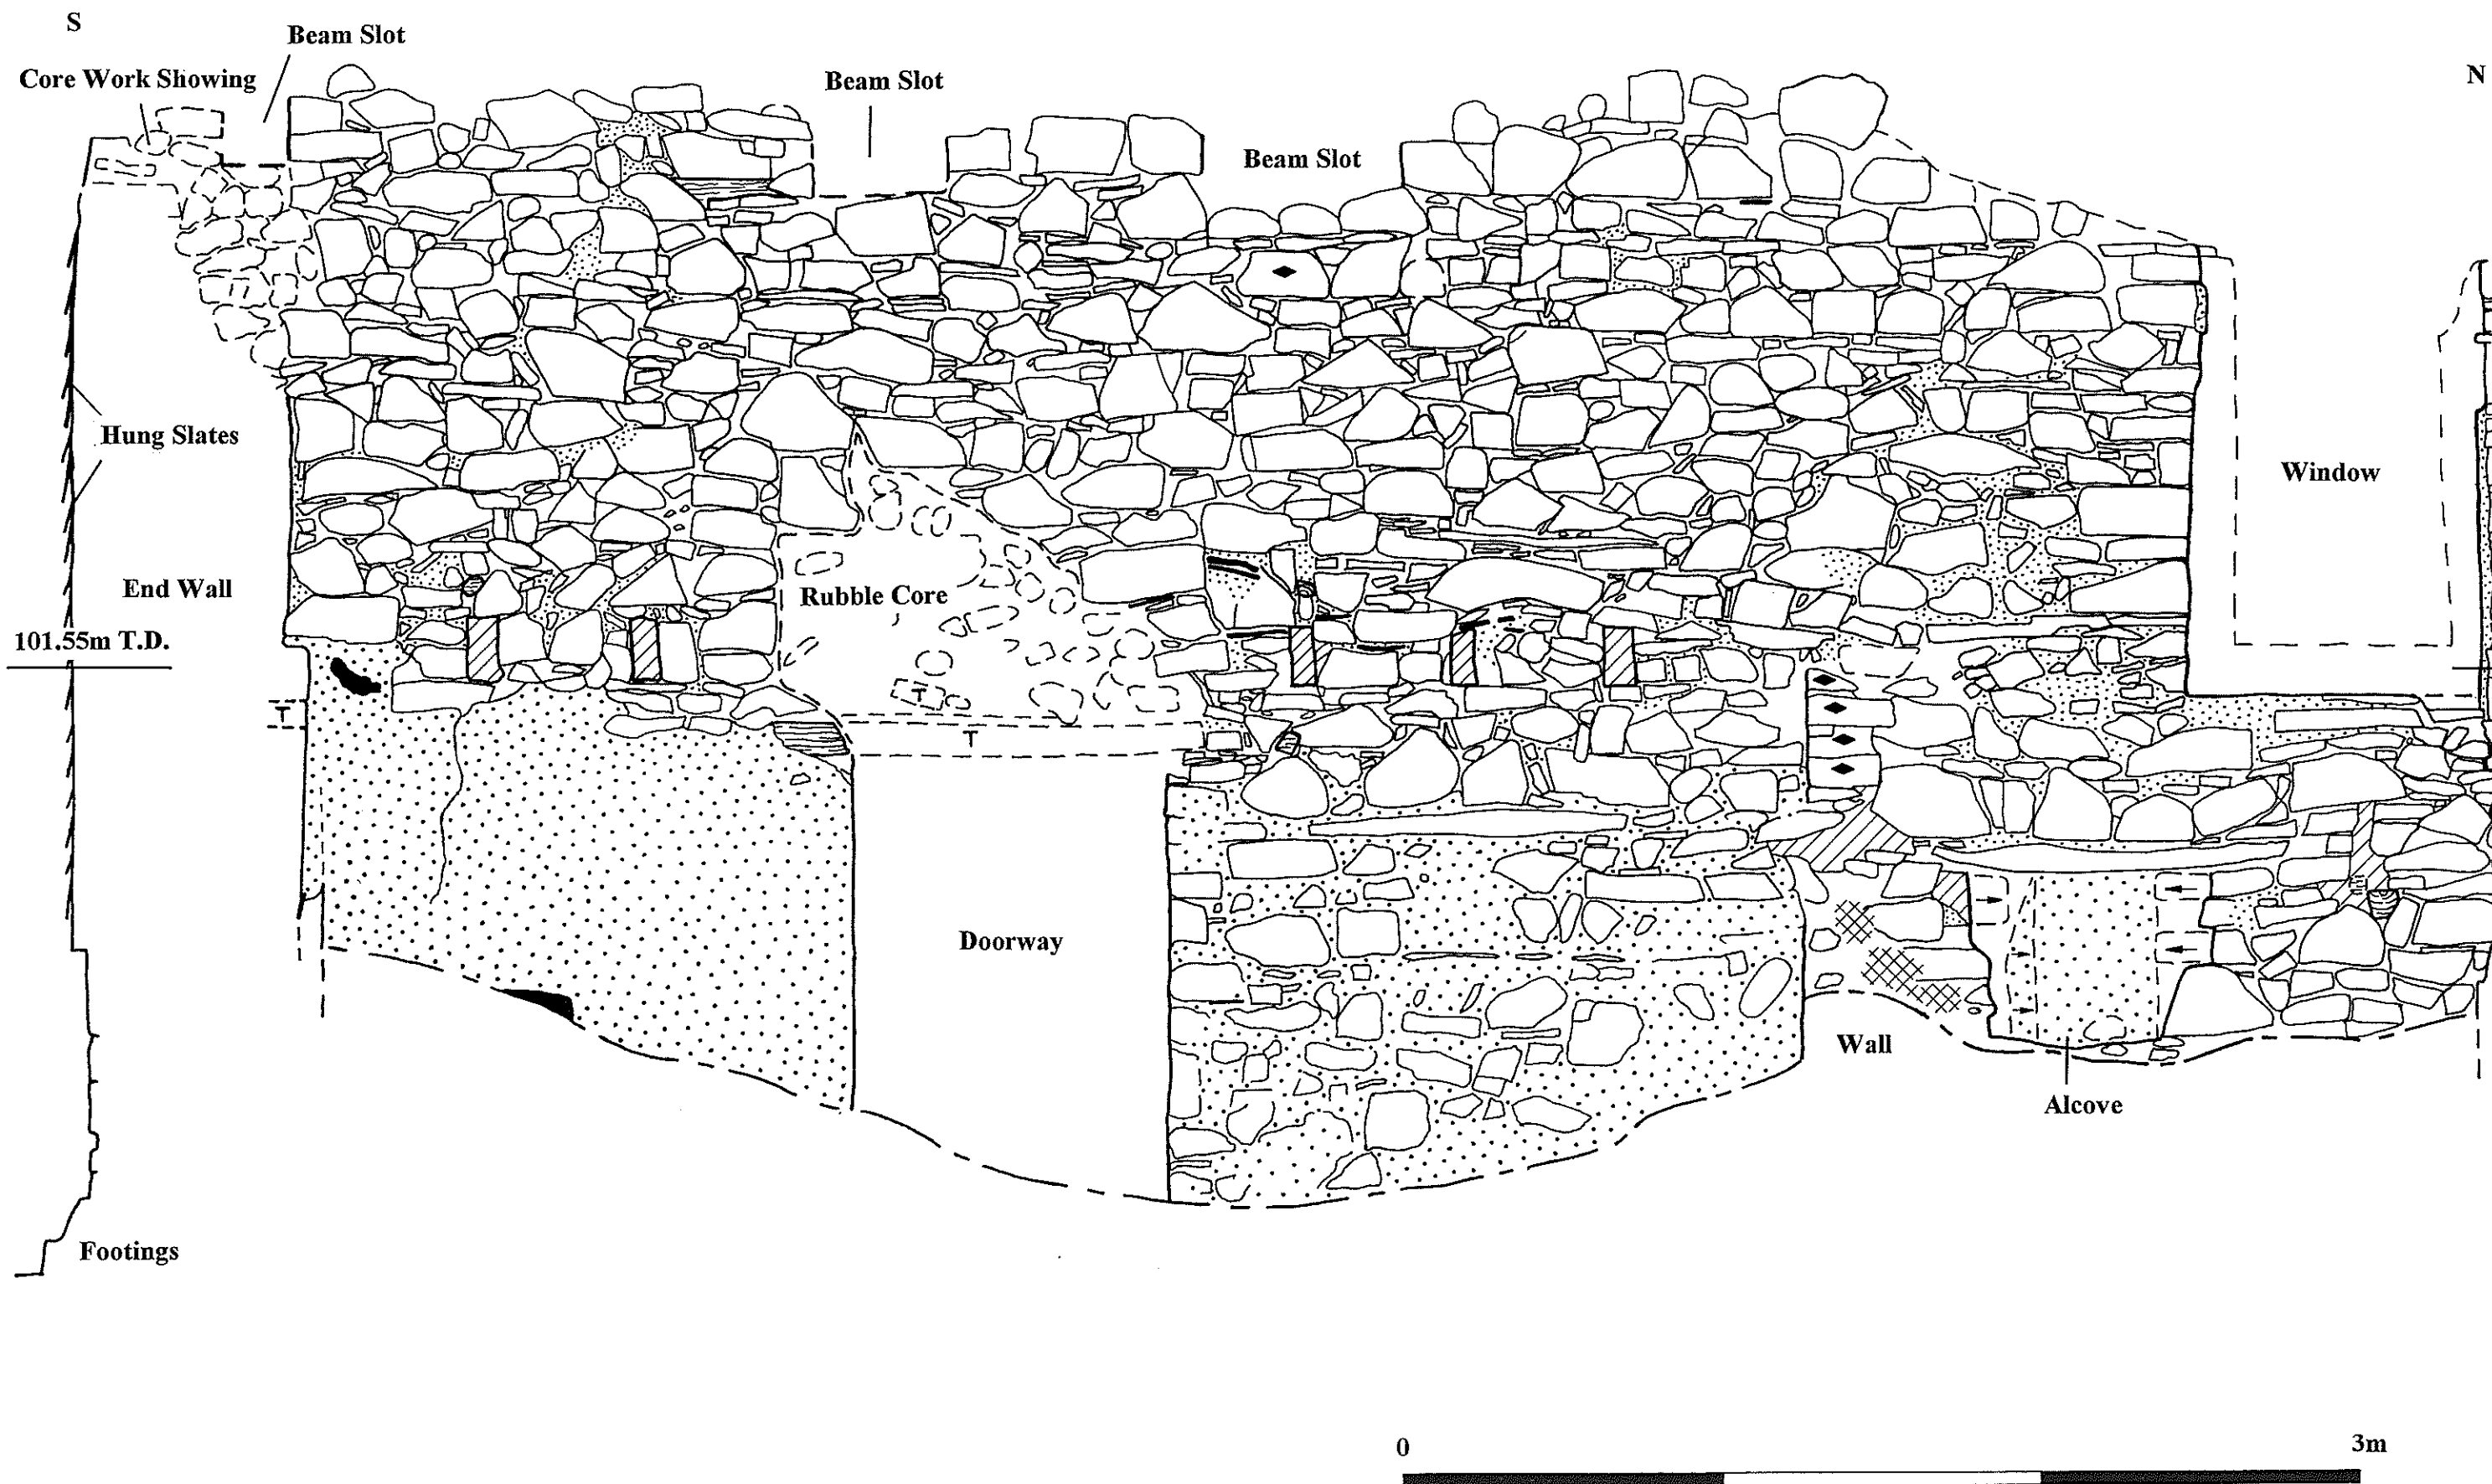
Figure 9

Directly to the south of the chimney in the main west wall of the farmhouse a window had been inserted (figures 9 and 10). This window lit the stairs and was between floor levels. South of the chimney, on the exterior face below the window, there were signs that this part of the wall may have been rebuilt. This was more evident in the interior, as the surviving inner wall face was nearly 100mm wider than the original face behind (figure 7). This inner face could be traced for approximately 1 metre to the south of the fireplace, but from there on and above, appeared to be dry or clay bond wall core of the later rebuild. No signs of an earlier doorway opposite the main front entrance could be seen, and appeared to be unlikely. This later widening of the wall stopped on a line above the southern part of the fireplace, possibly on an upstairs interior wall.

The alcove below and to the south of the window (figures 9 and 10), directly to the south of the fireplace, appeared to be contemporary with the later main wall build.

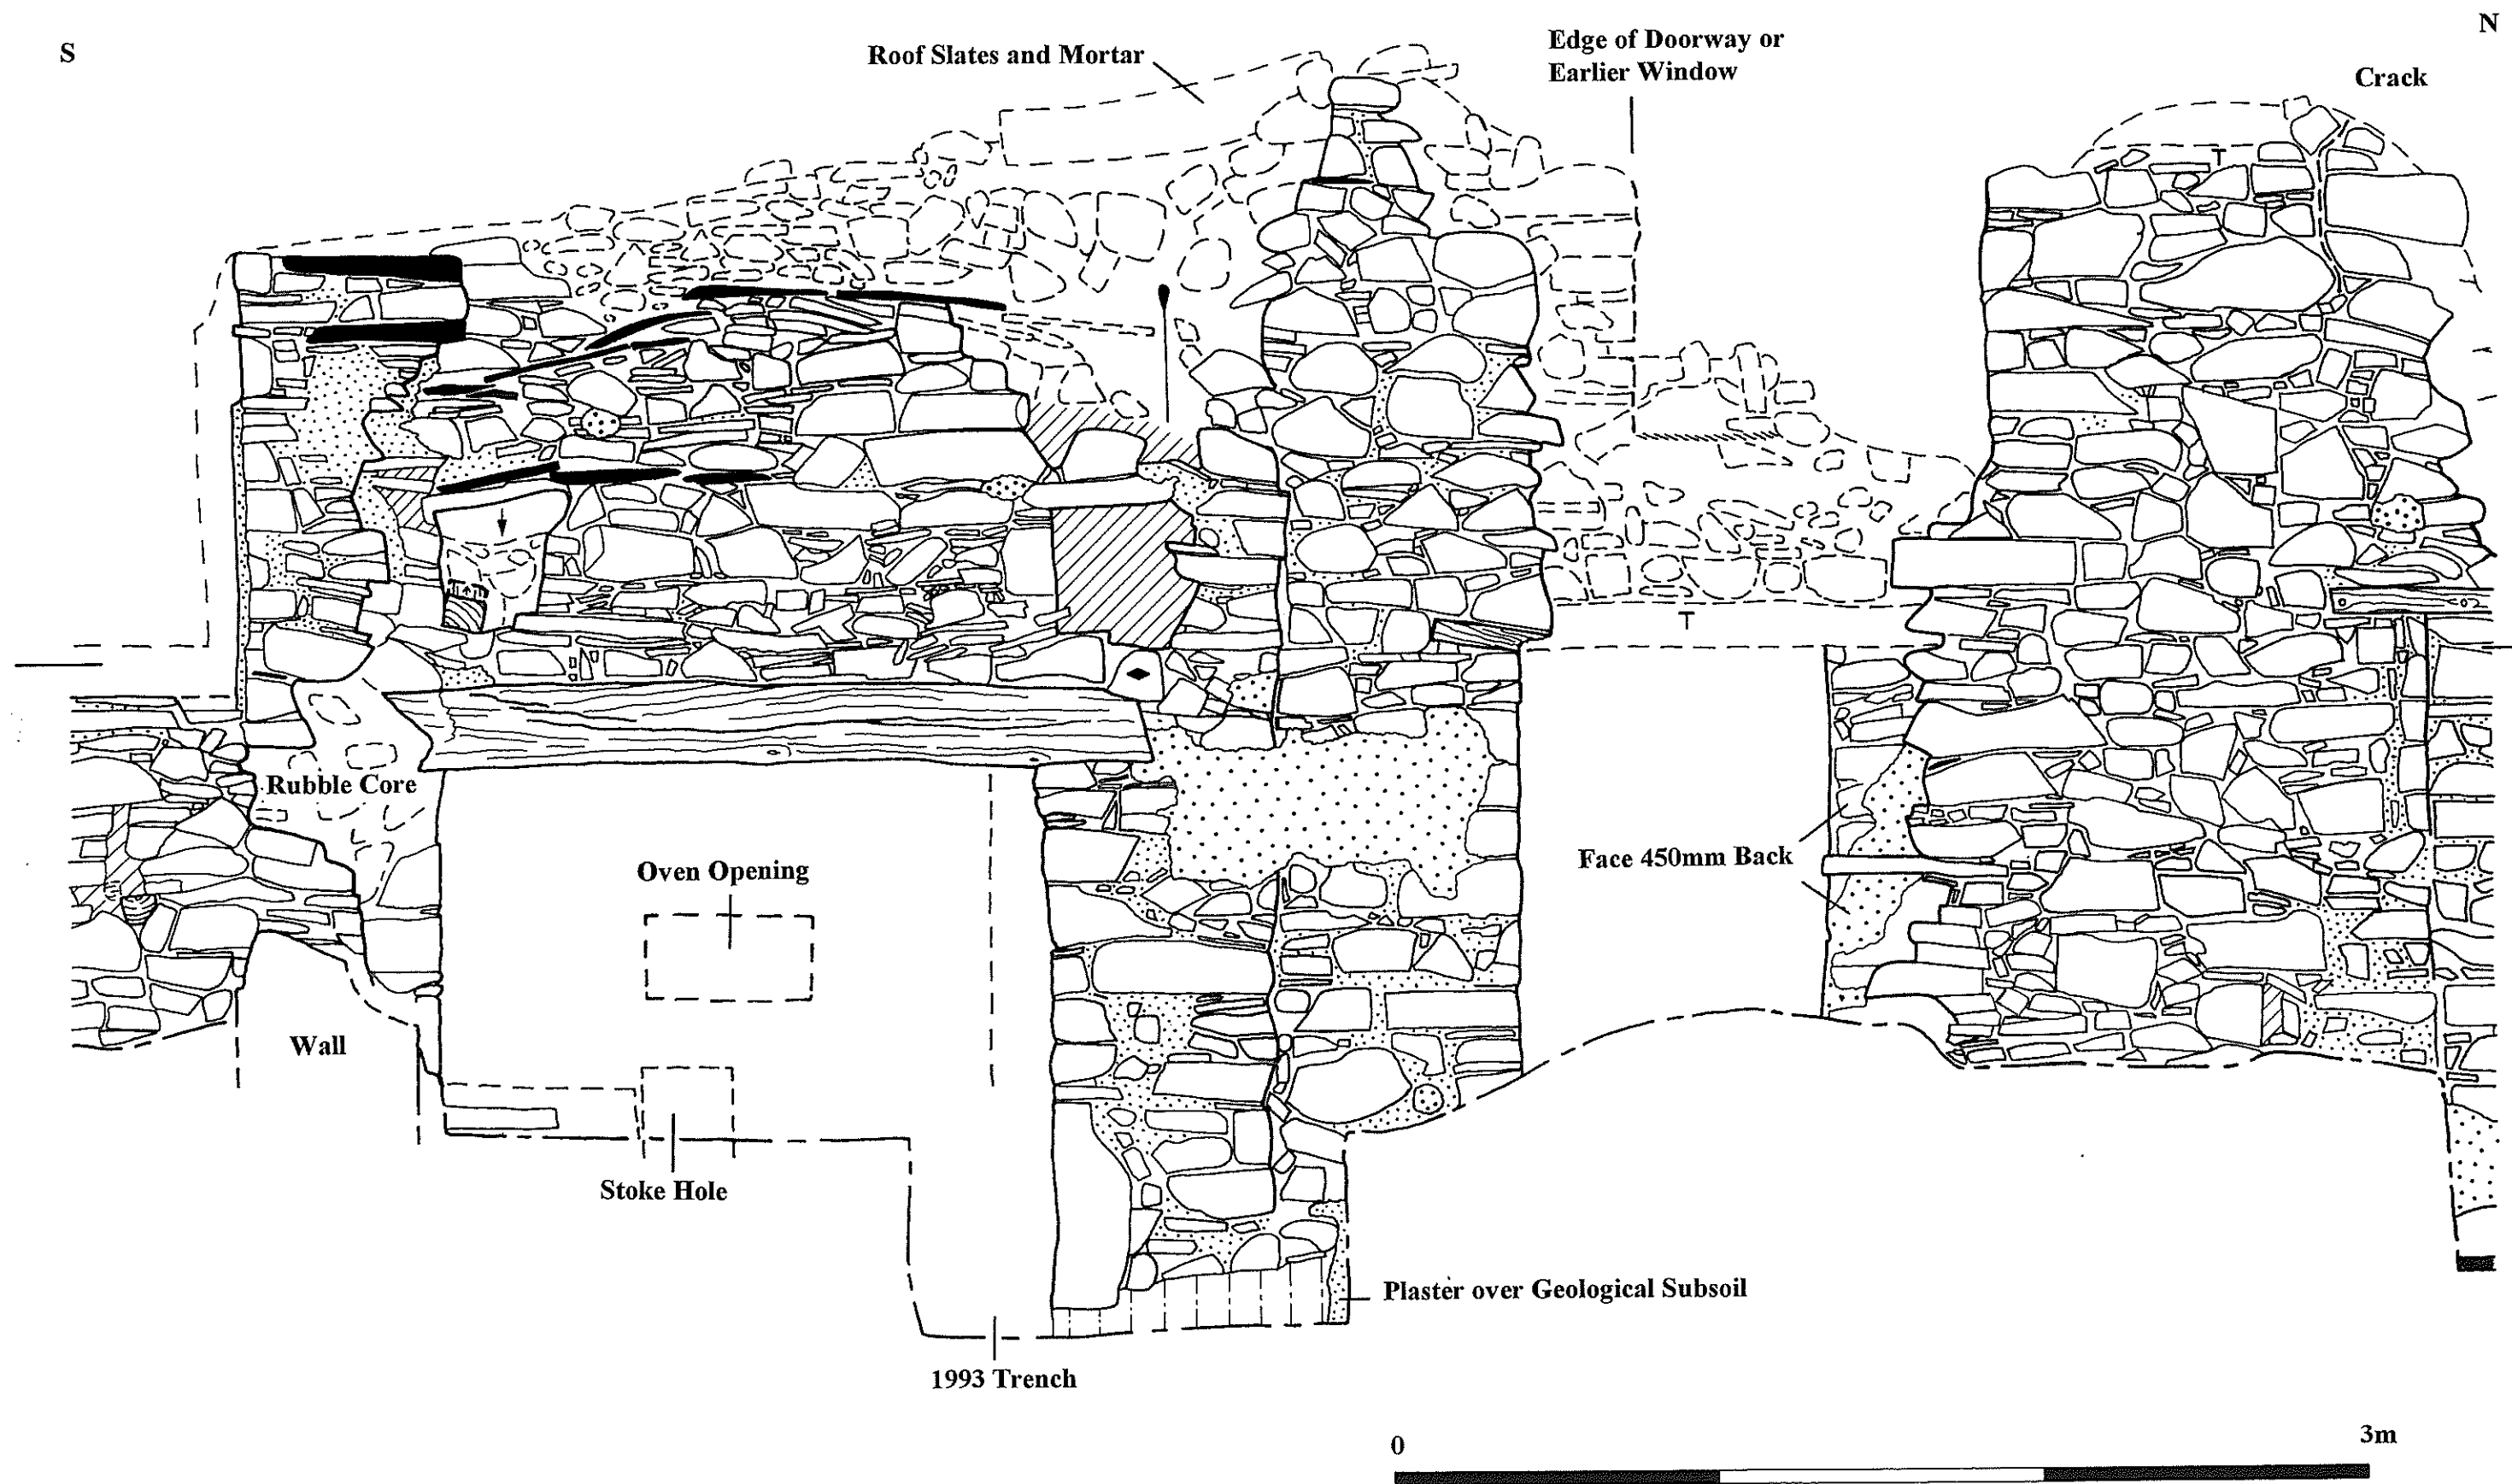
Figure 10

The interior face just to the north of the chimney had a butt joint (figure 10). The part to the north of this joint was later than the fireplace and likely to be contemporary with, and part of, the building of the extension to the middle of the western side of the farmhouse (figure 7). The upper part of this later extension was built over part of the fireplace/chimney structure (figure 10), probably indicating that the first floor or the height of the building had been altered. This later building extended to the south side of the door, into the western extension.

Pottery sherds from a single vessel were found in clay mortar above the doorway into the western extension (figure 10), approximately 350mm above the lintel and 200mm into the wall from the western side, and possibly

from the earlier build. Provisional identification (from Louise Lane) as a shallow bowl with almost no foot ring, sgraffito, probably Bristol or North Devon Gravel-free ware, date 17th-18thC. It must be noted that this part of the wall was very loose and had considerable root damage, therefore this pottery may have come from the later build.

To the north of the doorway into the mid western extension, by just under 2 metres, there were the remains of a blocked doorway (figure 10). The blocking was formed by the northern wall of the western extension, the face of which was at an angle to join with the extension to the north (figure 7). This would indicate that the extension to the north was earlier than that to the west (as shown on figure 4), but could be near contemporary. The southern door jamb appeared to be an earlier build than the rest of the face to the south (figure 10). This jamb was probably contemporary with the earlier wall on the west side (figure 7). Above this blocked door there were the remains of a wooden lintel, with some of the wall on the same line as that of the main part of the farmhouse.

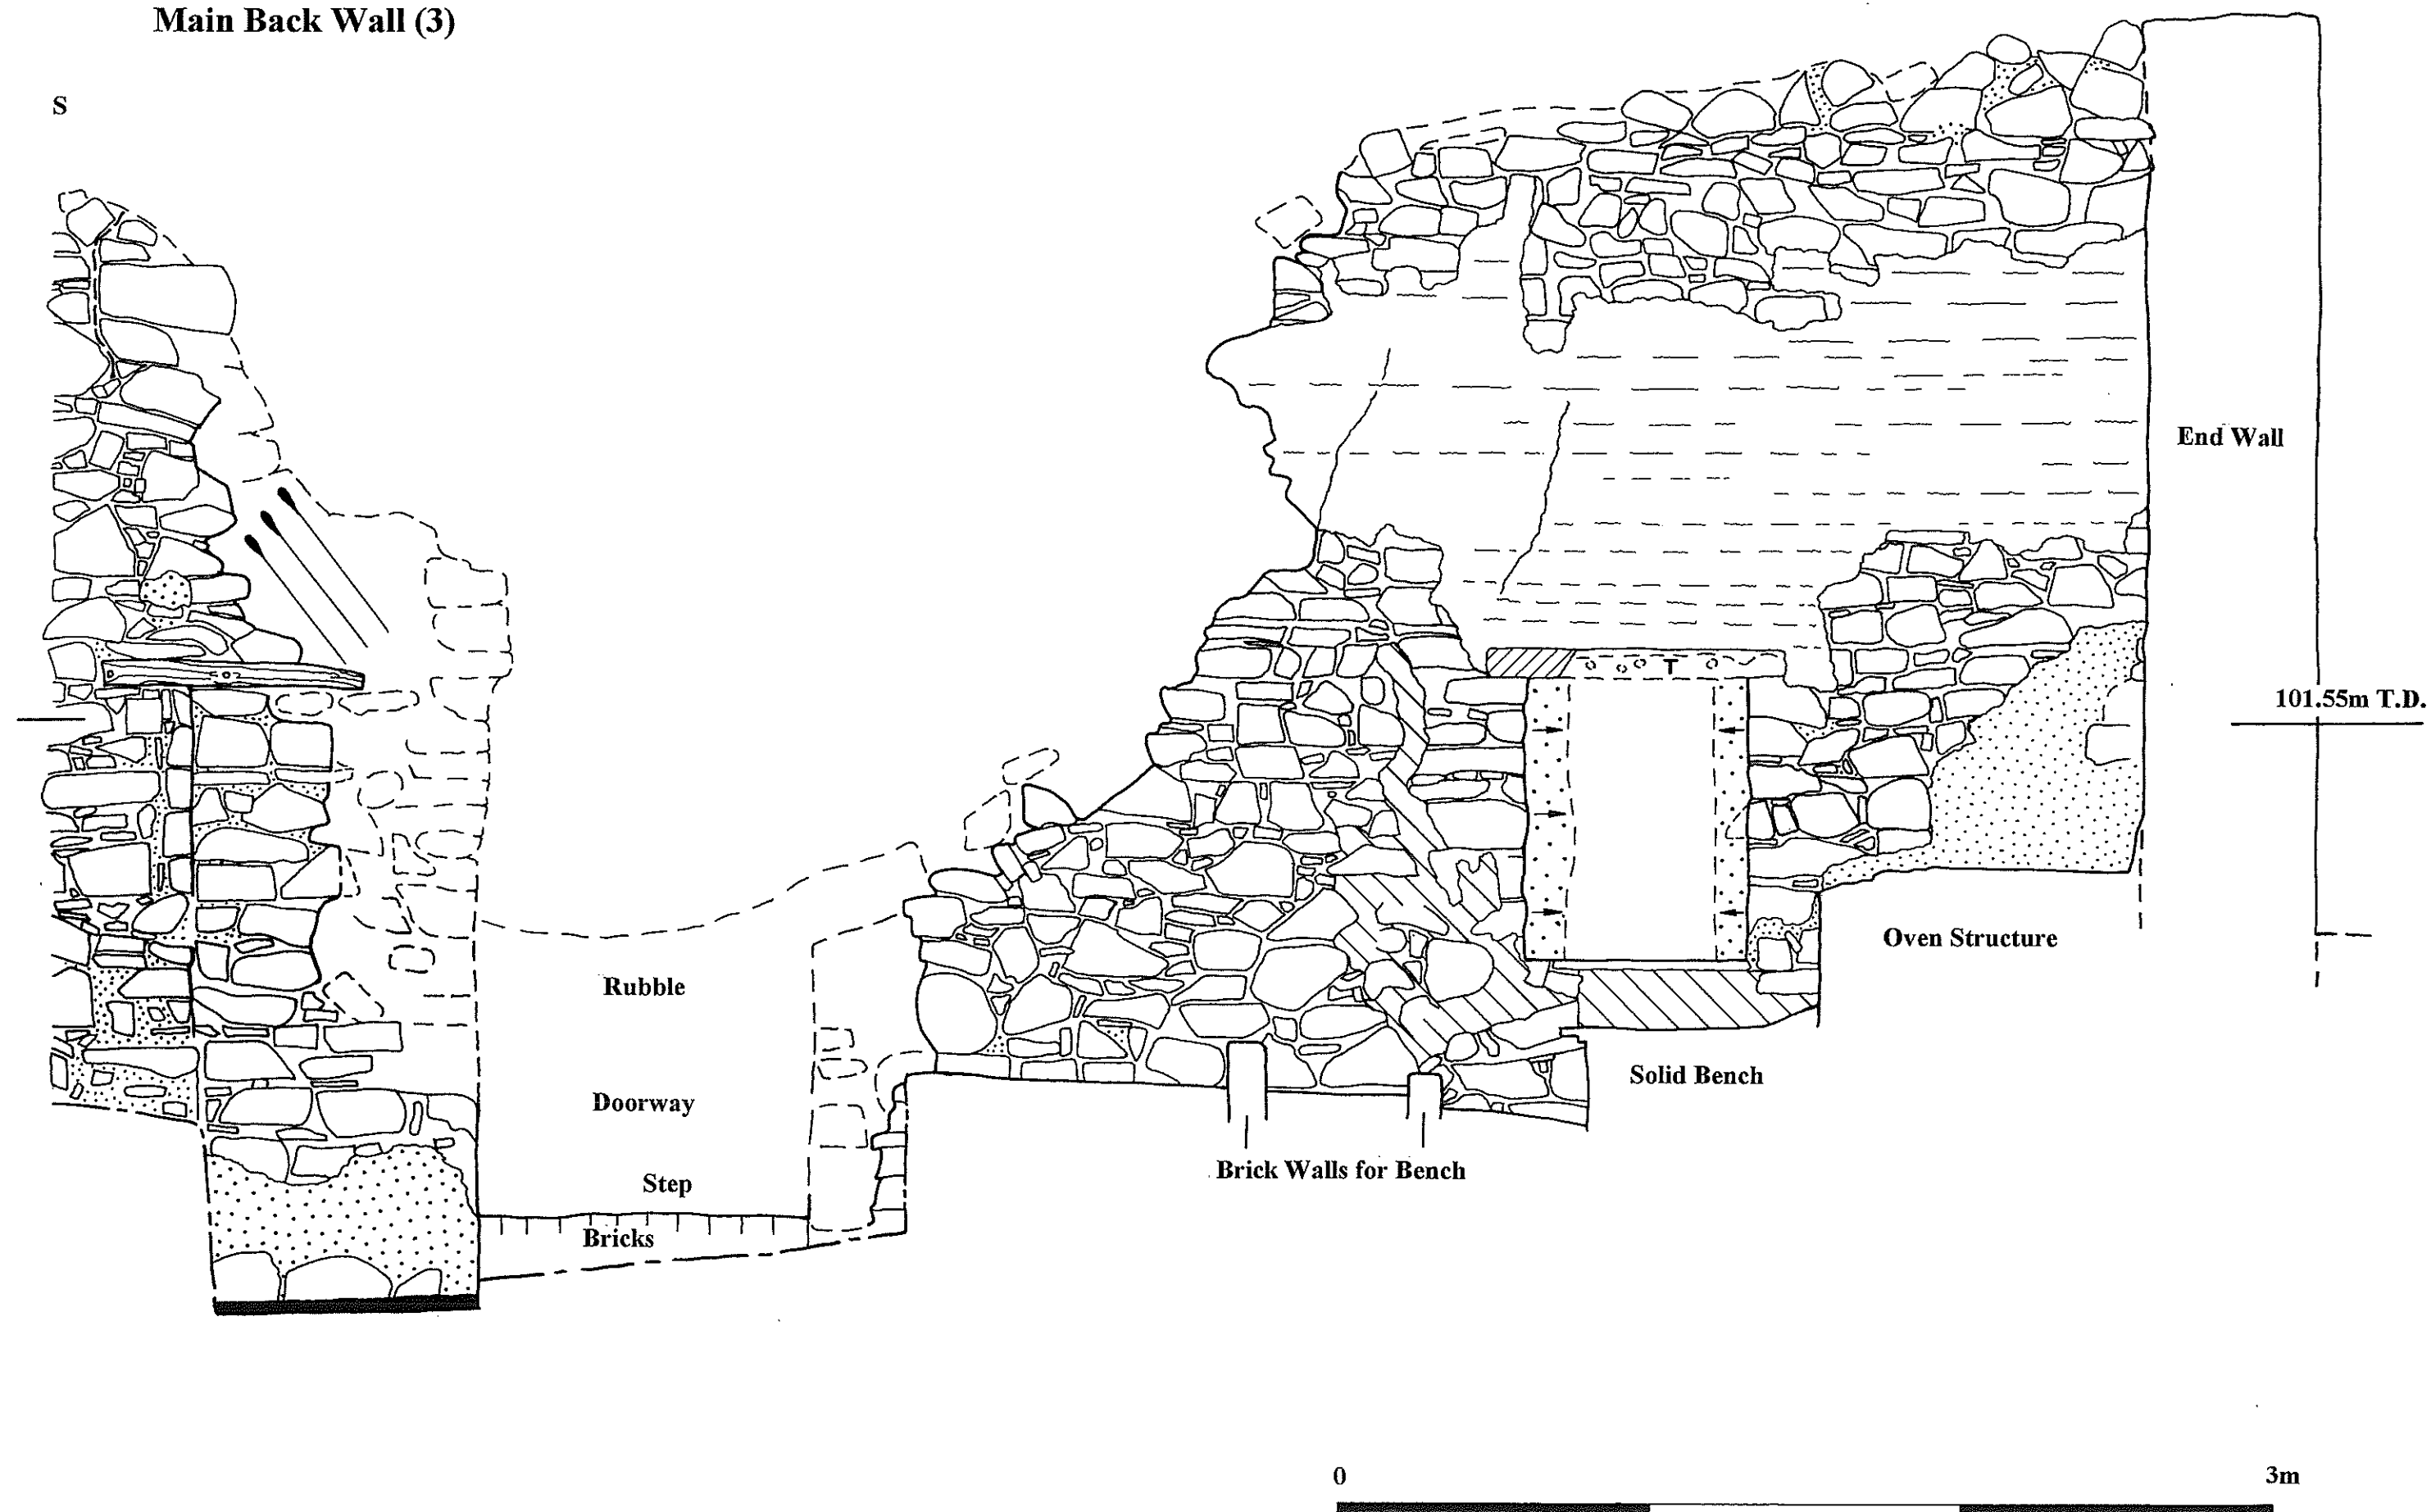
Figure 11

The later northern extension of the farmhouse had a high ceiling and no upper floor, unless in the loft (figure 11). Within the north west corner of this room was a large oven and a large fireplace to the east (figure 5); both of these internal features were later.

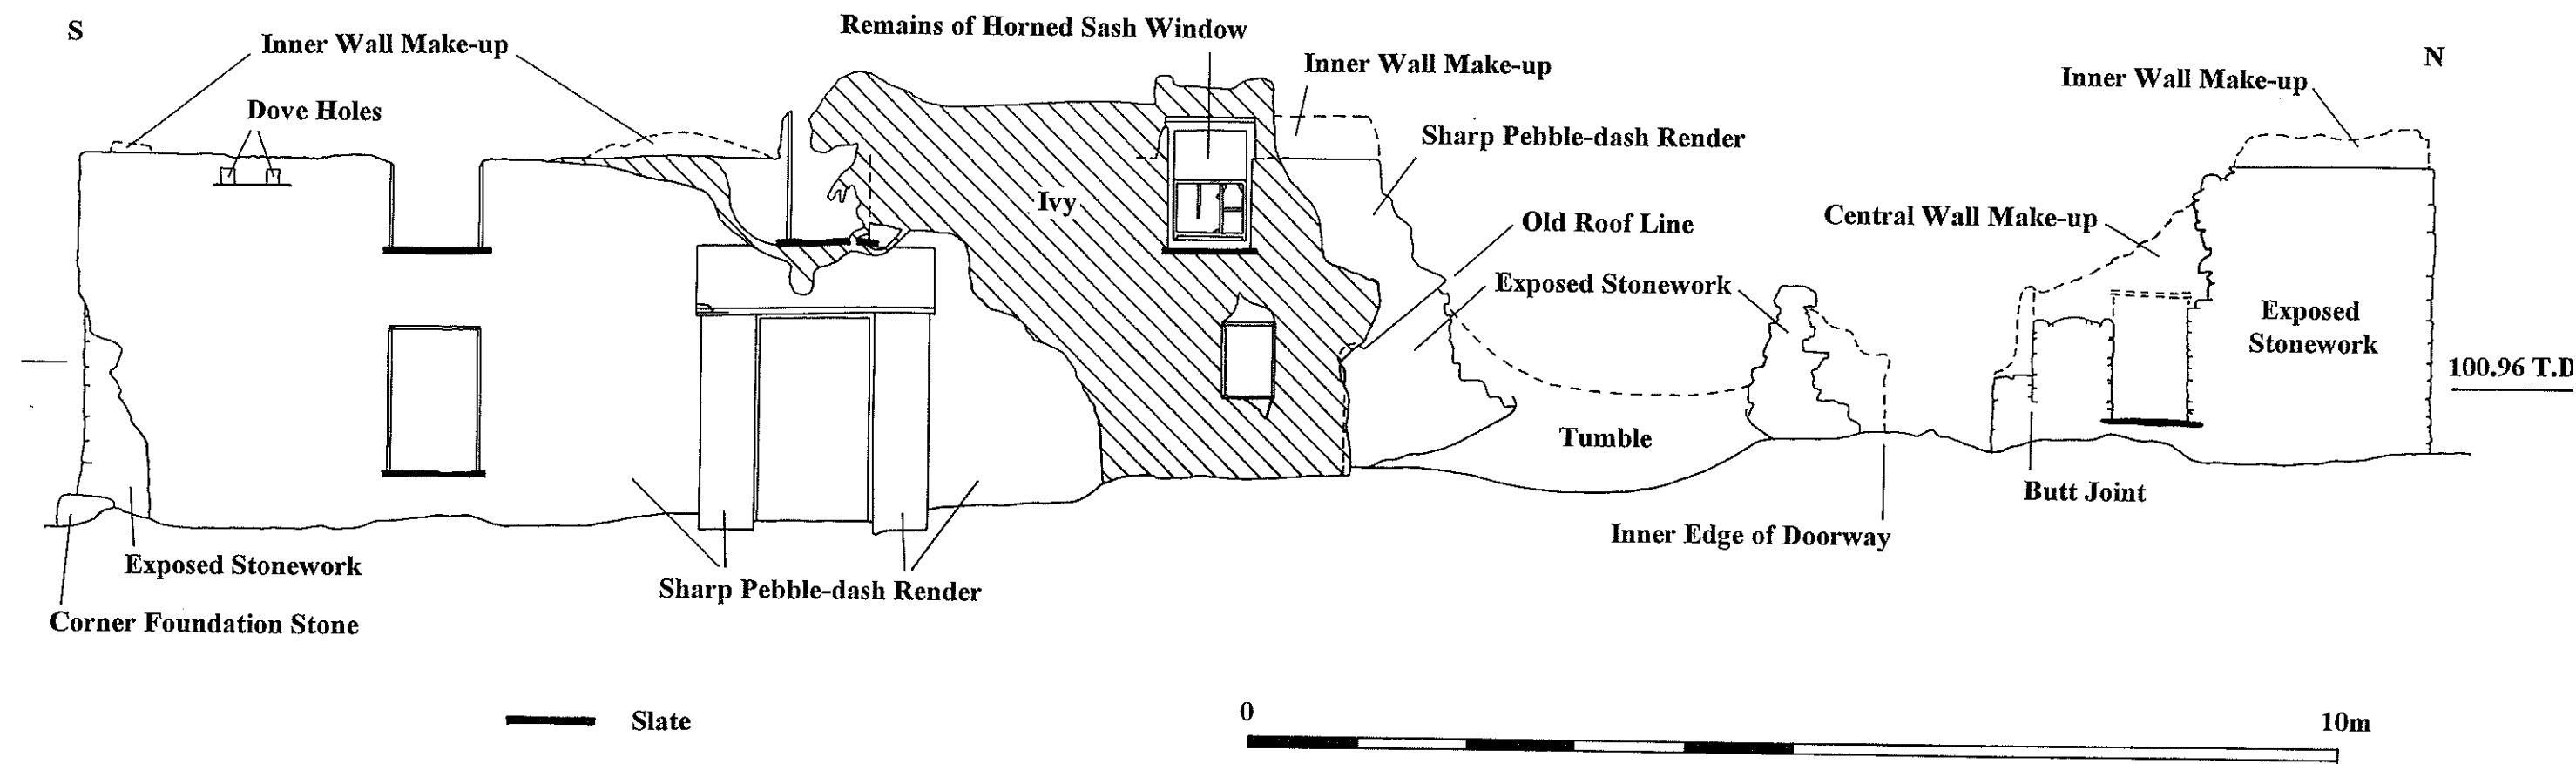
Figure 12

The exterior front elevation was drawn at 1:20, most of this was covered in hard cement render and pebble dash and, even where visible, individual stones were not drawn (figure 12).

Most of the front wall of the house was covered in ivy. In 1993 some of this wall was in perilous condition, but much of this section had subsequently collapsed. Most of the ivy and loose stone was cleared from the remains. However most of the surviving front face was covered with hard cement render, pebble dashed and dark pink in colour and details of construction could not be seen in this area. A roof line to the south of the northern front door was revealed (figure 12). The later extension to the north was not rendered but showed no detail, other than possibly the north side of the door, which was of lime mortar construction, although this was probably contemporary.

A watching brief is considered advisable when: render and pebble dash is removed from the front wall and any demolition or dismantling of the chimney area is undertaken. In our opinion, almost total dismantling of the structure will be necessary before these walls can be made good.
