BUILDING RECORDING AT THE OLD DAIRY BUTTERHILL FARM St. ISHMAEL'S PEMBROKESHIRE

APRIL 2007

RHIF YR ADRODDIAD / REPORT NO. 2007/36
RHIF Y PROSIECT / PROJECT RECORD NO. 62774

BUILDING RECORDING AT THE OLD DAIRY, BUTTERHILL FARM, St. ISHMAEL'S PEMBROKESHIRE

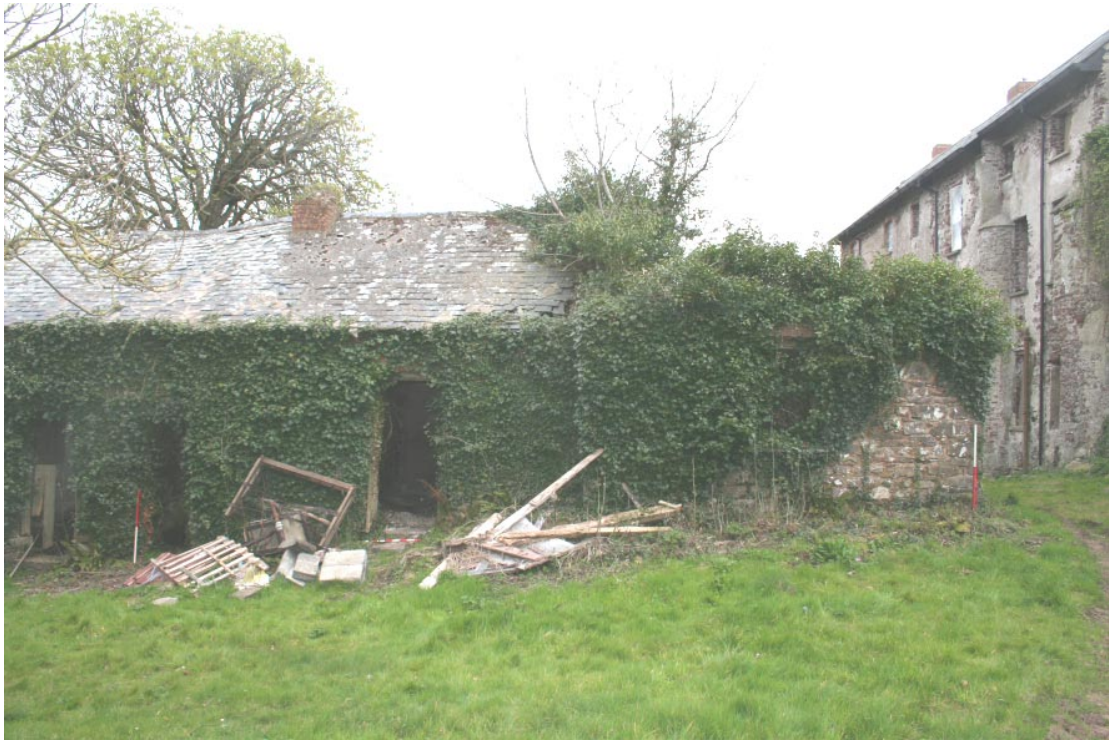
This elevation included door openings to rooms C, D, E, F, G and steps to the upper floor. The arched entrance to Room F includes a keystone bearing the date 1842. With the exception of a blocked first floor window above the doorway to Room D, no other evidence for alterations to the buildings could be discerned. The west-facing wall of Room H includes a red-brick arched opening at its base, for a drain.

Photo 1: West facing exterior elevation, south end

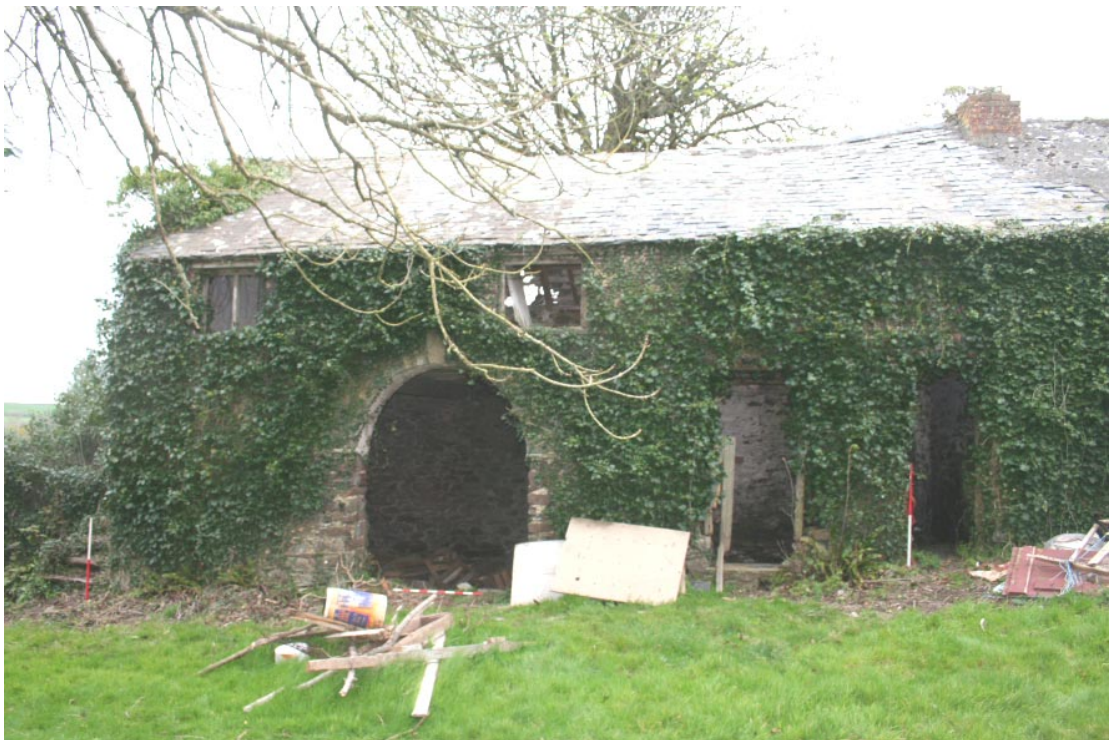
Photo 2: West facing exterior elevation mid section

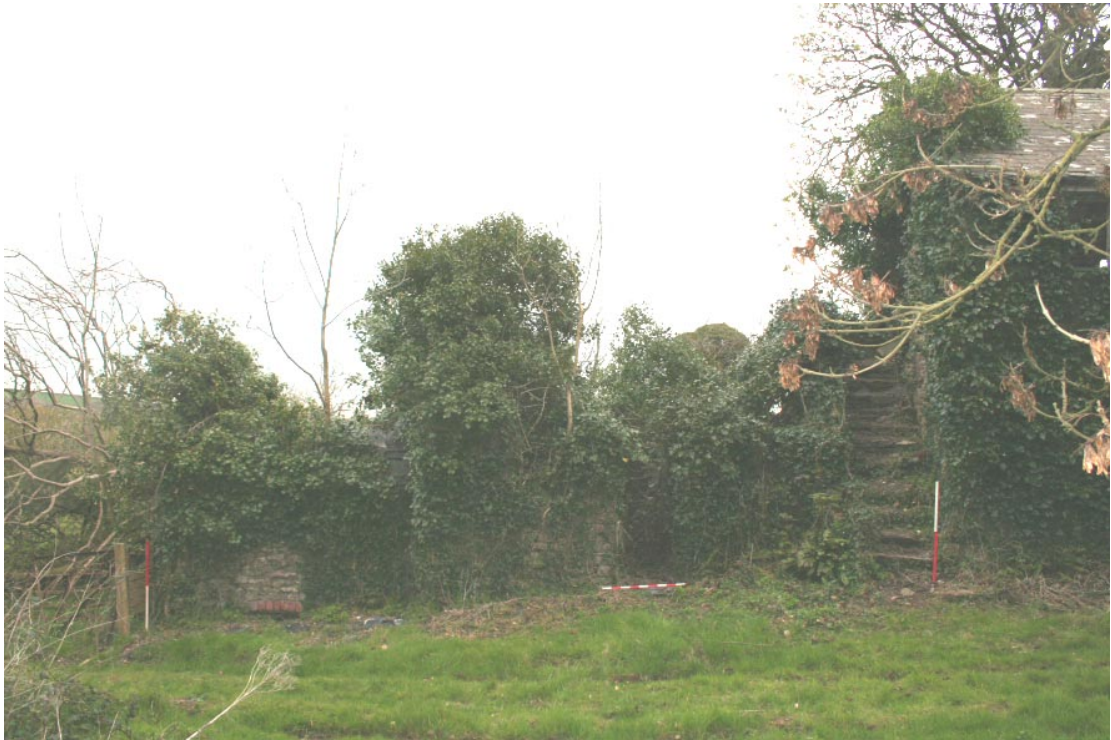
Photo 3: West facing exterior elevation, north end

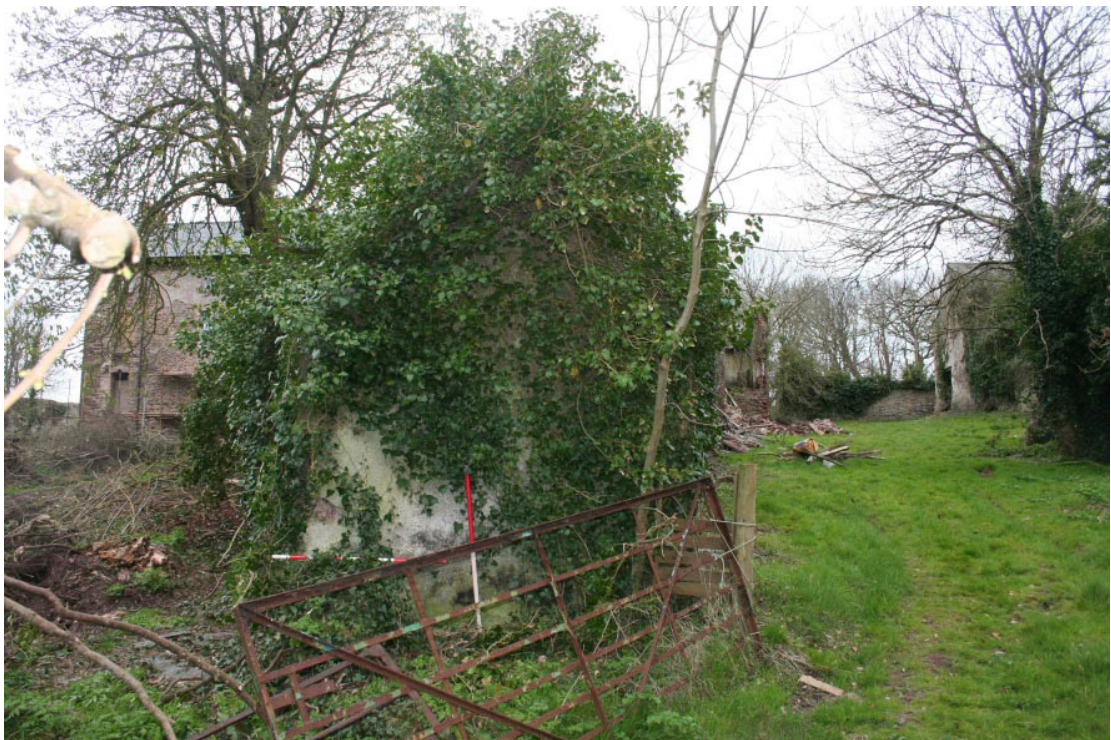
With the exception of the north facing wall of Room B, little of the north facing elevation could be discerned due to ivy growth. A stub of wall (of unknown significance) extends northwards from the north end wall of Room H, on its east side.

Photo 4: North facing exterior elevation, north end

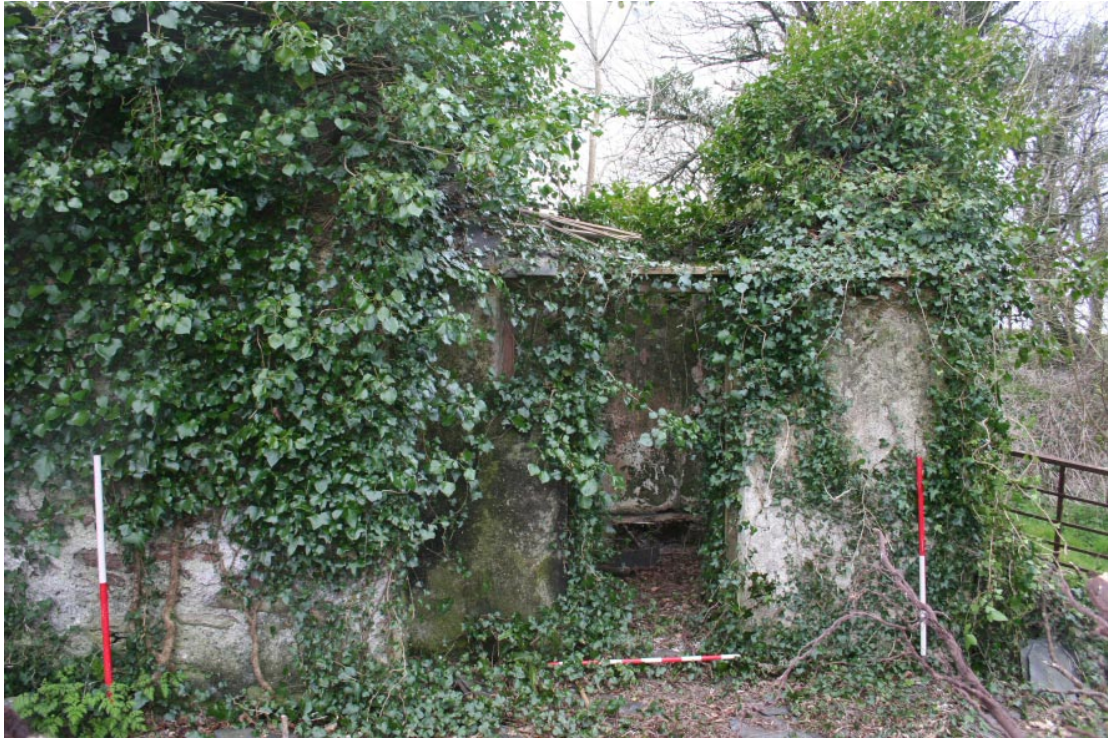
The east-facing elevation includes a door opening to Room H, and a window opening to Room C. The east wall of Room B contains one blocked and one open window opening. Two recesses on the wall of the dairy may have supported the roof of a lean-to structure on the east side of the building. No other significant features were apparent.

Photo 5: East facing external elevation, north end A

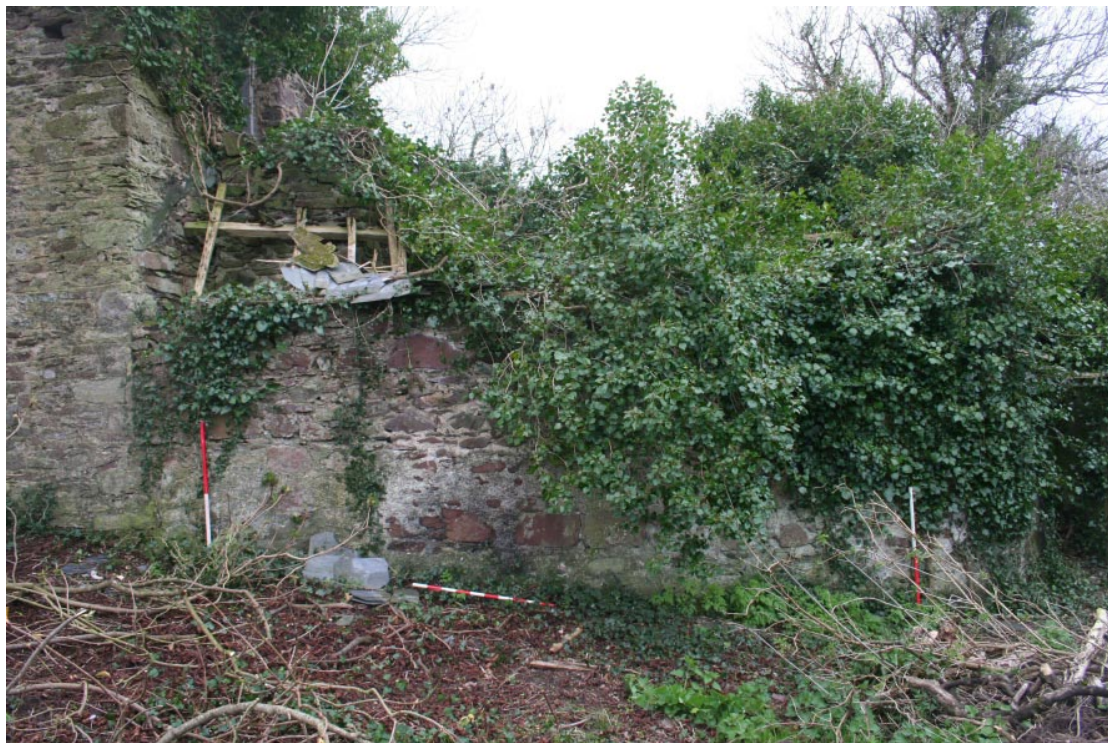
Photo 6: East facing elevation north end B

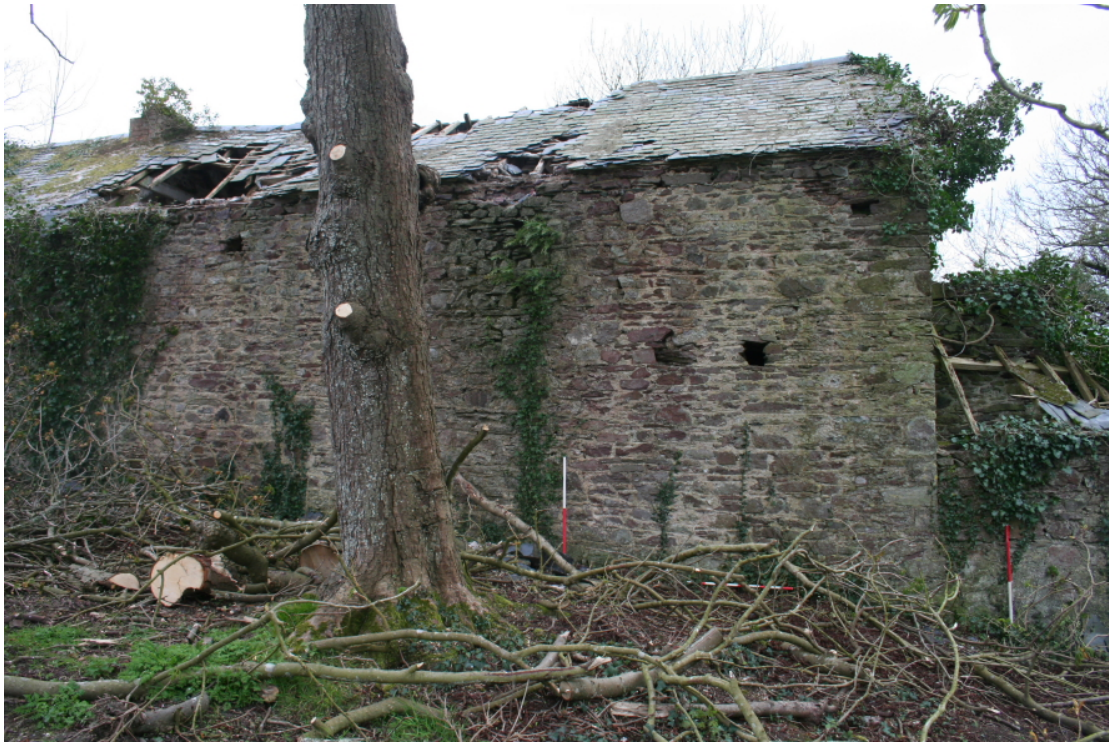
Photo 7: East facing external elevation mid section A

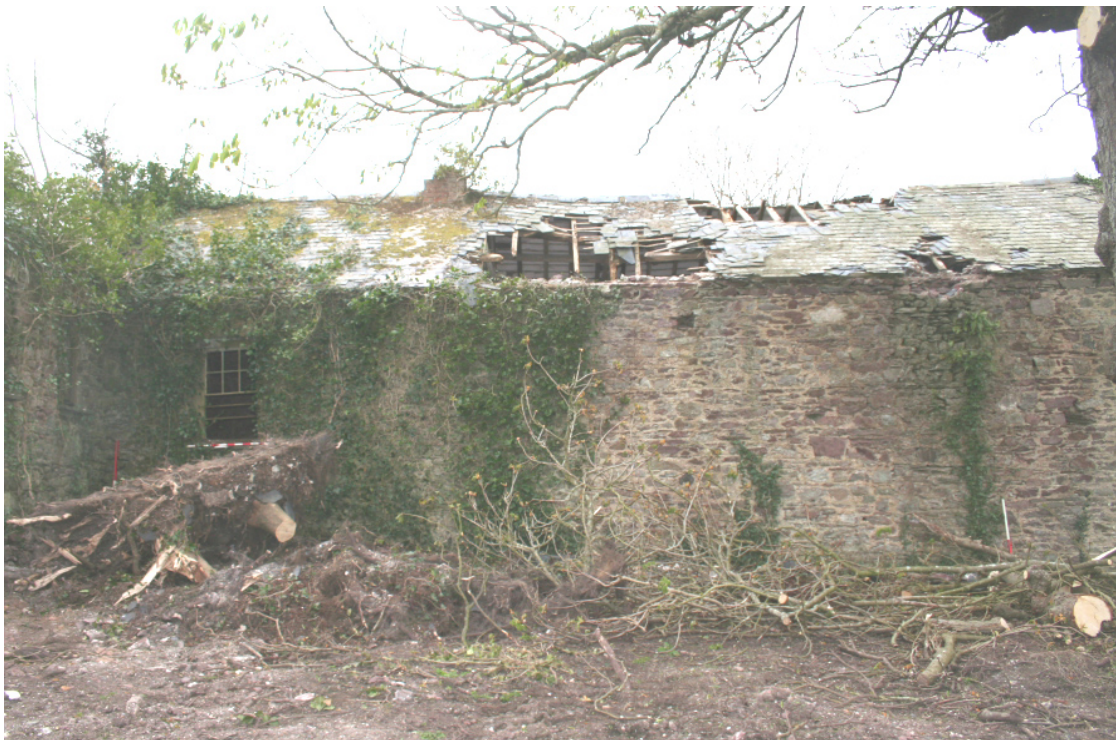
Photo 8: East facing external elevation, mid section B

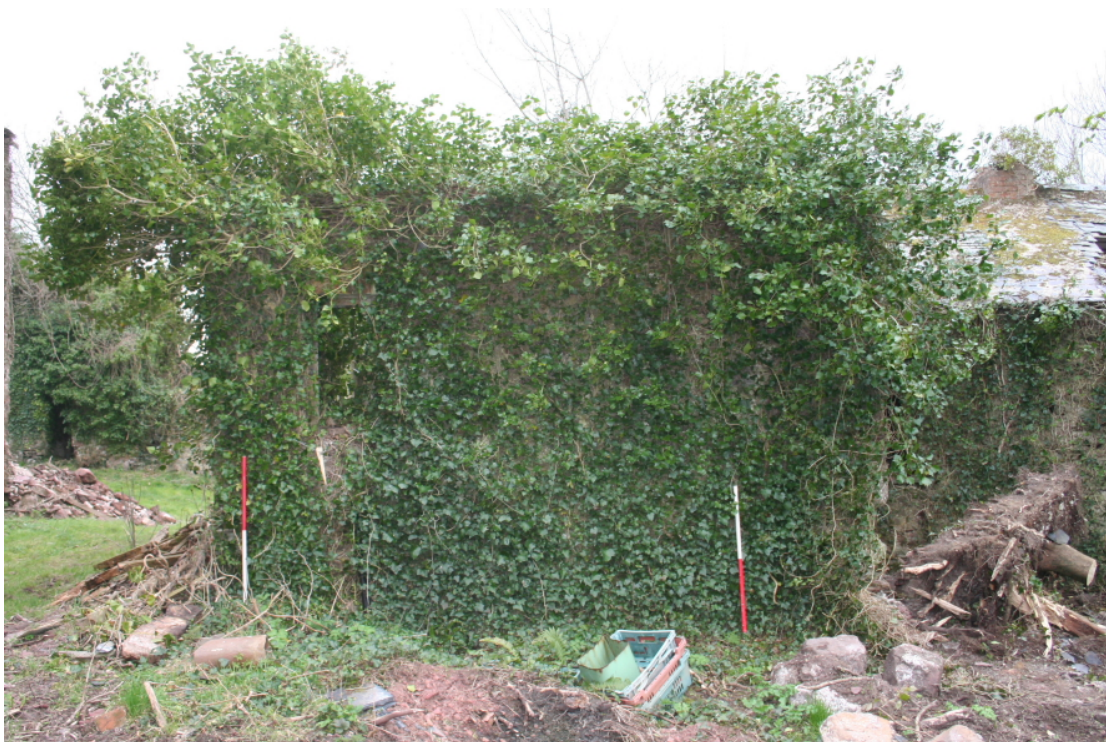
Photo 10: East facing elevation, south end of building

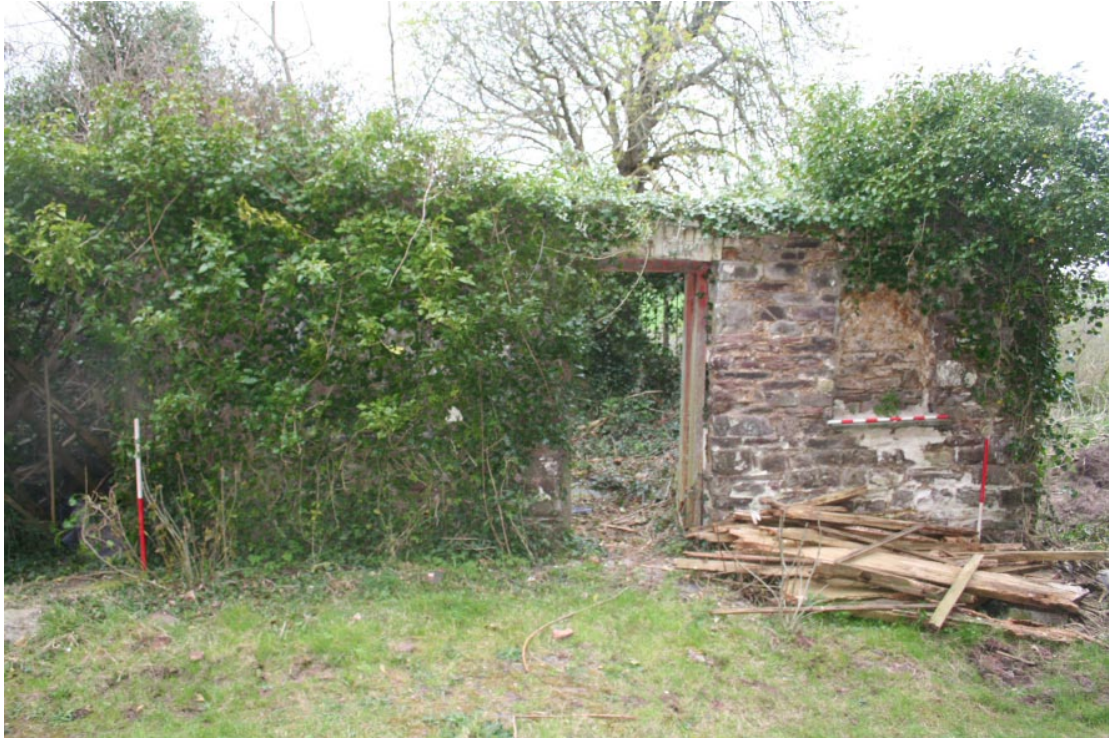
This elevation includes door openings to Rooms A and B and three blocked window openings.

Photo 11: South facing elevation A, south end of building

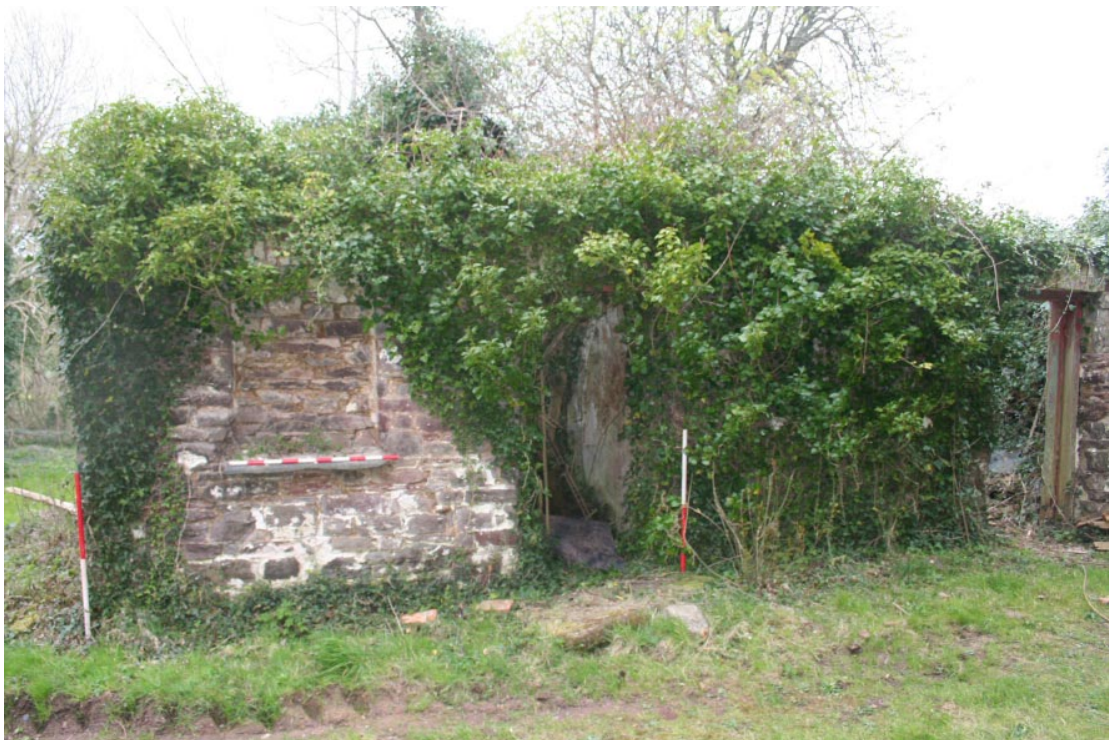
Photo 12: South facing elevation B, south end of building

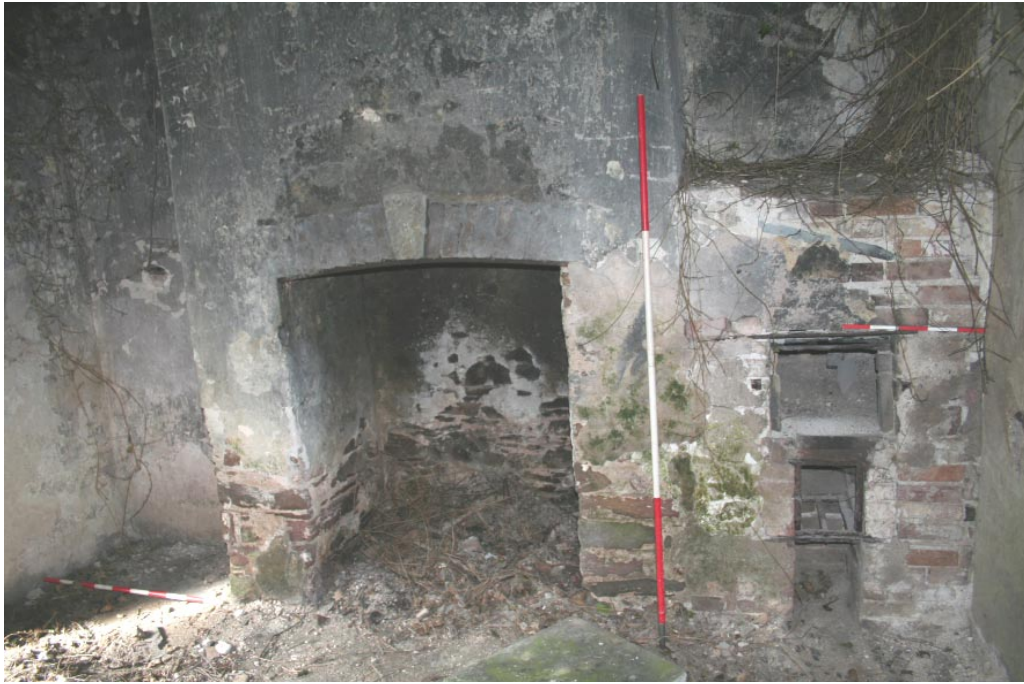
Room C had a single window in its eastern wall, a doorway in the south wall, leading to Room B, and a door opening in the west wall. The north side of the room consisted of a substantial stone built fireplace/hearth, with cupboards built into the western recess and a brick built oven built into the eastern recess. The dividing walls between Room C and D (on either side of the fireplace) butt up to the east and west walls of the dairy.

Photo 13: Room C, north wall

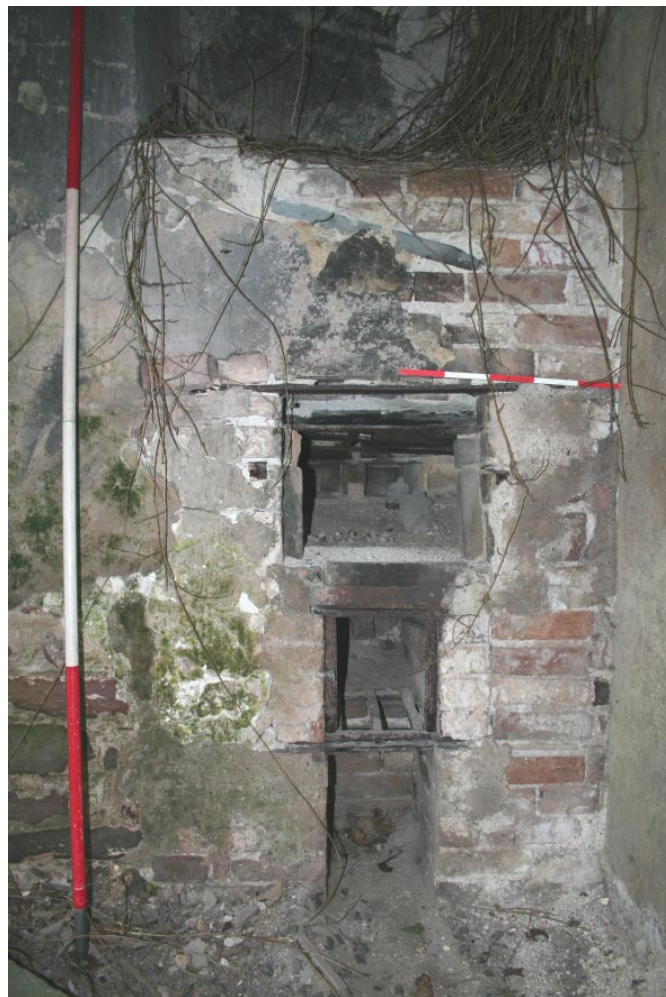
Photo 14: Room C, north wall, detail of oven

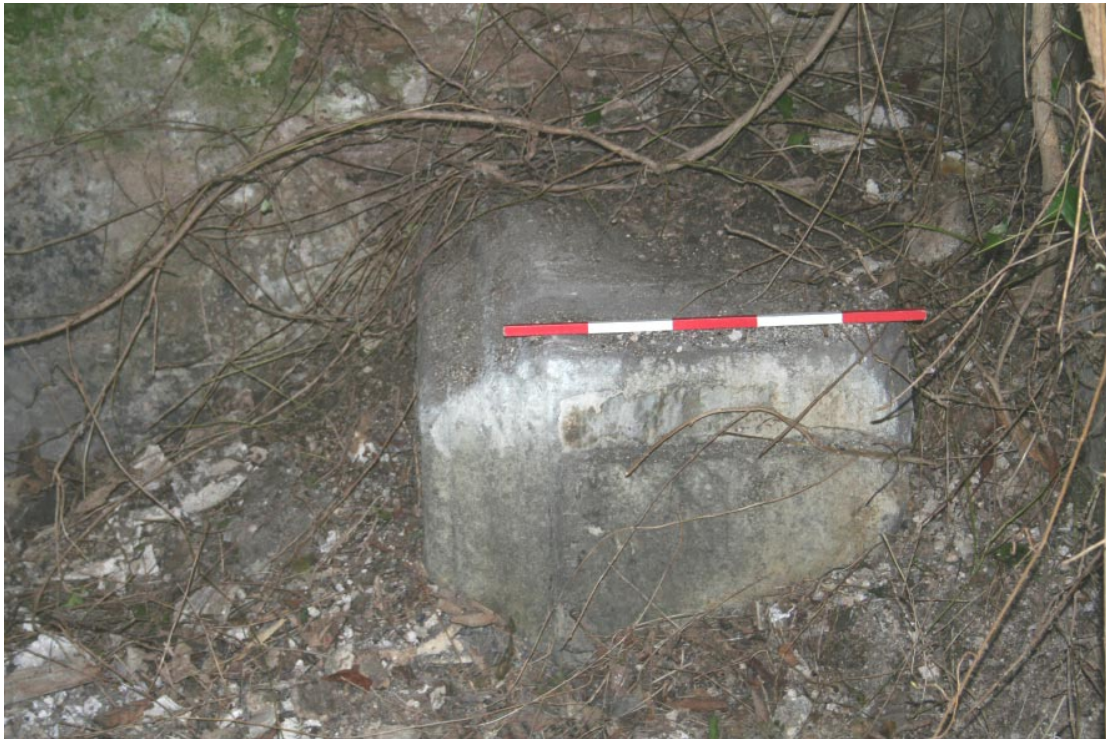
Any original floor surface in Room C appears to have been removed. A possible setting for an engine or generator appears to have been set into the floor in the southern half of the room. The remains of the roof timbers are also considerably blackened. A large stone block, possibly originally from a gateway, is situated in the southwest corner of the room.

Photo 15: Stone block in southwest corner of room C

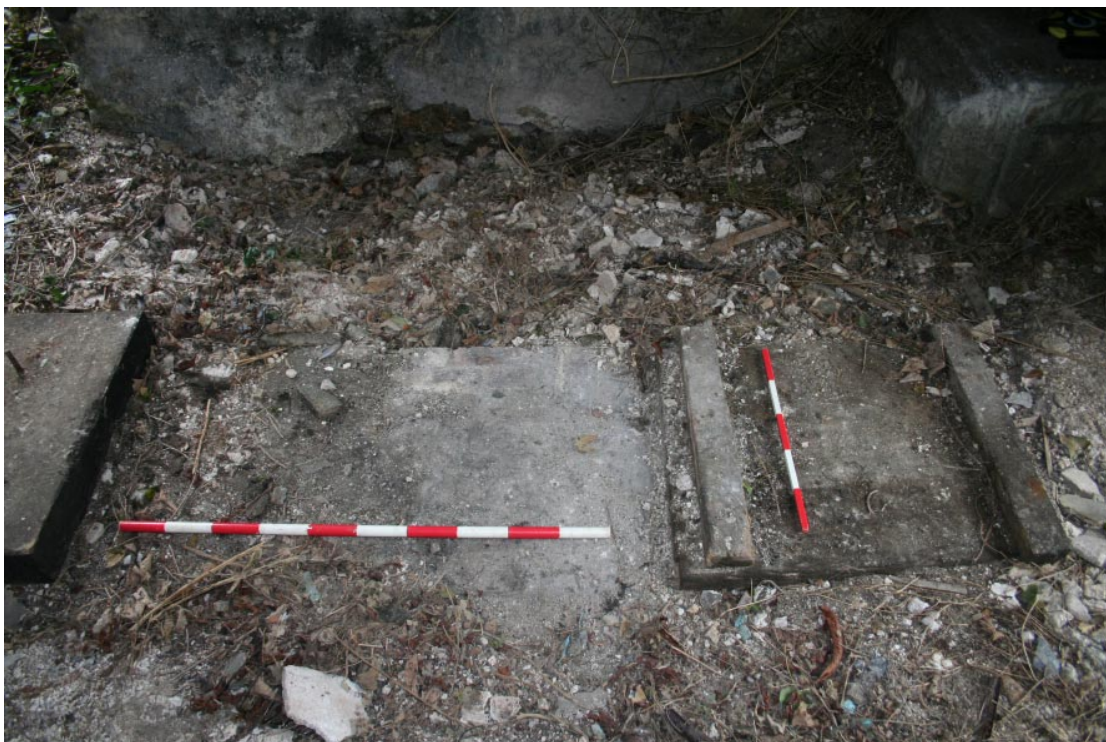
Photo 16: Engine setting? on floor of Room C

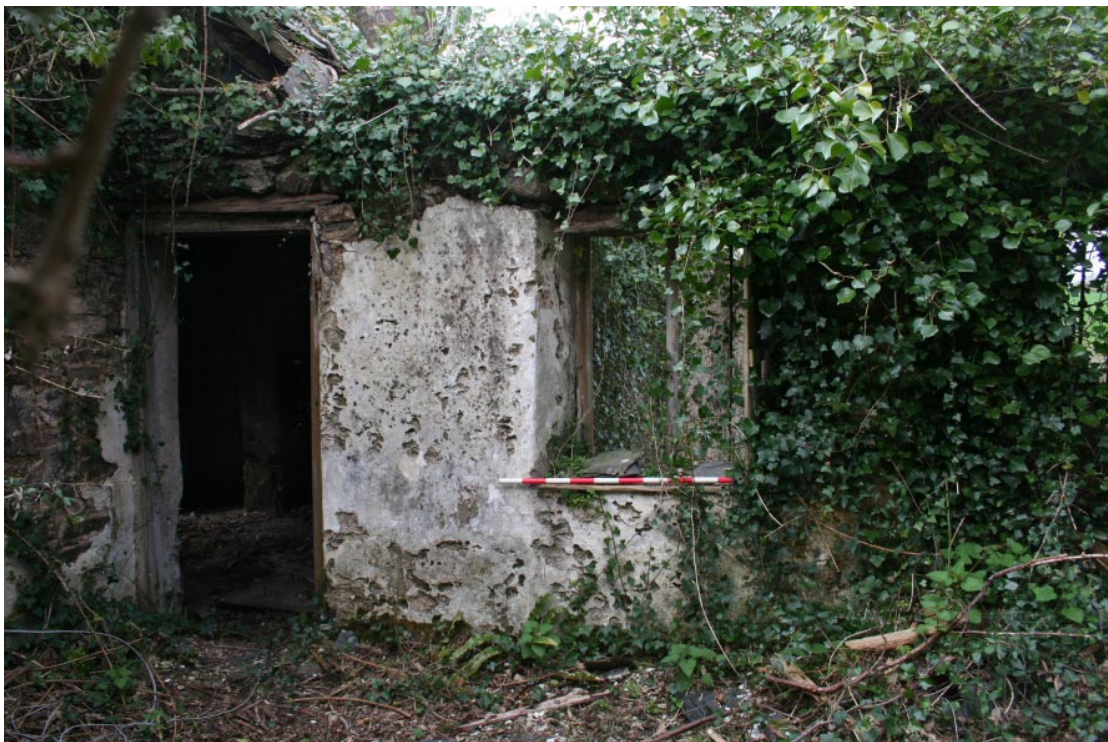
Room B was adjacent to Room A, but there was no communicating doorway between them. Room B has a door opening and two blocked window openings in its south wall, two window openings (the northernmost one blocked) in the east wall, and two window openings and a doorway in the north wall leading to Room C. No evidence of flooring was apparent.

Photo 18: North wall of Room B

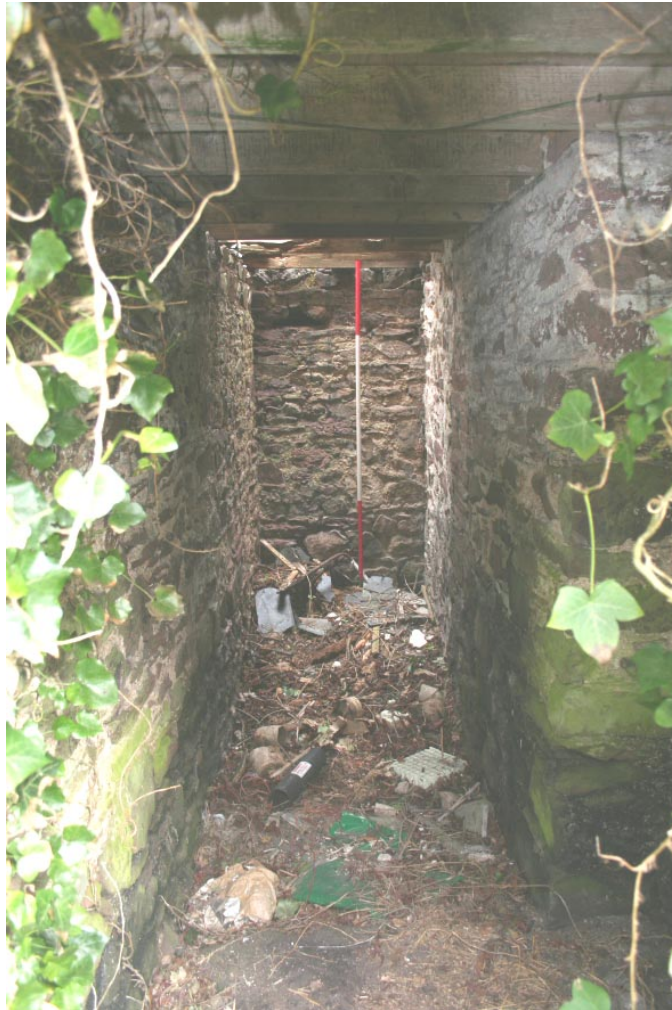
The walls of room D butt up to the east and west walls of the dairy. The only opening is the doorway in the west wall. There is a step up approximately 1.0 metre into the room. Any original flooring material appears to have been removed. This space may have functioned as a fuel store.

Photo 19: Room D, looking east

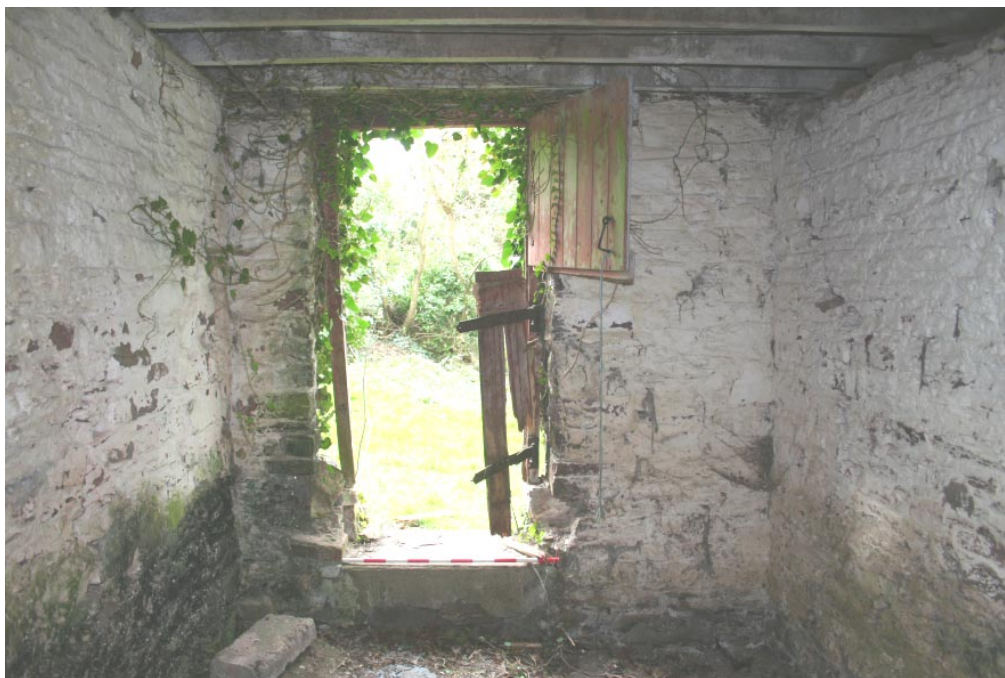
The north and south walls of Room E butt up against the side-walls of the dairy. The only opening is the doorway in the western wall, in which there is a stable-type door. The walls are whitewashed but not plastered/rendered. No evidence of former fixtures or fittings was apparent. There is a considerable difference between the exterior and interior ground levels, perhaps suggesting that the original flooring material (cobbles or slate?) has been removed. This room may have been used for stabling.

Photo 20: Room E, looking west

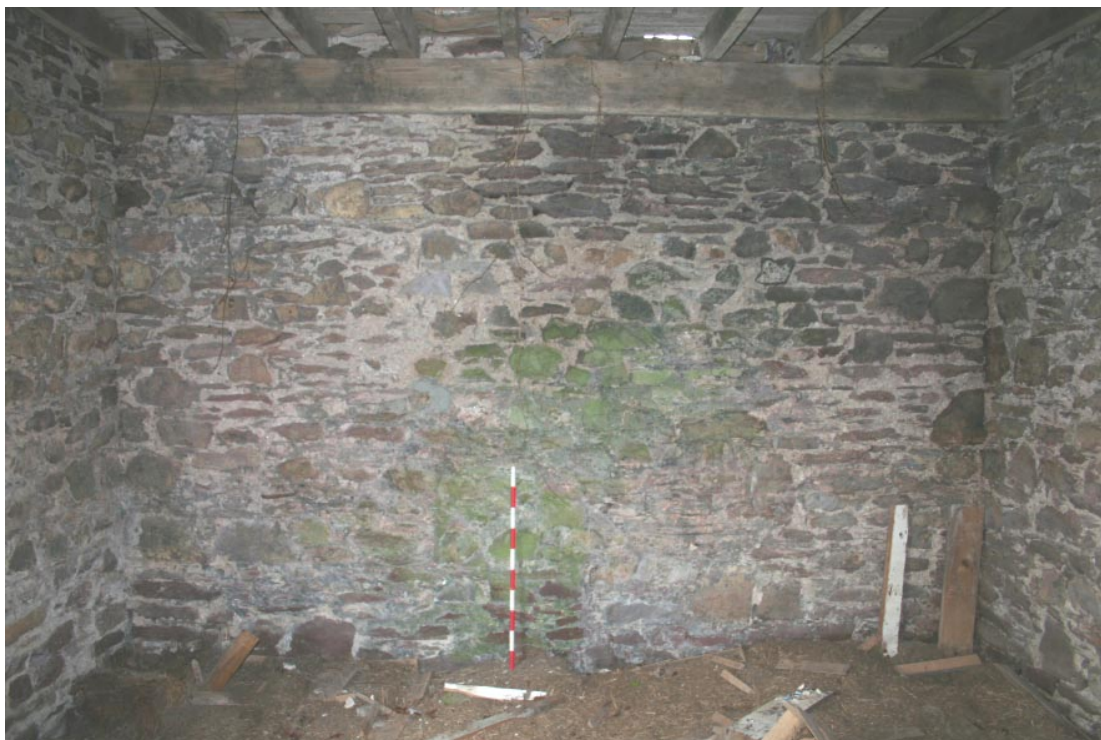
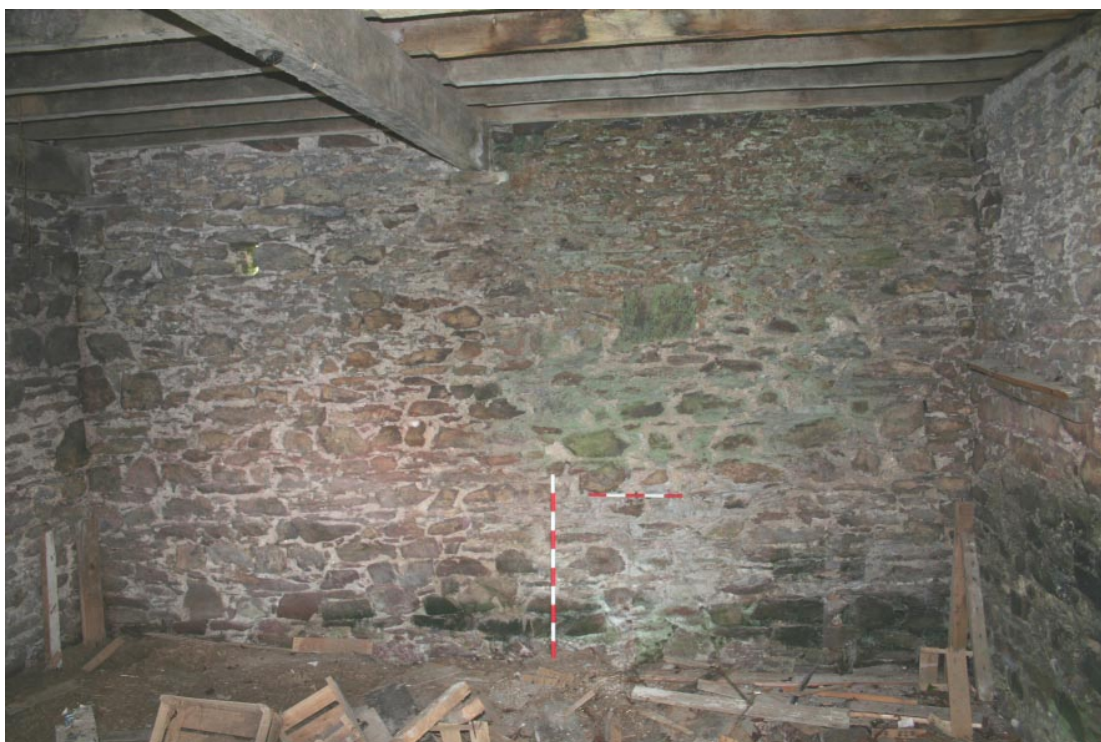
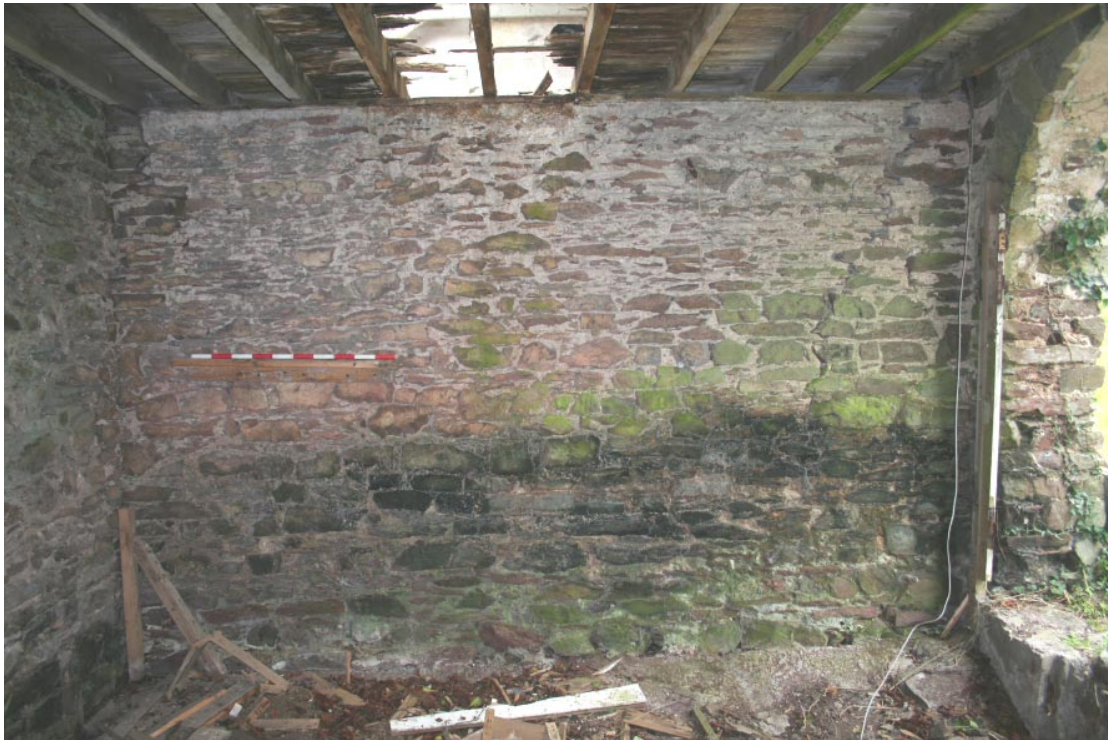
Room F has a single opening in the west wall, a fine archway 2.0m wide, constructed from dressed limestone blocks. The keystone is inscribed with the date 1842. The interior walls appear not to have been plastered, rendered or whitewashed. There was no apparent evidence of former fixtures or fittings. Uneven, natural bedrock was exposed in places at the base of the southern wall, suggesting that the original floor surface (cobbles or stone slabs?) has been removed.

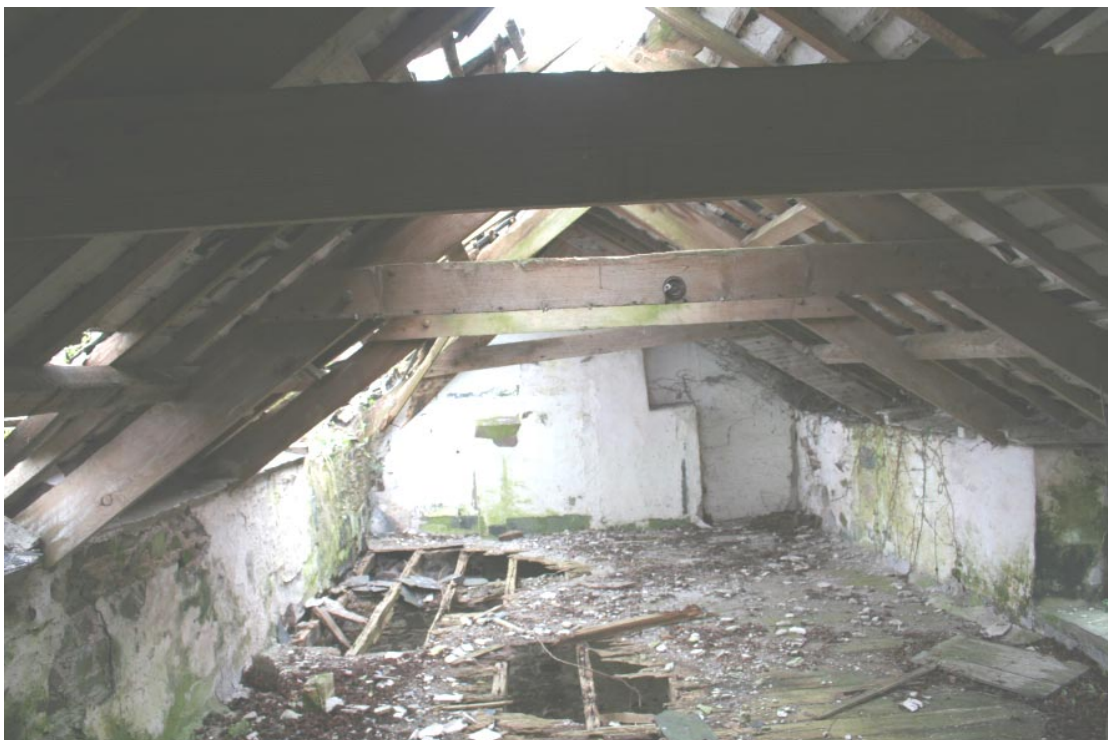
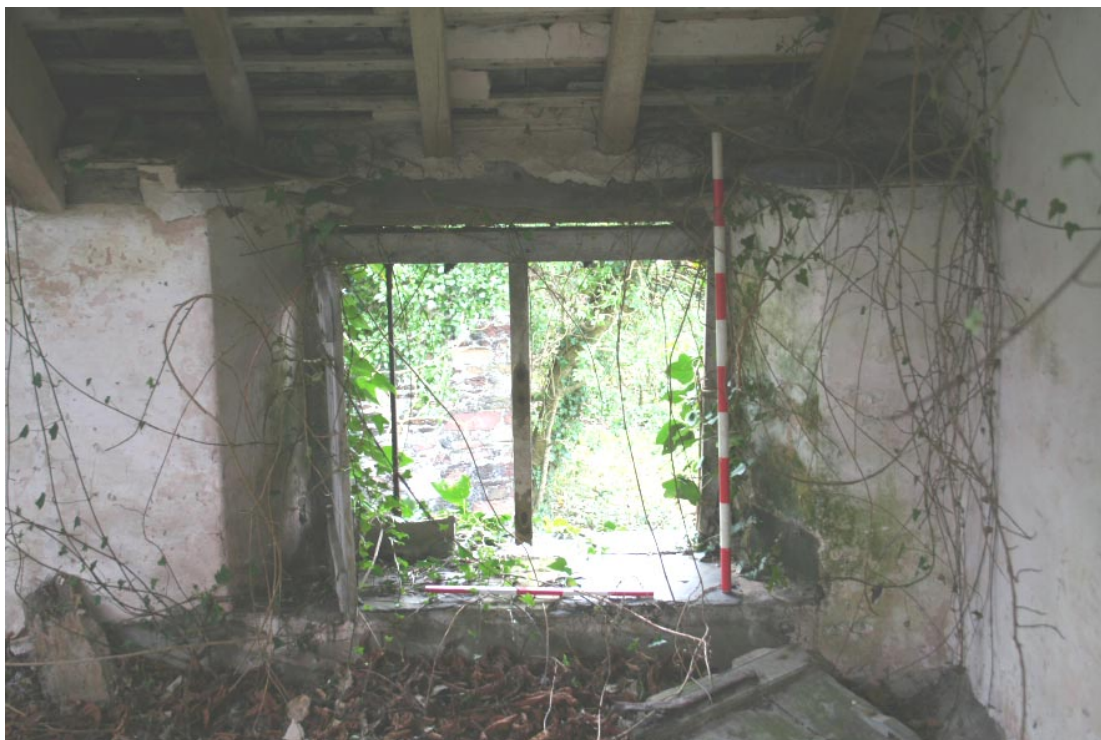
The upper floor of the dairy was considered too dangerous to access. The only access was from a door opening in the north wall, leading to the external staircase. A chimneybreast from the fireplace in Room C was visible on the south wall of the room. The west wall contained three window openings, the southernmost of which was blocked up. No evidence of former fixtures or fittings was apparent.
