TIR GOFAL MANAGEMENT PLAN: HERITAGE MANAGEMENT INFORMATION (HE2)

**Prepared for:
TRE-FAES-UCHAF**

**Tir Gofal Reference No
W/11/7206**

**ACA Report No. 2008/79
Project Record No. 63622**

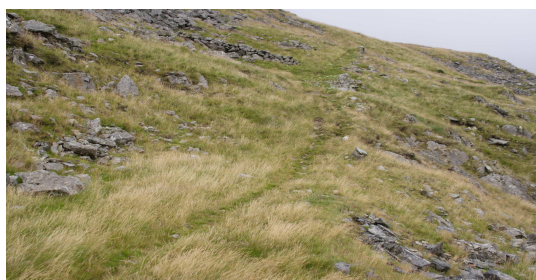
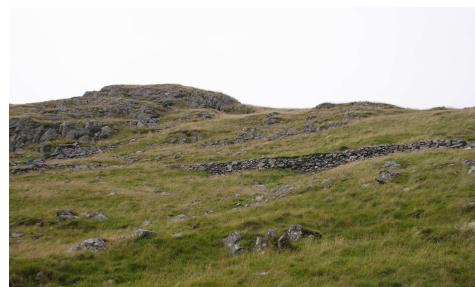
Stone revetted tramway contouring eastern hillslopes. Part of Hafan Tramway, PRN 38239. Connects with White Stone Quarry. Tramway survives intact with stone revetment in parts, but generally as a broad track through sitka. Structure appeared solid and stable in an area of low intensity grazing during the Tir Gofal archaeological farm visit of 16/07/2008.

Looking northeast and north, the line of tramway (PRN 38234) climbing the slopes above mine workings (PRN 9166)

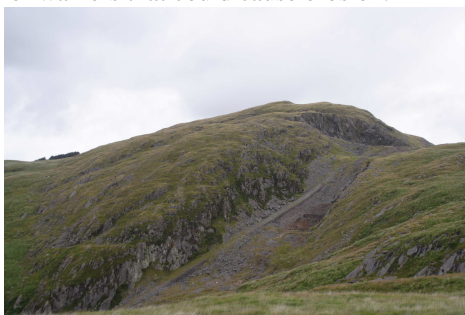
Tramway opened 1879 by Cambrian Railways. Course ascended 1 in 4 inclined plane to reach the quarries below Carn Owen. Tramway in use only for 2 years. See also PRNs 38247 & 38234. The course of tramway can be followed over agricultural land; partly in use as a track. Incline visible as it runs through Hafan Mine. CAP 1999. Two associated structures were recorded, either side of the tramway, one the possible base for winching gear, the other the likely remains of structure PRN 38243. The tramway appeared stable during the Tir Gofal archaeological farm visit of 16/07/2008. The area is under low-intensity farming and the area is unlikely to attract great numbers of walkers that could cause erosion.

Looking north, the line of the tramway (PRN 38239) up to the quarries

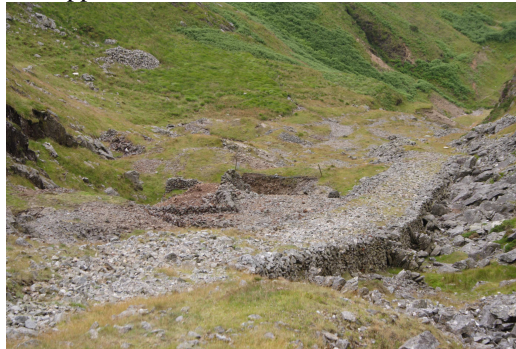
Structure recorded on 1906 Ordnance Survey map. Site seen during Tir Gofal archaeological visit of 16.07/2008. No immediate threats apparent to the structure.

Looking southwest, structure PRN 38243 to side of tramway PRN 38239.

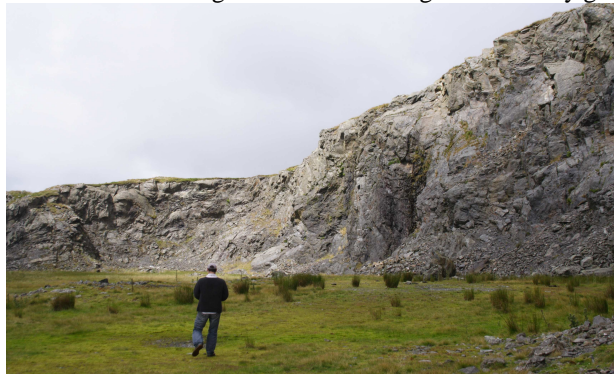
Large open quarry. Sited on land leased by FE. Extensive modern quarrying, which has cut through part of Hafan tramway and Hafan mineral workings. Sited on unplanted area. CAP 1999. Quarrying has left vertiginous cliffs of exposed rock overlooking levelled area being reclaimed by grasses and reeds. (2008)

Looking northwest, the Hafan Quarry cliffs (PRN 38249)

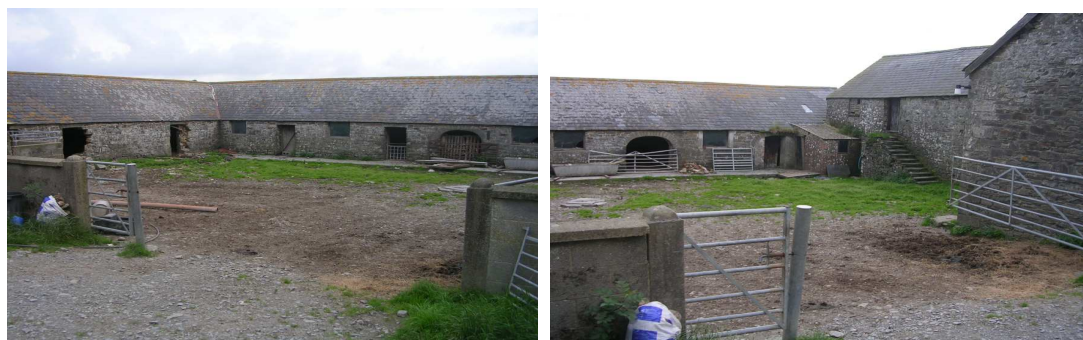
The courtyard farmstead remains substantially intact, constructed from stone with slate roofs. Much of the complex is given over to housing cattle with a single-storey cowshed on the northern side and long, open, single-storey shelter shed running down the eastern side.

Looking northeast and southeast across the Tre-faes-uchaf courtyard complex (PRN21306)

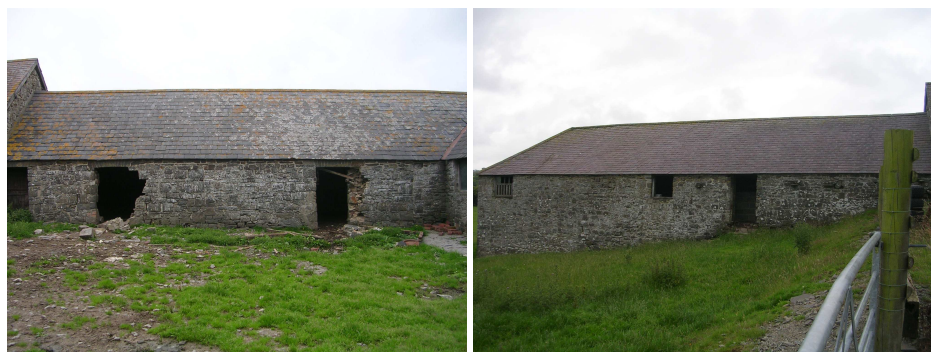
The cowshed is approximately 19metres in length and six metres wide with three doorways, one with a wooden door, two open entrances, along its frontage and a single doorway and two windows to the rear. The open entrances have suffered damage, with the outer stonework on the right edge of each having collapsed. There is possible indication that the stonework around these entrances has been patched up in the past. The interior was very dark by the time of the survey and no internal divisions were noted apart from a doorway leading to a separate room at the eastern end. Wooden feeding racks were fixed to the rear wall and a layer of manure obscured the floor.

Front (south-facing) and rear (north-facing) of the Tre-faes-uchaf cowshed

The Tre-faes-uchaf farmstead is largely intact. However dressing stones to the doorways into the south-facing cowshed and into the north-facing granary barn have become displaced. These buildings should be the focus of repair. The farmer has raised the wish to actually enlarge the cowshed entrances to facilitate easier mucking-out of the building. Unfortunately, although it is good that the building is still being used, such an action would alter the historic appearance of the building and would not be acceptable within the scheme.

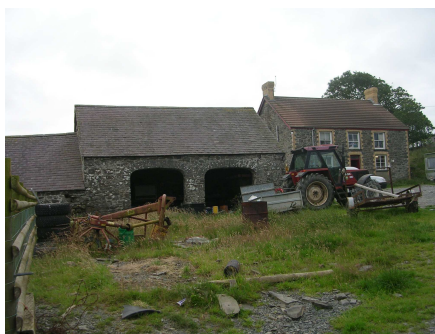
Adjacent to the cowshed, on its western side, is a cart shed, approximately 8m x 6m, that has two open-arches within its north-facing wall. The farmer informed us that this is a later conversion and that the building was also previously a cowshed. He also pointed out that the wooden roof trusses were now supported directly on the later arches.

Looking south, the archways of the cart shed frontage (rear of cowshed to the left) and the present farmhouse.

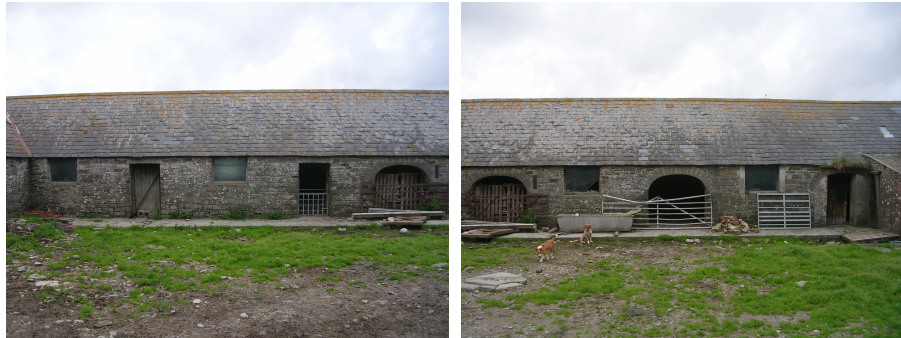
standard doorway. There are two further doorways and four, square windows along the frontage and a window and doorway noted to the rear. There is a concrete raised walkway running the length of the shed frontage and the interior is a large, open space with a concrete floor and lime-washed walls. A metal pipe suspended from the ceiling indicated that the shed had been used for milking in the past.

Frontage (west-facing) of the stock shed

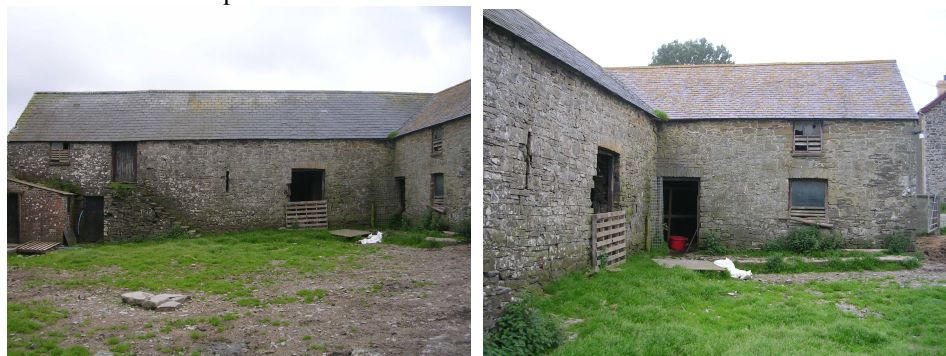
The southern range, approximately 15m x 6m, comprises a two-storey threshing barn and granary range with characteristic tall, wide threshing doorway and ventilations slits and stone steps leading to a loft. Again there is some damage to the stonework on the lefthand side of the doorway and there is no longer a door, the entrance now barred by a wooden pallet. The rear of this range has been restructured with breezeblock. A modern, red-brick outhouse has been built in the southeast corner of the complex.

A further two-storey barn? stable/ granary, approximately 7m x 6m is located, facing east, in the southwestern corner of the complex.

(Left) Frontage of granary barn, (right) stable and barn in southwest corner of complex – east-facing frontage.

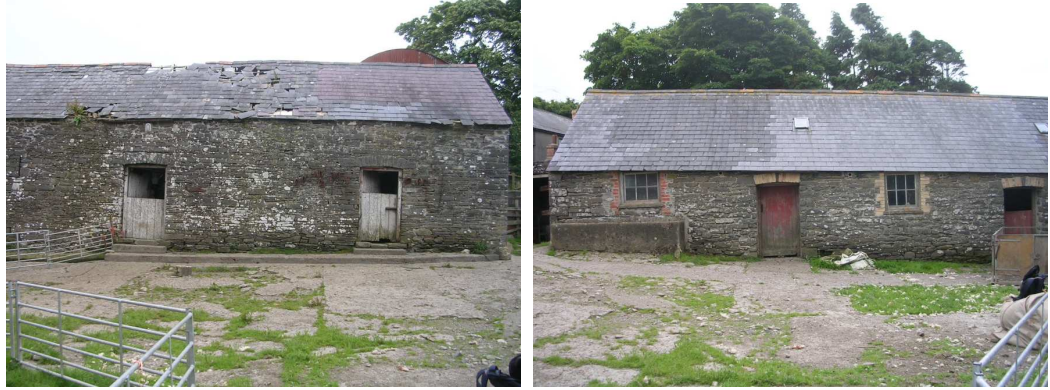
(Left), looking east, the front of the threshing barn – left door – and stable. (Right), looking south, the front of the cowshed.

The north-south aligned range, approximately 17 x 7 metres, on the eastern side of the courtyard contains the threshing-barn in the northern half and the stable in the southern. A breeze-block extension, approximately 6 metres in length, has been added to the northern end of this range. The wooden plank doors to both parts of the main barn are original and both doorways have a stone lintel above a brick arch.

The roof of the threshing barn and stable is now in a poor condition with many slates now missing and exposing the roof timbers.

- Repair is always preferable to replacement, keeping as much of the original fabric of the building in place as possible. Replacement is only to be carried out where necessary.
- Replacing roof timbers: As a general rule, replacement features should be modelled on similar surviving examples. Where these do not exist the emphasis should be on matching details appropriate for the locality and buildings age.
- Ideally the whole threshing barn and stable range should be re-roofed in slate, in the style that is appropriate to the locality

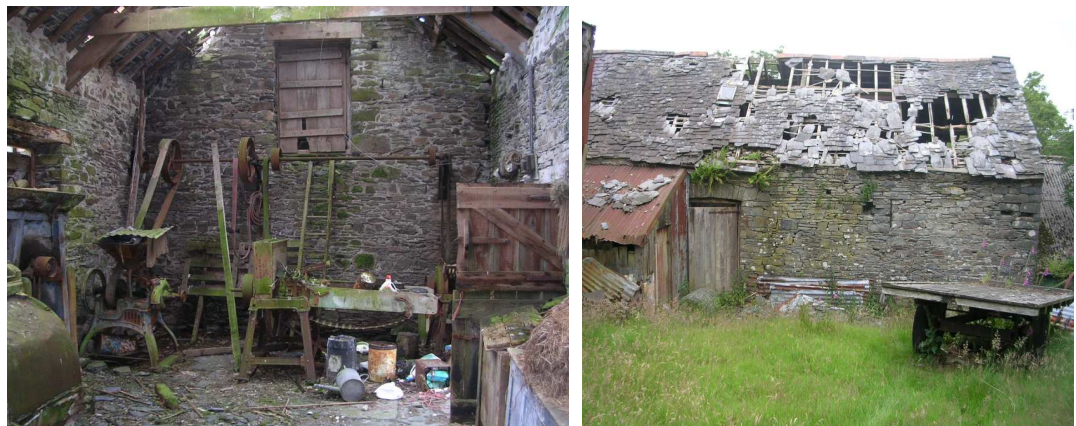
The threshing-barn stone floor, between the facing doorways in the front and rear of the building, remains intact. Inside are several belt driven machines (threshing, winnowing etc.). A corrugated-iron engine house is attached to the back of the building. A wooden door in the southern, dividing wall gave first floor access to the hay-loft above the stable. The walls survive intact but the slate roof is in disrepair with many dislodged slates, particularly to the rear of the building, exposing the roof timbers and leaving the interior open to the elements.

(Left), interior of the threshing barn, looking south towards access to the hay-loft with belt driven machines still in situ. (Right), rear of the threshing barn with, on the left of the picture, the engine-house for running the threshing machines.

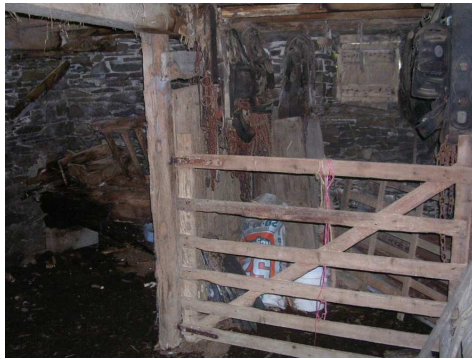
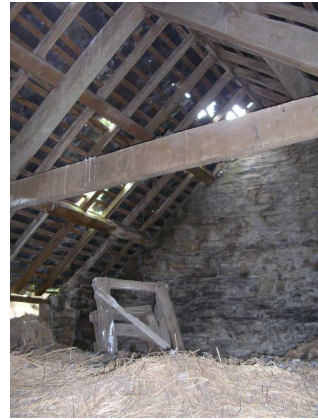
The stable block contained four stalls with wooden feeding racks. The hay-loft above can be accessed by a ladder and there is an open access at the back of this to allow hay to be dropped straight down into the racks below. The floor is concrete and there is a window located in the rear wall. Many items of horse equipment were still housed in the stable, including riding collars and a wooden curry-comb, and horseshoes hang from the outer front wall, either side of the doorway.

Inside the stable block (left), looking east, showing stall and shuttered rear window, horse equipment hanging from the walls and (right), looking southeast, the hayloft above.

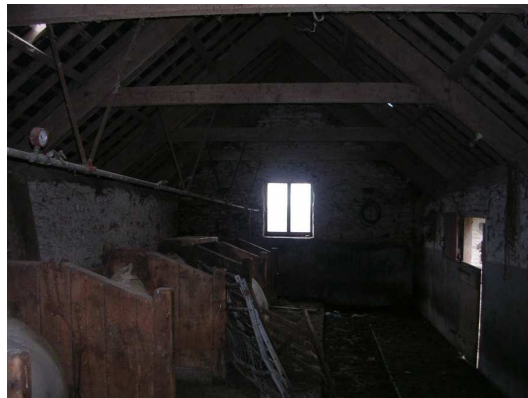
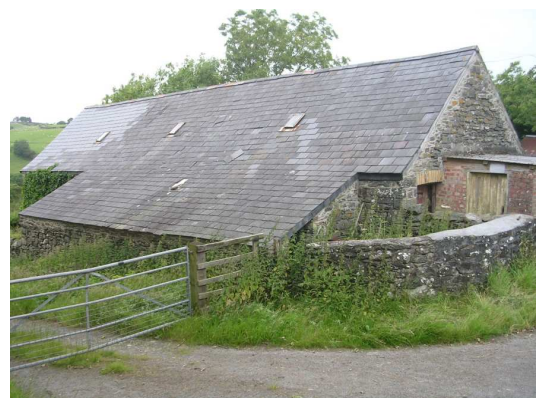
The cowshed, aligned east-west, measures approximately 17 x 7 metres with a shorter, lower extension to the rear incorporating a pigsty. The building remains largely intact and the slate roof is in relatively good condition. There are two doorways and two windows with yellow brick dressings facing onto the yard. The other window is edged with red brick, suggesting possible later repositioning or repair. A further doorway is in the east-facing sidewall, again with a yellow-brick arch above and a window is in the west-facing sidewall. All doors are painted red. Inside there are eight wooden stalls positioned along the length of the building, facing towards the rear wall. A drainage channel runs behind the stalls leading to an opening in the northwestern corner and a feeding galley ran along the rear wall. A milking rail is suspended above the stalls. The internal walls were limewashed.

A flat-roofed, square extension loose box is attached to the side (eastern) wall of the cowshed, built from stone on the northern side and extended in redbrick to the south, with a doorway both to the north and south. A large concrete water trough stood on the eastern side of the cowshed frontage.

(Left), looking west inside the cowshed, showing the wooden stalls, drainage channel and milking rail.
(Right), looking northwest, rear of the cowshed and curved wall of pigsty in right foreground.

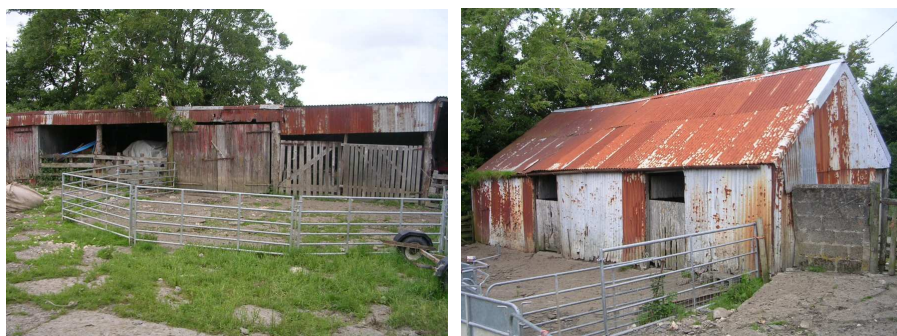
The structures forming the western and northern sides of the courtyard complex are later buildings of wood and corrugated-iron. The western range, is divided into open-fronted barns, or secured by either slatted wooden gates or solid wooden double doors. Farm machinery and equipment, including a wooden cart, is stored in these buildings. The building to the north of the courtyard had an entirely corrugated-iron exterior, with two doorways containing three-quarter length wooden gates in its frontage. The interior comprised two open areas divided by a central passageway running north-south. Wooden feeding racks were attached to the rear wall and the building was obviously used to house livestock.

(Left), looking west, corrugated-iron and wooden structures along the western range. (Right), looking northwest, livestock shed to north of farmstead complex.

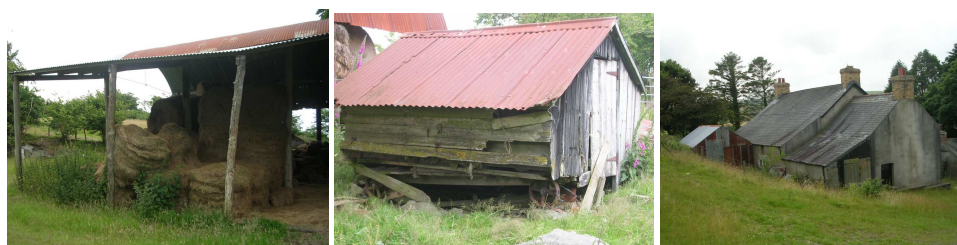
Other buildings include a large open hay barn, located behind the stable and aligned east-west. It is constructed from timber poles supporting a timber a corrugated-iron roof. To the southeast of the courtyard complex is a wooden henhouse with a corrugated-iron roof sat on top of a low, wooden trolley with small iron wheels. Behind the farmhouse is a further corrugated-iron outbuilding, possibly a workshop, although the interior was not seen during the Tir Gofal visit.

(Left), looking southeast, eastern end of the open hay barn. (Centre) looking east, the hen-house. (Right), looking southwest, the outbuilding behind the Moelwyn farmhouse.

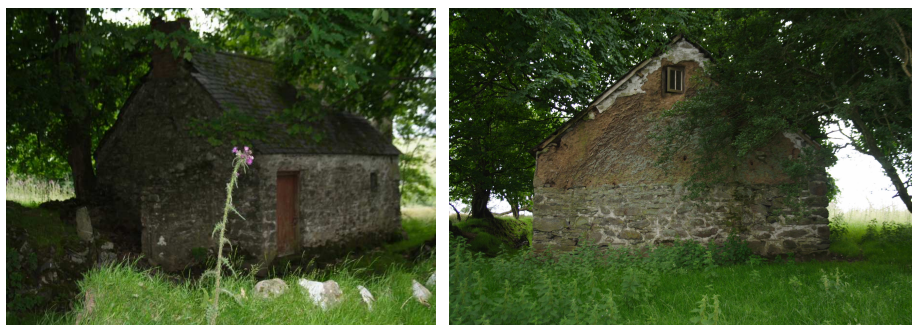
(Left), looking north, frontage of Banc Cottage (PRN 64240). (Right), looking southwest, clom and stone end wall of cottage.

The management aim within Tir Gofal is to prevent damage by vegetation to the cottage. Banc Cottage is surrounded by mature trees and the branches of one are damaging the clay wall, or clom, used on the northern side. The following recommendations apply:

- Replace missing or displaced roof slates.
- Repair and limewash the clom (clay) end wall. Contact the Dyfed Archaeological Trust for further advice if necessary.
- Consider carrying out stabilising works to the brick chimney, taking specialist advice from a suitably qualified builder or structural engineer.

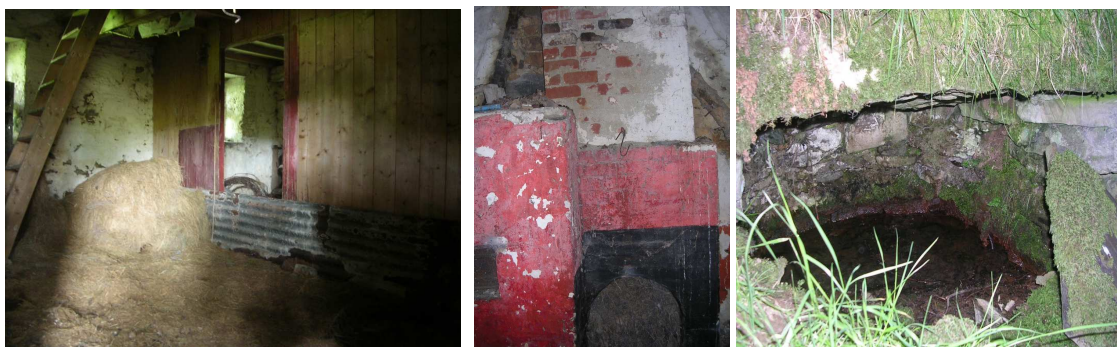
A later phase of rebuilding is evidenced by a red brick range, chimney and slate roof which may have replaced thatch and wattle originally, as was the tradition in the area: the sooty imprint of an earlier, possibly wattle chimney hood, can still be seen behind the new range.

Associated features nearby include a stone corbelled well, and the stone and earth footings of former outbuildings.

Interior of Banc Cottage (PRN 64240): (left), wooden partition dividing ground floor with ladder leading to loft space and (centre), brick fireplace and oven, blackened outline of previous chimney hood in top left corner. (Right), the well, looking north.

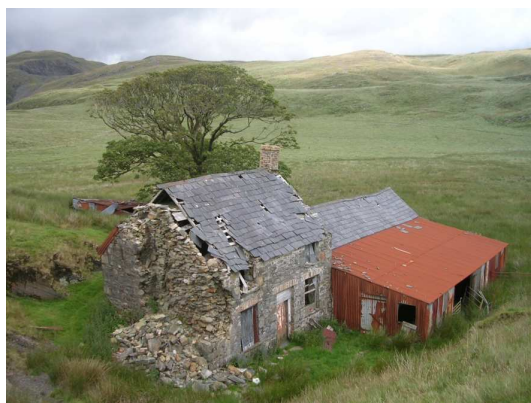
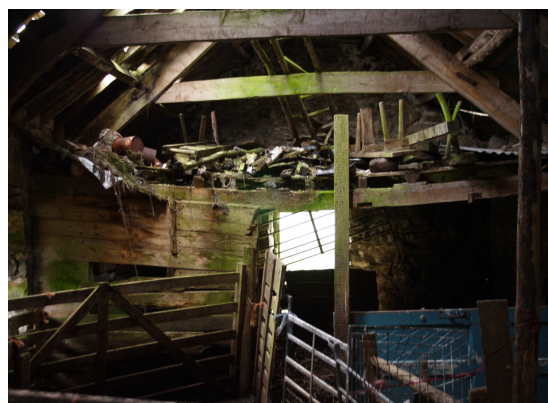
The Tir Gofal archaeological farm visit on 16/07/2008 found the Ffos Fudr farmhouse in a precarious state. The western wall is in a state of near total collapse – the outer skin of stone had already largely fallen and exposed the interior rubble - having suffered prolonged water-damage from the stream flowing from the southwest that had washed out the lime-mortar, and looked beyond reasonable repair. The roof structure is also damaged, with many missing slates exposing the roof timbers and allowing open access to the elements and the remaining chimney looks likely to fall soon. The windows are timber-framed with stone sills but all glass had gone, one window now blocked up with corrugated iron. The yellow bricks above the windows and door and forming the chimney are of 20th century date. Access to the interior was not sought on safety grounds, although wooden-panelled walls were visible within. The attached stone barn had been extended to the north and south by corrugated-iron constructions that appeared to be in relatively good condition. The roofs to these were supported on brick pillars on top of the stone walls of the barn. The original outbuilding exhibited a number of original features, including wooden plank doors, hinges and the wooden roof frame. The roof pegs were metal rather than wooden, indicating later construction. The barn is accessed through a doorway in the southwest corner and there were two window apertures in the northern wall and one in the southern wall. A further doorway in the end, eastern wall is a probable later insertion. Hurdles, wooden and metal gates and old doors divided up the interior, presumably for housing sheep. A few roof-slates were dislodged but otherwise the building appeared to be in reasonable condition.

Looking northeast, Ffosfudr Farmstead (PRN 9373) and, looking east, interior of attached barn

The Ffosfudr Farmstead is in a poor state of repair due to long-term water damage that appears to have washed out the lime-mortar bonding within the western wall and caused major collapse of the outer masonry. The slate roof of the farmhouse is also in urgent need of repair and many of the windows are open to the elements. This report cannot provide advice as to whether the structure of the farmhouse is repairable and any such works may prove both prohibitively expensive and potentially fruitless while the water-flow problem so close to the house remains. The roof could be made weatherproof through the use of galvanised corrugated-iron, a cheap and durable alternative to traditional slate and now a recognised historic material in its own right, and the windows could also be made secure against the elements. However, while the main body of the house is still under threat any such maintenance would seem inadequate, and this problem most likely requires the advice of a structural engineer.

- Consolidate areas of loose masonry using a traditional lime mortar mix, trying to follow the original mix and appearance as far as possible.
- Consider capping the wall tops of derelict and ruinous structures in order to prevent water from washing out lime mortar bonds and accelerating collapse.
