TIR GOFAL MANAGEMENT PLAN: HERITAGE MANAGEMENT INFORMATION (HE2)

**Prepared for:
Maesrhiw**

**Tir Gofal Reference No
W/12/7211**

**DAT Report No. 2008-116
Project Record No. 63663**

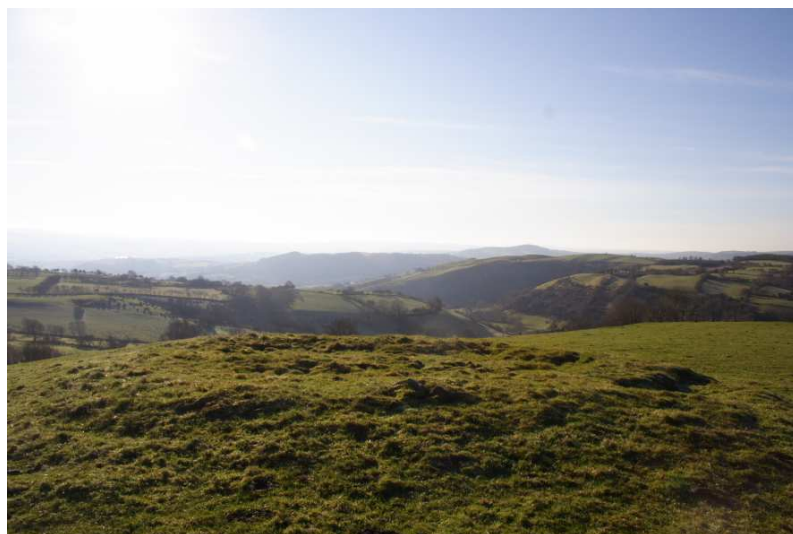
Looking southwest across the round barrow PRN 10449

The monument was visited during the Tir Gofal archaeological farm visit of 03/12/2008, when it was seen to be under a cover of grass, in an area of rough-grazing, with a few exposed stones, and there did not appear to be any immediate threats to the site. The barrow commands panoramic views to the south and west.

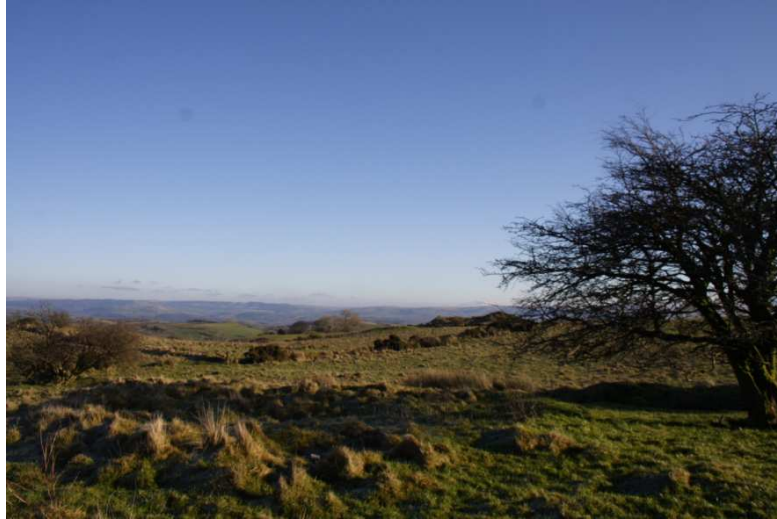
Looking northeast across the roundbarrow PRN 1904

The cairn is under a cover of grass in a remote area of rough-grazing and there are no immediate threats to the monument. It is approximately 10 metres in diameter with a distinct bank of earth and stone around the perimeter. The excavated area appeared to extend from the centre to the western edge of the cairn. It lies to the east of the summit of Mynydd Llansadwrn and commands panoramic views from the northeast to the south.

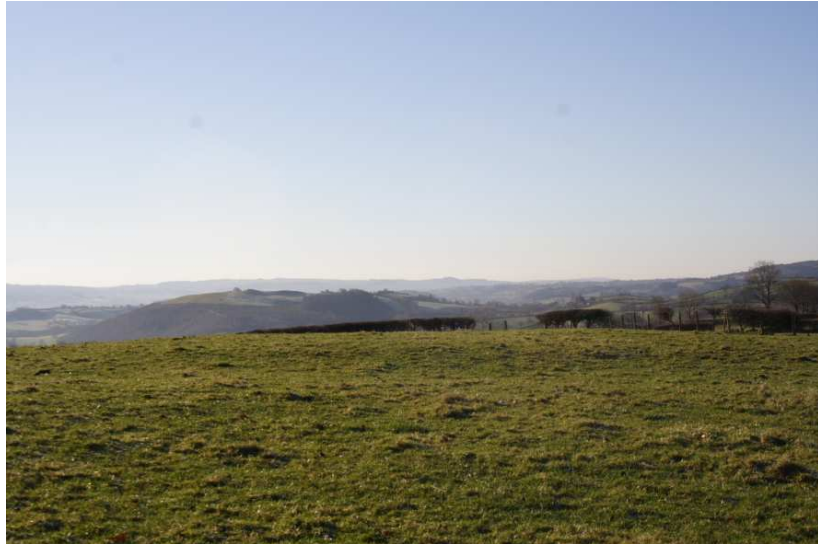
Looking southwest across the are of the Iron Age enclosure PRN 5110

The site was visited during the Tir Gofal archaeological farm visit of 03/12/2008 and the area of the Iron Age enclosure was found to still be under improved pasture, grazed by sheep, on the top of a ridge with panoramic views to the south. The earthworks are very ephemeral and indistinct but it is probable that archaeological deposits are preserved below ground. There did not appear to be any immediate threats to the monument, with no signs of breaks in the ground surface or erosion.

The area of the monument is currently under pasture but it is understood that it has been ploughed regularly in the past. Such practice should be discouraged in the future as the existing earthworks, already indistinct, will be eroded away completely and any surviving archaeological deposits below the surface could be damaged.

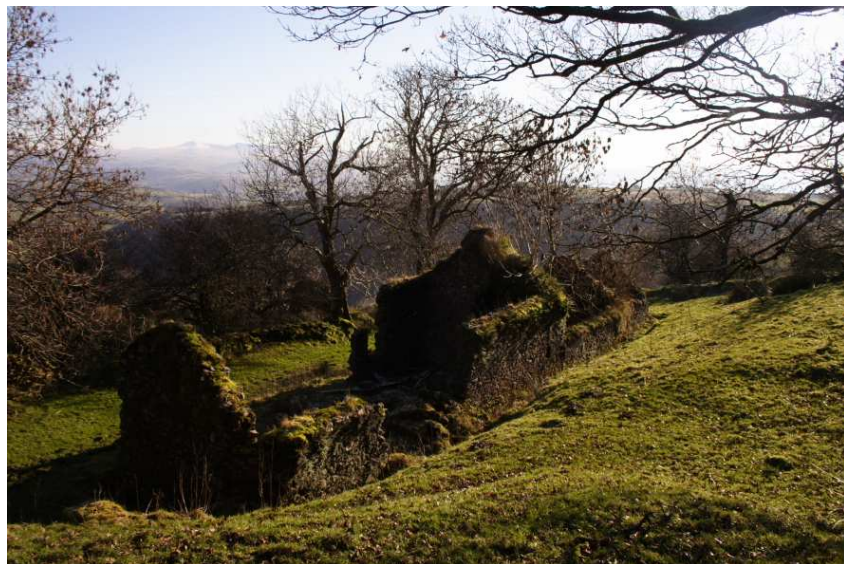
Looking east, ruined building PRN 6952

The living area is divided into two rooms, the southernmost of which contains the remains of a fireplace in the north-facing end wall and the remnant of a window aperture in the frontage. To the south of this the building is again divided into two areas but, as only the partial wall remnants survive, it is unknown whether this part of the building is of further domestic use or possibly agricultural. A further stone outbuilding, in a

bad state of disrepair, is located, on the same alignment, to the north of the main structure. A boundary wall curves around from the southeast corner of the main building and back up the hillside to the west.

- Monitor trees close to the building and consider felling mature trees that are at risk of windthrow and remove branches that pose a threat from falling.
- Consider cutting back vegetation on the walls, leaving the roots in situ. Spot treat to prevent re-growth.
- Consolidate areas of loose masonry using a traditional lime mortar mix, trying to follow the original mix and appearance as far as possible.
- Consider capping the wall tops of derelict and ruinous structures in order to prevent water from washing out lime mortar bonds and accelerating collapse.

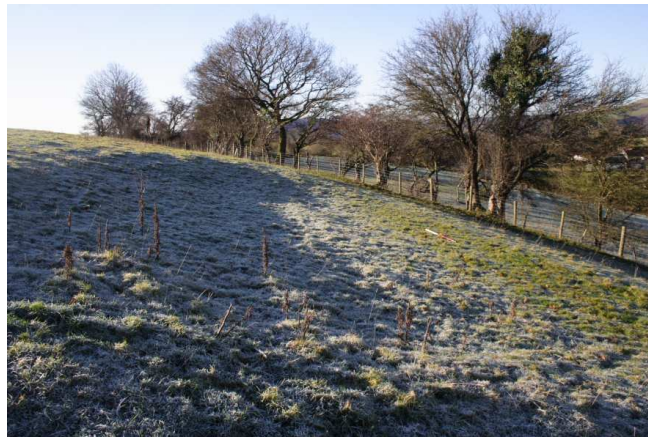
Recorded by the RCAHMS (NPRN 404678) as an earthwork indicating the site of a medieval or post-medieval house platform or longhouse. A levelled area, aligned southwest-northeast, scraped into the hillside north of the Iron Age enclosure PRN 5110 was located at NGR SN69963272 during the Tir Gofal archaeological farm visit of 03/12/2008. It measures approximately 12 metres x 4 metres. A hollow just to the northeast of this site looked like a possible quarry.

Looking southwest, platform PRN 64743.

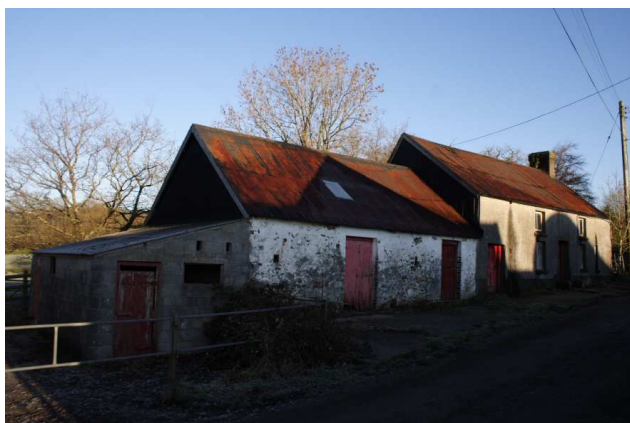
Bwlch-y-Gwynt longhouse PRN 6953

The cowshed is built of whitewashed stone with roughly squared quoins and a corrugated-iron roof incorporating a flush rooflight. The solid, wooden plank doors were locked during the Tir Gofal archaeological farm visit of 03/12/2008 so the interior was not seen. A breezeblock extension has been added to the southern side. The facade of the farmhouse, of stone and brick construction, is under concrete render and the roof is again of corrugated-iron.

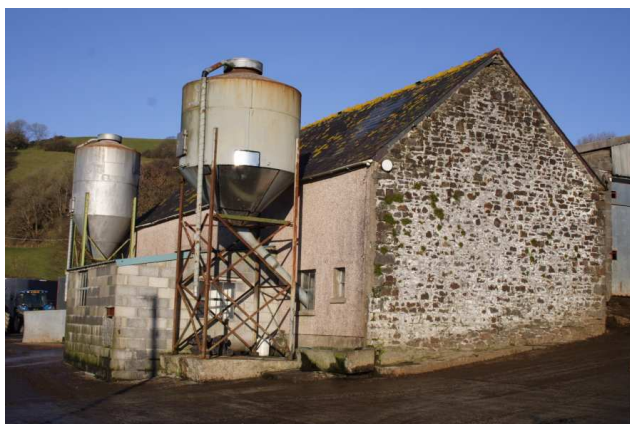
Looking north, former cowshed and stable, now milking parlour at Maesrhiw farmstead.

It is apparent from the southern gable-end that the building was whitewashed, although this weather-proofing has now deteriorated and the facade is under a concrete render. It is understood from the farmer that the building used to comprise a cattle-shed and stable but it has now been converted into a milking-parlour. Most of the original internal features of the building have been lost with this transition in use, with concrete render now to the height of the cross-beams, a concrete floor and a sliding metal-door entrance. The roof is open to the original roof-timbers. Modern farm buildings of breeze-block and box-profile corrugated-iron are now located immediately behind and to the north of this 19th century construction.

The southern gable-end of the milking parlour had evidently been painted with whitewash, providing weather-proofing for the stonework. This has now deteriorated and it would be worth considering applying a new coat. The façade is now under concrete render, while the back wall and northern end are closely abutted by later buildings. Vegetation is growing on the gable walls, particularly on the rather inaccessible northeast corner of the building, and some remedial action is needed.

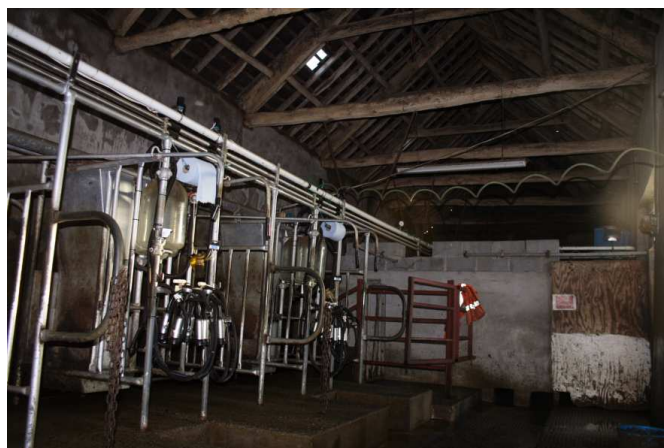
Interior of the milking parlour

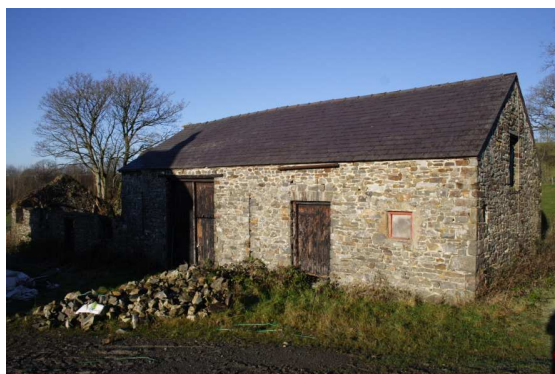
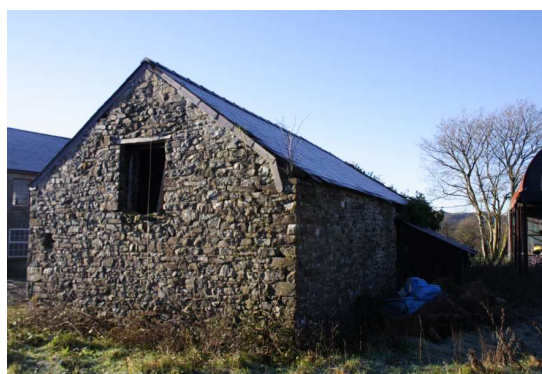
The front and rear of the threshing-barn and stable, showing the corrugated-iron engine house.

The gable-ended stable and barn are of rubble stone construction with roughly squared quoins and a pitched slate roof. The stable is the eastern half of the building, accessed by a wide, solid wood-planked door, with a hayloft above. Wooden and corrugated-iron partitions divide the interior into two stalls, with wooden feeding racks fixed to the wall with a gap above to allow hay to be dropped directly down from the loft above. The threshing-barn has a high, double-door entrance, with a wooden lintel just beneath the eaves, and ventilation slits to either side. A corrugated-iron engine house, which would have provided power for belt-driven threshing and winnowing machines, is attached to the back of the building. The interior is open to the roof timbers.

The barn and stable are intact and look in generally good condition although some small-scale remedial action is required, along with general maintenance. Several roof slates are loose, some sections of the slate weatherboarding are loose or missing and there is some vegetation growing on the walls.

There is some minor damage to the stonework and several gaps in the mortar of the barn and stable. Repair is always preferable to replacement, keeping as much of the original fabric of the building in place as possible. Replacement is only to be carried out where necessary.

- Repair or replace missing or displaced roof slates and weatherboarding.
- Re-pointing is necessary where mortar has weathered back to a depth equivalent to the joint width or is very loose. If possible, the original pointing should be matched in terms of material and finish. A flush or nearly flush finish is appropriate
- Use lime mortar. Try to follow the original mix and appearance as far as possible.

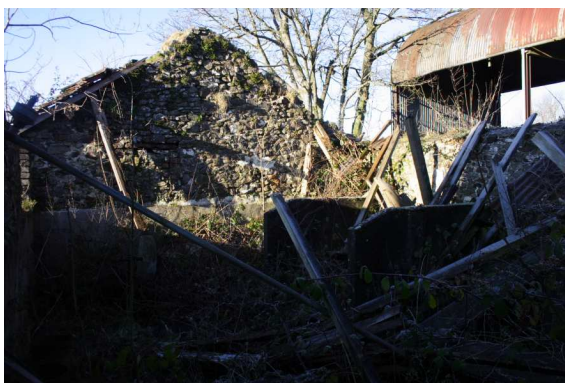
Interior of the cowshed

The walls of the adjacent cowshed stand intact but the roof is completely missing with the exception of a few clay tiles attached to the gable-end. This single-storey building is again of rubble stone construction with roughly squared quoins and redbrick dressings around the windows and doorways. The interior walls are concrete rendered to the height of the window ledges. Five concrete cattle stall partitions are in situ, facing along the rear wall, with tethering chains attached.

The cowshed is in a more ruinous state, with the roof missing and exposing the wall-tops to the weather. Although the roof timbers have collapsed the walls appear to stand to full height. Although it was roofed with clay-tiles at the time of its listing, these would appear to be modern and ideally the building should be re-roofed with slate in the same style as the buildings to either side. Corrugated-iron, however, might prove an acceptable, more economic alternative. This should be discussed with the Carmarthenshire County Council conservation officer. There is also a lot of vegetation, both on the walls and within the interior, which requires removal.

- Replacing roof timbers: As a general rule, replacement features should be modelled on similar surviving examples. Where these do not exist the emphasis should be on matching details appropriate for the locality and the age of the building.
- Ideally the cowshed should be re-roofed in slate, in the style that is appropriate to the locality.

If replacing the roof on the cowshed is not possible then the following actions are recommended in order to stabilise the structure.

- Cap the wall tops of derelict and ruinous structures in order to prevent water from washing out lime mortar bonds and accelerating collapse.
- Cut back vegetation on the walls, leaving the roots in situ. Spot treat to prevent re-growth.
- Monitor trees close to the building and fell any that are at risk of causing damage, either from windthrow or dropping branches.

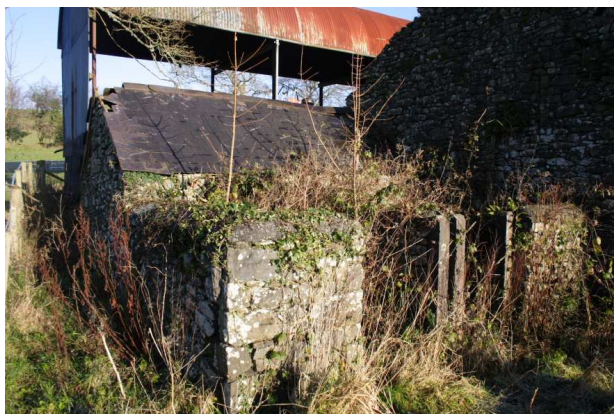
The pig-sty

Adjoined to the western end of the cowshed is a rubble stone, twin-penned pigsty with a gable-ended, slate-roofed pighouse. The tops of pen walls have been consolidated with concrete and there are concrete gateposts, although the gates have gone. Some stones in the rear wall of the pighouse have become dislodged and several of the roof tiles, slate weatherboarding and ridge tiles are dislodged, broken or missing.

The pigsty has damage to the rear masonry that has created a hole through the wall, leaving the surrounding stonework unstable. On the roof there are dislodged or missing slate tiles and ridge tiles and the slate weatherboarding is partially broken, exposing a roof timber. The wall tops of the pen have been capped with concrete but the vegetation growing on the walls and within the interior of the sty needs removing.

Repair or rebuilding of walls should aim to match the original appearance as closely as possible, using similar materials and methods of construction.

- Match the type of stone used originally, and the method of laying. Fallen stone may be salvageable, although additional local rubble stone brought to rough courses is appropriate.
- Consolidate areas of loose masonry using a traditional lime mortar mix, trying to follow the original mix and appearance as far as possible
- Repair or replace missing or displaced roof slates and weatherboarding.

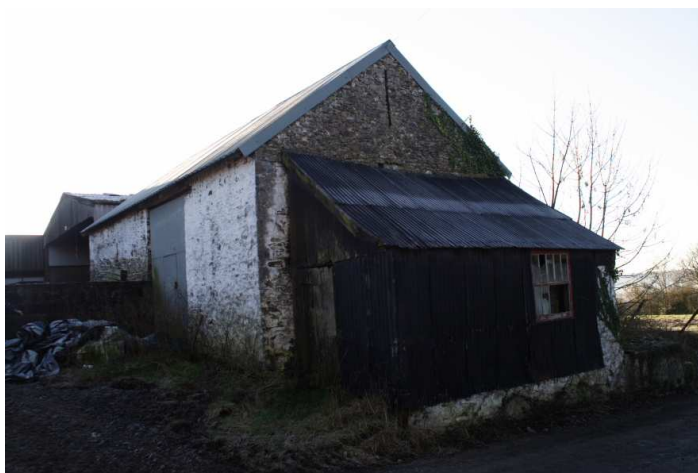
Threshing-barn with corrugated-iron lean-to workshop.

The threshing barn is a gable-ended building constructed from rubble-stone, whitewashed on the facade, with roughly squared quoins. The rear wall appears to have been damaged and has now been consolidated with breezeblocks. There are high, double width entrances at both front and back, although the original wooden doors have been replaced with metal ones, and several ventilation slits. The original roof, presumably of slate tiles, has been replaced with box-profile corrugated-iron. The interior was not viewed during the Tir Gofal farm visit of 03/12/2008. A lean-to building is attached to the northwest end of the barn, mainly constructed from corrugated-iron although the footing of the building is stone, suggesting a possible earlier construction. A timber-framed window is located within the northwest-facing wall and, although the interior was not seen during the farm visit, it seems plausible that the building was/is used as a workshop.

The farmstead buildings appear generally to be in good condition and weathertight and any recommendations for their upkeep concern preventative maintenance. The threshing-barn has been repaired and restored with modern materials but it was noted that there was ivy growing on the corner of the building. In addition, the facade of the barn was painted with whitewash, providing weather-proofing for the stonework, which has now deteriorated and a new coating would be advisable.

Vegetation is also growing on the stone foundation of the workshop lean-to and its window may require some remedial repair.

- Cut back vegetation on the walls, leaving the roots in situ. Spot treat to prevent re-growth.
- Consolidate areas of loose masonry using a traditional lime mortar mix, trying to follow the original mix and appearance as far as possible.
