TIR GOFAL MANAGEMENT PLAN: HERITAGE MANAGEMENT INFORMATION (HE2)

**Prepared for:
Trefach**

Castell Trefach

**DAT Report No. 2010/26
Project Record No. 64986**

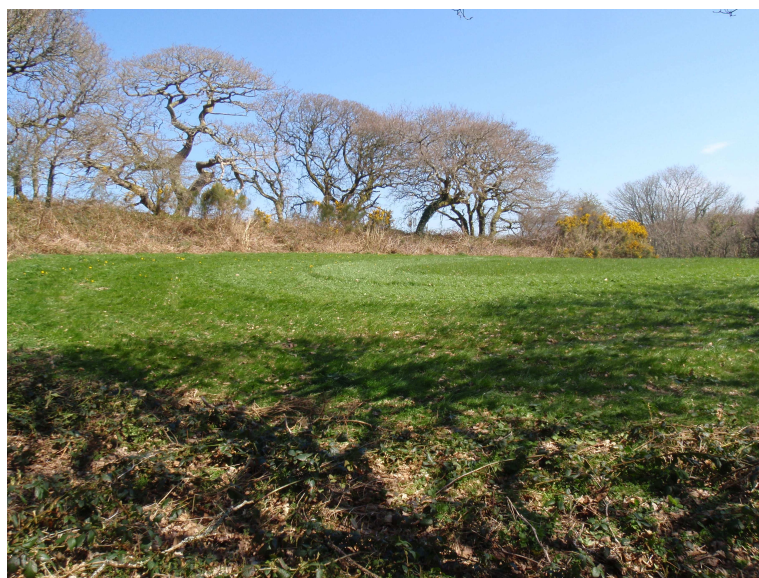
Looking northeast across the interior of the enclosure, with defensive bank lined by oaks

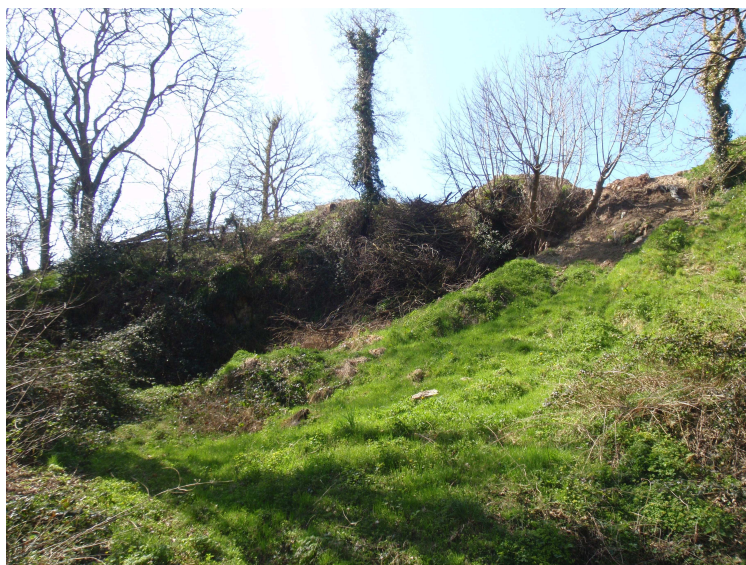
Looking southwest across area of quarry (PRN 94133)

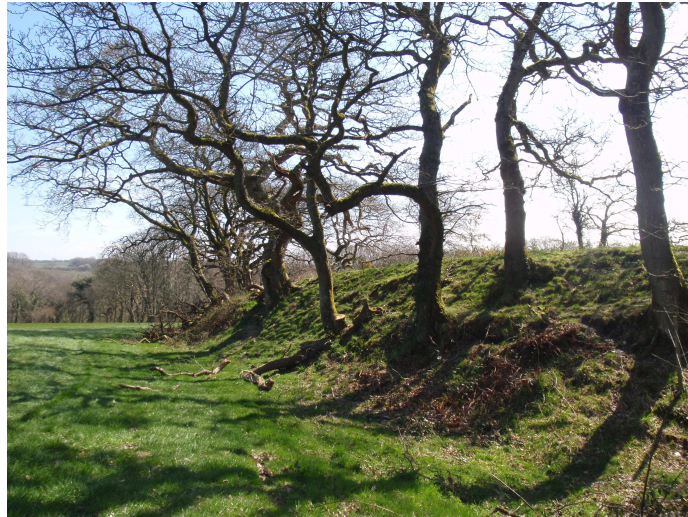
Oaks growing on the enclosure bank.

- 1) Some boughs have fallen from mature oak trees on the defensive bank.
- 2) There is one active badger sett on the defensive bank (external side). The grass cover around the old badger sett, to the west of the active sett, has improved.
- 3) Grass cover over the remainder of the site is good.

Condition: worsened.

- 1) Cutting split boughs from trees. Removing the felled boughs and fallen boughs from the defensive bank and scheduled area.
- 2) Hand cutting gorse and scrubby vegetation from the southern (internal) side of the defensive bank and removing debris from the scheduled area.
- 3) Removing debris from the previous cutting, from the northwest side of the scheduled area.

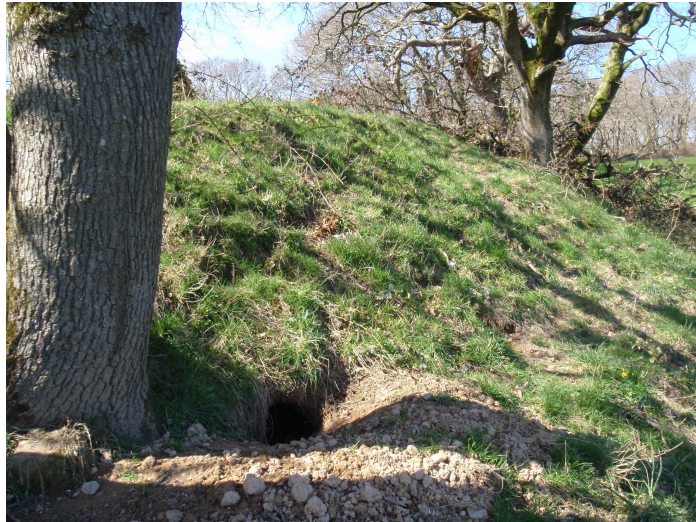
There is one active badger sett on the external side and one area of redundant sett, which is recovering in condition. Should the sett lie within the badger cull area it is recommended that it is infilled after the cull. This has been done at a few sites where badger setts have been abandoned.

Badger sett within the enclosure bank

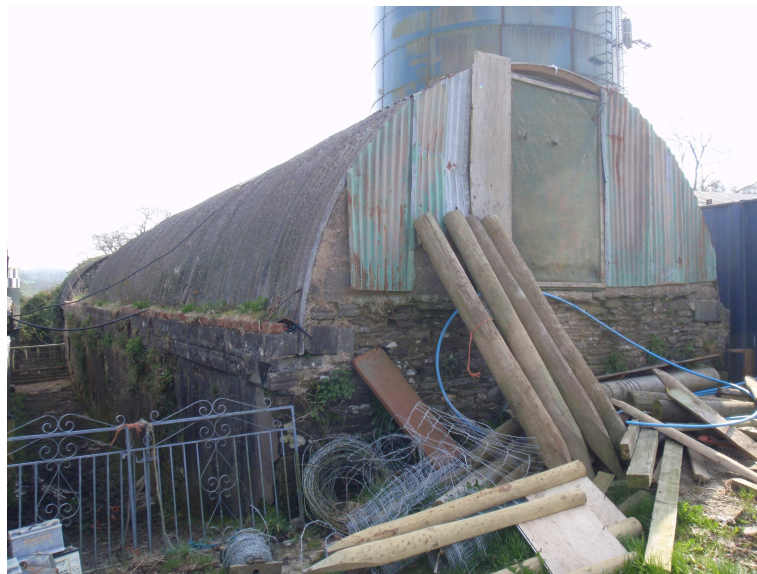
Western end and north-facing wall of the Trefach cow shed

The cow shed and cart shed lie to the west of the mill and are depicted on the late 19th - early 20th century OS maps as a single long range, some 30 metres in length and aligned east-west. Further buildings abutting the southern wall of the range are now gone. The range comprises an abutting cow shed and cart shed, which have since been substantially altered. A section in the centre of the range has been demolished, separating the cart shed from the cow shed.

Cut back vegetation on the walls, leaving the roots in situ. Spot treat to prevent re-growth.

Consider capping the wall tops in order to prevent water from washing out lime mortar bonds and accelerating collapse.

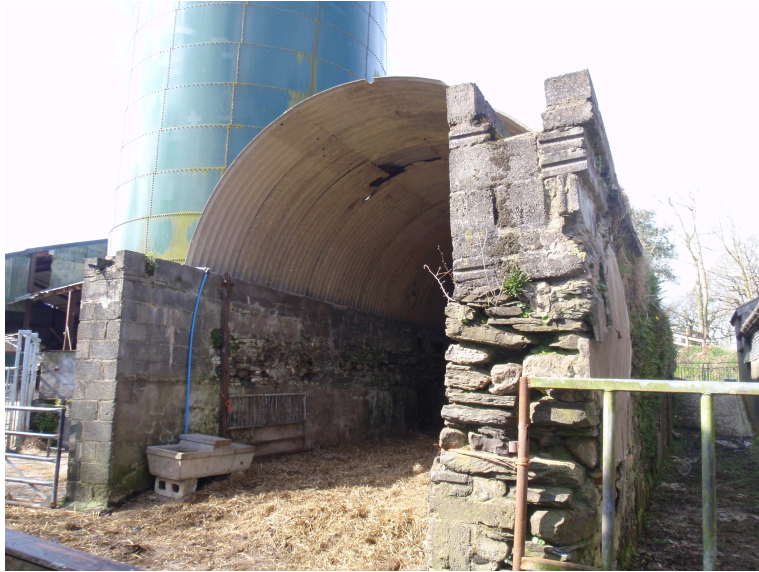
Partially demolished eastern end of the cow shed

The sidewalls of the cow shed have been shortened and consolidated with breezeblocks and concrete, and the building is now open-ended. Nothing of the original roof remains and the west-facing gable has gone completely having been replaced with curving, semi-circular, corrugated-iron that sits upon the reinforced wall tops. The outer walls, and parts of the inner walls, have been rendered with concrete and capped, in part, with red bricks. Three blocked doorways are discernible within the north-facing wall and there is a possible blocked-up window in the southern wall. The interior is now an open space, taken down below the level of the original loft space, and used as a calf shelter.

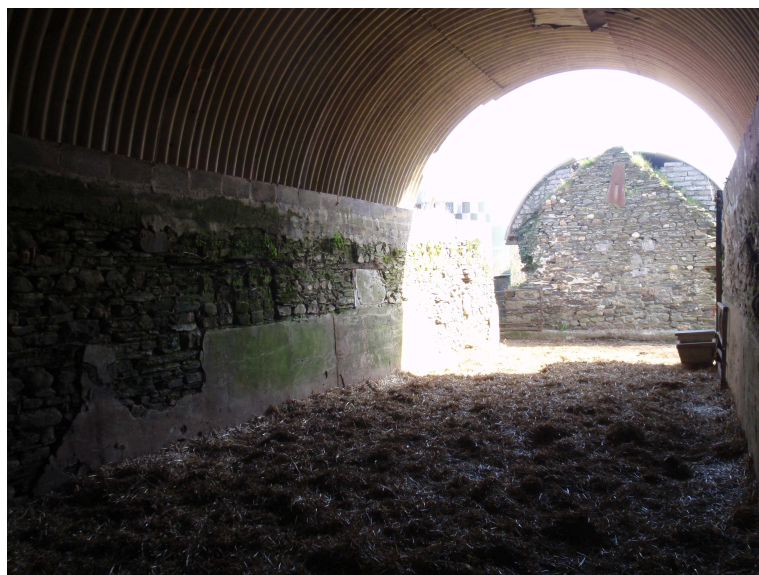
View from within the cow shed, looking towards the, now separated, eastern gable end and cart shed

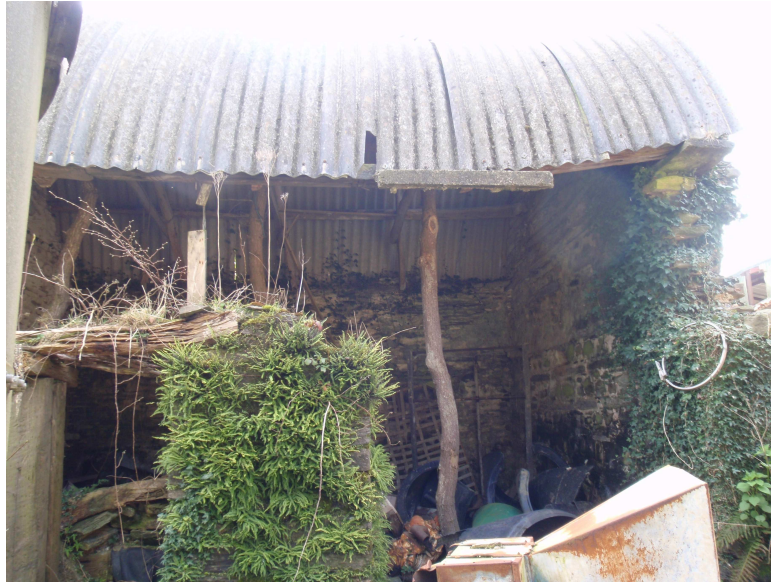
The cart shed is now much modified. Both gable-ends survive to full height and the original, A-frame roof timbers are intact, the roof has been replaced in similar fashion to the cow shed, with curved corrugated-iron sheeting now supported by timber poles. The rear, south-facing wall still stands to full height but the the facade has partly collapsed, meaning that its historic appearance is now difficult to discern.

North-facing façade of the cart shed, with stone pillar (under vegetation) in foreground

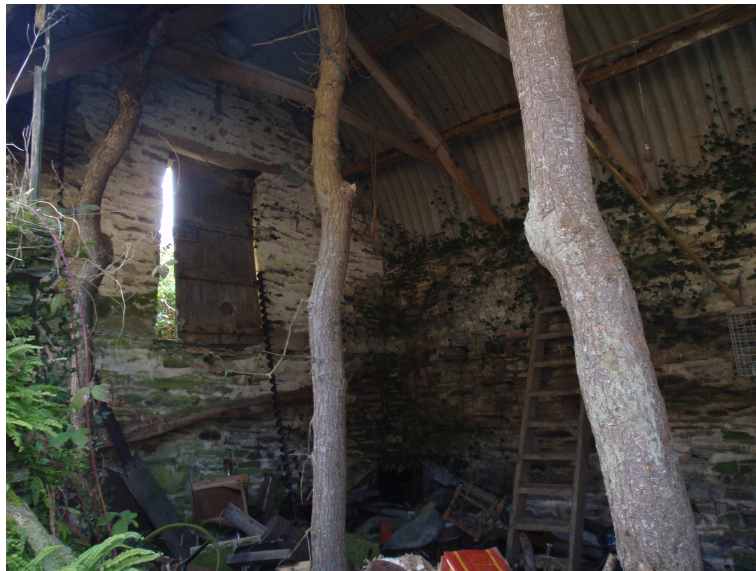
There is a doorway, with solid wood plank door, to the loft within the east-facing gable and sawn-off timbers within the rear wall indicate that the loft once extended across the whole building. Steps leading up to the loft door are depicted on the historical OS maps. The building is now used as a storage area.

Interior of cart shed, with eastern gable and loft entrance.

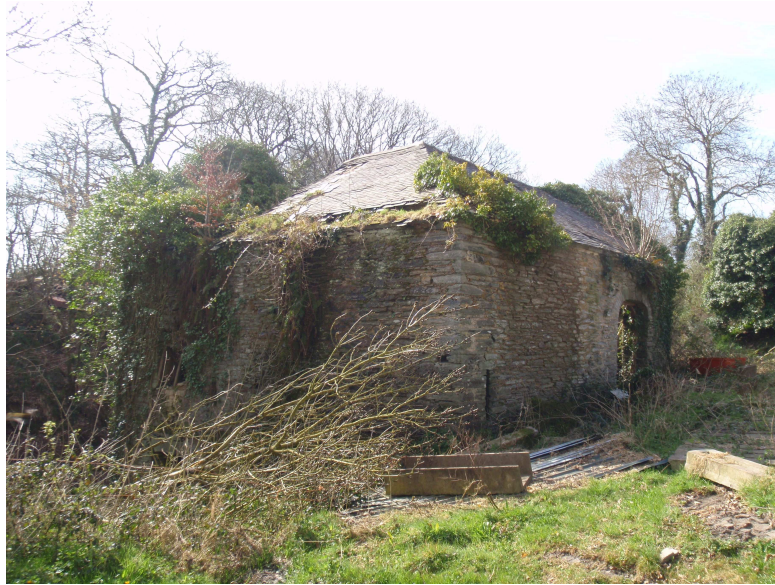
Looking east, the Grade II Listed Trefach Mill PRN 58966)

It is aligned southwest - northeast and backs onto a steep, western bank of a stream, just below a waterfall. A remnant of the waterwheel and housing is still in situ. The building is of rubble stone construction with semi-dressed quoins and the roof is slated. The main entrance is a wide, timber-framed doorway, in the northwest facing wall, with a lintel of vertically pitched stones (voussoirs). A remnant of one of the original timber doors hangs from a long, iron hinge.

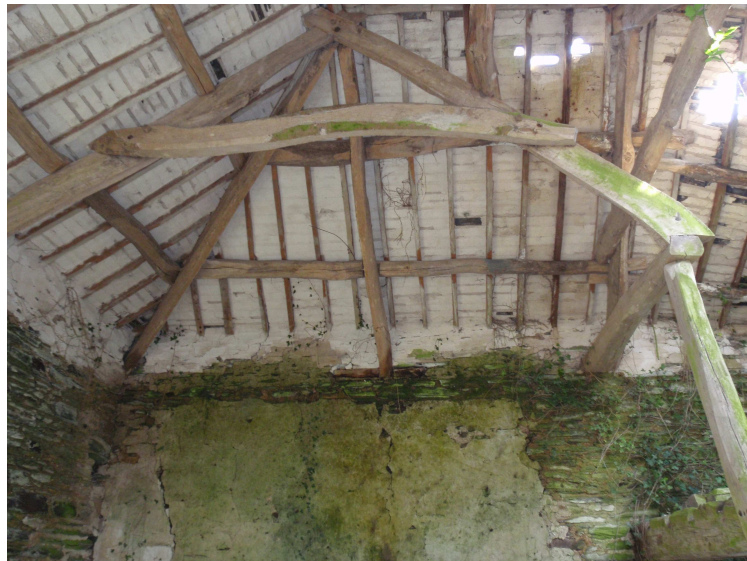
Looking north, roof timbers within Trefach Mill

The interior is open to the roof timbers, the trusses held together by iron pins, and much of the lime plaster torching beneath the slates survives. As the mill backs onto a slope it is on two levels, with the rear of the building dropping to the level of the stream, within which is an arched doorway that leads out to the wheel pit and a second door in the southwestern wall.

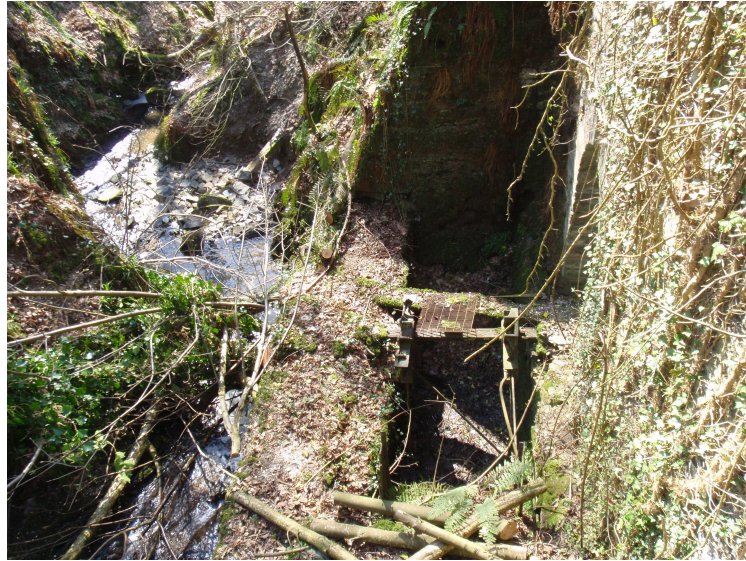
The wheel pit at the rear of Trefach Mill

The rear wall of the mill has been buttressed. The roof has collapsed in several areas and there is thick vegetation on the walls, both inside and out, including some scrubby trees, ivy, and bracken.

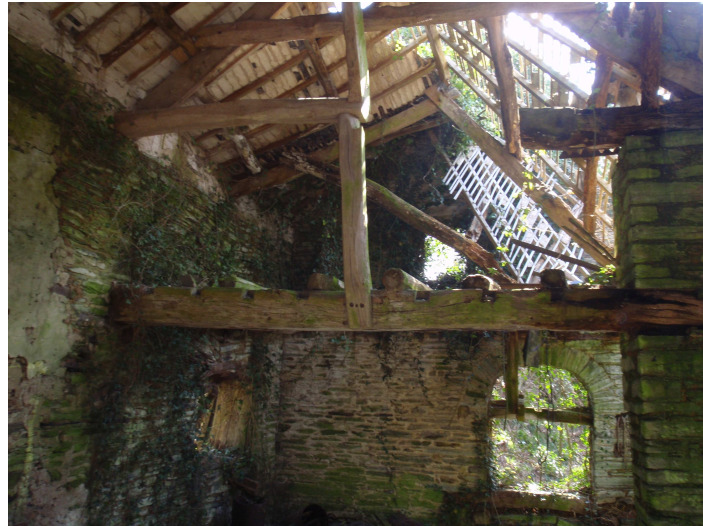
The most pressing need for repair appears to be the roof, particularly the northeast corner of the building where some timbers have collapsed, exposing the interior to the elements. Other roof timbers, generally to the rear of the mill, have broken or fallen and the supported slates have become dislodged, again creating holes in the roof.

Collapsed timbers within northeast corner of Trefach Mill

As the building is no longer weathertight there are signs of dampness on the interior walls, particularly on the north-facing elevation, and the heavy vegetation that covers much of the exterior of the mill is also encroaching inside. Further, smaller-scale renovation is required on the front elevation of the roof, where slates have slipped or are missing. Some areas of masonry also require remedial action, for example above the north-facing window where the stones have eroded, although the full extent of this is masked by the vegetation growth.

Replacing roof timbers: As a general rule, replacement features should be modelled on similar surviving examples. Where these do not exist the emphasis should be on matching details appropriate for the locality and the age of the building.

Repair or replace missing or displaced roof slates.
