PRICASTON FARM CASTLEMARTIN STANDING BUILDING RECORDING

RHIF YR ADRODDIAD / REPORT NO. 2009/4
RHIF Y PROSIECT / PROJECT RECORD NO. 94314

January 2009

PRICASTON FARM, CASTLEMARTIN STANDING BUILDING RECORDING

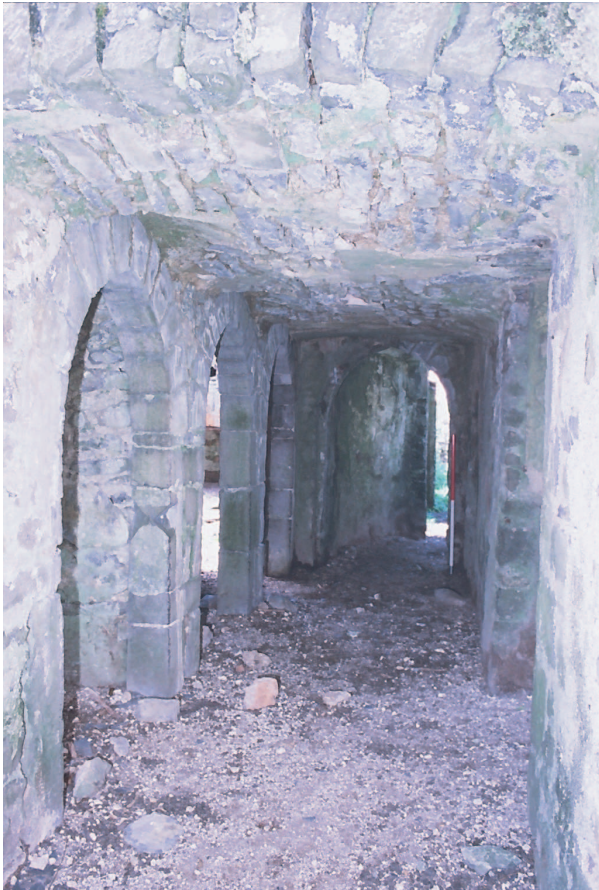
The main entrance to the house leads through a porch into a cross passage constructed of stone barrel vaulting, the passage vaulting does not extend the full length of the cross passage and evidence of a former lintel or slab is preserved in the impression of the plaster above. Three two centred stone arches lead into two service rooms to the southwest (Plate 3). A further two centred stone arch leads out to the northwest. It is not clear how the passage terminated beyond this doorway, as there is further early masonry beyond (AJ Parkinson NMR Item 1 1979). A central low stone arch is located in the centre of the northeast side of the cross passage leading into the hall (Plate 4). This opening has been reduced in width on the northwest side. The original arch to the entrance of the cross passage has been lost.

Plate 3: Cross passage from east
Wessex Archaeology

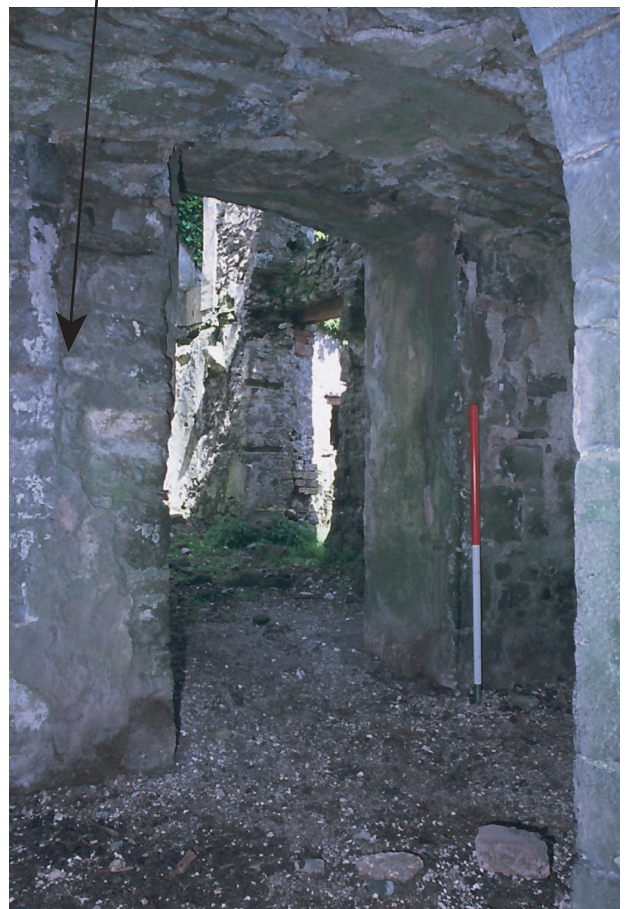
The doorway from the cross passage into the hall is located centrally in the northeast wall of the passage, it has been partially blocked on the west side (Plate 4 & 8).

Partial blocking of doorway

Plate 4: Doorway to hall from cross
passage
Wessex Archaeology

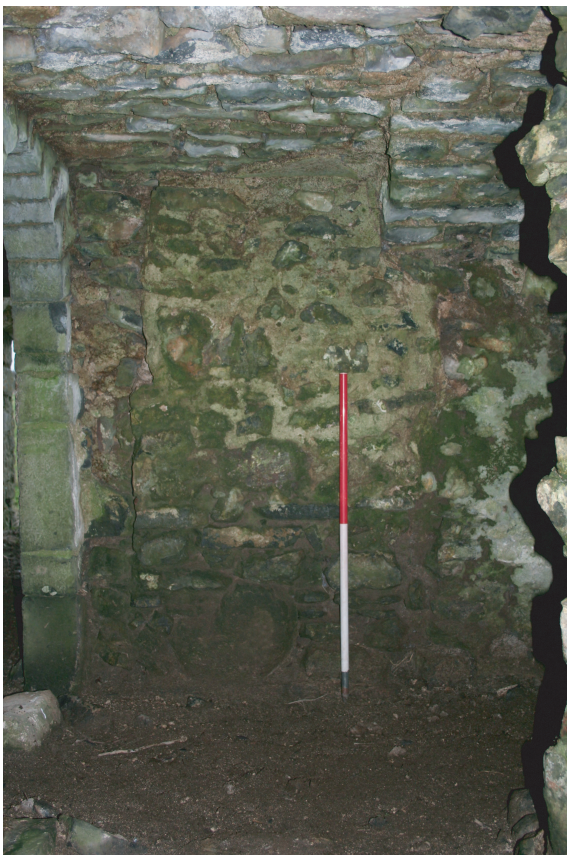
Plate 5: Blocked opening between
the service rooms

Inserted opening

Partial blocking
of doorway

Blocked
openings

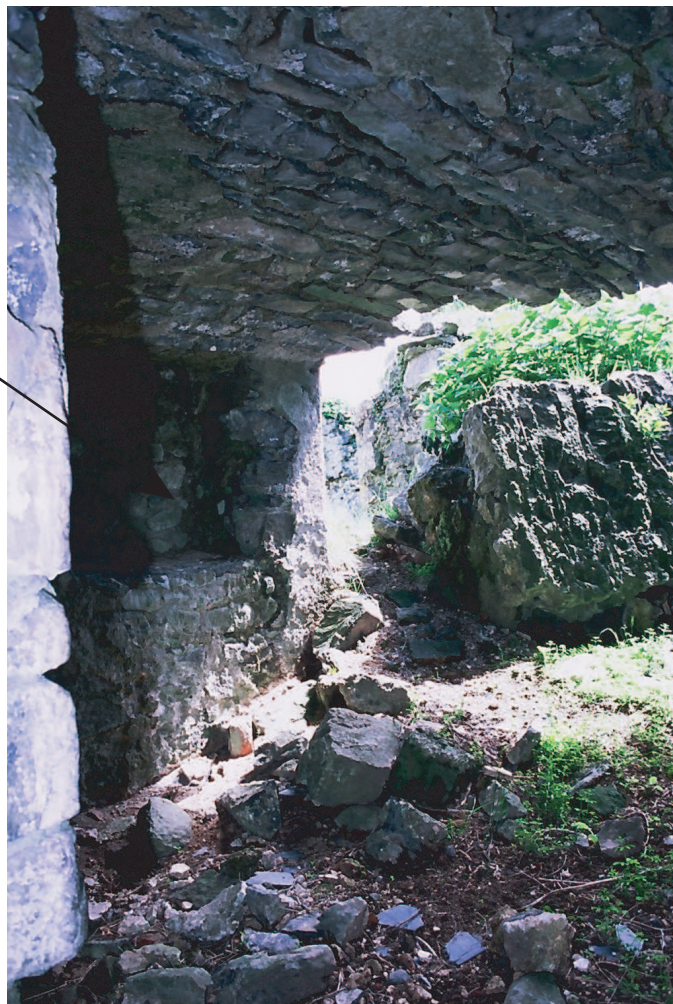
The southeast service room has partially collapsed along with the front façade, however a photograph by the RCAHMMW indicates there was a window opening in the rear, southwest wall (Walker 2003, 565 plate 23). A former window opening in the southeast wall has been blocked (Plate 7).

Plate 7: Southeast service room showing
collapsed vault
Wessex Archaeology

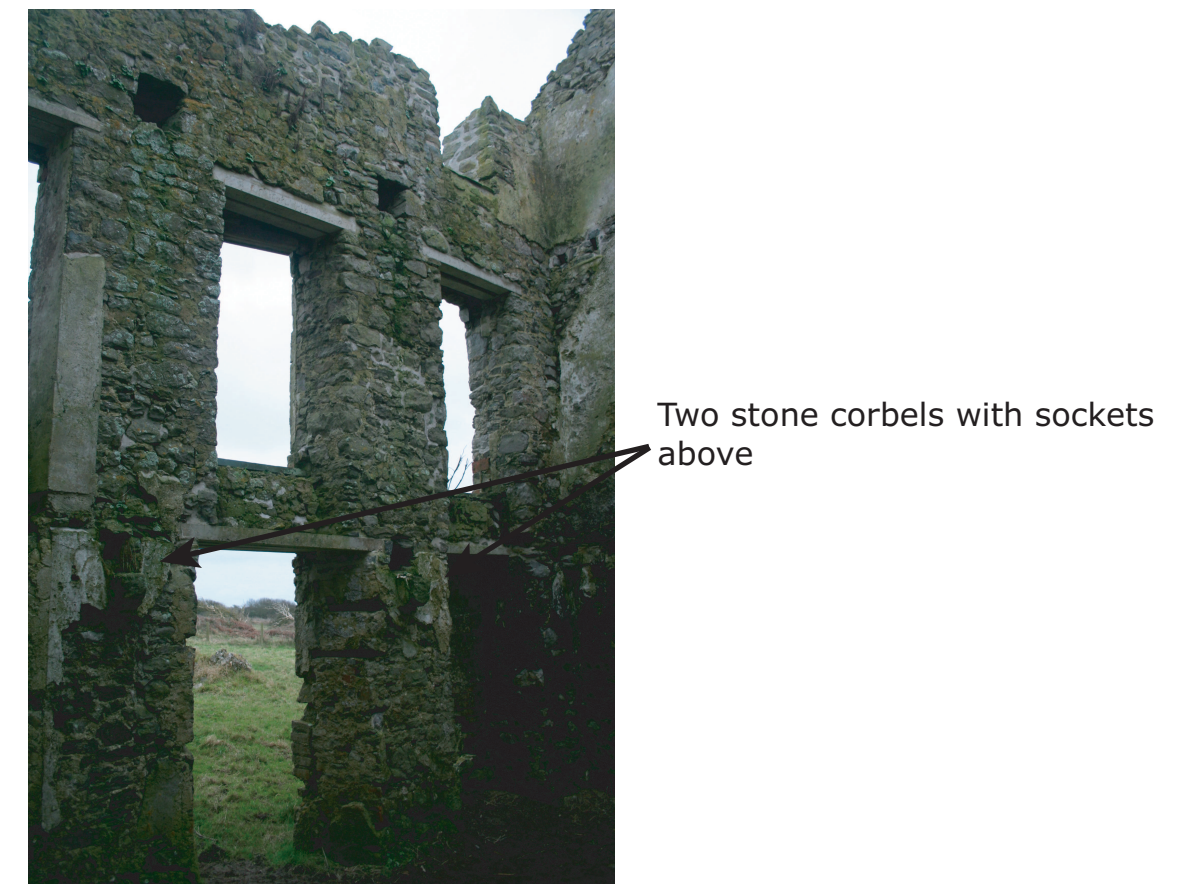
The hall has undergone much modification especially in the 18th century; in particular the southeast wall has been modified with the introduction of three openings; a central doorway flanked by a window either side, which have latterly been blocked with brick (Plate 9).

Plate 9: Southeast wall of hall
Wessex Archaeology

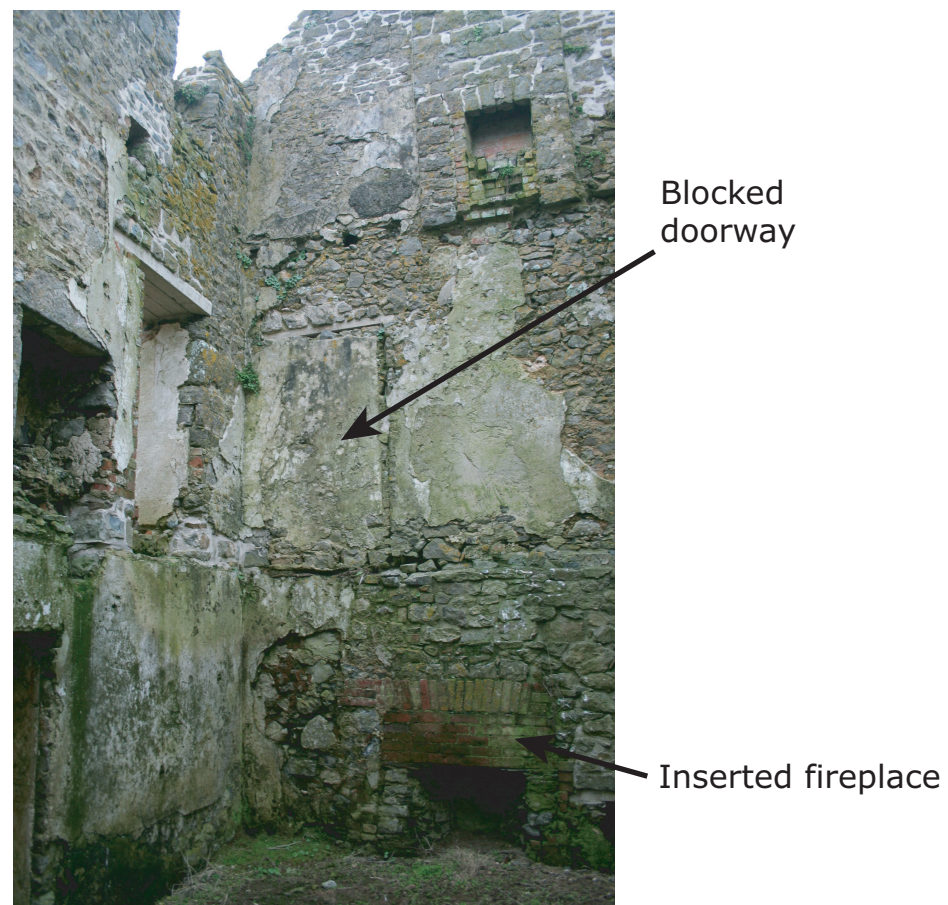
The northeast wall of the hall has a central fireplace introduced into the fabric using brick arches and brick blocking (Plate 10). To the east of the fireplace a void in the wall has a modern lintel inserted to support the wall face (which has recently been rebuilt) beyond it there is further evidence of a blocked doorway in the northeast corner. A photograph taken by Wessex pre-consolidation indicates that this area was heavily consolidated and there is the suggestion of a wider fireplace; certainly where the wall face collapsed there appears to be a void behind with possible smoke blackening (Plate 11).

Plate 10: Northeast wall of hall
Wessex Archaeology

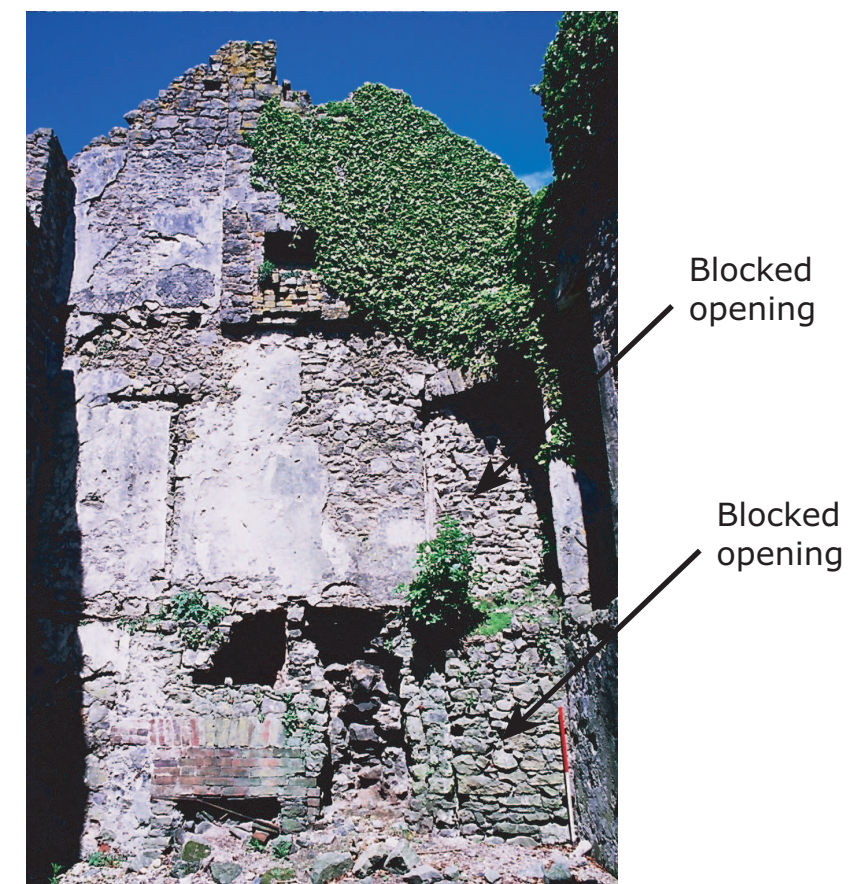
Plate 11: Northeast wall of hall
Wessex Archaeology

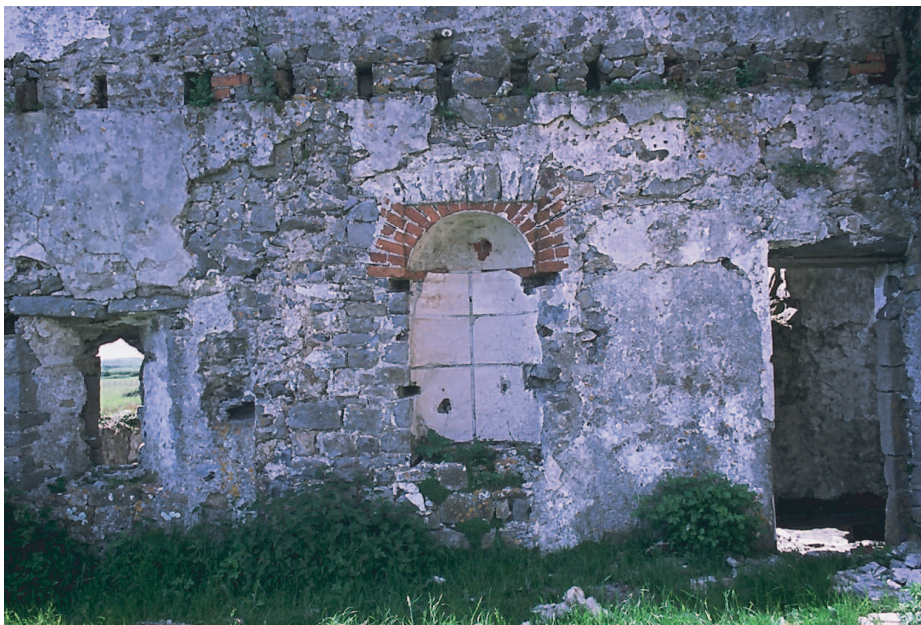
There was a fireplace in the northwest lateral wall of the solar (Plate 15 & 16), for which the corbelled chimney can be seen on the other side of the wall, this has latterly been blocked and a brick semi-circular niche formed partly in its place.

Plate 15: Northwest wall of the solar showing trefoil headed window and semi-circular niche - corbelled chimney behind
Wessex Archaeology

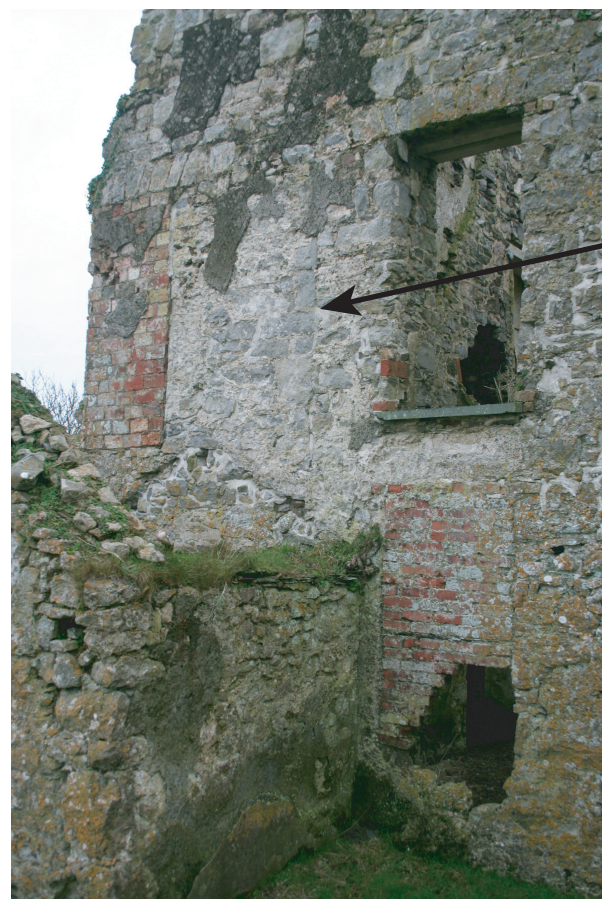
Vertical straight joint above porch

Plate 18: Exterior of northeast corner of solar above cross passage

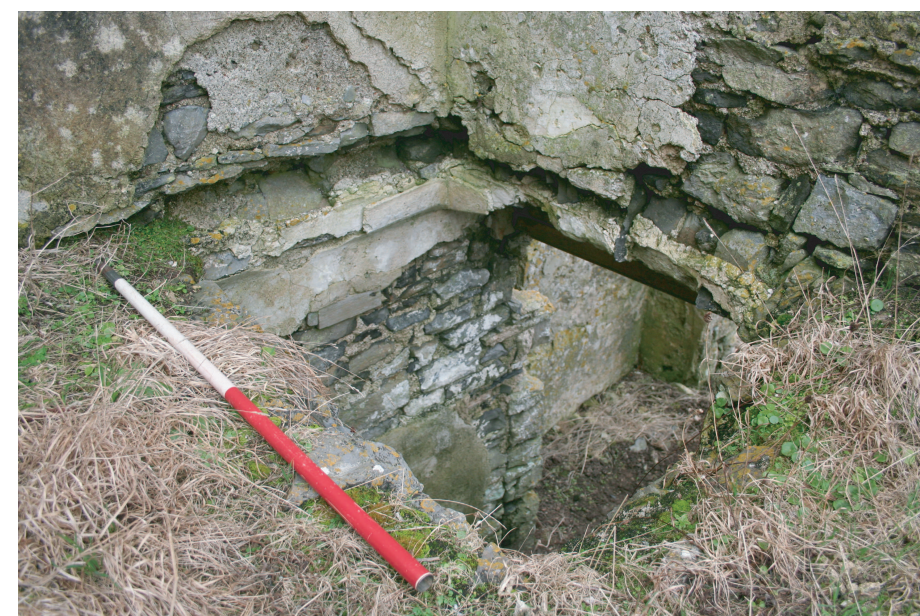
Plate 19: Break in floor of solar above cross passage

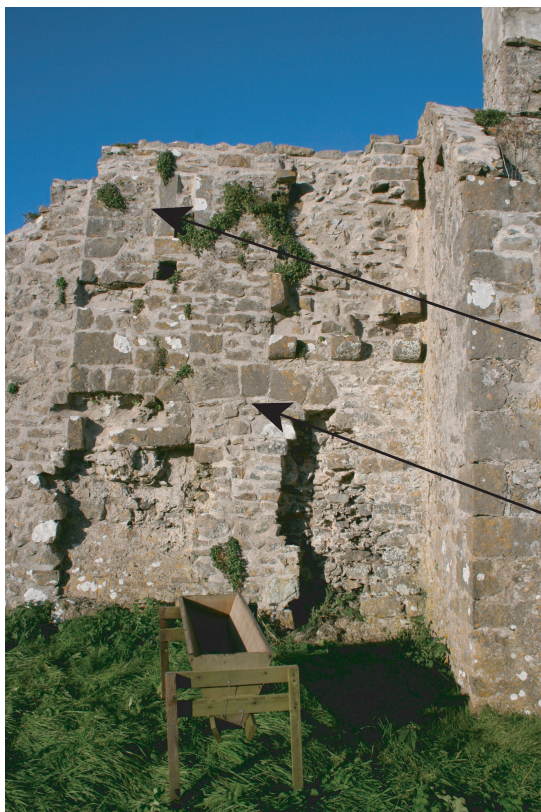
Plate 22: Southwest wall of tower

Jamb of
former
fireplace

Lancet
window

Stone
voussoirs
over blocked
doorway

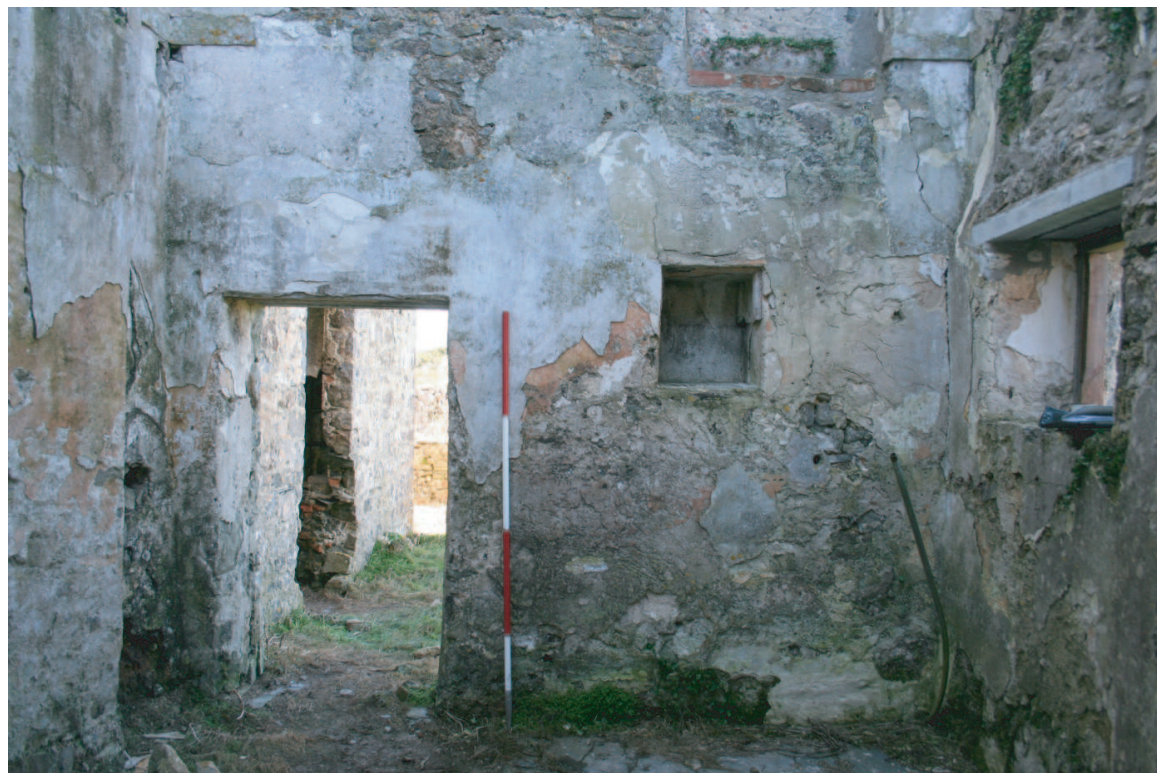
Plate 32: Northwest room of northeast range, northwest wall.

Blocked
window
opening

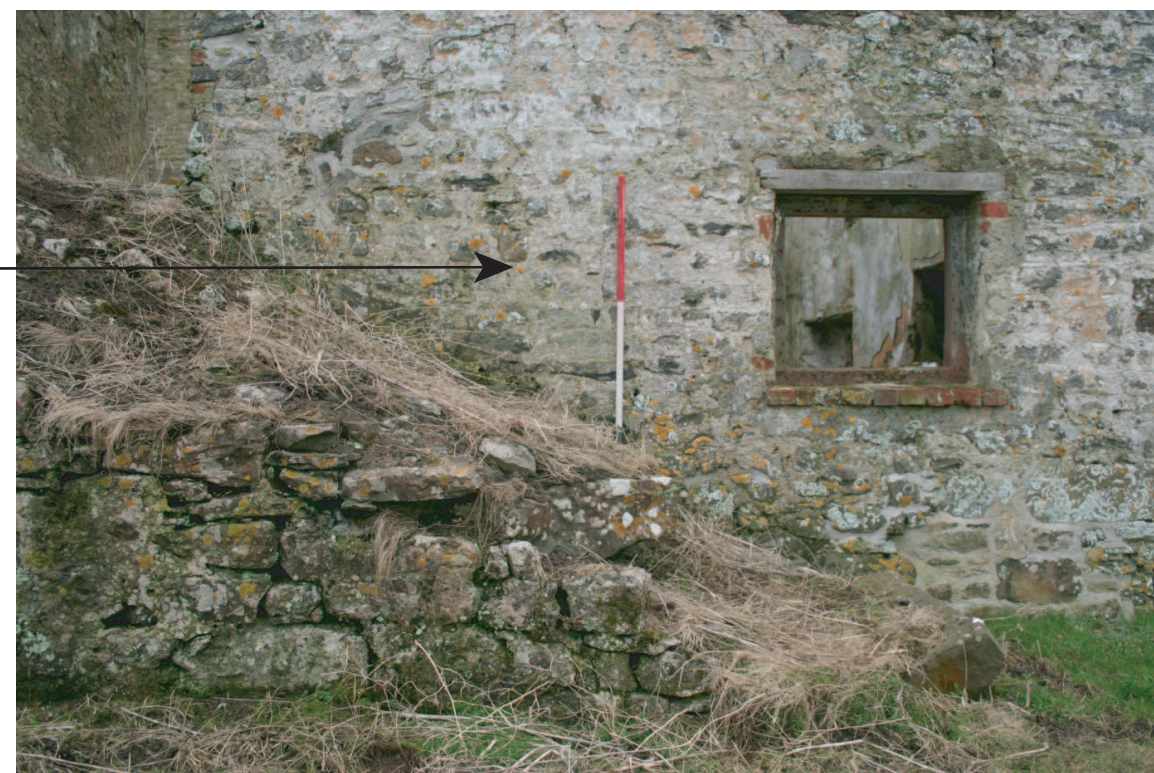
Plate 33: Northeast wall of northeast range, showing blocked opening behind steps

Disturbed
masonry
including
a blocked
doorway

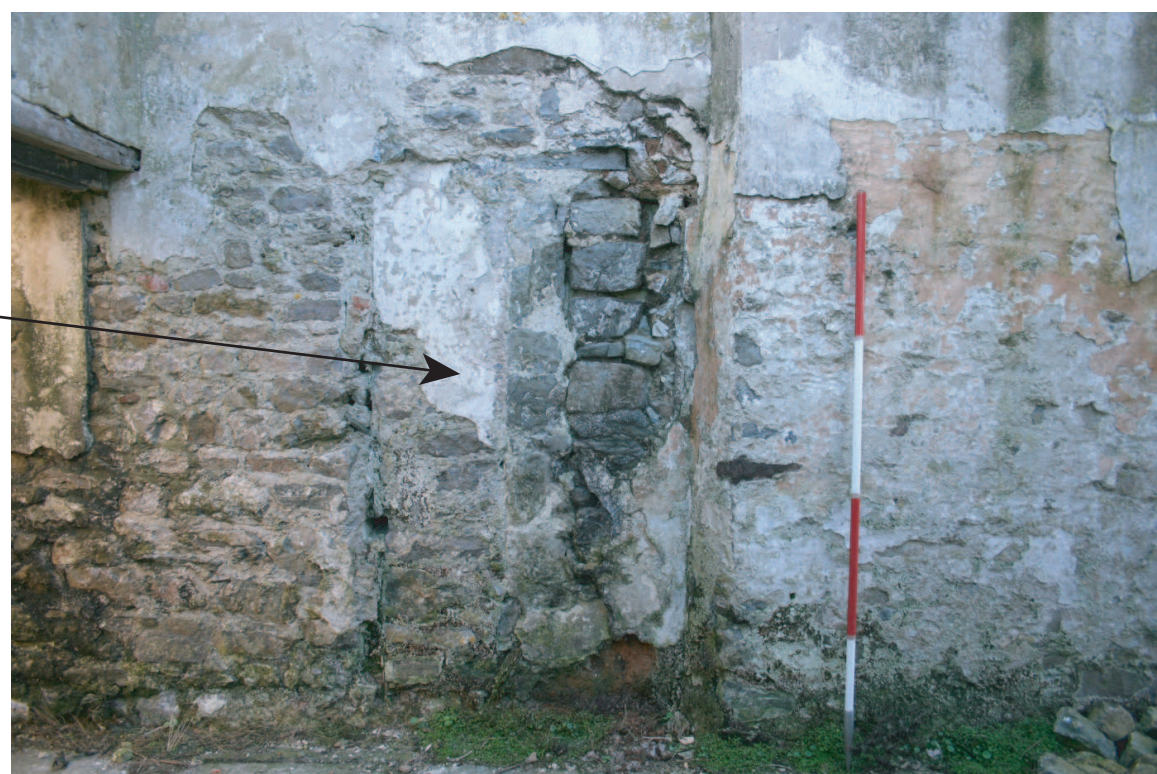
Plate 34: Northwest room of northeast range, southwest wall.

Blocked doorways
