# PUMP HOUSE, NORTH DOCK, LLANELLI: STANDING BUILDING RECORDING

RHIF YR ADRODDIAD / REPORT NO. 2008/101  
RHIF Y PROSIECT / PROJECT RECORD NO. 94417

*The pump house is a grade II listed building (CADW reference 24/a/61(1)) and to comply with recommendations made by the Local Planning Authority, Dyfed Archaeological Trust Field Services were commissioned by James Allen Consultancy to undertake a programme of photographic standing building recording prior to any development work at the building.*

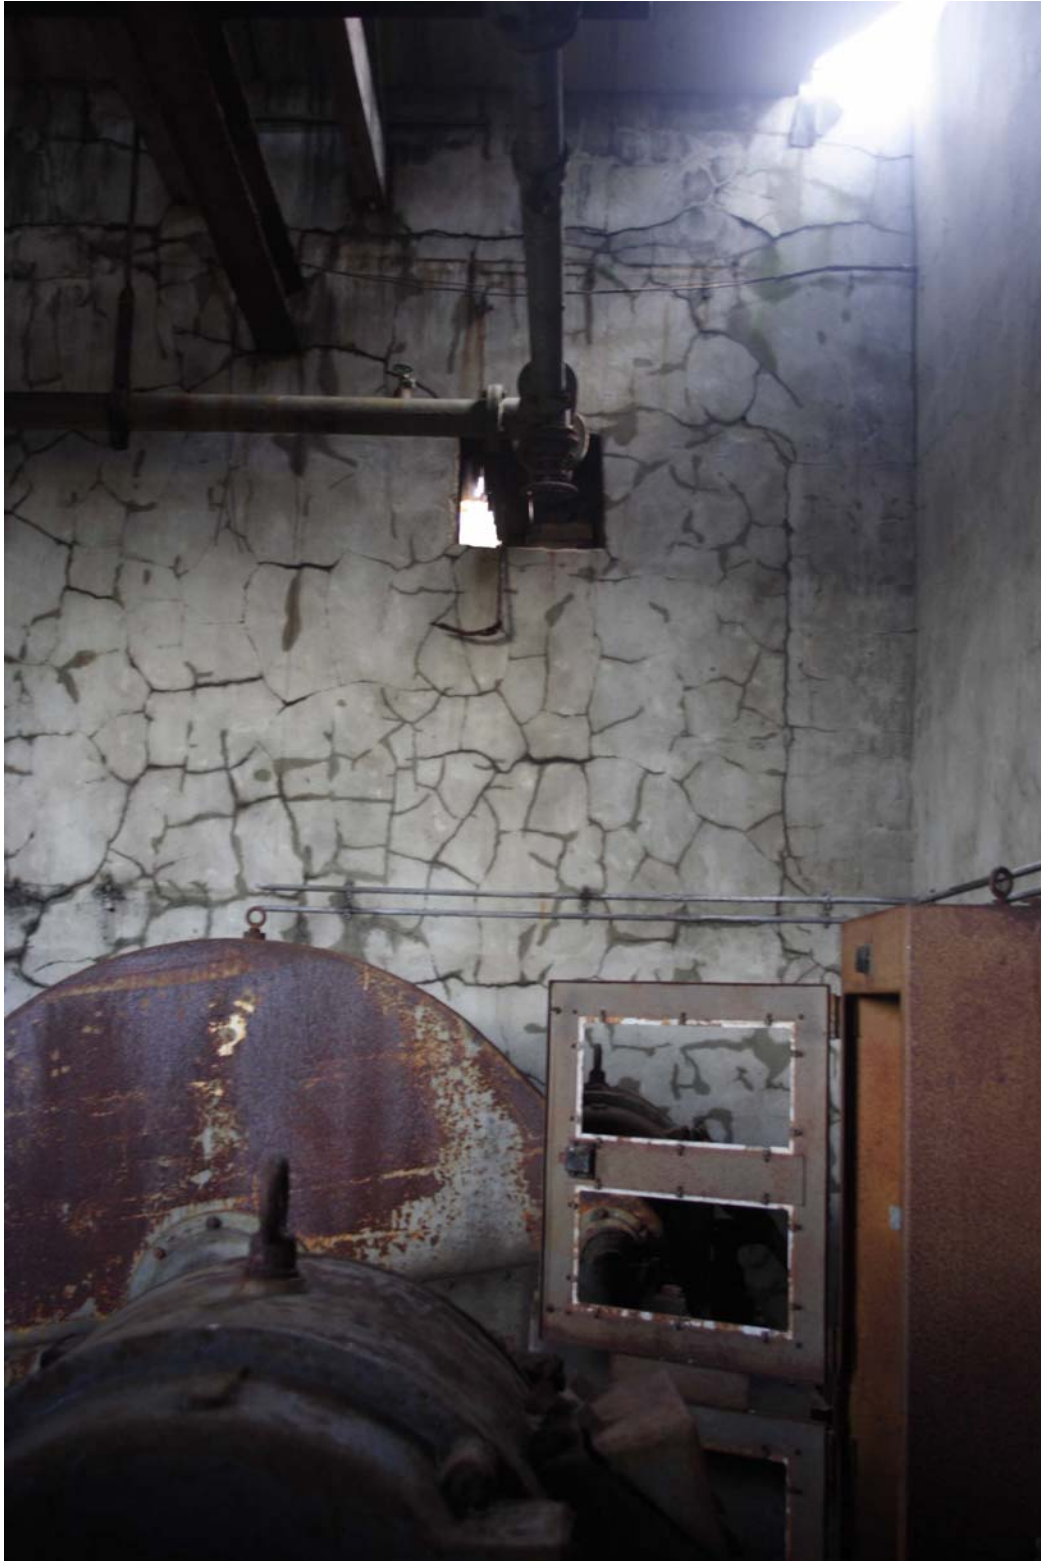
3922: Later pump room. Opening in wall carrying cast iron pipe to boiler house

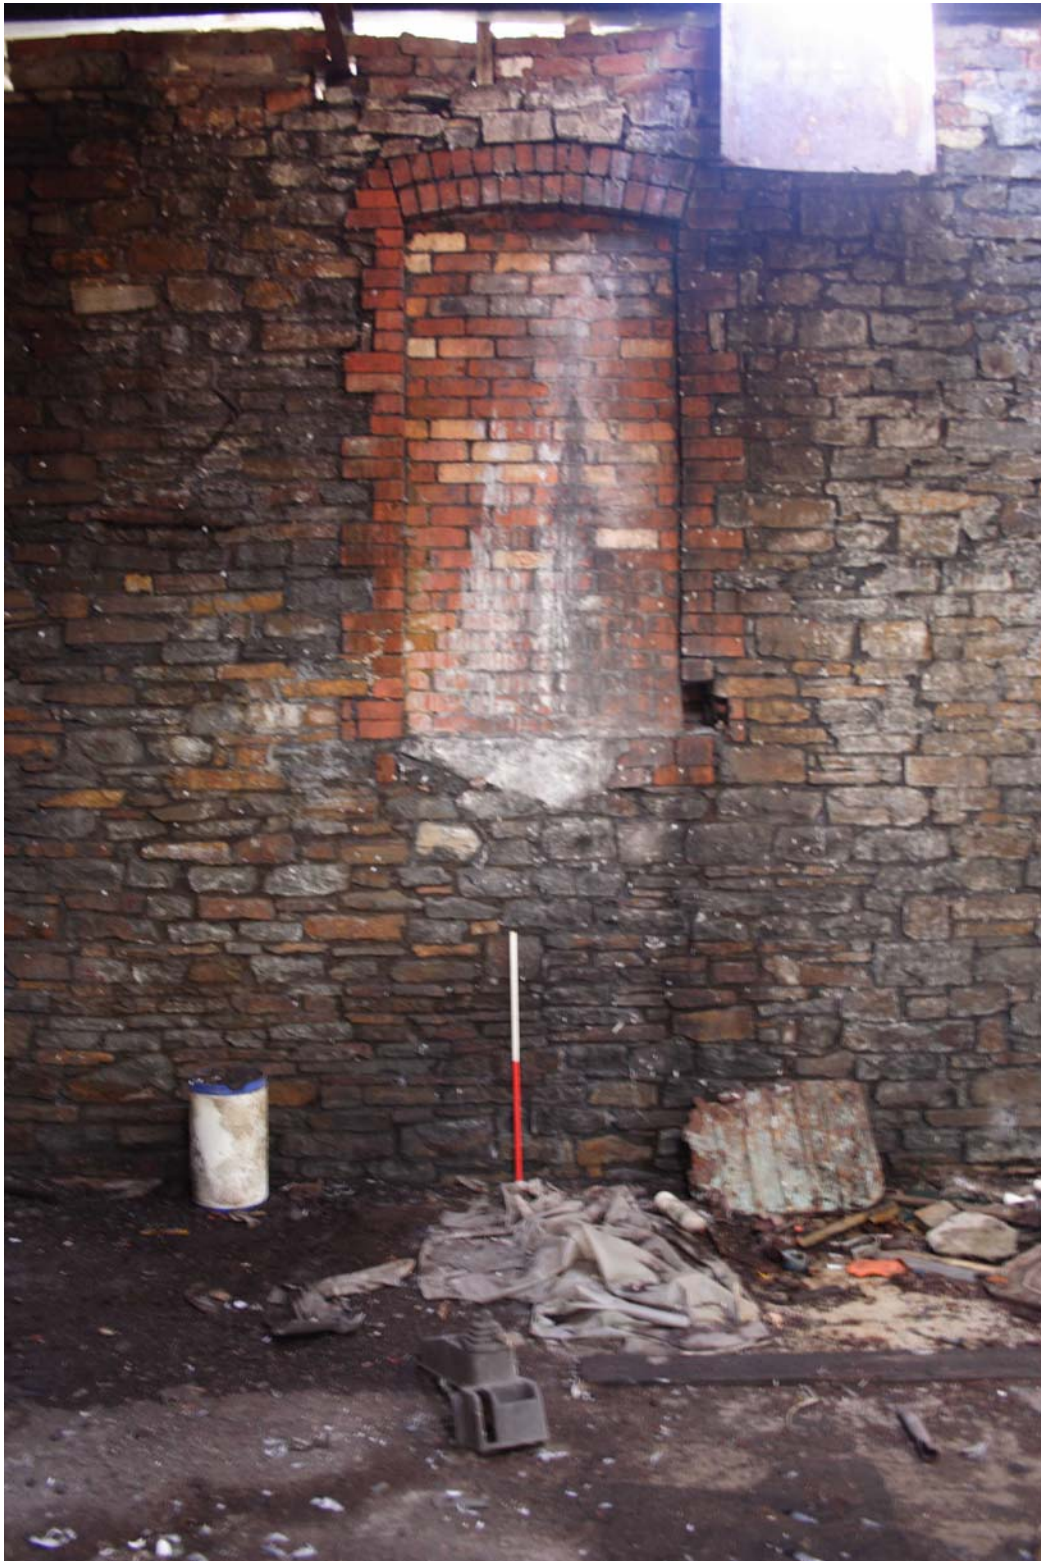
3935: Boiler house. Southernmost blocked window to Maintenance shed

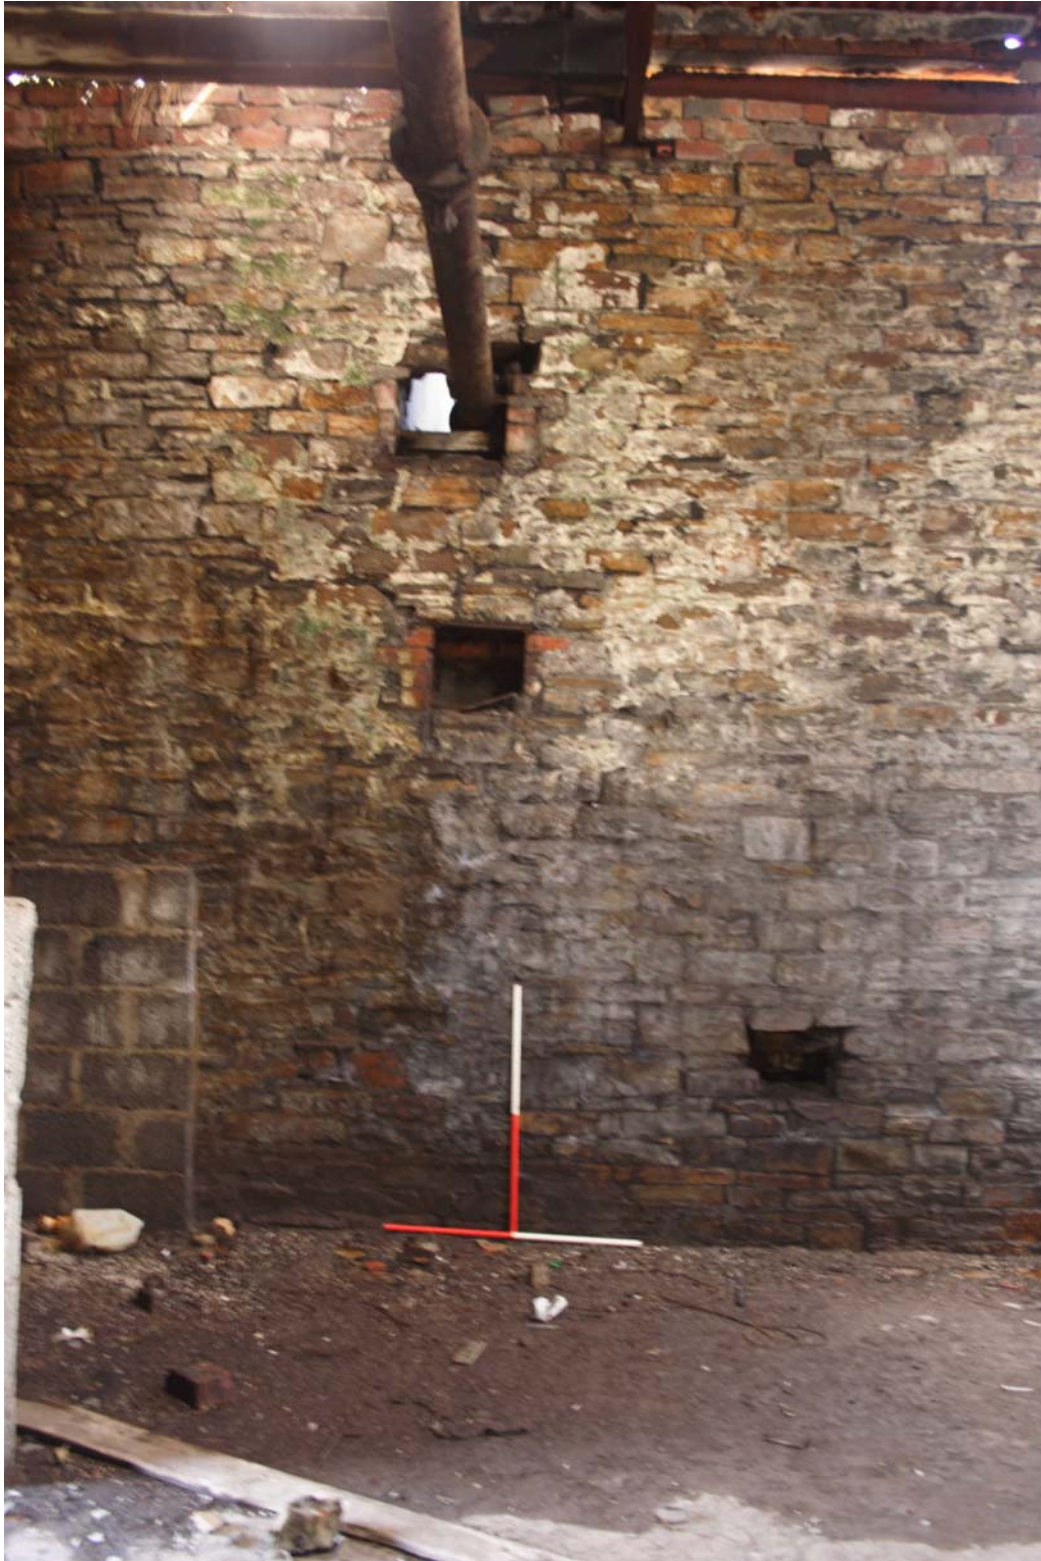
A series of three rectangular openings were present in the east wall of the room. These probably once fed steam pipes into the engine house to the west. The upper most opening carried the pipe noted exiting the maintenance shed. Nothing survived of the boiler itself.

3940: Boiler house. Openings in wall. Uppermost carrying pipe from later pump room

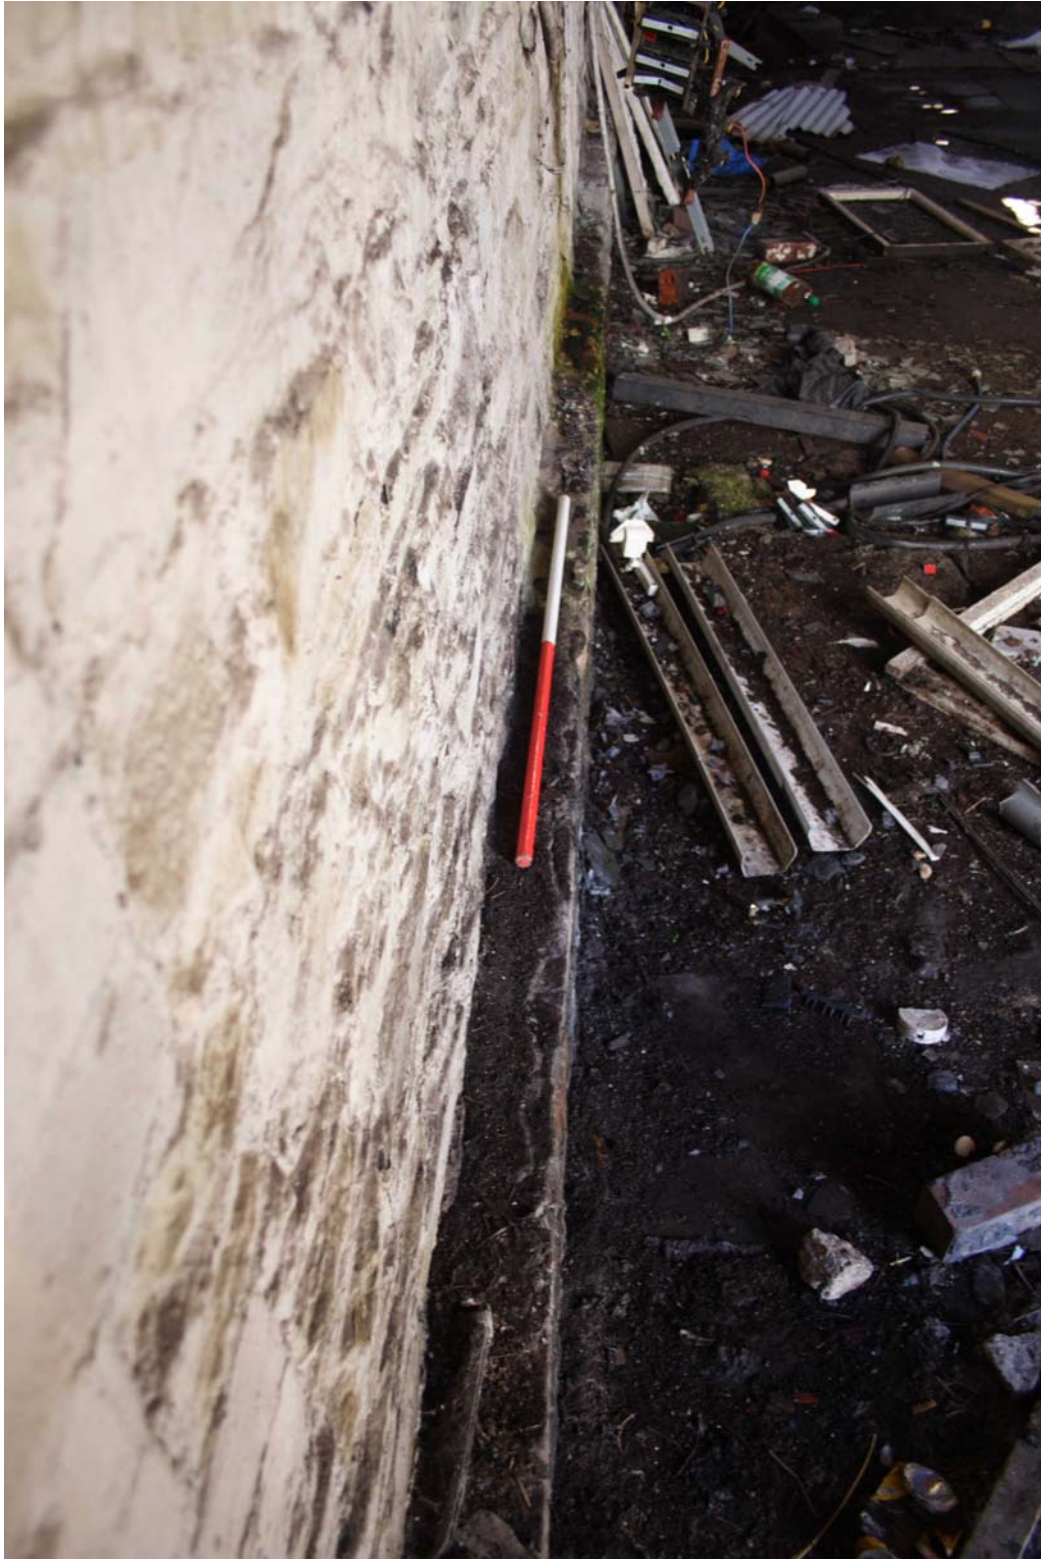
It is possible the engine house once had a raised floor that was evidenced by a plinth running along the south, west and east walls of the room and would have provided a raised working area for the engine operators.

3951: Engine house. Possible floor plinth

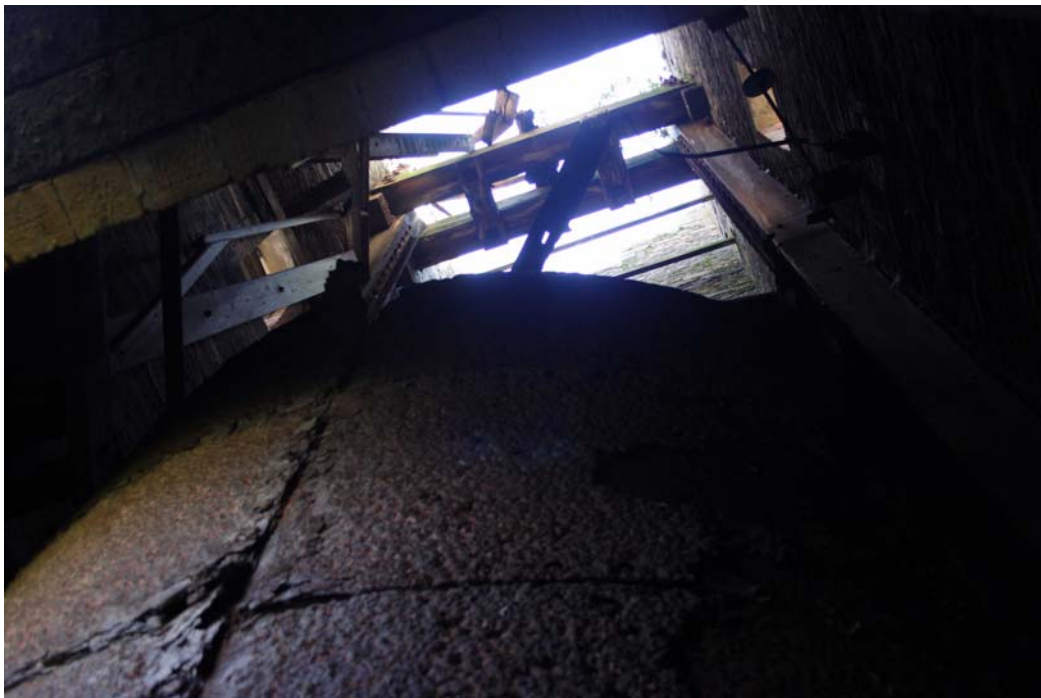
Access to the c.4m square tower was through a tall doorway piercing the northern wall that still retained its timber roller door. It was impossible to view the whole interior of the tower as the hydraulic cylinder and debris filled the space. The cylinder was constructed of riveted cast iron plates and was very heavily degraded with possibly only 50% of the structure remaining.

3957: Accumulator tower. Guide rails and frame to hold weight. Collapsed cylinder below

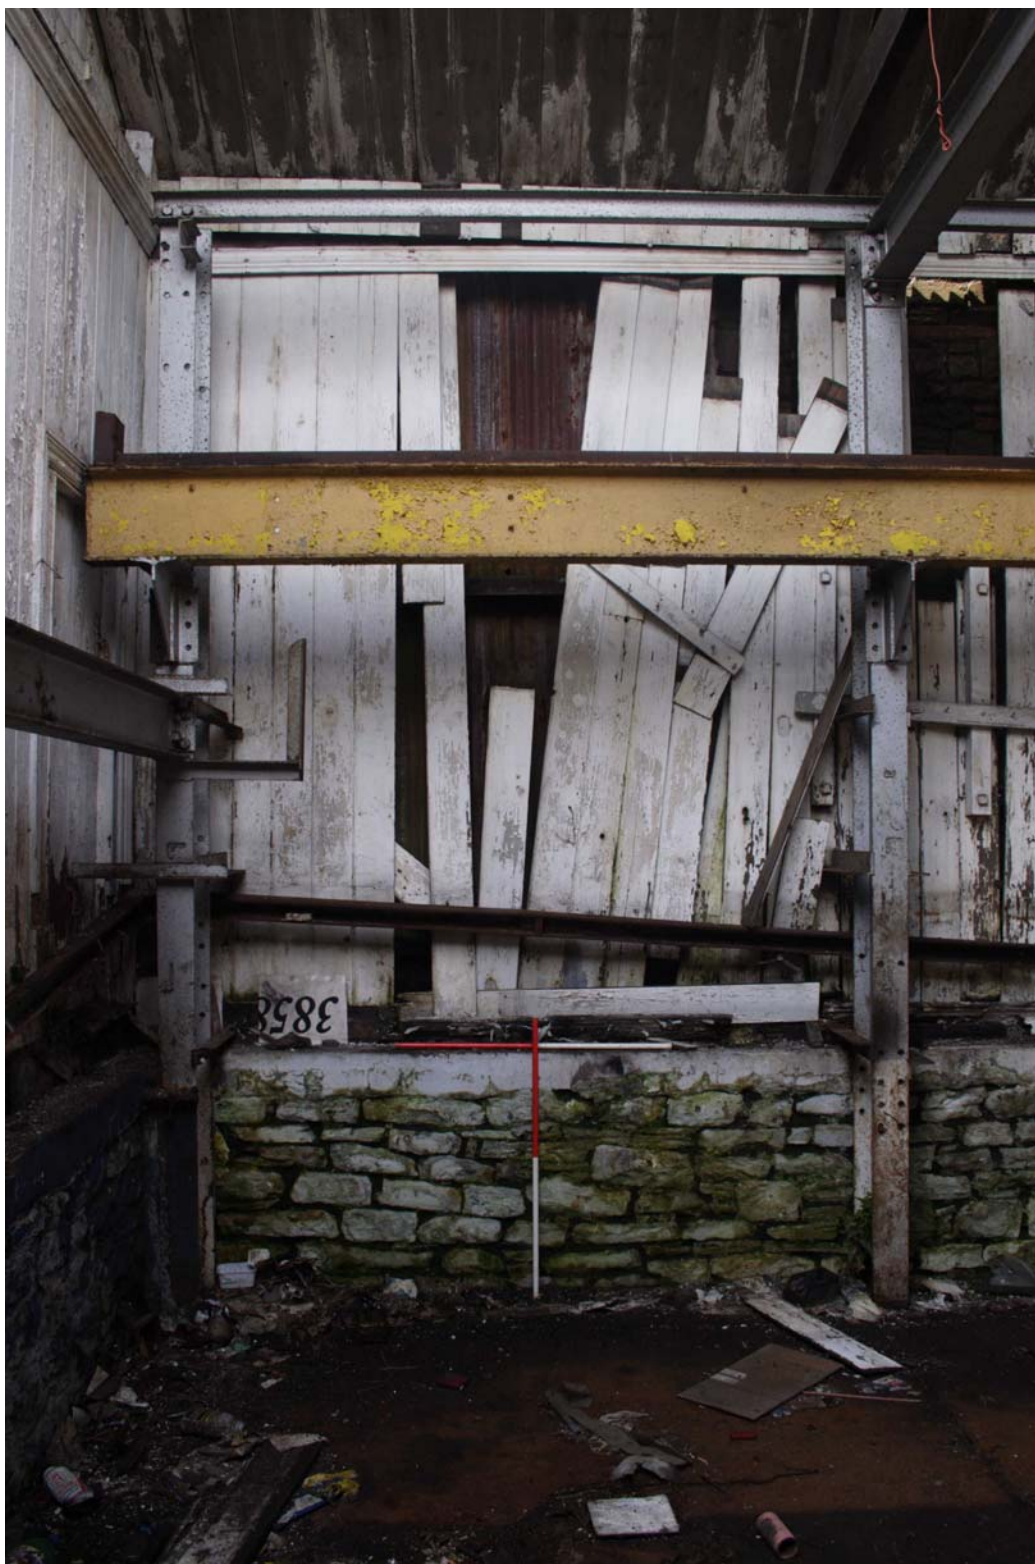
3978: Metal shed. Damaged wood panelling

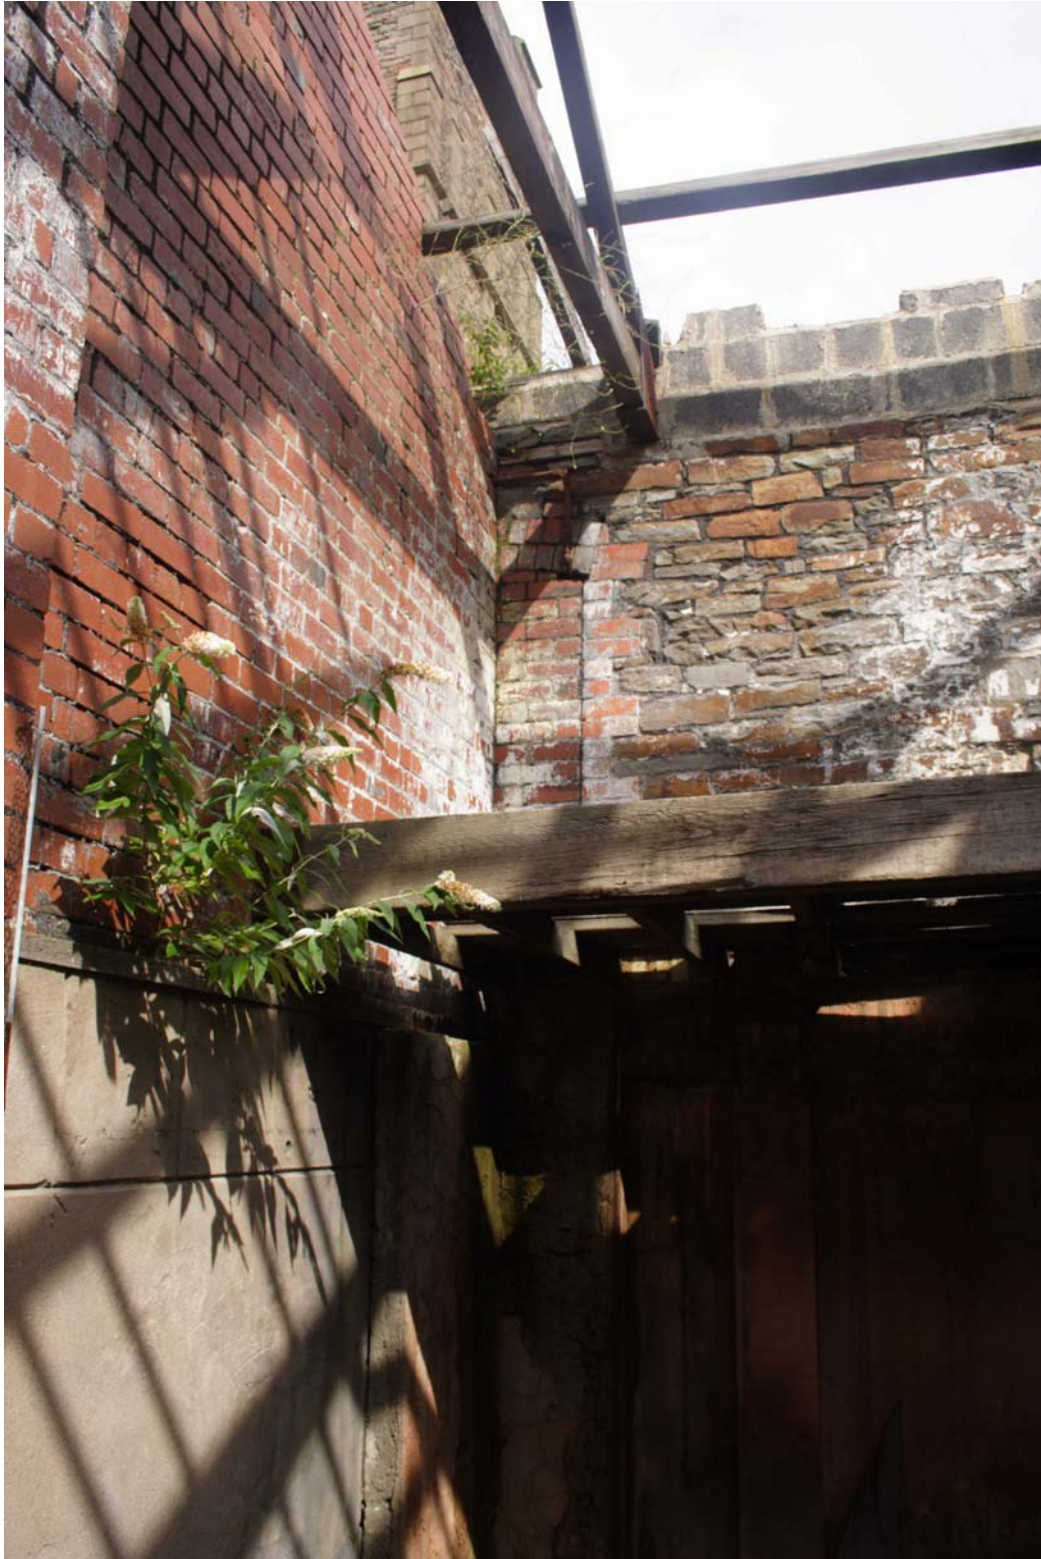
4006: Maintenance shed. Northernmost blocked window to boiler house. Partially obscured by later dividing wall

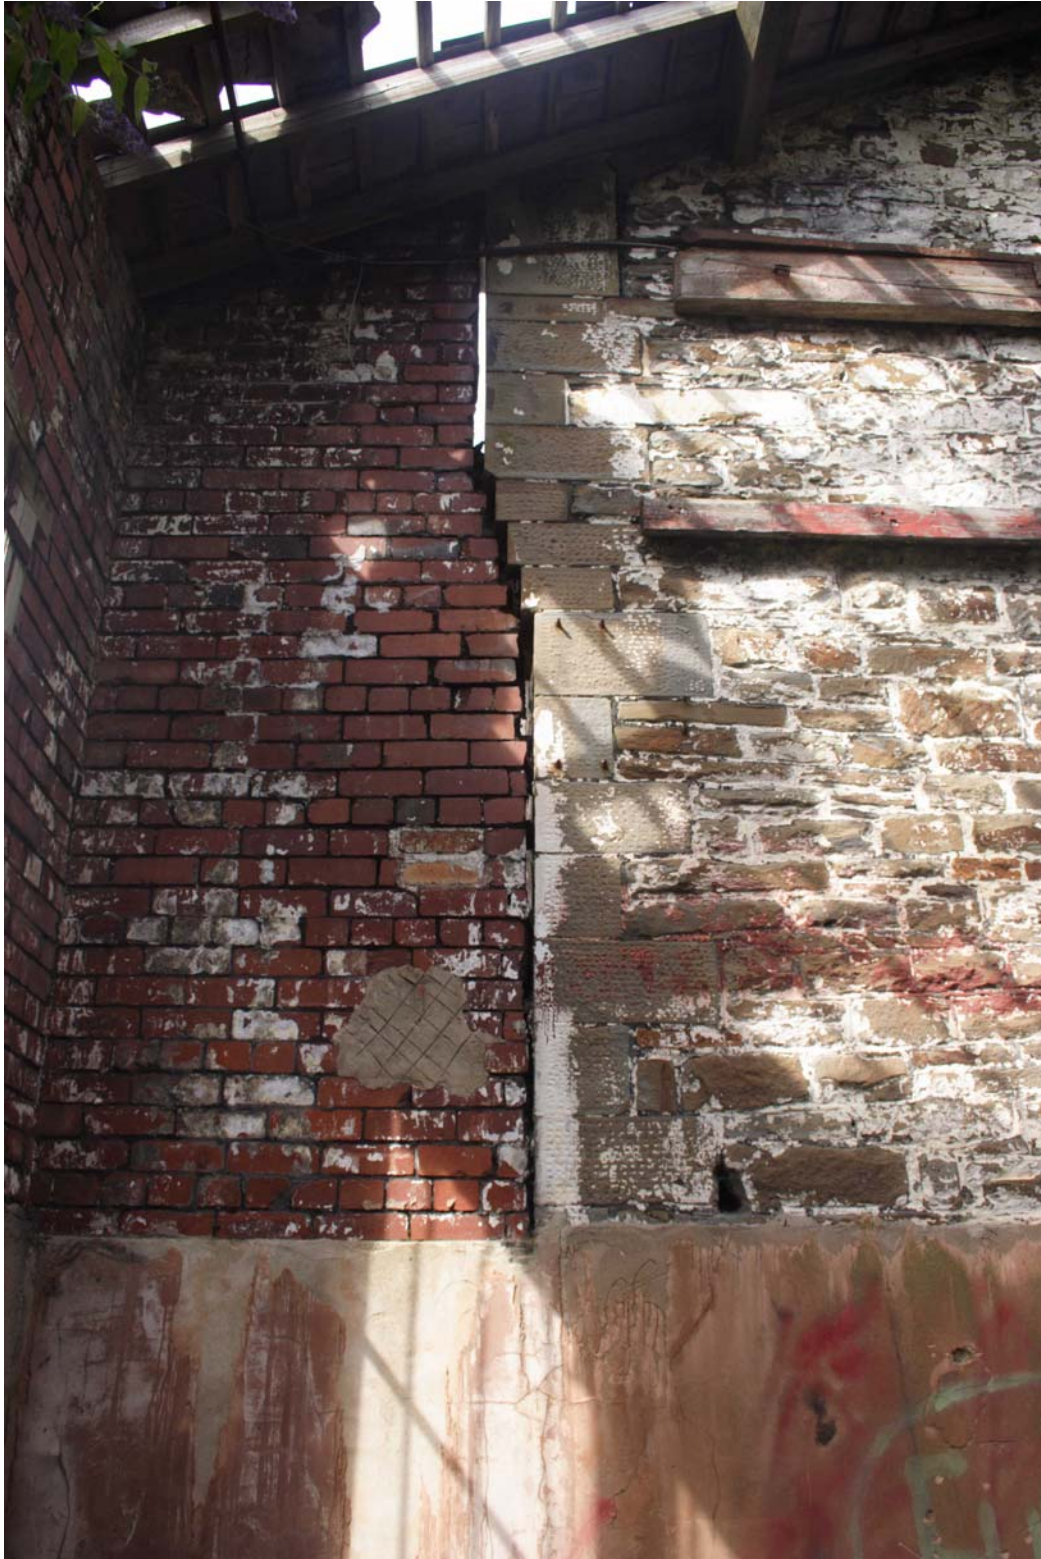
To the north west corner of the extension it was possible to view the brickwork just abuts the masonry of the earlier maintenance shed.

4010: Maintenance shed. Detail of straight joint with brick addition
