DINEFWR HOME FARM: RECORDING OF COURTYARD

RHIF YR ADRODDIAD / REPORT NO. 2008/102
RHIF Y PROSIECT / PROJECT RECORD NO. 94418

K Murphy

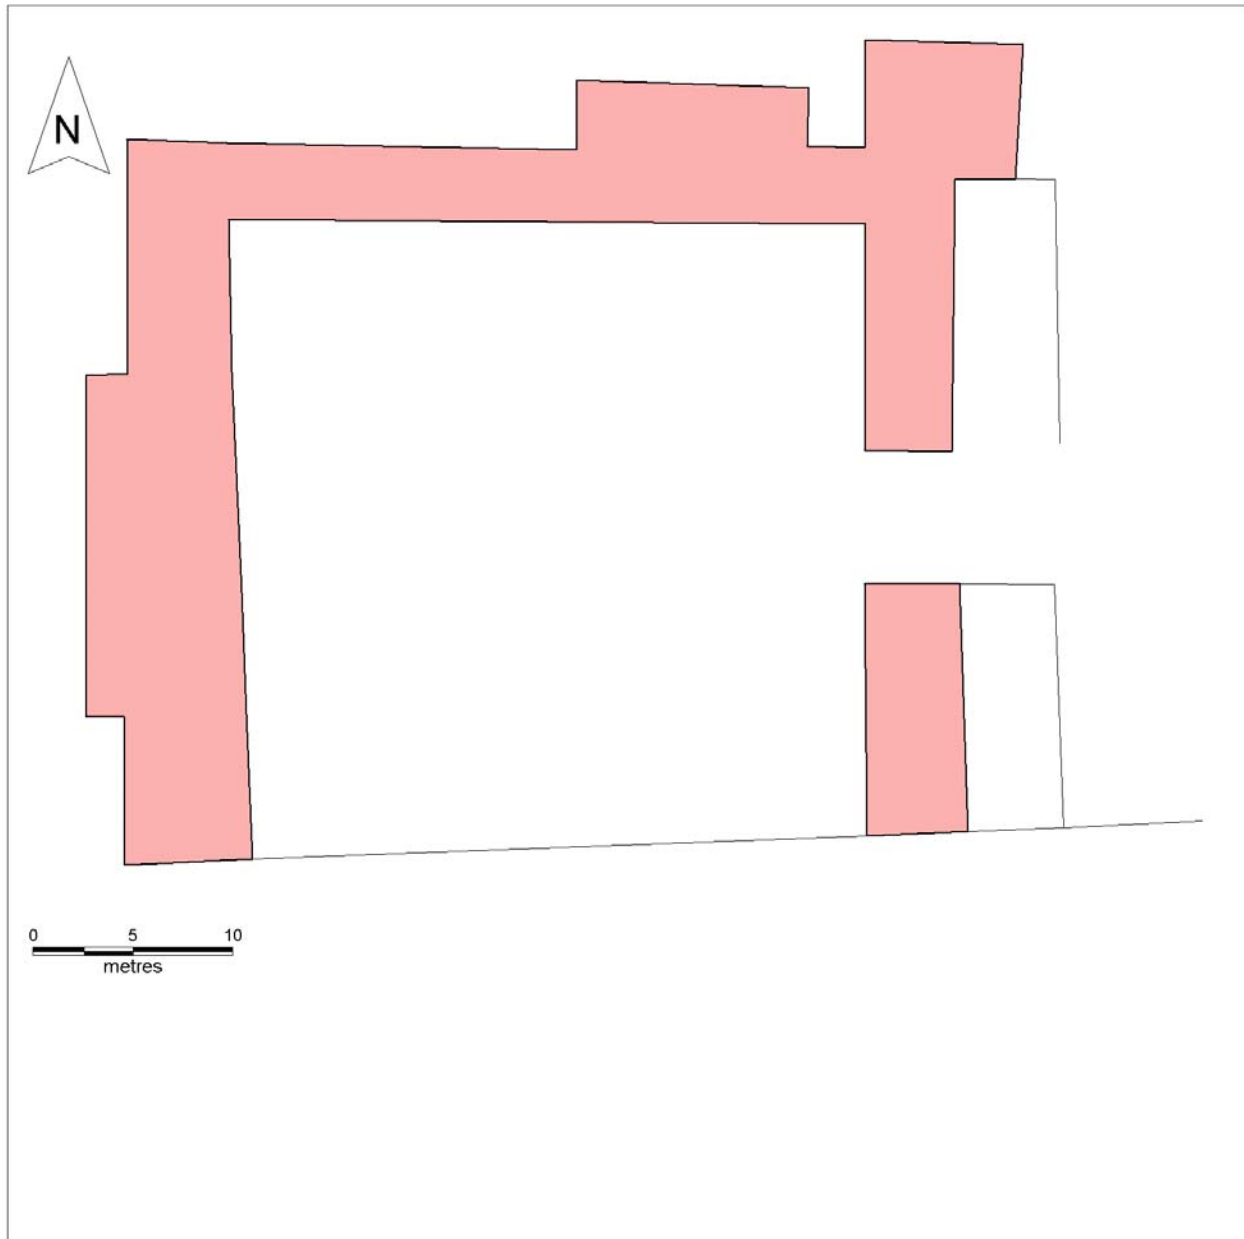
Owing to the small scale of the 1839 tithe map it is not always possible to equate the information shown with that depicted on later maps. It does contain, however, some very useful information, from which the map (Map 1) and the following description have been compiled. The 1839 map depicts buildings along the entire west and north sides of the courtyard (presumably including the cart shed and Hammel both extant in 2008), and two buildings on the east side. The southern side is open apart from a boundary.

Map 1. Dinefwr Home Farm Courtyard. Layout based on the 1839 tithe map. Buildings in pink, boundaries in black. The buildings on the north and west side are shown with confidence. The location of those buildings on the east side are less secure – it is possible that these should be slightly further west.

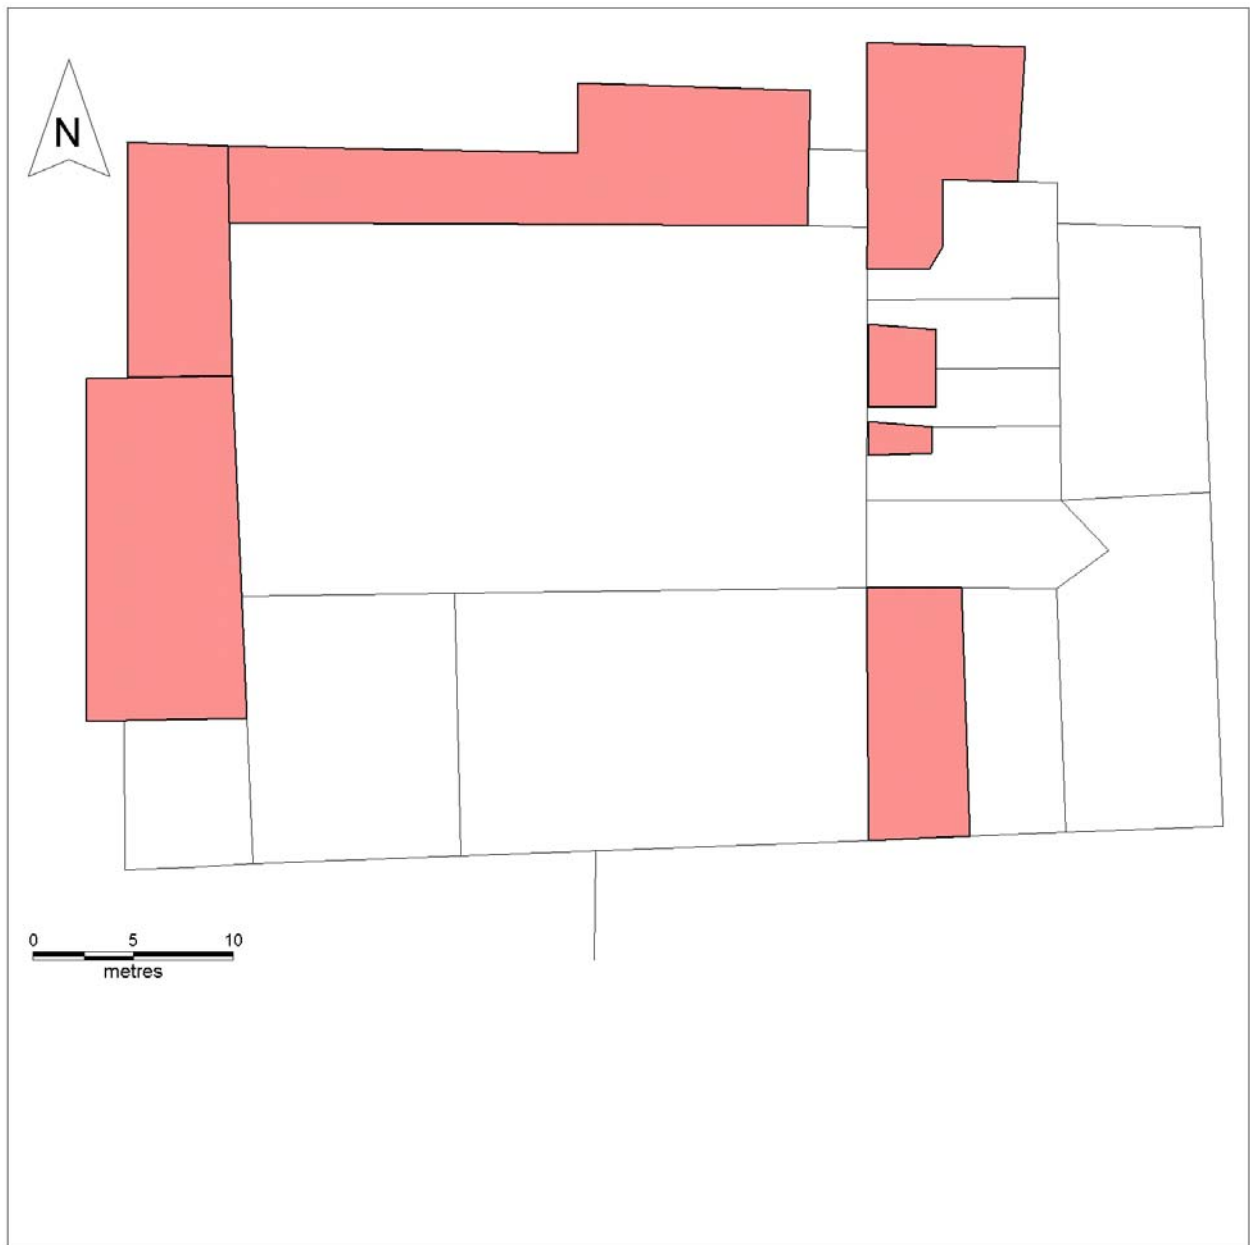
The Ordnance Survey 1st Edition 1:2500 provides the earliest reliable depiction of the courtyard. This shows the cart shed on the west side of the courtyard with a

building attached to its north end, as in 1839 but now gone, and a small walled yard area on its south side where a building was shown in 1839. As in 1839, a range of buildings, the Hammel, runs along the whole of the north side of the courtyard. The western end of the Hammel has now been demolished. A building lies towards the southern end of the east side, as in 1839, but towards the northern end two small buildings with yards have replaced a single building shown on the 1839 map (all these buildings and yards have now been removed). A boundary runs east–west dividing the courtyard into two unequal portions – the larger portion being on the north. This division equates with the cobbled area in the northern part of the courtyard and the stony area in the south as revealed in 2008. A second north–south boundary divides the southern portion of the yard. A boundary defines the south side of the courtyard: there are no buildings here.

Map 2. Dinefwr Home Farm Courtyard. Layout based on the 1886 1:2500 1st Edition Ordnance Survey Map. Buildings in pink, boundaries in black.

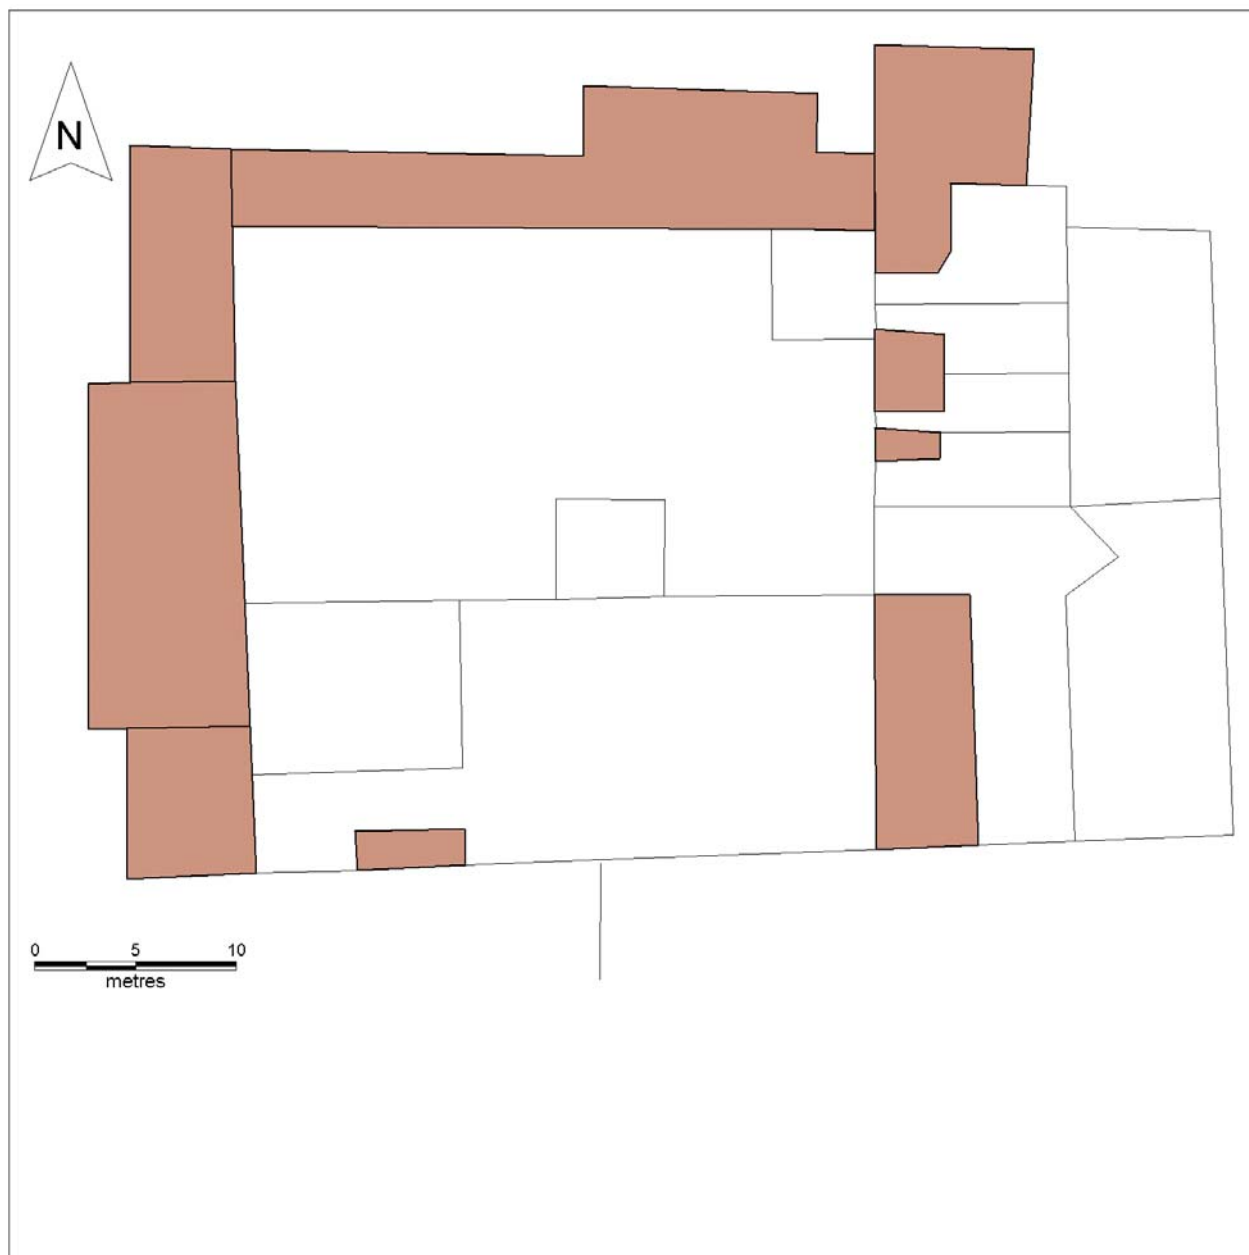
The 1906 2nd Edition 1:2500 map shows only minor changes had occurred since 1886. In the northeast corner of the courtyard a small yard has been constructed, and against the southern boundary wall towards its western end a new building with a yard can be seen. A square yard is shown towards the centre of the courtyard; this may be the urine/soak-away pit uncovered in 2008, although the location of the pit as surveyed in 2008 does not directly coincide with that shown on this map. The small yard on the south side of the cart shed as shown on the 1886 map has been converted to a small building.

Map 3. Dinefwr Home Farm Courtyard. Layout based on the 1906 1:2500 2nd Edition map. Buildings in brown, boundaries in black.

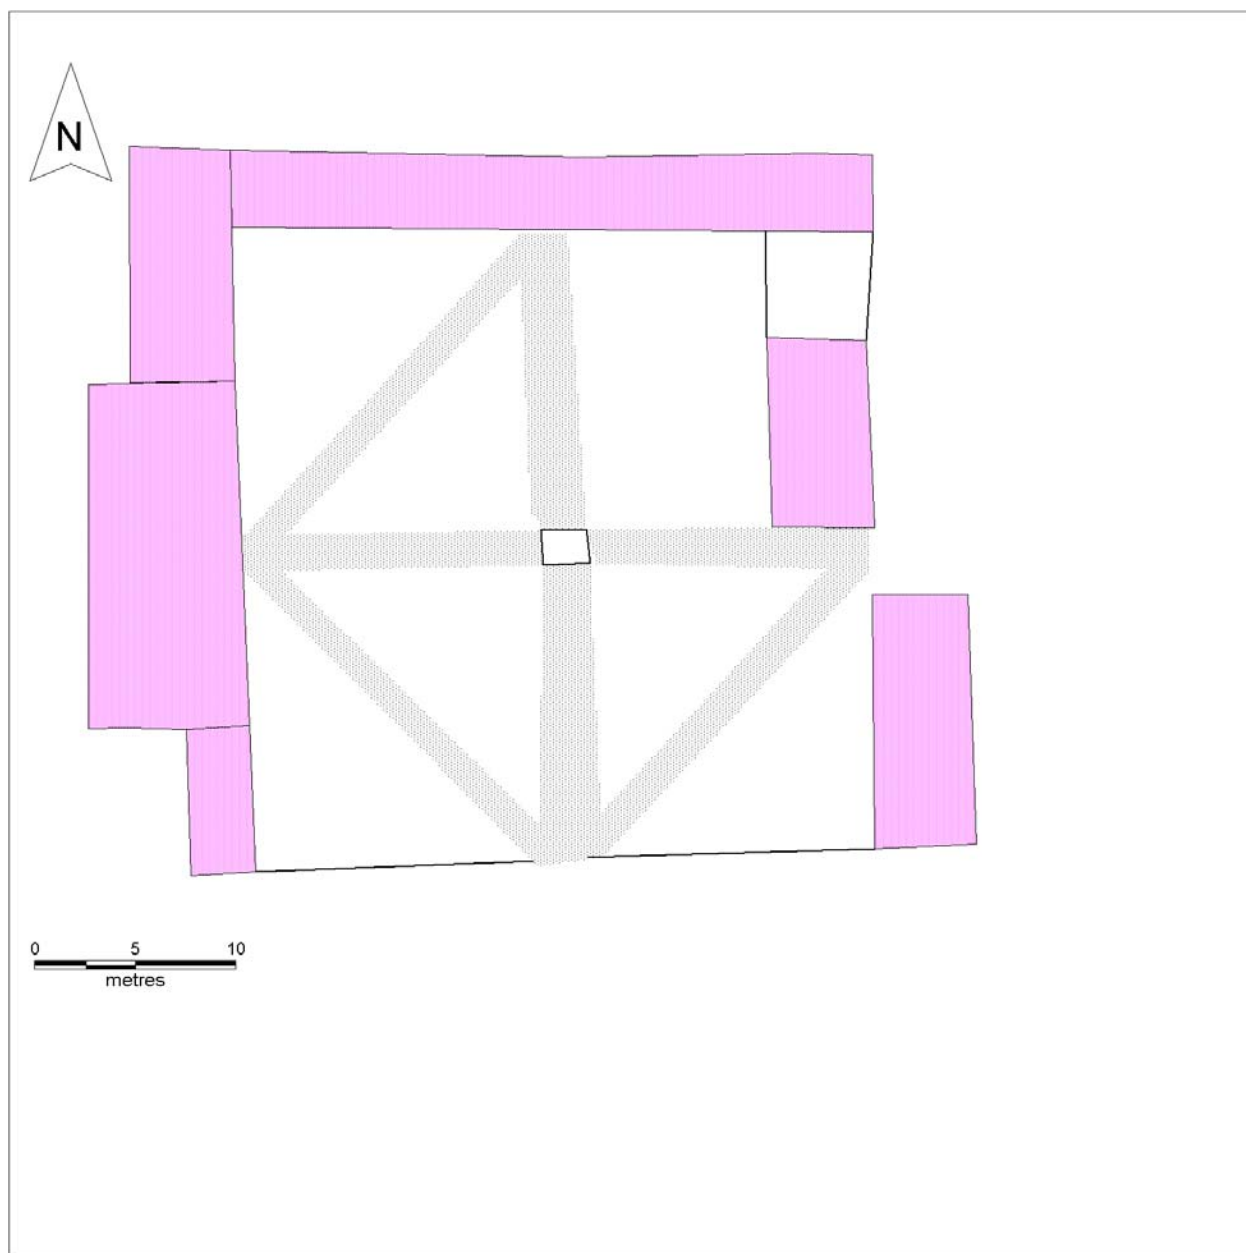
Due to the height at which they were taken it is not possible to detect detail on the vertical aerial photographs taken in 1946, particularly with regard to the size of buildings, and whether additions had been made to them since 1906. However, several general useful points can be gained. There appears to be little change to the buildings on the west and north sides of the courtyard, apart from the building towards the southern end of the west side seems to have been reduced in size (although this is not certain owing to deep shadows) and the building at the courtyard's northeast corner has been demolished. The two small buildings on the east side, shown on the 1886 and 1906 maps, together with their yards, have also been demolished. However, a new building has been added within the northeast corner of the courtyard next to the small yard area first shown on the 1906 map (the foundations and floors of this building and yard were revealed in 2008). The small building originally shown on the 1906 map against the southern boundary is not on the 1946 photographs. Detail of the courtyard interior is visible on the aerial photographs: the urine/soak-away pit uncovered in 2008 is clearly visible as are several worn paths. The latter are of interest as the courtyard surfaces, including the cobble surface, must have been covered with accumulated soil or other material for these to be created.

Map 4. Dinefwr Home Farm Courtyard. Layout based on 1946 vertical aerial photographs. Buildings in pink, boundaries in black. Note the central soak-away pit. Worn paths are shown stippled.

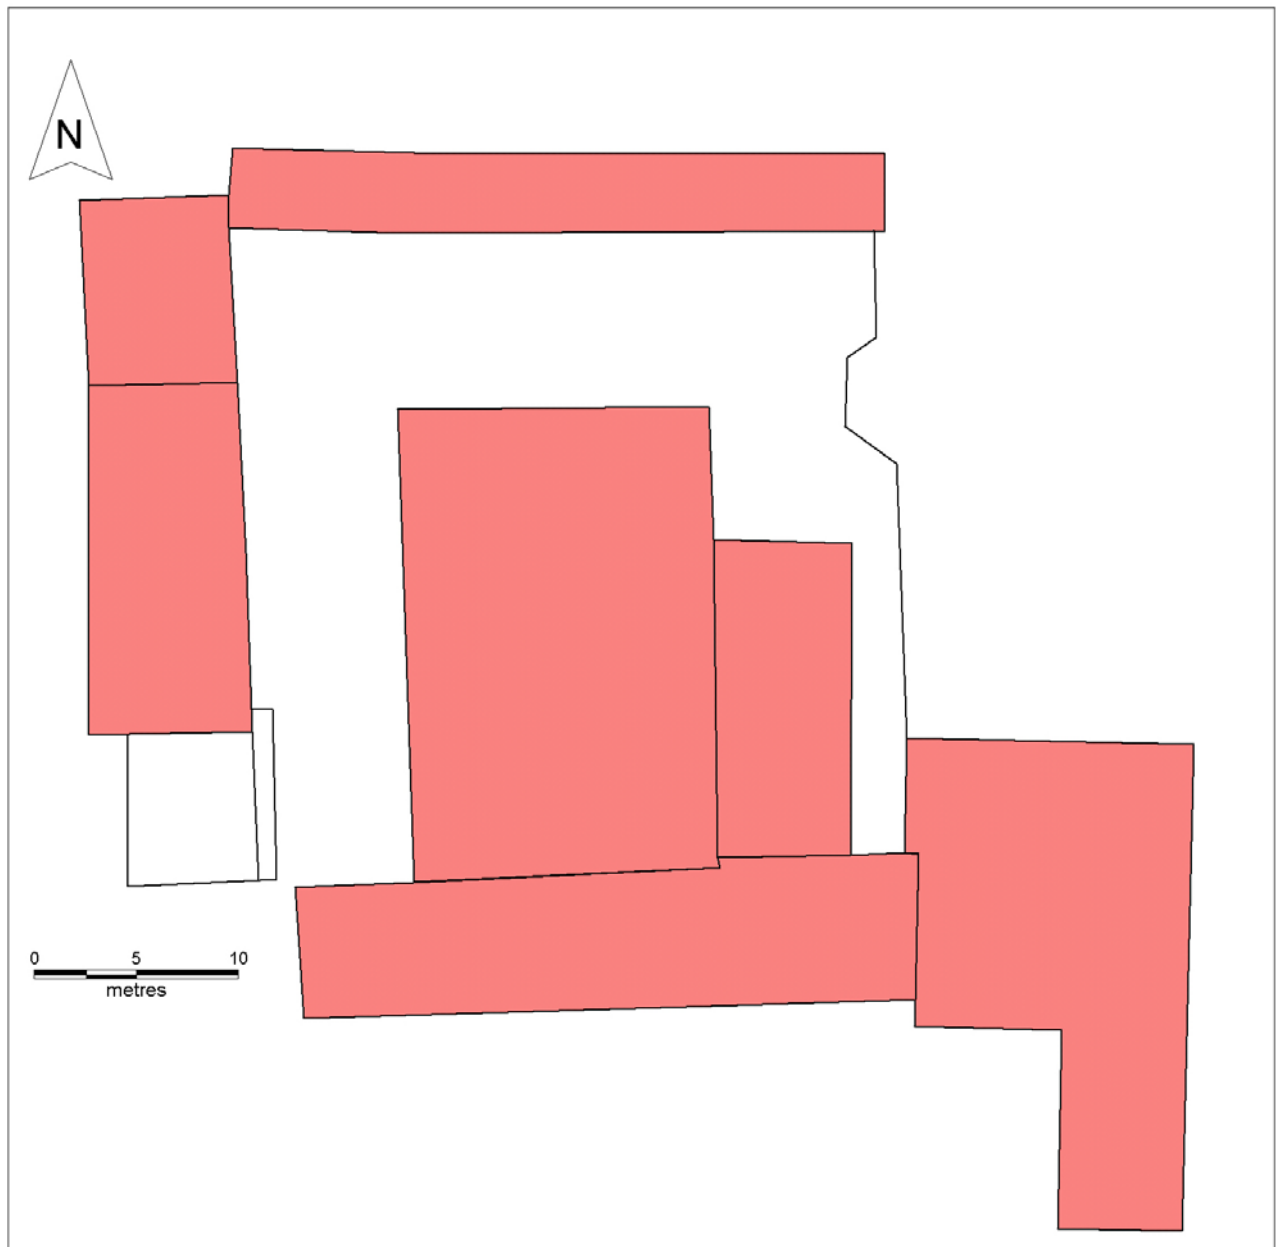
Dramatic changes took place between 1946 and the restoration works of 2008. Several large buildings were erected within the courtyard and thick concrete slabs were laid across the whole courtyard, inside and outside the buildings. The pre-2008 map also shows a building has been constructed along the south side of the courtyard, and a new large building added onto the southeast corner (built partly over the site of an earlier building present in 1946, but presumably demolished). The buildings shown on the 1946 map in the southwest and northeast corners of the courtyard appear to have been demolished. In addition the building in the northwest corner of the courtyard, which appears to have been present since 1839, has been demolished and replaced by a larger structure. All these buildings and slabs were removed in 2008.

Map 5. Dinefwr Home Farm Courtyard. Layout pre-2008 demolition showing buildings in pink and boundaries in black.

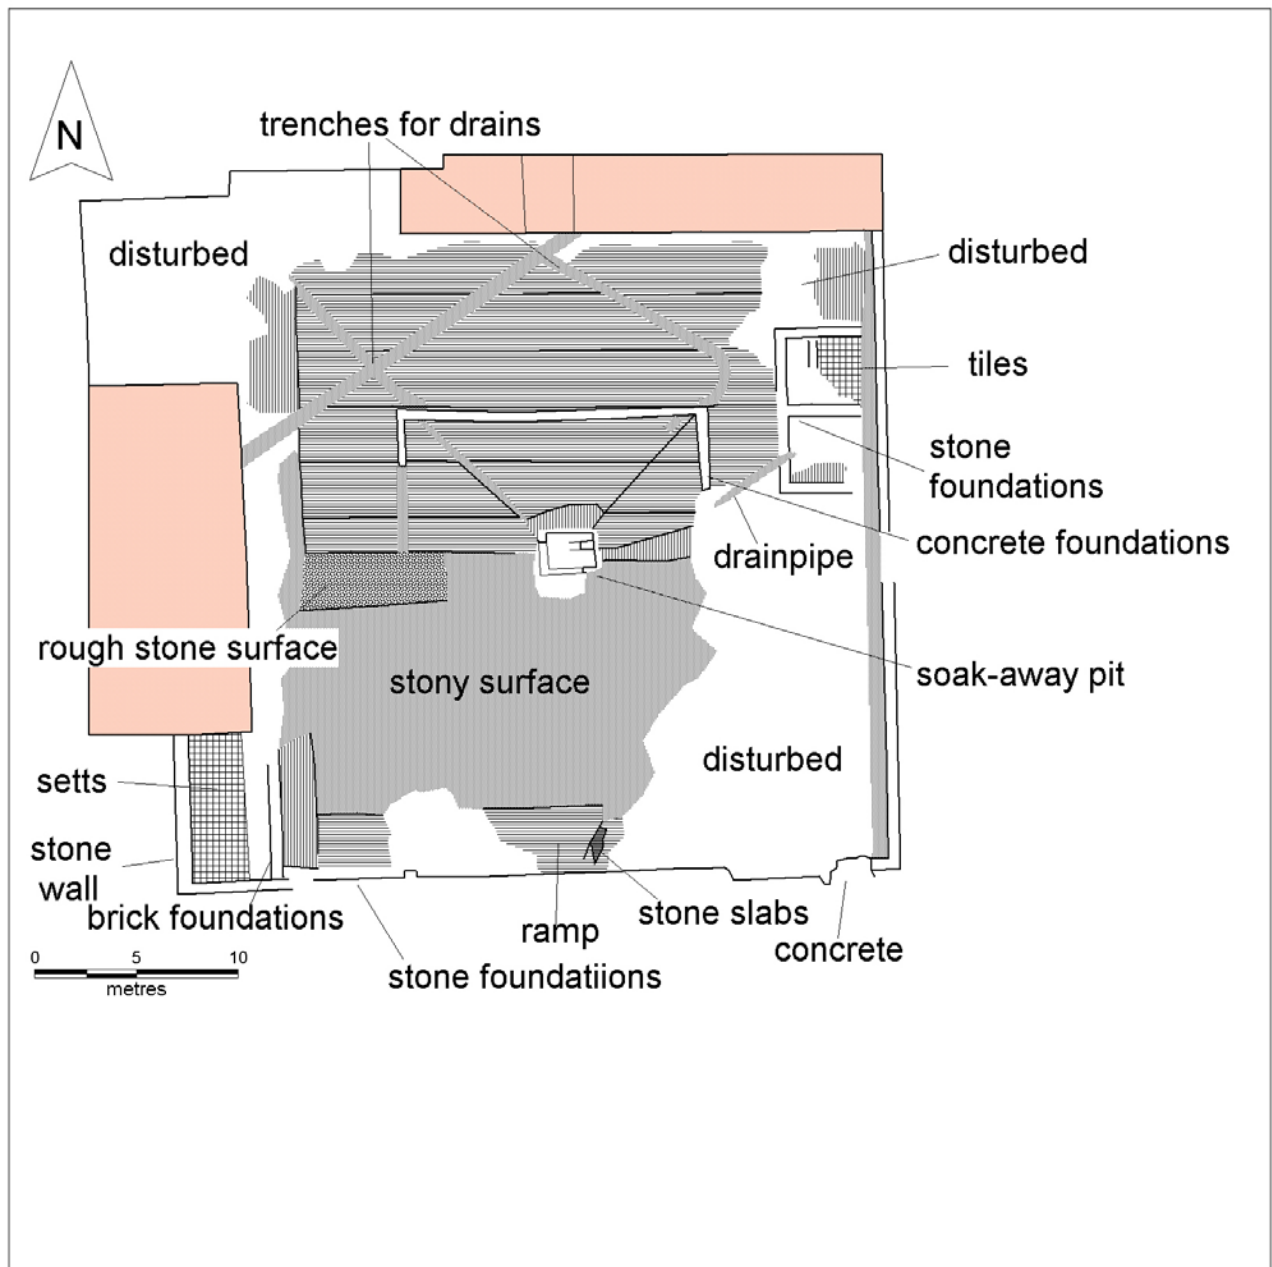
Following the building clearance and concrete slab removal the courtyard and surrounding buildings comprised: the cart shed on the west side of the courtyard, the Hammel (the west end demolished) on the northside, and the foundations and surfaces within the yard.

In the southwest corner of the courtyard foundations and ceramic setts of an interior floor surface were revealed during clearance. These remains are of a building constructed between 1906 and 1946, on the site of an earlier, larger building. The building measures 7.2m north–south and 3.7m east–west internally. The south and west walls are stone built, with the west wall surviving to c.2m high and the south wall just 0.6m high and revetting a yard surface to the south. Only the foundations of a brick wall on the east side survive. There is a gap of 1.1m between the ceramic setts and the east wall, perhaps for a passageway. The setts are laid in three clear panels. It seems likely that this building was used for accommodating animals, possibly a stable.

In the northeast corner a tile surface, a patch of cobbles and discontinuous stone foundations represent the remains of a building constructed between 1906 and 1946. To the north a patch of cobbling is all that remains of a small yard first shown on the 1906 map, against which the building was erected. Internally the building measures 7.1m north–south and 3.6m east–west, and was divided into two rooms, with a passageway or subdivision in the north room. The floor of the north room is constructed from one-foot square ceramic tiles. A patch of cobbles indicates the surface of the south room.

The removal of the modern concrete slabs across the courtyard revealed cobbled and other yard surfaces. The yard is divided into two clear zones that presumably represent the different functions of the two areas. The northern half is cobbled; the southern half is surfaced with compacted 'hardcore'. The cobbled surfaces slope gently down to the centre of the yard into a stone-lined urine pit or soak-away; the southern portion of the yard is fairly flat. The urine/soak-away pit was partly damaged in June 2008 by the digging of a hole to take a sewerage tank. The urine pit/soak-away is c.0.5m deep (measured from the cobbled surfaces), 2.2m east – west and 1.8m north – south, built with mortared stone walls and a stone-slab/cobbled floor (see photographs at end of report). A stone cross-wall was added to the pit at some time in the past, either to reduce its size or to divide it into two compartments. The cobble yard surfaces run over the edge of the urine pit walls, demonstrating that the pit either pre-dates the cobbles or, more probably, that they were constructed at the same time. The cobble surface is laid as six main bands running east–west. The remains of north–south laid cobble bands can be seen towards the corners of the courtyard. There is considerable disturbance of some of the cobble bands, particularly the north–south ones, and it is not known how extensive these originally were. A linear area of rough stone surface, bordered by a line of cobbles along its southern edge, located to the southwest of the east-west cobble bands may indicate the position of another such band of cobbles. On the south side of the courtyard there are the remains of a cobbled ramp that drops down into the courtyard.

The southern part of the courtyard is surfaced with compacted stones. These have worn to a smooth round shape in some areas, and in other areas have been disturbed. The original surfaces within the east, southeast and northwest parts of the courtyard have been heavily disturbed or destroyed, as has, probably, the western side fronting the cart shed.

Several drains have been excavated through the cobbled surfaces, as have the foundation trenches for the large buildings demolished in 2008.

Map 6. Dinefwr Home Farm Courtyard. Layout of the courtyard surveyed 2008. Cobbled surfaces are shown hatched in the approximate direction of the cobble bands.

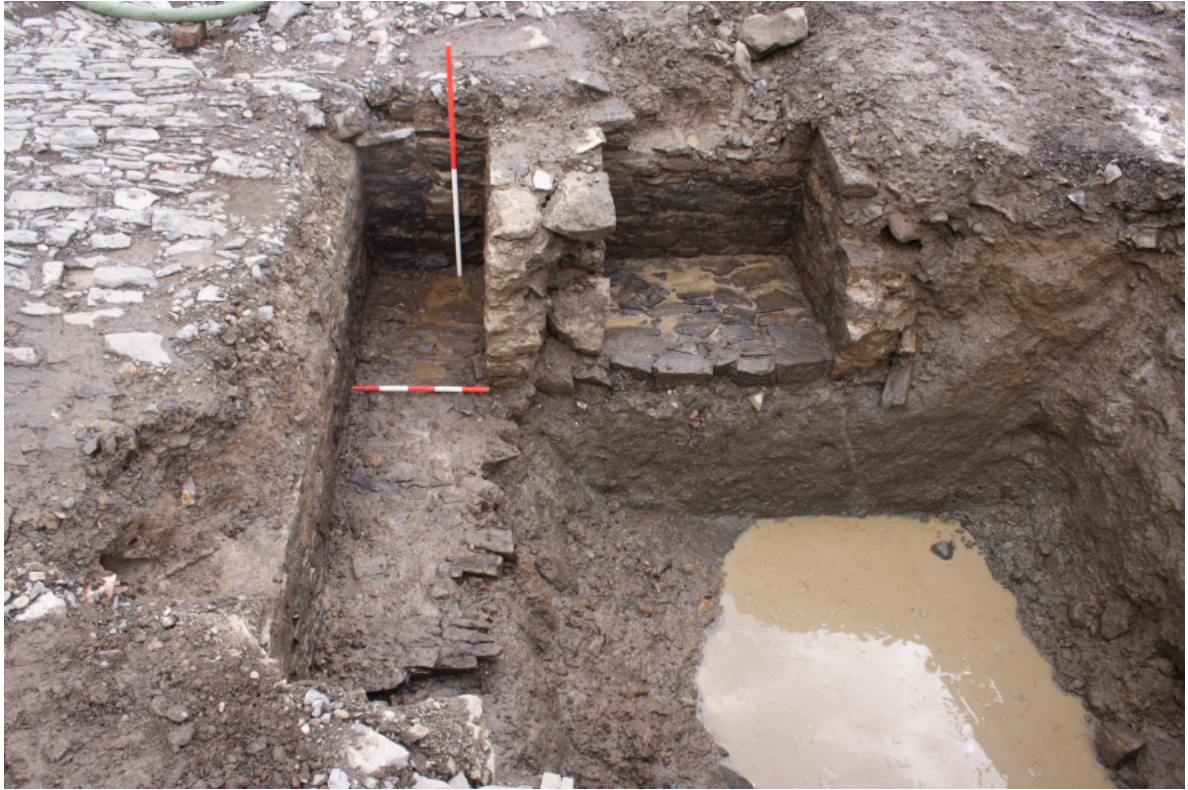
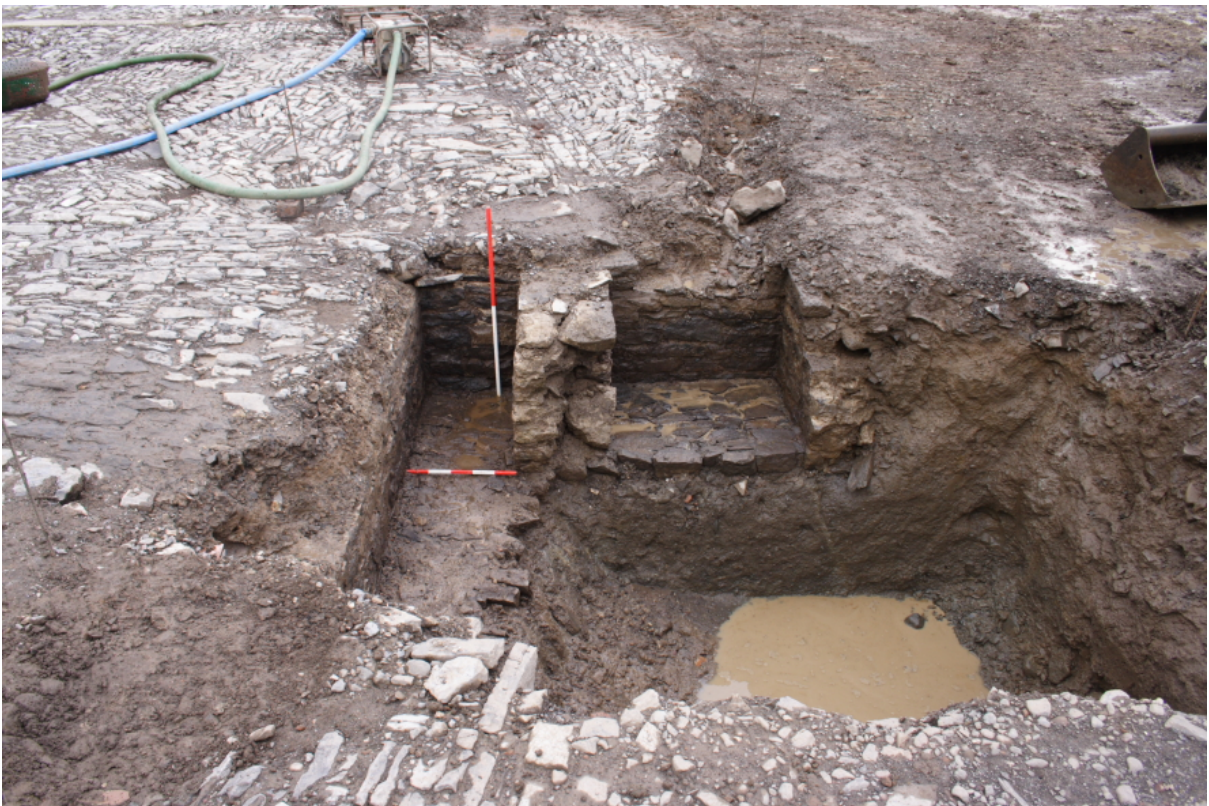
Two photographs of the central soak-away or urine pit during clearance of 14-15 August 2008.
