THE OLD MILL, HOREB, LLANELLI, CARMARTHENSHIRE: STANDING BUILDING RECORDING AND ARCHAEOLOGICAL WATCHING BRIEF

Prepared by Dyfed Archaeological Trust
For: Mr and Mrs Mark Evans

RHIF YR ADRODDIAD / REPORT NO. 2008/106
RHIF Y PROSIECT / PROJECT RECORD NO. 94221 & 94222 ✓ 94423
4 4

November 2008

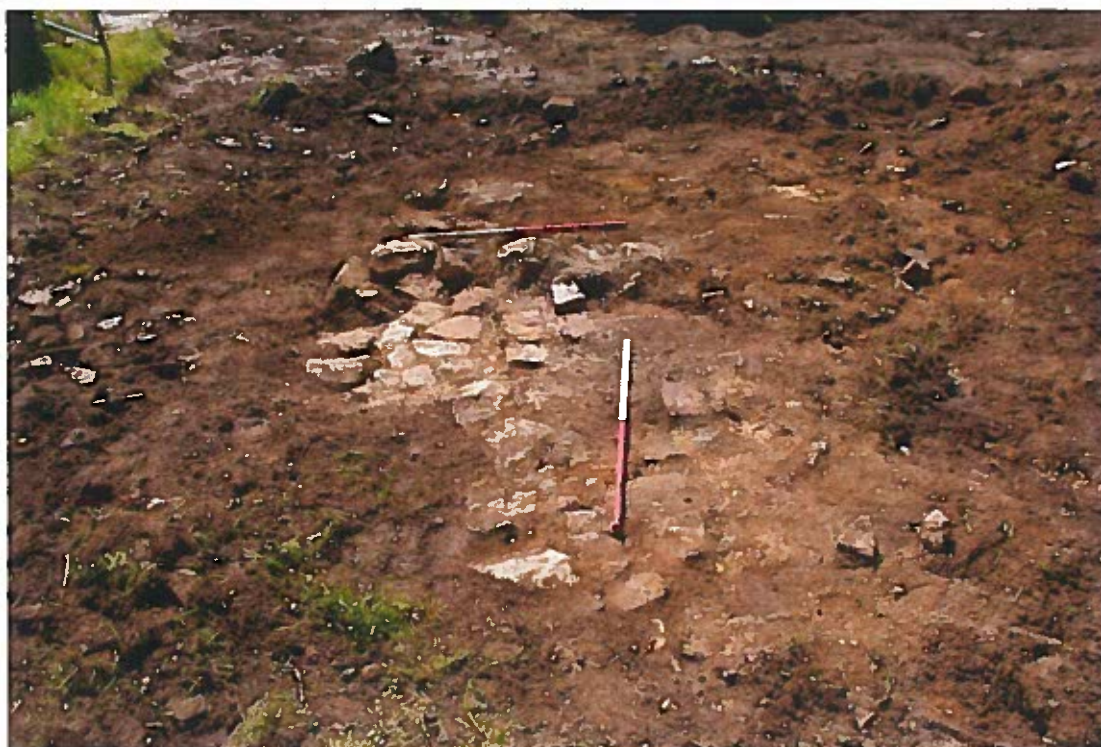
Two archaeological features were revealed and recorded during the clearance and topsoil stripping of the site. The first was a 3.3m x 1.6m metalled surface of large subangular stone that may have been part of a yard surface. Post medieval willow pattern stoneware fragments were recovered along with late 19th – early 20th century glass but these were not retained.

Plate 1: Metalled possible yard surface.

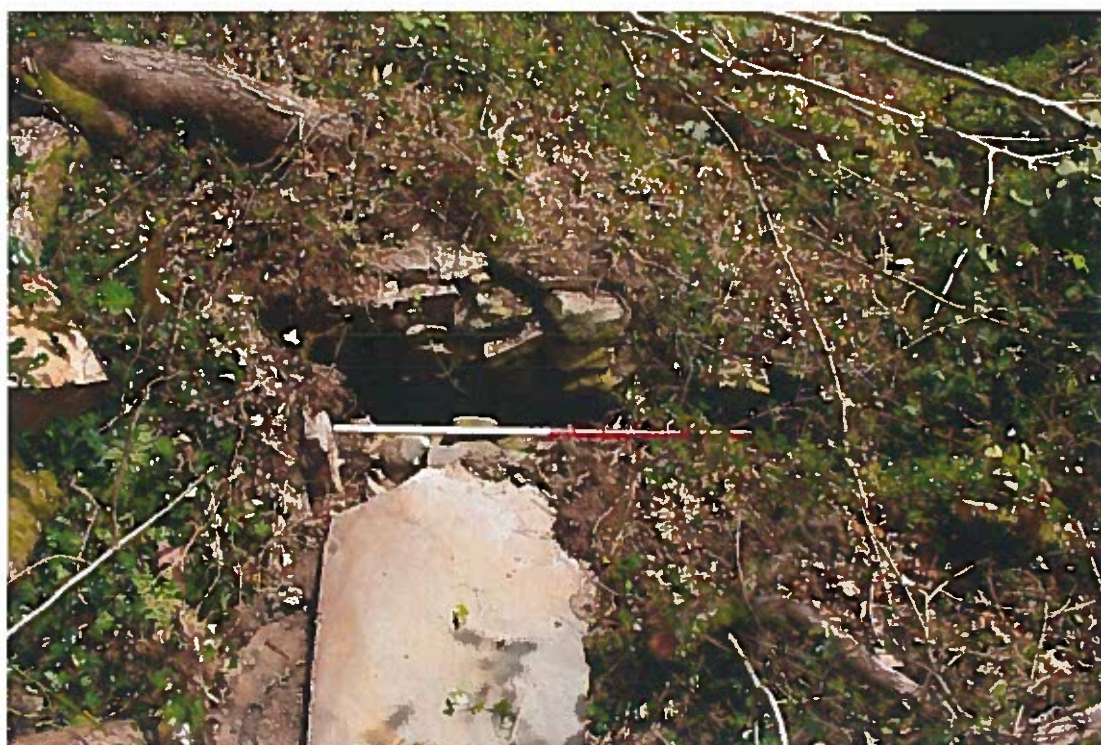
Clearance works to the northeast of the head race wall revealed a 3.75m long 0.9m wide, 1.4m deep stone channel that supplied water to power the water wheel. The full extent of the channel was unknown as it continued beneath the unexcavated area. The channel was capped with stone slabs, one of these was disturbed during the clearance works and was found to be 1.2m long, 0.5m wide with a thickness of 0.04m.

Plate 2: Stone water channel from west.

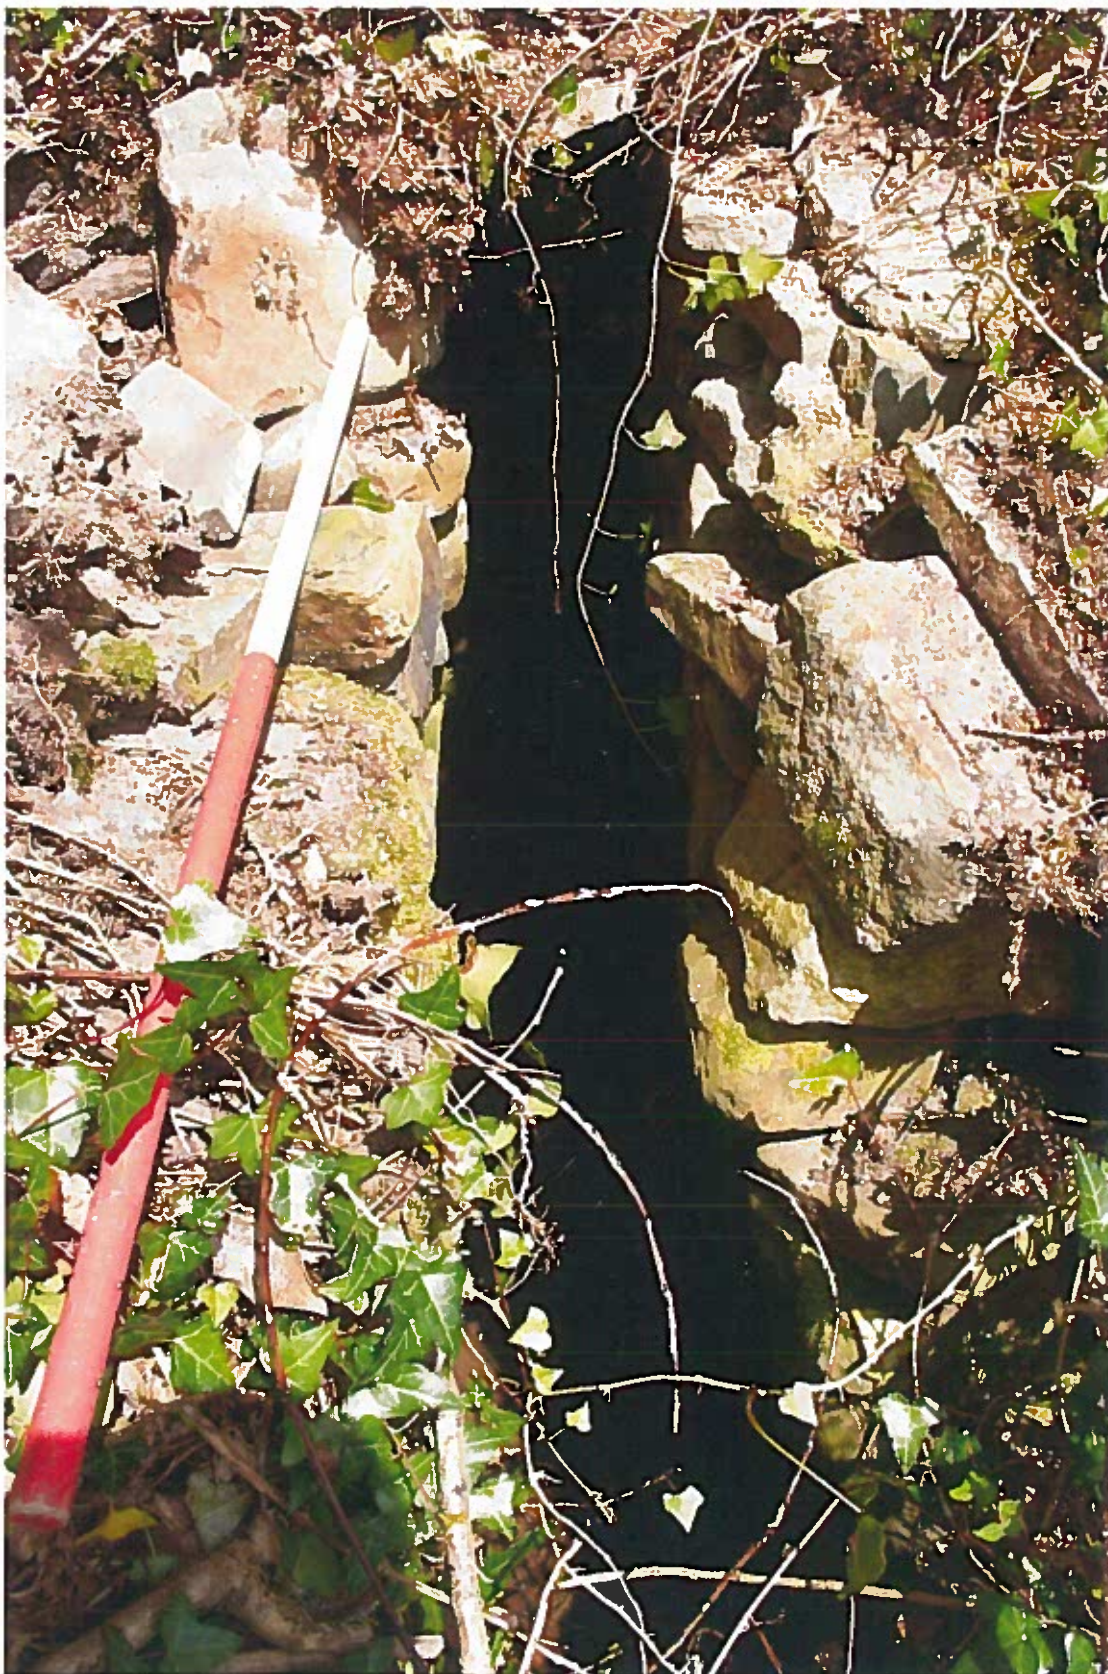
Plate 3: Stone water channel looking north.

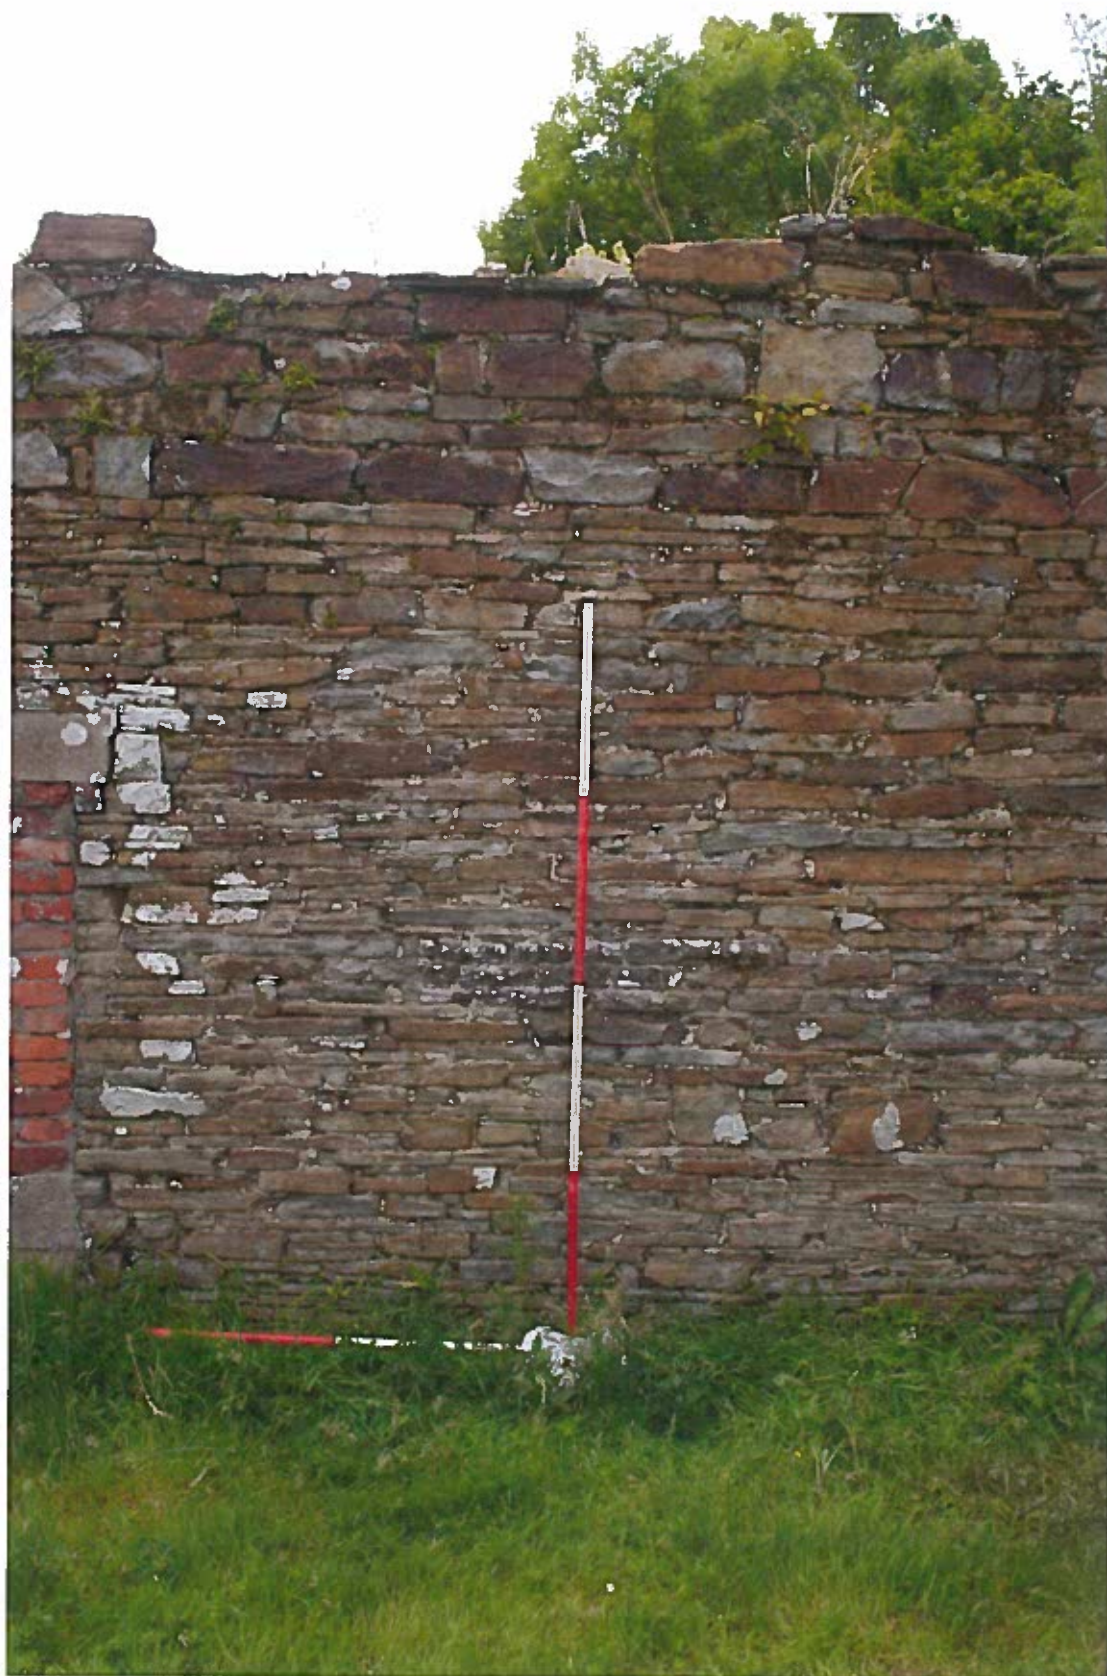
It was noted that the upper level of the southeast side wall was constructed of larger stone than the rest of the addition. This may suggest that it had been rebuilt. However, it is equally likely that it may be evidence for a different stone source and may represent a wall lift whereby the rubble coursing was levelled to provide a good base for the continuation of construction.

Plate 32: Extension wall from southeast area of larger stone visible above vertical scale. Shot 4.

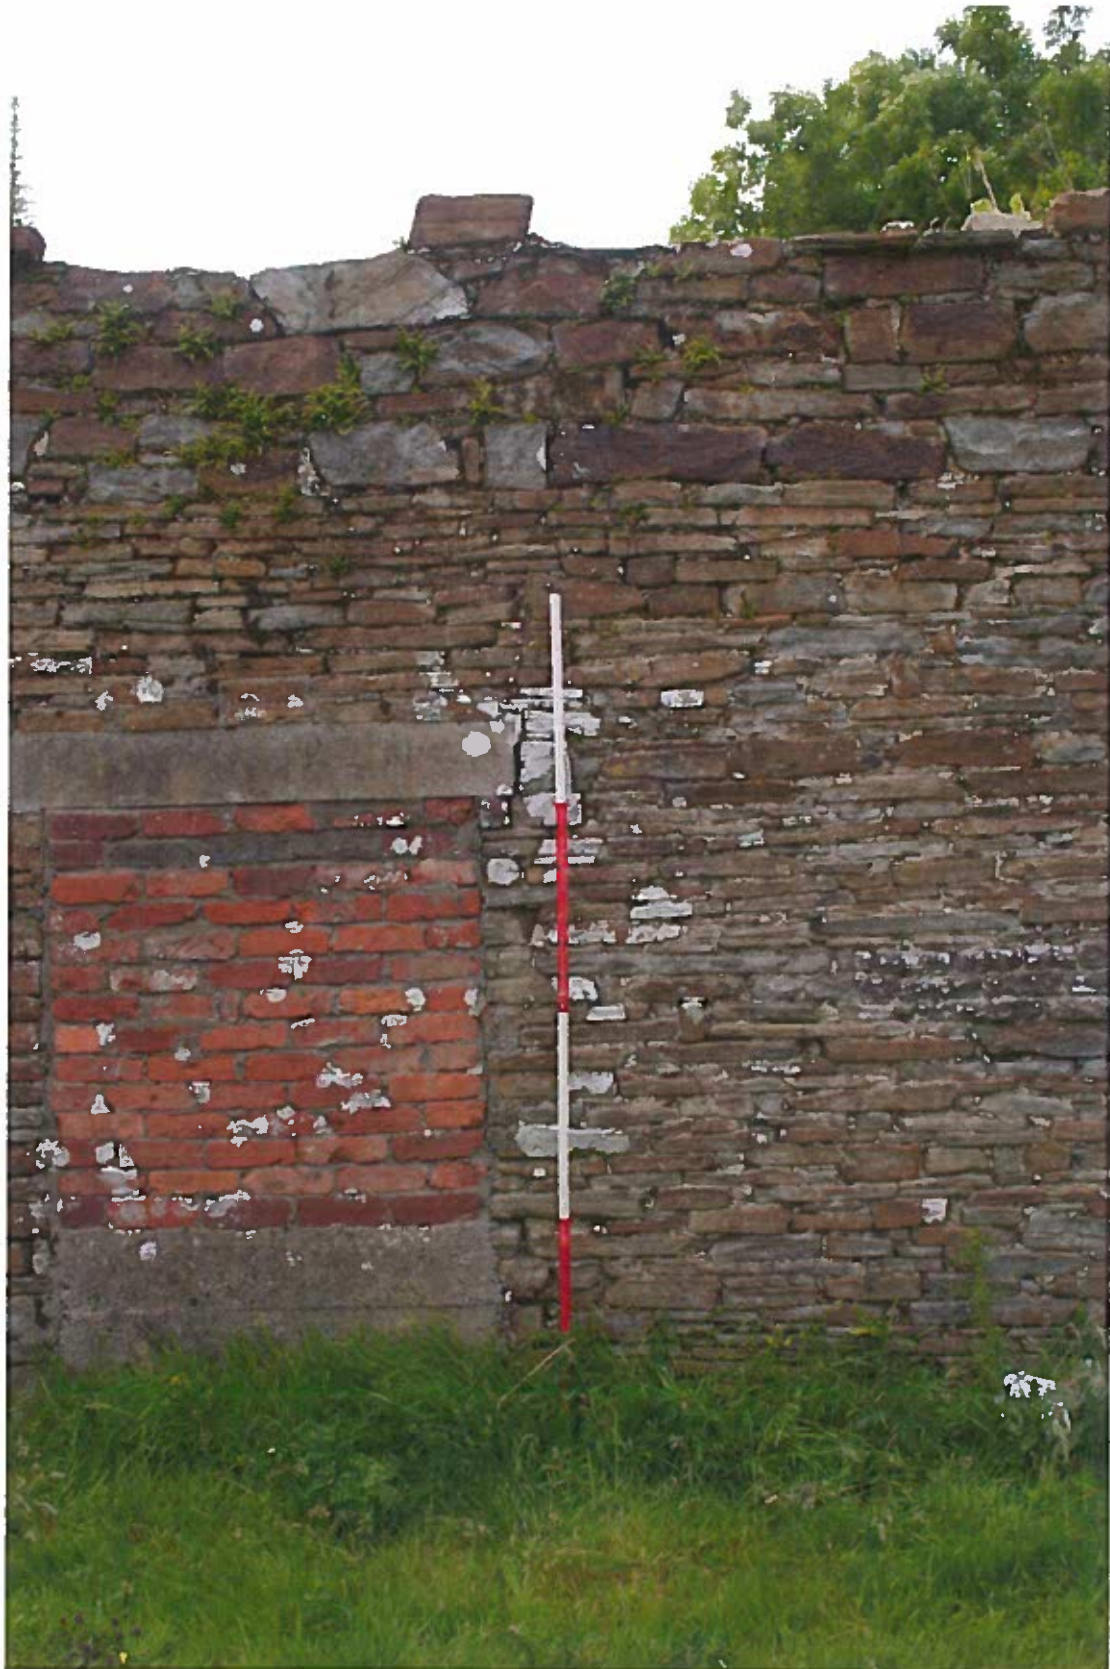
The ground floor of the possible later addition to the mill was originally accessed through doors in the side and gable walls. No direct ground floor access was possible to the original mill. Of these three original doors only the one in the northwest side wall was still open. The door in the gable end had been blocked with rubble whilst that in the southeast side wall may have been converted to a window by the insertion of a concrete lintel and plinth. This possible window was completely blocked with red brick.

Plate 33: Extension wall from southeast blocked door/window to left. Shot 5.

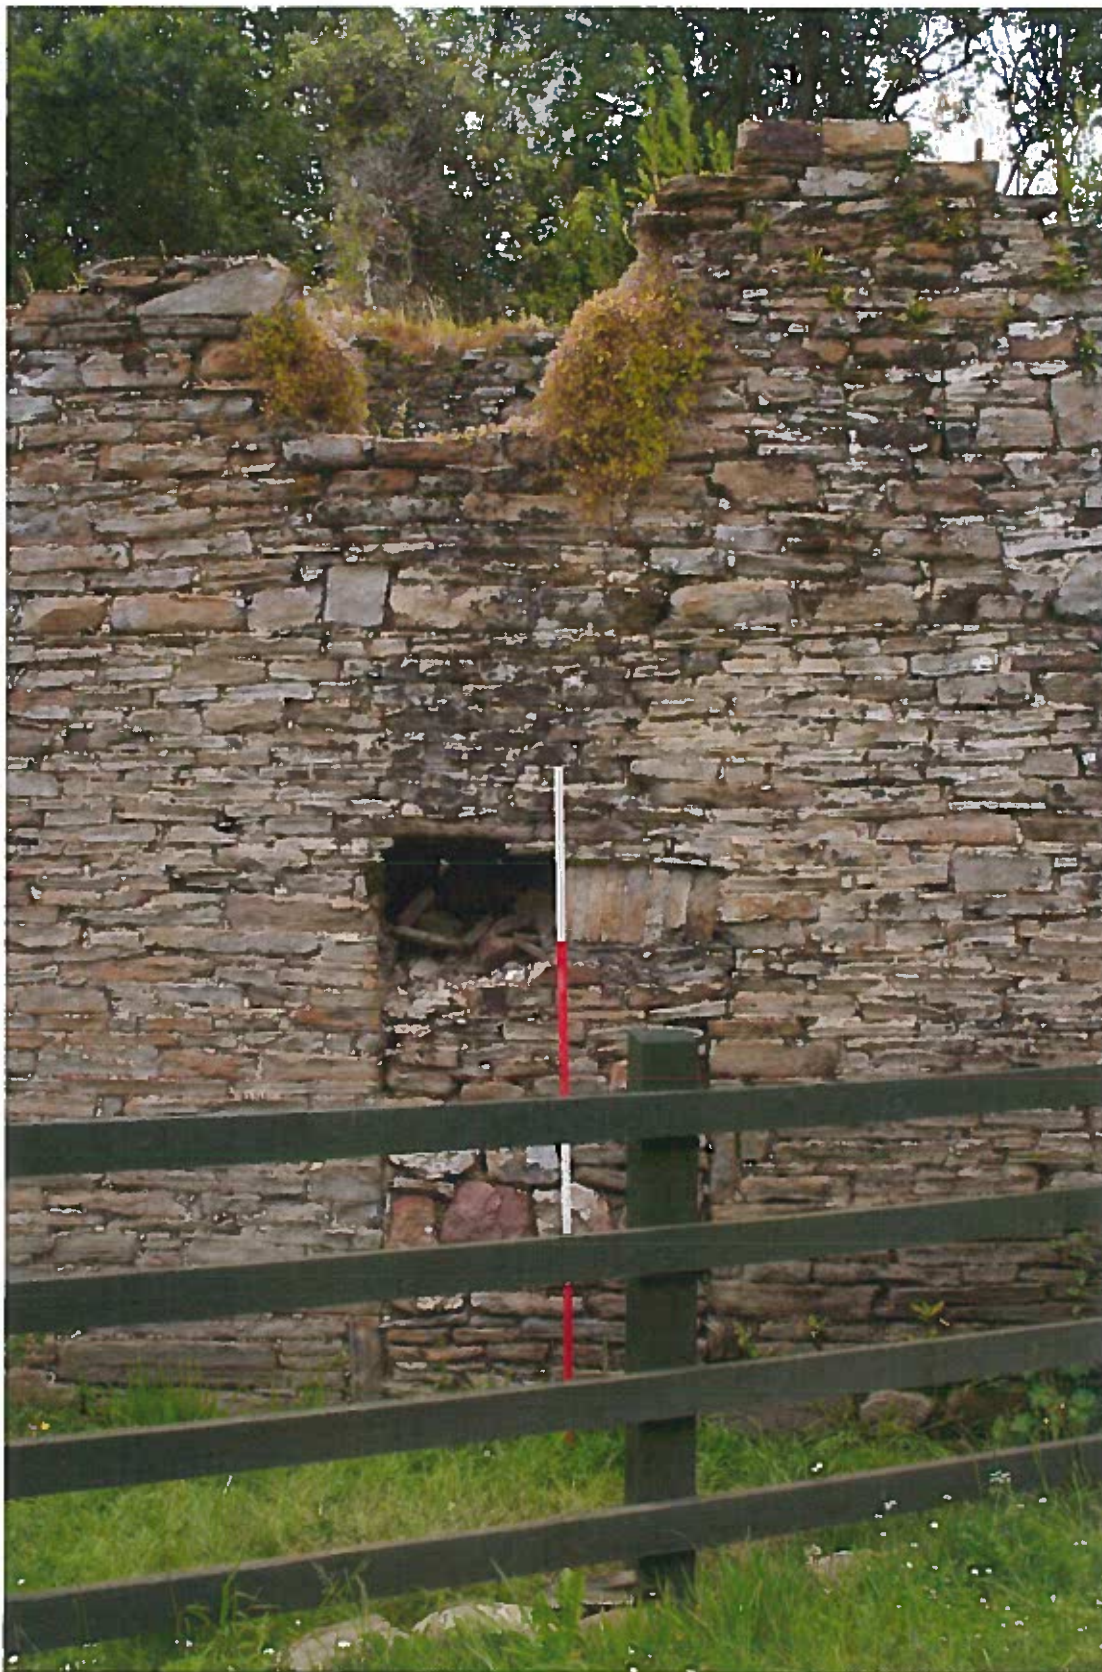
Plate 38: Extension gable end from southwest showing blocked doorway with window above. Shot 3.

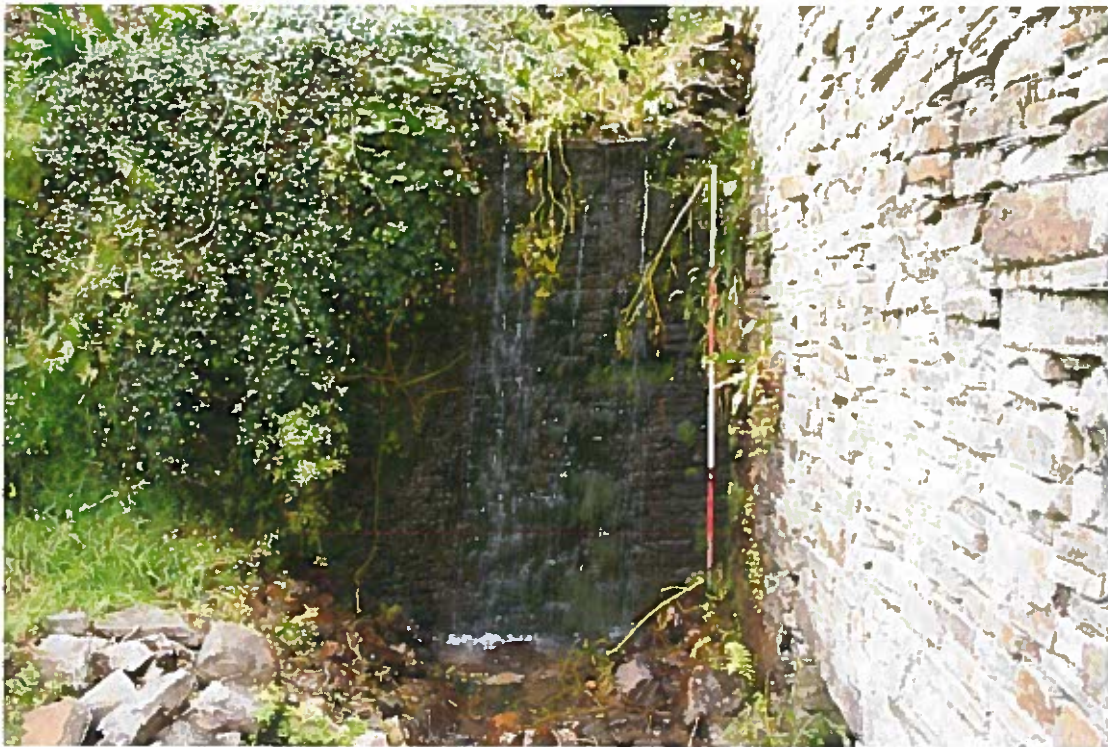
Running along the northwest side wall, and continuing to the site of the former wheel pit, a covered over tail race was noted. To the northeast of the wheel pit a c.2m high wall was noted, this once functioned as the head of the head race. Within the head race wall was a c.0.4 x 0.2m recess that may suggest the original waterwheel was breastshot whereby water entered the wheel below the top. However, the presence of sockets in the north west gable wall of the mill may indicate that a breastshot wheel was replaced by either an overshot or pitchback wheel whereby water enters at the top of the wheel. Both these forms of wheel provide more power than the breast shot system. This upgraded power system may have been installed at the same time as the extension to the original mill was constructed.

Plate 46: Head race wall from southwest.

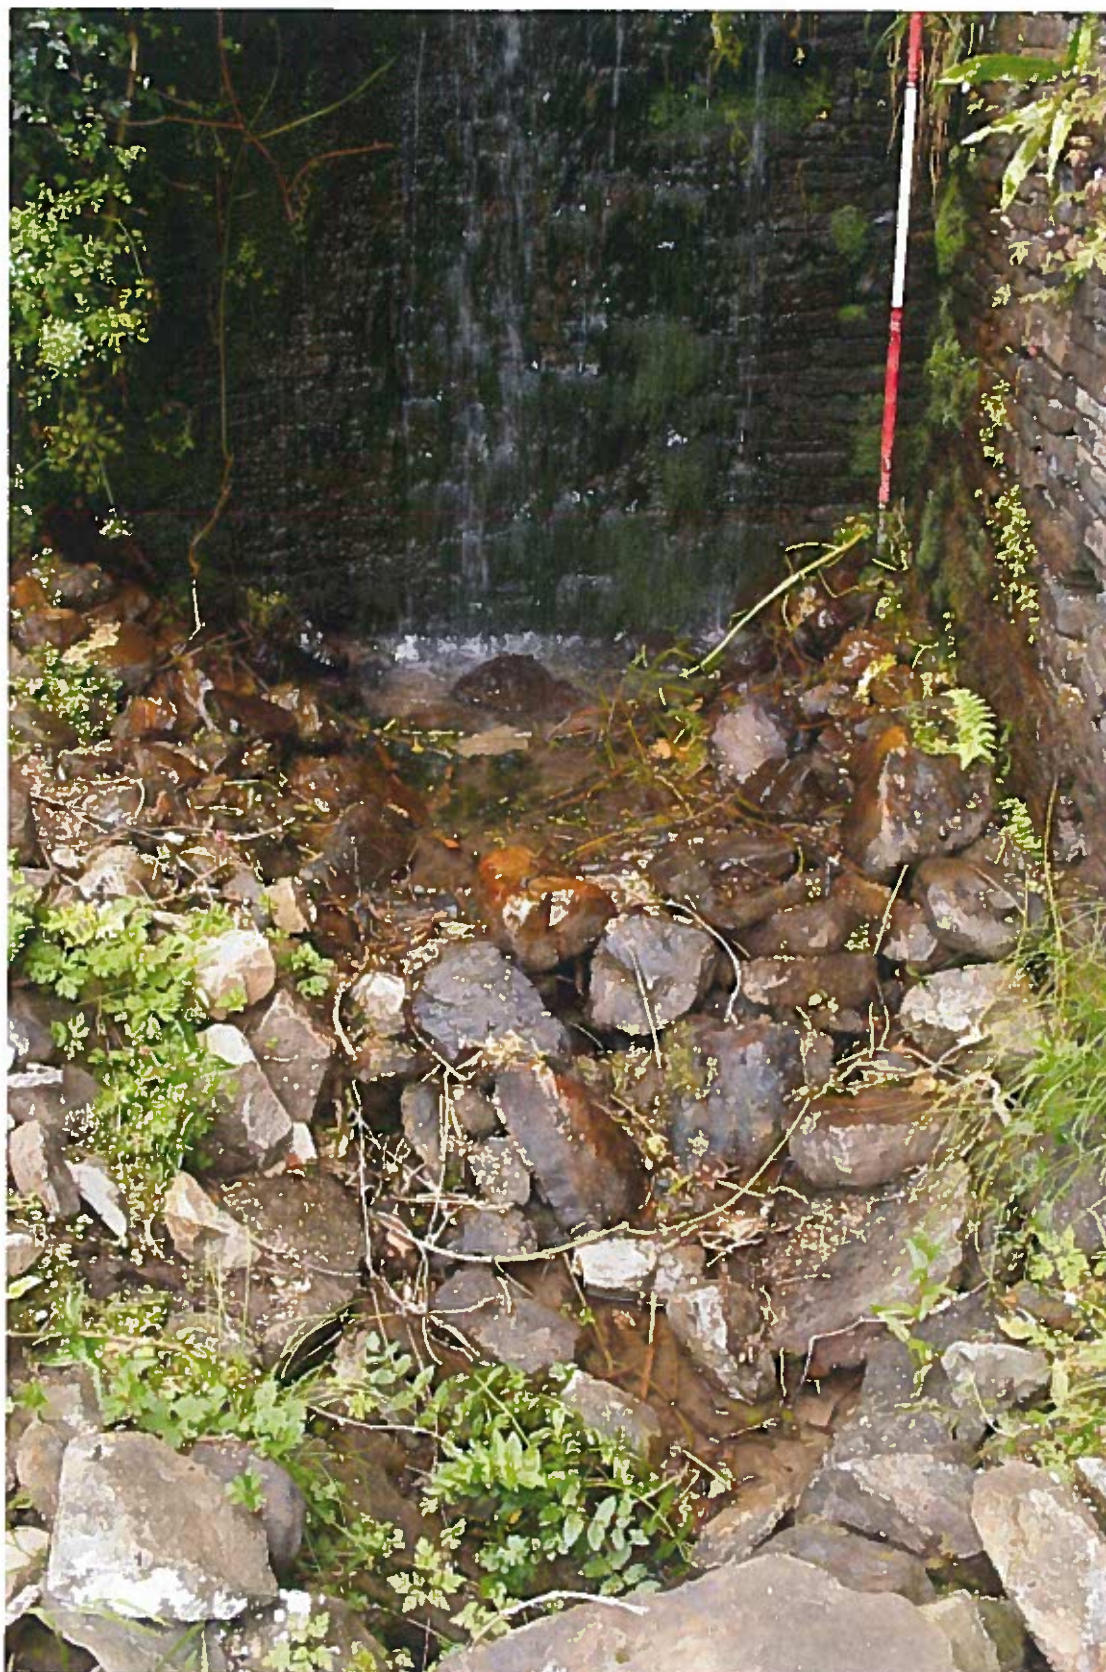
The northeast gable wall was pierced by two broadly square window openings set at high level. It was also noted that the scars of floor joists were present, which suggests that the mill once had a second floor. No indication of floor joists were noted on the southwest gable wall at this level which may suggest that the floor did not continue across the whole length of the structure. An additional opening was noted at ground level, this is likely to have been where the axle of the waterwheel entered the mill. Externally at this point the remains of a silted up wheel pit were noted along with the mill head race and covered over tail race.

Plate 47: Former wheel pit.

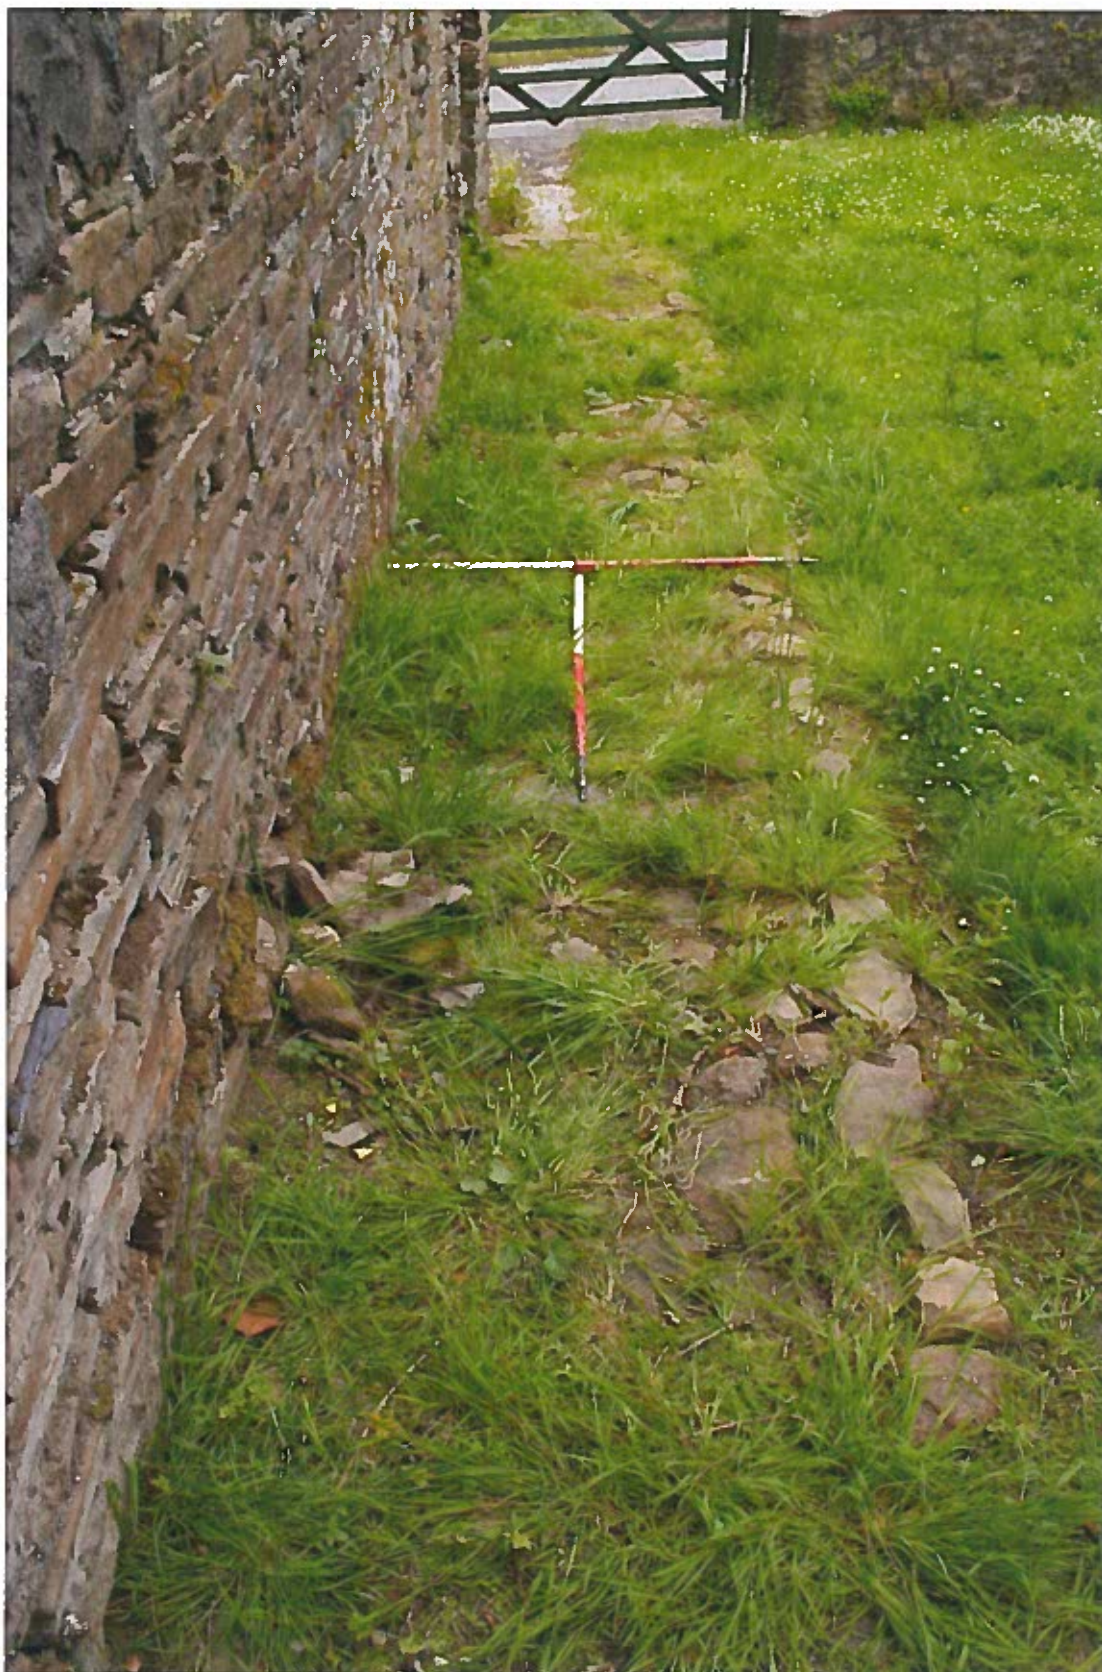
Plate 48: Covered tail race from northeast.
