PHILBEACH FARMHOUSE, DALE, PEMBROKESHIRE: BUILDING RECORDING AND ARCHAEOLOGICAL WATCHING BRIEF

RHIF YR ADRODDIAD / REPORT NO. 2011/28
RHIF Y PROSIECT / PROJECT RECORD NO. 94527

**PHILBEACH FARMHOUSE, DALE, PEMBROKESHIRE:
BUILDING RECORDING AND ARCHAEOLOGICAL
WATCHING BRIEF**

Simon Ratty

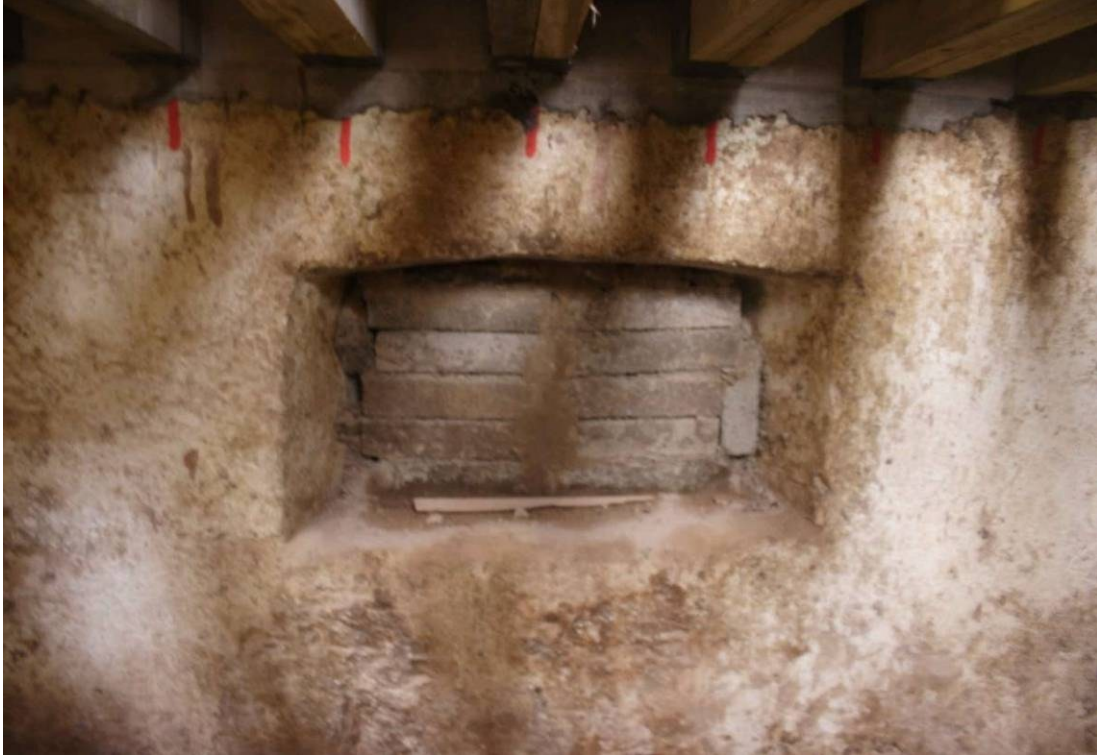
4.1.1 The cellar was accessed from Room 5 by a flight of stone steps (photo 1) located along the south wall to the east of which was a blocked arched opening representing the position of a former window (photo 2). To the rear of the steps was located a small space probably utilised for storage. Access to the main cellar space was by means of a single doorway piercing a limewashed stone wall. The cellar walls were obscured by limewash with a further blocked opening, comparable to that identified at the foot of the steps, centrally placed on the east wall of the space.

Photo 1: Blocked window in cellar

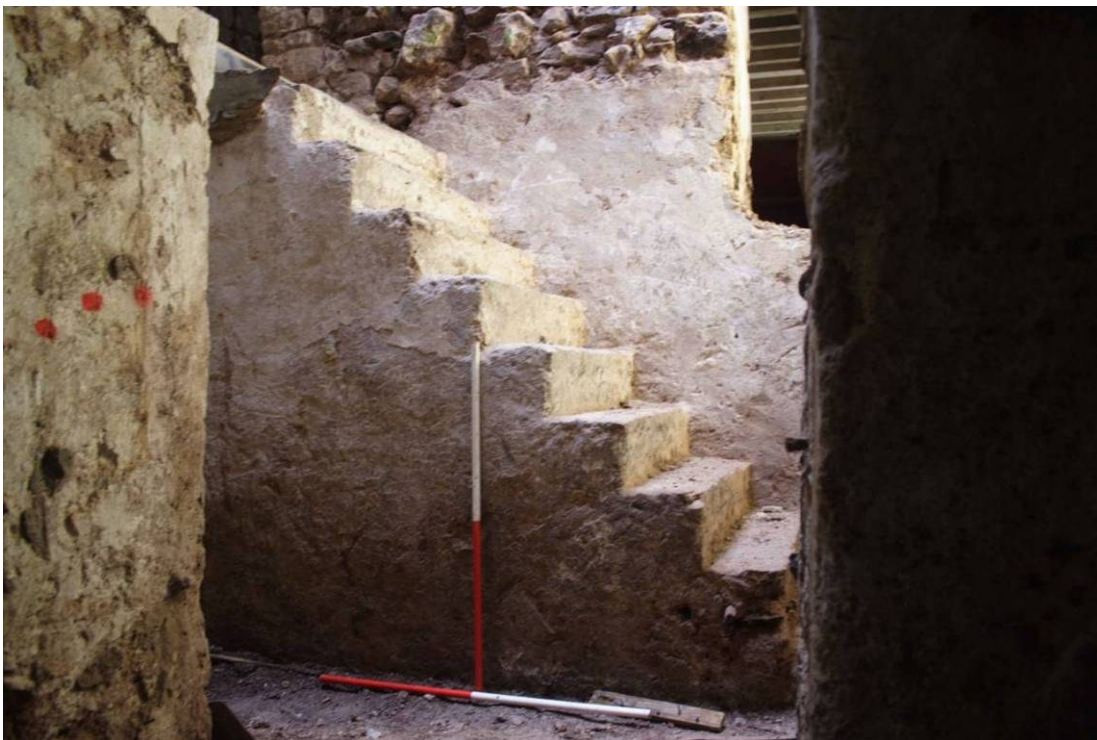
Photo 2: Access steps to cellar

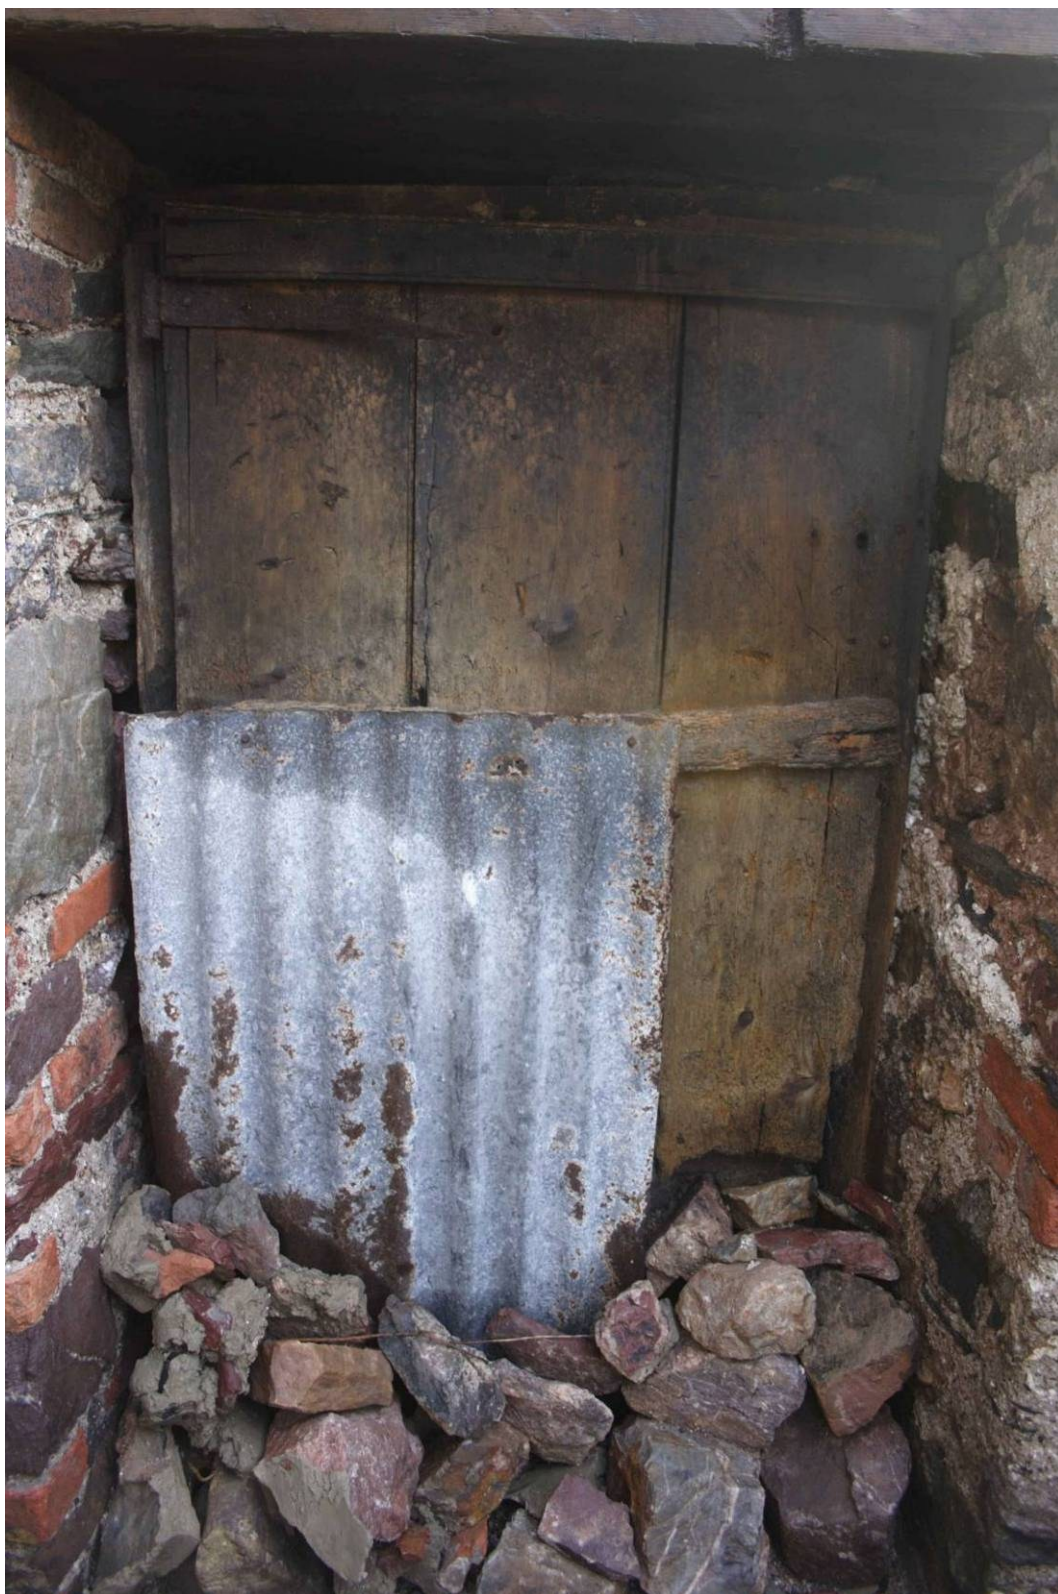
4.2.1 Room 1 was a single storied stone built lean-to structure measuring 2.26m x 5.4m and located at the far south end of the building. The east wall of the room contained a partially blocked doorway with red brick jambs and timber supporting lintel. A rough timber board door survives within the doorway and was hung on handmade wrought iron hinges secured by square headed handmade wrought iron clout nails (see photo 3).

Photo 3: Boarded doorway east wall, Room 2

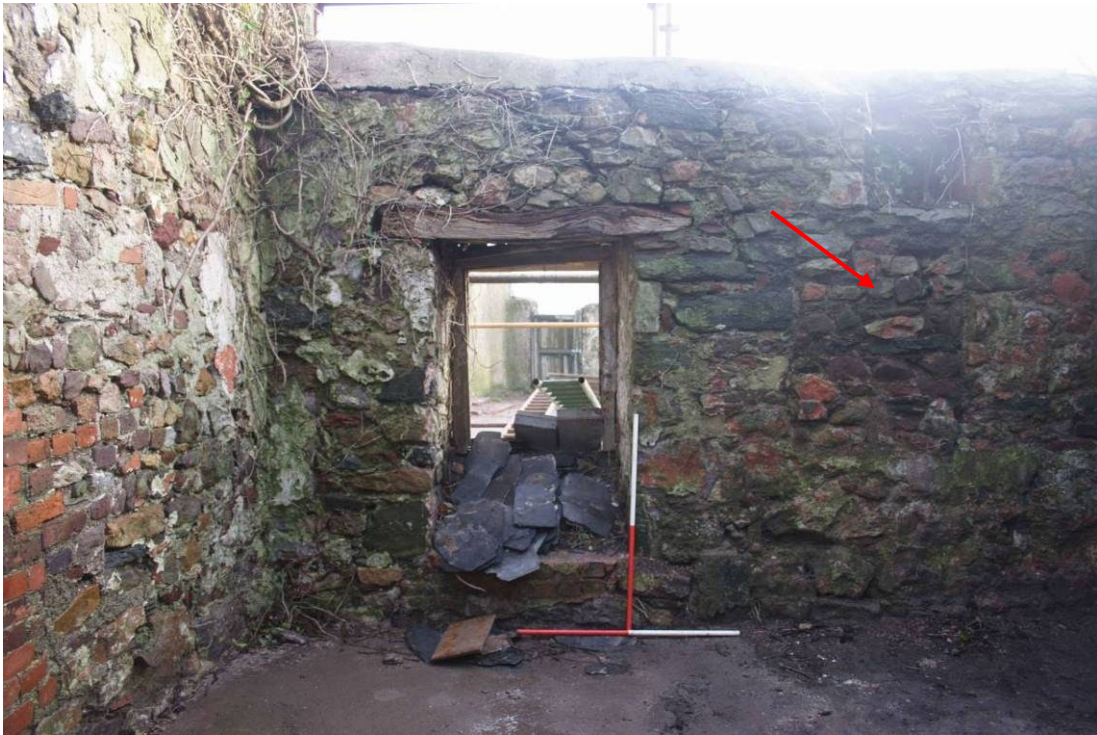
4.2.3 Room 2 was accessed from the adjacent lean-to structure through a centrally placed doorway in the south wall with modern timber lintel above. The east wall contained a single window with supporting timber lintel. A second window, now blocked, was identified to the south of the current window, above which was a further small recess (photo 4).

Photo 4: Window in east wall Room 2,
blocked opening highlighted with arrow

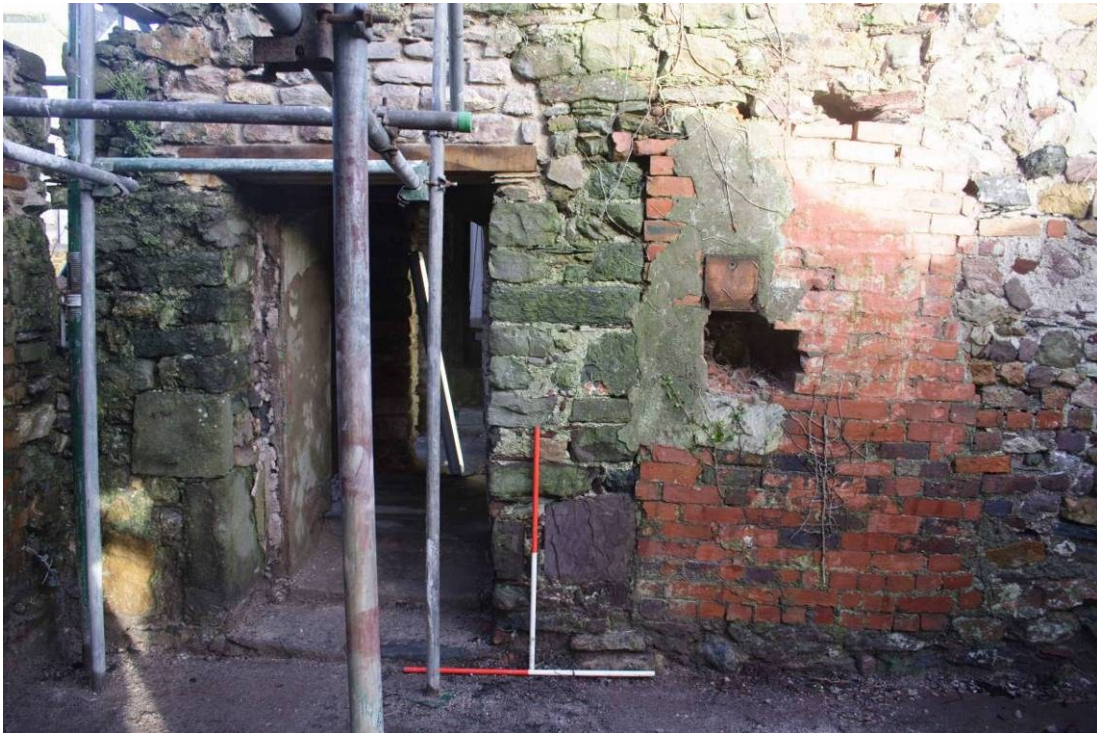
4.2.4 The north wall contained a substantial area of red brick infill that marks the rear of a later range inserted into the adjacent room (photo 5). A doorway, with modern timber supporting lintel, located in the northeast corner of the hall led into the adjoining room. A further area of red brick infill with modern timber lintel above was located in the west wall of the room and marks the site of a later oven (see photo 6). Adjacent on the south side of this later oven was a substantial fireplace with an opening 1.95m long and 1.82m supported by a modern chamfered timber bressumer. The internal depth of the fireplace was 1.2m (see photos 6 & 7).

Photo 5: Brick infill and doorway, north wall room 2

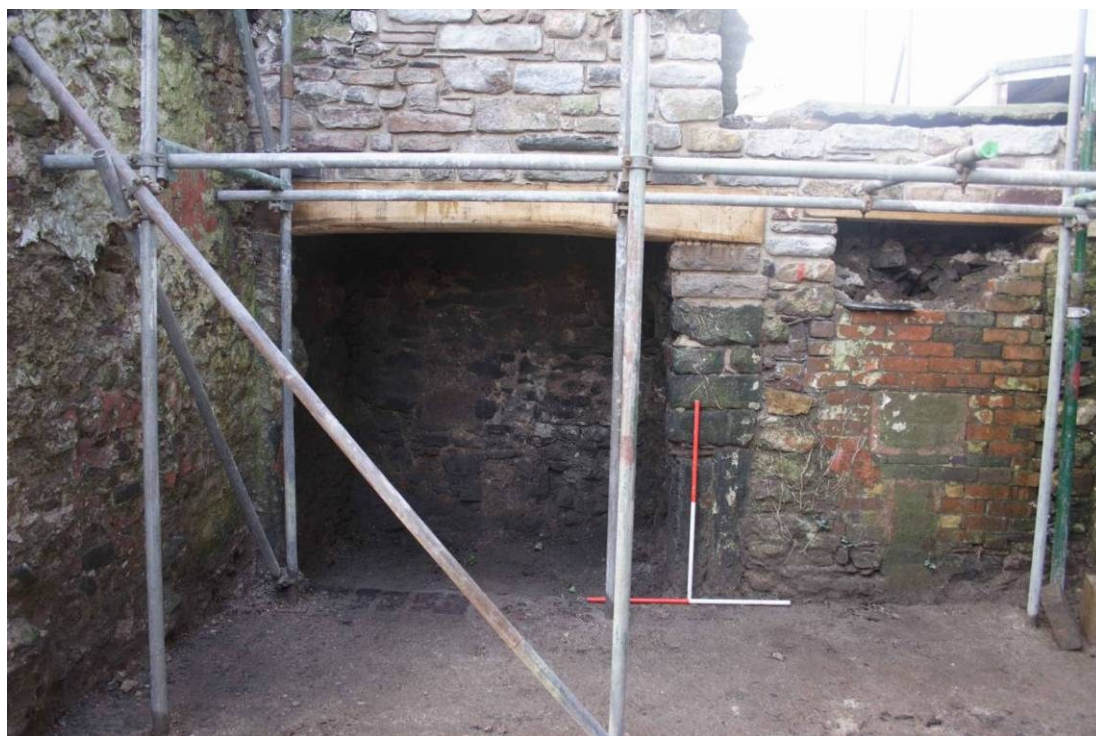
Photo 6: Fireplace Room 2, later oven to right

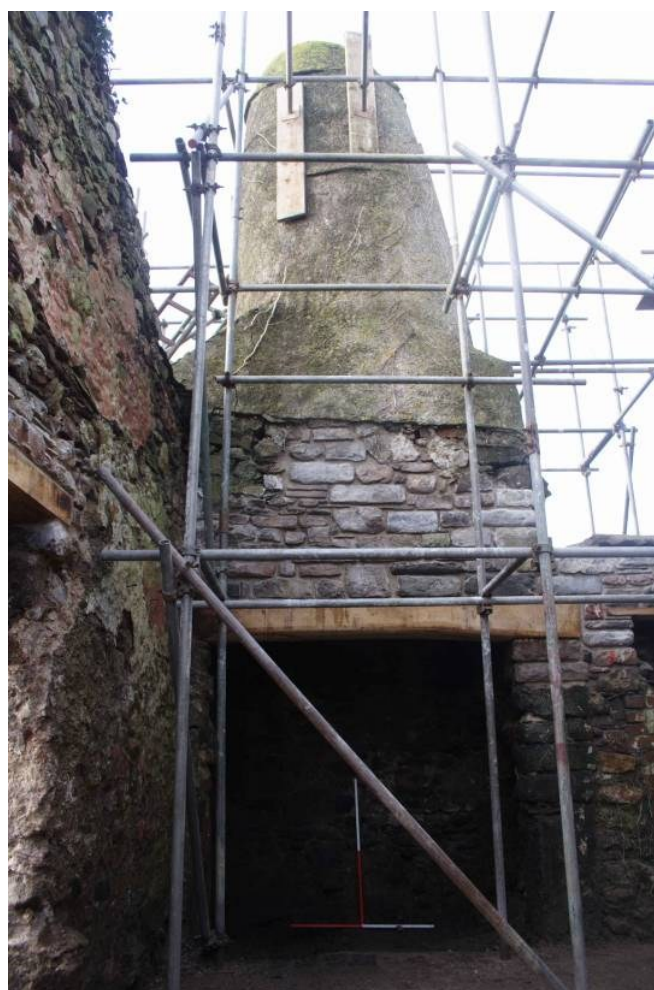
4.2.5 A large circular chimney with tapering smoke chamber and rectangular flue above, sat above the fireplace. A large stone set at an angle of c.45° was set on the west side at the mouth of the chimney flue. This stone may have acted as a basic chimney cap used to control downdrafts. Such chimneys are considered to date from the 16th century, when enclosed fireplaces became more widely used. In Pembrokeshire, however, it has been suggested that this style of chimney may pre-date this period, perhaps copying the chimneys of the greater houses and castles (Smith 1988, 20).

Photo 7: Fireplace with chimney, Room 2

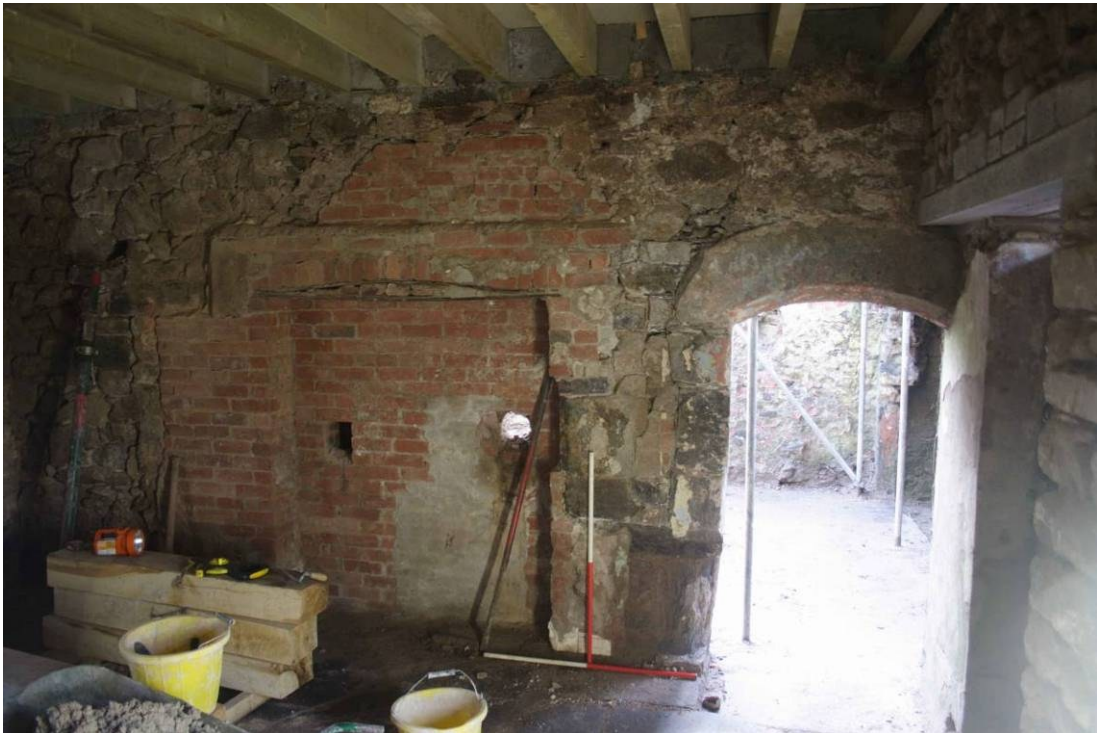
4.2.7 In the southwest corner of the room the connecting door between Room 3 and Room 2 consisted of a substantial chamfered pointed dressed stone door head, with dressed stone jamb on the east side (photo 8). The door jamb on the west side of the doorway was obscured by concrete render. Stylistically the doorway is considered to date from the 16th century and is comparable with an example located at the Tudor Merchants House in Tenby. The example at Philbeach farmhouse would have formed a principal doorway³ which suggests that the south wall of Room 3 probably dates from this period.

Photo 8: Late medieval doorway and later range, Room 3

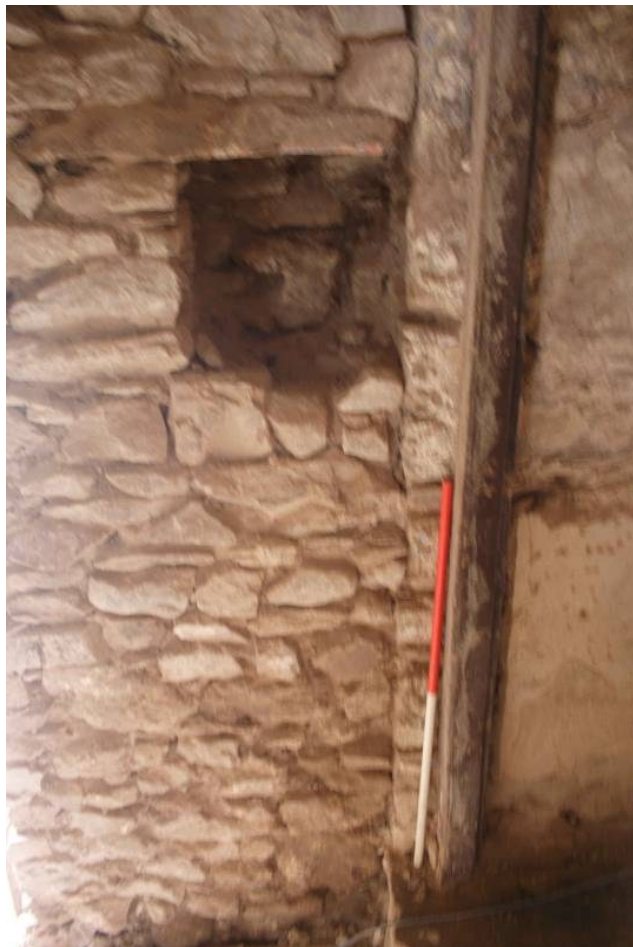
4.2.10 In the northwest corner of Room 3 a straight joint visible in the masonry suggests that the rooms beyond were a later addition (photo 9). Two doors (photo 10) pierced the west wall. The southernmost doorway had a red brickwork arch and contained a simple boarded wooden door with a 19th – 20th century lock, suggesting this door was probably inserted during the 19th – 20th centuries. The remaining slightly smaller doorway retained its timber doorframe, but no architectural detailing was discernable. The floor of Room 3 consisted of slate slabs.

Photo 9: Straight joint in masonry with recess, Room 3

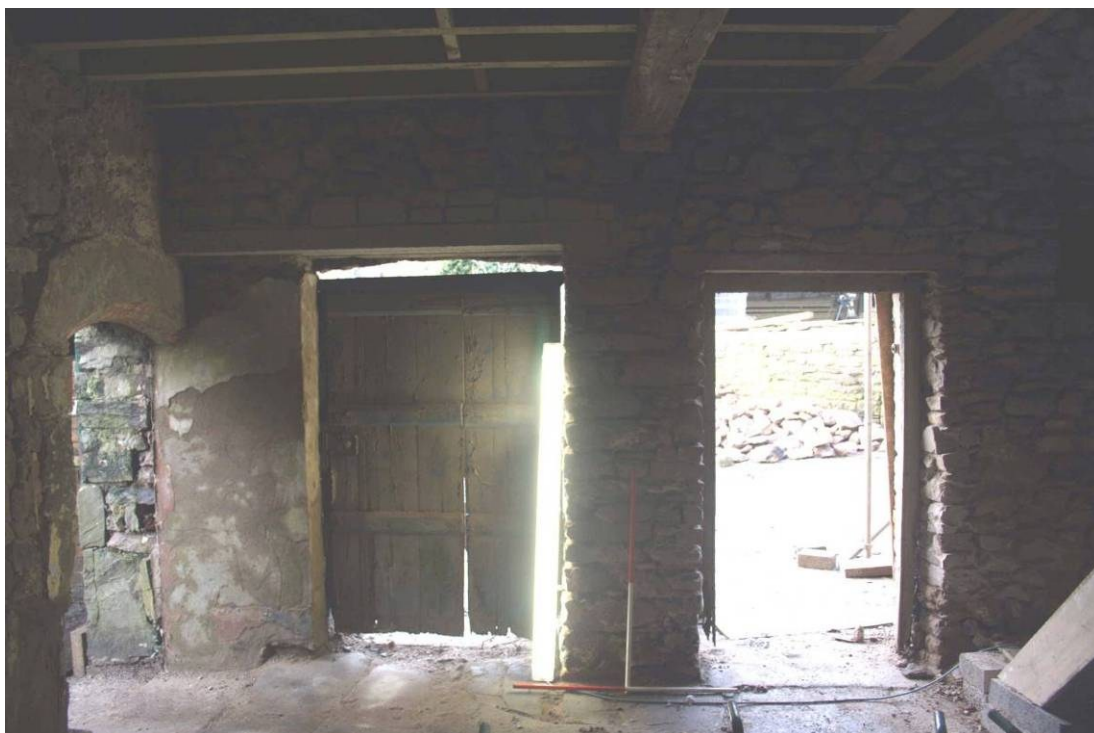
Photo 10: Doorways in west wall, Room 3

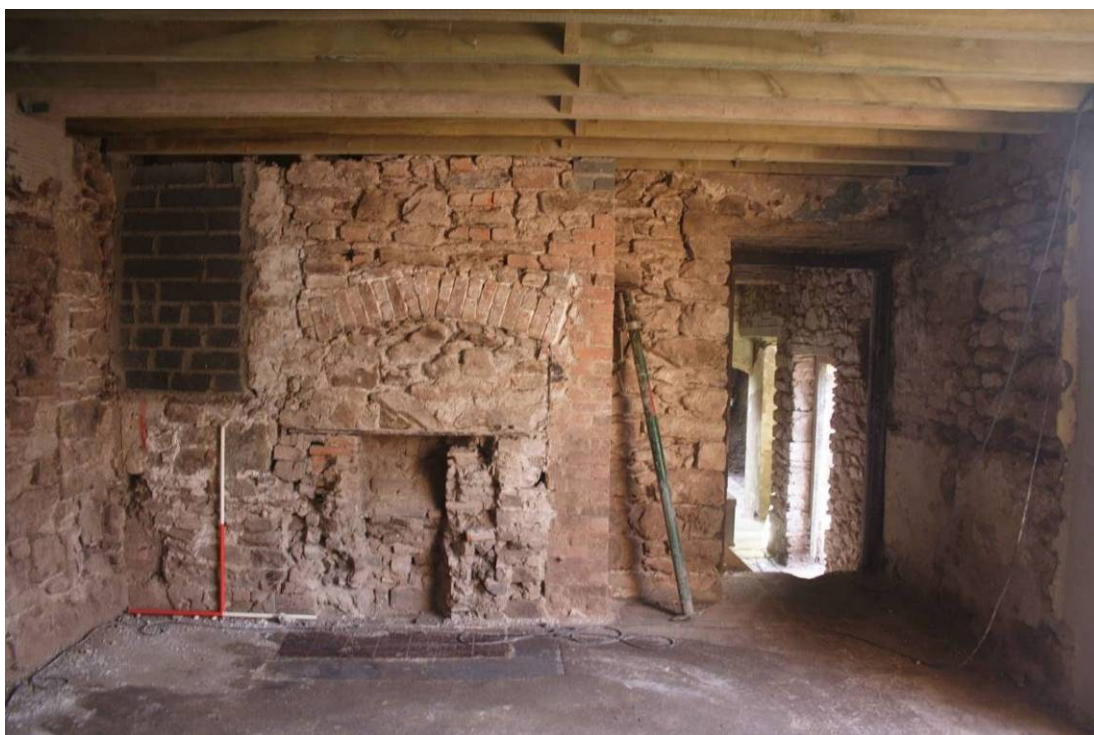
4.2.11 A heavily modified fireplace occupied much of the south wall of Room 4. The original fireplace appeared to have been a larger structure that was subsequently reduced in size with a brick arch and rubble and red brick infill, with a partially tiled slate hearth beneath. Immediately to the west of the fireplace set at height of c.1m above the present floor level was a former window that had been blocked recently with concrete blockwork (photo 11).

Photo 11: Fireplace, doorway and blocked opening, south wall Room 4

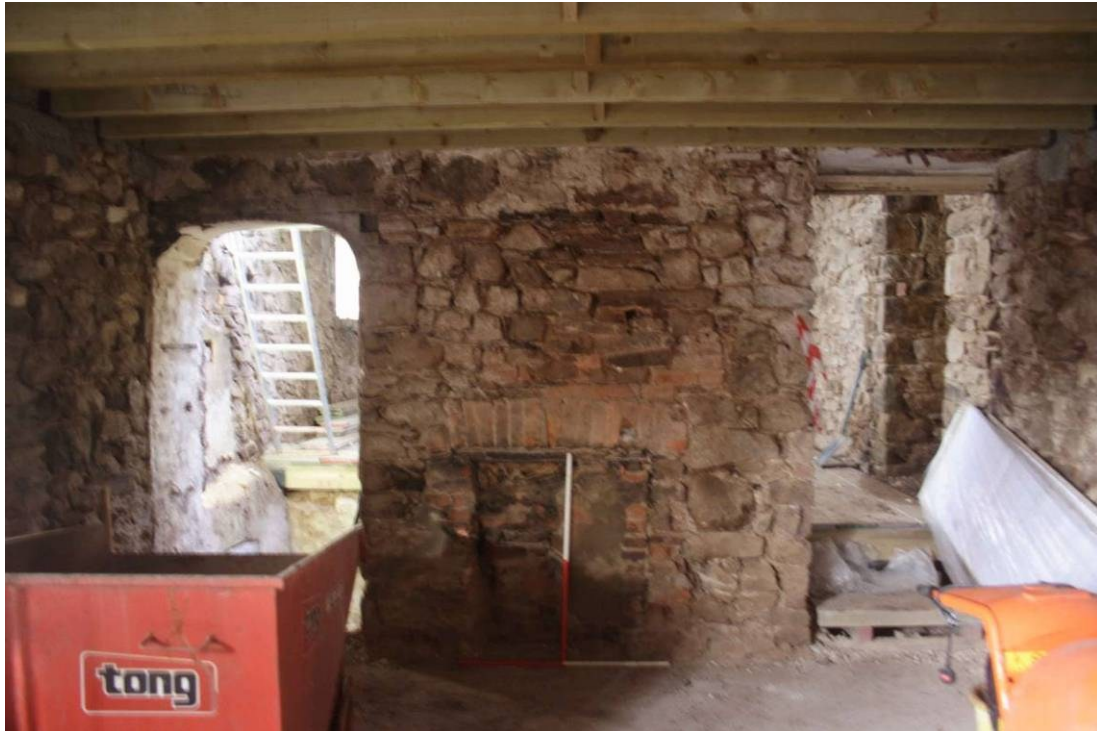
below. The fireplace appears to have been reduced in size by almost half from the original by the insertion of red brick infill (photo 12).

Photo 12: Doorways and central fireplace, north wall Room 4

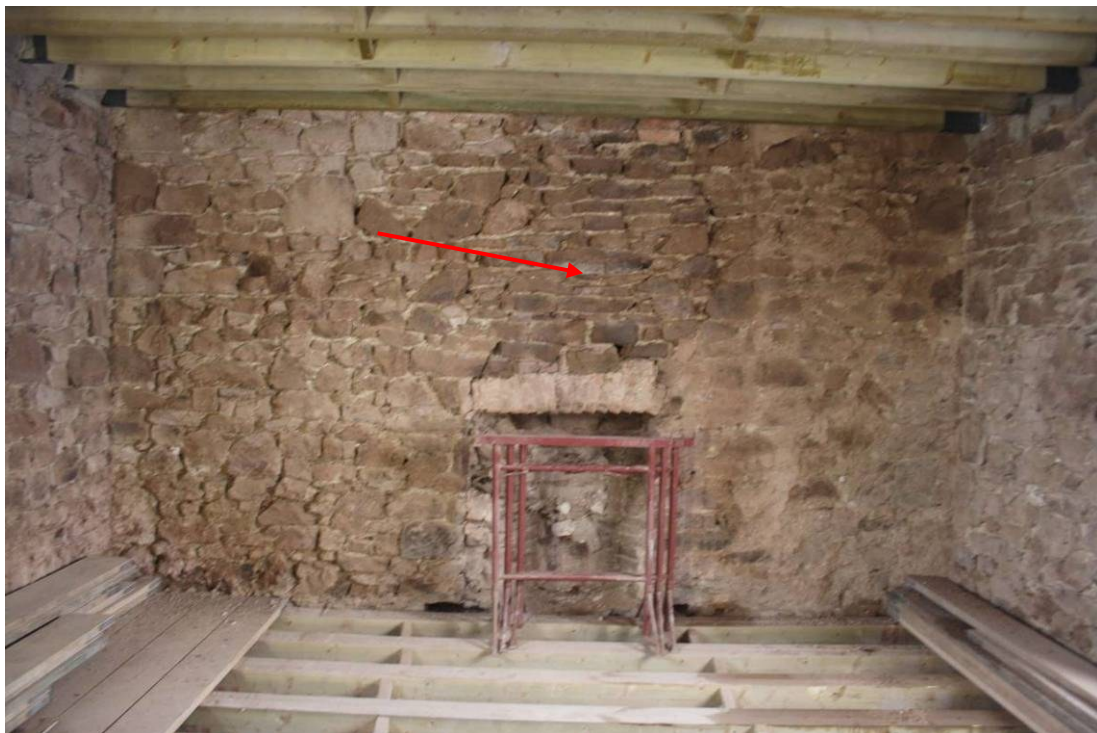
4.2.14 Room 5 was only partially accessible, due to the majority of the floor being missing. A doorway blocked with ply wood sheeting was present in the east wall that exited outside. Adjacent, on the north side of the doorway was a splayed window that internally extended down to floor level. A modern concrete lintel and block-work had been inserted above the window. The north wall contained a single centrally placed fireplace with a single course of red brick inserted above. Above the red brick-work an area of disturbance in the wall fabric may represent relining of the chimney flue or subsidence due to the failure of the original lintel that was subsequently replaced with the red brick (photo 13).

Photo 13: Fireplace, chimney reworking highlighted by arrow, north wall Room 5

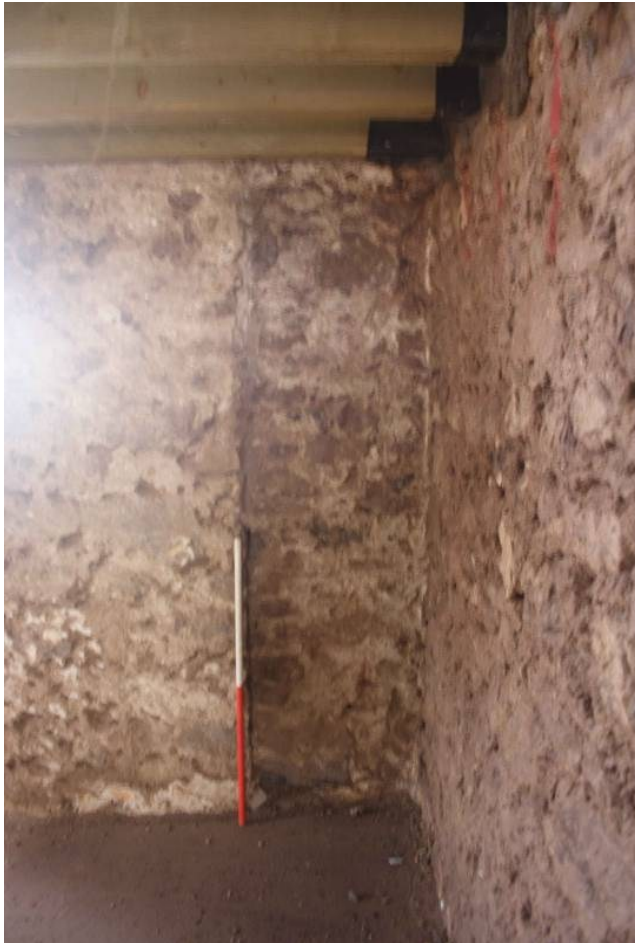
4.2.17 The eastern wall of the room was much disturbed with lead piping protruding from the wall suggesting the presence of a former sink. Above this was a centrally placed rectangular splayed window. In the southeast corner of the wall a slight recess that appeared to extend up into Room 13 was present (photo 14).

Photo 14: Recess in east wall Room 7

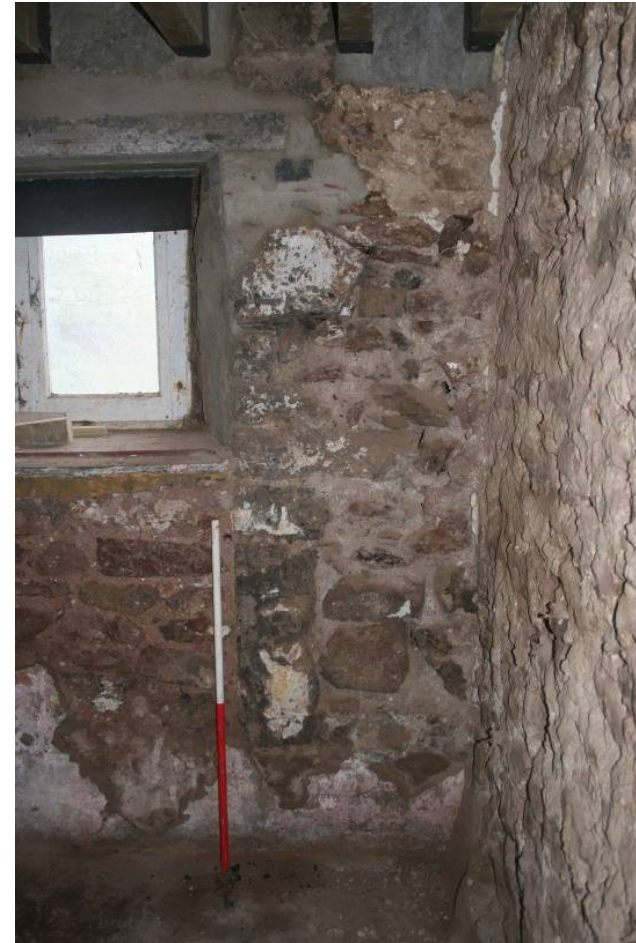
Photo 15: Possible straight joint in north wall, Room 7

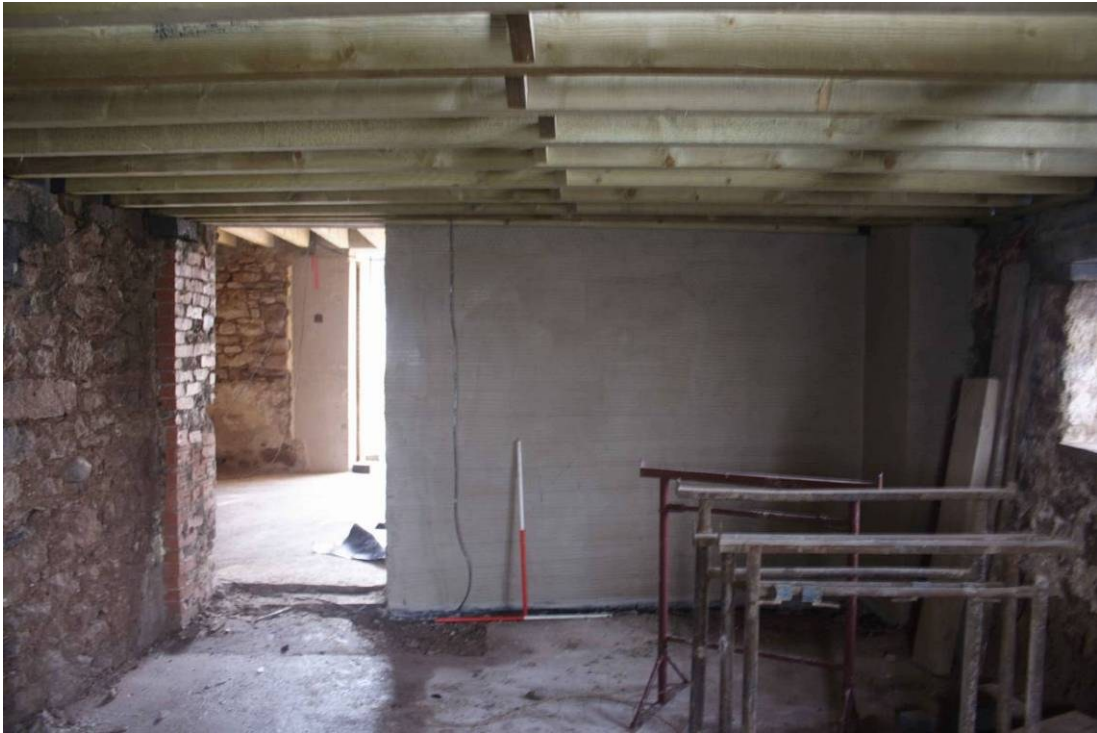
4.2.18 Two splayed rectangular windows pierced the north wall of Room 7, both of which appeared to have been reduced in size as evidenced by joints in the masonry. A possible straight joint was identified in the northeast corner of the wall, further evidence of which was visible above in Room 13 (photo 15). The west wall of Room 7 was obscured by recently applied lime render (photo 16).

Photo 16: Recently rendered west wall, Room 7

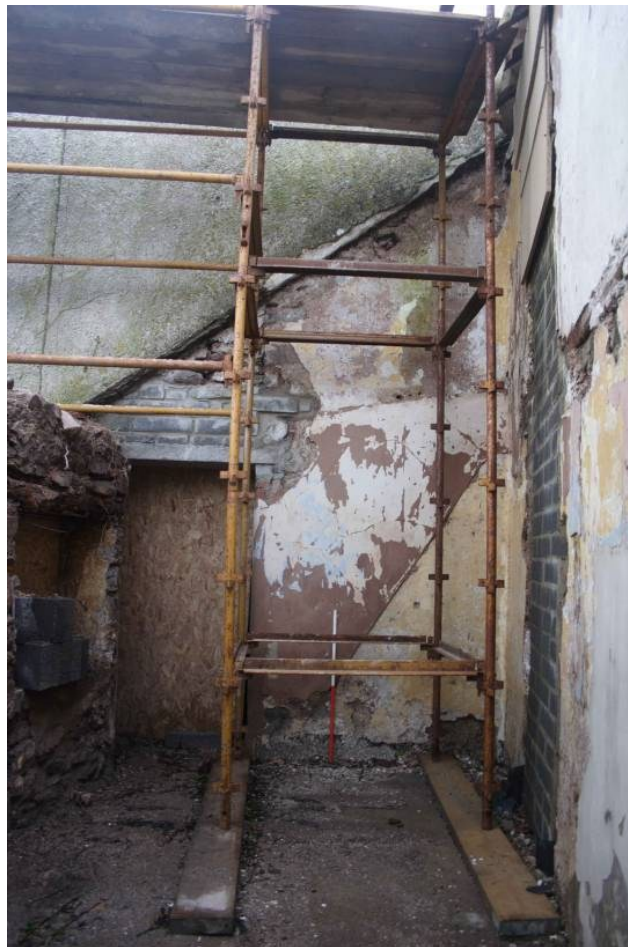
Photo 17: West wall Room 8 showing former position of staircase

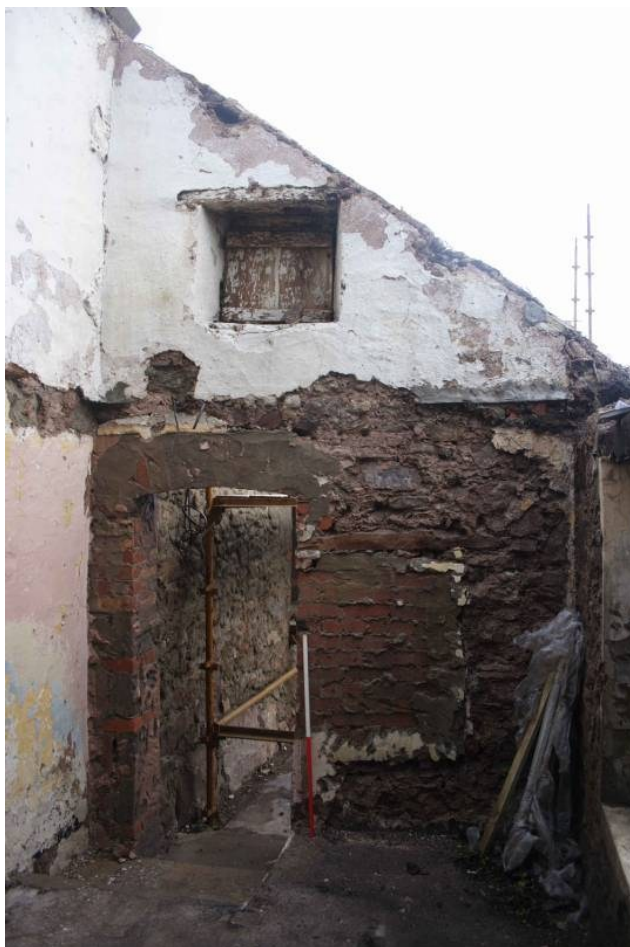
4.2.21 A single arched doorway of redbrick construction pierced the east wall of Room 8 and provided access to Room 9. Further red brick-work visible on the south side of the doorway may represent a blocked former opening. Scarring for a former floor level was also visible on the east wall of the room, as was a centrally placed small square opening retaining its original timber shutter set at roof height (photo 18).

Photo 18: East wall, Room 8

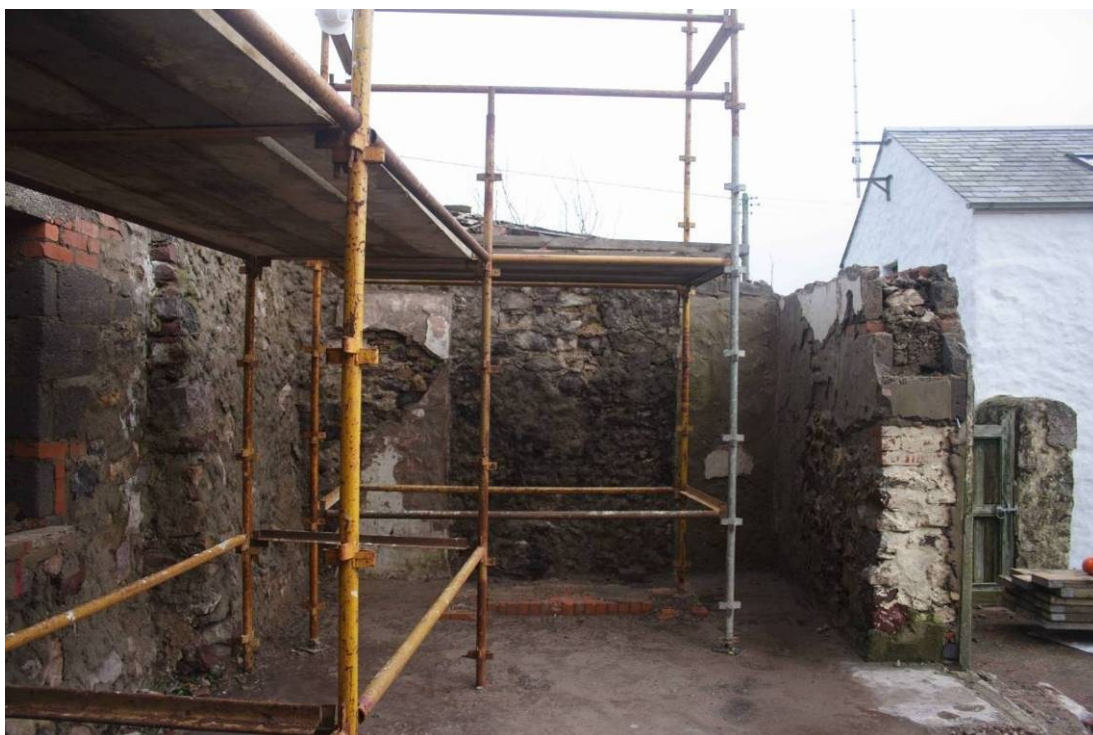
Photo 19: Room 9 looking towards site of range

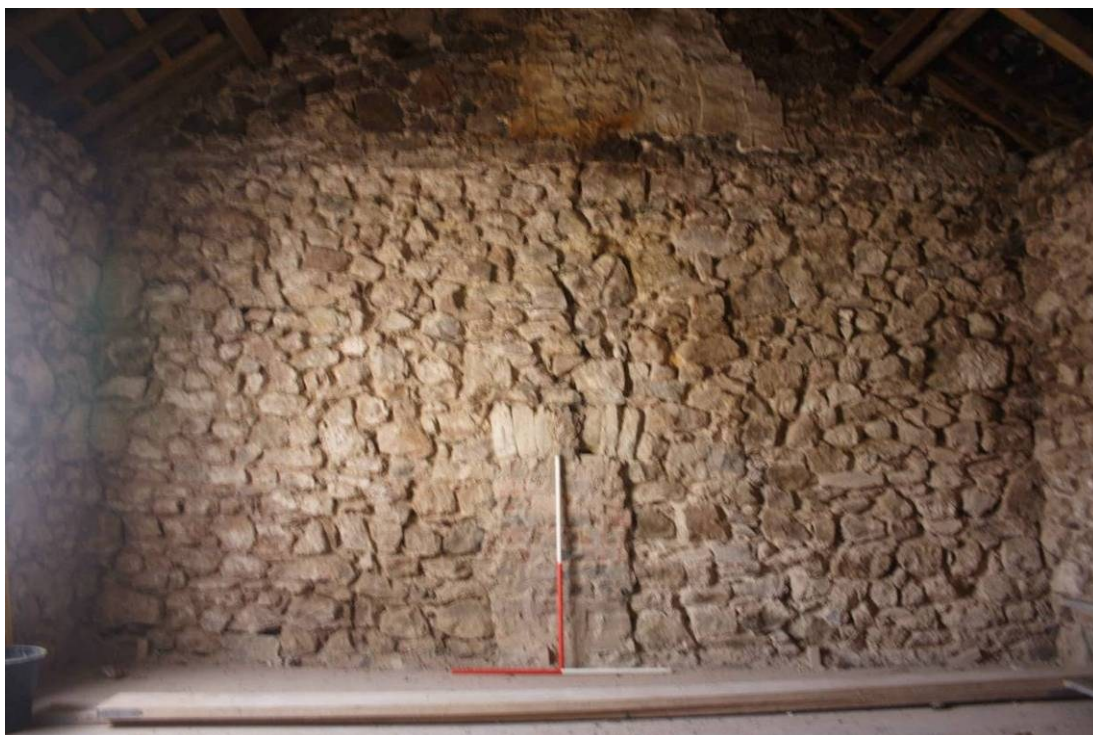
4.3.1 A centrally placed partially blocked fireplace with stone bressumer occupied the south wall of Room 10 (photo 20). The north wall contained stone in-filling which may suggest the presence of a chimney.

Photo 20: Fireplace north wall Room 10

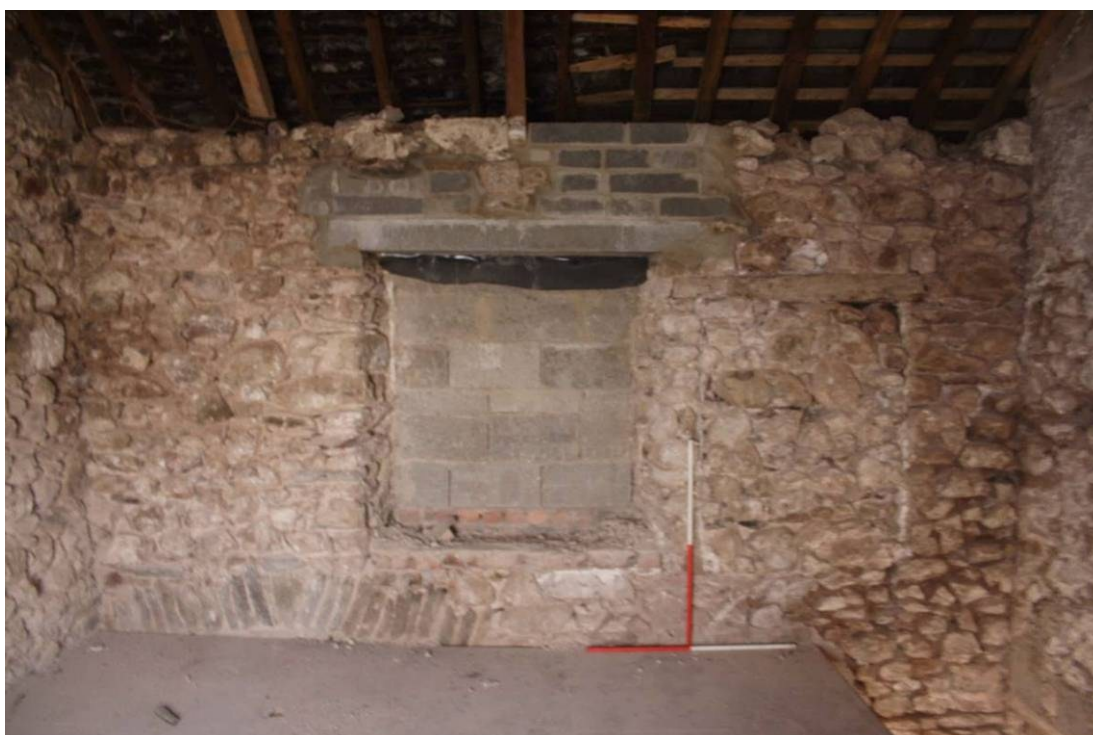
Photo 21: East wall Room 10 showing blocked windows and relieving arch

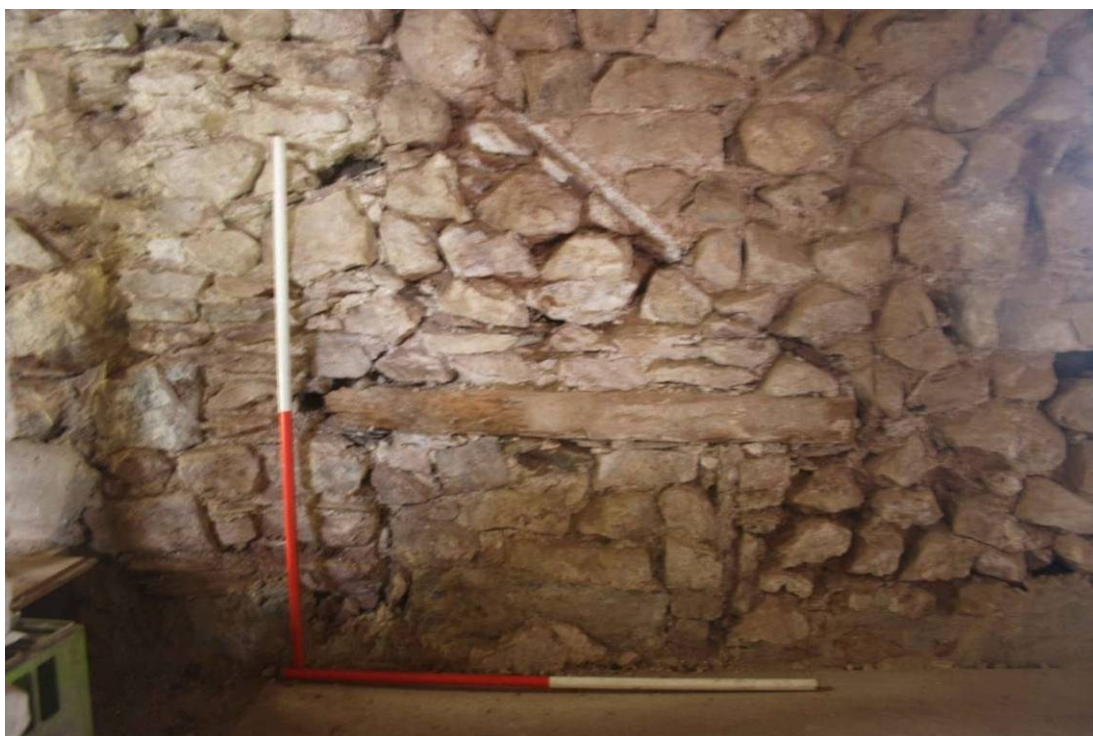
the fabric of the west wall of Room 10 suggesting that the gable end of an earlier structure has been incorporated into the present farmhouse (photo 22).

Photo 22: Detail of blocked window and former roof line, west wall Room 10

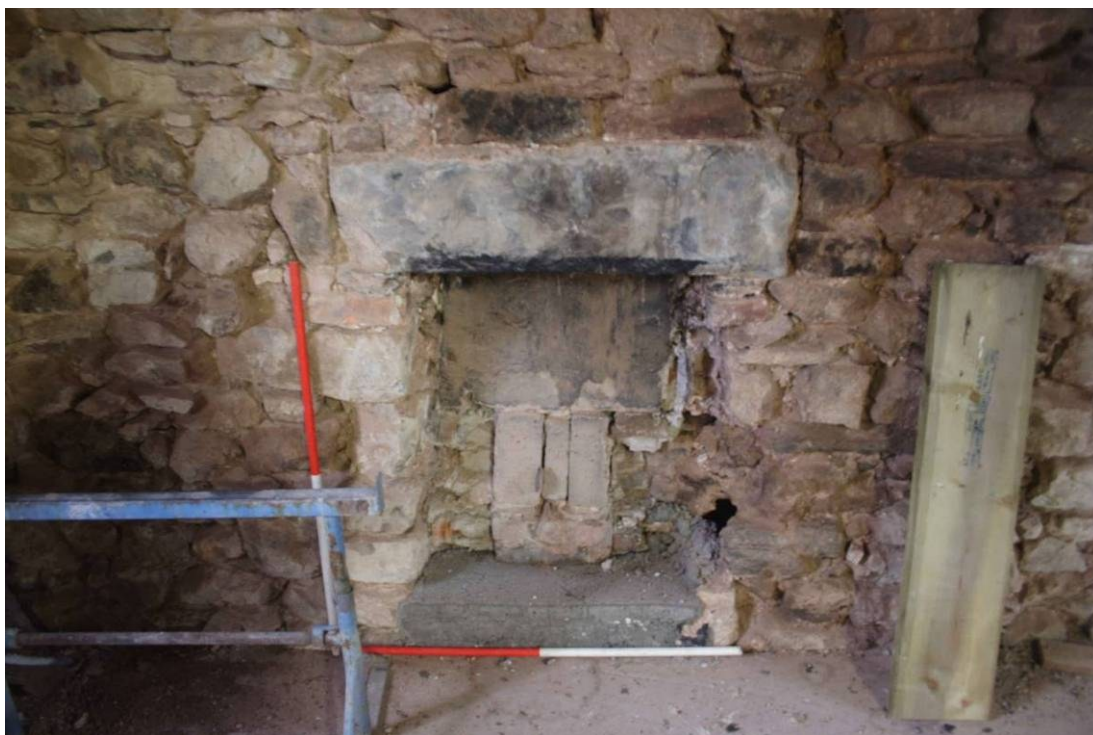
4.3.4 The north wall of Room 11 had a doorway at its eastern end that provided access to Room 12. A centrally placed fireplace with stone bressumer over and stone hearth, also occupied the north wall (photo 23). The presence of brick infill at the rear of the fireplace suggests modification or repairs of probable 19th century date.

Photo 23: Fireplace, north wall, Room 11

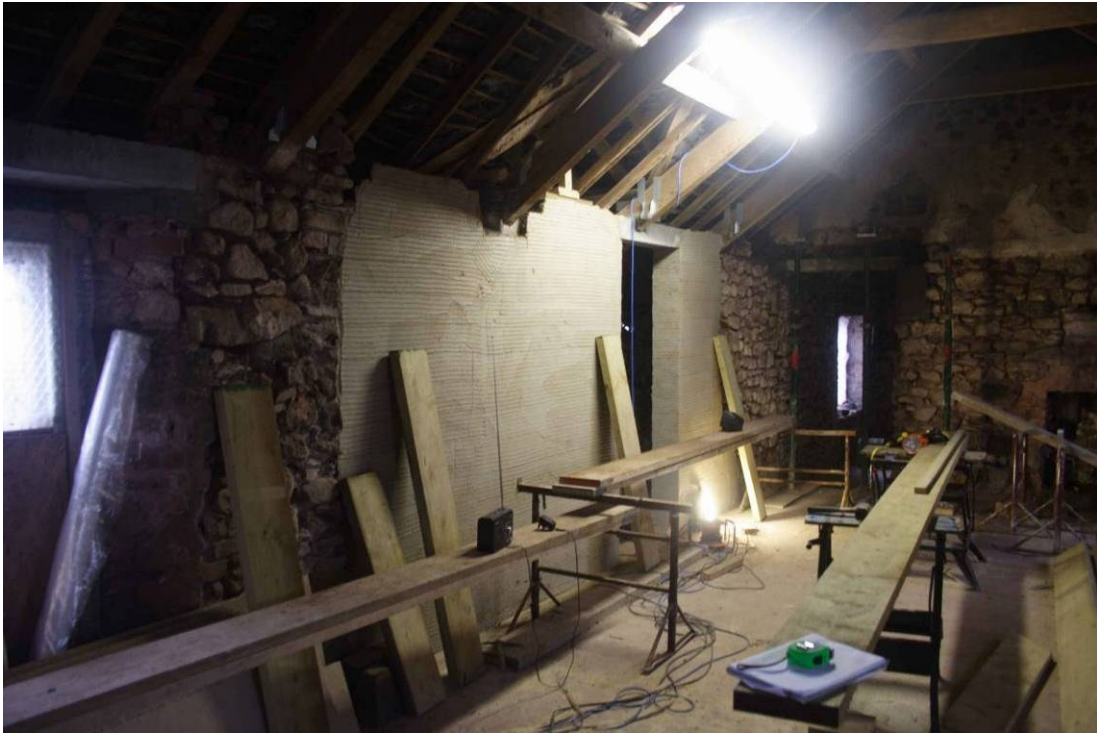
4.3.6 Approximately 50% of the length of the east wall of Room 11 had been recently lime rendered obscuring any architectural features, but the doorway leading into Room 13 remained (photo 24). At the northern end of the wall a single splayed window opening containing a four paned sash window of probable 19th century date was present. The edges of the window consisted of red brick suggesting reworking of the opening. The west wall of the room contained two further windows both containing 19th century sash frames and brick edging comparable to that found in the east wall. A blocked window retaining traces of plaster and a timber lintel was present between the two windows in the west wall of the room (photo 25).

Photo 24: Lime rendered east wall, Room 11

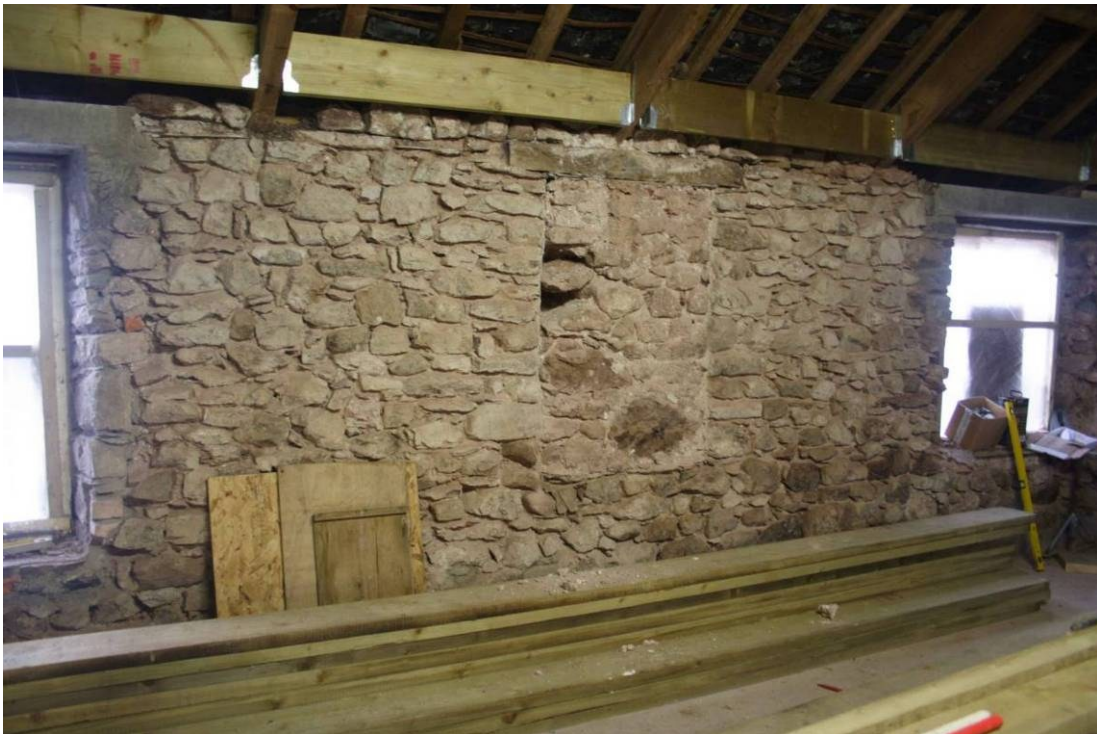
Photo 25: Blocked window, west wall, Room 11
