PHILBEACH FARMHOUSE, DALE, PEMBROKESHIRE: BUILDING RECORDING AND ARCHAEOLOGICAL WATCHING BRIEF

RHIF YR ADRODDIAD / REPORT NO. 2011/28
RHIF Y PROSIECT / PROJECT RECORD NO. 94527

**PHILBEACH FARMHOUSE, DALE, PEMBROKESHIRE:
BUILDING RECORDING AND ARCHAEOLOGICAL
WATCHING BRIEF**

Simon Ratty

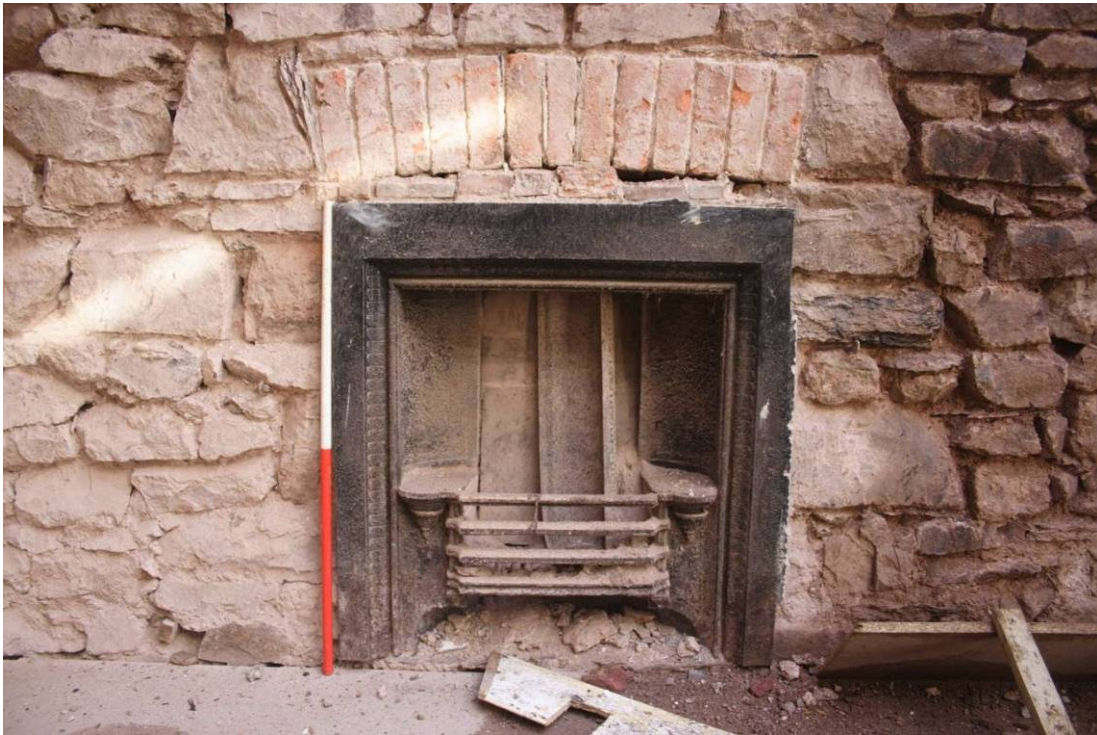
4.3.7 The current floor level of Room 12 was c.1m above that found in the adjacent Room 11. The north wall of the room contained a centrally placed fireplace arched over in red brick with cast iron decorated fireplace of probable 19th century date (photo 26).

Photo 26: 19th century cast iron fireplace, north wall Room 12

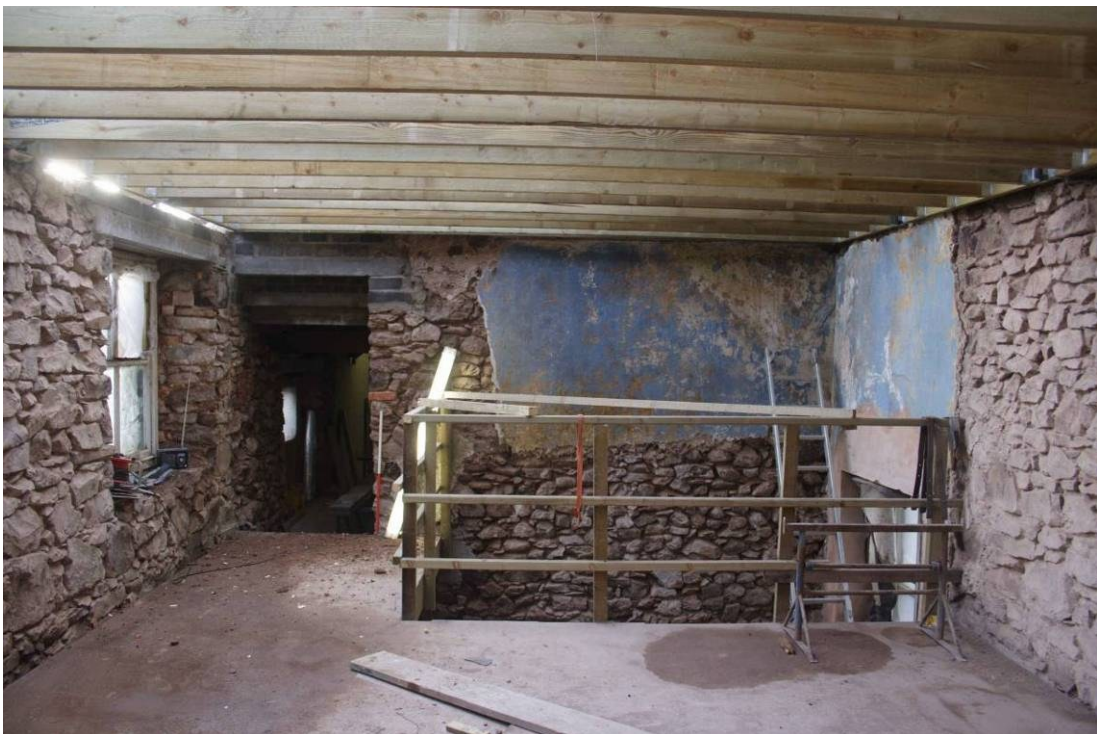
Photo 27: Room 12 facing south showing position of former staircase

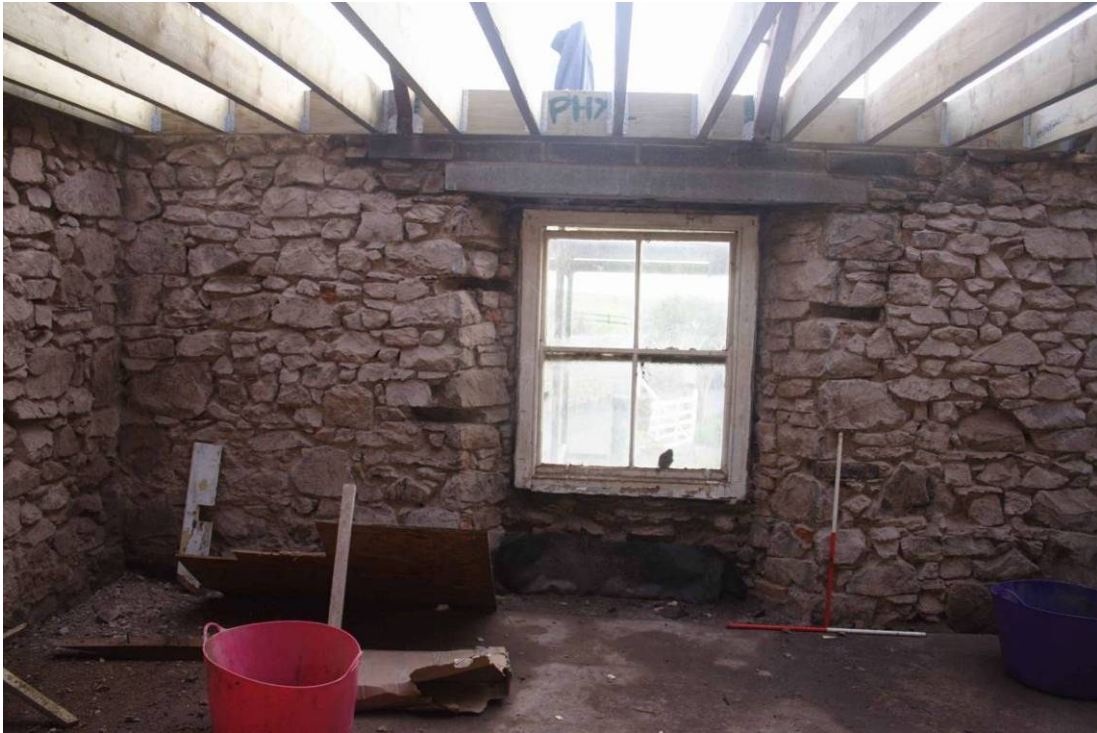
4.3.9 The east wall contained two splayed window openings with replacement concrete lintels above. Both openings contained four-pane sash windows which appear to be of 19th century date (photo 28).

Photo 28: Four paned sash window, east wall Room 11

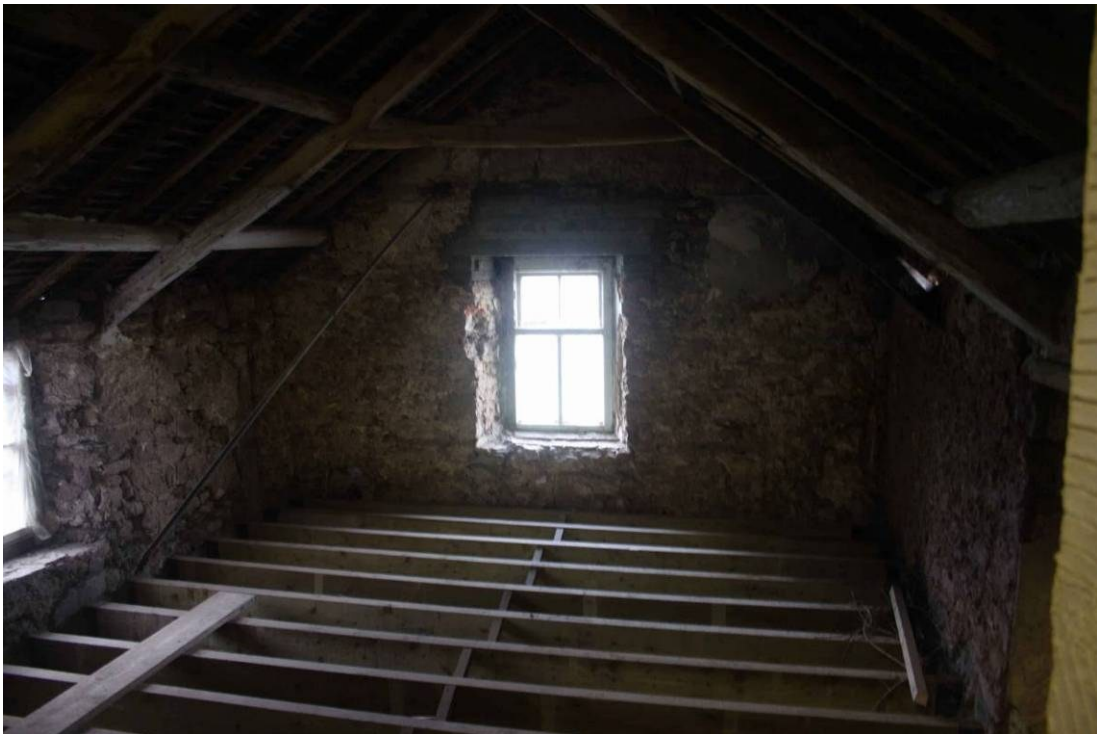
Photo 29: Four paned sash window, east wall Room 13

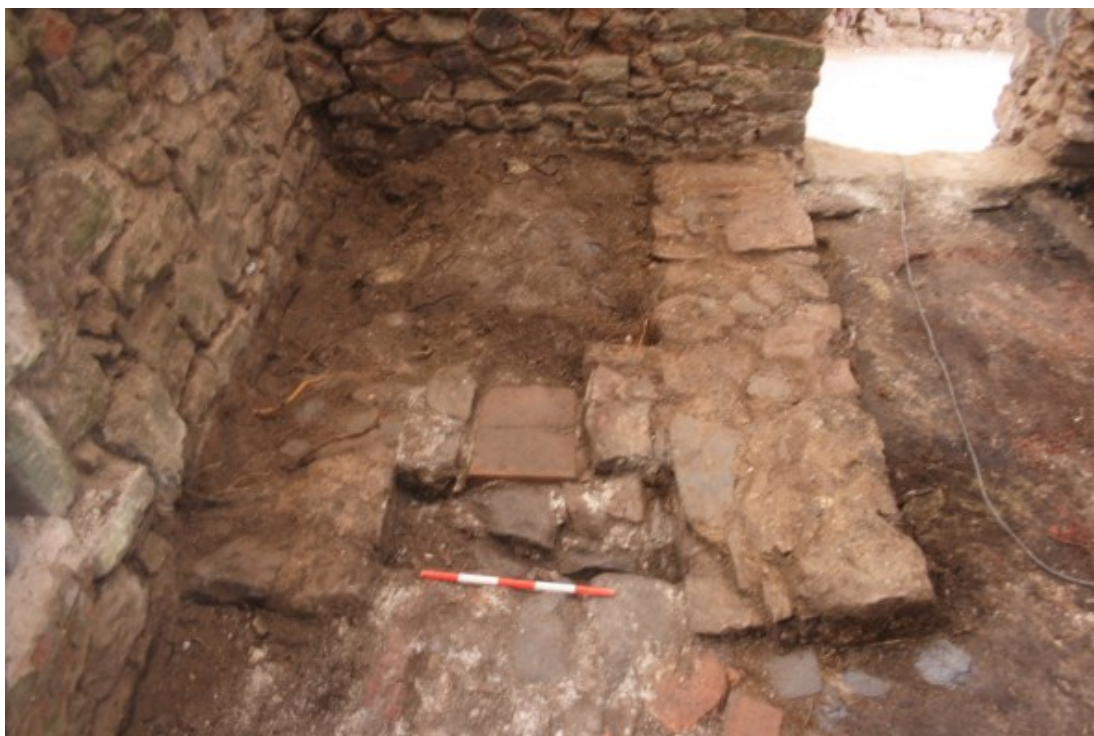
Photo 30: Corn drier in south east corner of Room 2

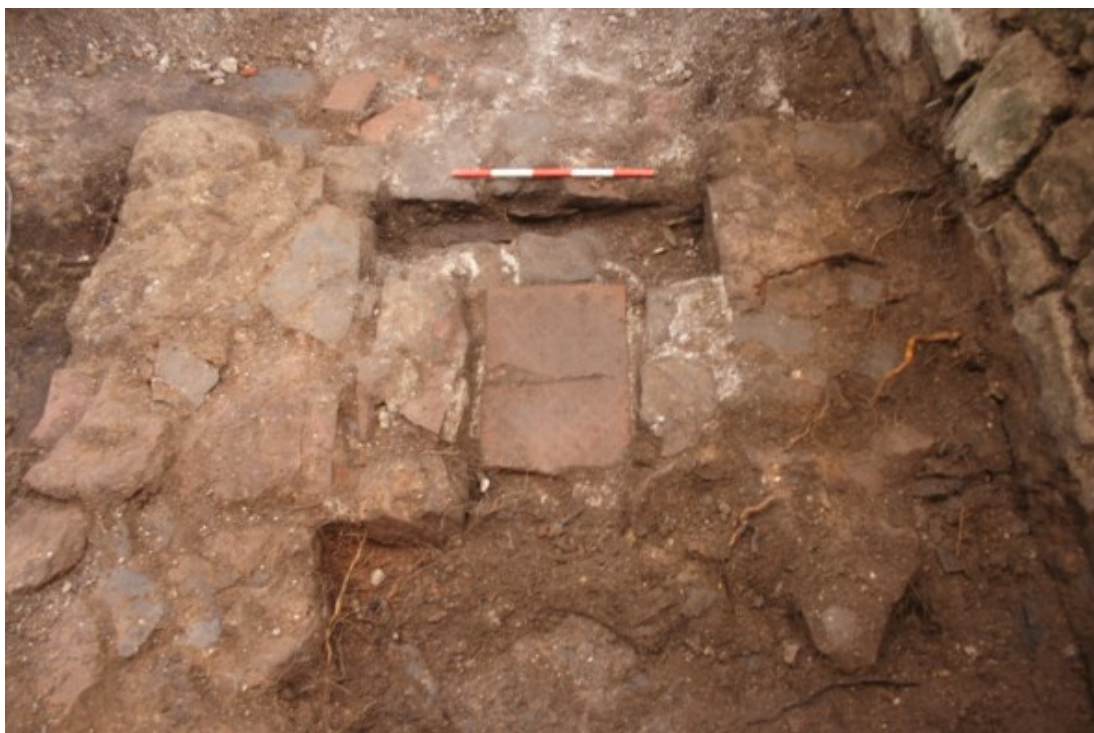
Photo 31: Detail of corn drier, Room 2
