# A Survey of Garn Fawr Hillfort, Pembrokeshire

Prepared by Dyfed Archaeological Trust  
For: The National Trust and  
Pembrokeshire Coast National Park  
Authority

RHIF YR ADRODDIAD / REPORT NO. 2009/34  
RHIF Y PROSIECT / PROJECT RECORD NO. 94874

June 2009

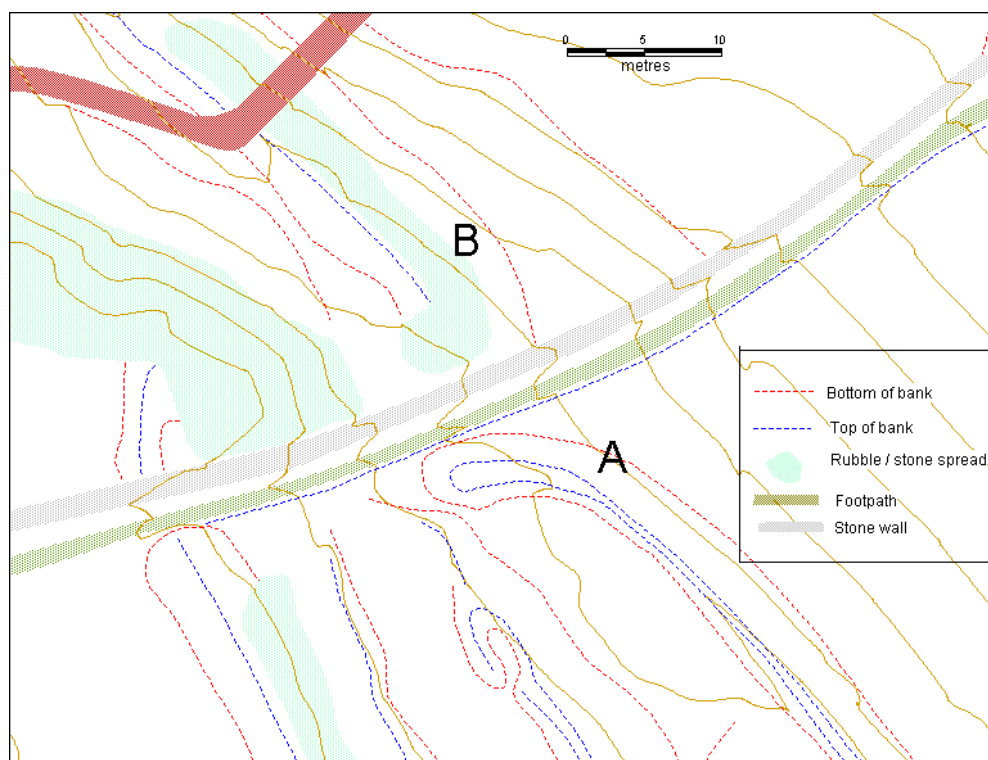
Figure 4: extract from the survey showing the shapes of ramparts A and B, probably parts of the original entrance into the hillfort.

This survey generally agrees with Hogg in considering the east side to be the original entranceway, as illustrated in figure 4, below. Although the modern pathway has indeed caused damage to the ramparts, the shape of rampart A, in particular, suggests an original entrance. Where most of the ramparts have clearly been truncated by the path and the stone field walls, rampart A appears to still have an original form, curving inwards (westwards) and being matched in shape on the opposite side of the path by the remains of a stone (or stone-faced?) rampart (labeled B, see figure 4). This impression is strengthened if Edward Lhuyd's sketch is also considered (see figure 5), which appears to show a clear entrance on the east side.

However, immediately to the west, the path breaks through a rampart formed largely by a stone spread, (visible on fig 4, above) and here the path and the wall clearly truncate the rubble spread. It is not clear exactly what the relationship is between the path / wall and the earth bank at this point, but it is worth noting that the stone spread appears to overlie, and therefore post-date, the earth bank. This may indicate that the substantial stone defences at this site are, in fact, a re-modeling of earlier earth banks.

The vehicle track, which can just be seen at the top of Fig. 4 is, presumably, later in date than 1973 as Hogg's detailed descriptions make no mention of it. The way in which this modern track breaks through the earthworks provides a useful comparison for other areas where paths and tracks cross the earthworks, note in Fig. 3 the "clean" nature of the track's passage through the northern parts of the earthworks, the banks are clearly and squarely truncated. This is in contrast to the pathway which runs between ramparts A and B, further giving the impression that this pathway in fact utilized an original entrance.

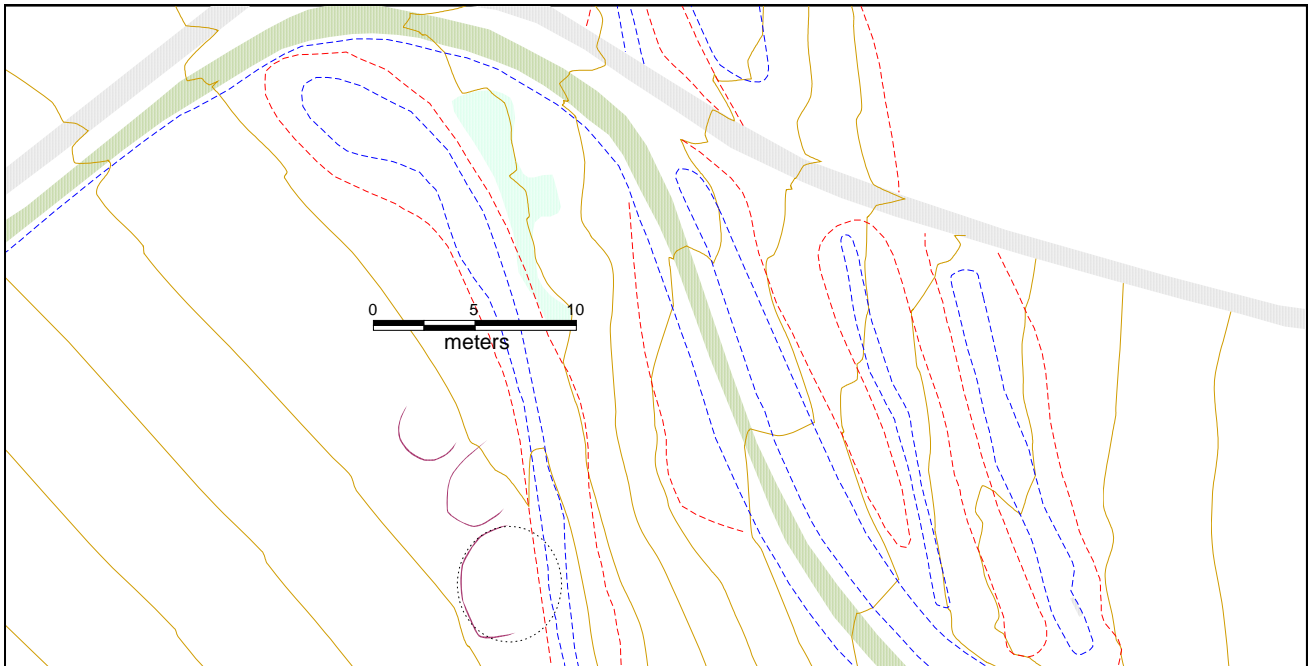
Figure 6: extract from survey section A showing three partial hut-circles which survive close to the eastern ramparts. The lowest of the three has been “completed”, using a broken line to complete the circle and show how the hut circle may underlie the earth bank.

Of particular note in section A are three probable hut circles lying tucked against one of the eastern ramparts. These were the only hut circles which this survey identified outside the main interior of the fort. They are similar in dimensions to the other hut circles, but their positioning is interesting. Although unclear on the ground, the survey suggests that if the largest of them (now an incomplete survival) were to be completed in a roughly circular form it would, in fact, lie underneath the earth bank of the outer defences (see figure 6). It is possible, therefore, that these hut circles represent an earlier phase of use, abandoned as the defences were remodelled.

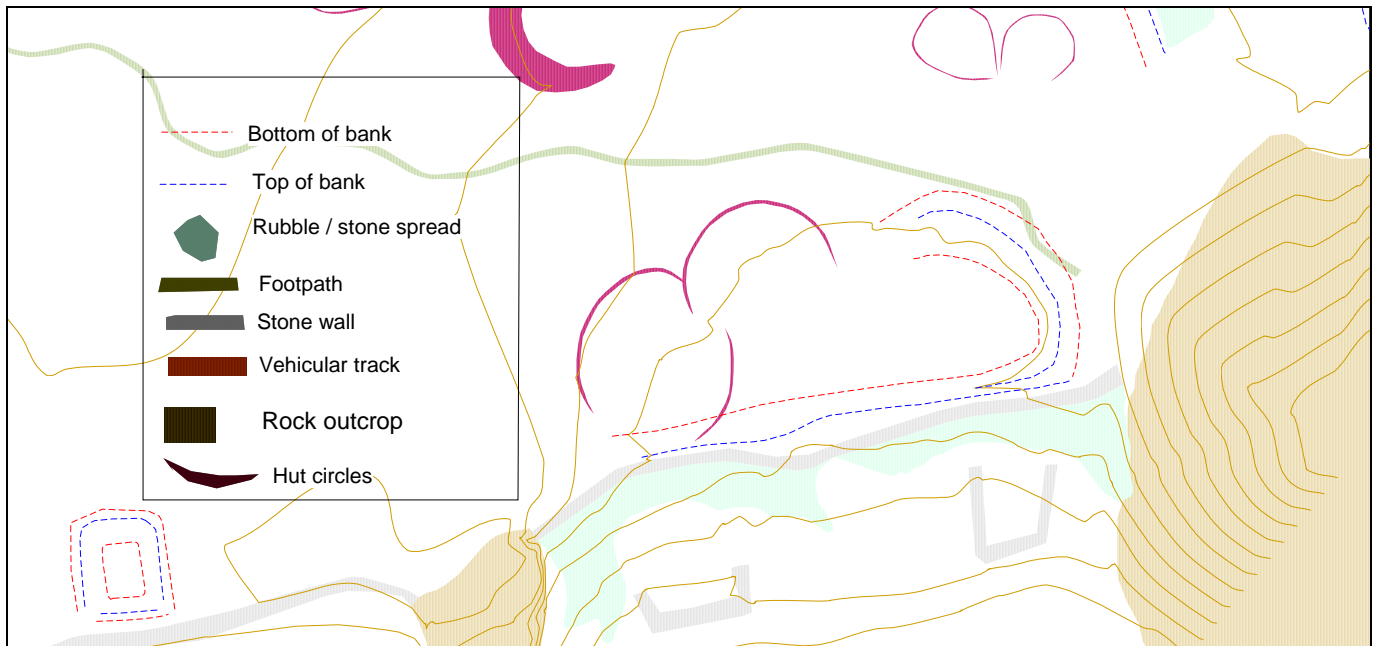
Figure 8: showing 'cabans' on south side of the interior of the fort

It can be seen in Fig. 8 that the rubble spread is probably part of the original ramparts of the fort, running between two natural rock outcrops. At a later date, a stone wall has been constructed along the top of the rampart, using the stones from this rampart. Similarities in construction and states of preservation between the 'cabans' to the south of the wall, and the wall itself, suggest that the two may be roughly contemporary. The stones for the construction of the shelters are also likely to have come from the ramparts. The stone wall then continues to the west, linking up two further rock outcrops (see section B of the survey drawings) and running along the line of what may have been original defences, now showing as a bank and ditch exaggerating a natural scarp.

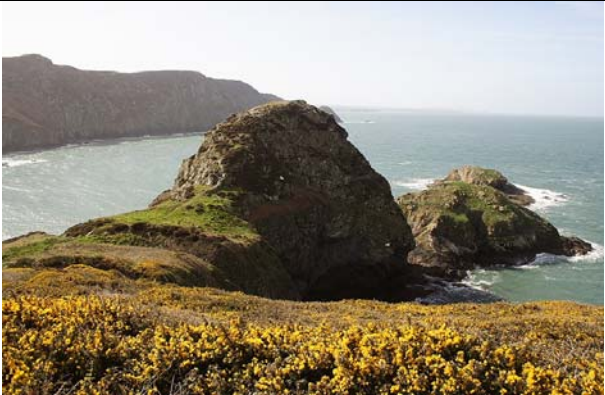
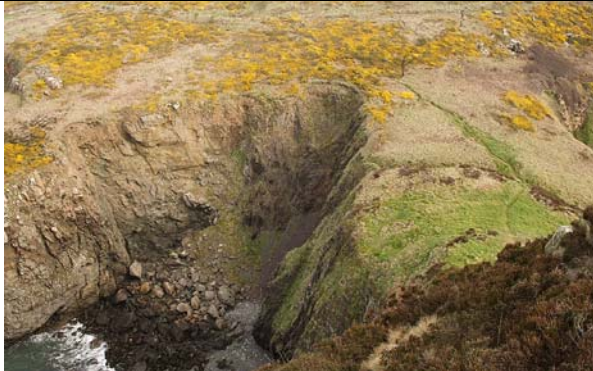
</div> <div style="display: flex; justify-content: space-around; margin-top: 5px;"> <p><i>View SSE of the promontory</i></p> <p><i>View NE of the eroding coastal cliffs and damage it is causing to the inner defences</i></p> </div>				
<p><b>Description</b></p> <p>DINAS MAWR</p> <p>An Iron Age hillfort occupying a rocky promontory on the coastline in front of the larger Garn Fawr hillfort. A narrow neck of land is defended by two banks with external ditches. The outer defences currently consist of a low bank on sloping ground, c.0.6m high, c.4m wide and running for c.11m but fading to the east. The outer ditch is c.0.6m deep, greater on its northern side due to the sloping hillside and c.2m wide. A footpath goes through a gap c.2m wide just west of centre.</p> <p>Another 17m to the south lie the more prominent inner defences, consisting of a bank c.5m wide and c.1.5m high (4m high from the base of the ditch). This runs for c.18m up to the footpath, beyond which (to the east) it soon becomes very indistinct. The bank is fronted by an impressive ditch c.7.8m wide, 2m deep, running for c.50m but getting shallower to the east and infilled centrally for the footpath, which itself may follow the route of the original entranceway.</p> <p>According to the RCAHMW (Driver 2007) these banks were originally stone revetted with slabs lining the entranceway through the inner bank.</p> <p>Internally there is relatively level area c.20-25m north-south by c.29m east-west, within which lies one possible hut circle (Driver 2007) before the promontory rises dramatically onto a rocky pinnacle. A ledge up to 3m wide runs around the eastern side of the pinnacle, the western side is inaccessible. The summit of the pinnacle is accessible from the northeast and presents a rocky but roughly level area c.23m by 33m.</p>

Due to the small area defended and the dramatic appearance of the pinnacle it has been suggested that the fort may have a ritual or ceremonial use (Driver 2007), however it is clear that large sections of this fort have also been lost to the sea.
<b>Condition</b>
The footpath is causing some minor erosion to the outer defences and some burrowing is visible but does not appear extensive. The inner defences and interior of the fort are grass covered and stable. The major threat to this site is the natural eroding sea cliffs. A large proportion of the outer defences and lower ground around the main pinnacle is likely to already have been lost to the sea and this process is continuing. The site itself is a Scheduled Ancient Monument (PE075).
<b>Management Recommendations</b>
The footpath is currently causing little erosion but this should be monitored, especially in the busier summer months to ensure damage is not occurring to the defences. The natural cliff-erosion should also be monitored, if the current condition of the defences and interior of the fort become threatened then a more detailed archaeological survey of the site may be beneficial to record features in detail prior to future erosion.

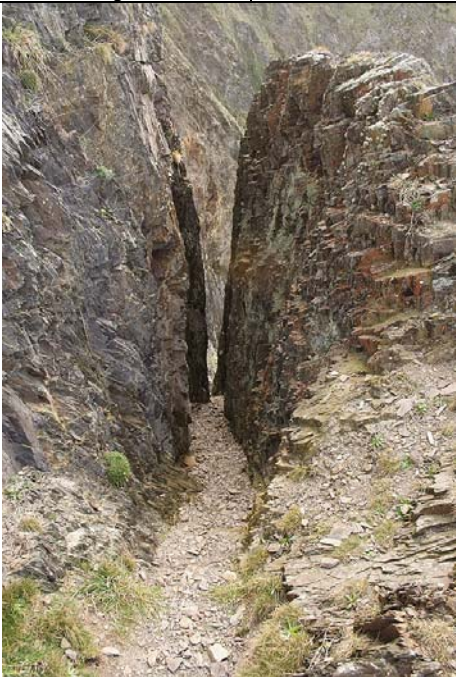
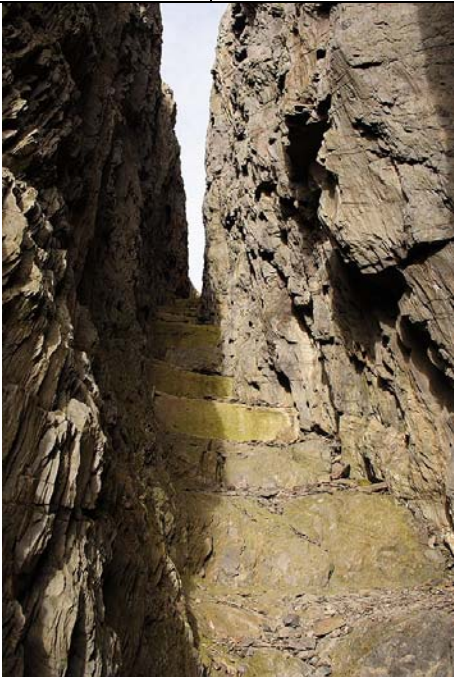
<p><i>Left; View southeast looking down the stairs and track cut through the rock.</i></p> <p><i>Right; View northeast looking back up through the cleft</i></p>

<b>Description</b>				
PORTH MAENMELYN				
Cleft cut through rock for access to the small cove below. The cleft is c.1m wide and 5m deep with rock cut steps. Lower down this path has been eroded away. Some of the steps have been reinforced with concrete and remnants of a metal-wire handrail run down the seaward side of the path.

The path is shown on the 1:2500 1 <sup>st</sup> edition Ordnance Survey map of 1889 but no longer shown on the 2 <sup>nd</sup> edition map of 1907. At the top of cleft lies a hollow measuring roughly 6m by 6m, retaining waterlogged ground, and a dry-stone wall runs along the cliff top at this point but the main purpose of the trackway remains unclear. Presumably it gave access to the cove to allow goods and materials to be brought in by boat and may be associated with local later post-medieval industrial activity.	
<b>Condition</b>	
Generally in good condition although the shale rock is naturally eroding resulting in loose shale covering much of the upper path. The lower portion has been eroded by the sea and could not be examined closely, the upper portion remains protected in its cleft.	
<b>Management Recommendations</b>	
The rate of decay of these steps should be monitored. The erosion of the lower portion meant a detailed examination of its condition could not be undertaken and they may subsequently be beyond preservation, but considerations should be given whether to conserve them or leave them to decay. If non-intervention is decided upon, then the lower steps may need to be fenced out in the interests of public safety.

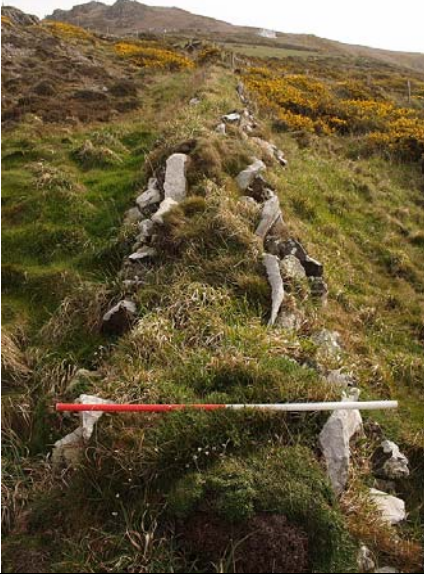
<p><i>View ESE along the remains of the field wall. Scale 1x1m.</i></p>				
<b>Description</b>				
The remains of a dry-stone wall extending into the coastal area. The wall is a continuation of field boundaries to the north but has been disused for some time. Built of large angular natural boulders, 1.3m wide at the base, tapering to 0.5m wide at the top and at most 1.3m high. It runs for c.21.5m before being cut by the coastal path and fading out beyond.				
<b>Condition</b>				
Grass covered, it appears fairly stable.				
<b>Management Recommendations</b>				
No specific recommendations
