ROCH CASTLE, PEMBROKESHIRE (SM 8803 2121)

ARCHAEOLOGICAL DESK- BASED ASSESSMENT AND BUILDING APPRAISAL

Prepared by Dyfed Archaeological Trust
For: Acanthus Holden Architects

RHIF YR ADRODDIAD / REPORT NO. 2009/36
RHIF Y PROSIECT / PROJECT RECORD NO. 95174

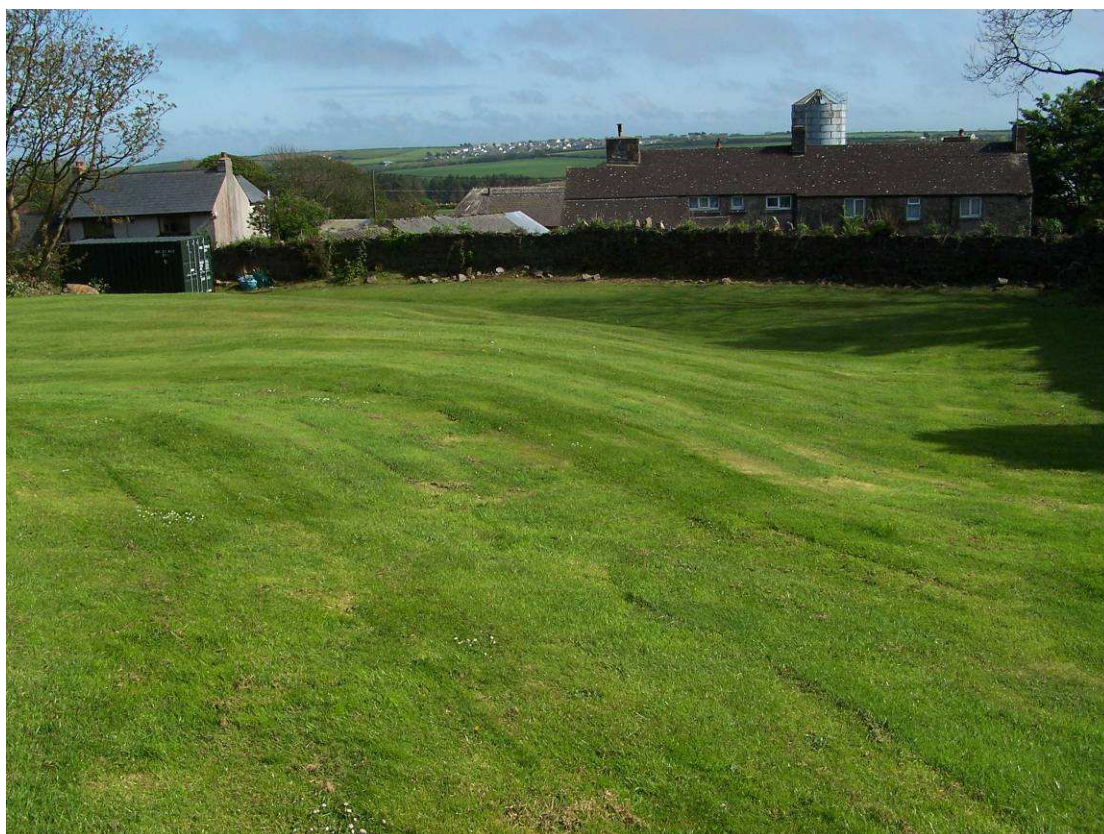
- 3.3.6 The ditched moat shown on the early OS maps was mostly removed during landscaping of the gardens during the 20th century. A slight depression in the lawned area to the southeast of the castle is still visible, although the previous owner, Dave Berry (pers. comm. 06/05/09), mentioned that the land had been cleared and leveled fairly recently (photo 1).

Photo 1: Lawned area to southeast of castle showing possible depression of former moat (view southeast)

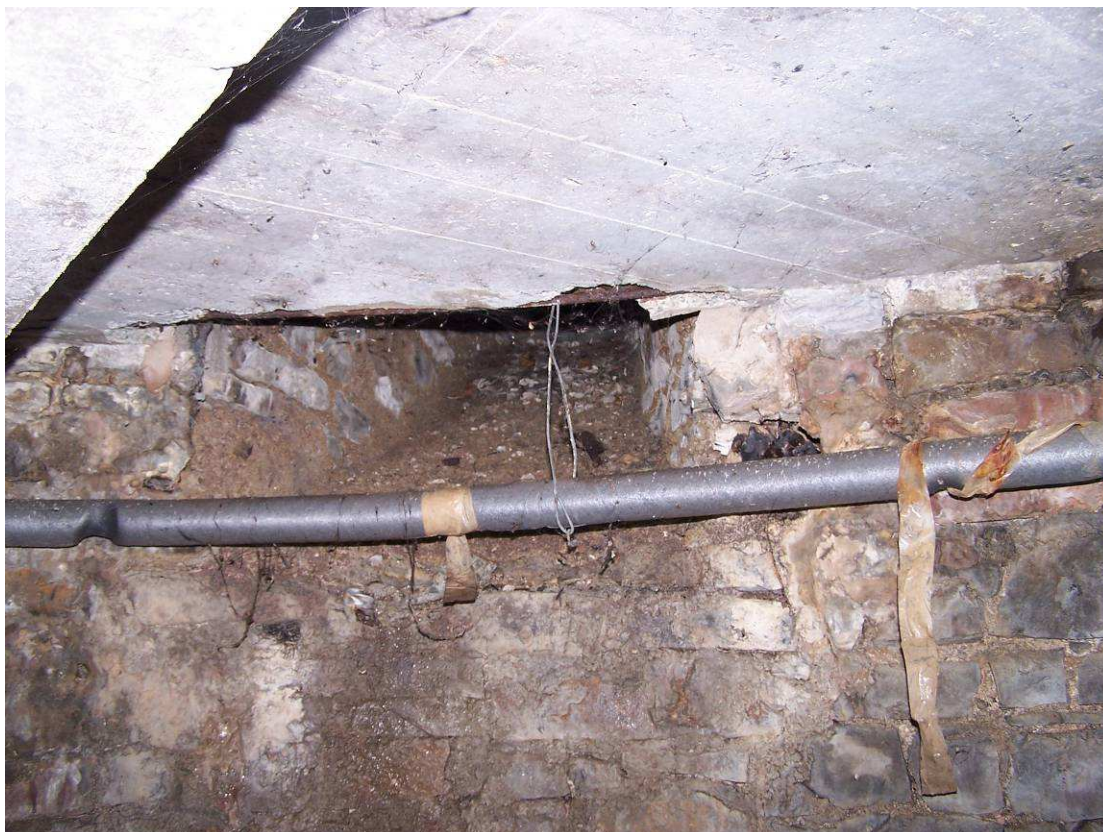
- 4.4.4 The outer walls of this room are original and include part of an original window light that projects into the southwestern apsidal wall of the building (although the modern floors above have partly covered the window; Photo 16). The room has a small doorway through to an adjacent corridor which runs along the northern face of the rock outcrop (Photo 17). The rock outcrop occupies the majority of the rooms, and it was noted that the rock has been smoothed. The internal stone walls are original and un-rendered.

Photo 16: Window Light in Room 2 (Barrack Room) with modern concrete floor above (view southwest from doorway)

Internal photographic survey and drawn and written record of details of the layout of the rooms and any features which may provide evidence as to their original function should be undertaken. Detailed record of the visible area of the window opening should be made, to ascertain its relationship with the floor level and the window opening above within the Court Room.

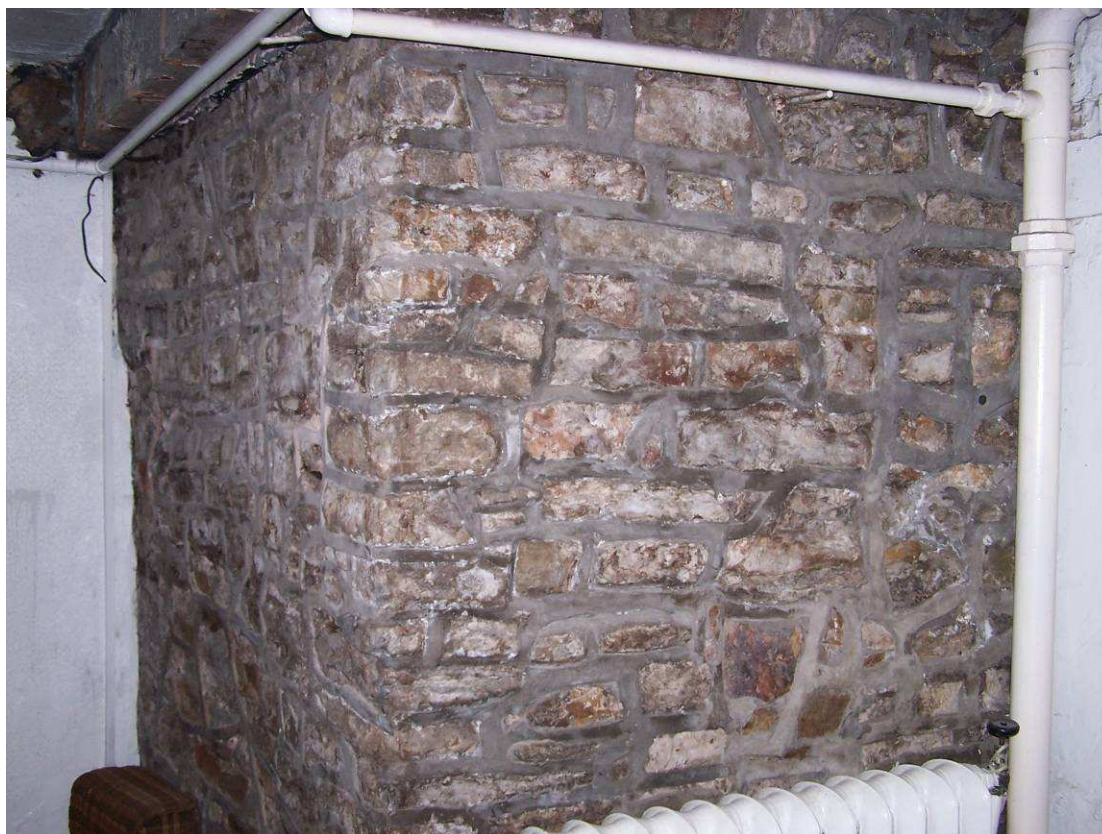
Photo 18: View of northern wall of Court Room (Room 3) showing exposed stonework, and modern breach on left hand side of photograph

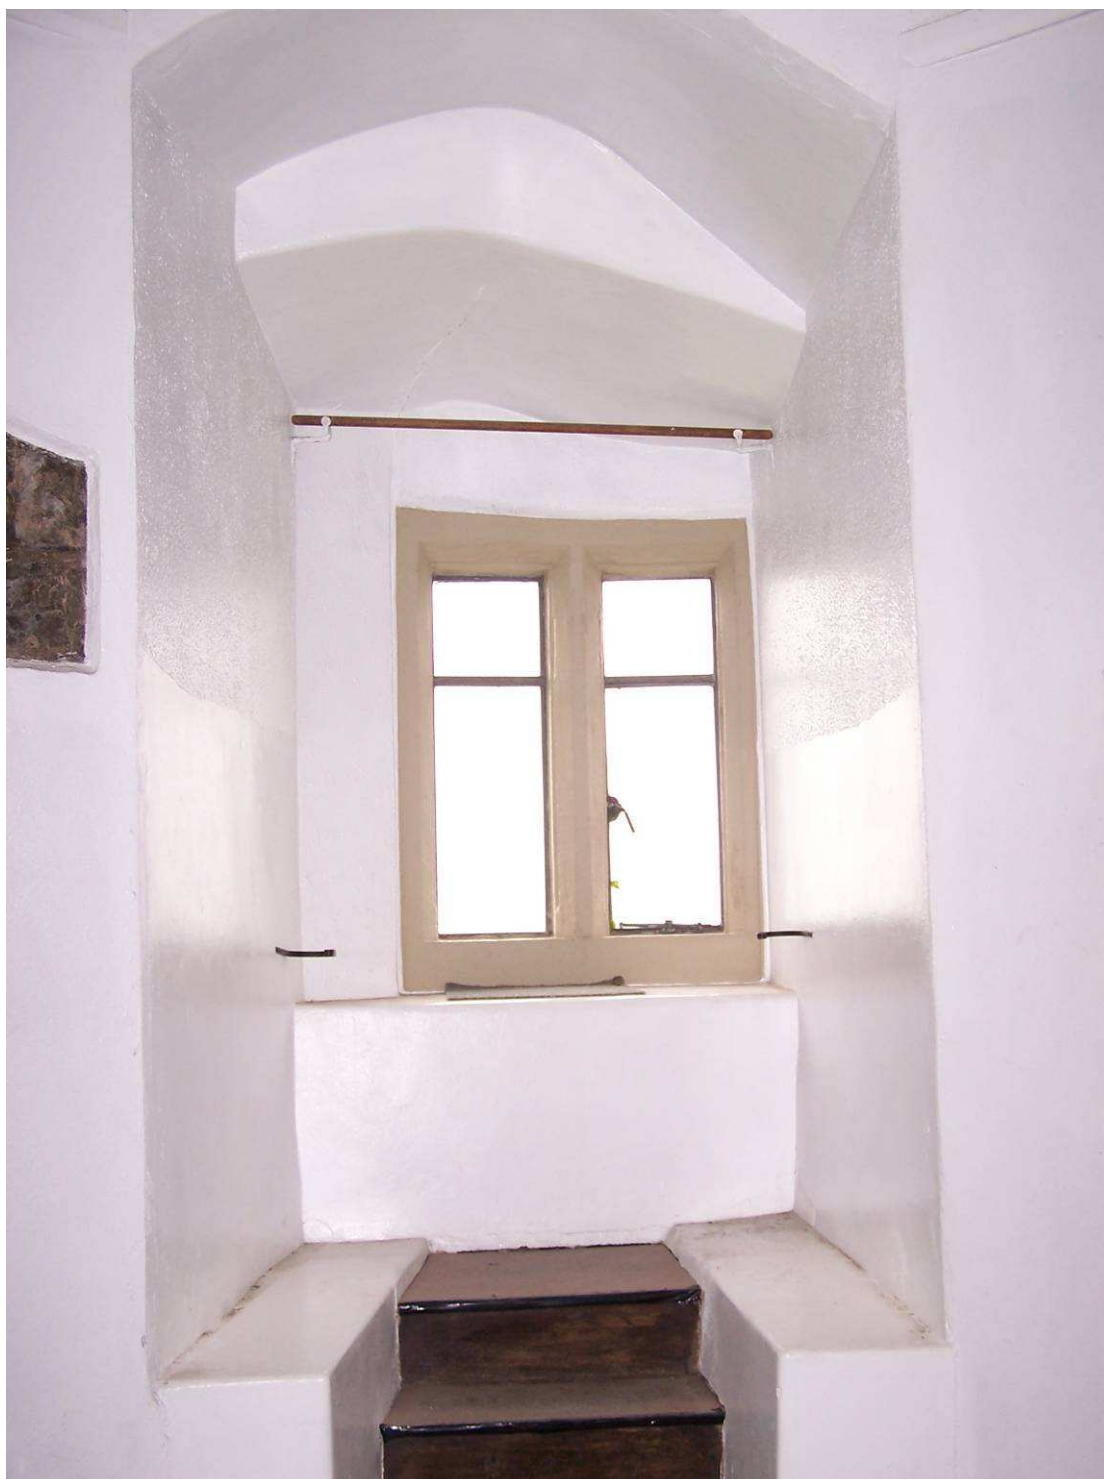
Photo 19: Window opening in southern part of west wall of Court Room (Room 3), an original medieval opening with modern window inserted

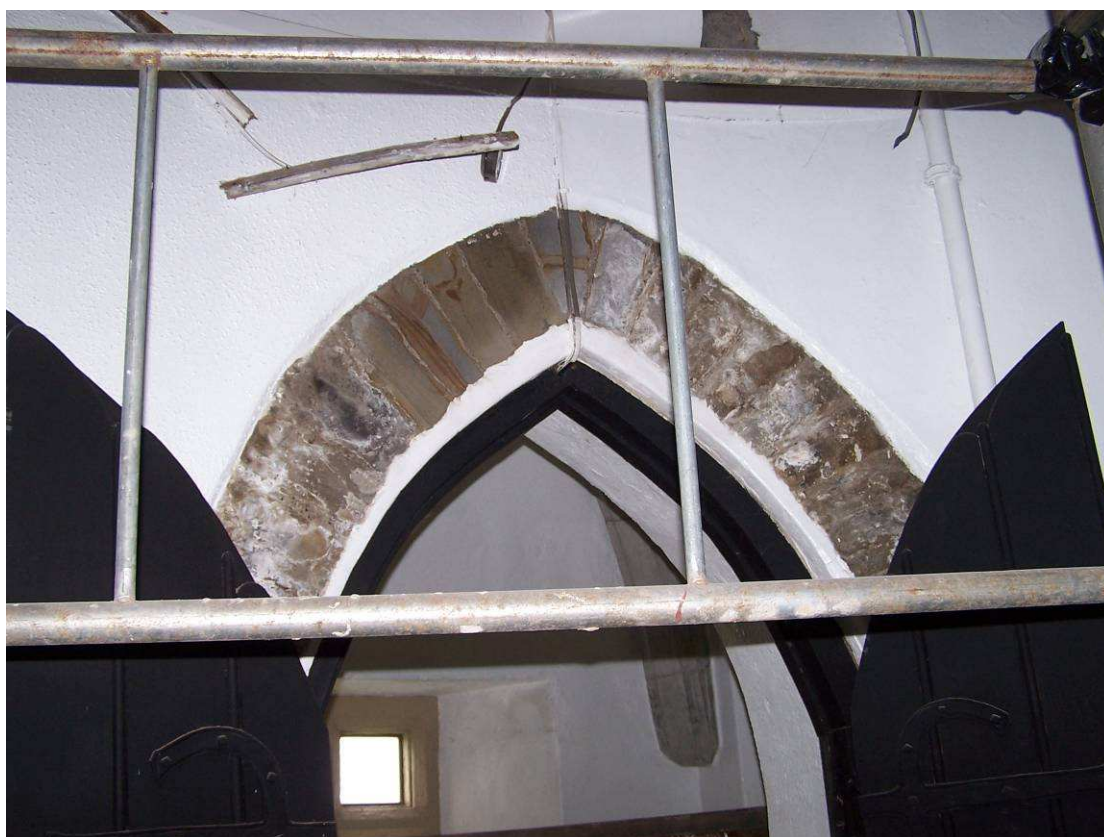
4.4.8 An arched doorway also leads through to Room 5 from the Court Room (Room 3) (Photo 20). The room has original walls on all sides, with an original window opening, window light and alcove. The description from 1864 states that it has a vaulted ceiling, although that which exists today comprises exposed modern sandstone ribs with plasterboard vaulting. Four vents are present through the plasterboard and it was noted that a concrete ceiling was present above, implying that the original vault seen in 1864 was removed and a visual facsimile rebuilt using modern materials.

Photo 20: Arched doorway through to Room 5, with both original and replacement voussoirs, showing white imitation vaulted ceiling and modern sandstone ribs inside the room

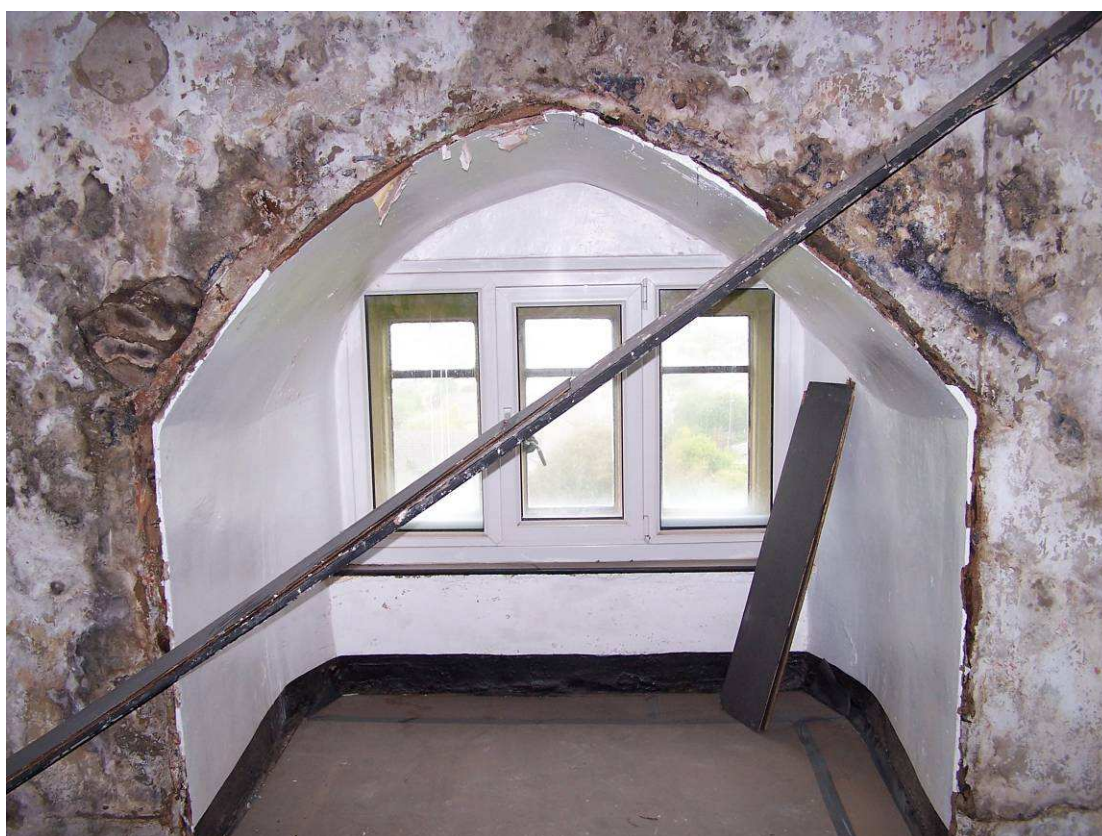
Photo 21: Arched window opening in west wall of Room 6, with stone voussoirs visible on left hand side of photograph above arch

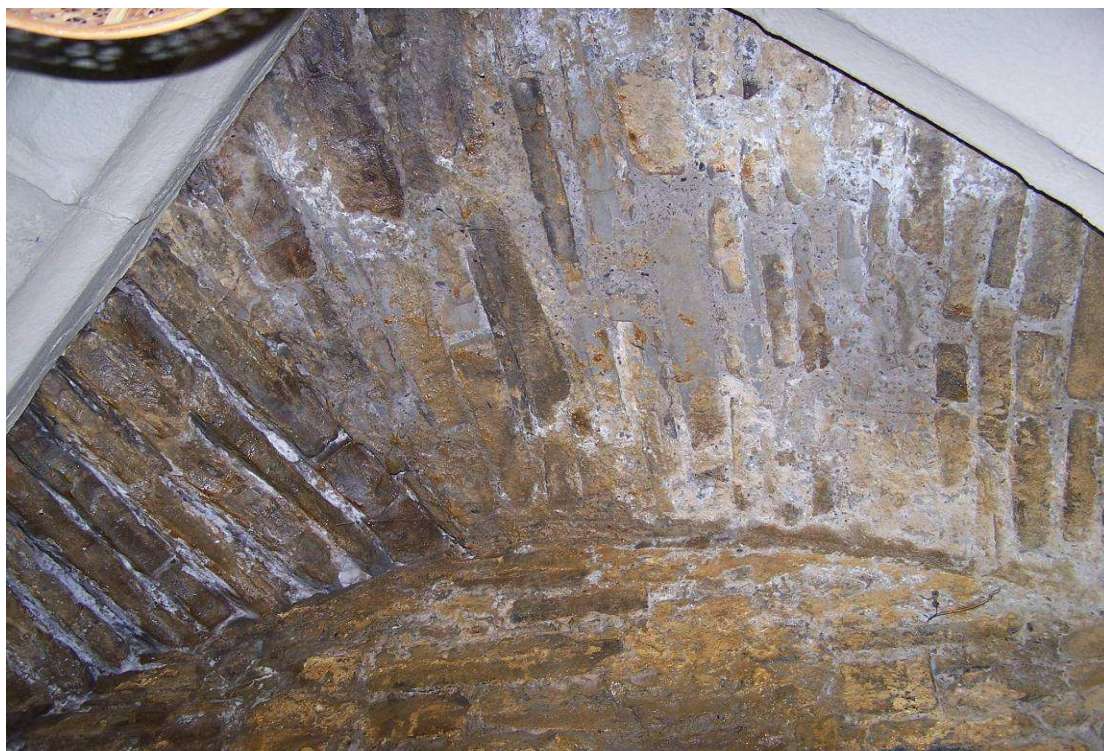
4.4.12 Bedroom 2 is located in the southern projecting square tower above Room 5 (the Chapel). Unlike the room below this room has a substantial area of original stone vaulting (part exposed, Photo 22) and some original stonework within the ribs survives. An original alcove is present within the northeast wall of the room, and an apparently original window opening is present to the southwest. It is probable that the window opening on the southeast wall is modern, although is situated within an original window location. Most of the walls of the room would appear to be original, although substantial repaired areas are likely to be present on the southeastern part.

Photo 22: Original exposed stone vaulting in northwest part of Room 9

Following the removal of render, where present within the room, photographic record of the walls on all sides should be carried out, to include description and drawings where original fabric is revealed and especially in the areas of window openings, the doorway, alcove or any other features. Detailed record of the vaulting and ribs should also be undertaken. An aim of this work would be to establish the extent of repair carried out on the southeastern wall of the tower. A detailed record of the stairway between Room 9 and 10 and the layout of this area should also be undertaken.

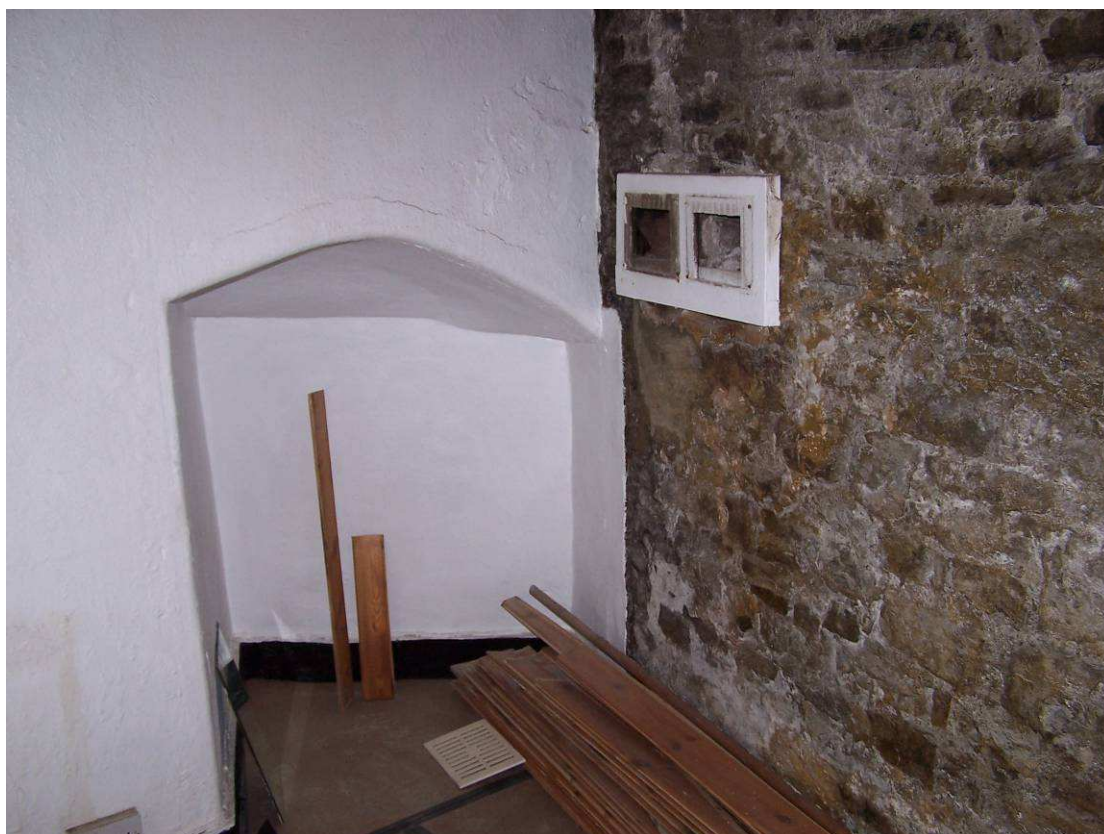
Photo 23: View of eastern part of Room 13 showing original stone walls and alcove (and modern vents)

Following the removal of render from the plastered walls a photographic record should be carried out, to include description and drawings where original fabric is revealed, window openings, doorways, alcoves and any other features. The record should aim to ascertain the extent of rebuilding of the southern wall of the southern projecting square tower. For the staircases to the north of the room, a record of their layout should be made, with a detailed written and drawn record. The infilled area within the eastern wall above Room 10 (Garderobe) should also be undertaken in the aim of establishing what its original function was.

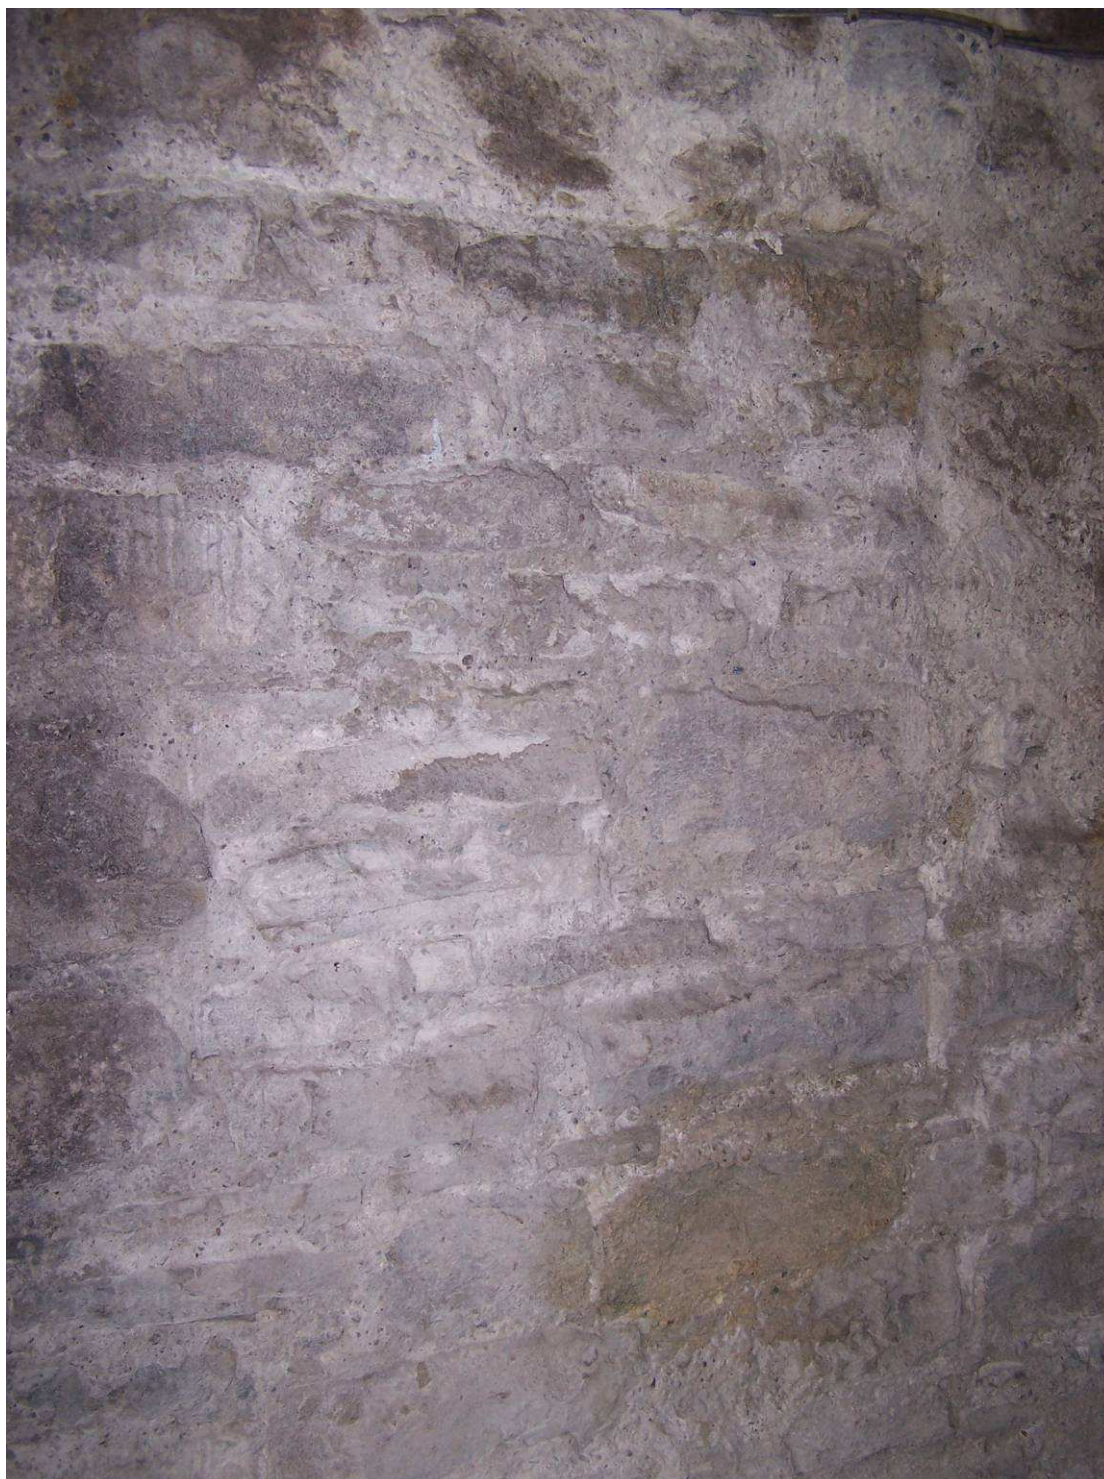
Photo 25: View of eastern wall above Room 10 (Garderobe) which shows infilled window or alcove as seen by straight joints in the stonework

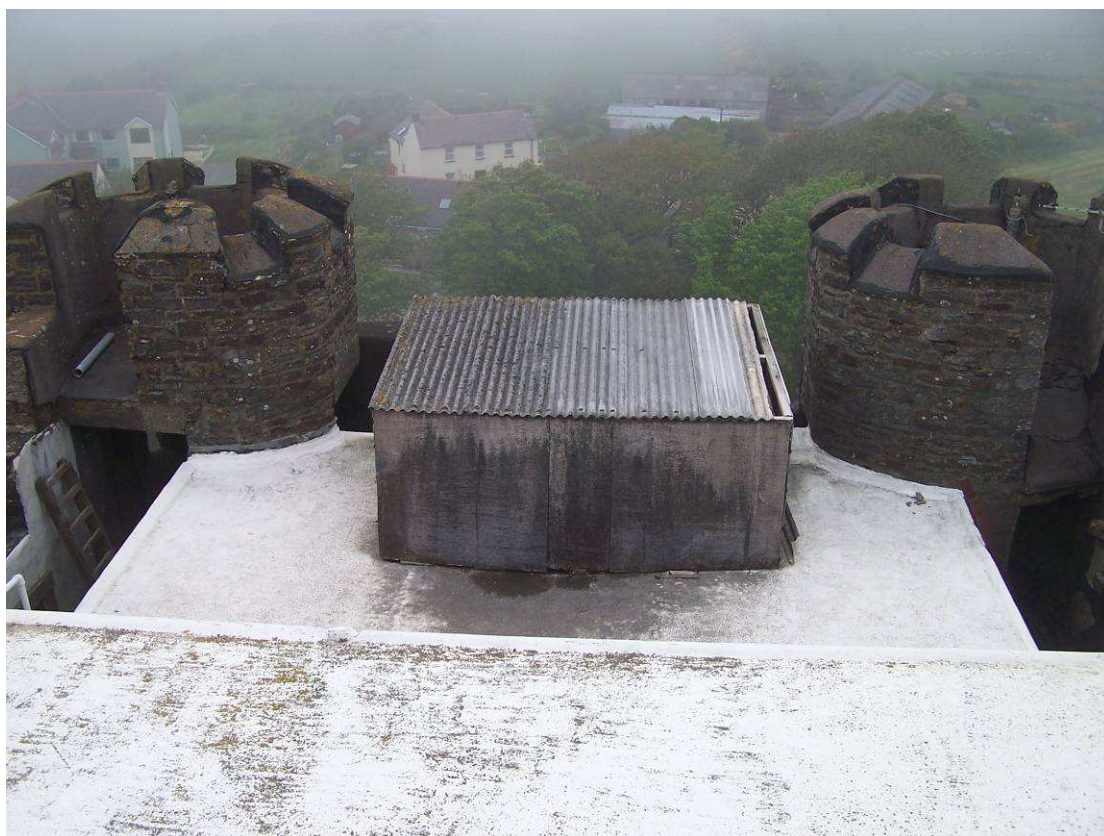
4.4.17 The majority of the accessible roofed area is located on top of modern concrete ceilings associated with the 1900s renovations (Photo 26 and 27). The roofs have then been covered with asphalt to prevent leakages (as noted above). The crenellations around the tops of most of the walls have been rebuilt during the renovations also, or have been covered with concrete render and asphalt preventing direct observation of the fabric. An water tank housed in an asbestos structure is located above the

northern end of Room 11 (Photo 26). The top of the southern projecting square tower is curved on the inside edge, mirroring the arc of the western side of the southern part of the structure.

Photo 26: Asbestos structure housing water tank above Room 11, viewed from the modern roof above Room 12. The two turrets are visible in the background.

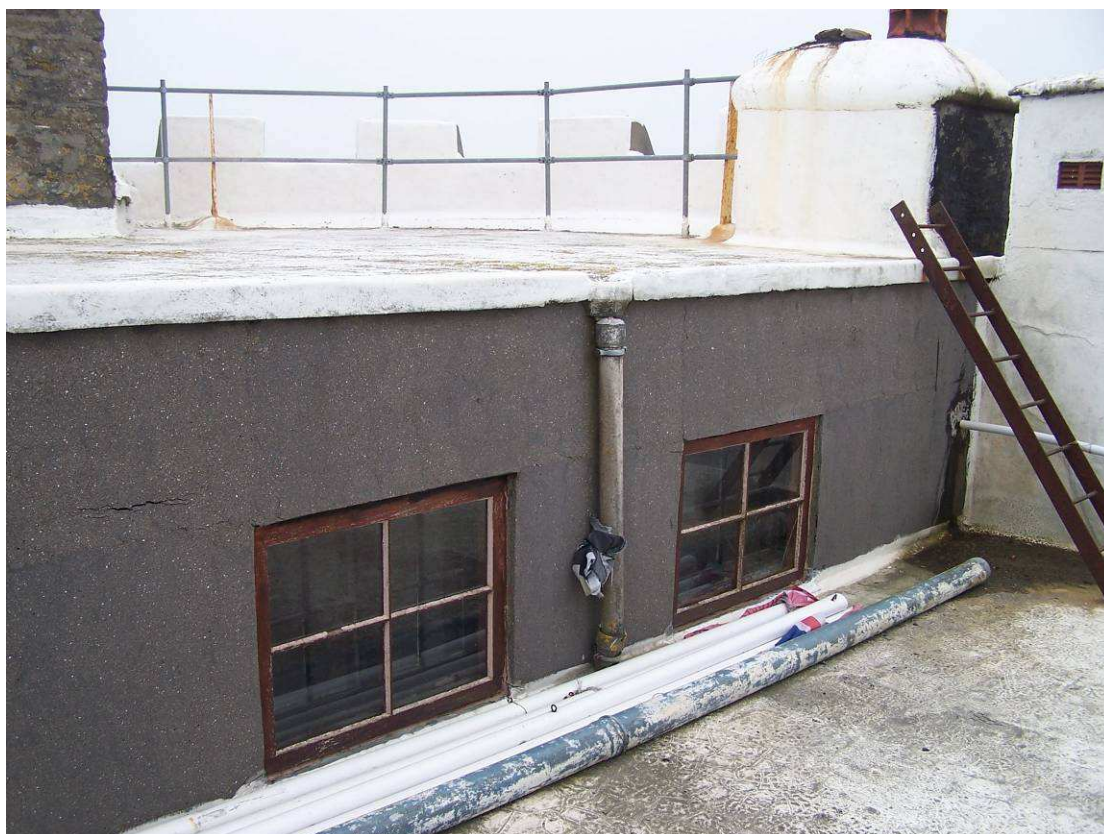
Photo 27: Top part of the modern Room 12 viewed from the roof above Room 11

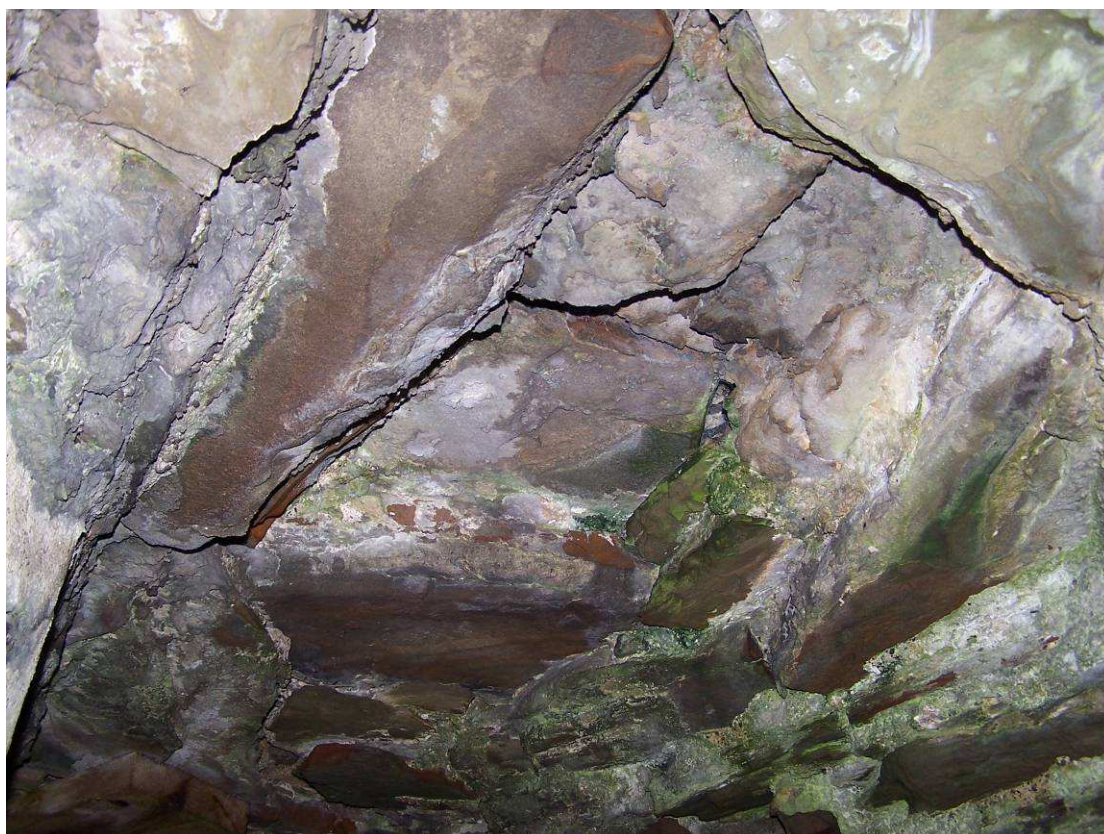
Photo 29: Underside of turret floor showing stone corbelling suggesting original medieval fabric

Following the removal of the asphalt from the inside walls and floor of the upper part of the turret a photographic record should be carried out, to include description and drawings where original fabric is revealed and any features. A detailed written and drawn description of the corbelling on the underside of the floor and possible steps leading up to the floor should be recorded.

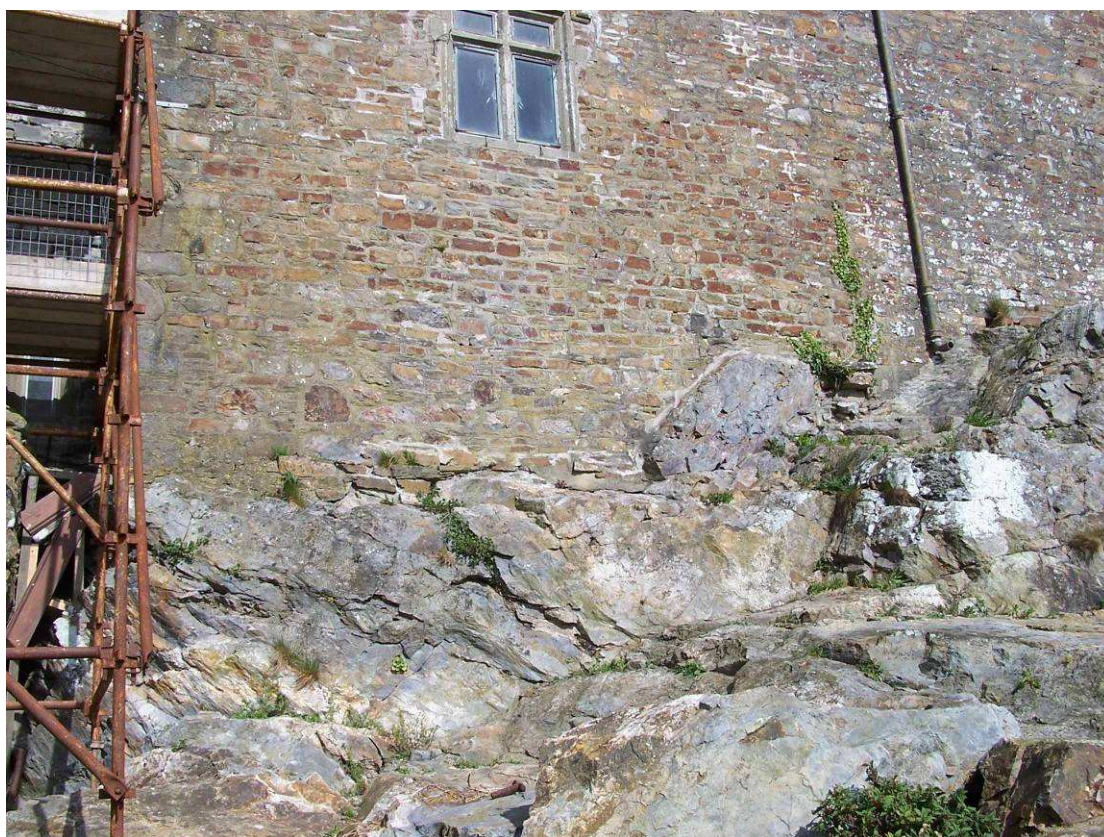
- 4.5.5 As noted above, the Western Turret is substantially a modern rebuild, although may potentially have some original fabric on the outer wall above the course of corbels.
- 4.5.6 The corbel course would appear to be original.
- 4.5.7 The castle is built directly upon the rock and it is assumed that the majority of the lower stonework is original fabric, although with some patching and re-facing (Photo 32).

Photo 32: Lower part of western elevation built directly upon bedrock

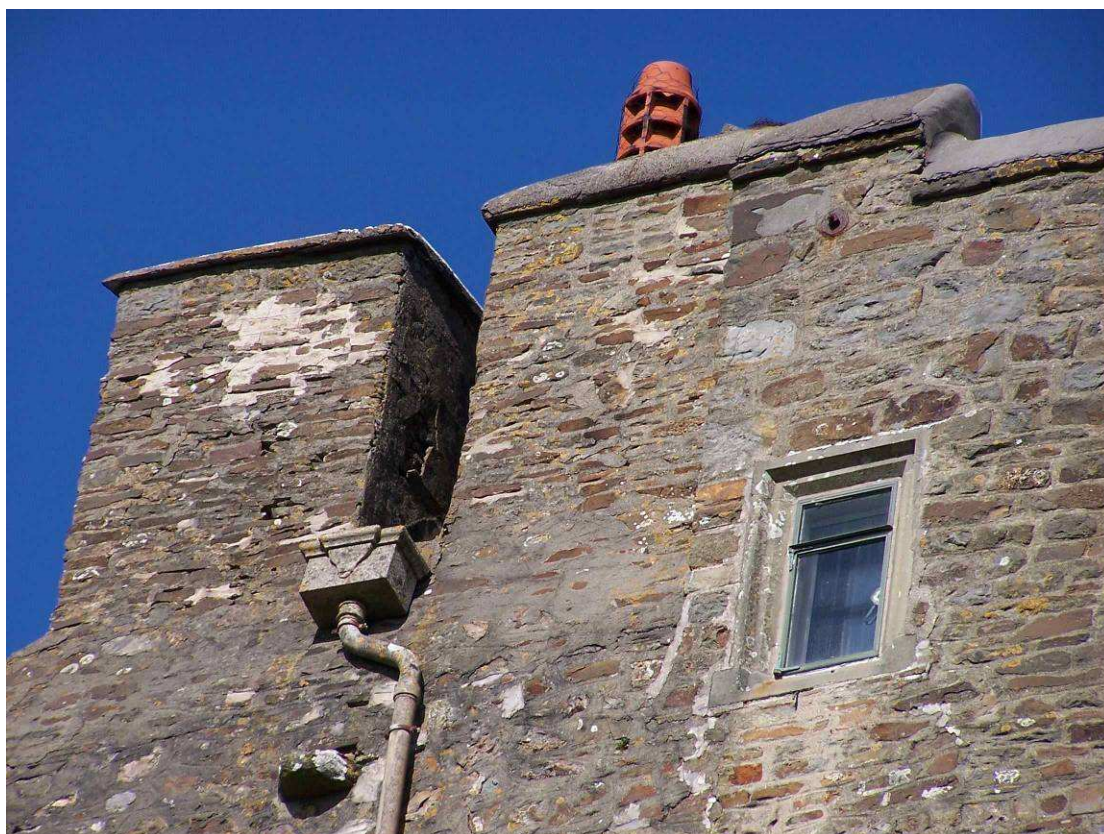
- 4.5.8 The crenellations in the centre of the elevation indicate different phases of building, with vertical joints visible through the stones (Photo 33), and it is considered likely that the area to the left hand side of the photograph is original fabric, with that to the right being later rebuilding of the adjacent crenellations. A tall vertical stack of stonework is visible on illustration 2 that is likely to correspond with this. Concrete re-pointing is also visible on the wall surface, as are smaller areas of repair of different dates, including a patch beneath the window which is presumably of more recent date.

Photo 33: Evidence of Phases of Rebuilding in Crenellations

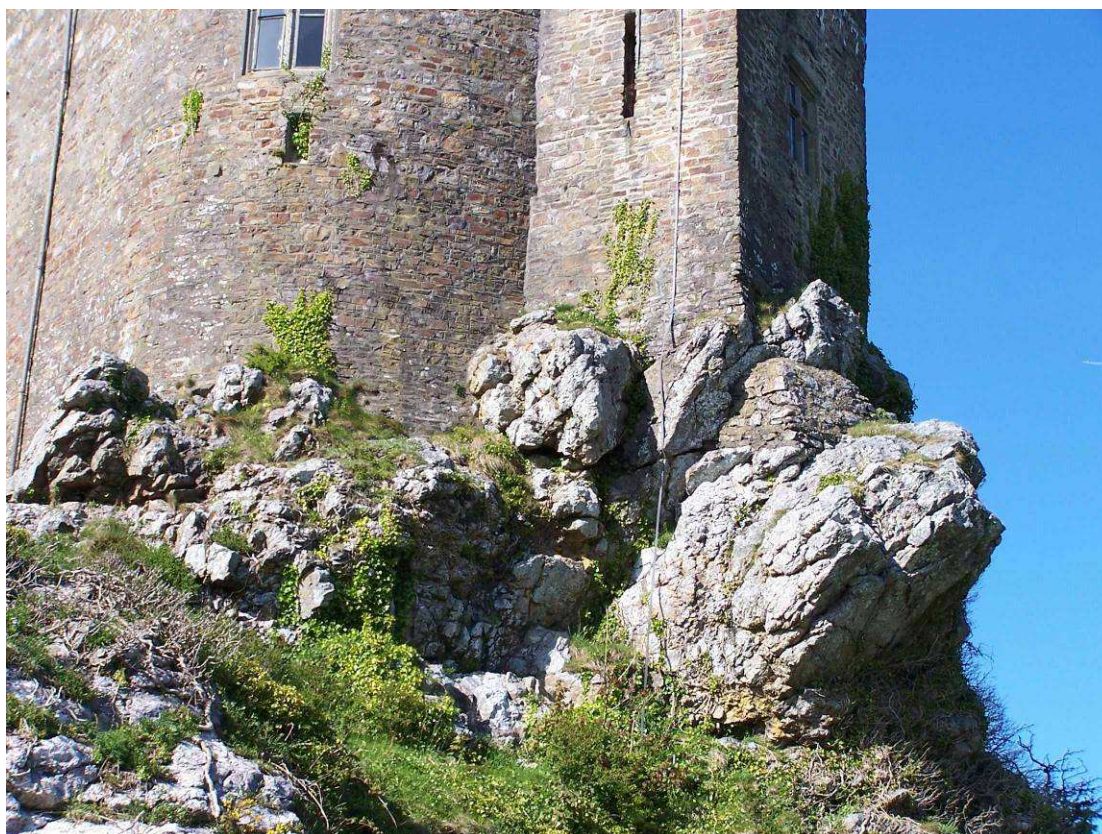
- 4.5.12 The castle is built directly upon the rock and it is assumed that the majority of the lower stonework is again original fabric, although with some patching and re-facing (Photo 36).

Photo 36: Southwestern elevation of Roch Castle showing how walls have been built directly upon the rock outcrop.

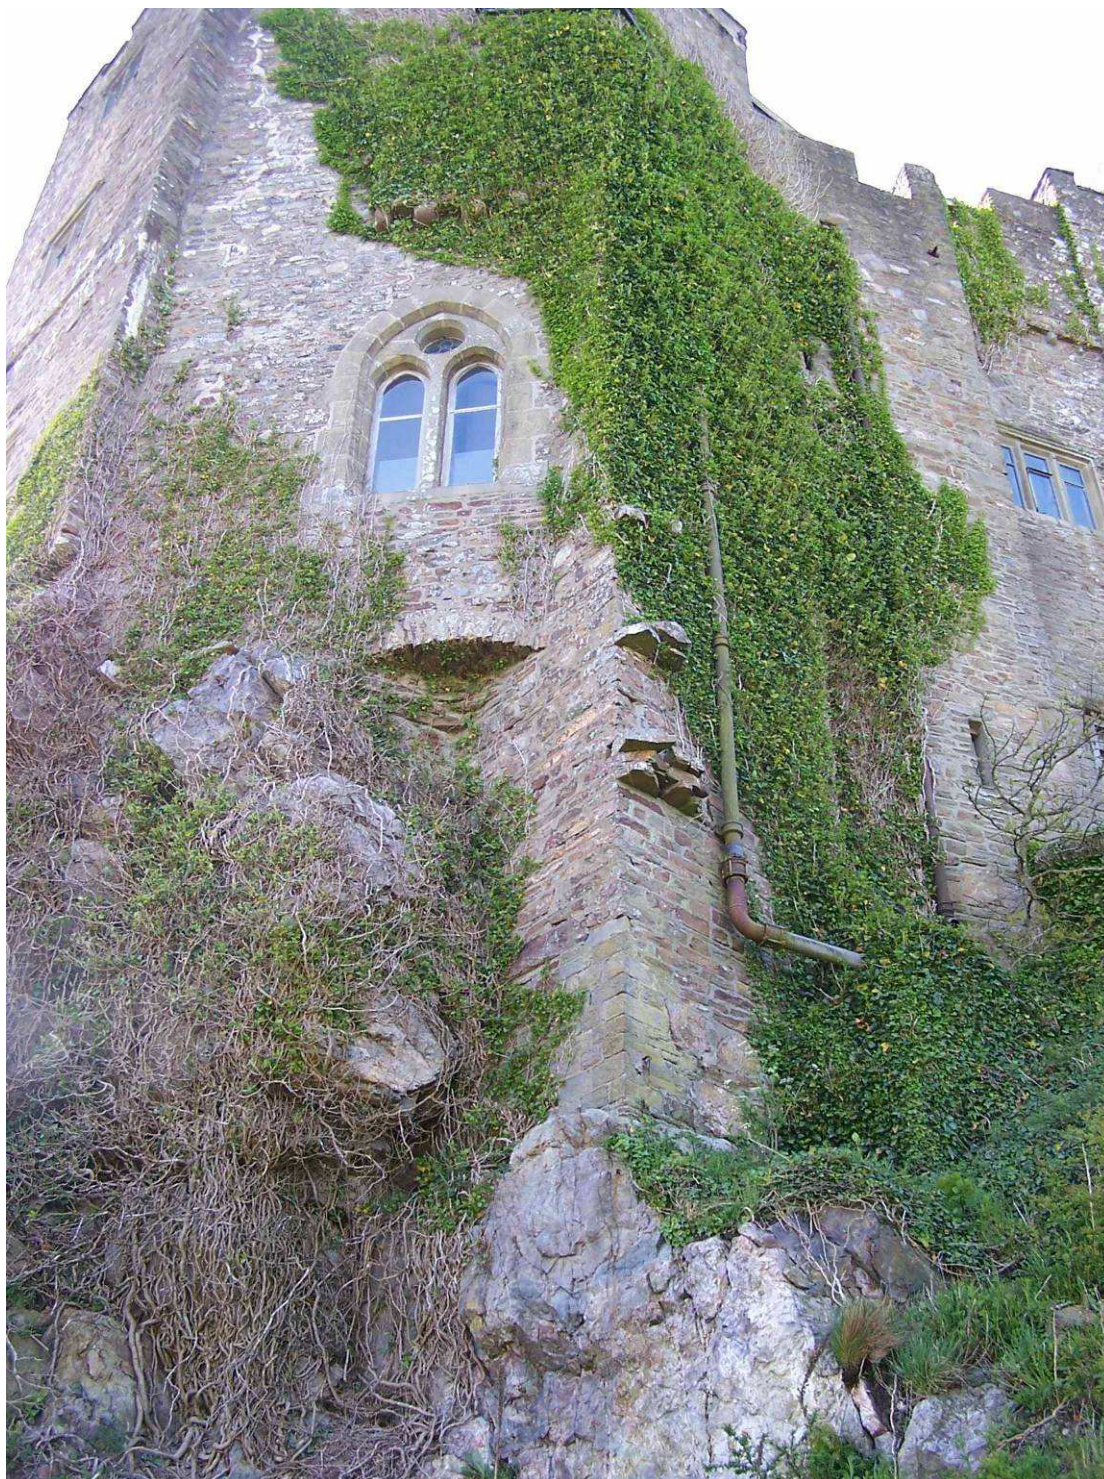
the base of Room 4, to join the wall sitting directly on the upper part of the rock outcrop with the lower stone built wall to the north. This arch is still visible today (see Photo 38).

Photo 38: Southeastern elevation showing Gothic window inserted in 1900s, relieving arch beneath and three sets of projecting stones to the right.

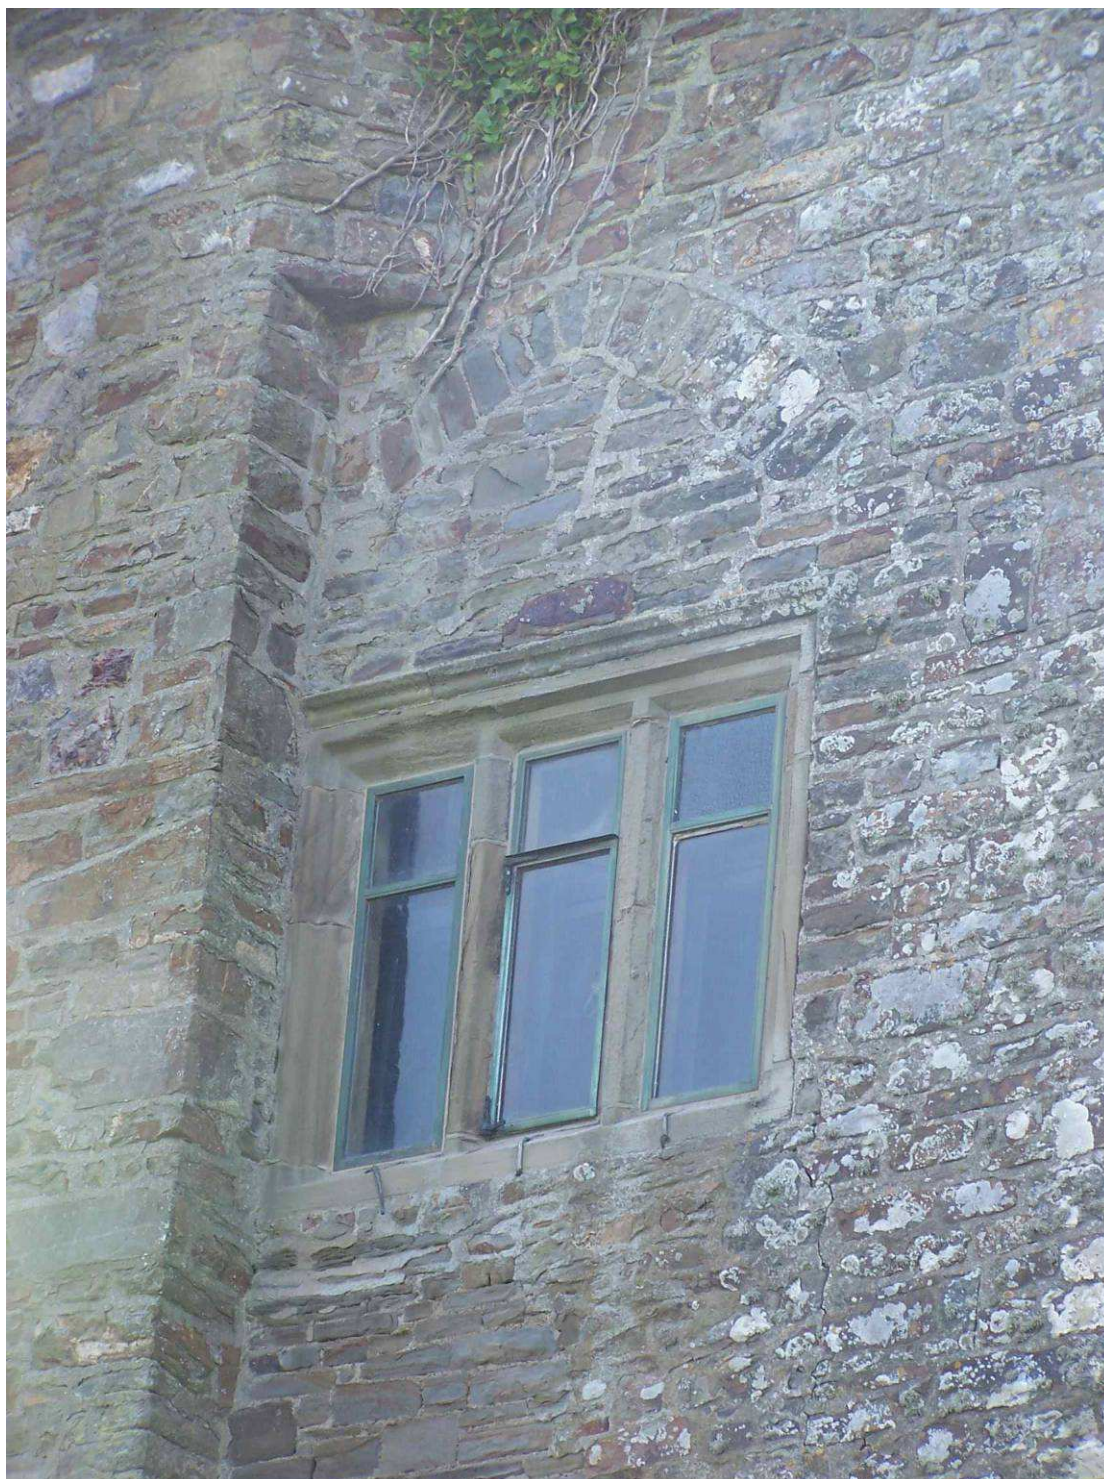
Photo 40: Former arch above replacement and rebuilt window in eastern façade
