ABERYSTWYTH WORKHOUSE, BRONGLAIS HOSPITAL (SN 5911 8182)

HISTORIC BUILDINGS APPRAISAL

Prepared by Dyfed Archaeological Trust
For: Laing O'Rourke

RHIF YR ADRODDIAD / REPORT NO. 2009/51
RHIF Y PROSIECT / PROJECT RECORD NO. 95175

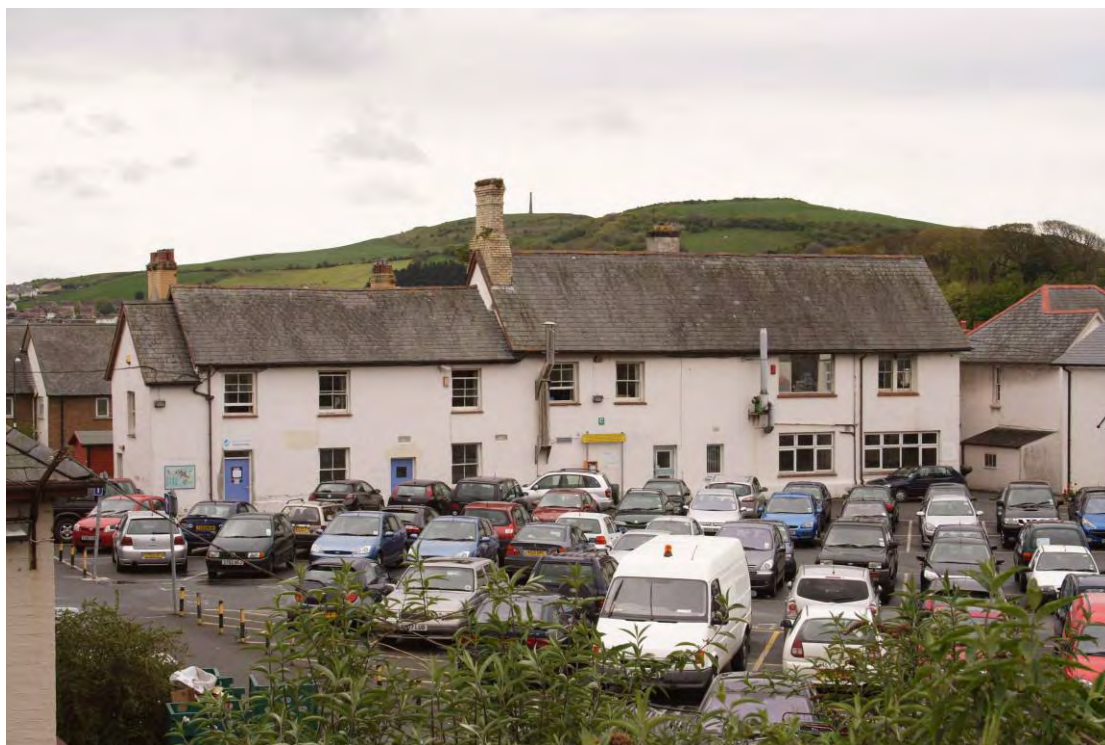
- 4.1.1 The northern façade of the south wing of the workhouse comprises three parts, a taller two storey element to the west which has been substantially rebuilt following demolition of the rest of the workhouse; a slightly lower and shorter two storey block in the eastern part; and a very narrow and shorter still addition at the very eastern end. It would appear that the majority of the eastern part of the northern façade is original, and as far as can be ascertained, the eastern block of the building (left hand side of photo 3) contains mostly original window openings and doorways. The original windows are all simple 4 paned sashes, mostly located in the eastern part of the building, with two visible in the upper storey of the western block.

Photo 3: Northern façade of southern wing

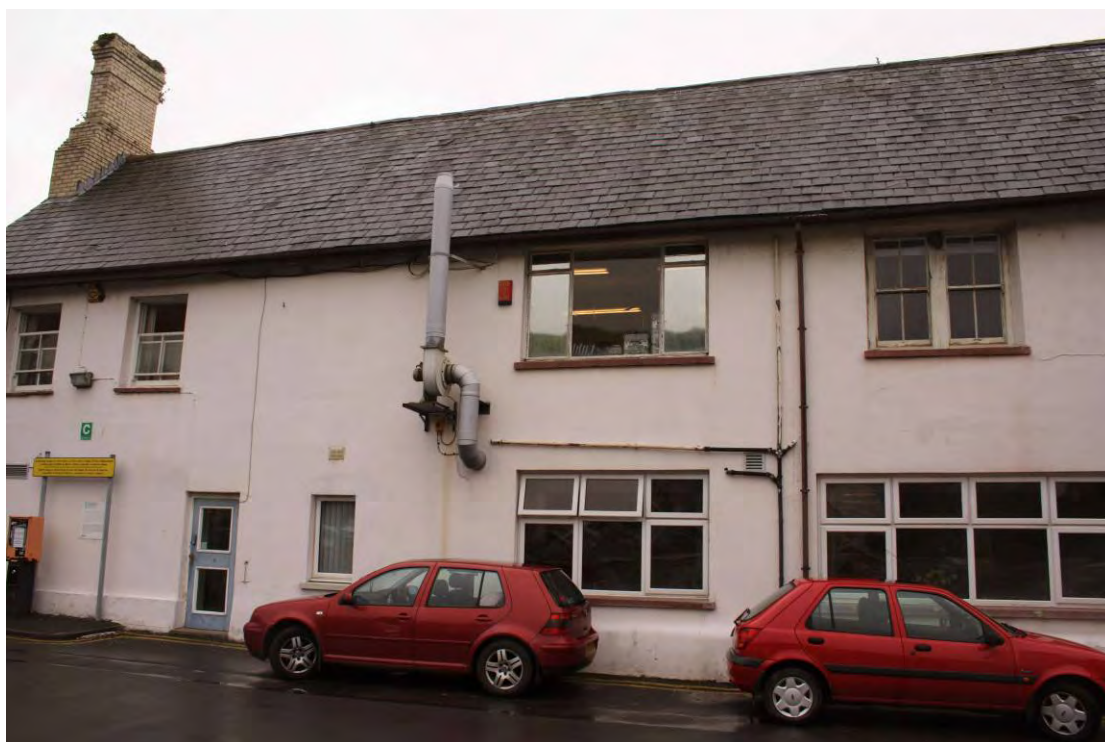
- 4.1.2 At the western end of the building are more modern windows (photo 4), which were inserted within the area of the wall which must have been constructed in the 1960s when the majority of the workhouse was demolished. New doorway openings have also been added into this area. One single more ornate sash window (8 paned) is present on the first floor level at the very western end of the northern façade, which is similar in appearance to some of those located within the building erected on the Caradoc Road frontage (dating between 1905 and 1939), with a wide wooden divider between the sashes (photo 5). A similar window is also visible on the second storey on the western gable end of the building (photo 6) which also originally had a third row of windows above the sashes very similar to those on the southern façade of the Caradoc Road building.

Photo 4: Area of rebuilt wall on northern façade, with modern windows.

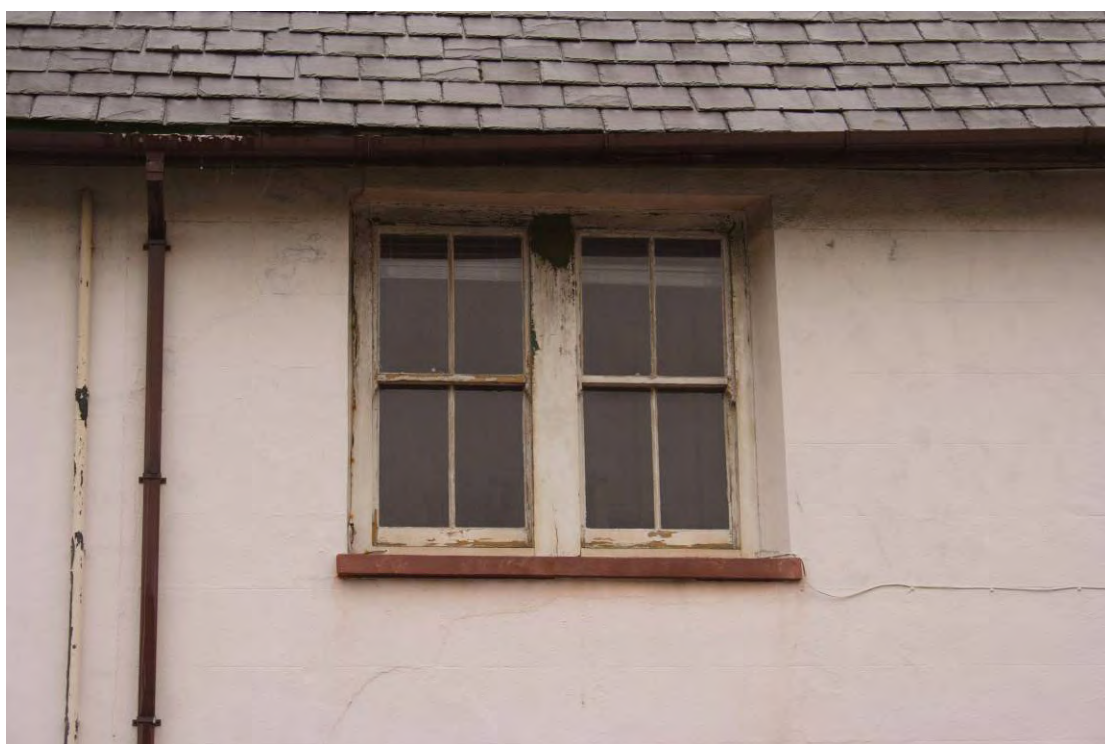
Photo 5: Sash window of style similar to the Caradoc Road frontage building

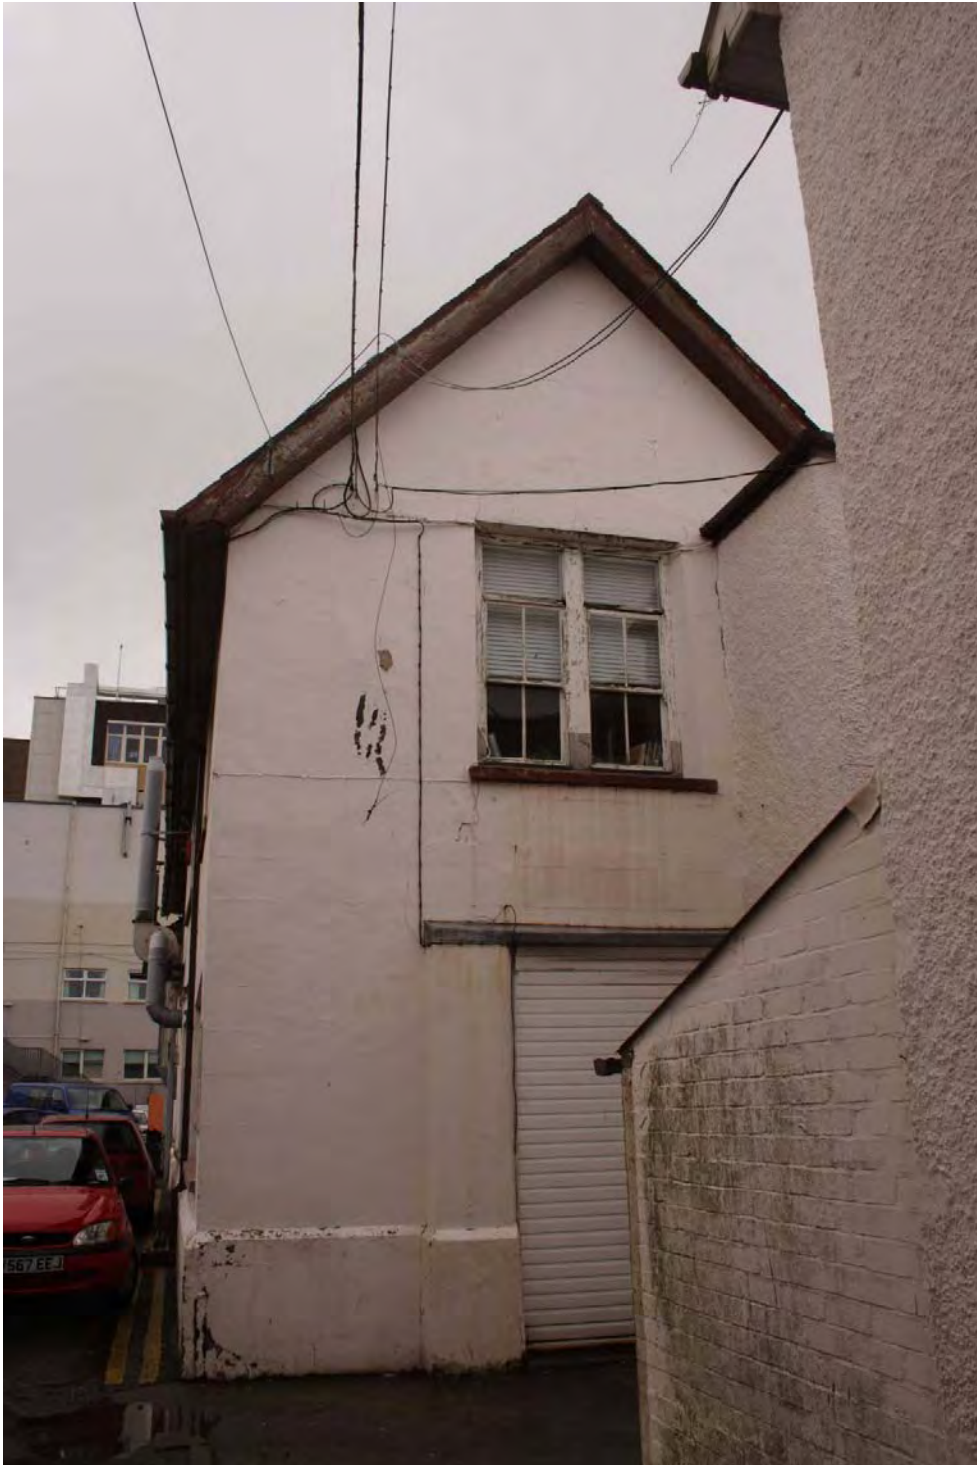
Photo 6: West facing gable end wall with sash window upper storey and new roller shutter door to ground floor

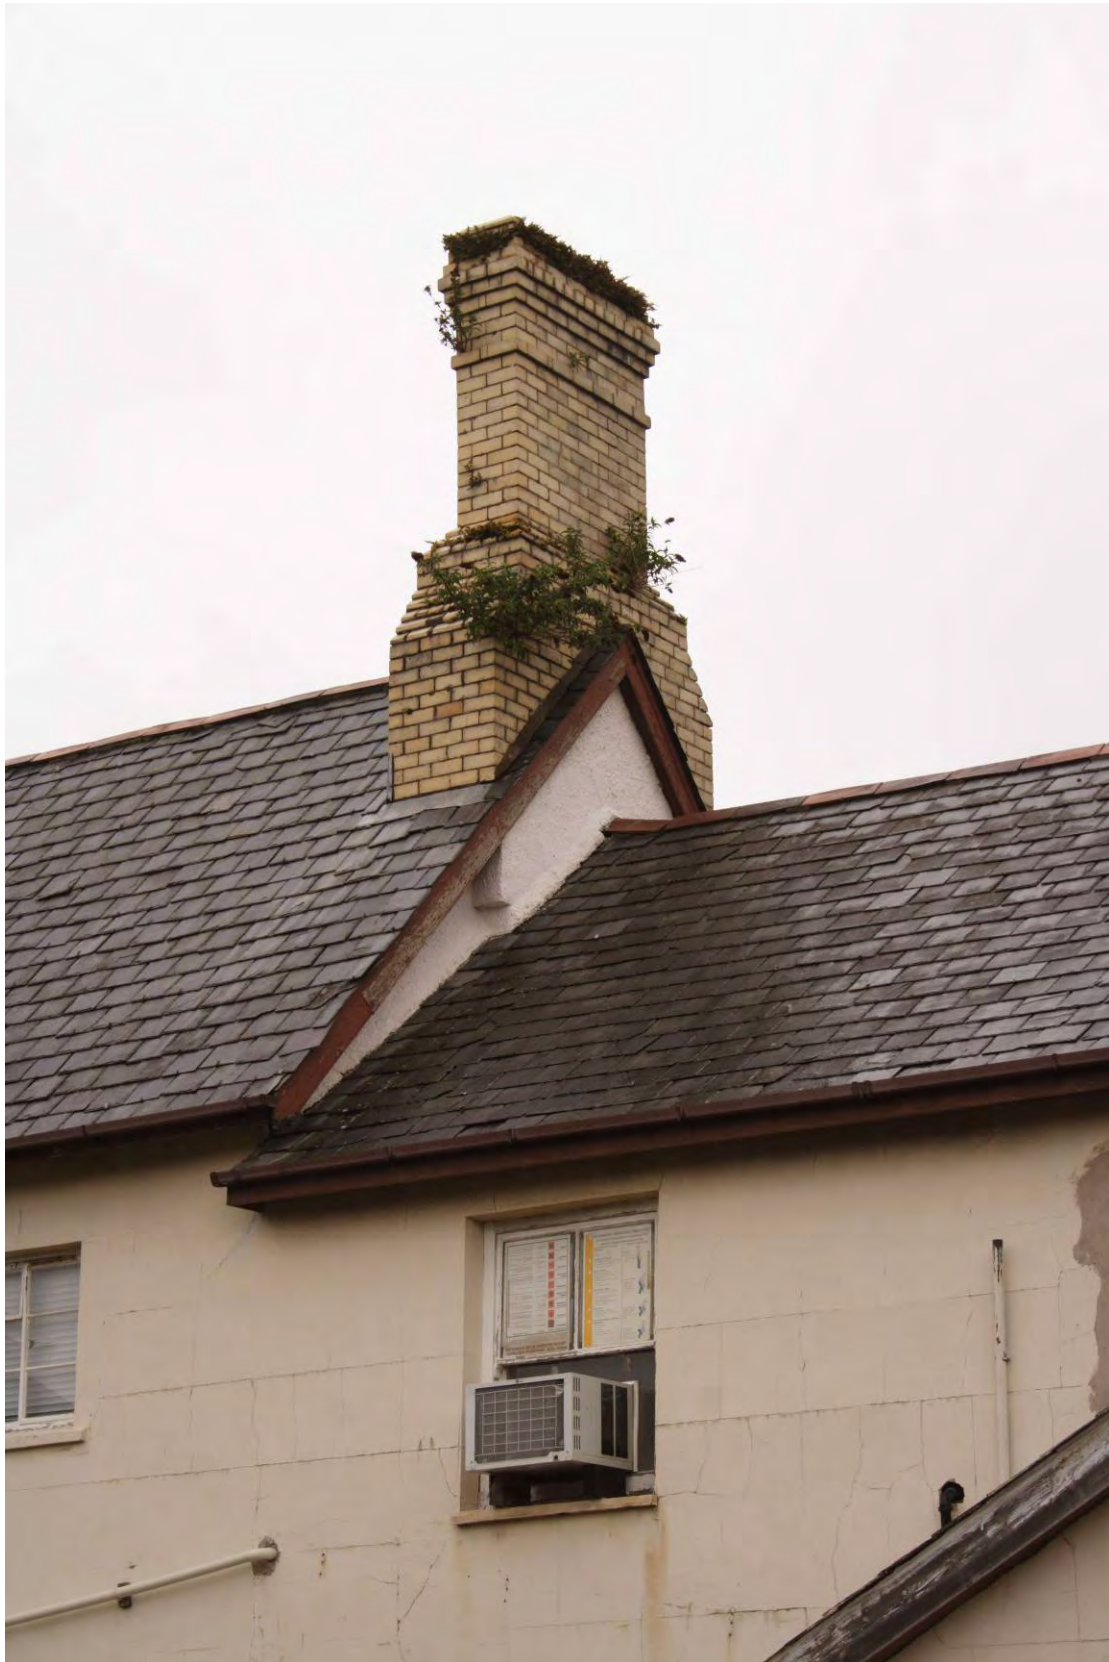
- 4.1.3 Some rebuild of the western end of the roof must have occurred when the remainder of the workhouse was demolished in the 1960s, although this was not clearly evident. This may indicate the whole of the roof of the western block was redone at this time, or perhaps tiles were reused. An ornate chimney in yellow brick is present on the western block before the change in level to the block to the east, as is clearly seen on a view of the southern façade (photo 7). The chimney is an original feature of the workhouse.

Photo 7: Chimney between western and eastern blocks of building
as viewed on from south

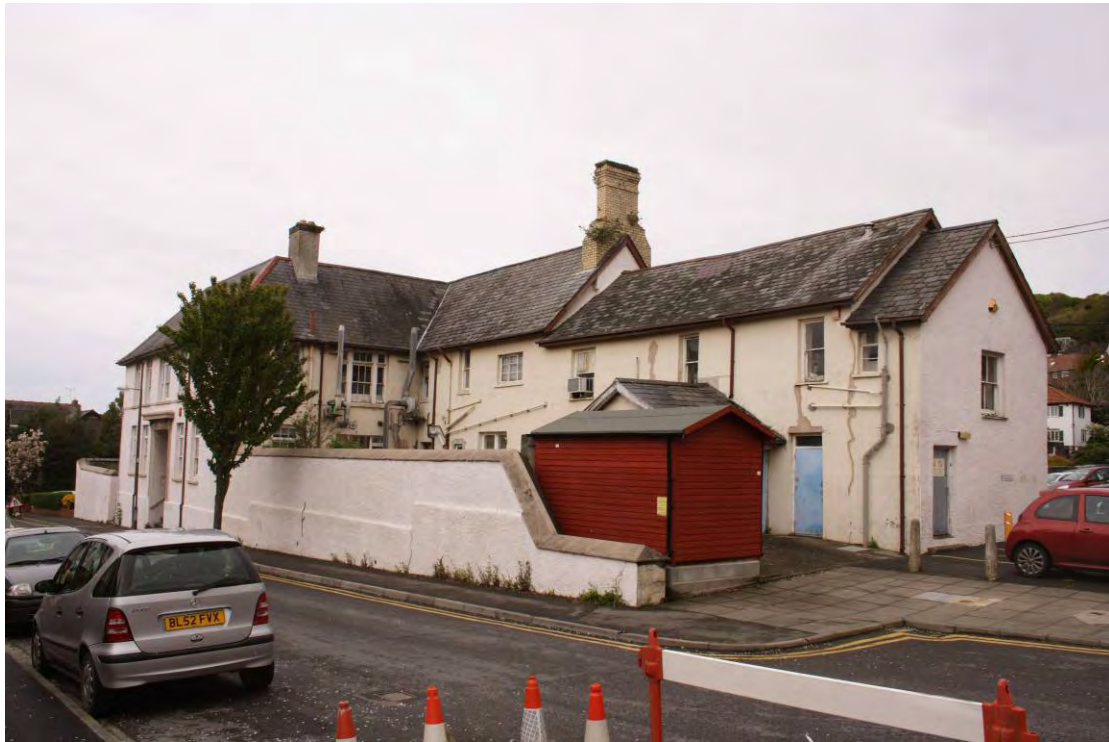
- 4.1.4 The southern façade was not as clearly visible as that of the north, due to the presence of a large boundary wall enclosing an inaccessible area (photo 8).

Photo 8: Southern façade of building from south-east

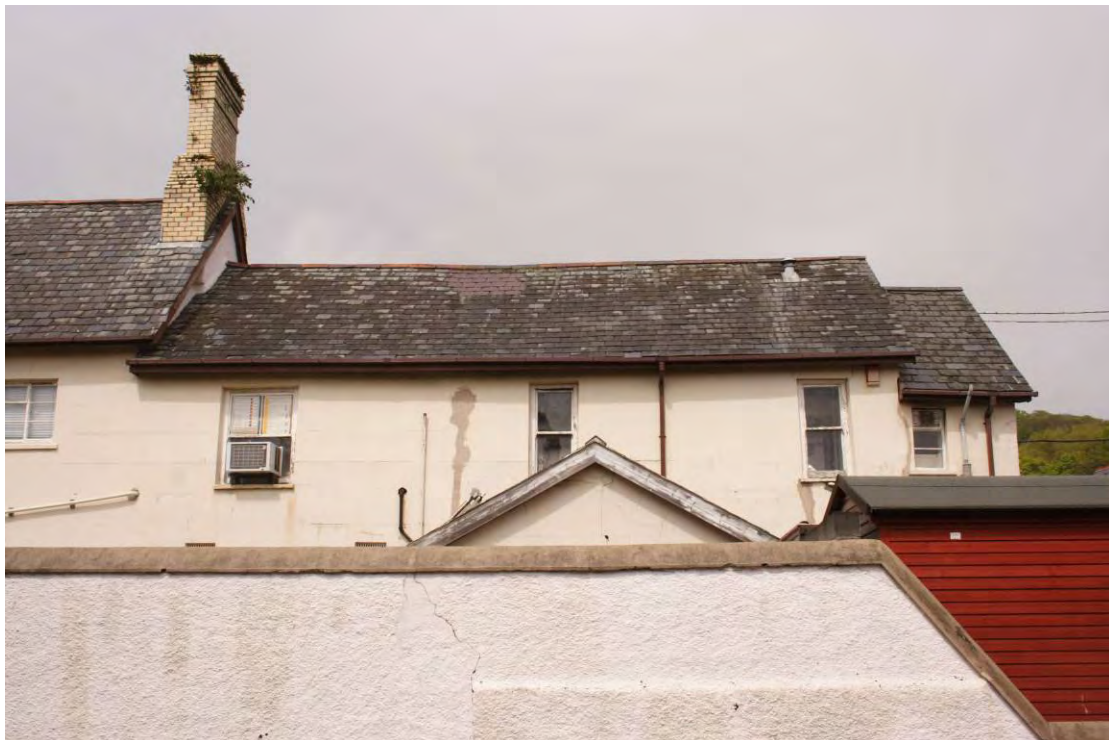
Photo 9: Southern façade, eastern block of building

4.1.5 The southern façade of the eastern block (photo 8) appears to have survived relatively intact with three windows visible on the second floor, one 4-paned sash window (now altered for an extractor fan), and two

narrow 2-paned sashes to the east (photo 9). The small additional block to the east has a single window on the second storey (another narrow 2-paned sash). The presence of numerous drainage and soil pipes would imply that narrow and shorter build on the eastern end would have been a toilet block (photos 8 and 9).

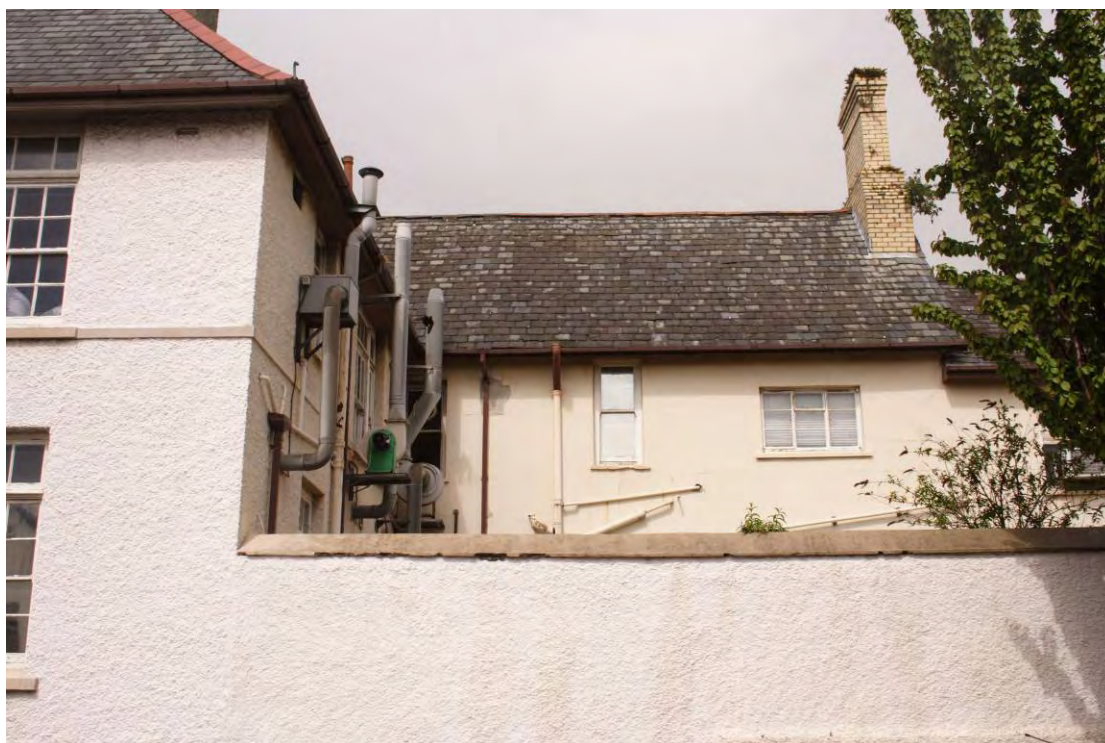
- 4.1.6 The western block has been significantly altered by the additional structure added to the south-western corner of the workhouse by 1939, which provided a new entrance from Caradoc Road. Only three windows were visible at second storey level, two narrow 2-paned sash window (the same as those seen on the eastern block façade) and a more recent metal framed window to the east, which is considered to be a later replacement (photo 10 and 11).

Photo 10: Southern façade, western block of building

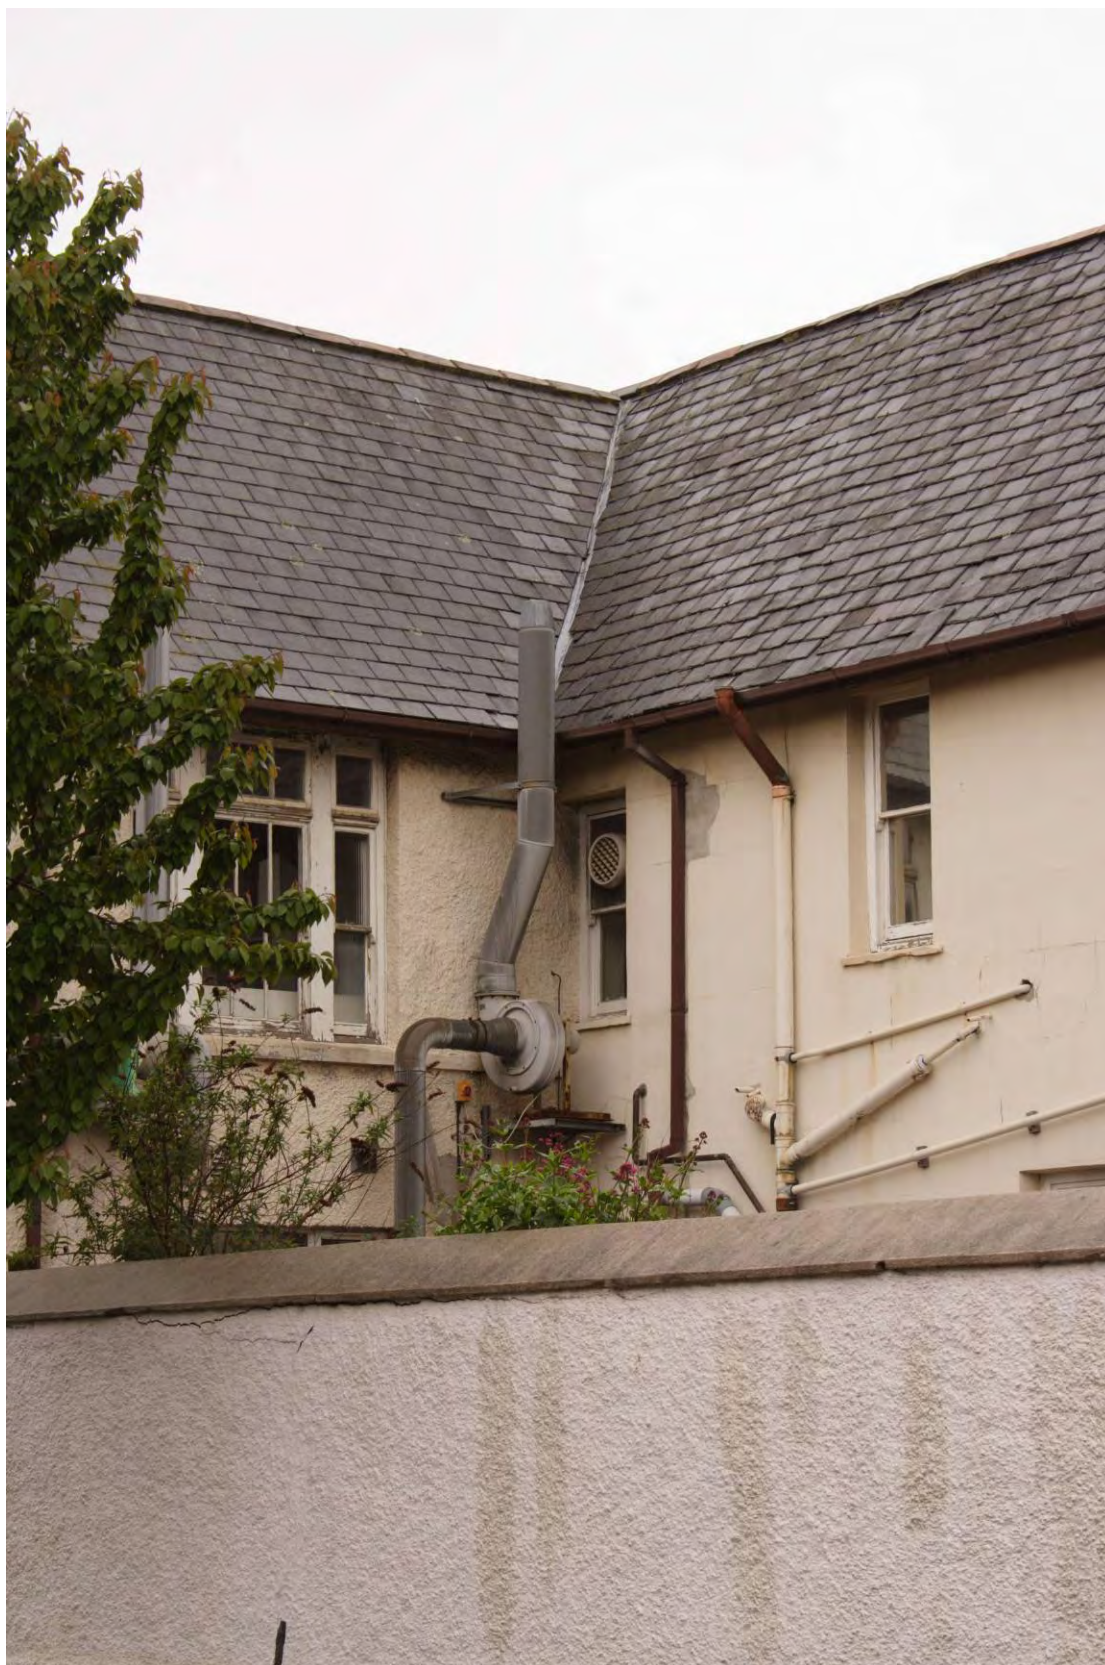
Photo 11: Junction between western block and additional structure fronting Caradoc Road

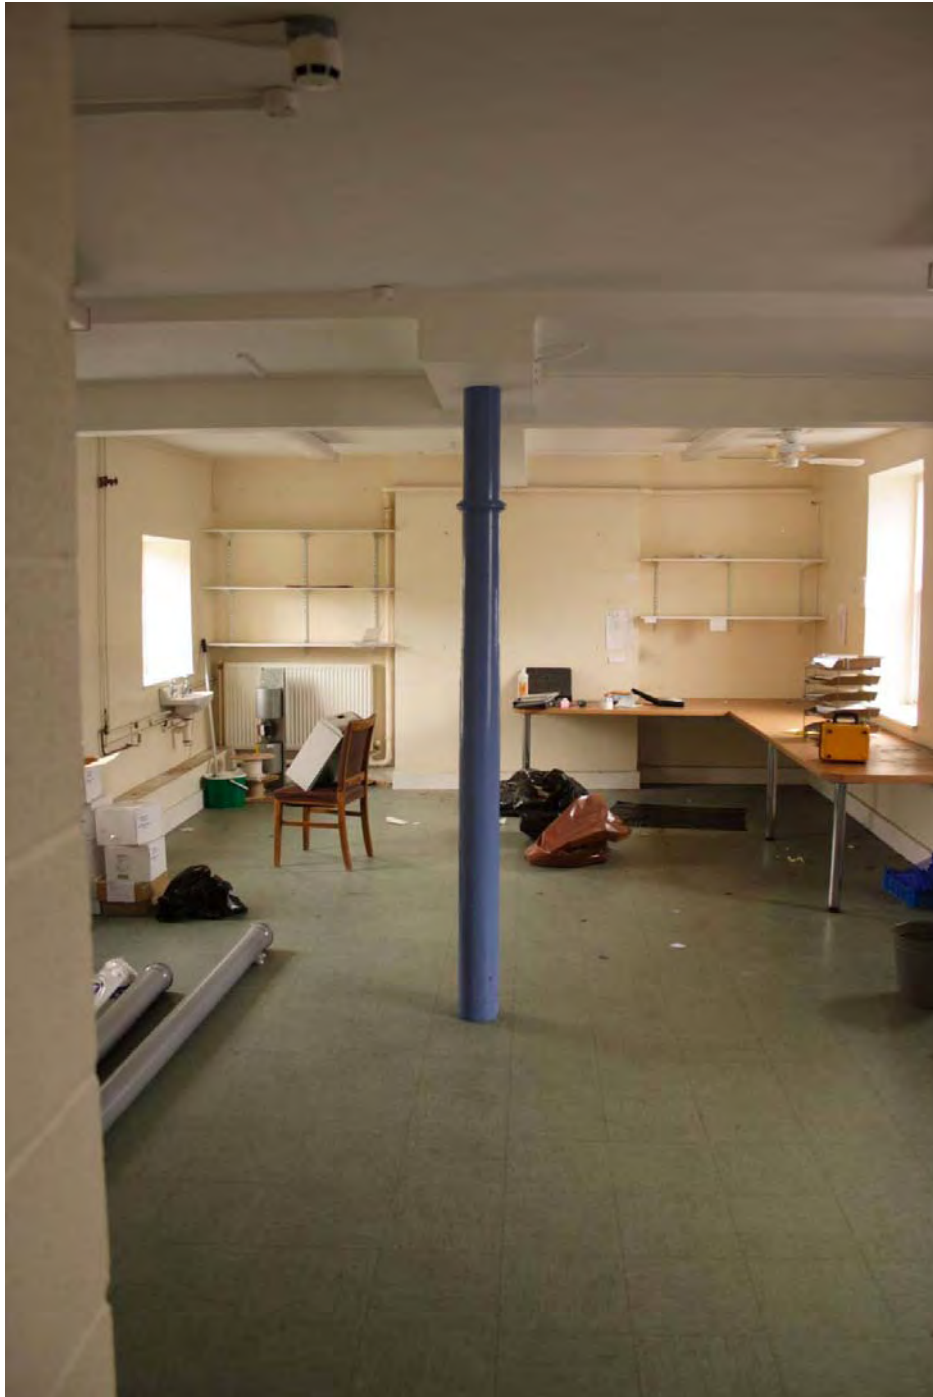
Photo 12: Ground floor of eastern block facing west towards covered fireplace

4.2.2 The ground floor of the eastern block was vacant when the buildings appraisal was undertaken. This allowed full view of the groundfloor of this building (photo 12 and 13) which was 10.80m x 4.85m in size. A covered fireplace was visible at the western end of the room (photo 12), corresponding with the large chimney above at the junction between the western and eastern blocks of the workhouse. A modern breeze-block internal addition was present at the south-eastern end of the building (photo 13) associated with the extension to the building that projected from the southern façade at ground level.

4.2.3 A steel column is present midway along the room supporting the second storey floor (photos 12 and 13). The column has a simple band decoration at a height of 1.84m from floor level (photo 14). There would appear to have been some alteration in the ceiling as there is a change in height just after the pillar,

and a non-continuous ceiling beams stops just to the east of the column (photo 12).

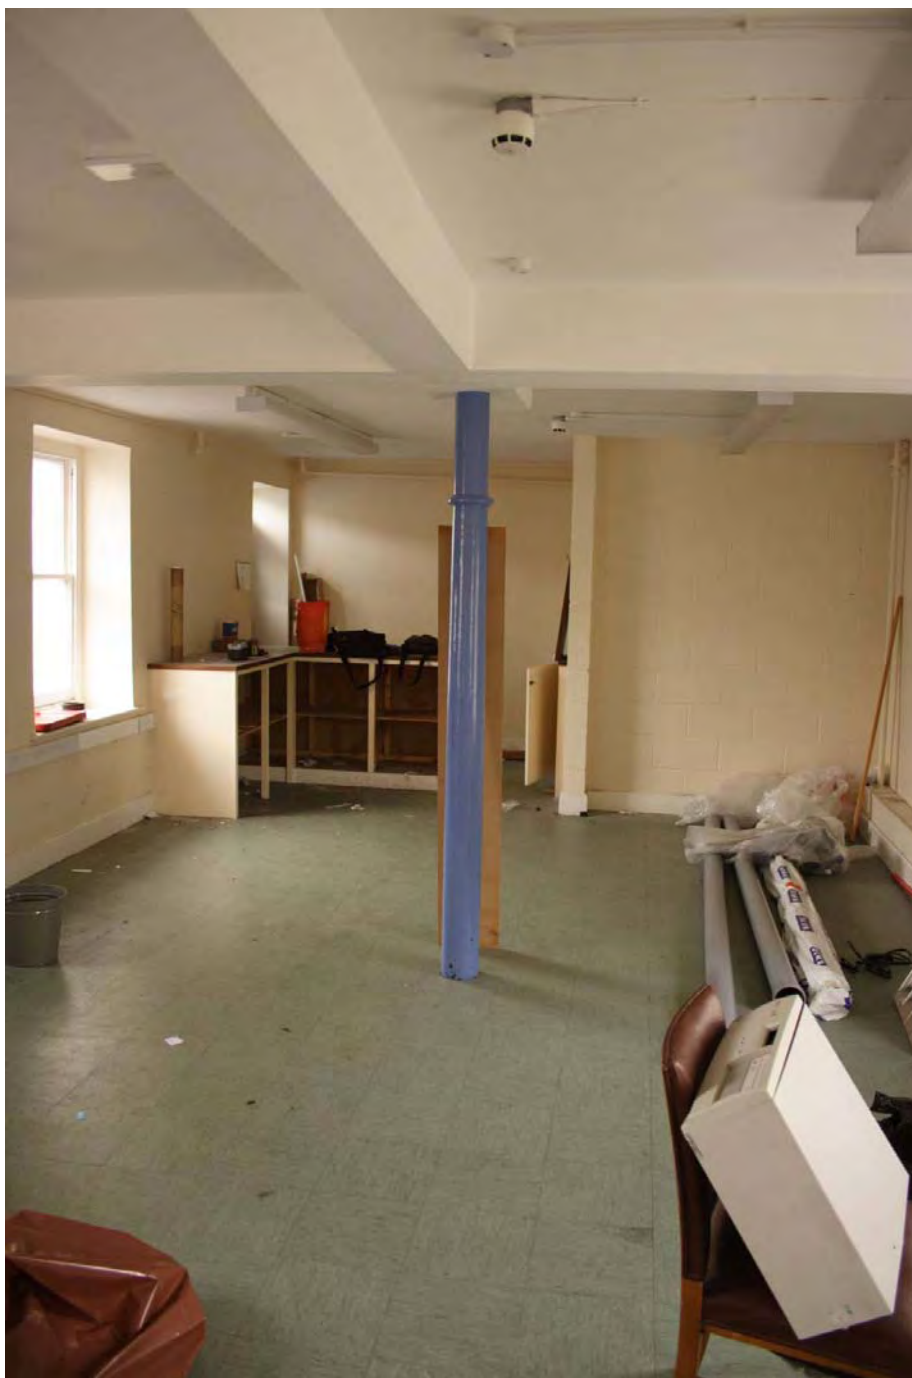
Photo 13: Ground floor of eastern block facing east towards breezeblock addition

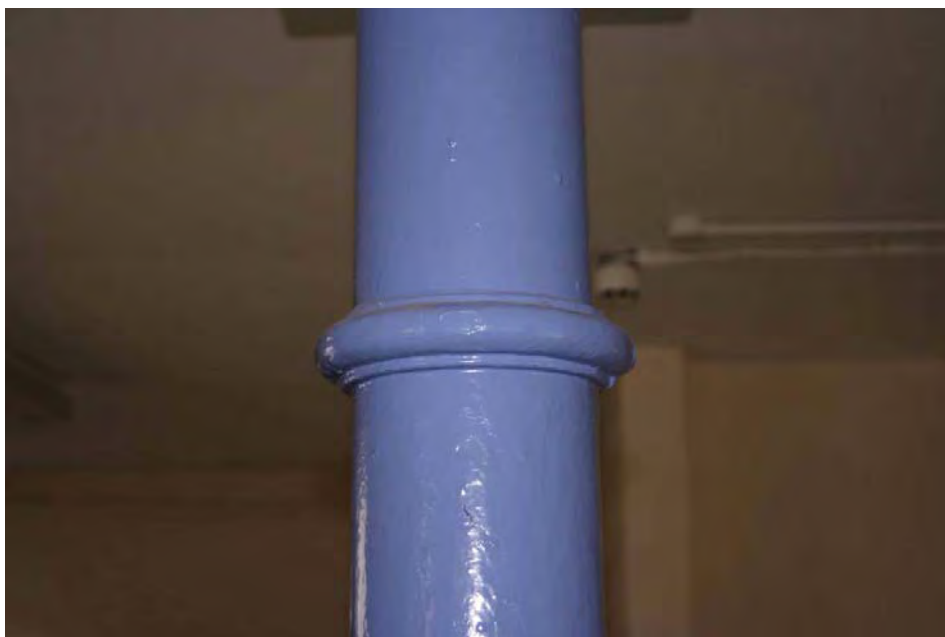
Photo 14: Detail of steel column decoration

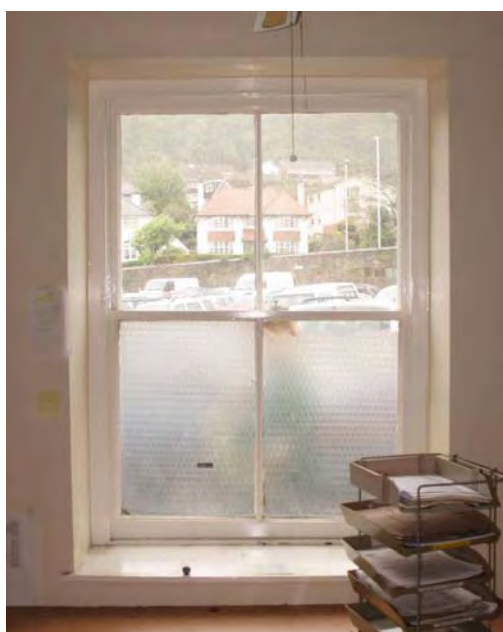
4.2.4 Two windows and two doorways are present in the northern wall of the room. The two windows are both 8-paned sashes (photo 15 and 16), and the windows openings are roughly the same sizes (eastern – 1.18m wide x 1.62m in height; western 1.15m wide x 1.56m in height). The windows themselves are very basic with no decoration or horns and may be simple functional windows placed within one of the day rooms. The doorways have been modernised and no original features remain. It is possible that one of the doorways is an adapted window opening, but this could not be confirmed.

Photo 15: Detail of western window
north wall

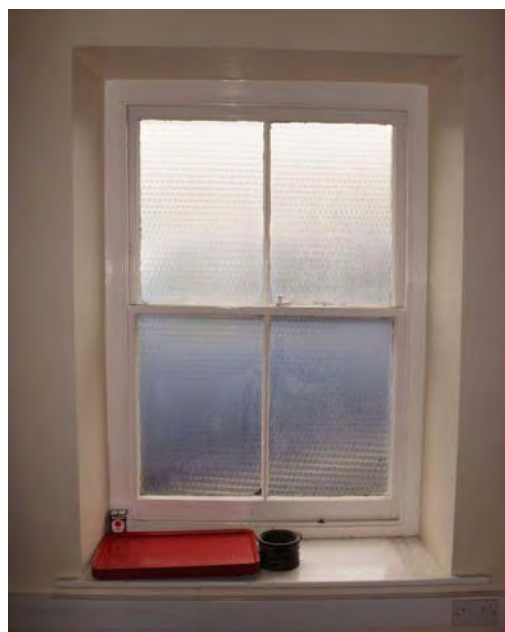
Photo 16: Detail of eastern window
north wall

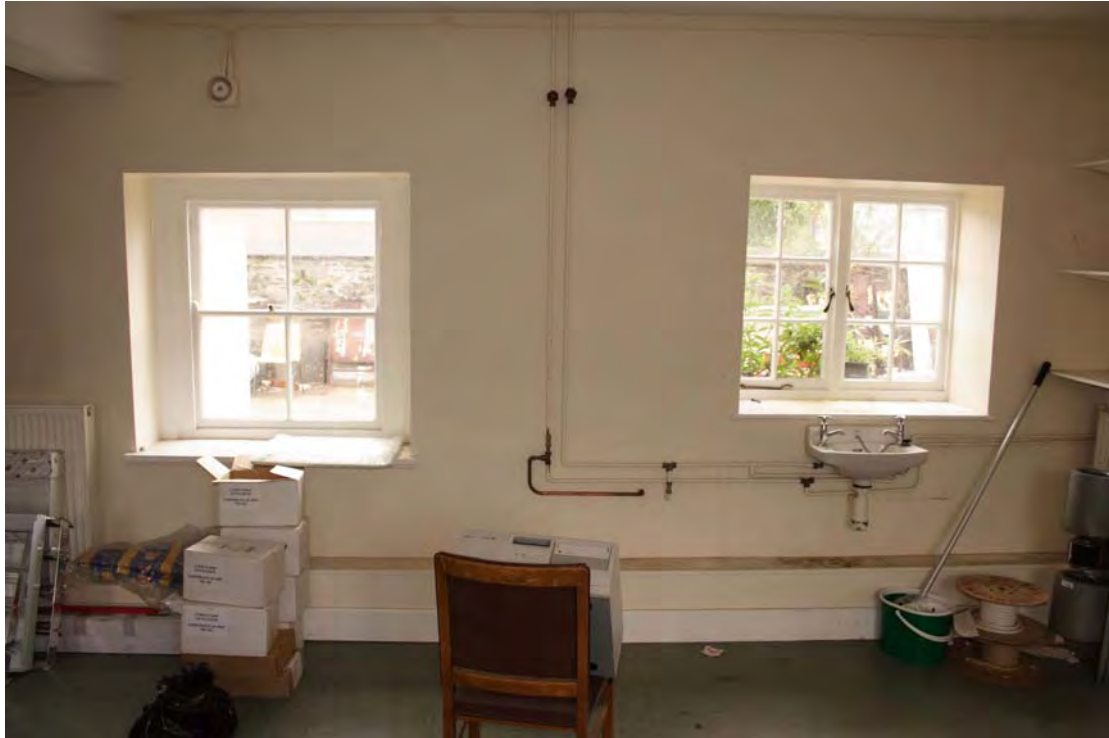
4.2.4 The south wall has only two windows visible (photo 17). A doorway may be present behind the breeze block addition. The eastern window is an 8-paned sash, whereas the western one is a 12-paned casement window. The window openings are different sizes (eastern – 1.18m wide x 1.18m in height; western 1.14m wide and 1.00m in height). The western window opening may be original but adapted (height reduced), although this is unclear. The sash window is basic but does have vertical horns at the top of the lower frame.

Photo 17: South wall showing (view south) showing window openings

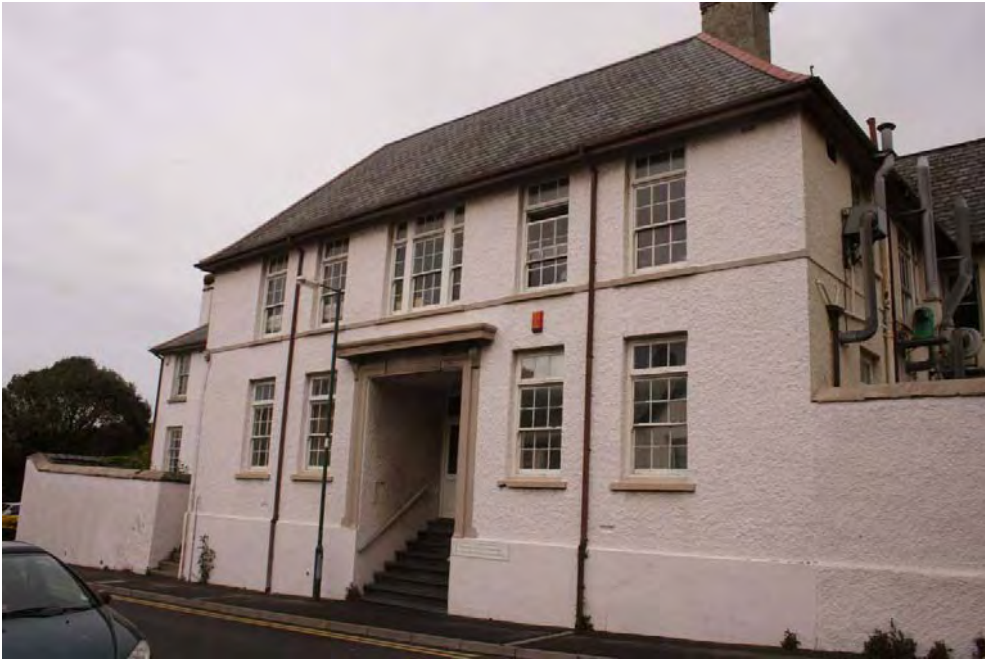
Photo 18: Caradoc Road frontage of Caradoc Road building

- 4.3.1 As noted above, the main building which currently fronts Caradoc Road (and which is attached to the south wing of the former workhouse), was constructed before 1939. The building has an ornate entrance with moulded stone architrave and a stone flat hood/cornice above leading onto Caradoc Road comprising a set of large slate steps leading into the building to a main entrance way (photos 18 and 19). A frieze is present below the cornice, but no evidence of engraving or removed plaque / sign is visible.
- 4.3.2 The building has a hipped roof to the west and partially hipped to the east, leading into a projection which is joined into that of the main workhouse (as can be seen in photo 8). The building is tiled in slate, with red ceramic ridge tiles along the apexes of the roof.

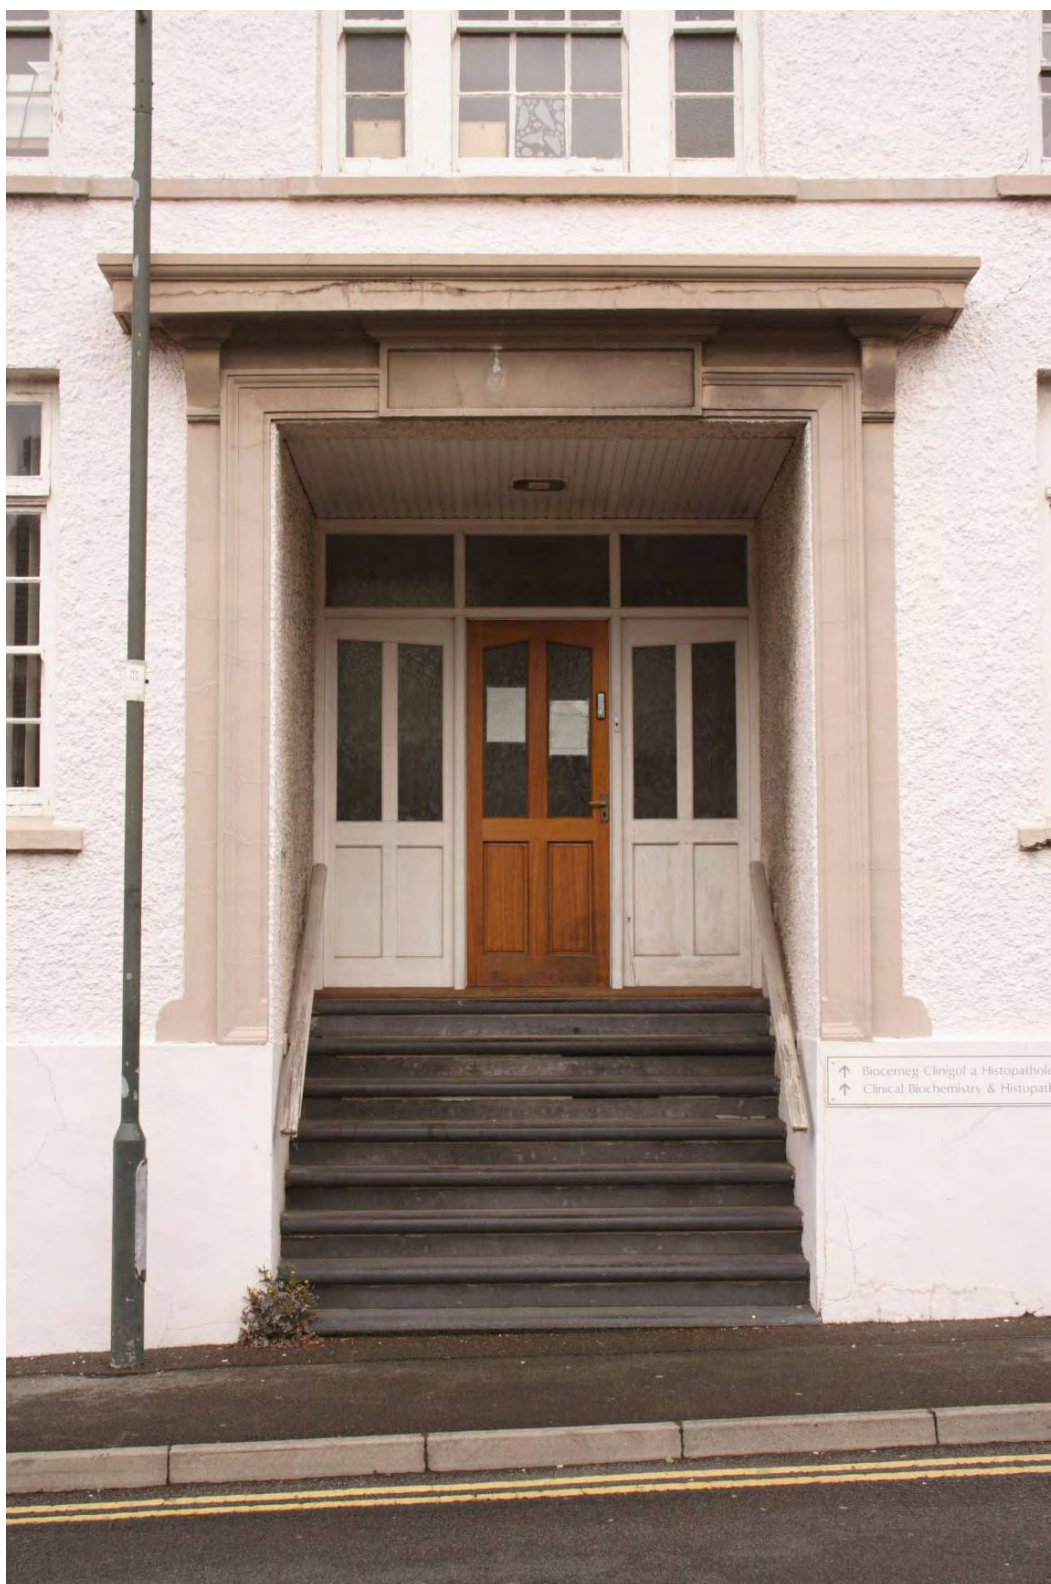
Photo 19: Slate steps leading up from Caradoc Road to main entrance of Caradoc Road building

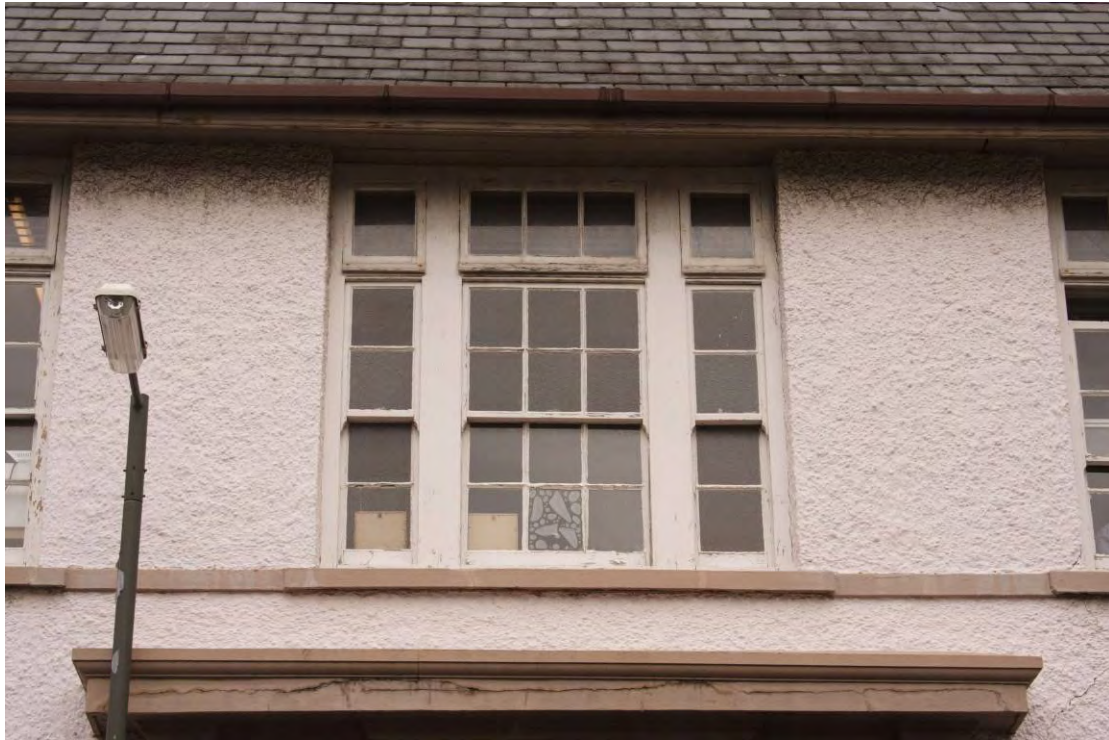
Photo 21: Detail of central sash window above main entrance of Caradoc Road

4.3.2 The sash windows within this building are of a more ornate type than the original ones on the south wing of the workhouse. Those on the frontage are all 15-pane windows comprising a standard 12 paned sash with a bottom opening casement of three panes above. The central window above the entrance (photo 21) also has narrow 5 paned windows to either side (4 paned sashes, with single bottom opening casement above) separated by wide wooden dividers. Similar styled windows with the wooden dividers are present in places on the southern wing of the workhouse, although the top row of bottom opening casements are not present. The sashes have simple moulded horns.

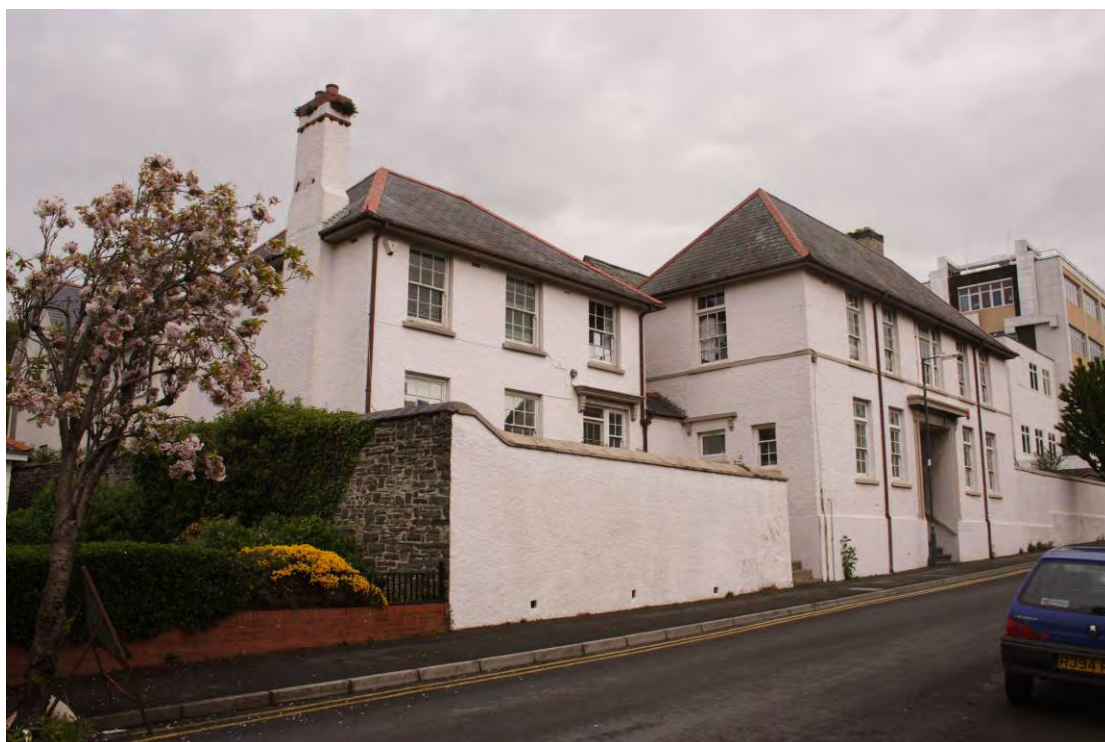
4.3.3 To the west of the main building fronting Caradoc Road is another presumably contemporary structure (photo 22 and 23). The structure is simpler in nature, and has the appearance of a dwelling. The structure may have provided new living quarters for the staff of the Poor Law Institution, at which point it would have acted more as an infirmary for the elderly, frail, disabled and mentally ill, requiring more specialised nursing care. Alternatively it may have been a single residence for the medical officer of the infirmary or similar. A number of features are very similar between the two buildings, including the stone flat hood/cornice above the front door (photo 24) and the slate tiled roof with red ceramic ridge tiles (photo 22 and 23).

Photo 22: View from south-west showing the two buildings fronting Caradoc Road

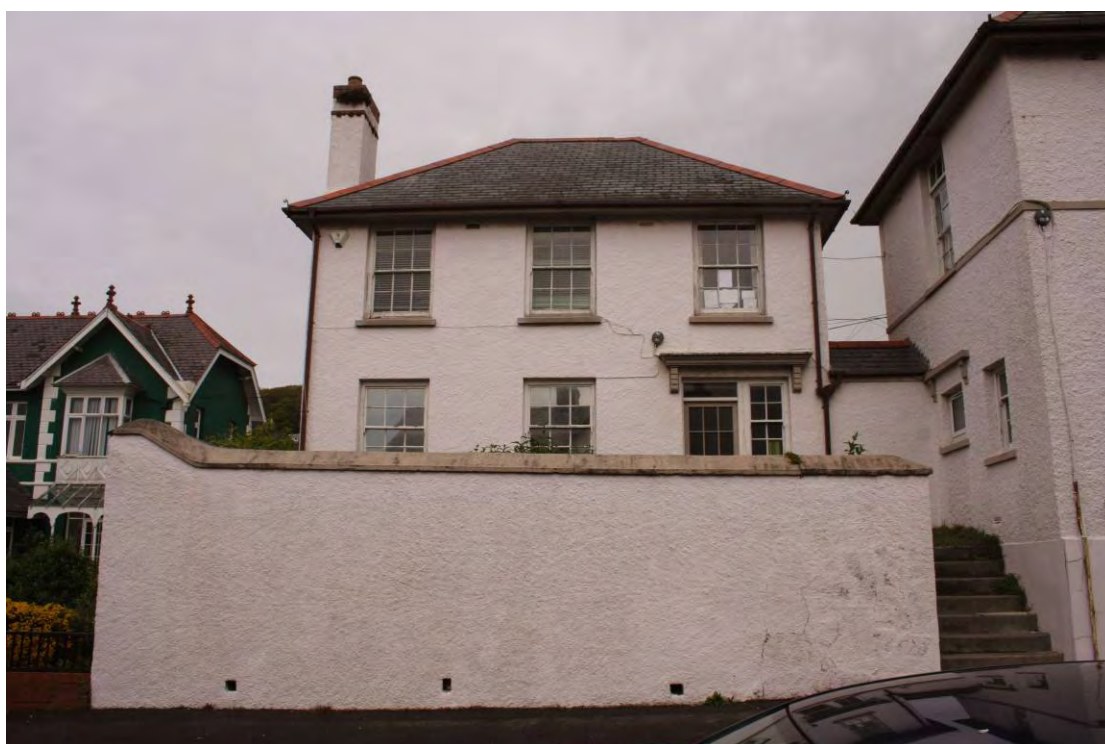
Photo 23: Building attached to the west of building on south-western corner of former workhouse (Caradoc Road frontage)

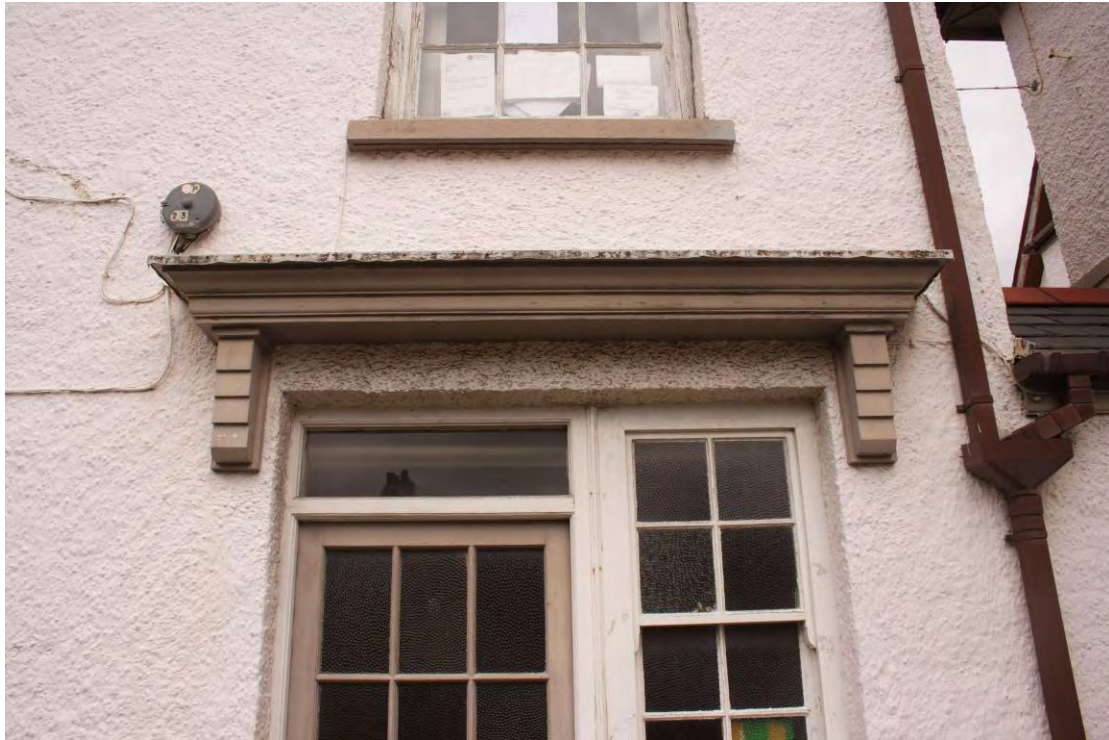
Photo 24: Stone cornice above doorway entrance of western building on Caradoc Road frontage
