ABERYSTWYTH WORKHOUSE, BRONGLAIS HOSPITAL (SN 5911 8182)

HISTORIC BUILDINGS APPRAISAL

Prepared by Dyfed Archaeological Trust
For: Laing O'Rourke

RHIF YR ADRODDIAD / REPORT NO. 2009/51
RHIF Y PROSIECT / PROJECT RECORD NO. 95175

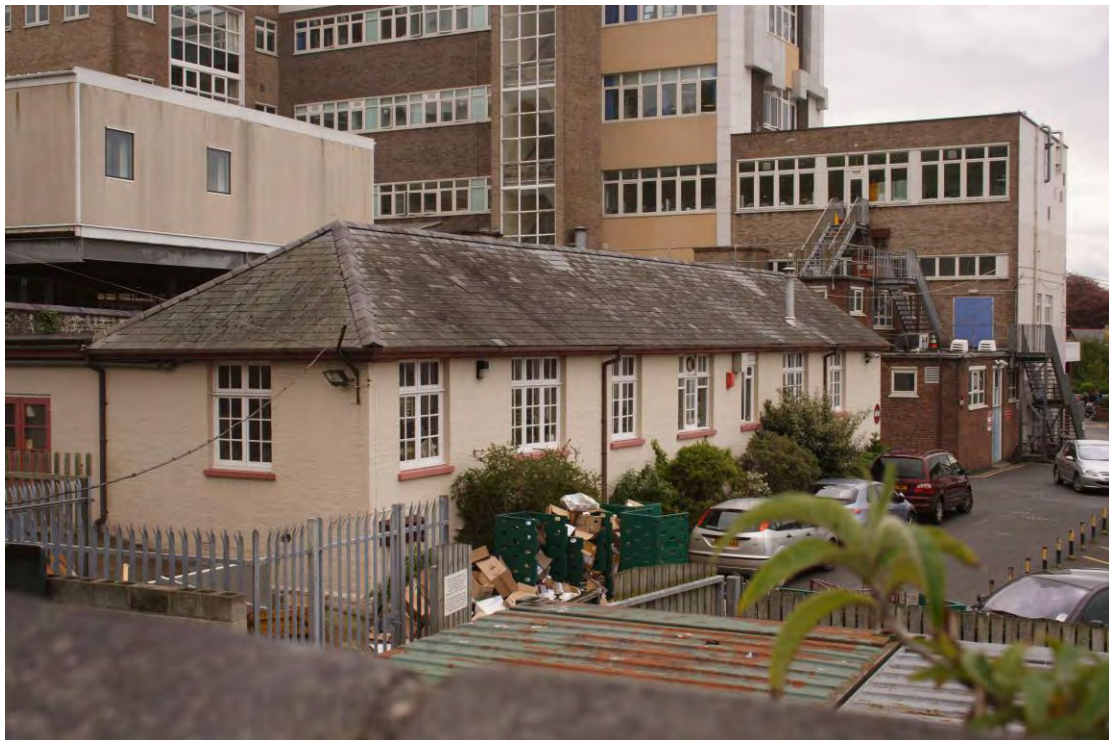
Photo 25: Estate Workshops western façade viewed from Penglais Road

4.3.3 The estates workshop lies to the north-east of the south wing of the former workhouse. The building is first shown on the 1939 Ordnance Survey map, and it is unclear if the building was actually part of the Poor Law Institution. The building is single storey. All of the windows have been replaced with modern double-glazing. The roof is hipped, a similar

style to those buildings on Caradoc Road frontage, but have grey ceramic ridge tiles. The building has been extended externally on its eastern side, with flat roofed additions surrounding the original hipped roof, as can be seen on photo 26. The building may have been associated with the workhouse, but its original function is not known.

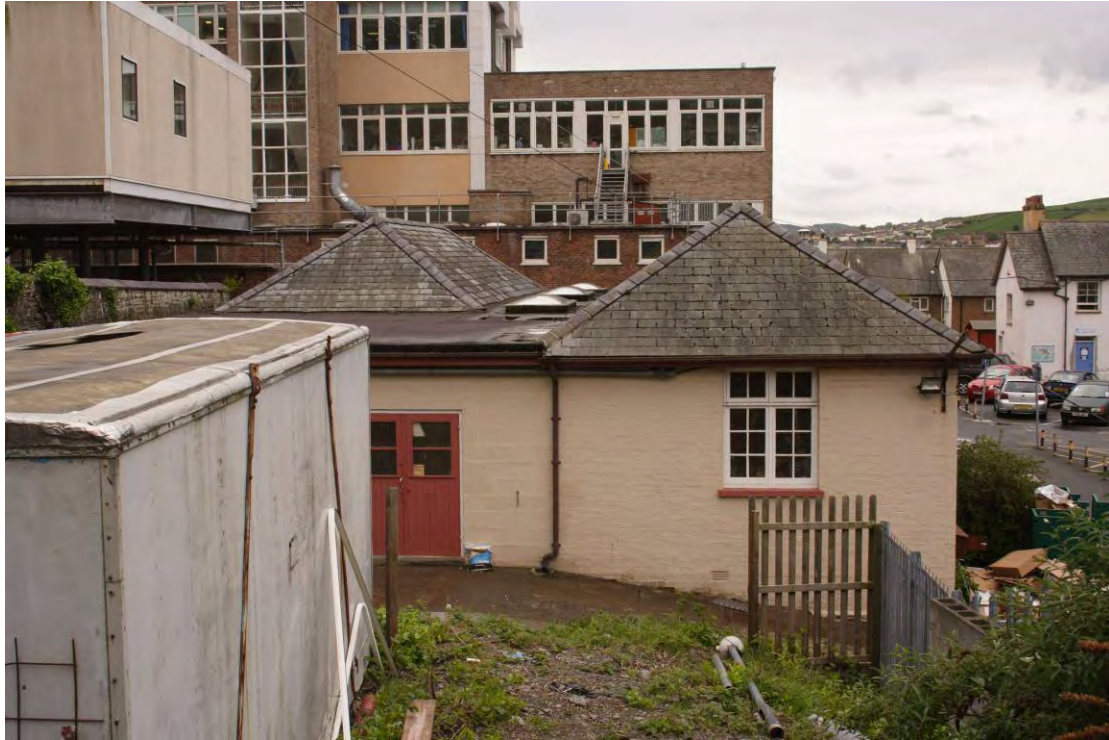
Photo 26: North gable ends of estates workshops viewed south from Bronglais Road (the eastern end of the surviving wing of the workhouse is just visible on the right hand side of the photograph)
