**LLANSADURNEN PARISH CHURCH,  
CARMARTHENSHIRE  
(SN 2816 1026)  
ARCHAEOLOGICAL WATCHING BRIEF**

Prepared by Dyfed Archaeological Trust  
For: Salem Construction

RHIF YR ADRODDIAD / REPORT NO. 2009/83  
RHIF Y PROSIECT / PROJECT RECORD NO. 98515

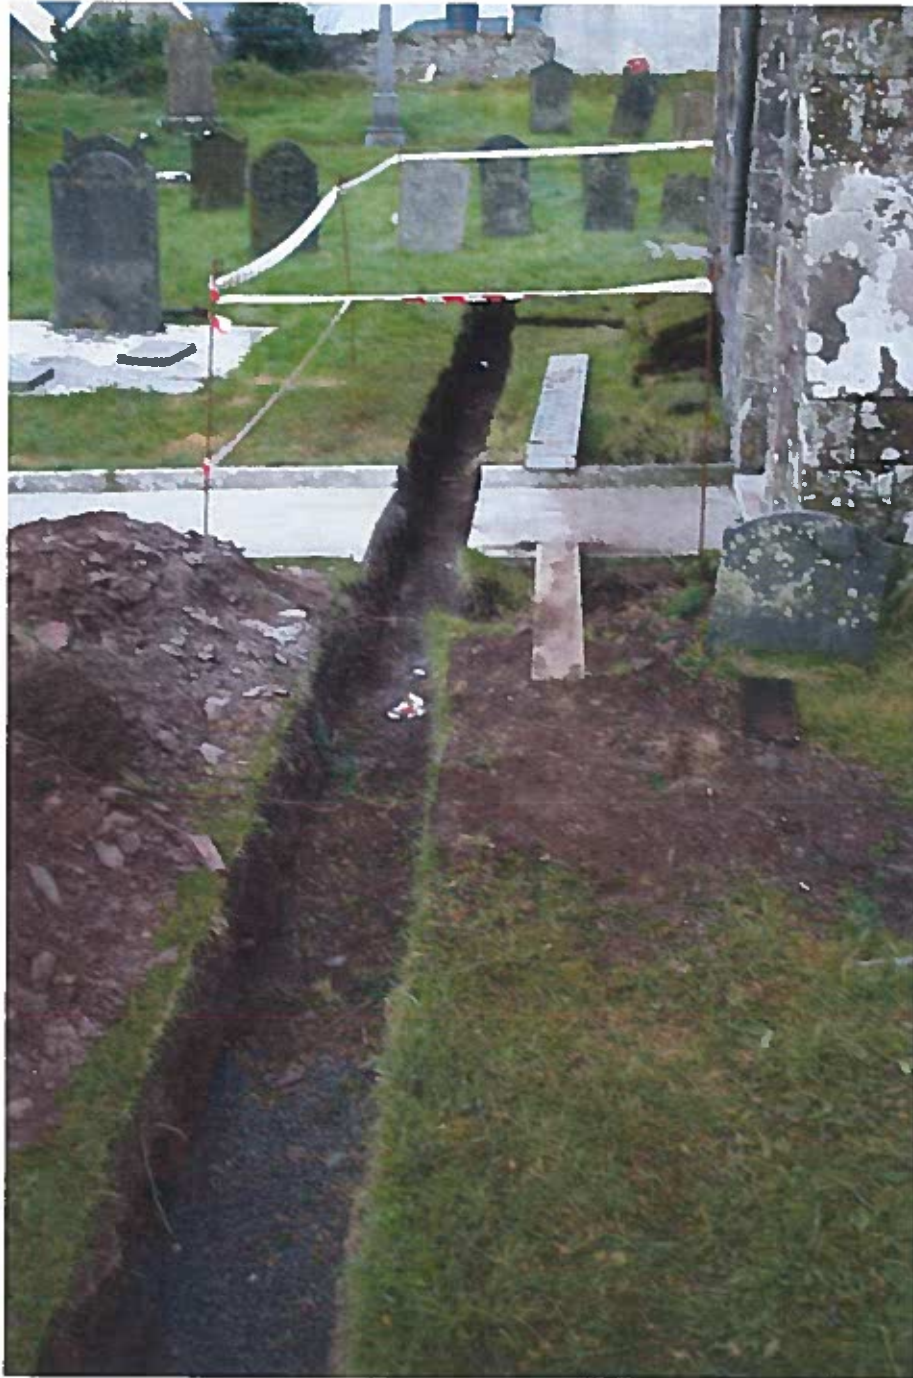
The excavation of the drainage trench revealed dark brown silt clay topsoil, which was 0.15m in depth and contained occasional flecks of mortar. Underlying the topsoil was a mixed mortar layer 0.15m in thickness containing rare pieces of roofing slate and occasional small sub angular stones. This layer appeared to be a building debris layer, which possibly relates to the rebuilding of the church in 1859.

The subsoil was revealed at a depth of 0.30m below the churchyard ground surface and comprised a light reddish brown silt clay containing rare flecks of mortar and rare pieces of disarticulated human bone.

**Photo. 1:** West facing section of Drainage pipe cut.

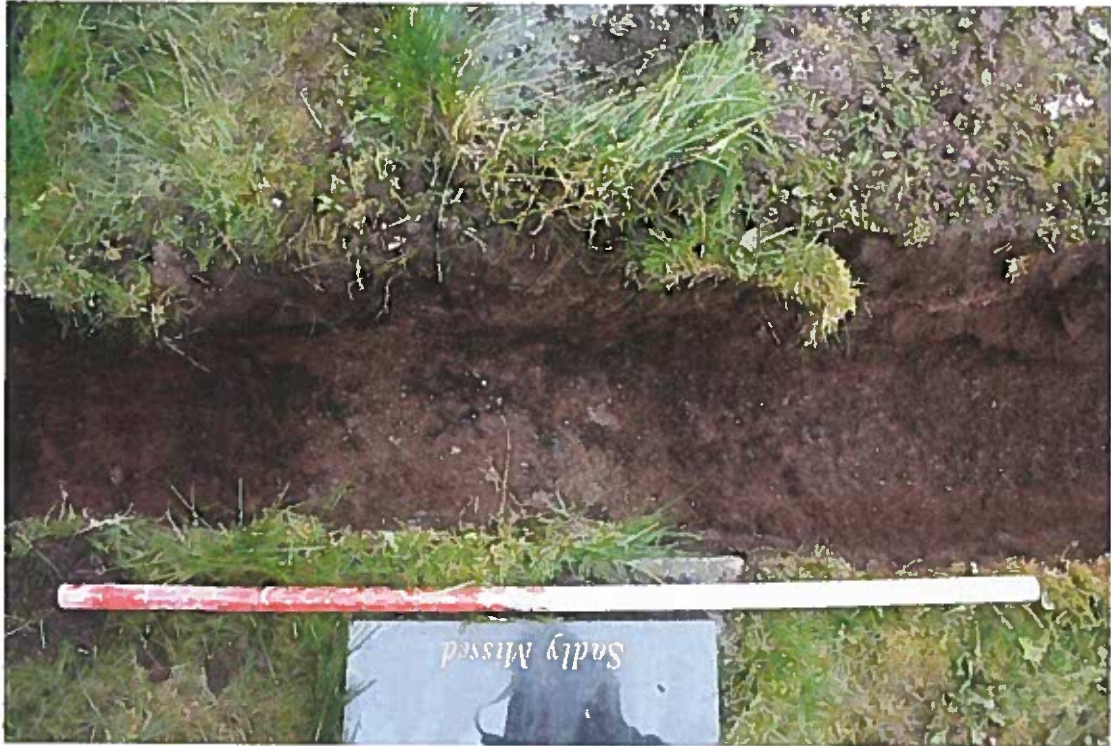
A linear feature measuring 0.41m in width and 0.38m in length was observed running northeast to southwest across the trench. Due to the trench being relatively small it is difficult to discern whether this was a possible grave cut. It was noted that the fill of the feature was a light reddish brown silt clay mixed with mortar and building debris, perhaps suggesting that this feature post-dates the 1859 rebuilding of the church and that the back fill of the feature included material from the building debris layer seen at a higher level.

**Photo. 2:** Probable 19<sup>th</sup> century grave cut revealed in Drainage cut on south end of church.

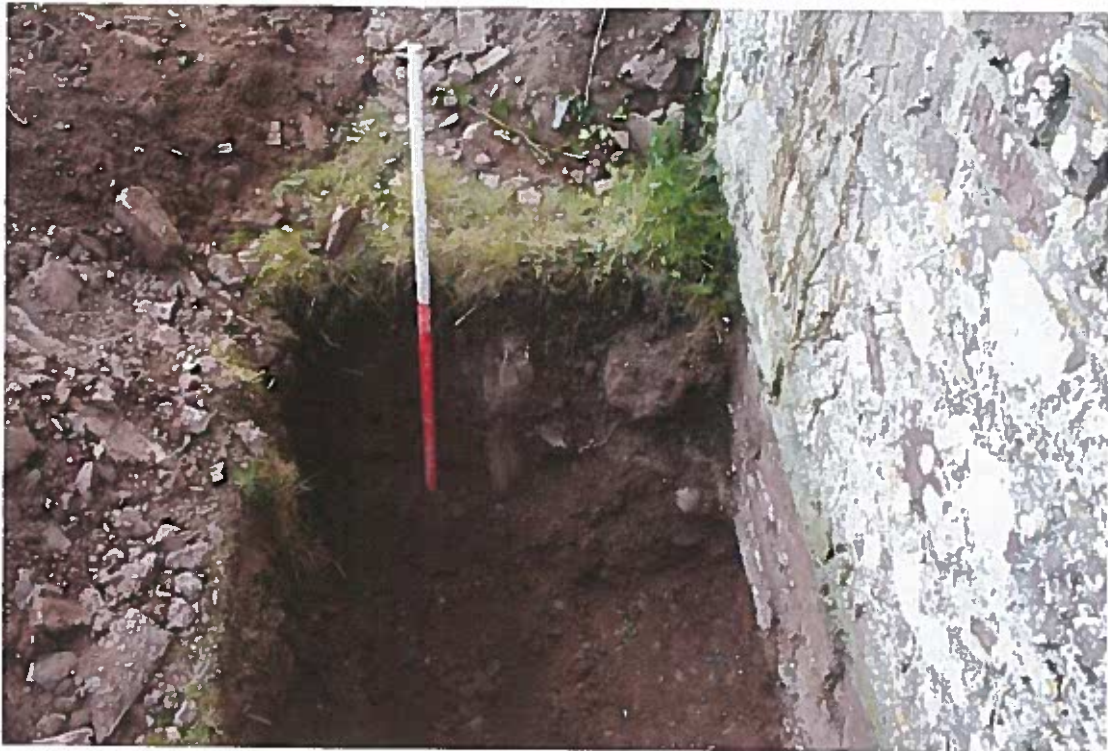
Part of a geotechnical test pit was excavated by hand on the eastern side of the church to expose the base of the foundation of the church wall. The pit measured 1.30m running parallel to the church wall and 1.10m perpendicular to the building. The pit was not excavated to a significant depth as it was felt that it had the potential to significantly disturb any underlying deposits and following discussion with the client it was agreed that further discussions should be held with the archaeological advisor to the DAC before it was completed. The southern section of the pit revealed what was possibly either the foundations of the 1859 church or potentially the foundations of an earlier church wall, conceivably of medieval date. Unfortunately no dating material was discovered, and it is not possible to confirm the date of the foundations.

The archaeological watching brief has demonstrated that the churchyard at Llansadurnen still has the potential to contain significant archaeological remains, associated with both the 1859 rebuild of the church and evidence for earlier church building remains. Possible remains of an earlier church wall were recorded in the aborted geotechnical test pit excavated at the eastern end of the church, although the date of this could not be confirmed without further investigation.

**Photo. 3:** view South of possible earlier church wall or foundations.

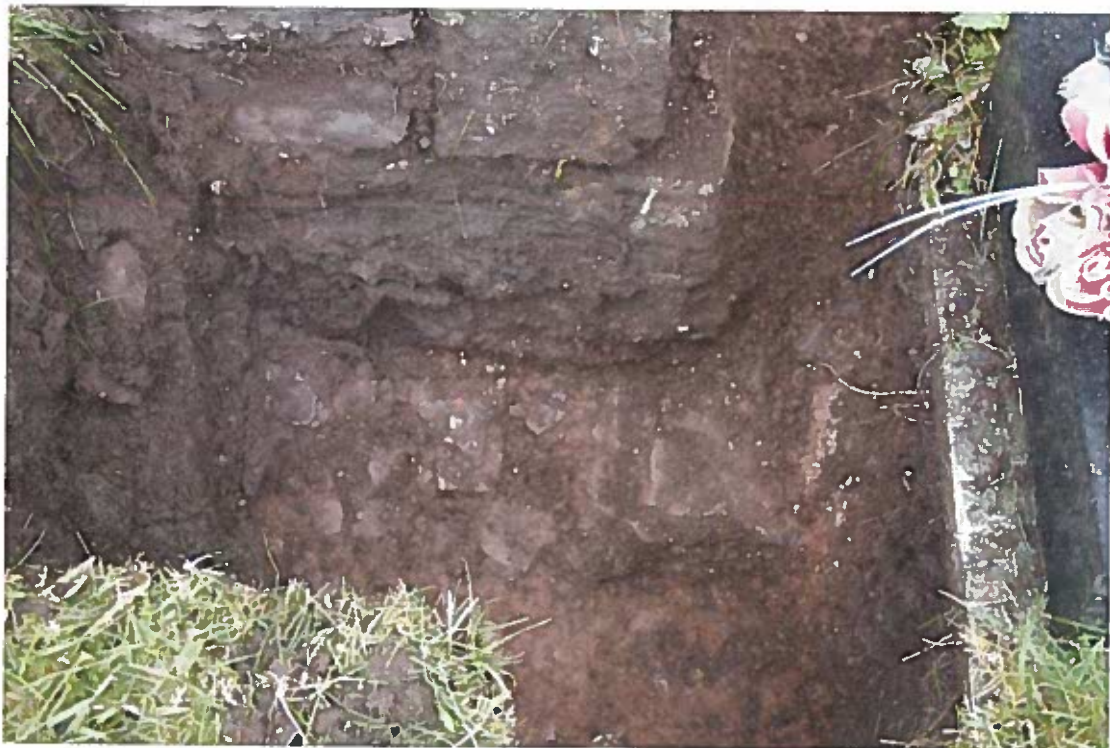
The northern end of the trench was excavated up to the church wall and revealed the possible footings of the 1859 rebuild of the church wall.

**Photo. 4:** View looking north in first trench showing footings of church.
