**LLANSADURNEN PARISH CHURCH,  
CARMARTHENSHIRE  
(SN 2816 1026)  
ARCHAEOLOGICAL WATCHING BRIEF**

**November 2009**

RHIF YR ADRODDIAD / REPORT NO. 2009/83  
RHIF Y PROSIECT / PROJECT RECORD NO. 98515

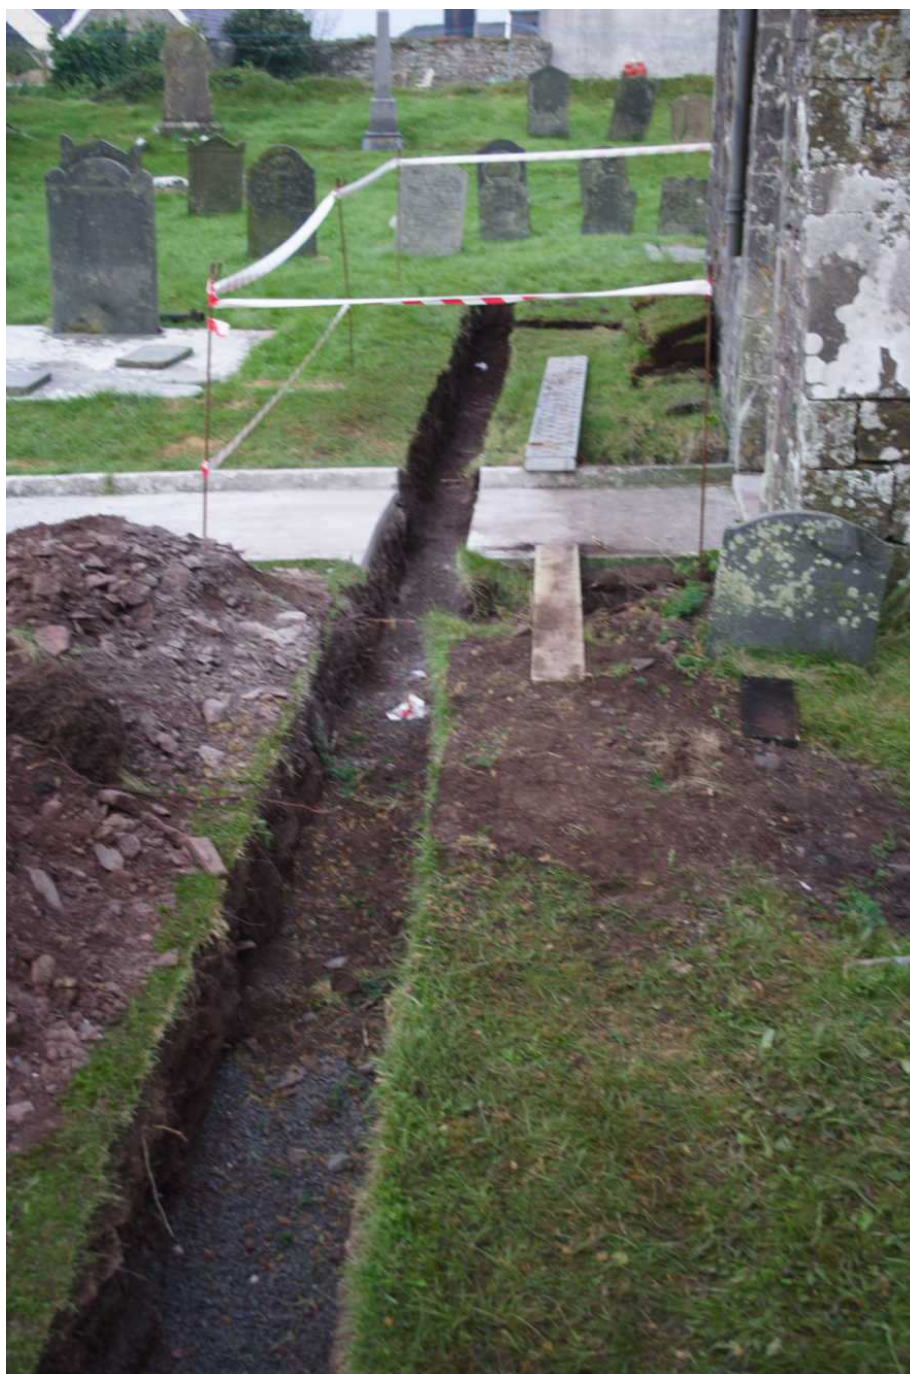
The excavation of the drainage trench revealed dark brown silt clay topsoil, which was 0.15m in depth and contained occasional flecks of mortar. Underlying this layer the topsoil was a mixed mortar layer 0.15m in thickness containing rare pieces of roofing slate and occasional small sub angular stones. This layer appeared to be a building debris layer, which possibly relates to the rebuilding of the church in 1859.

The natural subsoil was revealed at a depth of 0.30m below the top of the churchyard's ground surface grass surface and was comprised a light reddish brown silt clay containing rare flecks of mortar and rare pieces of disarticulated human bone.

**Photo. 1:** West facing section of Drainage pipe cut.

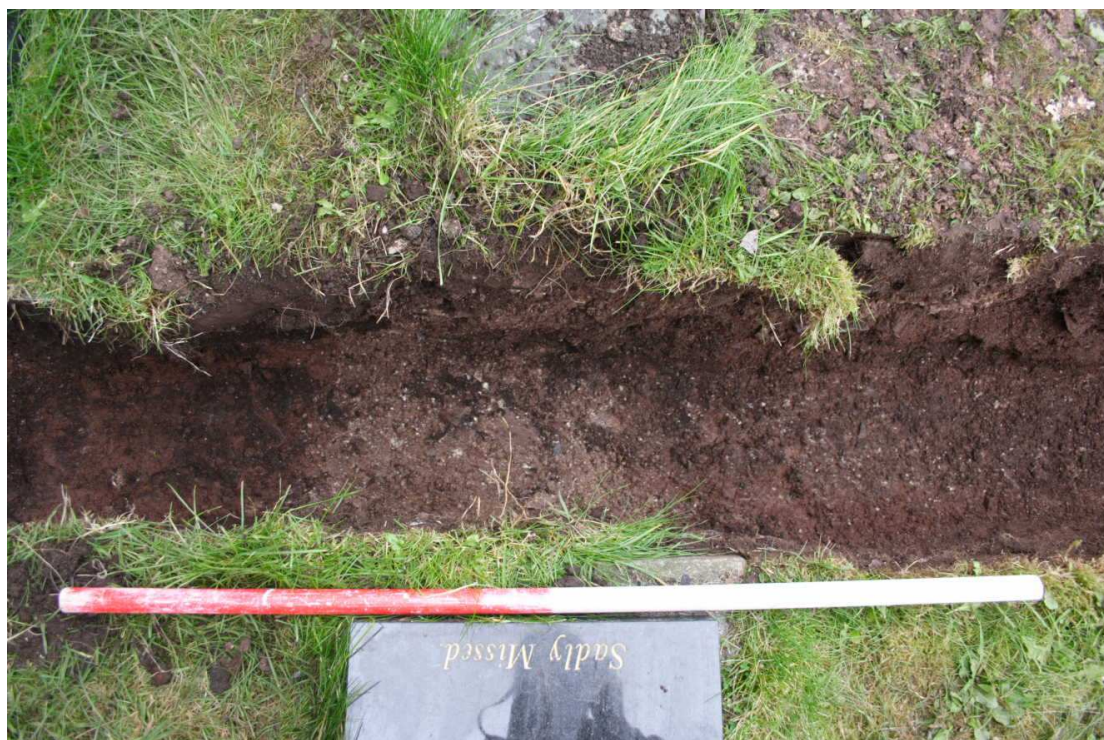
A linear line-feature measuring 0.41m in width and 0.38m in length was observed to be running northeast to southwest across the trench disappearing under either side. Due to the trench being relatively small it is difficult to discern whether this was a possible grave cut. It was noted that the fill of the feature was a light reddish brown silt clay which contained 40% mixed with mortar, and building debris, perhaps suggesting which would suggest that this feature was possibly created after the post-dates the 1859 rebuilding of the church and that the back fill of the feature fill of the feature has come from the backfilling of the disturbed upper layers included material from the building debris layer seen at a higher level.

**Photo. 2:** Probable 19<sup>th</sup> century grave cut revealed in Drainage cut on south end of church.

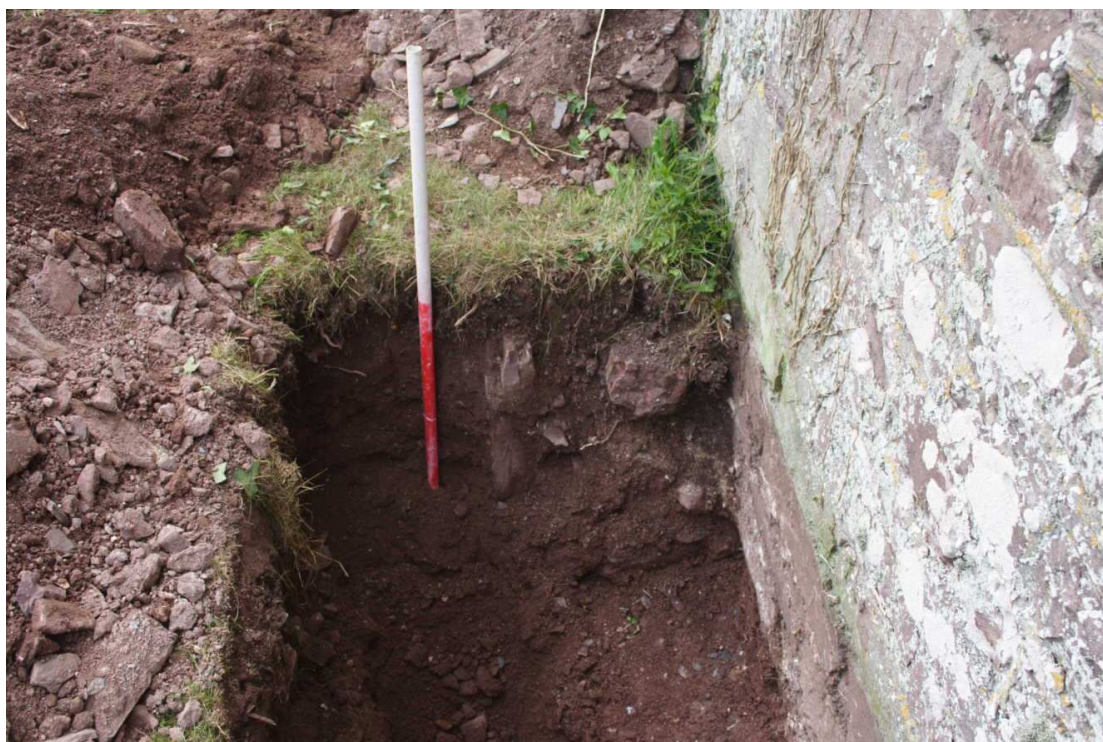
Part of a geotechnical test pit was excavated A pit for the engineer to view was excavated by hand on the eastern side of the church and to expose the base of the foundation of the church wall. The pit measured 1.30m running parallel to the church wall and 1.10m out perpendicular east of to the building. The pit was not excavated to a significant depth as it was felt that it had the potential to significantly disturb any underlying deposits and following discussion with the client it was agreed that further discussions should be held with the archaeological advisor to the DAC before it was completed. The southern section of the pit revealed what was possibly is either the foundations of the 1859 church or potentially the foundations of the an earlier much older Medieval church wall, conceivably of medieval date. Unfortunately no dating material was discovered, however and it is not possible to confirm the date of the foundation this hypothesis cannot for certainly be ascertained without further excavation.

The archaeological watching brief has demonstrated that the churchyard at Llansadurnen still has the potential to contain significant archaeological remains, associated with both the 1859 rebuild of the church and evidence for earlier church building remains. Possible remains of an earlier church wall were recorded in the aborted geotechnical test pit excavated at the eastern end of the church, although the date of this could not be confirmed without further investigation.

**Photo. 3:** view South of possible earlier church wall or foundations.

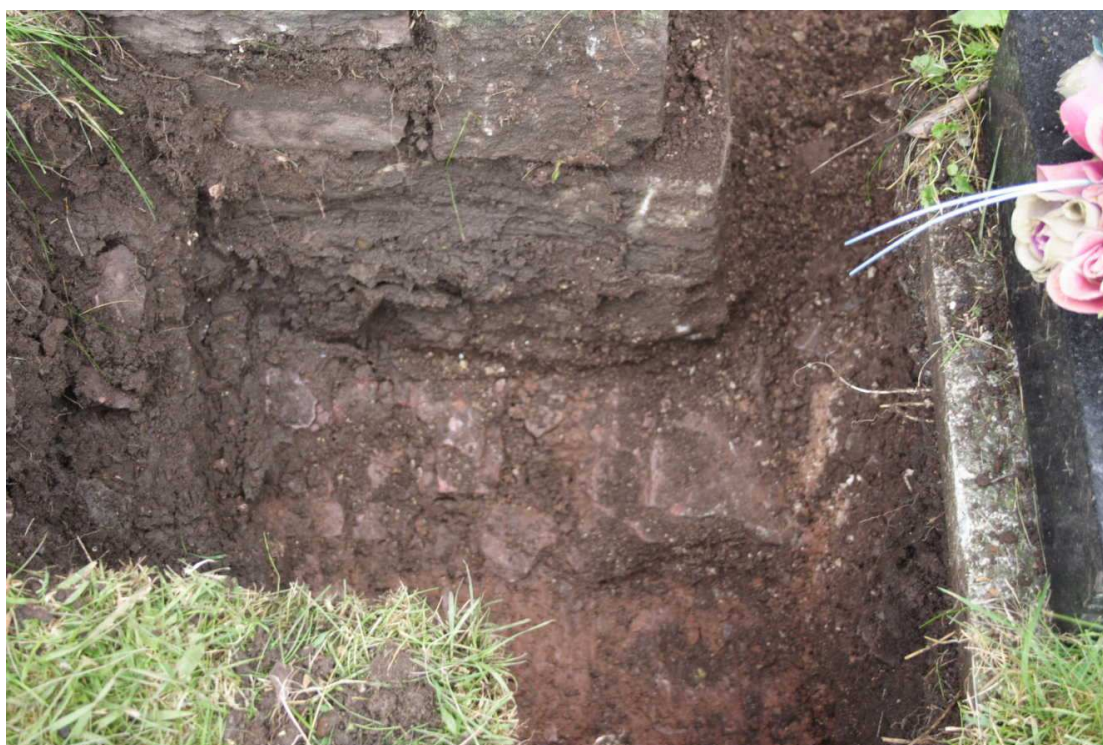
The northern end of the trench was excavated up to the church wall and revealed the possible footings of possibly the 1859 rebuild of the church wall.

**Photo. 4:** View looking north in first trench showing footings of church.
