ST. DAVID'S CHURCH, MEIDRIM, CARMARTHENSHIRE (SN 2891 2086) ARCHAEOLOGICAL WATCHING BRIEF

RHIF YR ADRODDIAD / REPORT NO. 2009/84
RHIF Y PROSIECT / PROJECT RECORD NO. 98516

James Meek

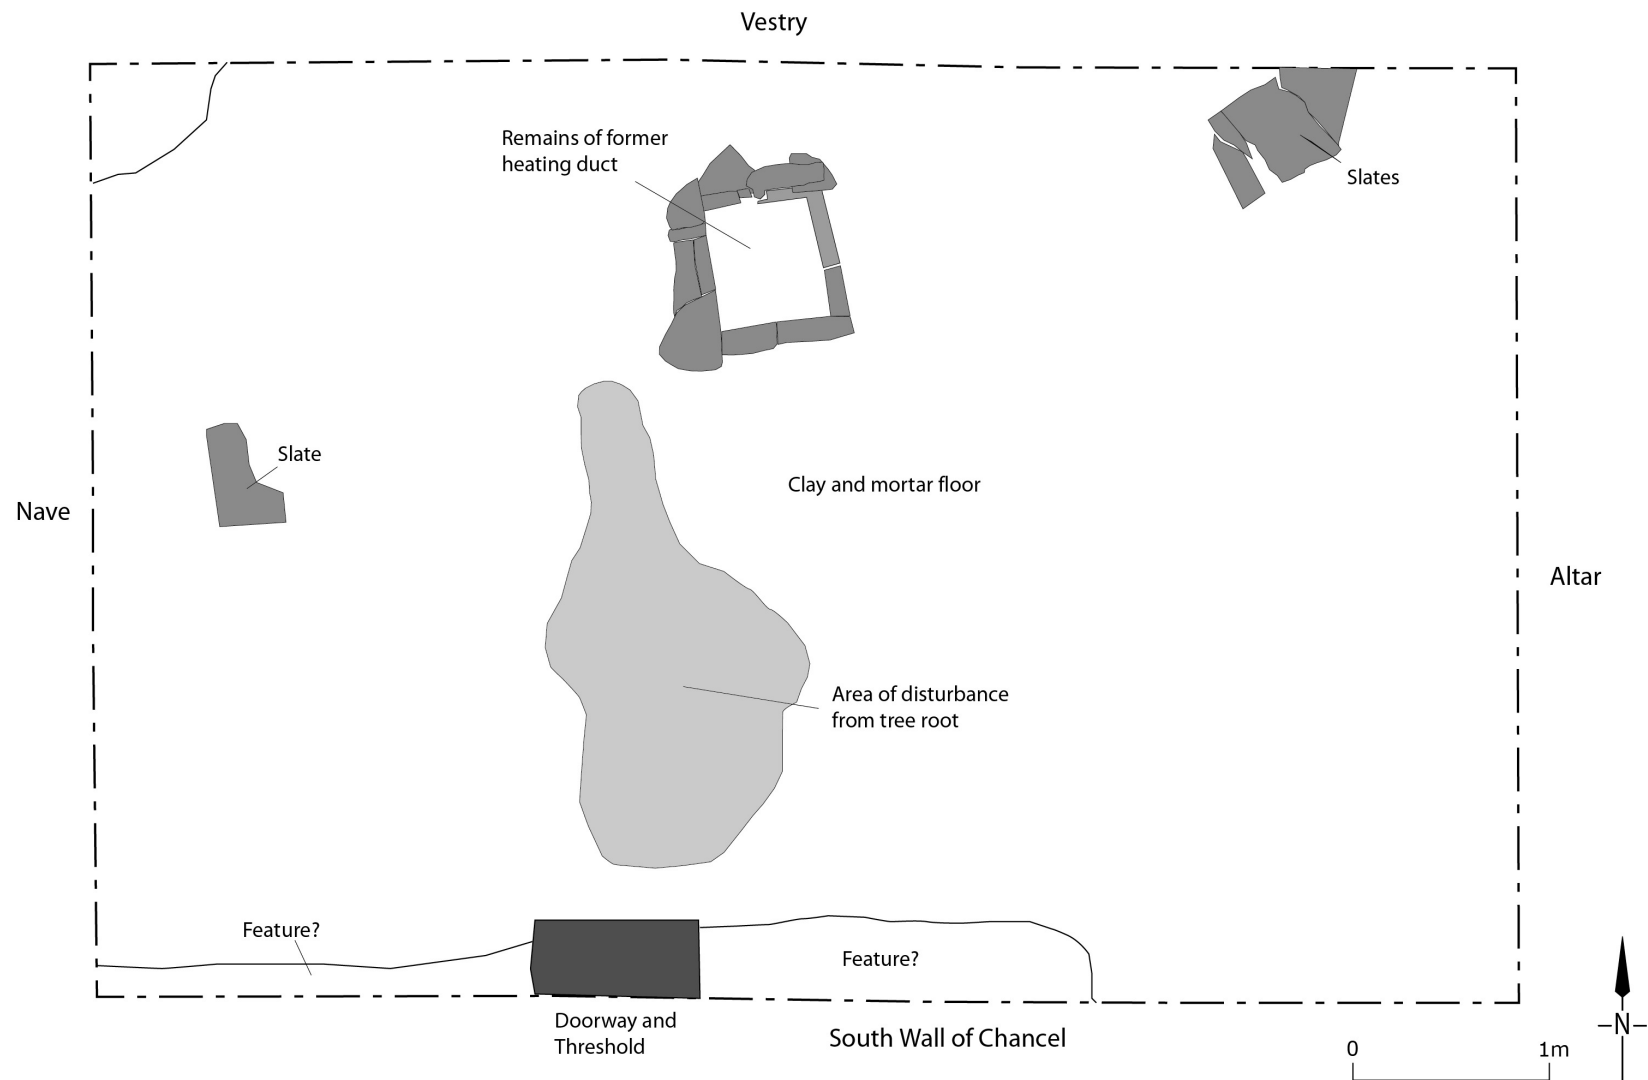
Figure 4: Plan of Chancel Floor following removal of concrete floor and rubble

- 3.2.6 Following removal of the concrete and rubble from the entire area of the chancel, the earlier clay and mortar floor was found to be present across almost the entire area of the floor (fig. 3) except in one or two places where it had been previously disturbed.

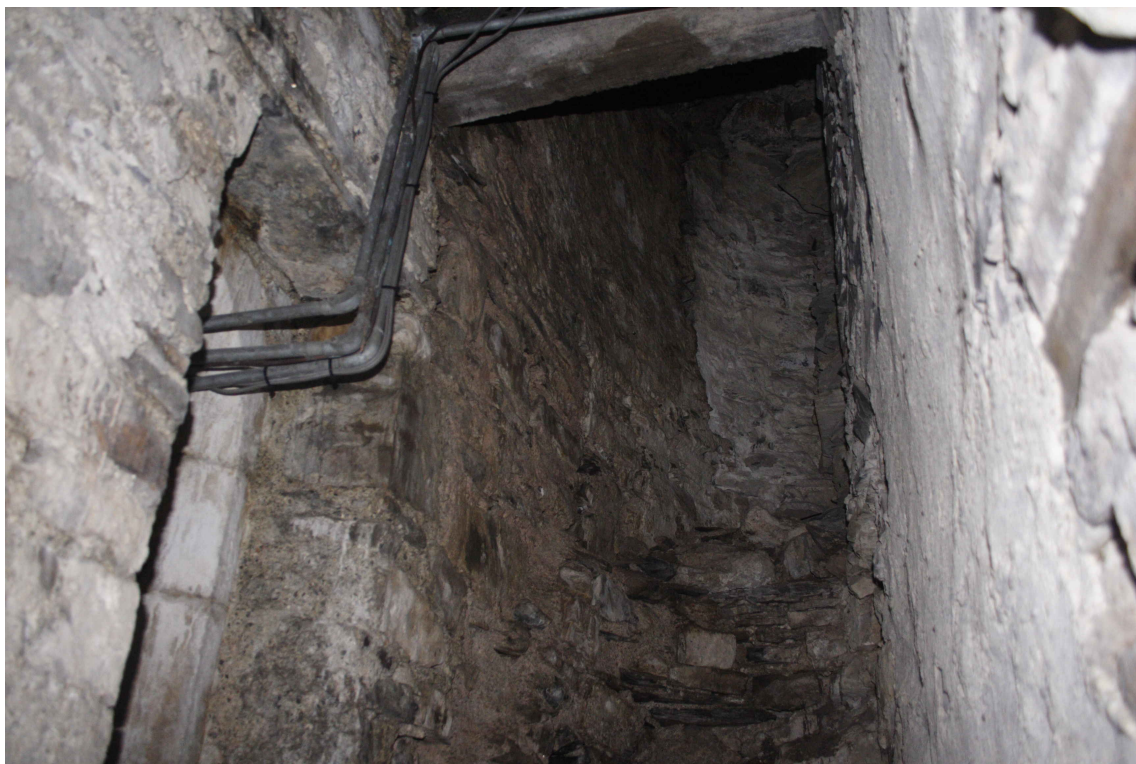
- 2.2.5 It is considered likely that the oldest part of the church lies in the northern transept of the church, where a set of stairs is present leading up to an area which is no longer accessible (photo 1), but may have been to a leper's squint or to a rood screen (Rev. J Gainer, 2007). During the watching brief, the stair well was accessed and it could be seen that a window formerly lit the stairwell on its eastern side (now blocked by the vestry; photo 2). On the exterior of the church, a projecting lump of masonry is visible in the area of the stairwell, potentially indicating a former raised area of the church, now mostly covered by more recent alterations and roof lines (photo3). The presence of the later vestry on the northern side of the church and the rebuilding of the rooflines on the transept and vestry, has obscured much of the evidence of what this stairwell would have accessed.

Photo 1: Former stairwell adjacent to and predating vestry

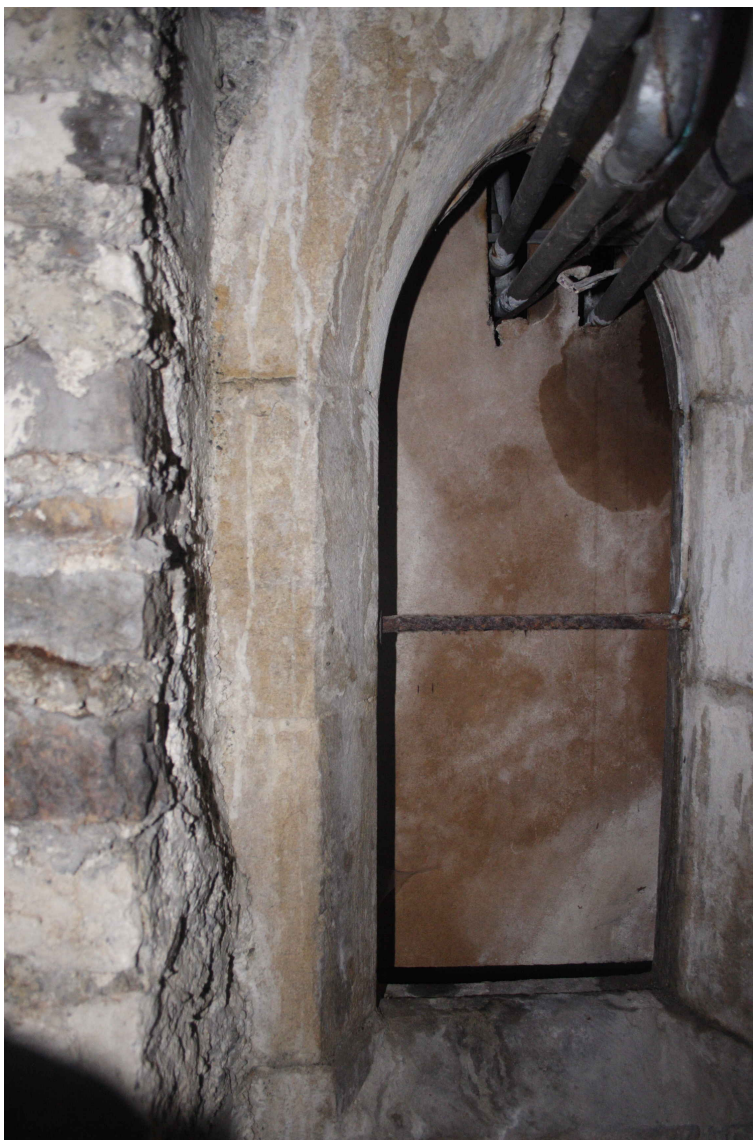
Photo 2: Window within stairwell wall, now blocked by vestry

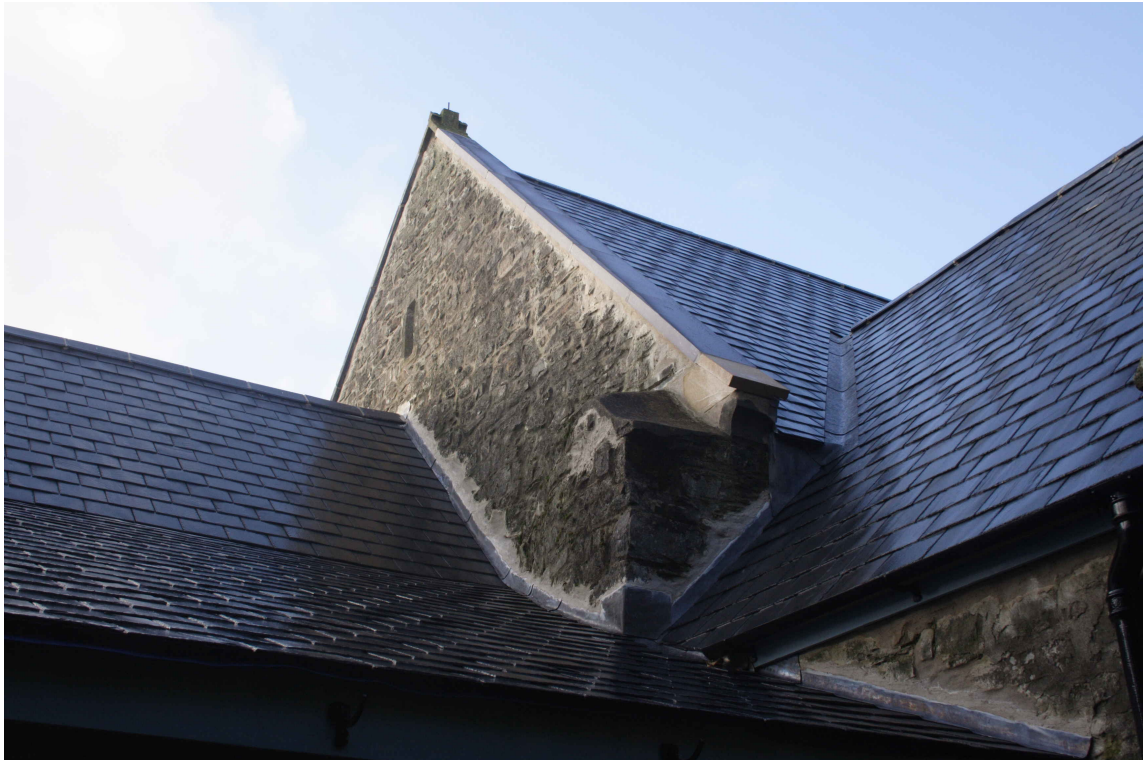
Photo 3: Stub of wall in area above stairwell, on side of north transept, with the catslide roof of the vestry visible in foreground of photo

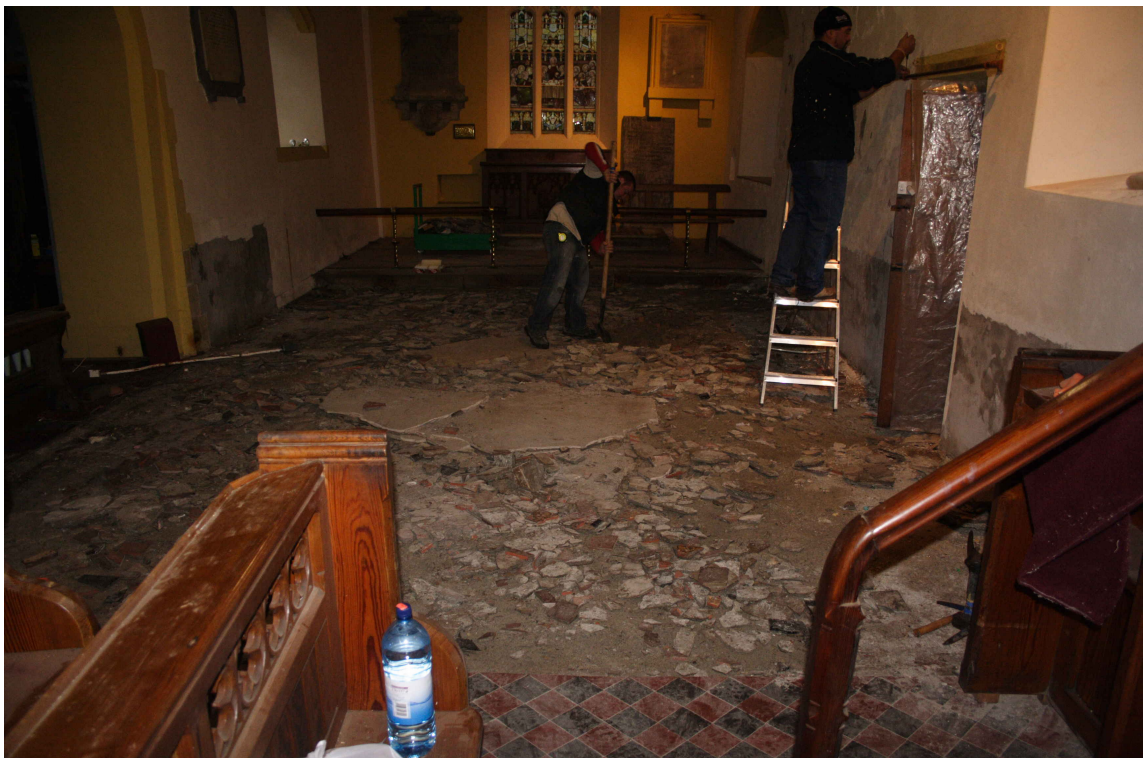
- 3.2.1 The tiled floor within the chancel had been removed prior to archaeological attendance (photo 4). The tiles were bedded onto a layer of concrete which ran from the altar to the east, to the nave floor to the west, and between the south wall of the church and the vestry wall to the north.

Photo 4: Chancel floor following removal of tiled floor

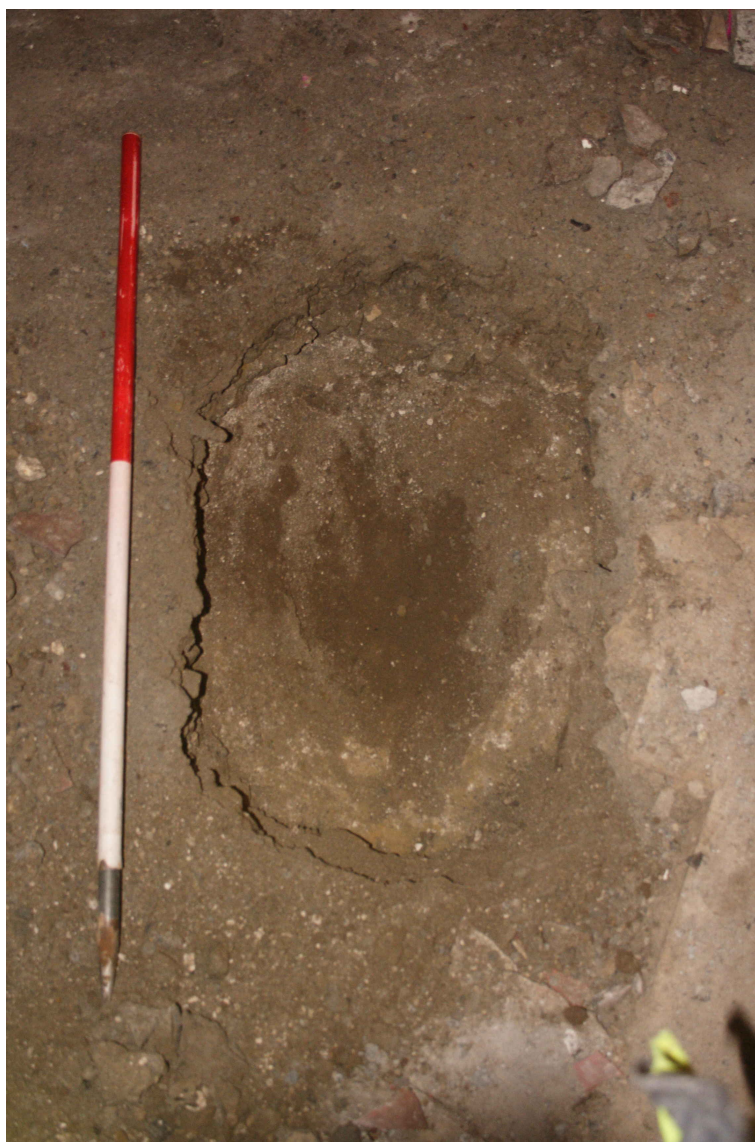
- 3.2.3 The test pit (photo 5) indicated that the existing floor comprised a shallow depth of concrete surface (c.0.06m), onto which the tiled floor was laid. Below this was a c.0.15 – 0.20m depth of rubble used as leveling material. A compact mortar and clay layer was revealed across the base of the test pit, which was partially cut through by the excavation. This layer was c.0.02m thick, of mostly light brown colour and is presumed to represent an earlier floor surface. Beneath this layer was a dark brown soil containing small stones and occasional fragments of bone. Excavations did not continue below this level.

Photo 5: Test pit excavated through chancel floor

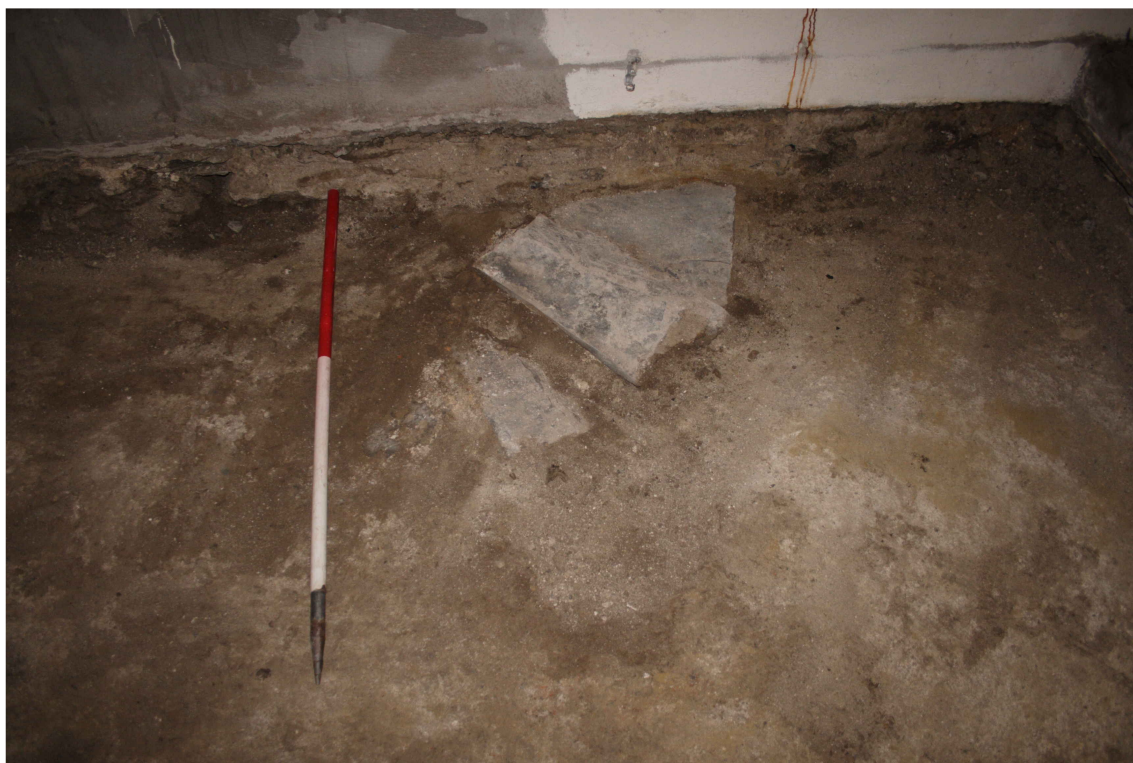
- 3.2.7 A number of slate slabs were present set within the layer. These were located fairly randomly and did not appear to be structural or represent flooring (photo 8).

Photo 8: Slate slabs lying on or within clay and mortar floor

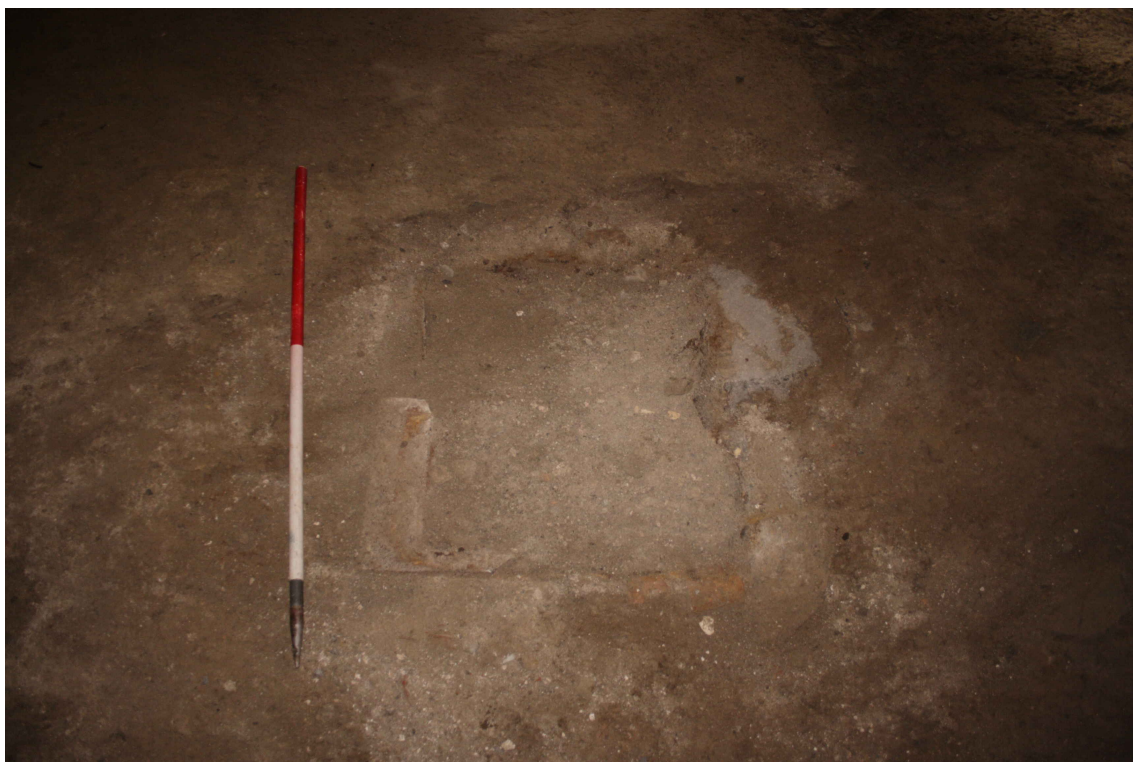
- 3.2.8 A brick lined pit was also present cutting through the floor. This was a former heating duct associated with an earlier heating system within the church (photo 9).

Photo 9: Modern heating duct pit cut through earlier clay and mortar floor

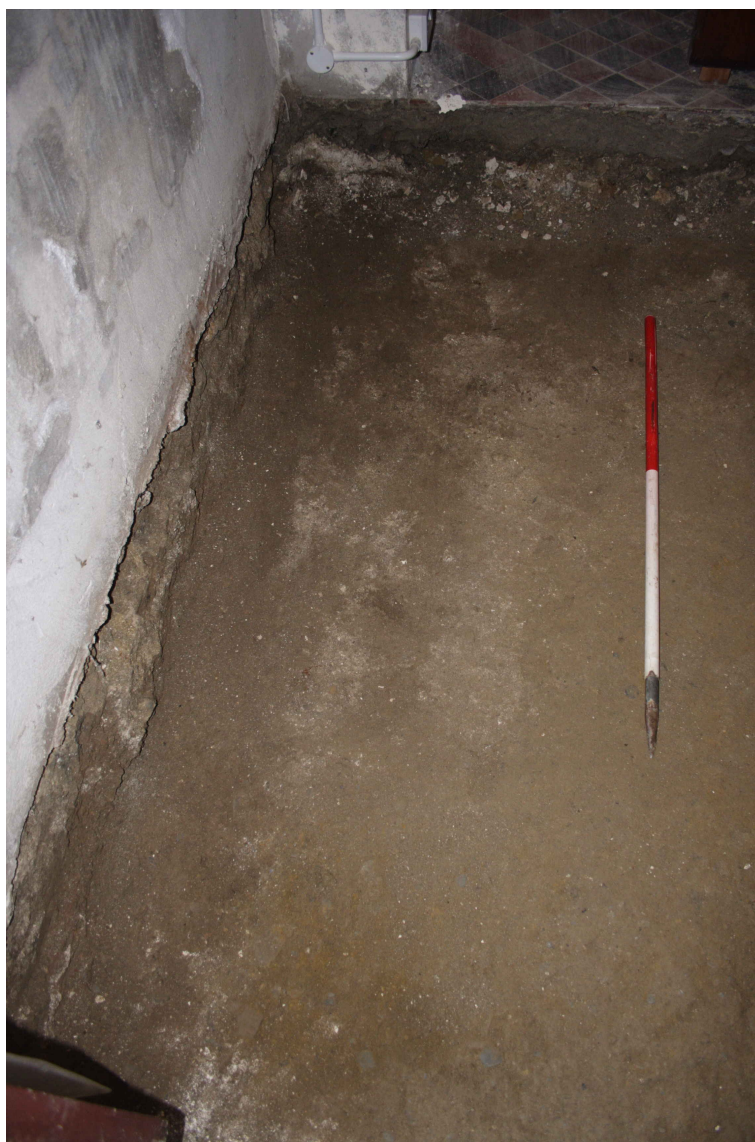
- 3.2.9 The clay and mortar floor was not clearly present along the inside of the southern wall of the chancel (photo 10). It is unclear if it had been worn away in this area, or had been truncated through by a later feature. In this area a small void opened up during the works, within which a number of fragments of human bone were noted, including a number of finger bones and a possible coffin nail. It is presumed a burial was present in the area adjacent to the southern wall, lying beneath the clay and mortar floor. The burial was not investigated further, and the void was carefully filled to prevent further collapse.

Photo 10: Area along southern wall, where clay and mortar floor was absent

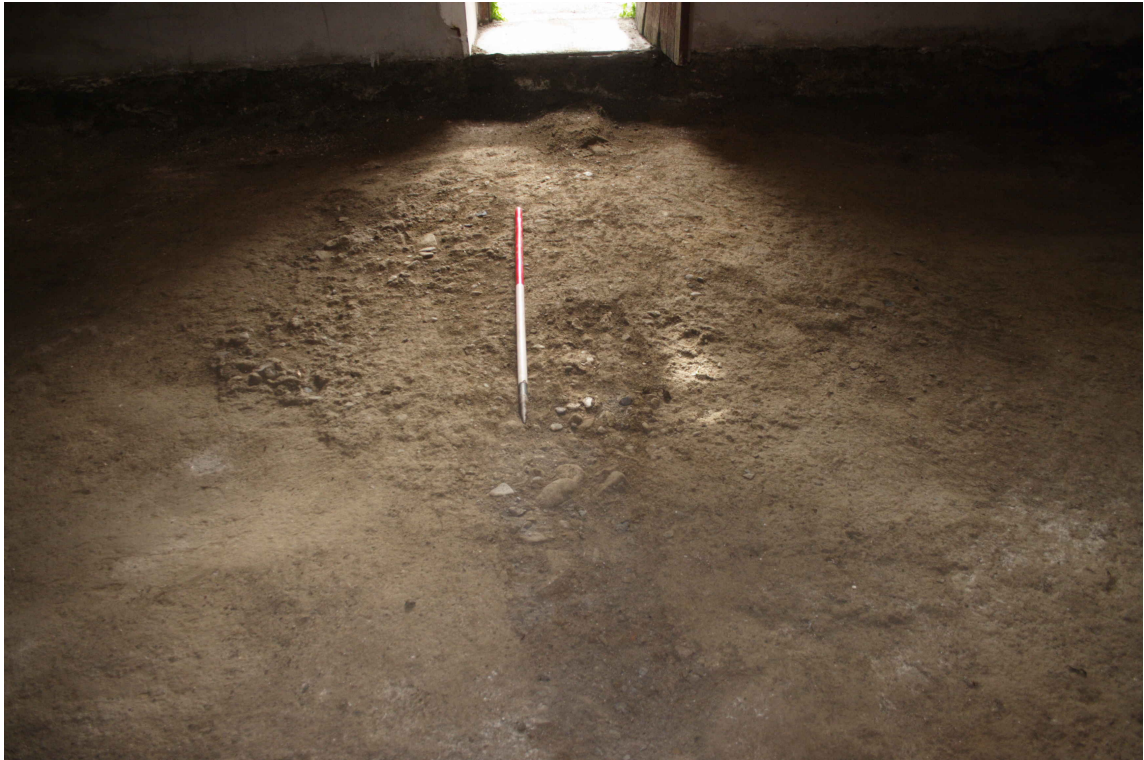
- 3.2.5 During removal of the concrete layer, a patch of deeper and harder concrete was noted, which is thought to represent the 20th century repair undertaken following disturbance to the floor from a tree root.

- 3.2.10 The clay and mortar floor had also been disturbed by the same root action that damaged the later tiled floor, and which was repaired in the 20th century by a thicker layer of concrete (photo 11).

Photo 11: Line of root damage through clay and mortar floor, which caused damage during 20th century to tiled floor above

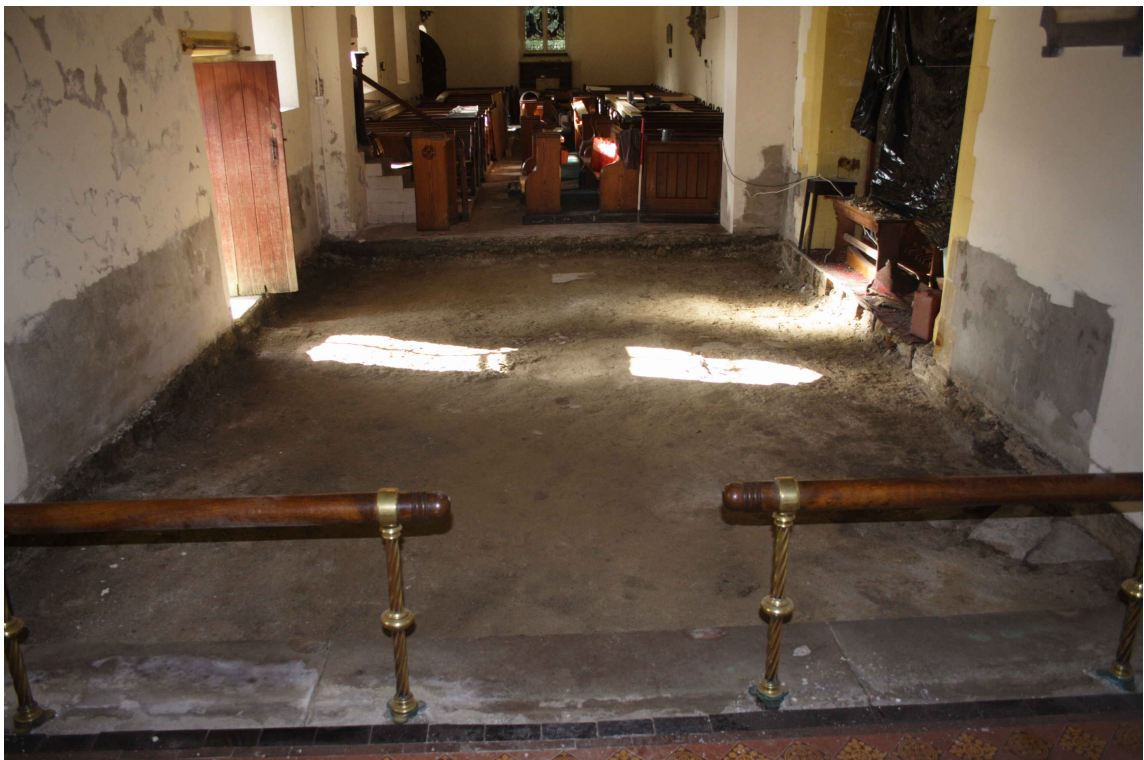
Photo 12: Overall view facing west of chancel following excavation of concrete floor and rubble, immediately prior to backfilling with material for new flooring

- 3.2.13 Following the complete removal of the flooring, and after recording of the exposed surface (photo 12), leveling material was laid for the new floor. This comprised small stone aggregate, laid by hand before the new lime mortar floor was laid over the top.
