THE 'OLD HOUSE' AT TREFENTY FARM, ST. CLEARS, CARMARTHENSHIRE

PHOTOGRAPHIC BUILDING RECORD

RHIF YR ADRODDIAD / REPORT NO. 2010/36
RHIF Y PROSIECT / PROJECT RECORD NO.99808

Medi 2010
September 2010

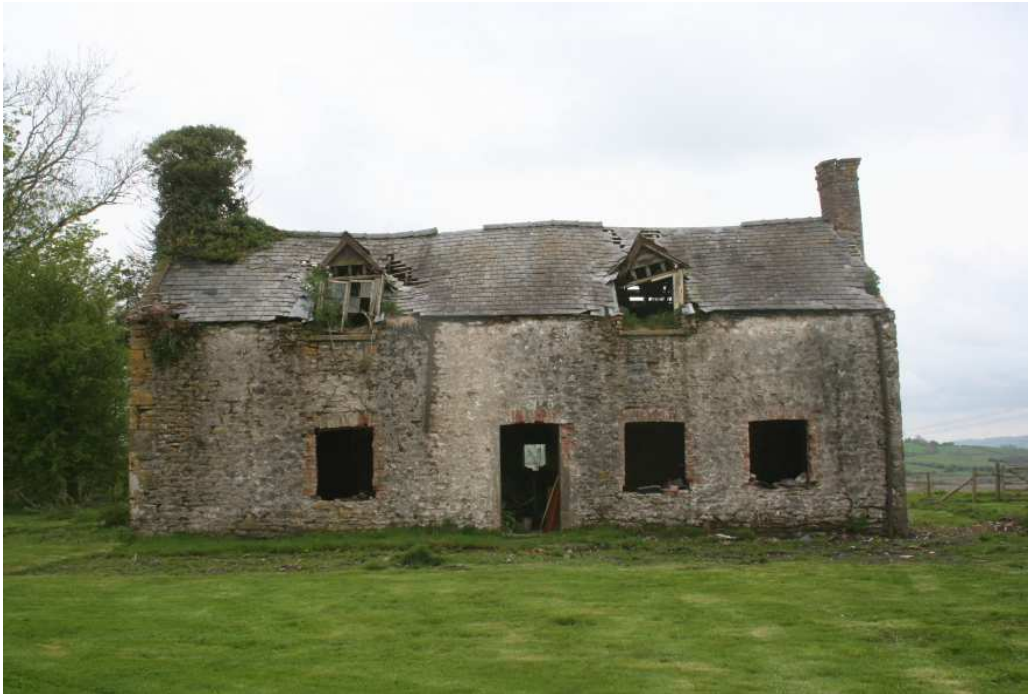
4.1.2 The main façade of the building faces east (Photo 1). Although uncertain, the existing ground floor doorway and window openings (and the blocked first floor openings) are possibly later modifications to a building of earlier origin. Although there is no clear surviving evidence of any openings associated with this earlier building, these are likely to have been destroyed by the later modifications, blocked openings on the western wall, however, may be associated with this earlier phase of the building.

Photo 1: East facing façade

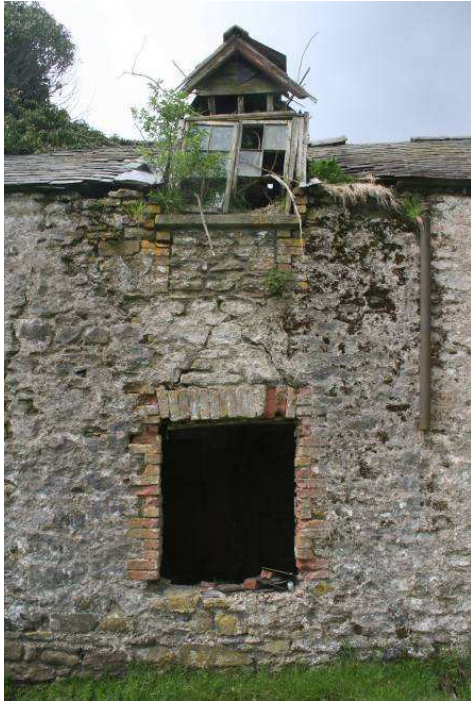
Photo 2: Window openings in the eastern wall, southern side

4.1.4 Two blocked first floor window openings are apparent, located above the windows flanking the ground floor doorway (Photos 2 & 3). There is no apparent evidence for other blocked first floor window openings.

4.1.5 The blocked first floor windows have been replaced by two gabled dormers, the sills of which are set into the top of the wall, within the area of the earlier blocked windows (Photos 2 & 3).

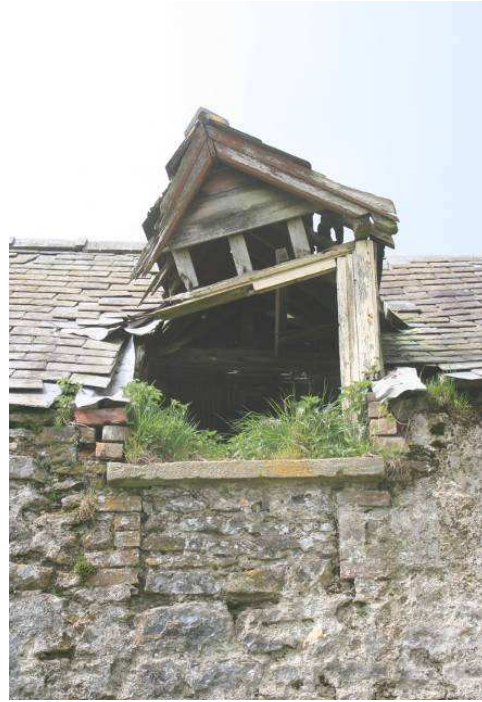
Photo 3: Window openings in the eastern wall, northern upper

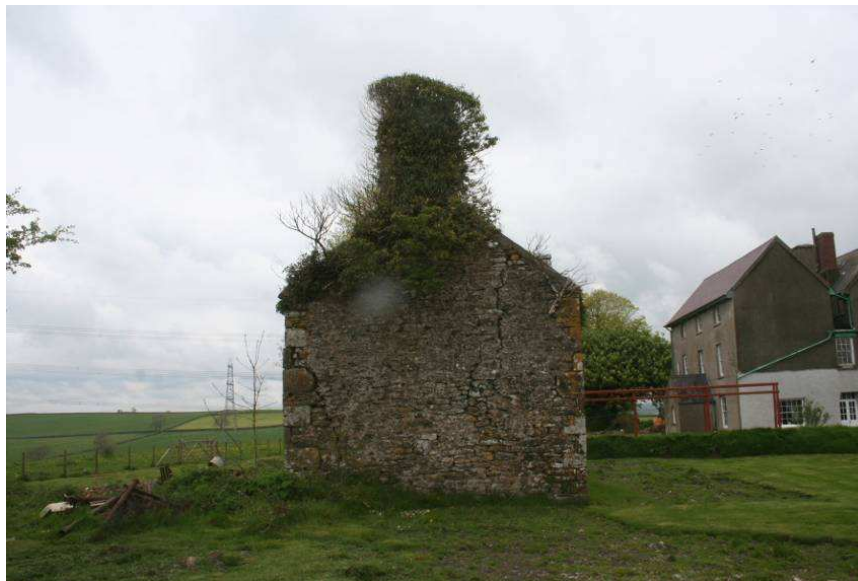
Photo 4: South facing gable end

4.1.6 Although there are two reasonably large cracks in the masonry, the south facing gable end elevation (Photo 4) shows no evidence of any repairs, rebuilds or blocked openings. The masonry is roughly coursed, and some stone is dressed and decorated and has presumably been re-used from a nearby earlier building (Photos 5 & 6). The chimneystack is a later, brick-built modification.

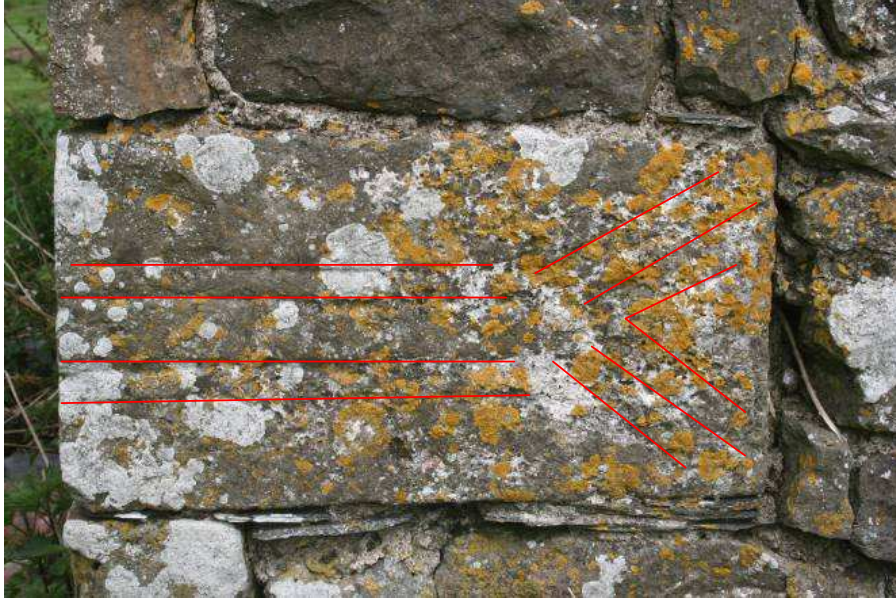
Photo 5: Stone with carved decoration. It is thought this stone may have been part of a grave, but this is by no means certain.

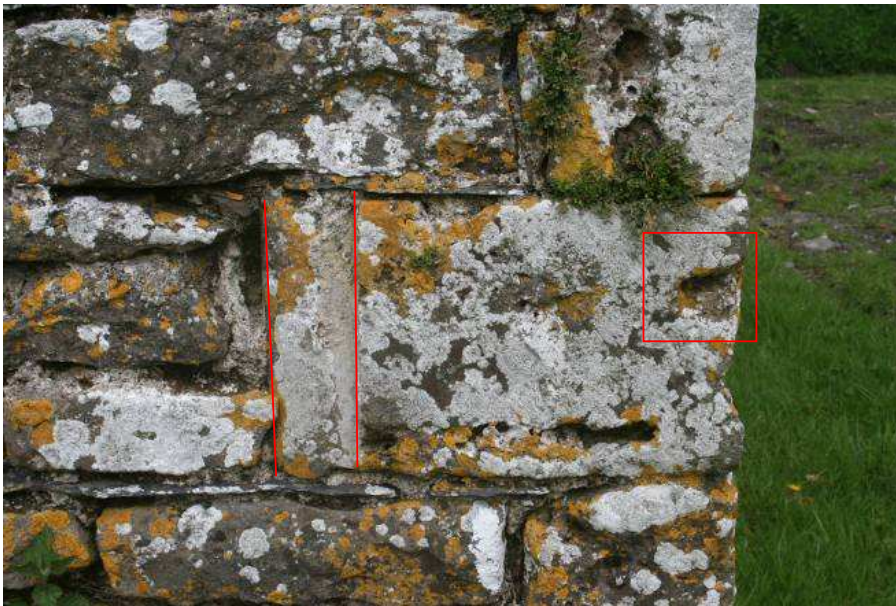
Photo 6: Stone with carved moulding. This stone may be part of a former window opening

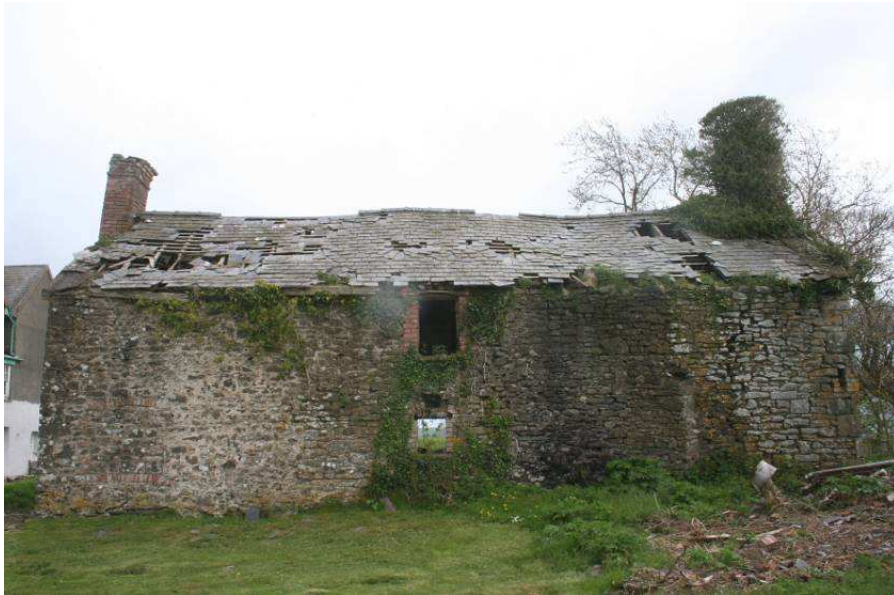
4.1.7 The west facing elevation now contains only one opening on the ground floor and one on the first floor (Photo 7). The elevation also shows more evidence of rebuilding and alteration to the building.

Photo 7: West facing façade

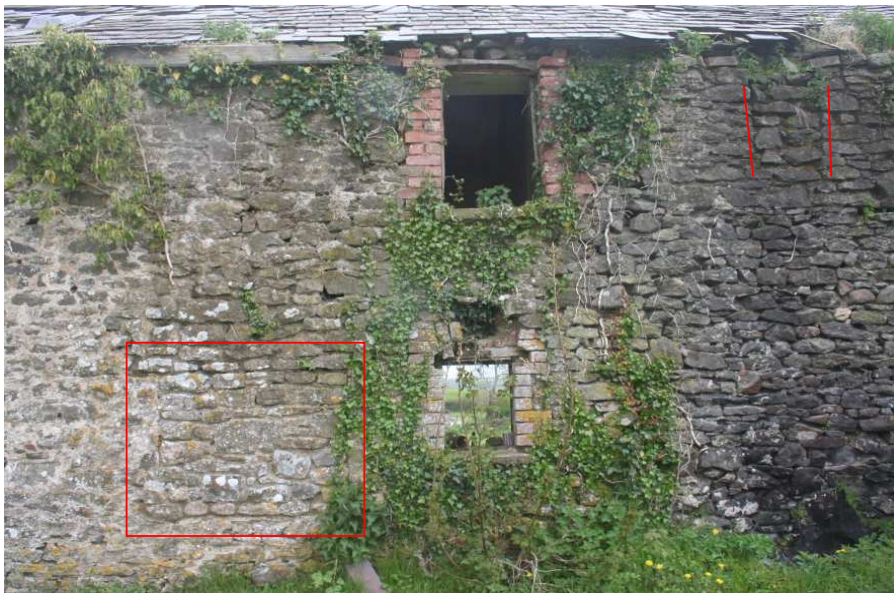
4.1.8 The brickwork surrounding the window openings suggests they are contemporary with the with the blocked first floor windows on the east façade. It is apparent, however, that the two windows are differently proportioned and slightly offset, perhaps suggesting that there may have been earlier (smaller) windows in at least one of these locations. To the right of the upper window, a small blocked window opening is visible (photo 8 top right).

Photo 8: West facing façade middle section

4.1.9 A straight joint (bottom left in photo 8) is partial evidence of another earlier opening. A slight difference in the stonework to the right of this joint may suggest a blocked opening.

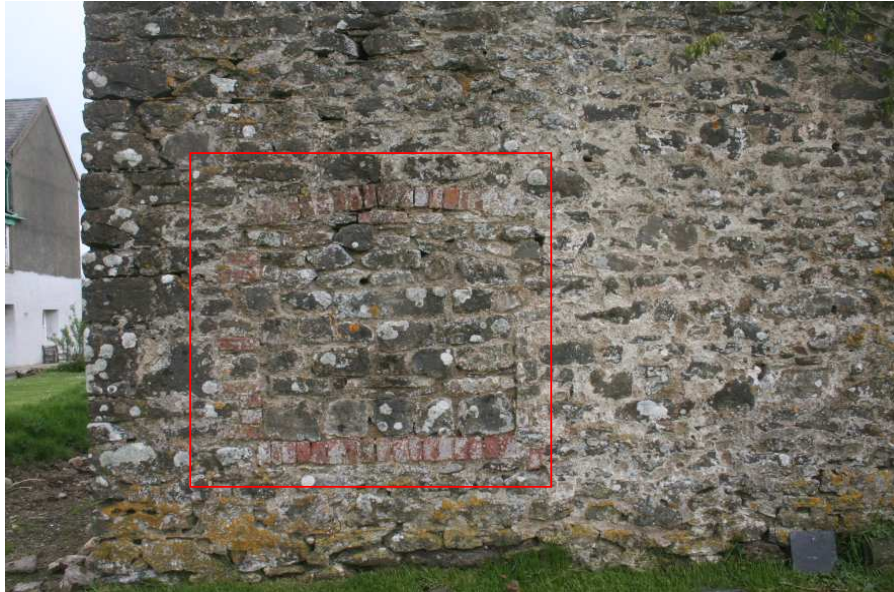
4.1.10 There is also clear evidence of a mostly brick surrounded window opening blocked with stonework (Photo 9) on the northern end of the façade. This window is of different construction style and dimensions to those on the east façade. The south side of the opening is, however, not built of brick, suggesting there may have been an earlier and smaller opening in this location.

Photo 9: West facing façade northern section

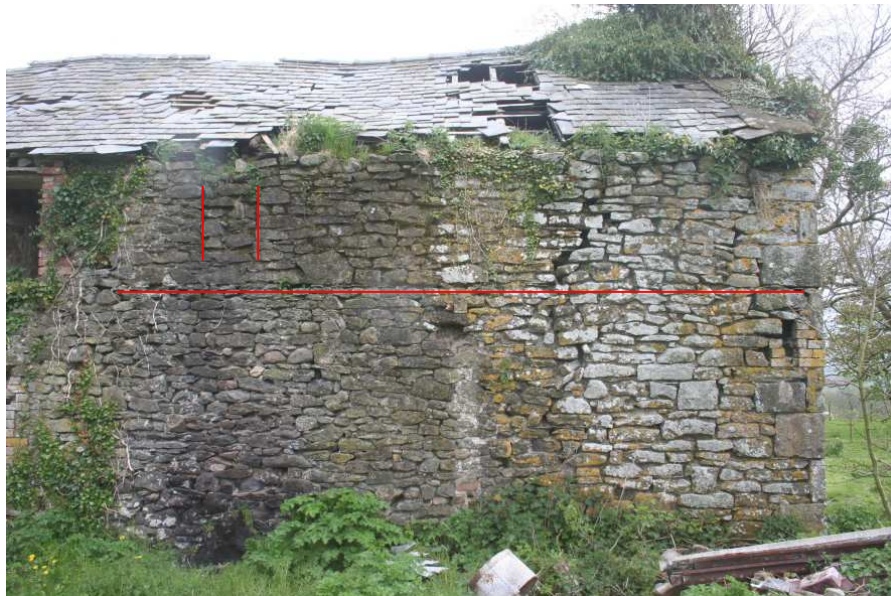
4.1.11 A levelling course is visible at first floor level (Photo 10). The presence of the blocked opening suggests this is an early construction detail, rather than a later re-build. The levelling course is not visible at the north end of the façade. The crack in the wall (Photo 10) does not appear to follow the line of a repair or rebuild.

Photo 10: West facing façade southern section

4.1.12 At the south corner (right) a number of the quoin stones are dressed masonry re-used from another building. Several of them show evidence of having held probable iron fittings (Photos 11 & 12). It is possible that some of the hidden faces of the blocks would show other such features.

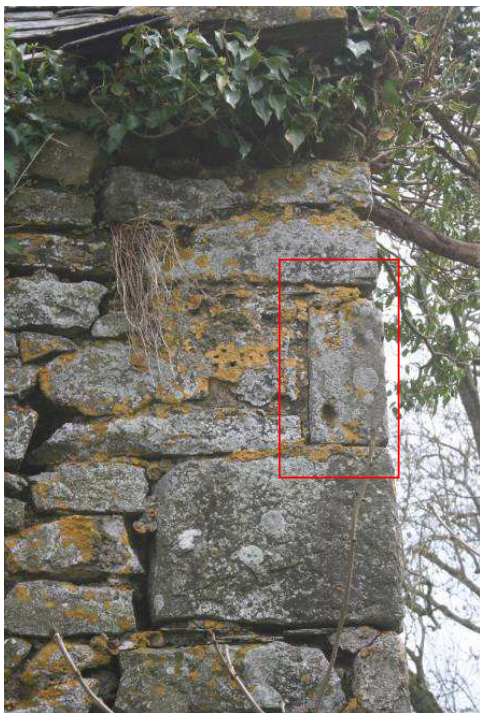
Photo 11: A dressed block with a block with part of a socket

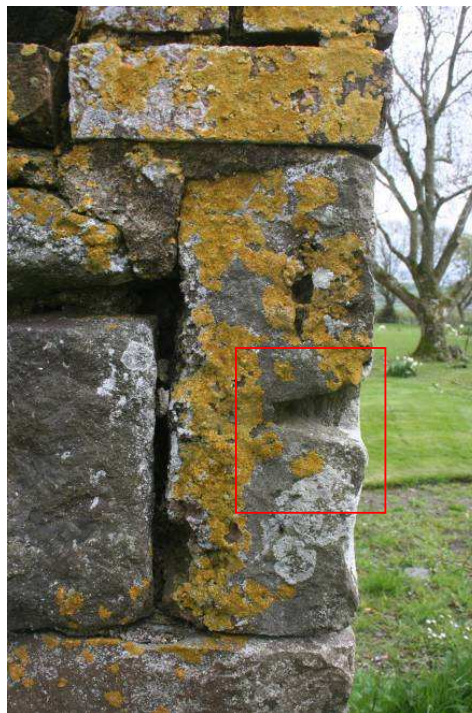
Photo 12: Another dressed possible shallow socket

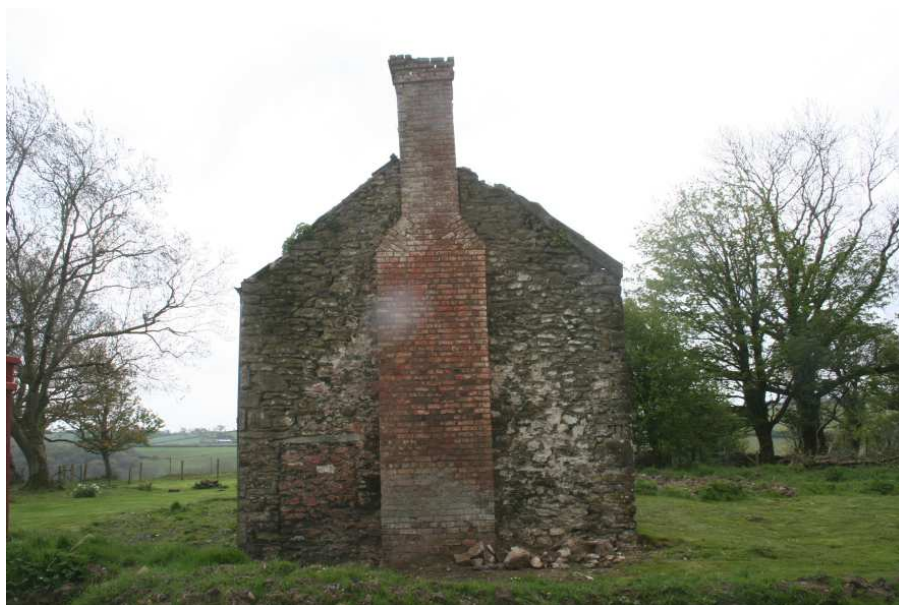
Photo 13: North gable end

4.1.13 The north Gable end is constructed of roughly coursed, rough dressed stone and mortar, and has an inserted brick built chimneystack, presumably contemporary with the brick openings on the east façade (Photo 13)).

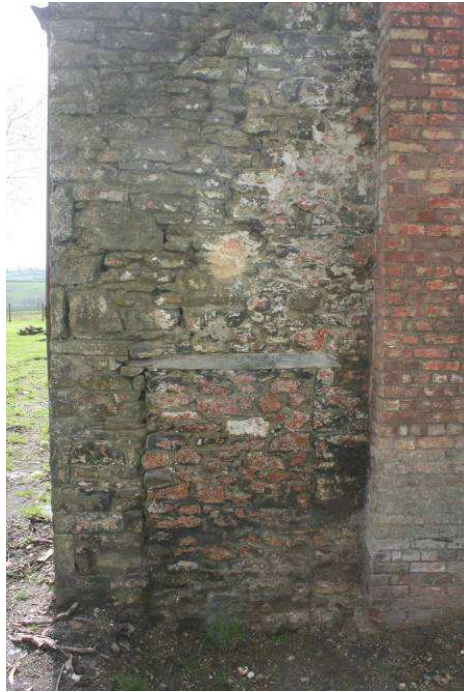
Photo 14: Blocked doorway in north gable end

4.1.14 On the east side of the chimney, is a blocked doorway opening with a wooden lintel (Photo 14). The function of the doorway is uncertain, although it is perhaps significant that previous ground works at this end of the building revealed a deep rectangular feature cut into the natural subsoil. This cut (now backfilled), had vertical sides and was the same width as the building (Photo 15). It was of unknown function and no evidence of a lining was apparent (Mr Thomas pers. com).

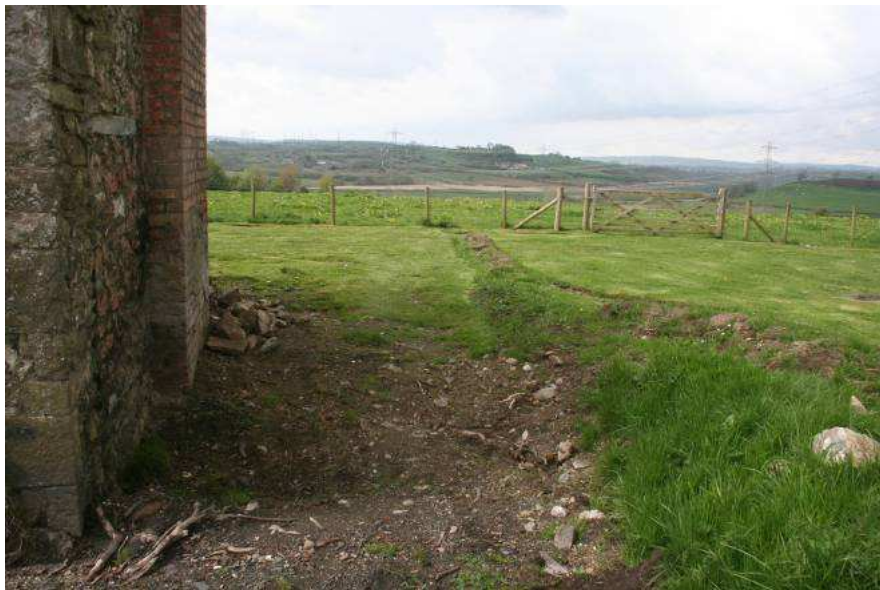
Photo 15: The area of disturbed ground indicates the location of the backfilled rectangular cut at the end of the building.

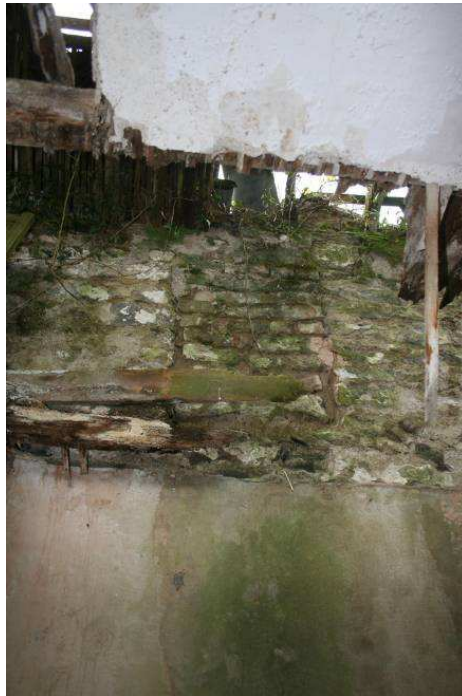
Photo 16: Former first floor window in west wall blocked with stone (see also Photos 8 & 10).

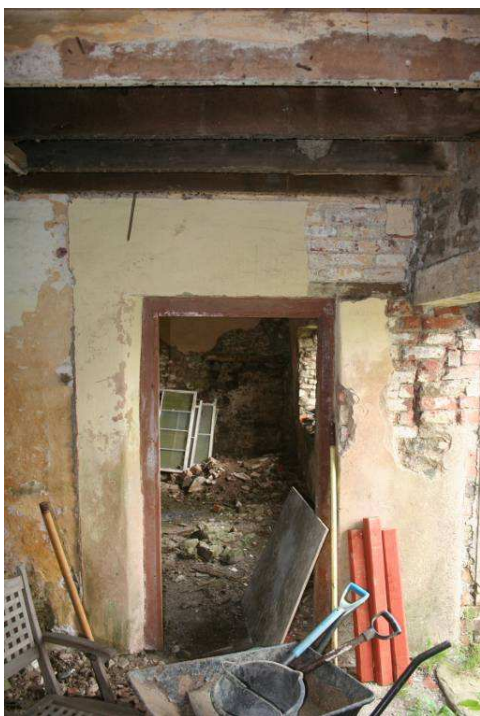
4.2.3 The ground floor is divided into two rooms, by a wall constructed of red brick (Photo 17). Access from the front door, is directly into the southern room. The main fireplace built from red brick was constructed against the south wall, with an alcove on its east side (Photo 18).

Photo 17: Ground floor dividing wall, constructed of brick

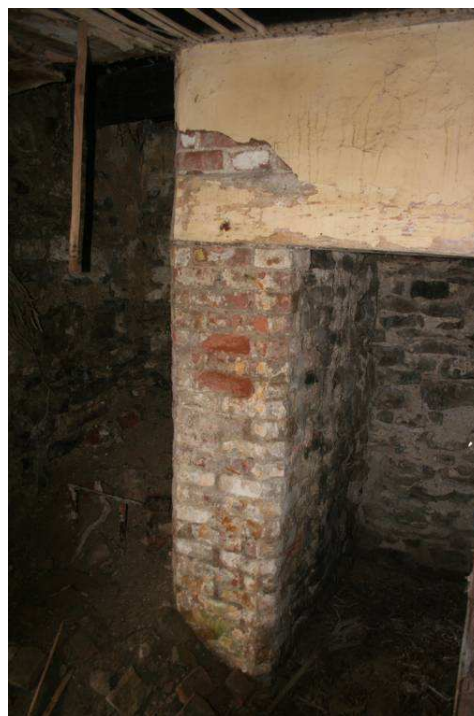
Photo 18: Fireplace against south wall, constructed from brick.

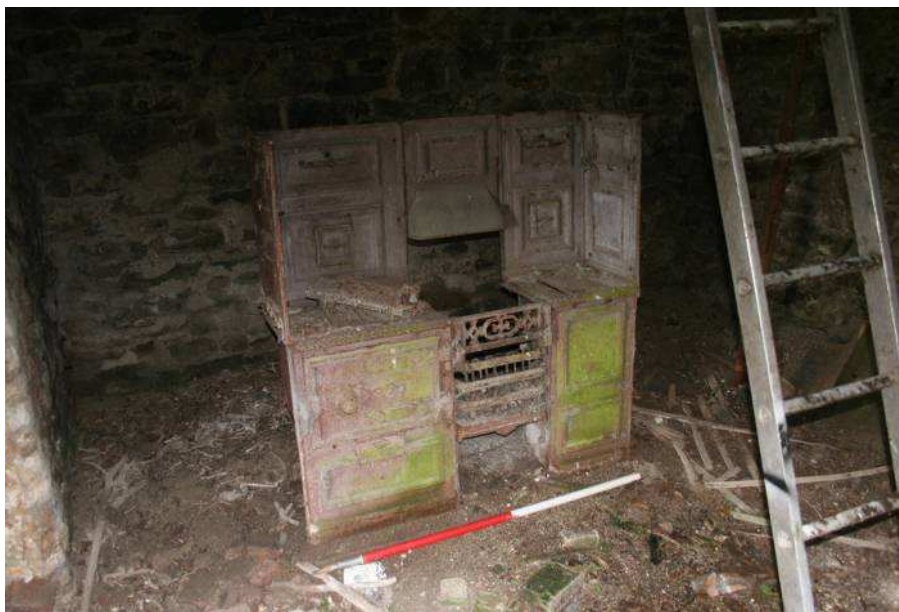
4.2.4 An old range within the main fireplace may be contemporary with the brick alterations to the building (Photo 19). A smaller fireplace constructed from red brick was inserted into the north wall (Photo 20).

Photo 19: The old range within the main fireplace

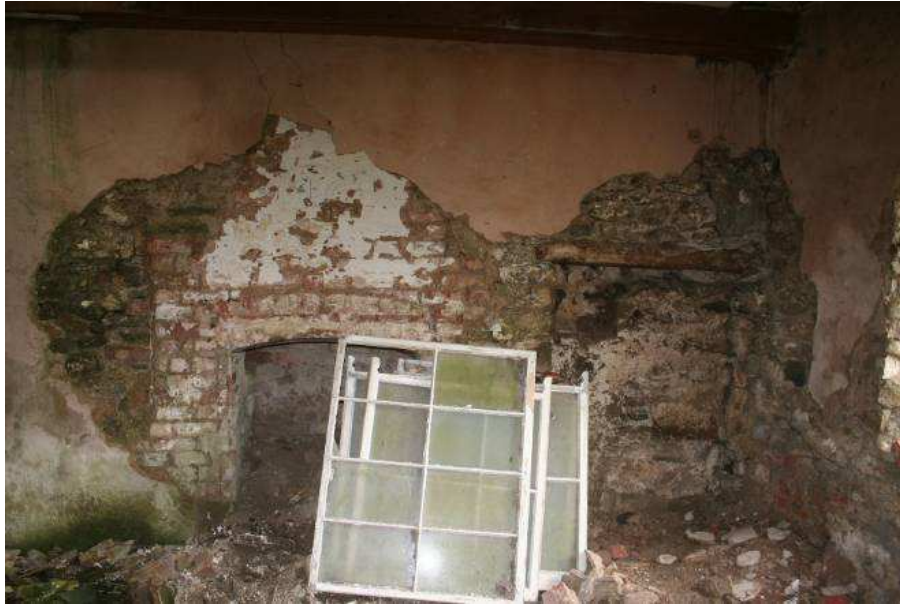
Photo 20: North wall, showing inserted brick fireplace and chimneystack and doorway to right, with wooden lintel and blocked with stone.

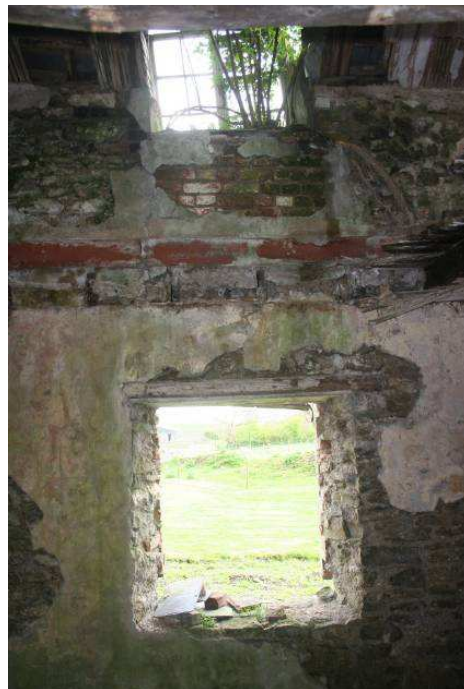
Photo 21: Ground floor and first floor windows at south end of east wall.

4.2.5 The rough faces of the stonework of the window reveals on the interior of the east wall, may suggest there were originally smaller openings that have been enlarged (Photos 21 & 22). The blocked window at the northern end of the western façade was visible (Photo 23), and clearly demonstrated that it was brick infilled on the interior with a stone fronting on the outer façade.

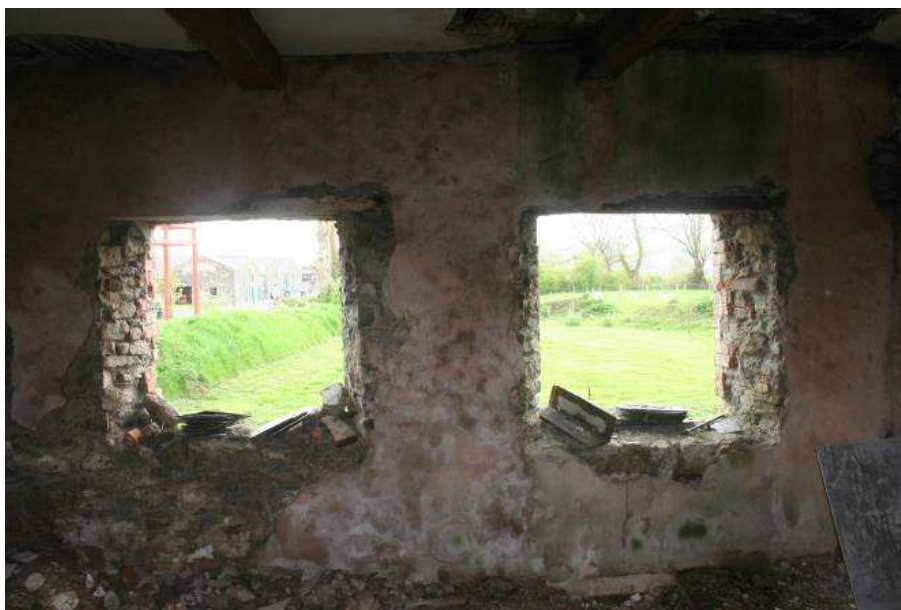
Photo 22: Ground floor windows in the east wall of the northern room

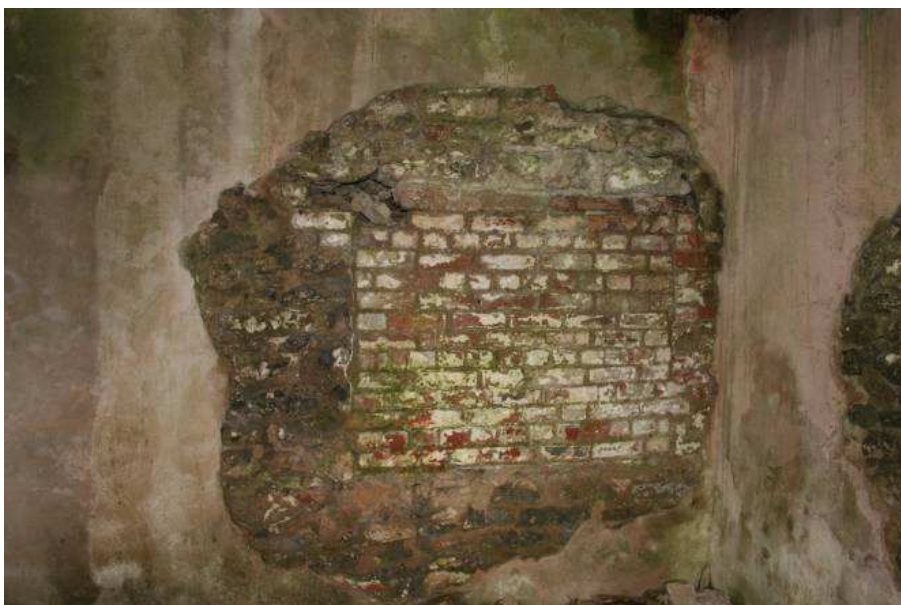
Photo 23: Brick-blocked window at the north end of the western wall (see also Photo 9).
