YNYSLAS HULKS, YNYSLAS, CEREDIGION: ARCHAEOLOGICAL INVESTIGATIONS 2016 - 2017 INTERIM REPORT

RHIF YR ADRODDIAD / REPORT NO. 2016/15
RHIF Y DIGWYLLIAD / PROJECT RECORD NO. 107509
Cadw Project No. DAT 135

Mawrth 2017
March 2017

James Meek MCIfA

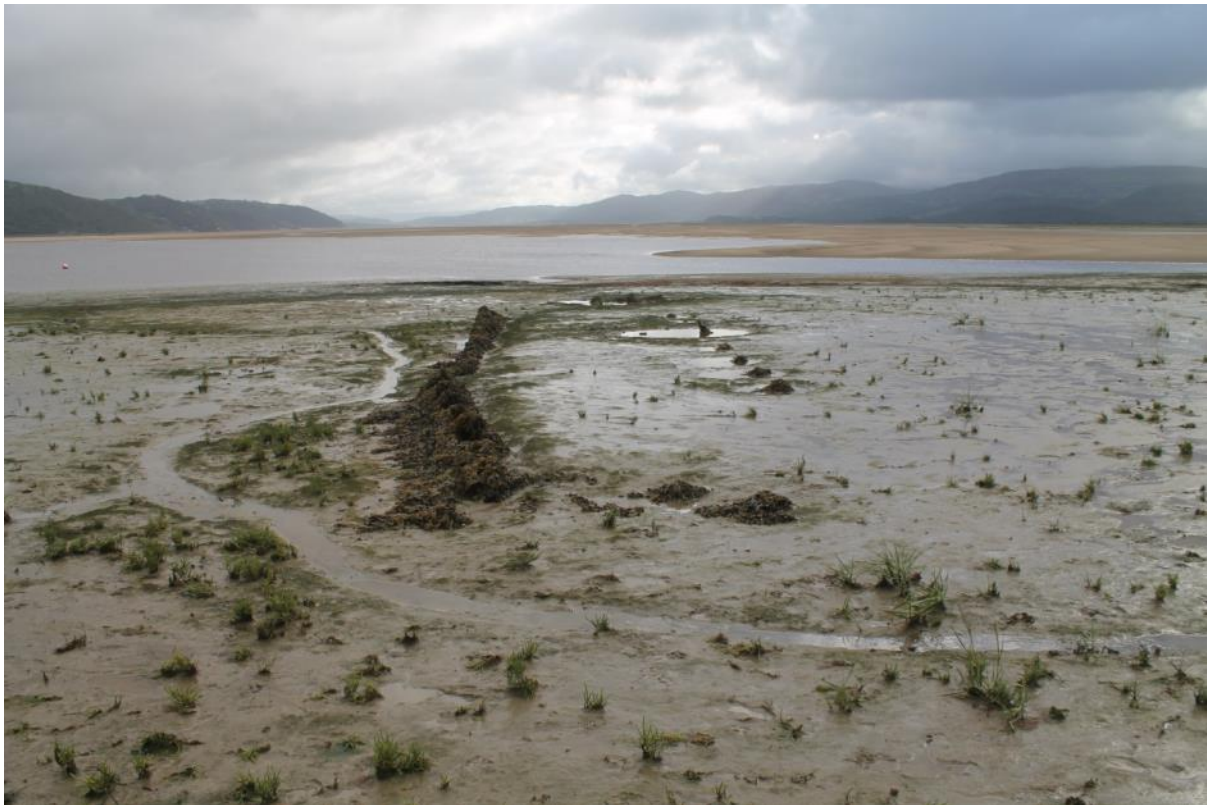
Photo 1: Wreck 1, facing east – 08/09/2016

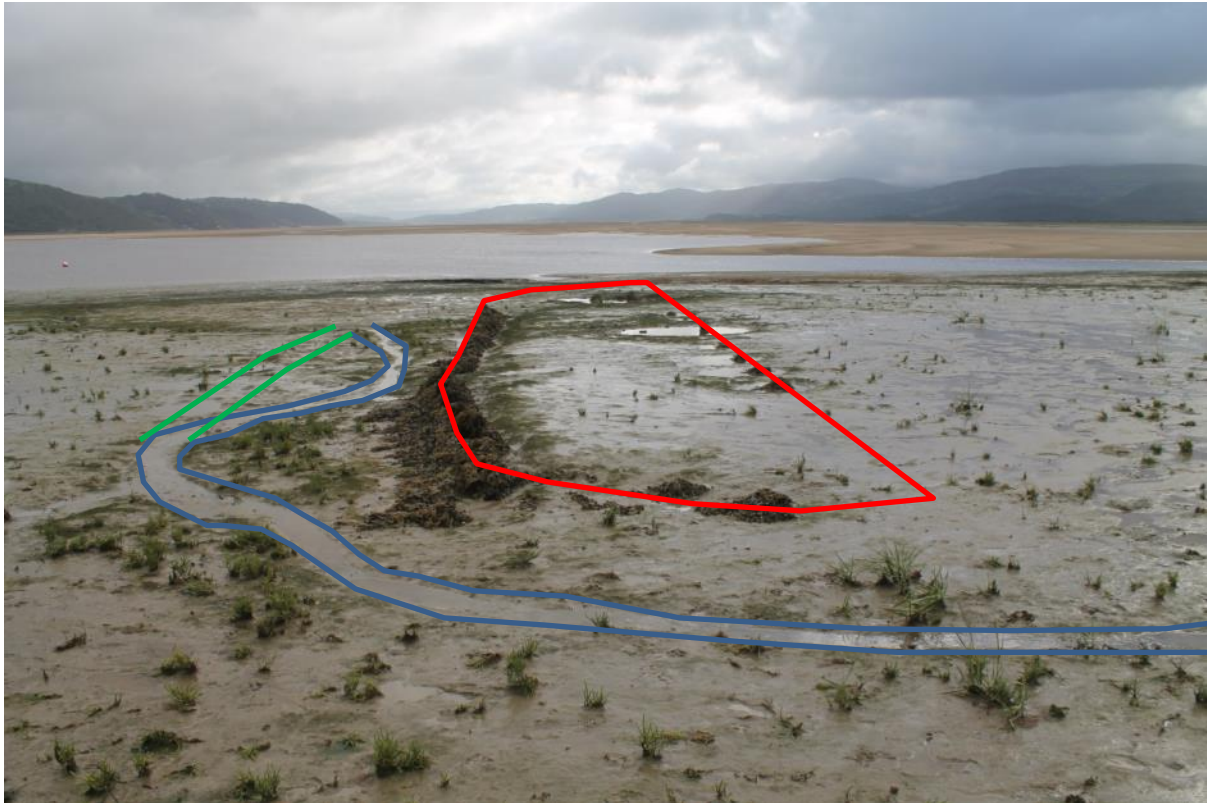
A small water erosion channel had formed on the western side of the wreck. The exposed timbers along the remains of the vessels hull have caused a slight damming of silts to the east of the wreck, leaving the silts at a slightly higher level than those to the west (Photos 1 and 2). As the tide ebbs, water thus drains more quickly along its western side causing slight erosion of the hull timbers. A channel has then formed as the last of the water drains from wide and shallow pools within the higher silts to the west, down along the change in silt levels (Photo 2).

Photo 2: Wreck 2, facing east showing water channel erosion, outline of wreck and suggested new channel – 08/09/2016

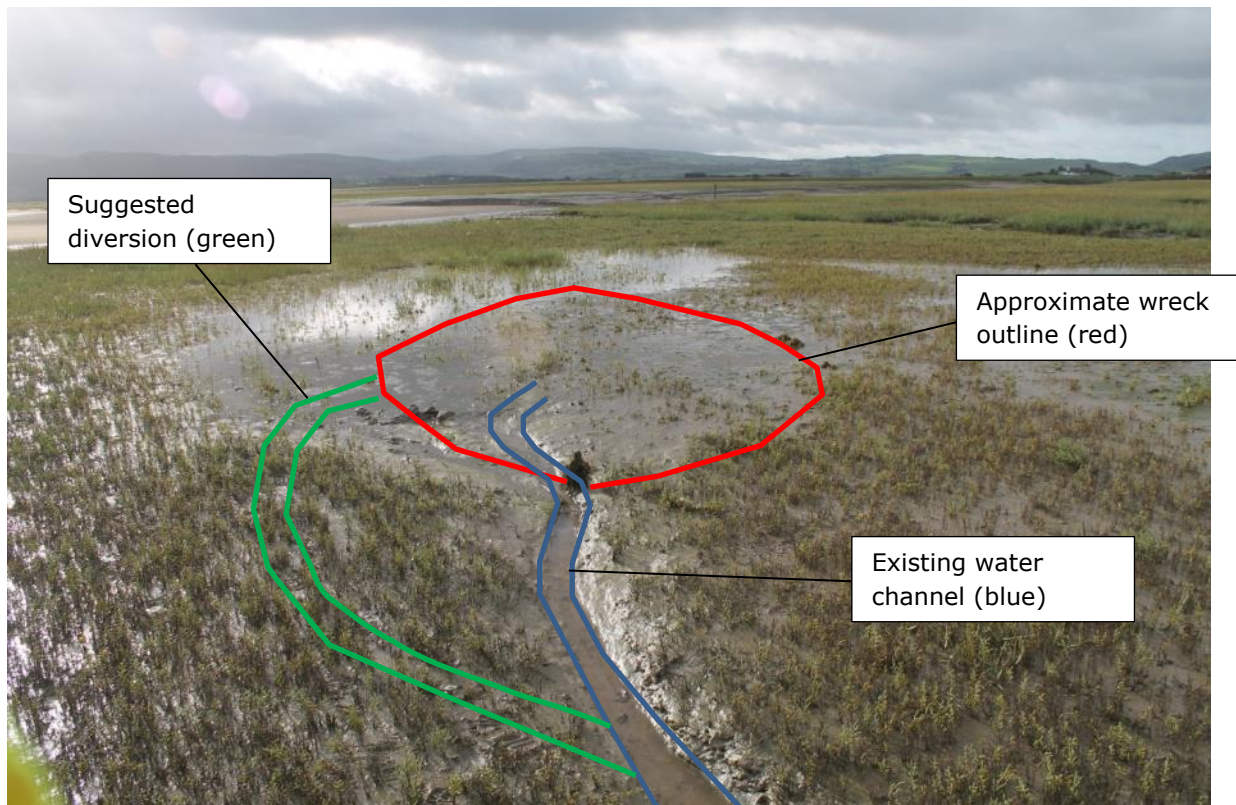
Photo 4: Wreck 2, facing south-southeast showing water channel erosion, outline of wreck and suggested new channel – 08/09/2016

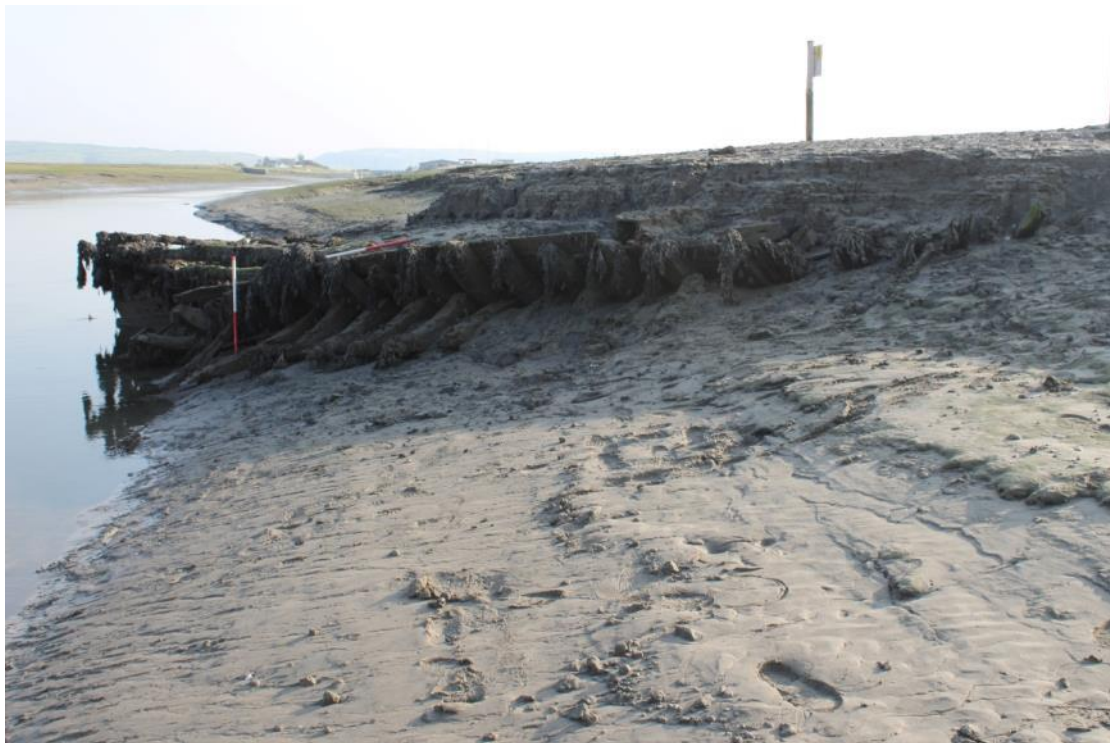
Almost the complete length of the starboard side of the vessel is exposed to some degree (Photo 7). The stern is almost completely exposed, with the wreck becoming more submerged in the silts as you head towards the edge of the river channel. The cant frames towards the bow of the wreck can be seen to curve quite sharply inward in their layout, to produce the blunt nose as the vessel would have originally had (Photo 8).

Photo 7: Full view of the exposed part of the starboard side of the vessel
(September 2014)

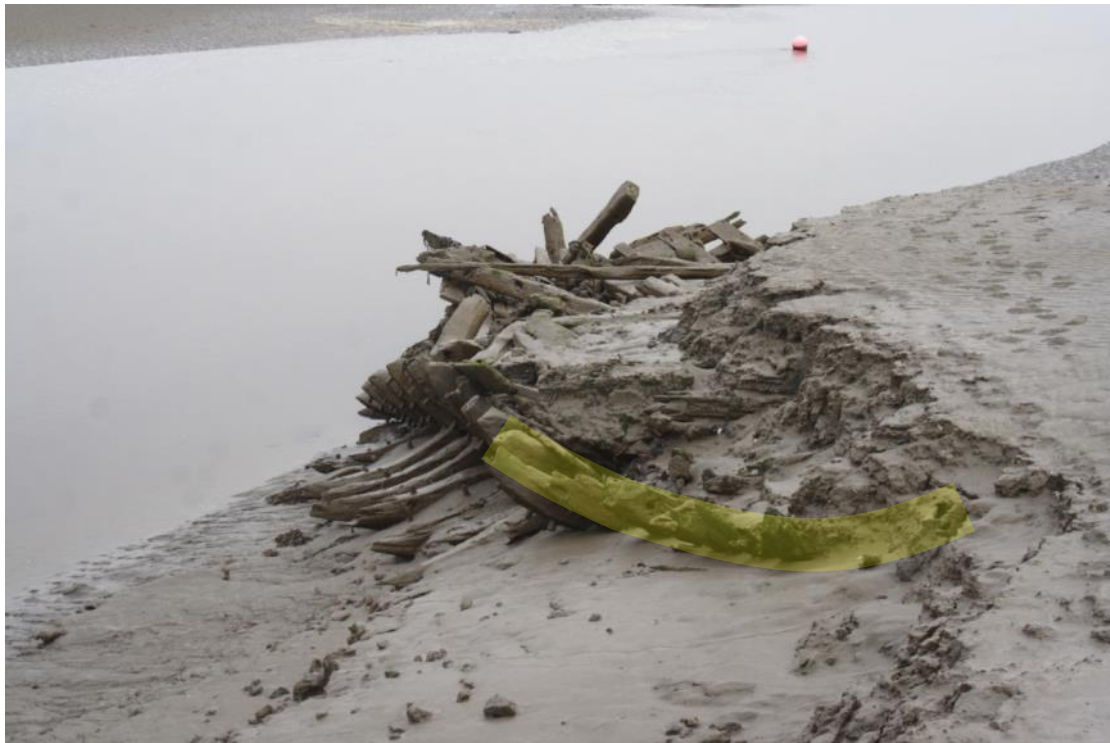
Photo 8: Bow end of the starboard side, with cant frames highlighted curving in towards bow stempost as revealed in 2014 excavation (March 2016)

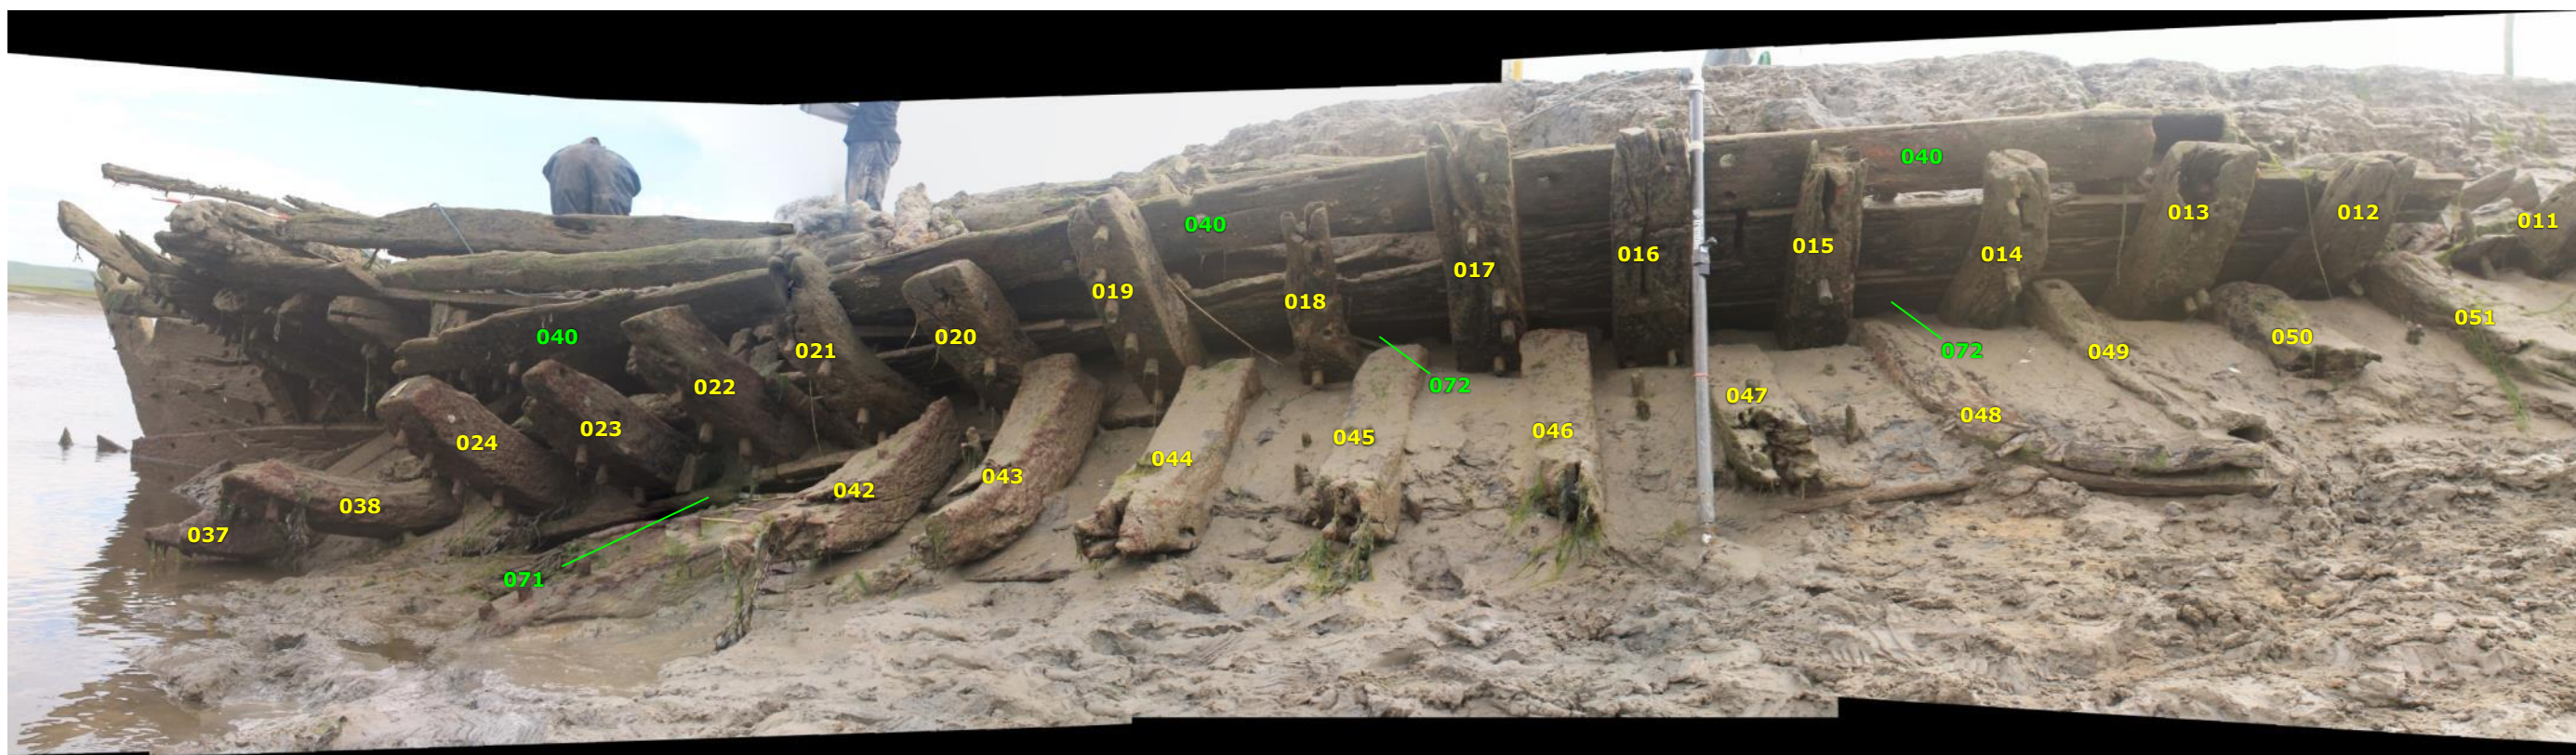
Photos 10 and 11 show the majority of the remainder of the starboard side. Although the ends of floor frames could be identified along the rest of the starboard side, it was not possible to see these attached to the keel which was hidden below silt and other timbers. Collapsed 1st futtocks could be seen, many still attached by treenails to underlying outer planking. Simple scarf joints had been used to join these to the floor frames. Filler frames remained in-situ.

Photo 11: Collapsed frames along the starboard side; Frames (yellow) and inner planking (green)
(merged photographs from June 2015)

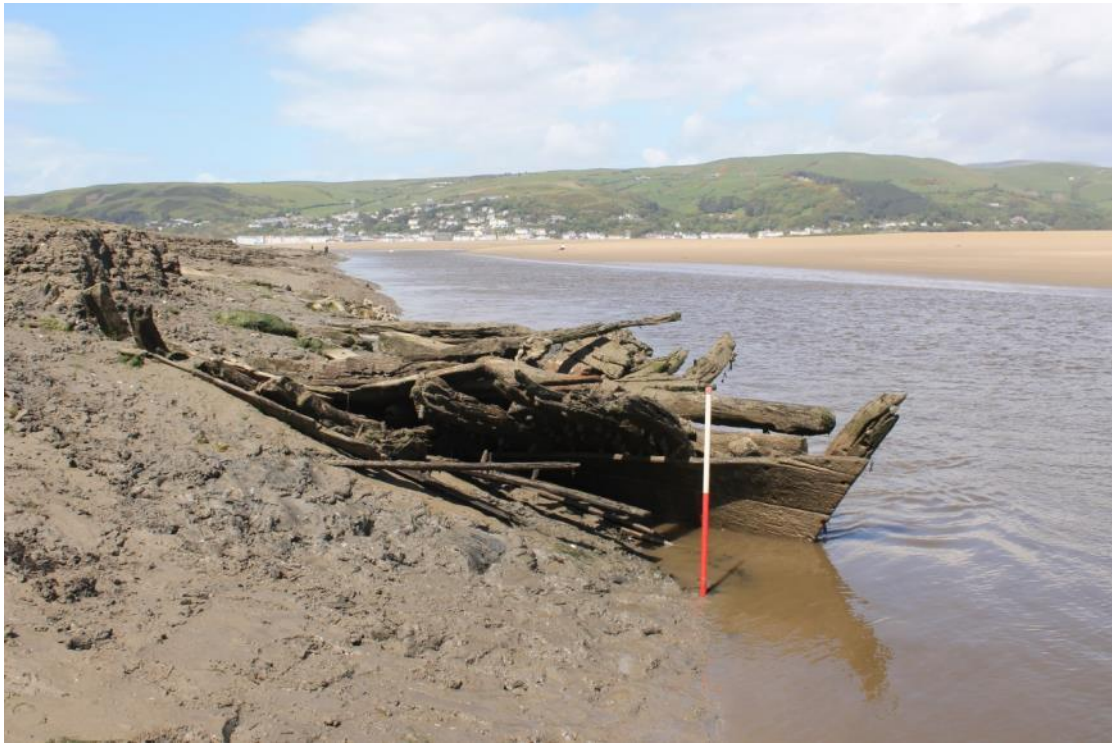
The surviving part of the port side of the wreck still remains mostly buried in the silts of the river edge (Photo 12). It has certainly become more exposed since it was first recorded in 2010, but only the stern of the vessel is exposed to a significant depth. Some outer planking survives in situ, with the uppermost surviving planks towards the stern having collapsed outwards. A number of the frames towards the centre of the vessel project almost vertically out of the silts towards the present river channel edge (Photo 13). The exposed ends of the frames were almost all very badly eroded and decayed.

Photo 12: Full view of the exposed part of the port side of the vessel (June 2015)

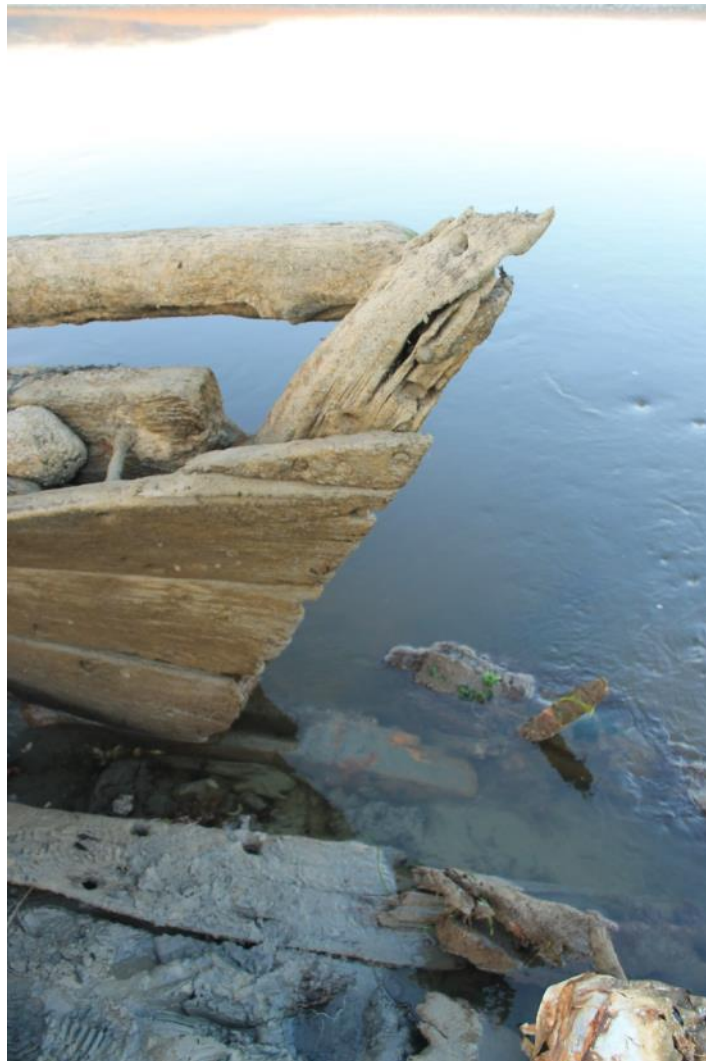
Photo 17: Stern of vessel on port side, showing lower timber projecting below the waterline with hole within it (September 2015)

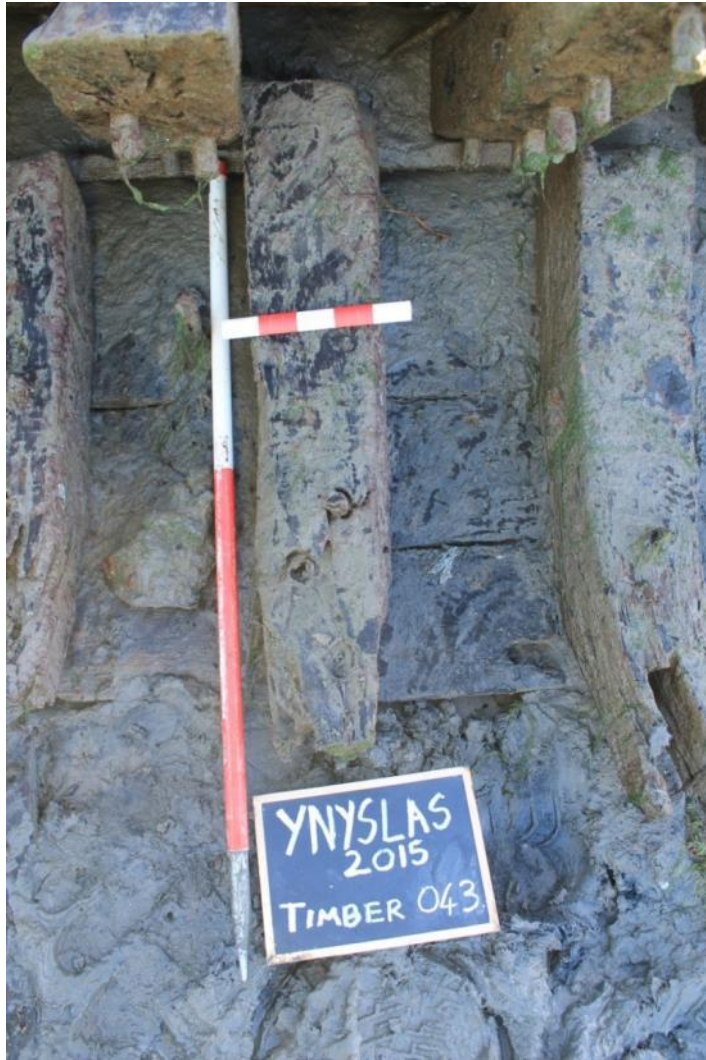
Photo 21: Fallen 1st futtock attached to collapsed outer planking in June 2015

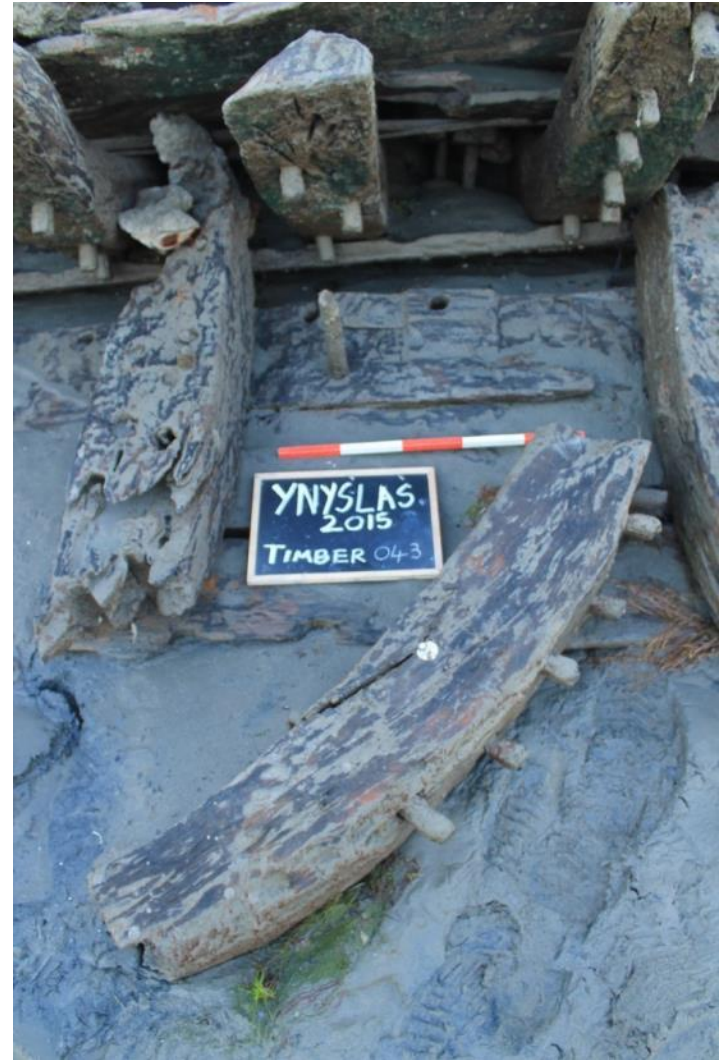
As stated in the 2015 report 'The wreck contains a significant number of timbers, a number of which are loose or collapsing A number of loose pieces are present on the exposed hold. These are under threat of being lost through further erosion and tidal movement.' This still remains true, but in mitigation a record has been made of the timbers to provide a 'present state' record of the vessel (based on the June 2015 survey). Changes were visible by the Phase 2 works undertaken in September, as an example timber 043, a fallen 1st futtock, was attached to the collapsed outer planking (by treenails) in June (Photo 21) but had become detached and moved by September (Photo 22). The timber had not moved much more by March 2016 having been embedded in silts.

Photo 22: Fallen 1st futtock detached from collapsed outer planking and moved by September 2015

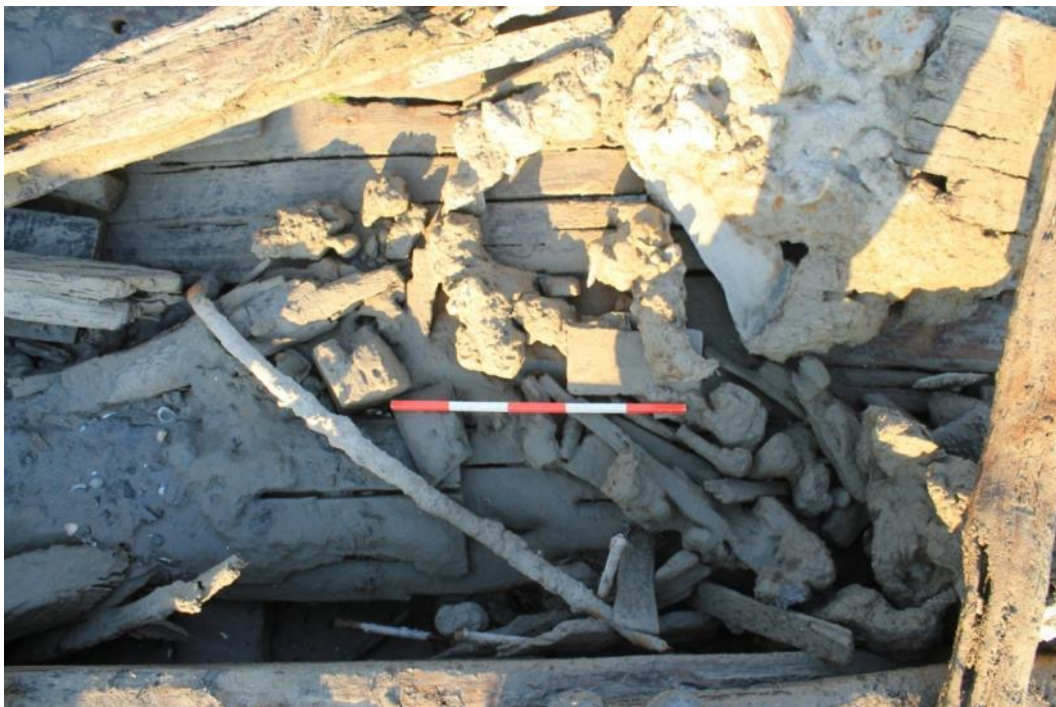
Changes had also occurred to the upper surface of the wreck where objects were quite well embedded in silts during the survey in June 2015 (Photo 23), but by September much of the silt had been washed away and the objects looser and under far greater threat of being lost through tidal movement (Photo 24).

Photo 24: Same part of the surface of the hold of the wreck in September 2015 showing that the silts have been washed away and numerous small objects had become exposed and under threat of being washed away

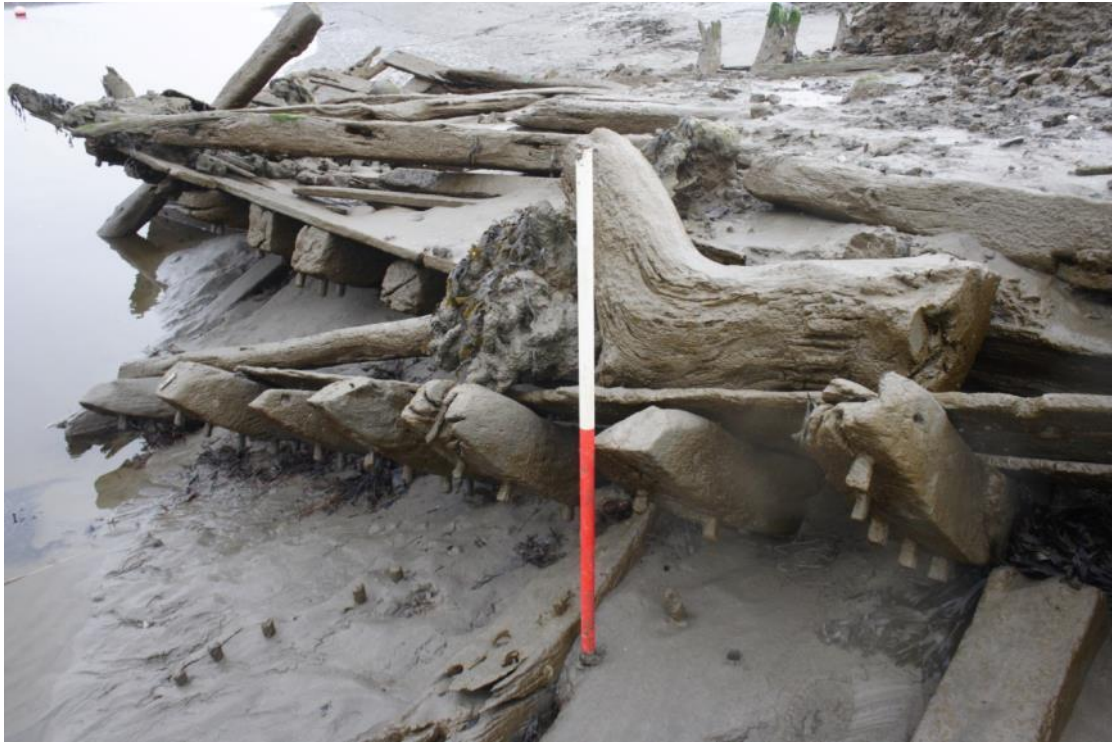
As was noted above, the possible boom 213 that was formerly located on the keelson at the stern of the wreck had moved by March 2016 and also a number of loose timbers and iron on the surface had slipped down the side of the wreck (Photo 25).

Photo 25: Alterations to the wreck by March 2016, showing possible boom 213 over the stern of the wreck in the top left of the photo and loose timber 206 and adjacent lump of corroded iron chain slumped further down on the starboard side

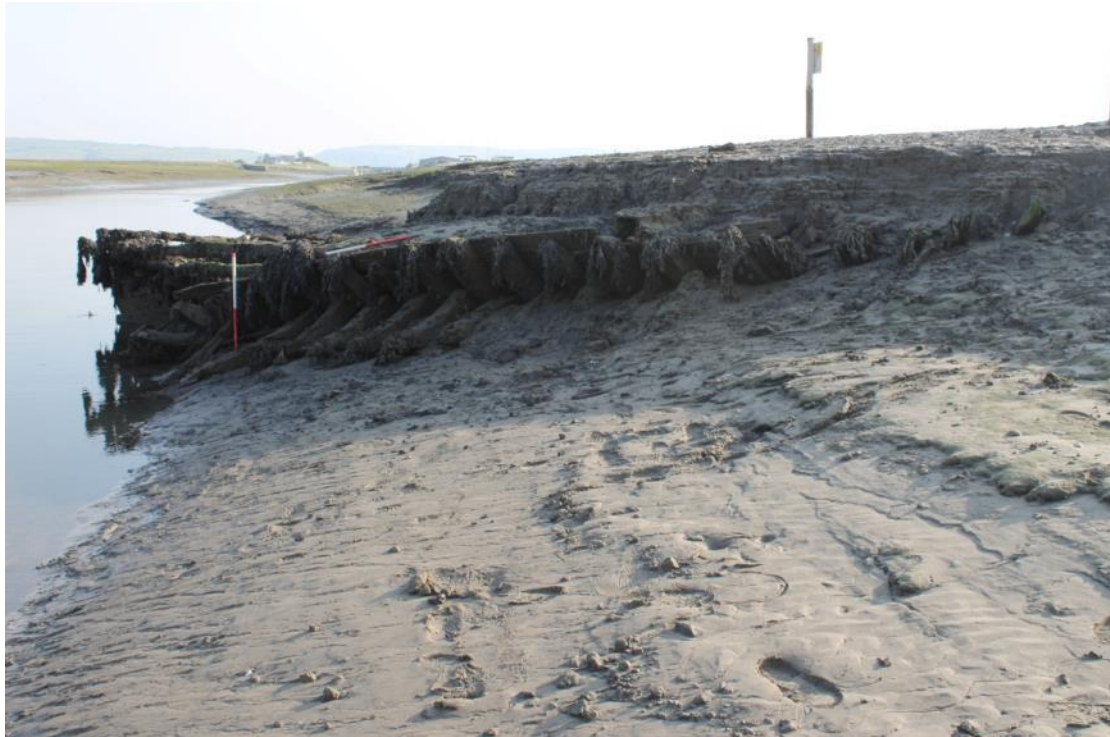
Photo 1: Showing the hulk eroding into the Afon Leri, viewing south

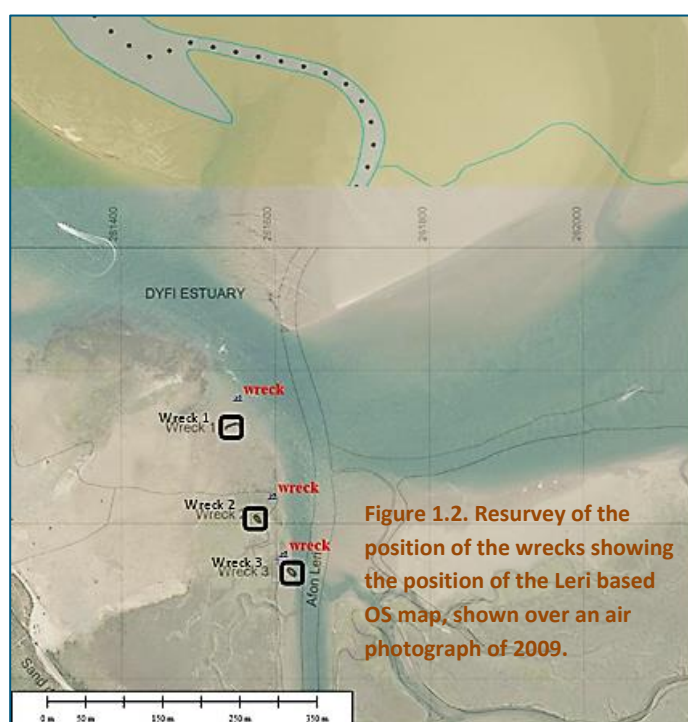
Over the last decade the wrecks have become increasingly exposed. As can be seen in Figure 1.2, as the channel has swung to the west, Wreck 3 is now increasingly at risk from erosion at the edge of the channel. Wrecks 1 and 2 have also become more exposed, although their

Figure 1.2. Resurvey of the position of the wrecks showing the position of the Leri based OS map, shown over an air photograph of 2009.
