ST MARY'S CHURCH, CYNGHORDY CARMARTHENSHIRE: ARCHAEOLOGICAL WATCHING BRIEF 2012

RHIF YR ADRODDIAD / REPORT NO. 2012/09
RHIF Y PROSIECT / PROJECT RECORD NO. 102633

Chwefror 2012
February 2012

ST MARY'S CHURCH, CYNGHORDY, CARMARTHENSHIRE: ARCHAEOLOGICAL WATCHING BRIEF

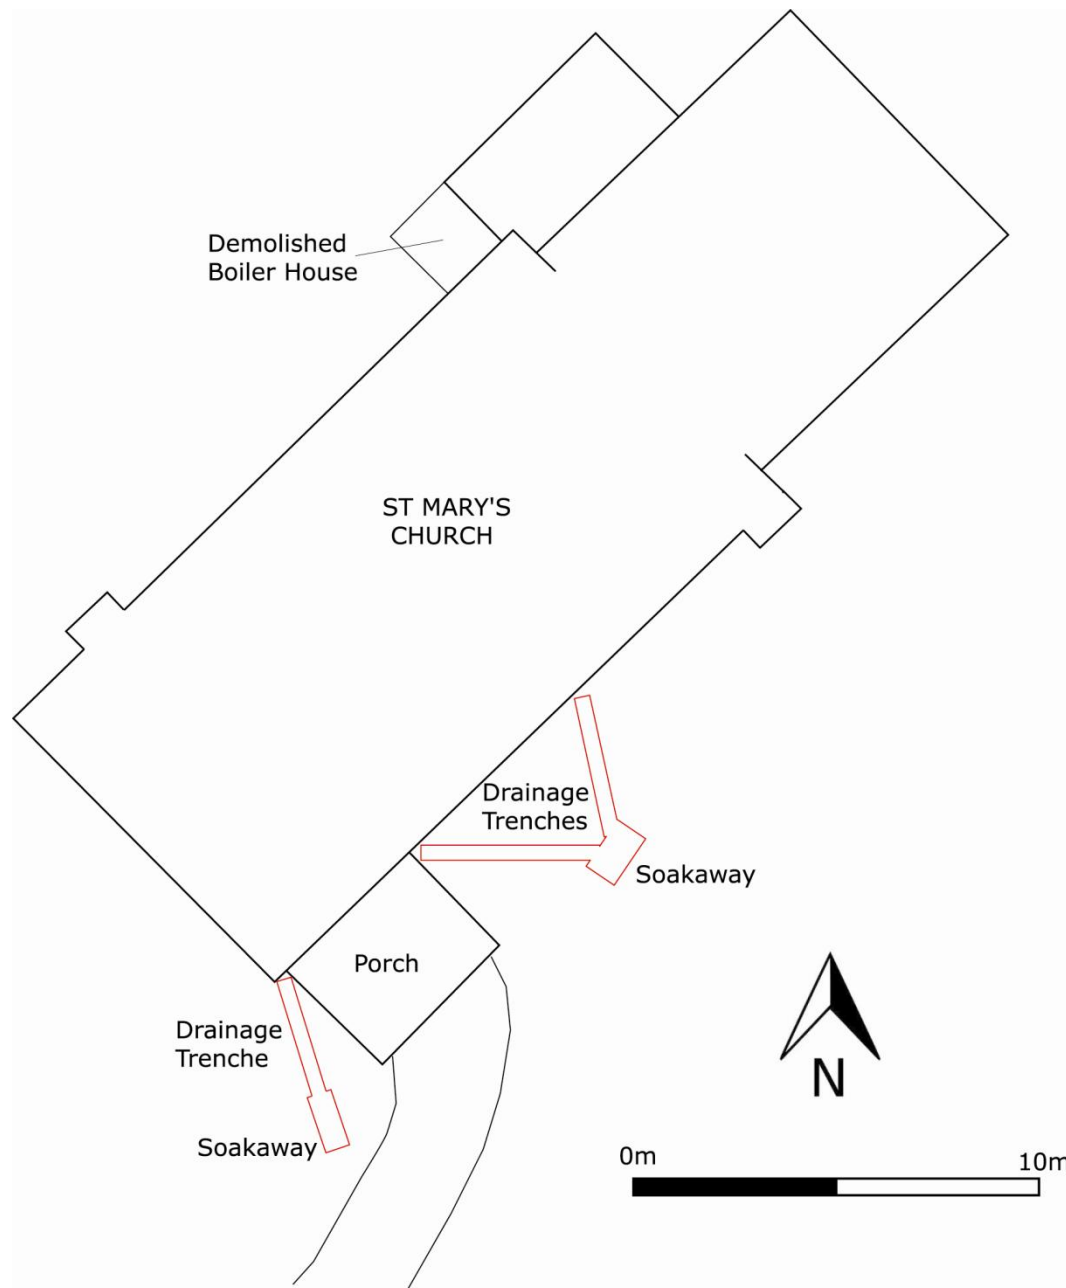
Figure 2: Sketch plan (the given scale is an approximation only) showing the main church building and rough location of the drainage trenches and soakaways.

- 3.2 The groundworks consisted of the excavation of three drainage trenches leading from the gutter down pipes along the southeast wall of the church. These trenches ended in soakaways (see Figure 2). The works also included the relaying of the floor inside the porch, but these works were not observed. The works also included the demolition of the modern boiler house, but this did not involve any below ground works and therefore did not warrant an archaeological attendance.

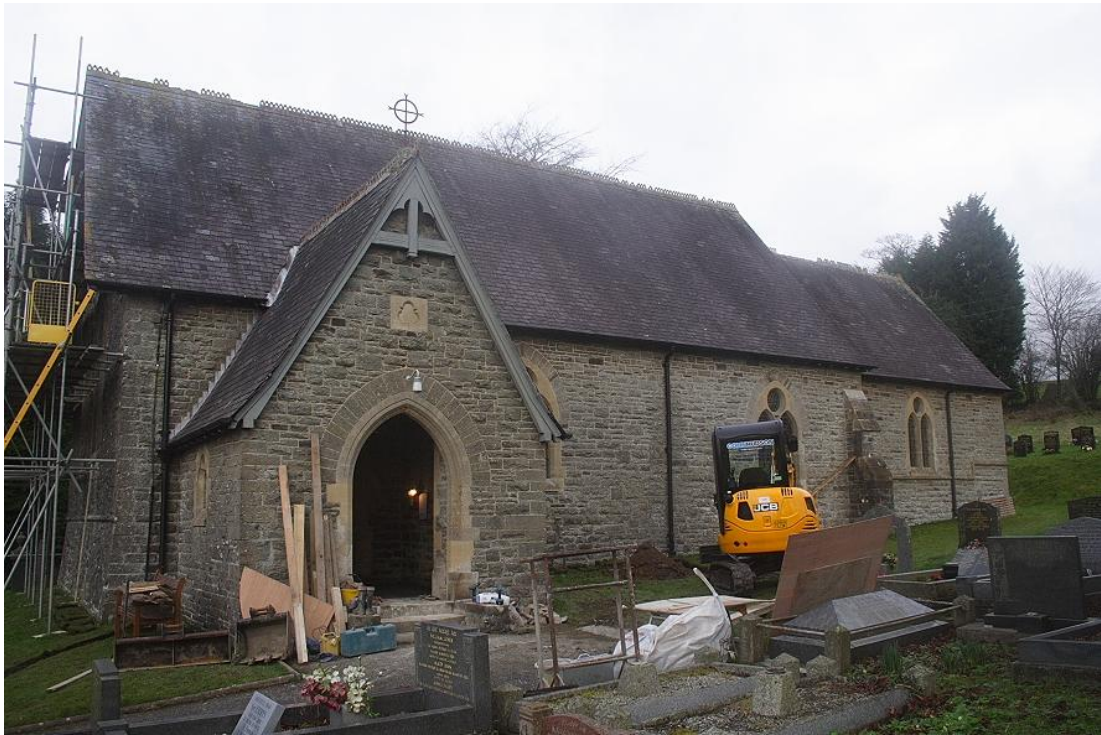
Photo 1: St Mary's church, showing renovation and drainage works in progress.

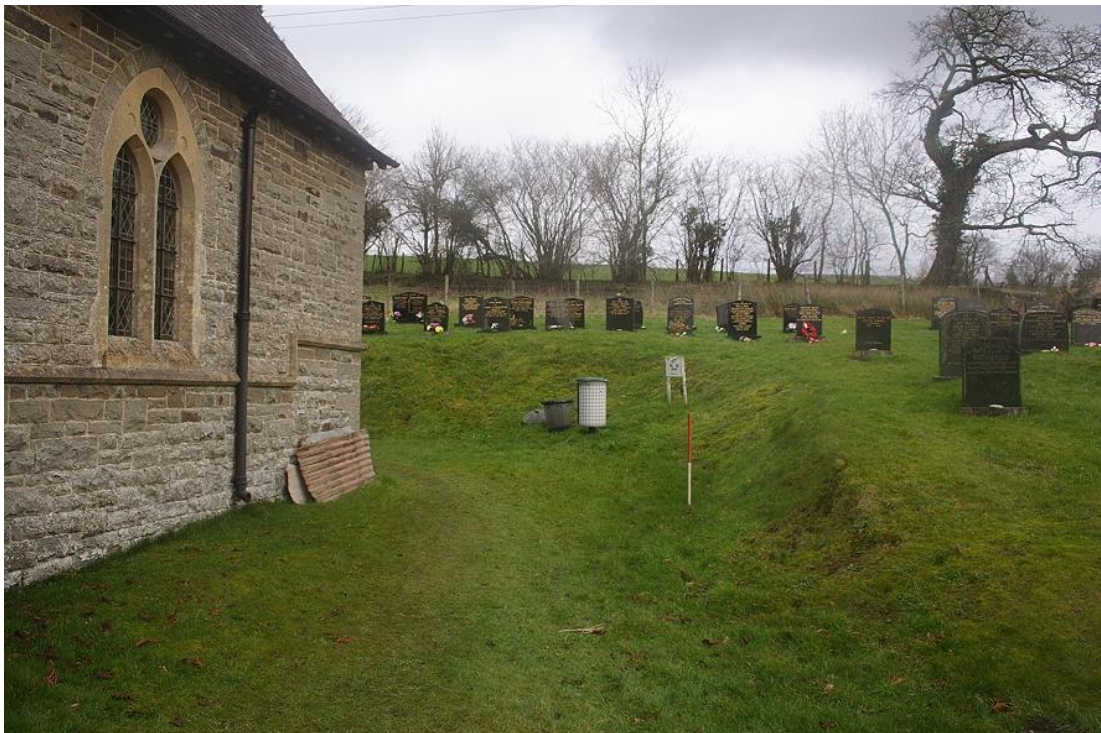
- 2.1.3 The church sits on the edge of the floor of the Bran valley, with the land dropping away to the southwest. The river itself runs some 400m to the west. The church has been partly terraced into the falling ground (Photo 2).

Photo 2: Looking north, showing the terracing of the hillslope and the graveyard.

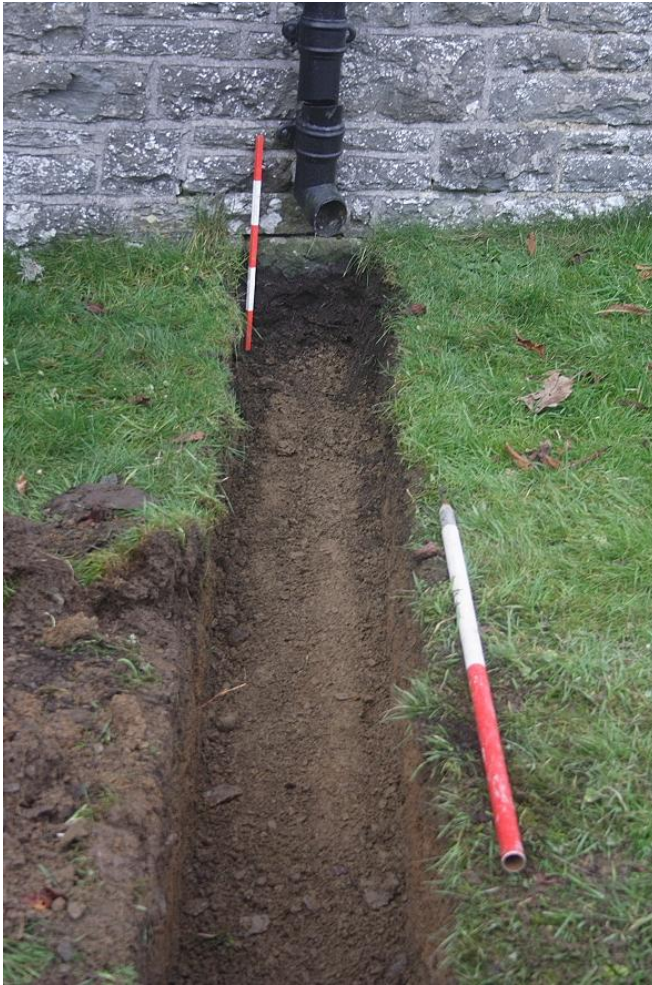
- 4.1 The two drainage trenches to the north of the porch (Photos 3, 4, 5 & 6) were 0.3m wide, at most 0.3m deep and between 3.2m and 3.5m long. A soakaway was excavated at the point where they intersected, measuring 1.3m by 0.9m and 1.1m deep (Photo 7). Consistent deposits were recorded throughout these groundworks.

Photo 3: The northernmost drainage trench. 1m & 0.5m scales.

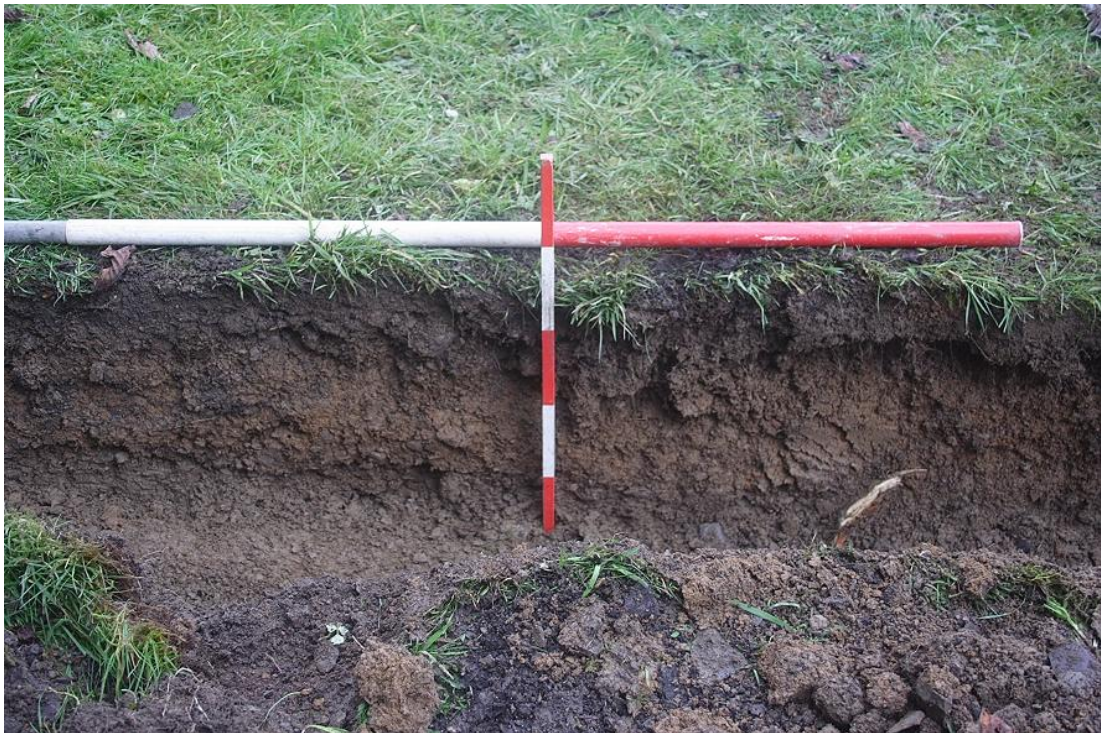
- 4.2 The topsoil (100) comprised a dark grey-brown clayey-silt. This was typically 0.1m thick, although increased in thickness close to the church wall, where it contained a large quantity of broken slate roof tiles. Occasional fragments of floor tile and late 19th/20th century pottery were also spread throughout the topsoil.

- 4.3 Underlying the topsoil was a 0.1m thick layer of mid orange-brown clayey-sand subsoil (101), including the occasional sub-rounded stone. This appeared to be naturally occurring subsoil. Below this was mid grey clayey-sand stony subsoil (102), up to 0.2m thick. The soakaway revealed a compacted layer of fragmented shale bedrock (103) 0.4m thick underlying this, which in turn lay on top of solid bedrock (104). No finds or features of archaeological interest were noted within these deposits.

Photo 4: Typical section of the northernmost drainage trench. 1m & 0.5m scales

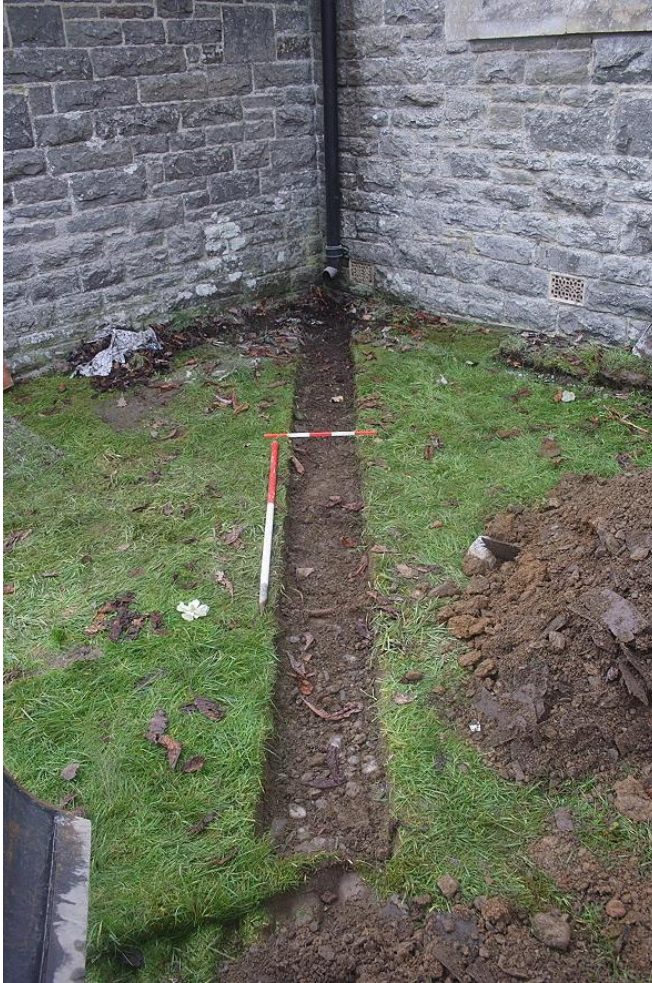
Photo 5: The central drainage trench. 1m & 0.5m scales.

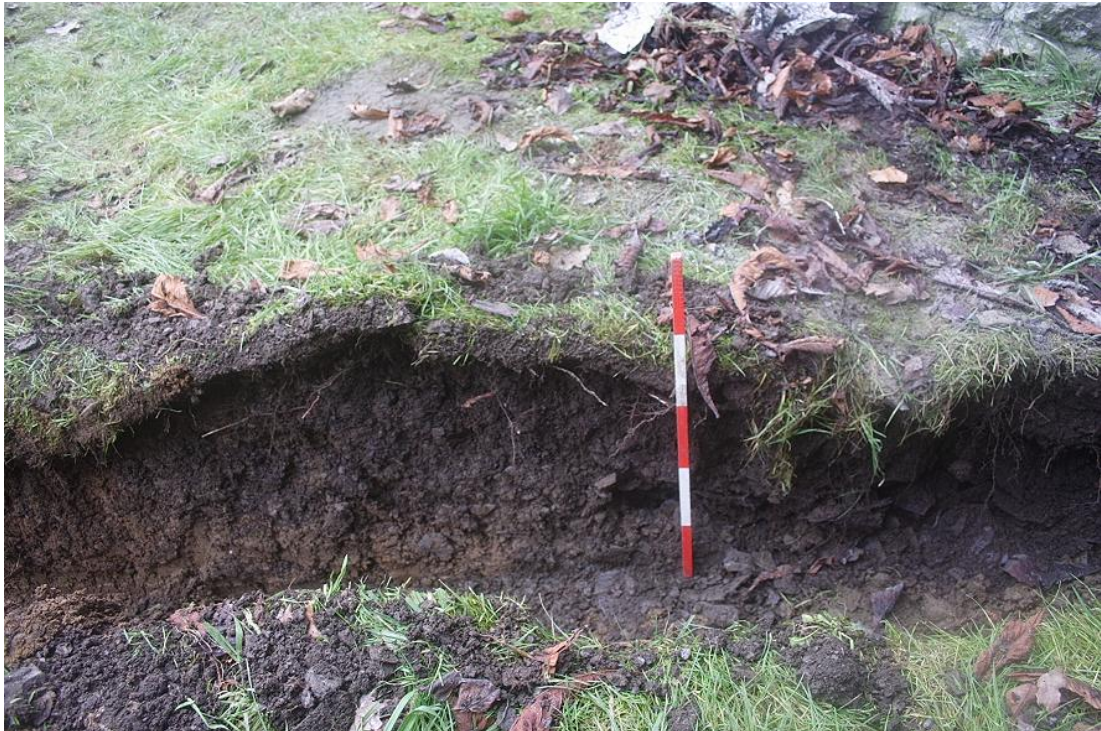
Photo 6: Typical section of the central drainage trench. 0.5m scale.

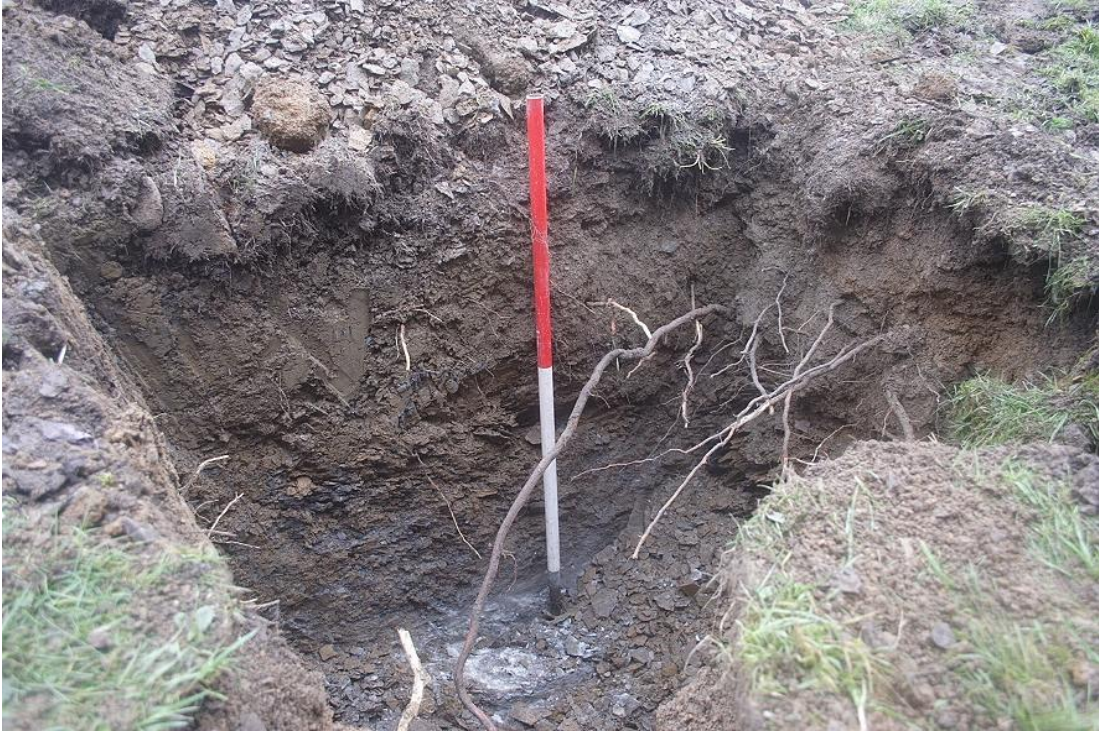
Photo 7: Section of the northernmost soakaway. 1m scale.

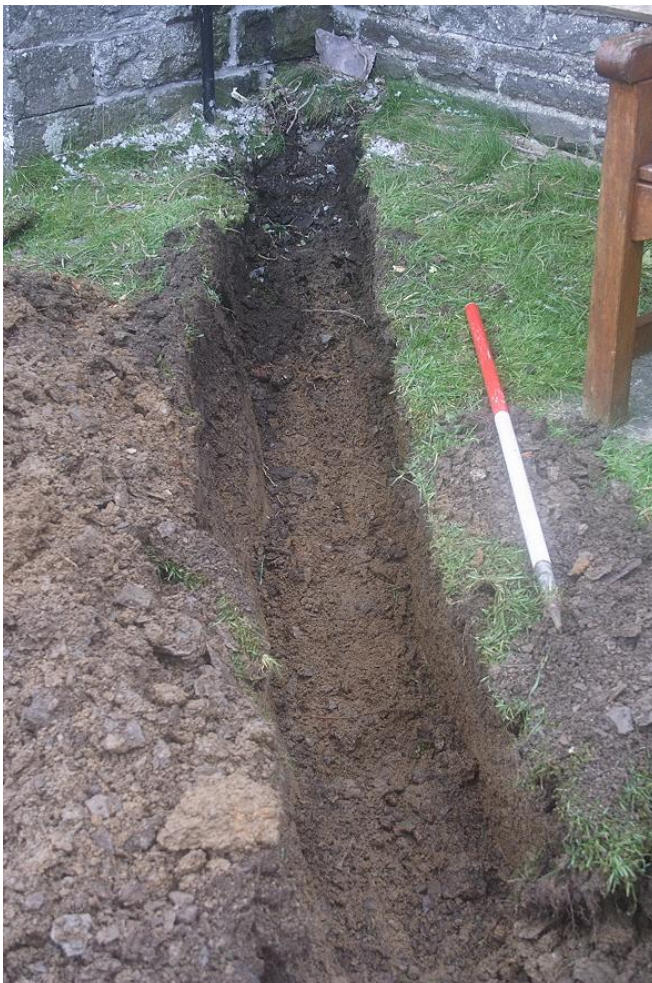
- 4.4 The drainage trench and soakaway (Photos 8 & 9) to the south of the porch revealed a slightly different arrangement of subsoils. This trench measured 2.9m long, 0.3m wide and 0.4m deep. The soakaway at the end measured 0.6m wide, 1.4m long and 1.8m deep.

Photo 8: The southernmost drainage trench. 1m & 0.5m scale.

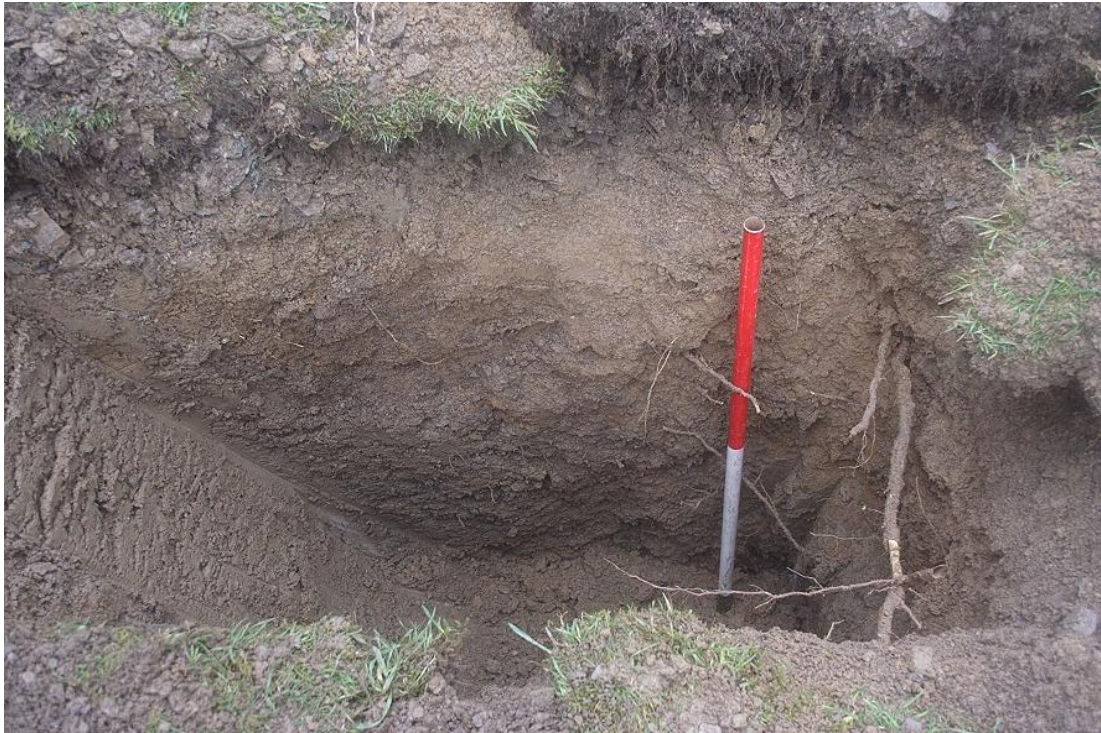
- 4.5 The topsoil (200) remained similar, but with no obvious slate inclusions. Below this was a light brown-grey sandy-clay (201), 0.15m thick, with occasional sub-angular shale inclusions. Below this was a mid orange-brown sandy-clay (202), similar to the upper subsoil 101 visible to the north, this deposit however was thicker, up to 0.5m deep. The underlying subsoil (203) was also similar to deposit 102, but again much thicker, being up to 0.55m deep. Traces of compacted fragmented shale bedrock (204) were revealed below this at the base of the soakaway.

Photo 9: Section of the southernmost soakaway. 1m scale.
