BOULSTON MANOR, PEMBROKESHIRE: BUILDING RECORDING

RHIF YR ADRODDIAD / REPORT NO. 2012/27
RHIF Y PROSIECT / PROJECT RECORD NO. 102767

Mawrth 2012
March 2012

P Poucher & H Wilson

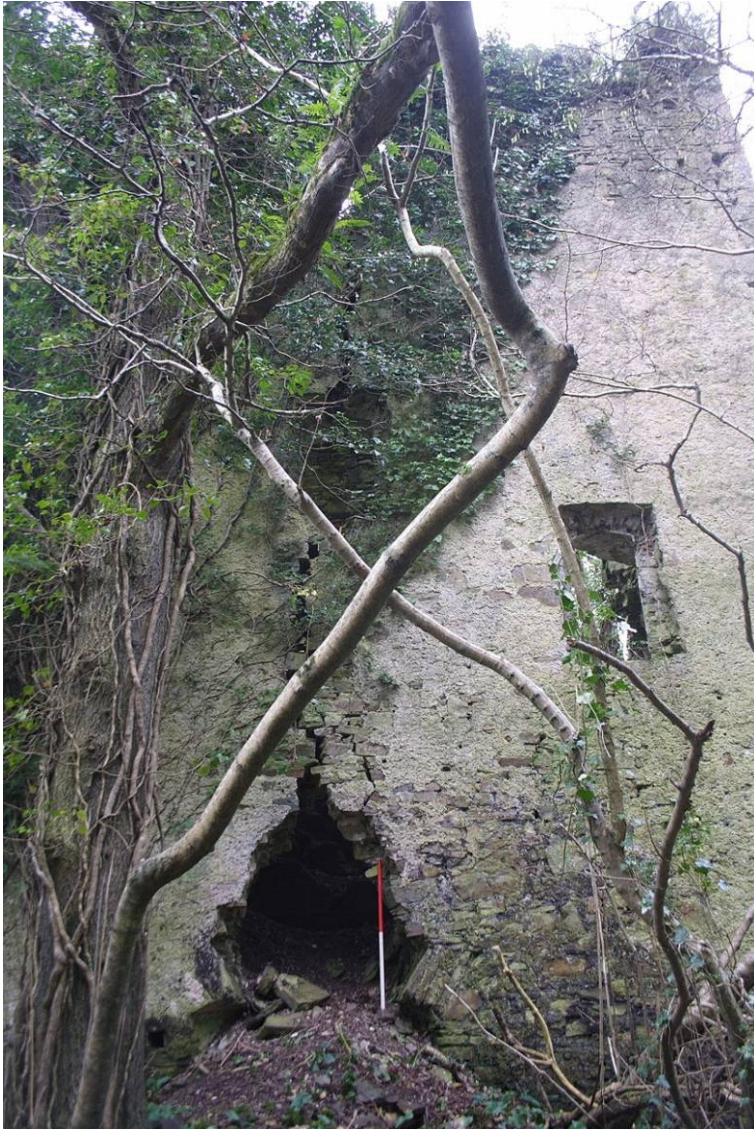
There is a ground floor arch, presumably for an entranceway, in the centre of the east gable tower wall, just visible above the build-up of rubble and soil (photo 9). The top of the arch has collapsed, which has caused stonework immediately above to fall in, and a large crack has opened the full height of the tower. This entrance opens into a narrow space 0.8m wide, and opposite a blocked narrow splayed opening in the undercroft wall.

Within the eastern tower of the main hall a large crack has formed running the full height of the eastern wall where the lower arched entranceway has collapsed. Within the undercroft the ceiling shows clear signs of subsidence on its western side, although there are no obvious signs of recent movement. However, should the undercroft be allowed to collapse it is possible that this will also weaken the remains of the eastern tower, as they are directly connected.

Photo 9: Closer view of the collapsed archway and vertical crack above. 1m scale.

All these structural issues should be monitored regularly to ascertain if they are causing further deterioration, and to establish the best way of repairing or preventing further structural deterioration.

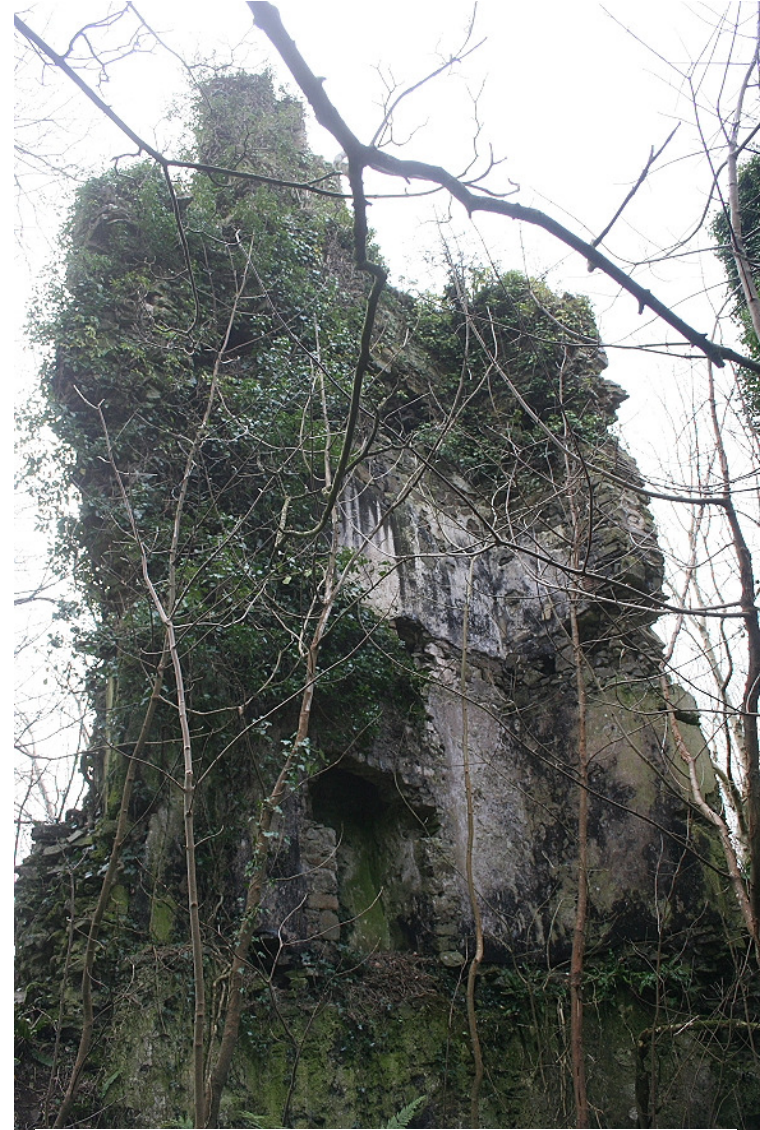
Photo 17: Looking north along the western wall of the Western Tower, showing the outward lean. 1m scale.

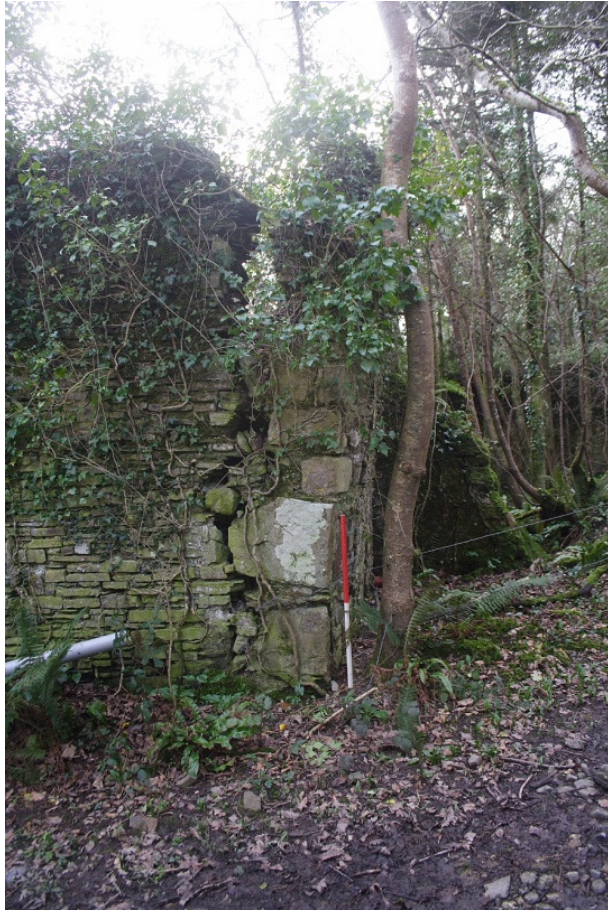
Photo 43: Damage at the north-eastern corner of the Garden Enclosure. 1m scale.

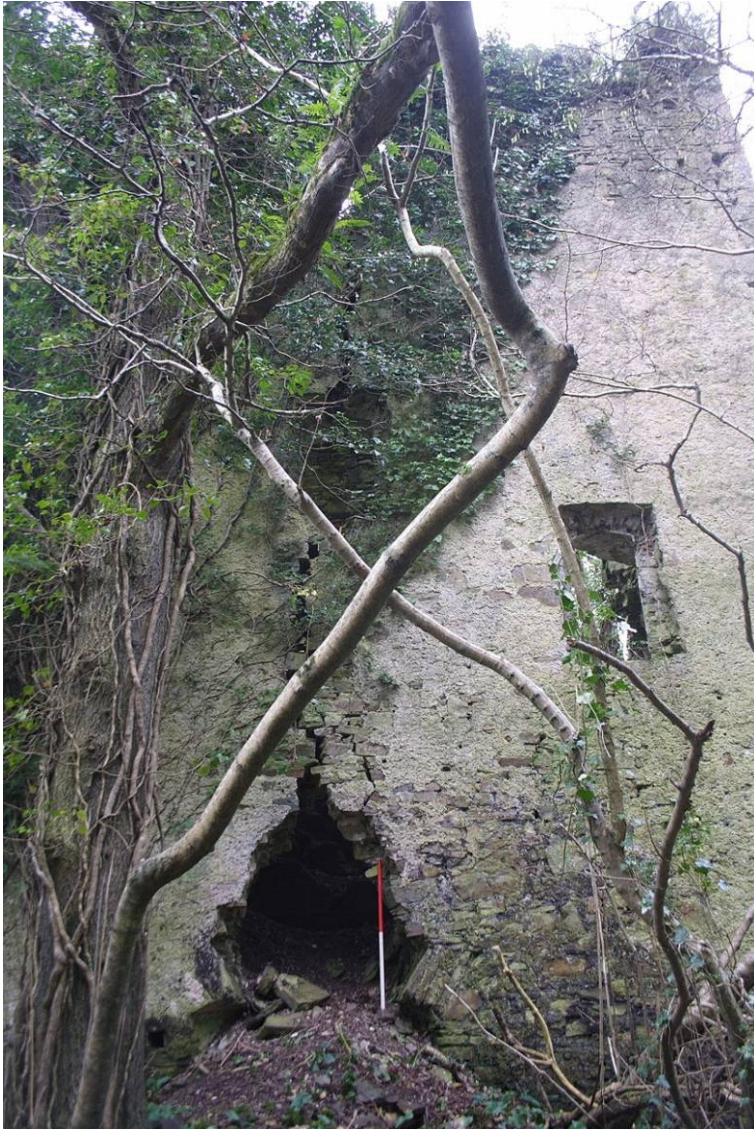
There is a ground floor arch, presumably for an entranceway, in the centre of the east gable tower wall, just visible above the build-up of rubble and soil (photo 9). The top of the arch has collapsed, which has caused stonework immediately above to fall in, and a large crack has opened the full height of the tower. This entrance opens into a narrow space 0.8m wide, and opposite a blocked narrow splayed opening in the undercroft wall.

Photo 9: Closer view of the collapsed archway and vertical crack above. 1m scale.

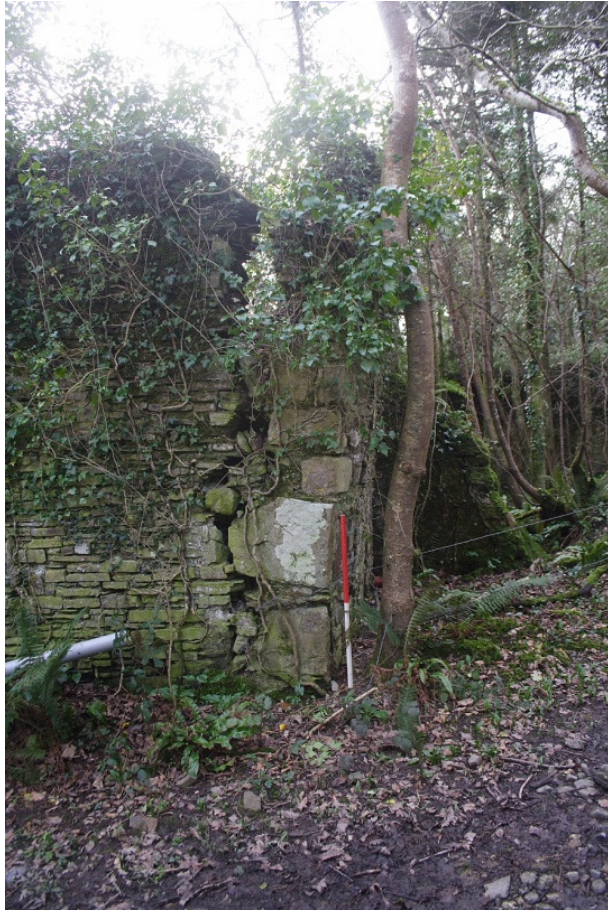
Photo 43: Damage at the north-eastern corner of the Garden Enclosure. 1m scale.

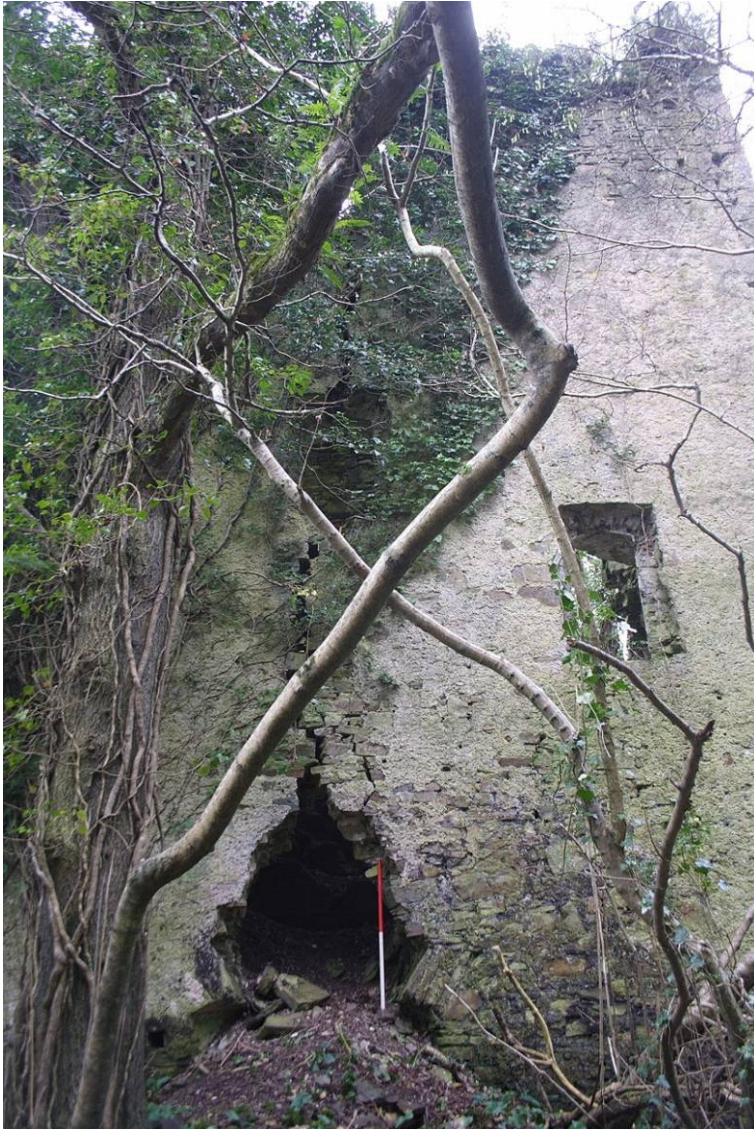
Photo 9: Closer view of the collapsed archway and vertical crack above. 1m scale.

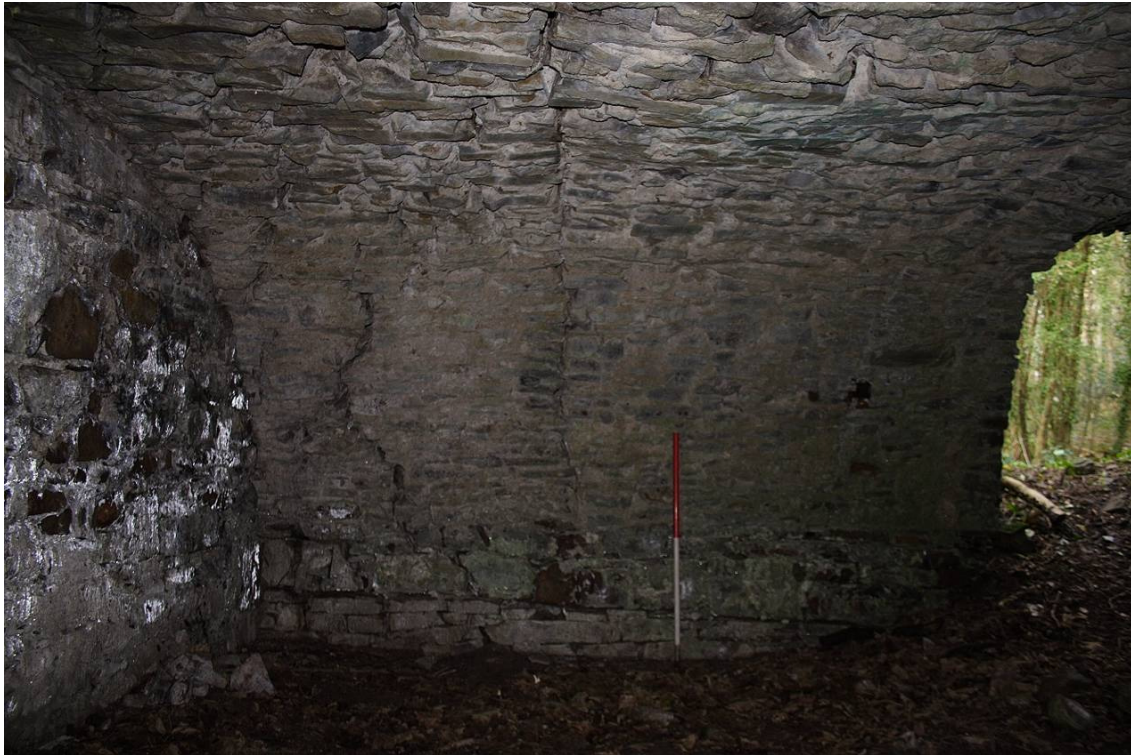
Photo 32: The interior of the undercroft looking west, showing the collapse in the ceiling and upper courses of the western wall. 1m scale.

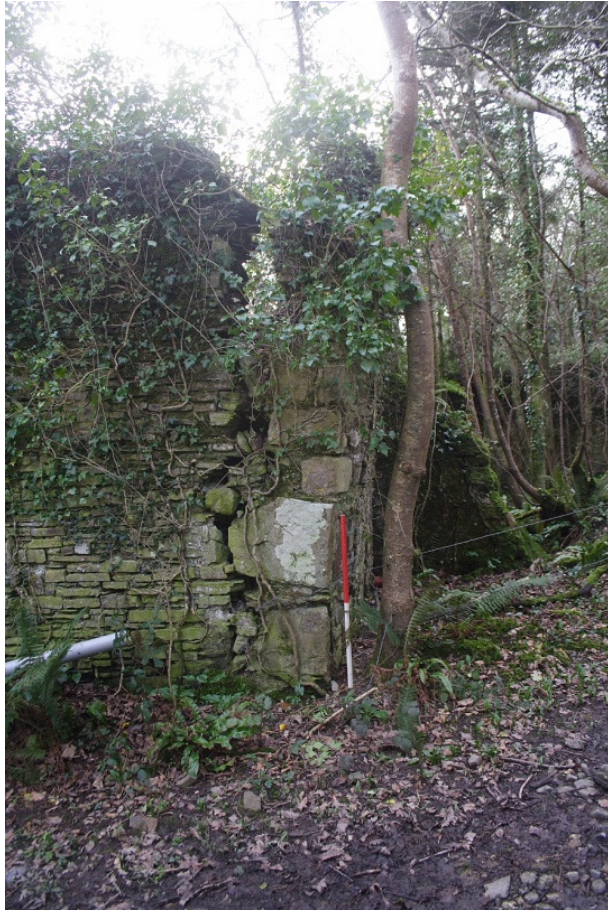
Photo 43: Damage at the north-eastern corner of the Garden Enclosure. 1m scale.
