NEW MILL, NEW MOAT, CLARBESTON ROAD, PEMBROKESHIRE: ARCHAEOLOGICAL BUILDING RECORDING

Prepared by Dyfed Archaeological Trust
For: Mr and Mrs Masri

RHIF YR ADRODDIAD / REPORT NO. 2015/25
RHIF Y PROSIECT / EVENT RECORD NO.108523

Mai 2015
May 2015

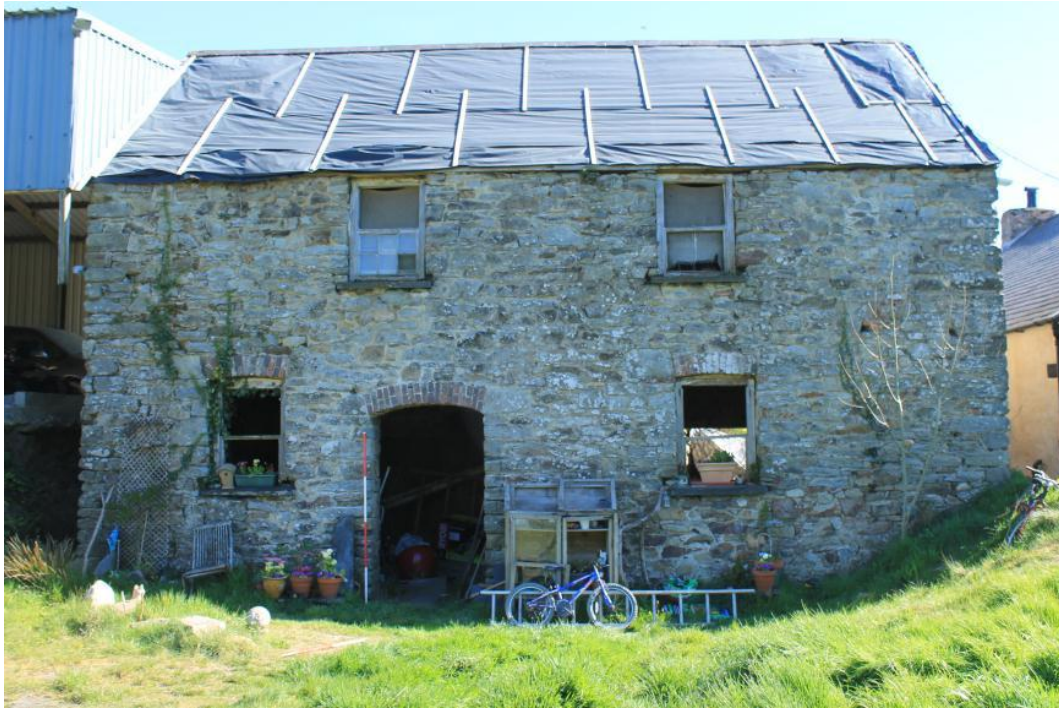
Photo 1: Southwest facing exterior elevation

The front elevation (Photo 1) shows that the upper 12-pane sash windows (Photo 2) are symmetrically arranged. They are directly under the eaves/wall plate, with no lintels. The ground floor openings are not symmetrically arranged. The ground floor windows (Photo 3) house the remains of 12-pane sashes (Photos 2 and 9) in openings with cambered brick heads. The door (Photo 4), to the left of centre, has similar cambered brick heads. A subterranean rock-cut drain may run under the floor of the building below the door opening. This is suggested by two stone slabs set into the floor in front of the rock outcrop, directly below the leat opening (Photo 17).

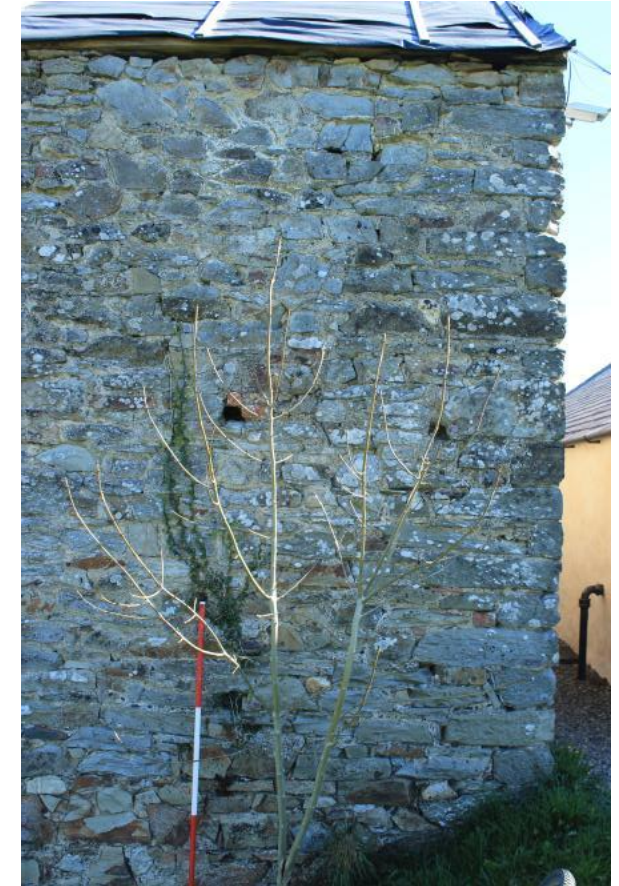
Photo 5: Putlog holes on southwest facing exterior elevation

Four putlog holes (Photo 5) are visible on the right hand side of the front elevation. It is unclear what these may represent. If they had any mill related function at all, perhaps they could have held the horizontal bars of a tentering frame for drying and stretching textiles (see discussion).

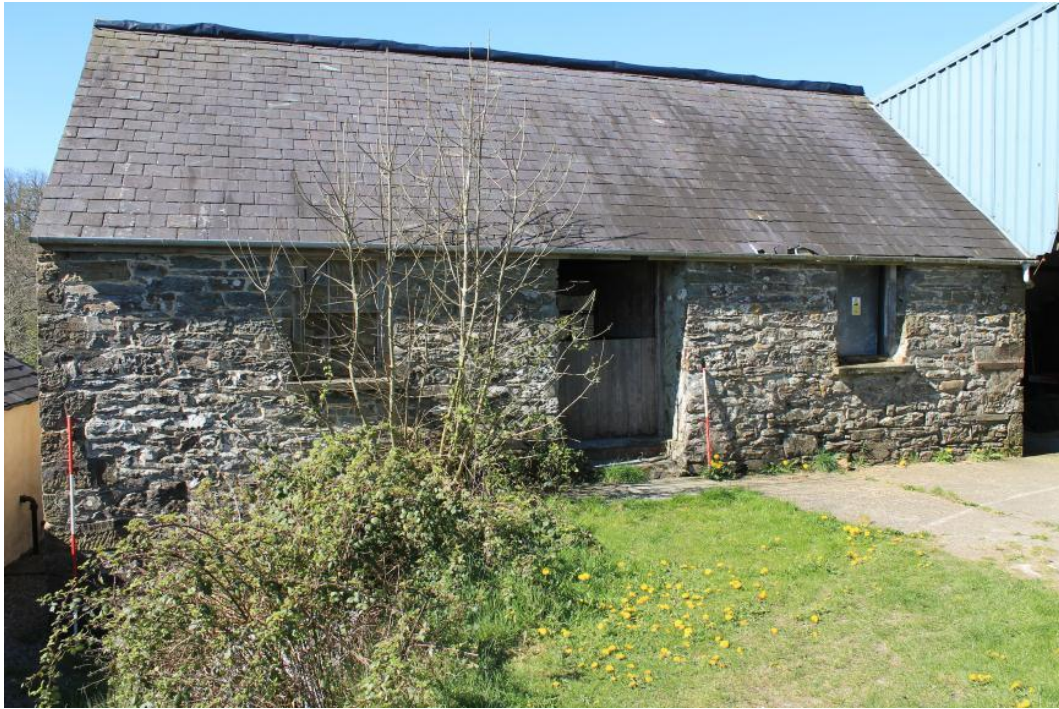
Photo 6: Northeast facing elevation (First floor)

The rear northeast facing elevation (Photo 6) is built into a bank. The openings are not symmetrically distributed. The first floor windows each side of the door, are directly under the eaves, with no lintels. The left window (Photo 9) retains a 12-pane sash. The right side window contains a modern metal clad shutter. The doorway (Photo 8) is not centrally located. It has slate threshold steps, and a boarded stable-type door.

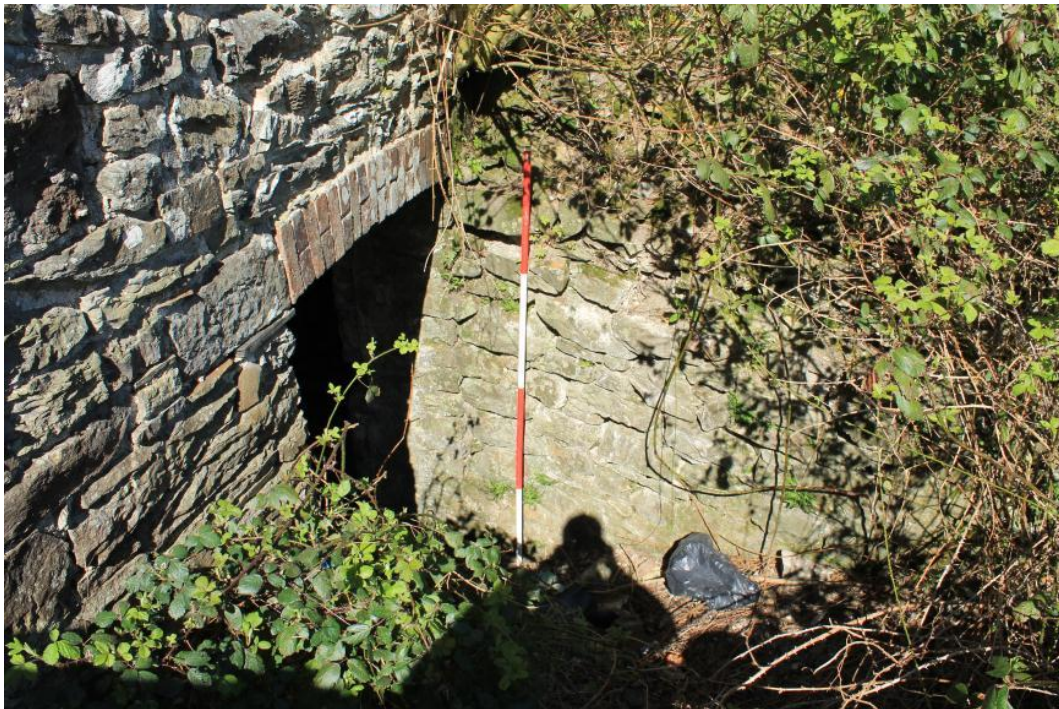
Photo 7: Former stair to ground floor, northeast facing elevation

There is a red brick-headed basement door (Photo 7) opening to the left (at ground floor level), accessed via an external slightly curved former flight of steps leading from the first floor level (the top of the bank). The rear elevation quoins are of dressed sandstone.

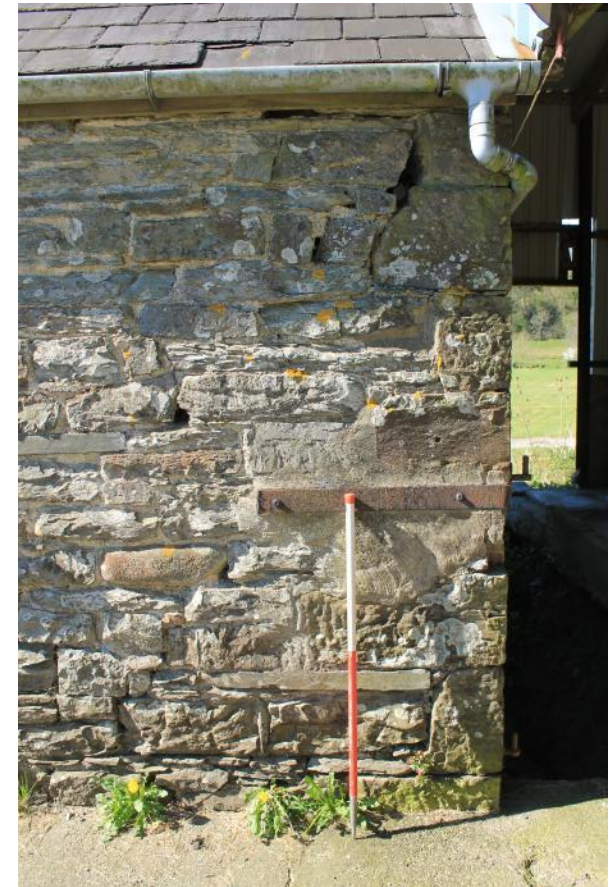
Photo 10: Iron gate hinge bracket, northeast facing elevation.

Photo 10 shows a pair of iron gate-hinge fittings on the right hand corner of the building. These presumably relate to the former wheelpit.

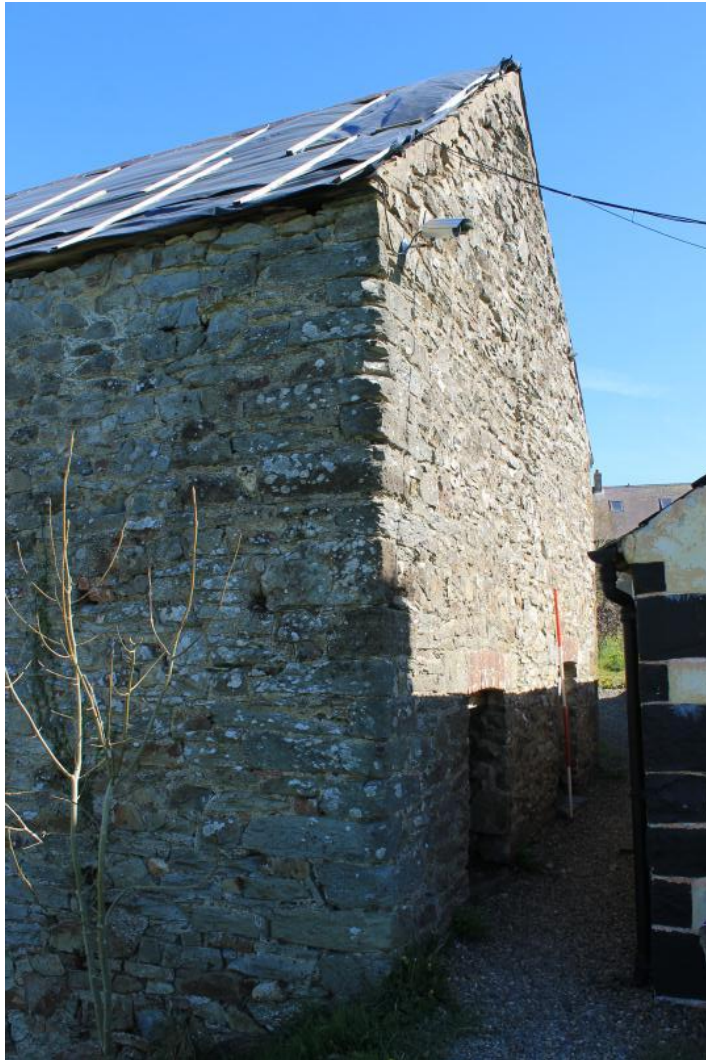
Photo 11: Southeast facing gable end elevation

The east facing gable end wall (Photo 11, Plan 4), opposite the rear of the old farmhouse has two symmetrically distributed windows at ground level with cambered red brick heads (Photo 12). The windows are at different heights, reflecting the rising ground level to the northeast. No other features are visible.

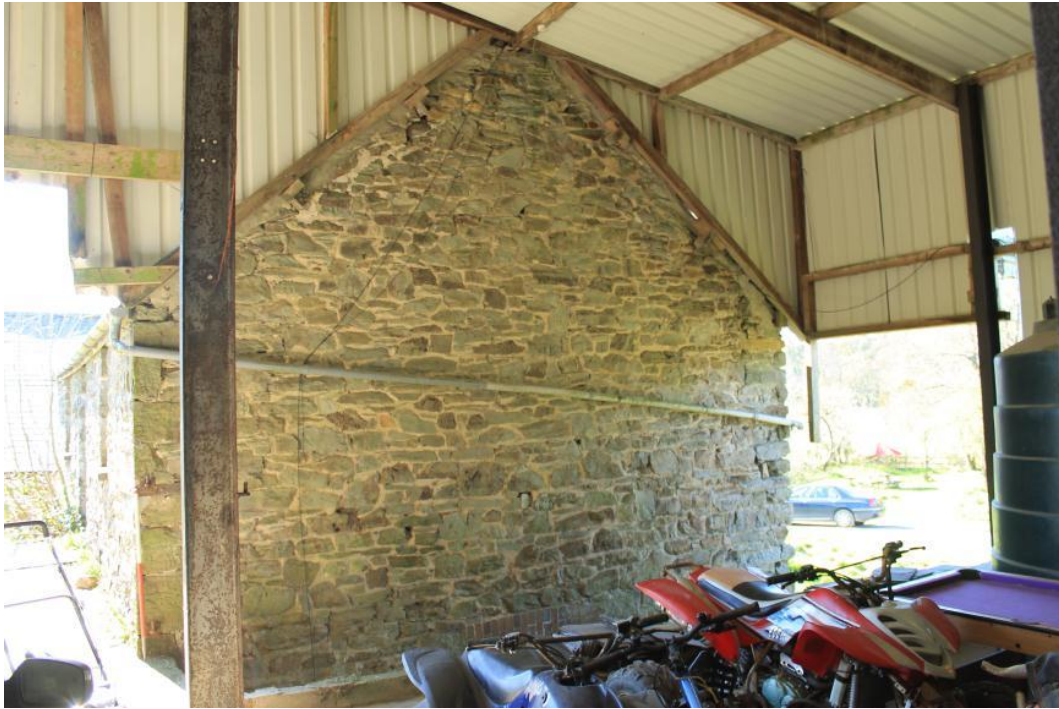
Photo 13: Northwest facing gable end elevation (upper part)

The northwest facing exterior elevation (Photos 13 and 14) has a single red brick-headed doorway opening at ground floor level. To the right of the door is a small opening through the wall (Photos 14 and 20). This is the only visible candidate for an opening that could have housed the driveshaft for a waterwheel on this side of the building.

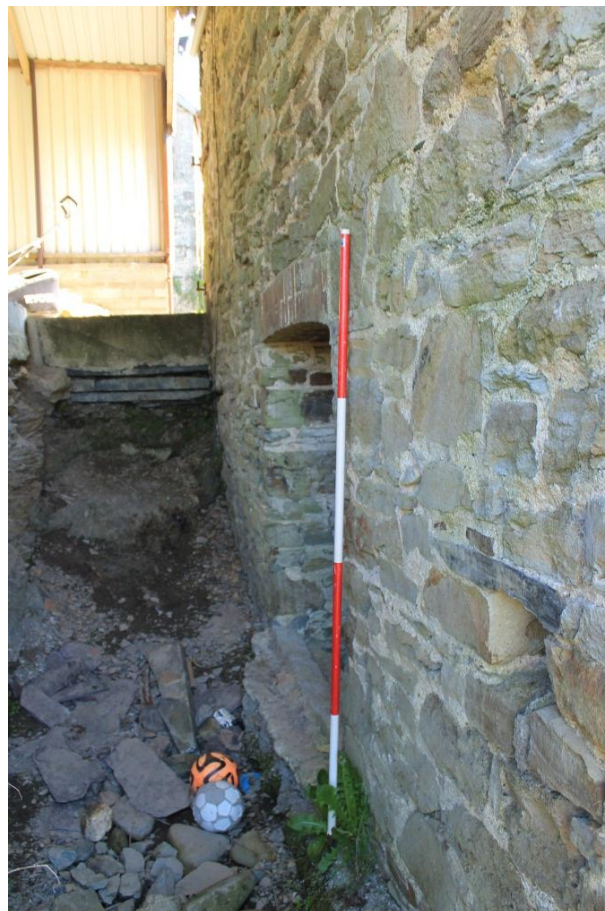
The doorway appears to have led to a narrow cutting reportedly a former wheelpit and later sheep dip (Photo 14). Although little clear evidence for the wheelpit survives, what appears to be an arched rock-cut leat is visible at the back of the narrow cutting (see Photo 15). The surviving features suggest this

Photo 14: Northwest facing gable end elevation (lower part- possible former wheelpit and later sheep dip), with door opening and possible opening for drive-shaft in wall to right of picture.

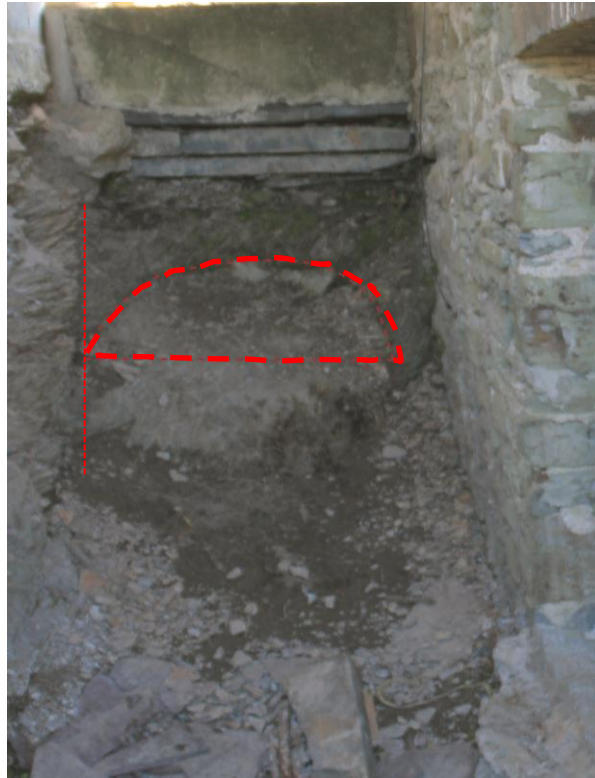
would have been an 'under-shot, rather than an 'overshot' wheelpit. Alternatives to the wheelpit interpretation are explored further in the discussion section below.

Photo 15: Rock-cut possible leat (red semicircle) at back of former wheelpit. Vertical line indicates the edge of the possible wheelpit cut.

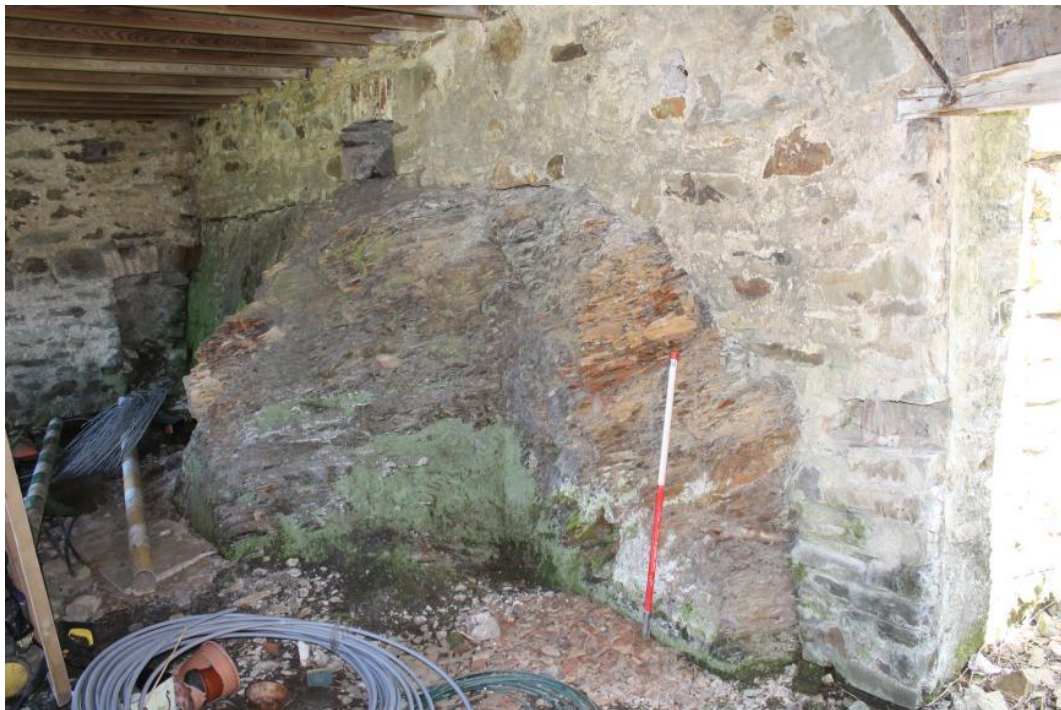
The top of the outcrop appears to have been levelled flat (Photo 17, Plan 3) in order to build the wall on it. In addition, the right hand side of the outcrop has been fashioned to form a right-angled recess with vertical sides (Photos 16, 17; feature B on Plan 3), presumably to accommodate part of the mill machinery (Plan 6 and later discussion). Some slight evidence for the rock having been shaped to the left of the leat opening (dotted line on Photo 17; feature A on Plan 3), may suggest the former location of another tank, or other structure. It is interesting to note the wear to the rock outcrop below the leat opening, although it is unclear whether this is related to the functioning of the mill.

Photo 16: Bedrock outcrop on ground floor. Note shaping of rock to form right angled vertical faces, possibly to house a fulling tank?

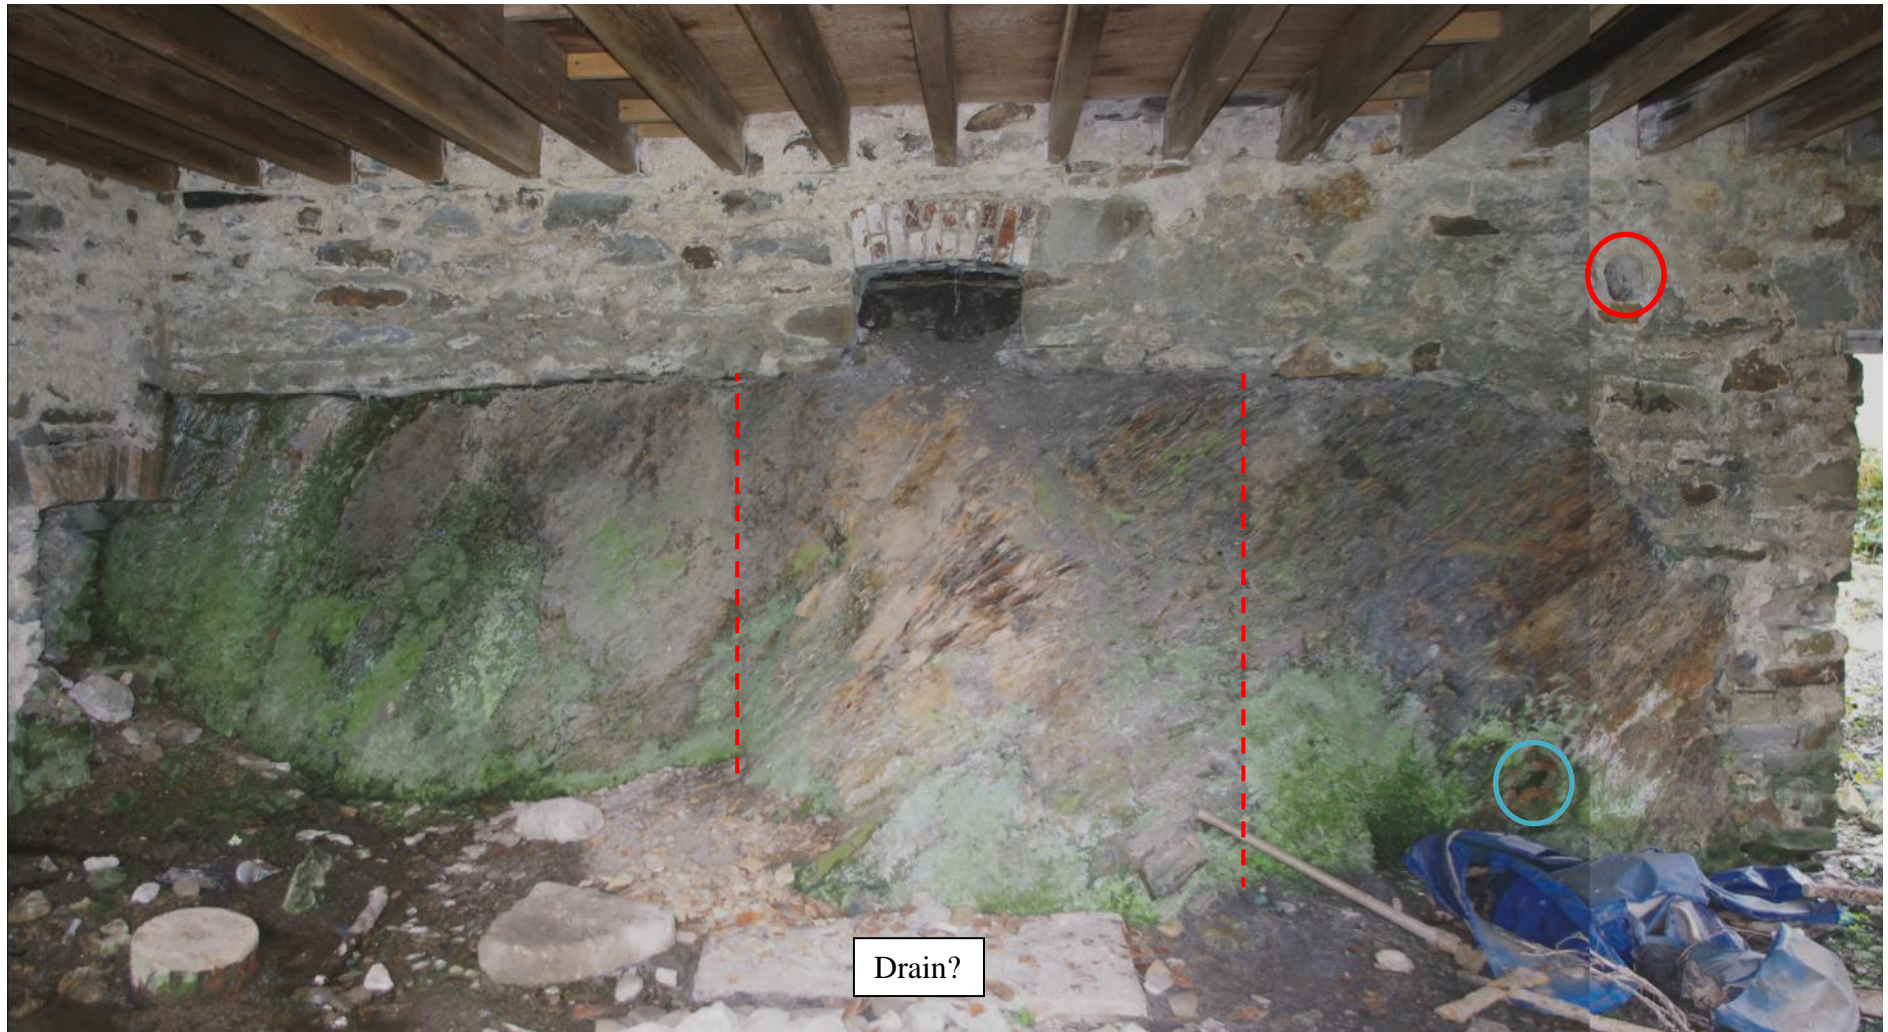
To the upper left of the doorway (Feature C, Plan 3) in the northeast wall is a recess that may have held a wooden partition support or other structure (circled in red in Photo 17). A similar hole (Feature D, Plan 3) has been cut into the carved rock-face on the right-hand side close to ground level. This presumably held a timber associated with the mill machinery (circled in blue in Photo 17). On each side of the doorway is a small wooden inset (Plan 3) at slightly different height. These may suggest that this opening originally had a stable-type door.

Photo 17: Natural shale bedrock foundation to the northeast wall (southeast facing). Note niche for beam (circled in red) and vertical cut faces (dashed lines)

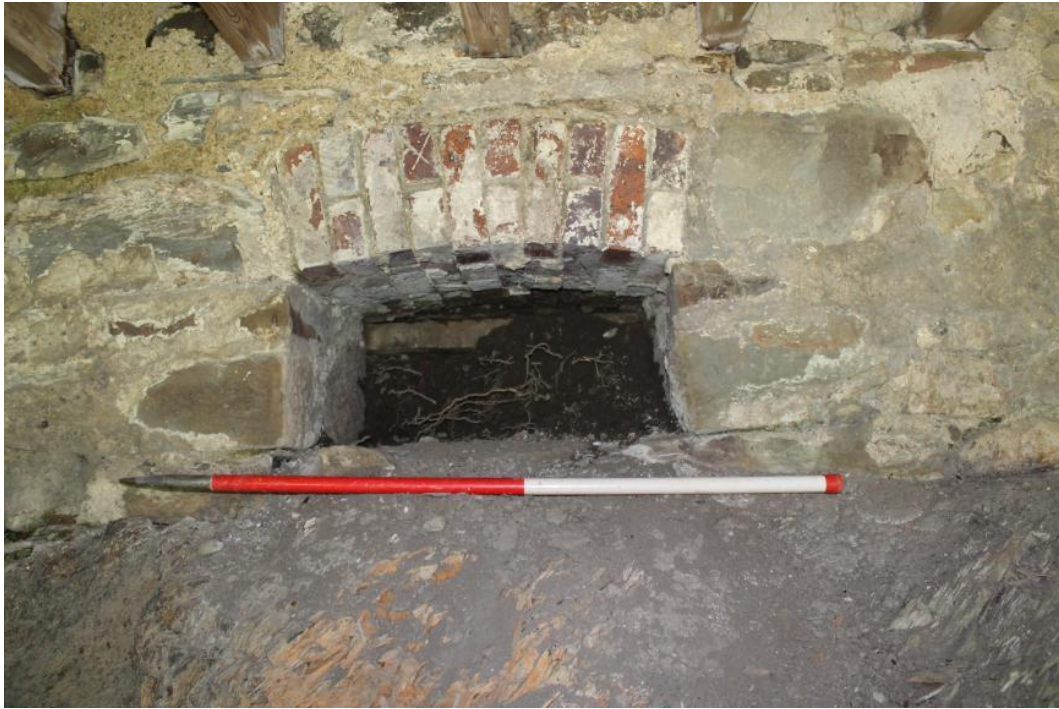
Photo 18: Inlet in northeast wall from main leat into mill building

Immediately above the rock outcrop, and centrally located in the wall is an inlet from the main leat that runs to the north of the mill building (Photo 18, Plan 3). Large stone slabs in the floor in front of this inlet (Photo 17) are assumed to cover a leat beneath the floor and exiting the building beneath the doorway threshold. Presumably water from the inlet was used to fill tanks used in the fulling process. It may also have been used to power other machinery.

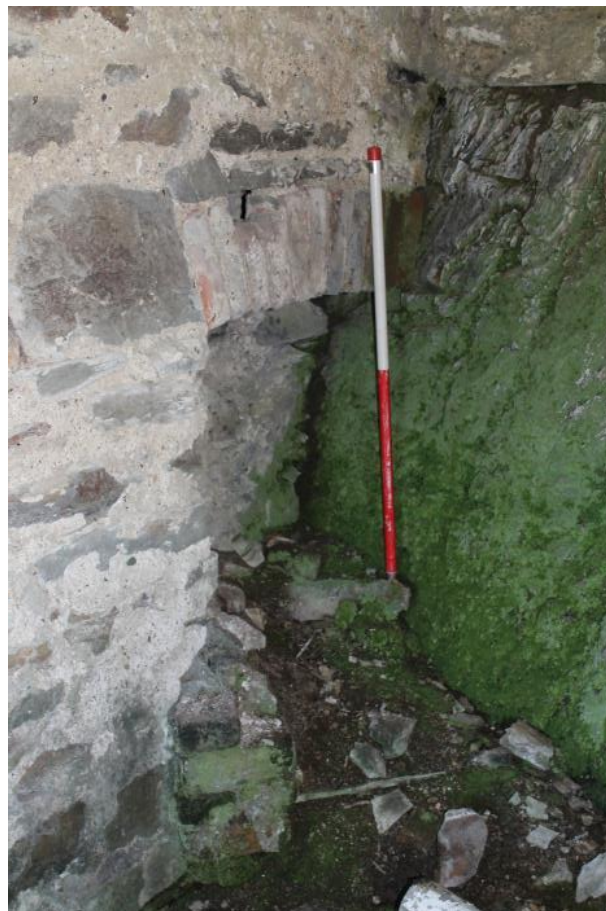
At the lower right end of the east facing elevation is a curiously positioned small hearth (Photos 19 and 20), the right hand side of which is formed by the natural rock outcrop. It is possible that this hearth is an adaptation to an earlier feature that may have channelled water from inside the building, into the wheelpit (or *vice versa*), although no clear evidence of this was visible in either the interior or exterior masonry at the time of the recording visit.

Photo 19: Possible former leat opening (in northwest gable end wall) for channelling water in/out of mill.
Later converted to a fireplace.

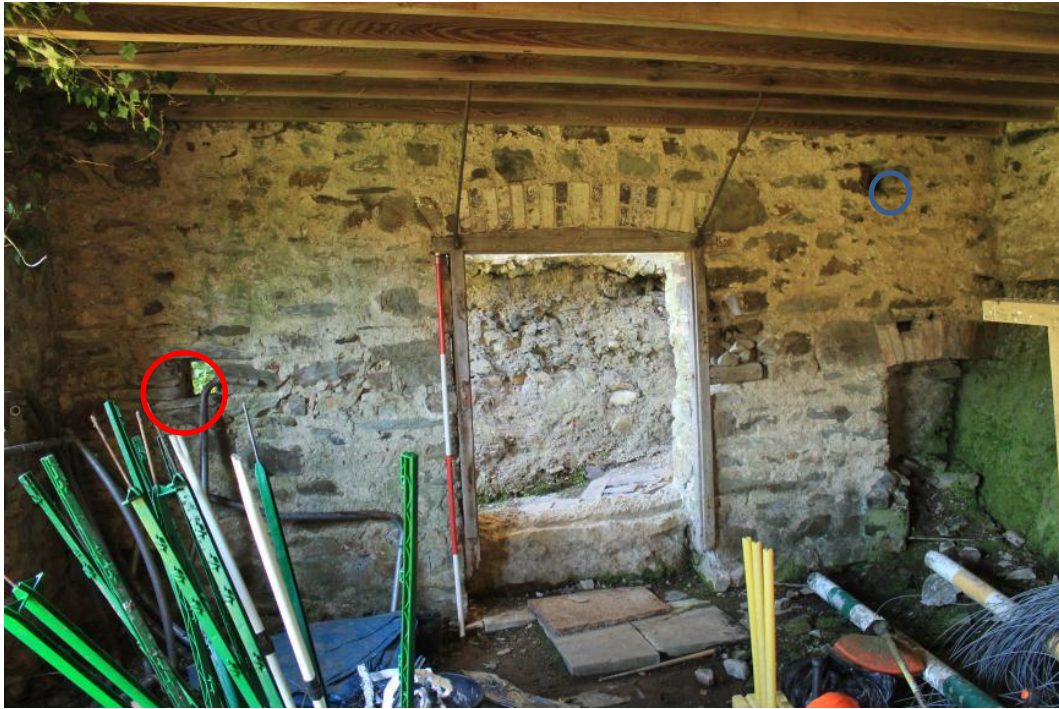
The east facing elevation (Photo 20, Plan 5) contains a centrally positioned wide doorway that would have given access to the wheelpit, presumably for maintenance or some other purpose. It is also possible that the housing for the waterwheel and drive shaft connecting it to the mill mechanisms may have been located in this opening.

To the left of the door opening (circled in red in Photo 20) is a much smaller aperture that could also have housed the drive shaft from the waterwheel. A small niche in the top right (circled in blue in Photo 20) is of uncertain purpose.

Photo 20: Interior ground floor southeast facing wall with wide opening to wheelpit. Note possible drive-shaft hole to left (circled in red) and niche for beam (circled in blue).

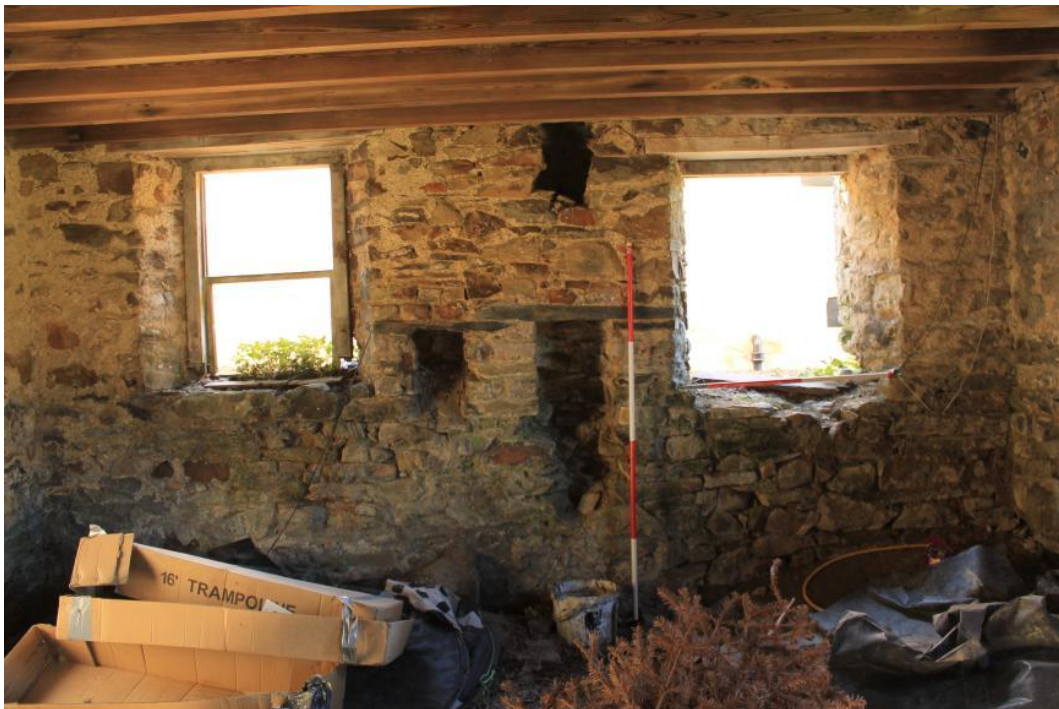
Between the windows (Photo 21) are the remains of a small fireplace or opening for a chimney flue below, with a hole broken through to the chimney above. To the left is a small niche of uncertain purpose. Apart from the window and door openings, no features are visible in the northeast facing elevation of the southwest wall.

Photo 21: Northwest facing interior ground floor elevation (southeast gable end). Small hearth, recess and void in chimney breast (above).

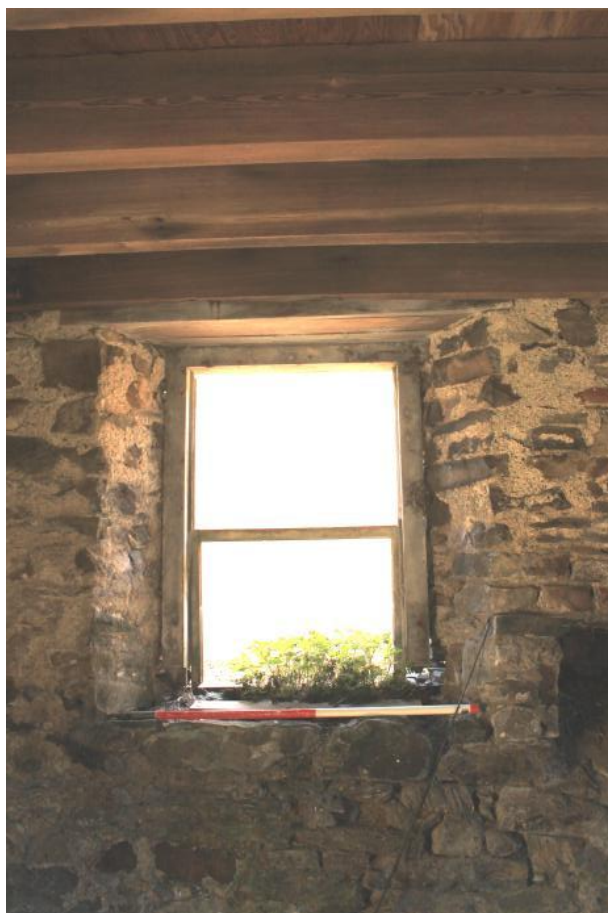
Photo 22: Northwest facing interior ground floor elevation. Window detail.

The northwest facing elevation (Photo 21, Plan 4) of the southeast gable end wall contains two symmetrically positioned window openings (Photos 12 and 22) with slightly splayed reveals. The sill height of the right hand window is lower than the left hand window, reflecting the sloping ground level outside.

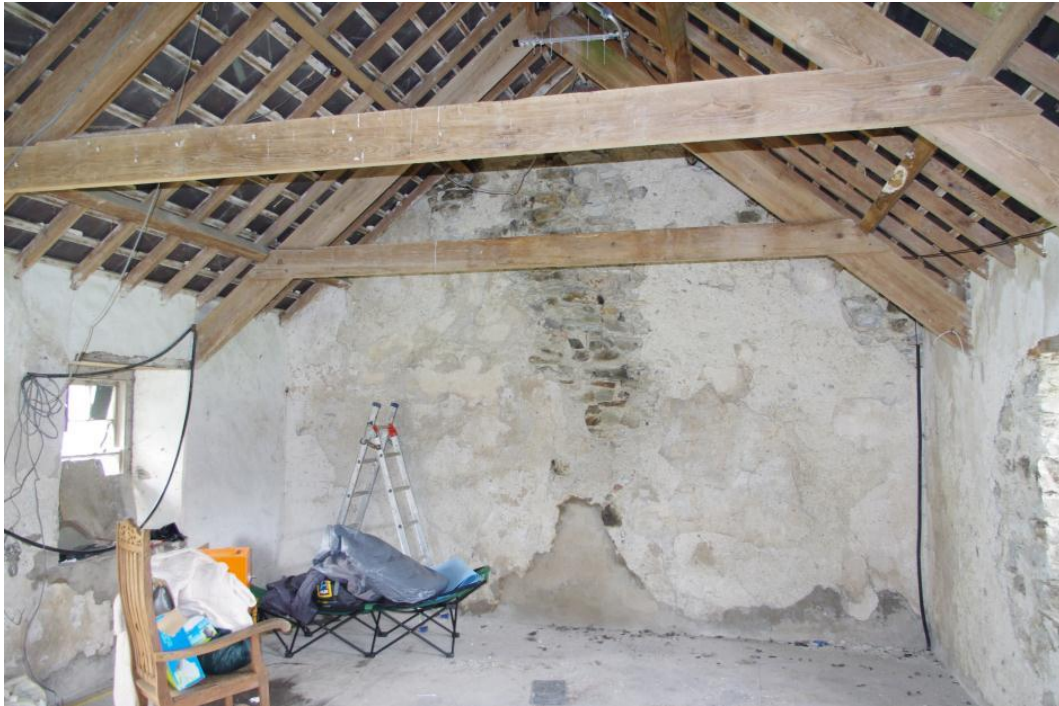
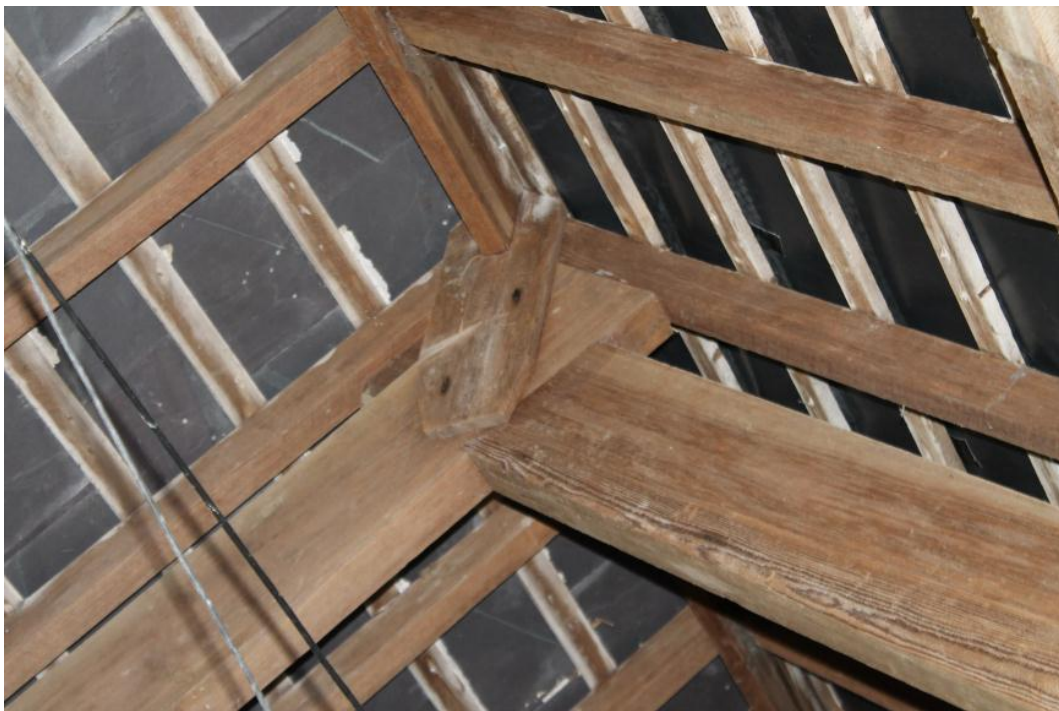
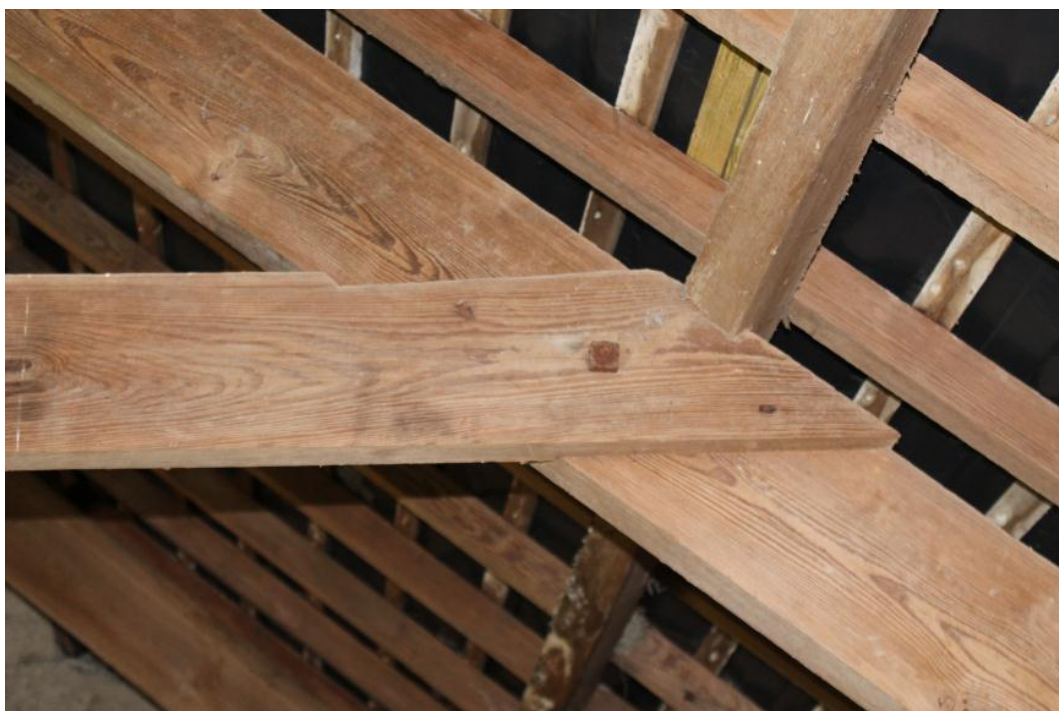
The roof and floor timbers (Photos 24, 25 and 26) appear likely to be a 20th century replacement of the original roof and floor after the building had ceased to be used as a fulling mill. There was no evidence for former openings in the floor for drive belts to transfer power from the ground floor to run machinery on the first floor. It appears that if the ground floor was originally stone flagged, though these have been removed.

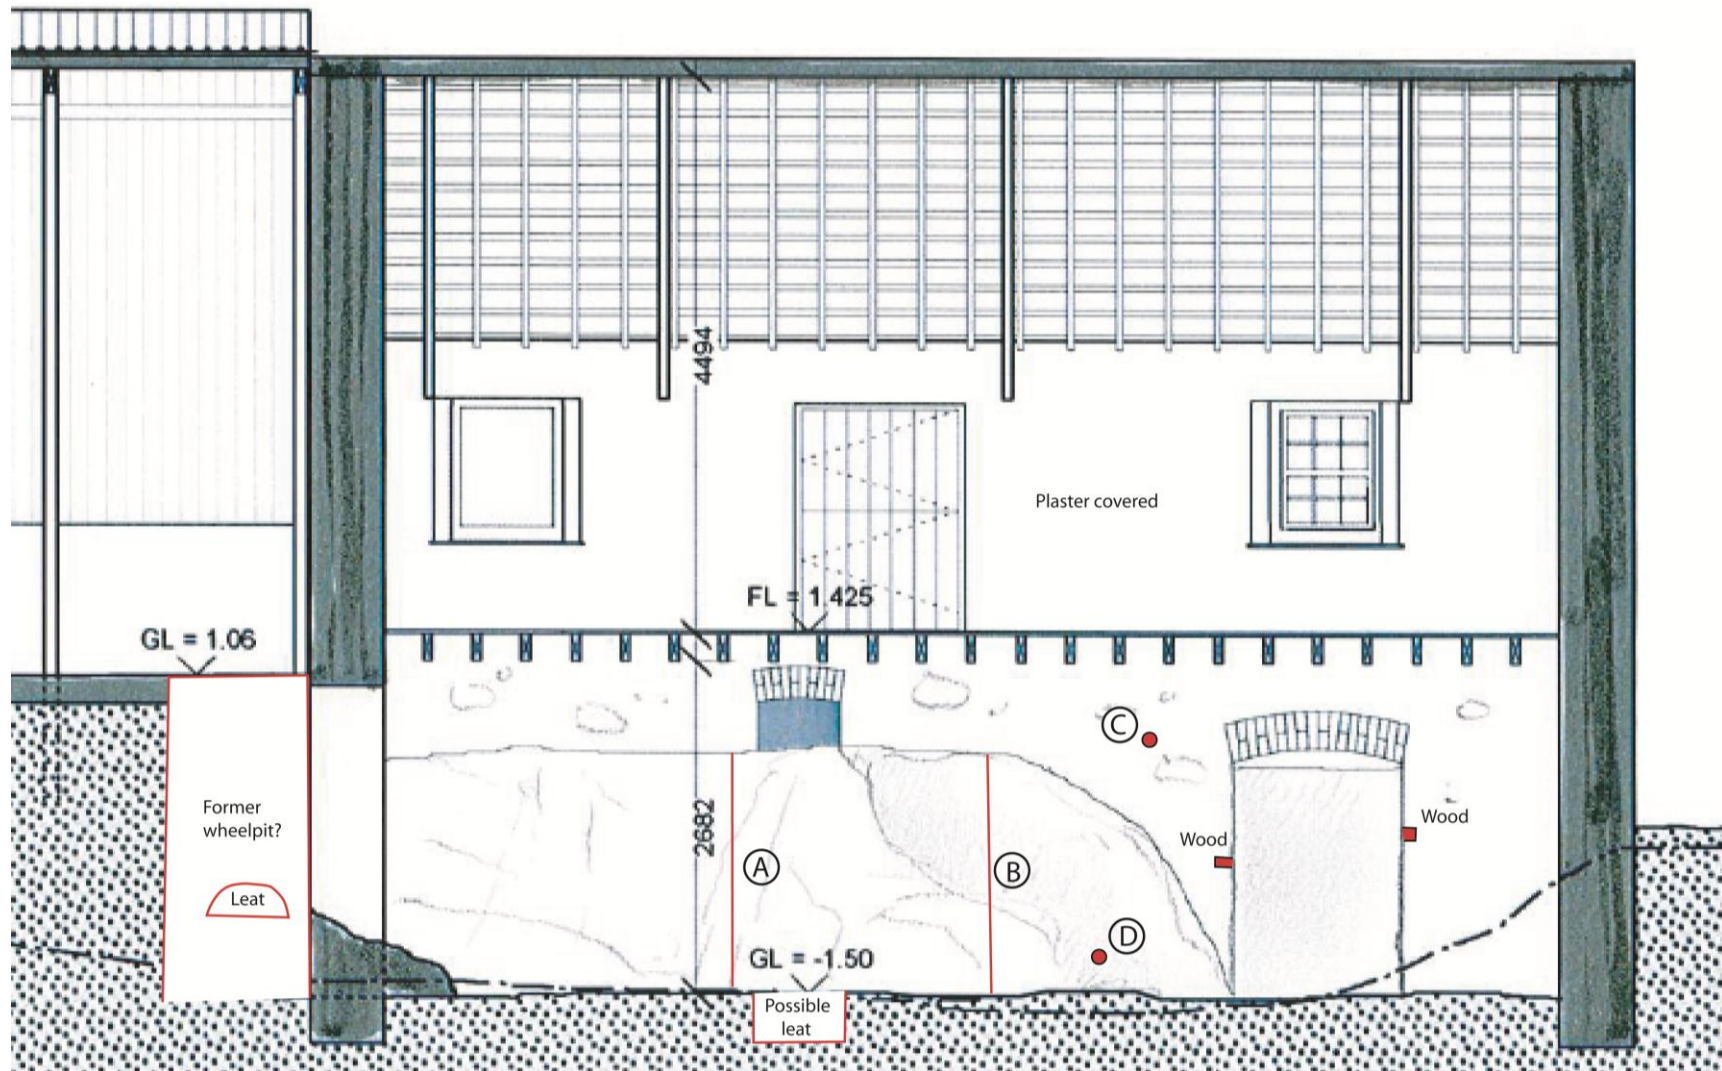
Plan 3: Southwest facing interior elevations with observed features in red (northeast wall).
