SOUTH HOOK SLIPWAY PEMBROKESHIRE

SITE VISIT

Prepared by Dyfed Archaeological Trust
For: Pembrokeshire Coast National
Park Authority

RHIF YR ADRODDIAD / REPORT NO. 2012/8
RHIF Y PROSIECT / PROJECT RECORD NO. 102613

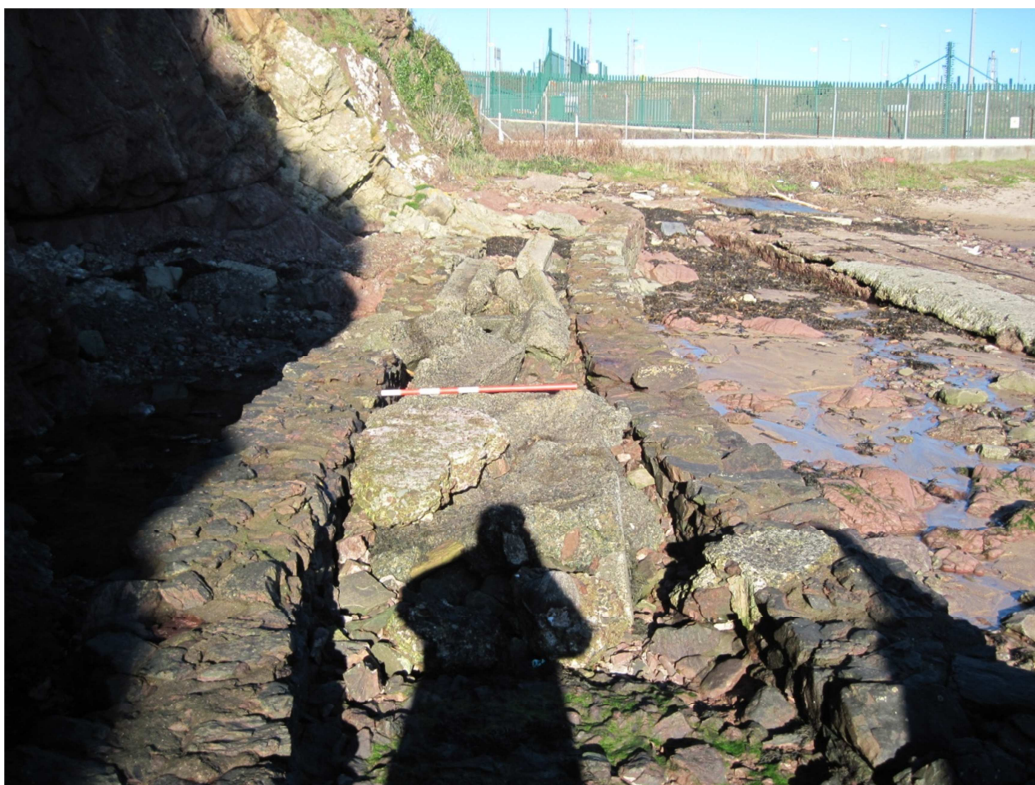
The slipway would appear to be over 90% intact. The major damage apparently lay towards the upper, inland end, where a later concrete repair has suffered more from erosion than the paved surface of the slipway (Photo 1). The mid section surface is still in good repair (Photo 2) and the lower, southern end appears to be in fair condition but covered by a lot of seaweed (Photos 3 and 4). The general condition is fair to good with no evidence of any very recent damage.

Photo 1: Inland part of slipway with broken up concrete repairs. View N. Scale 1m
Modern slipway to right (East)

The slipway does not appear to be deteriorating rapidly and therefore it is not considered that consolidation is necessary at this time. However, it is recommended that a full photographic survey is undertaken when light conditions are suitable (this will, by necessity, have to be done on a low spring tide). It should then be monitored at half yearly intervals for the next five years. If the monitoring notes further deterioration then consolidation may be necessary and costed proposals should be prepared for consolidation as part of a long term management plan for the site.

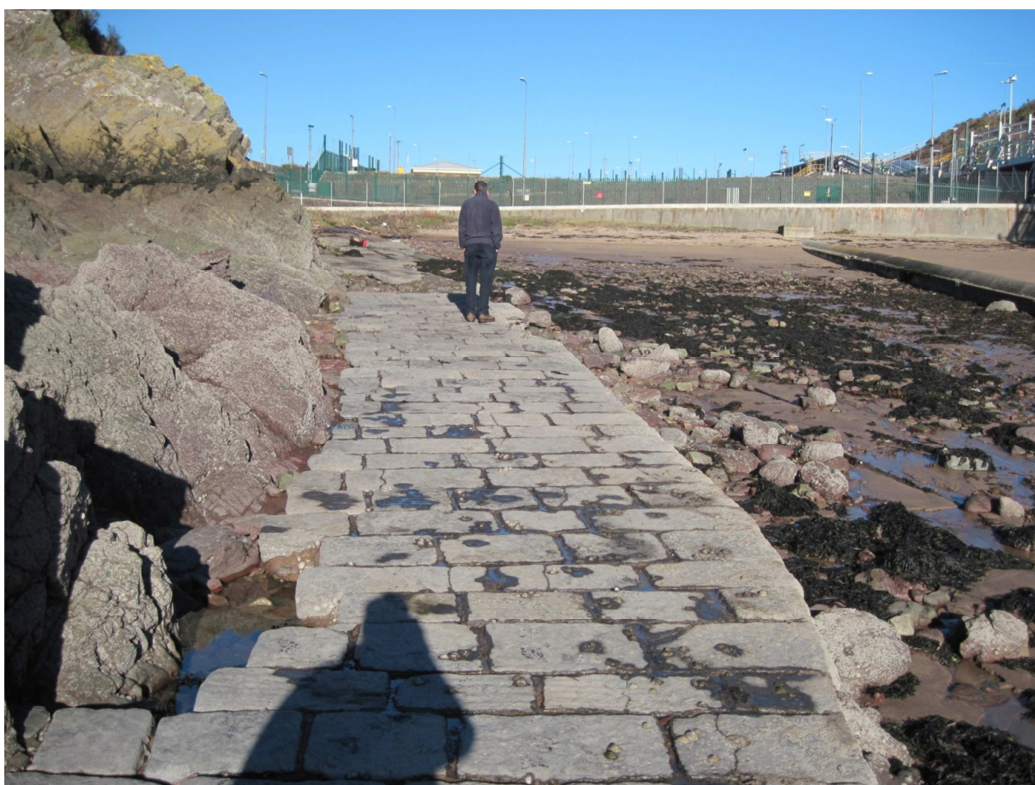
Photo 2: Mid section of slipway surface. View N

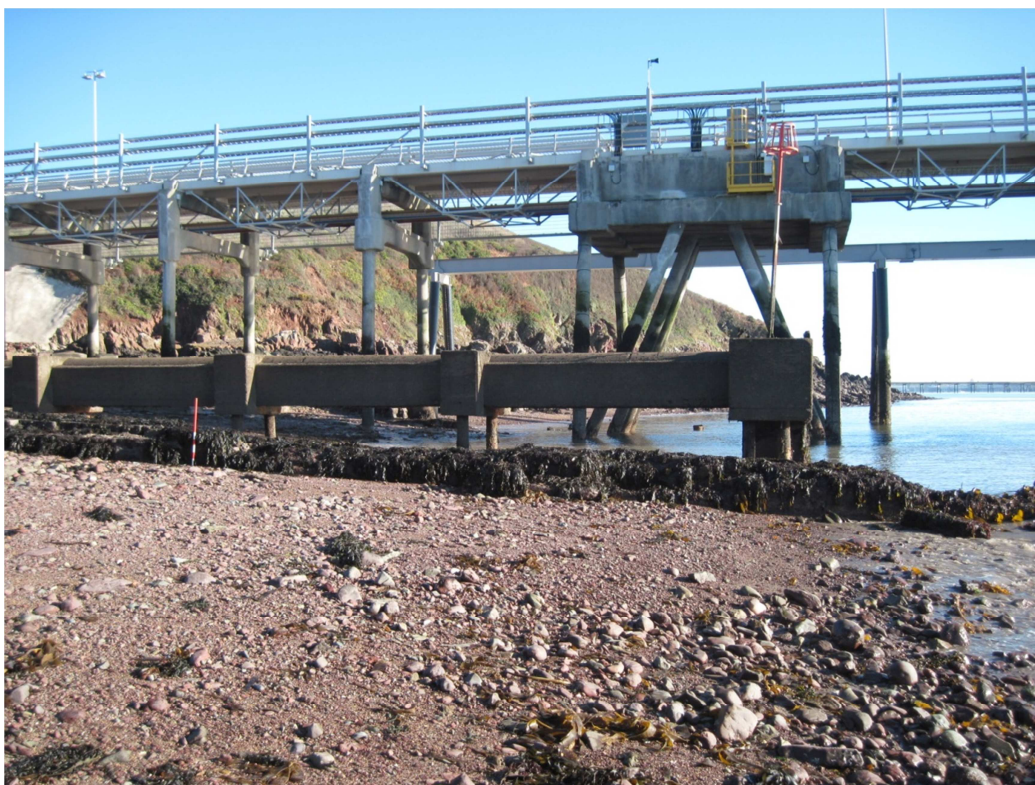
Photo 3: Lower part of slipway. View E. Scale 1m

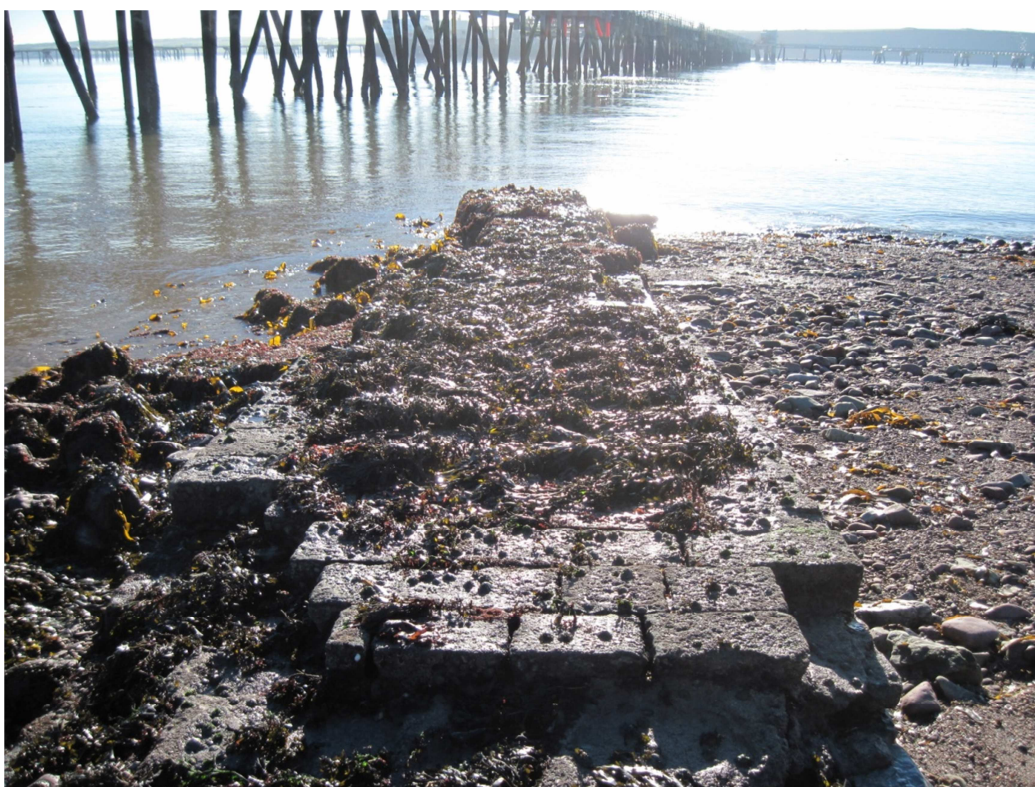
Photo 4: Southern end of slipway surface. View S

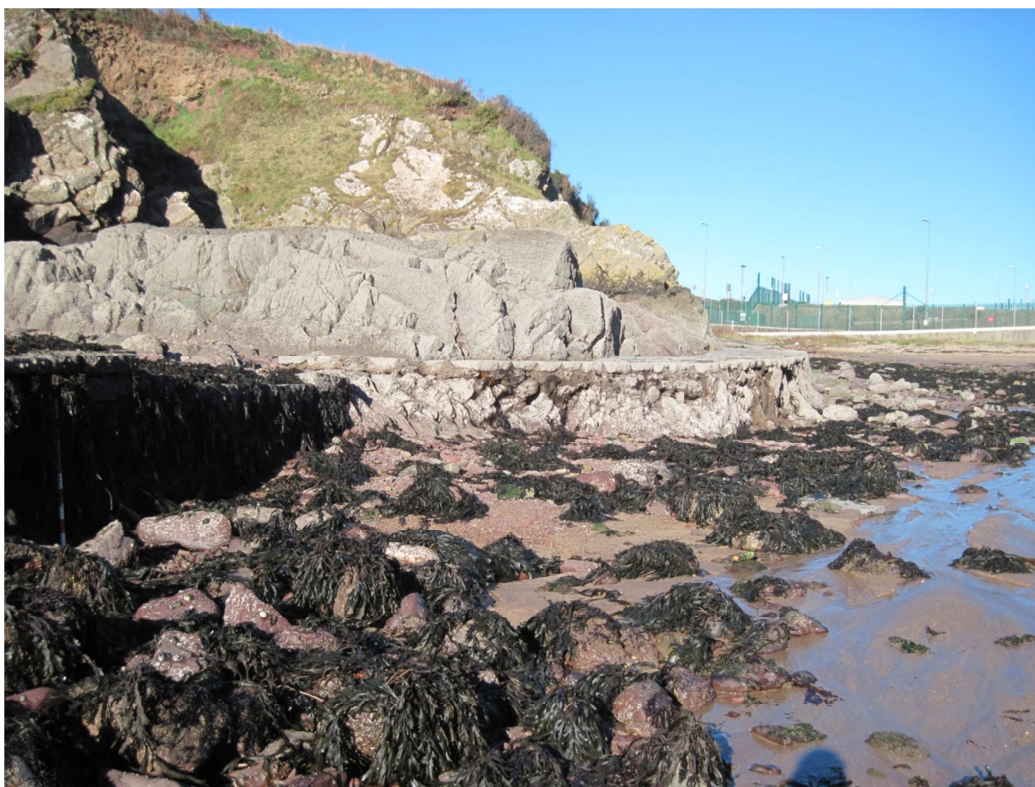
The site was visited on 20 January 2011 at low tide when the whole length of the slip was visible. Unfortunately the clear weather with strong sunlight hampered photography (see below). The slipway was constructed of ashlar facing with a thick flagstone capping, both probably of granite. The core was possibly of rubble and the whole structure appears to be mortar bonded, but its structure was not examined in detail. There are two straight lengths of slipway (Photos 1 and 4) between which there is a dogleg section running around the base of the cliff (Photo 5). In total it is about 100m long, just over 2m wide and between 0.5 to 1.5m high. The upper and middle part of the structure was constructed onto the levelled and cut back base of the cliff (Photos 1 and Photo 5)

Photo 5: Middle part of slipway around headland. View N. Scale 1m.
