Chapel seen whilst driving past.

AM 30/4/85.

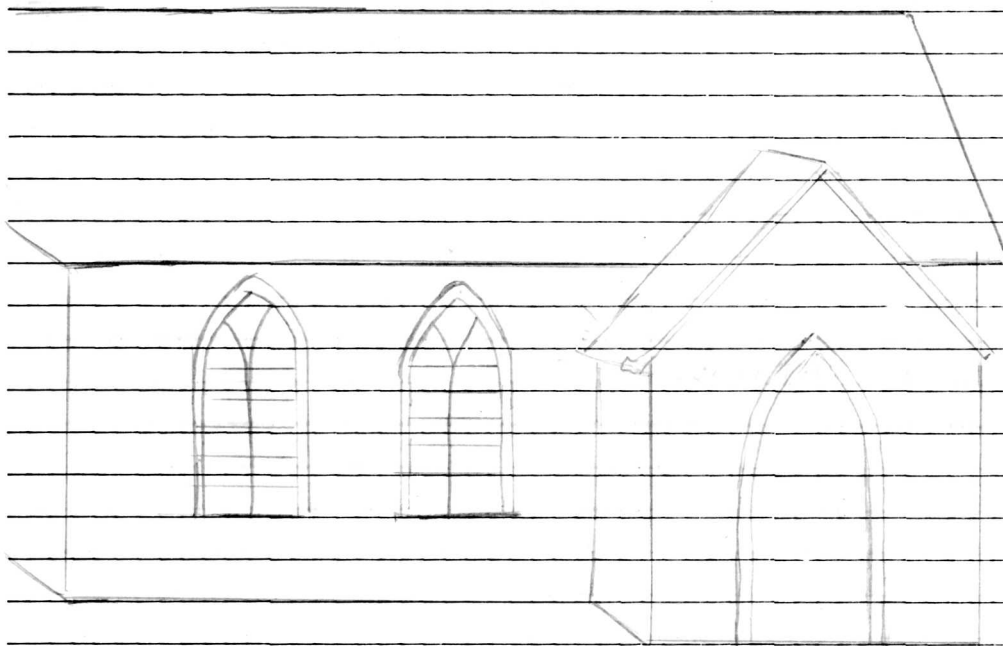
Stone built, disused, slate roof partly missing. Within high walled enclosure.

Entrance porch with mock-norman arch.

Arched window with brick surround.

Inside fixtures: wooden paneling, wooden benches, floor is wooden, partly rotten.
