Jan  
Field obs. J.H. Williams, 1977

A S Mawll  
1/3/84

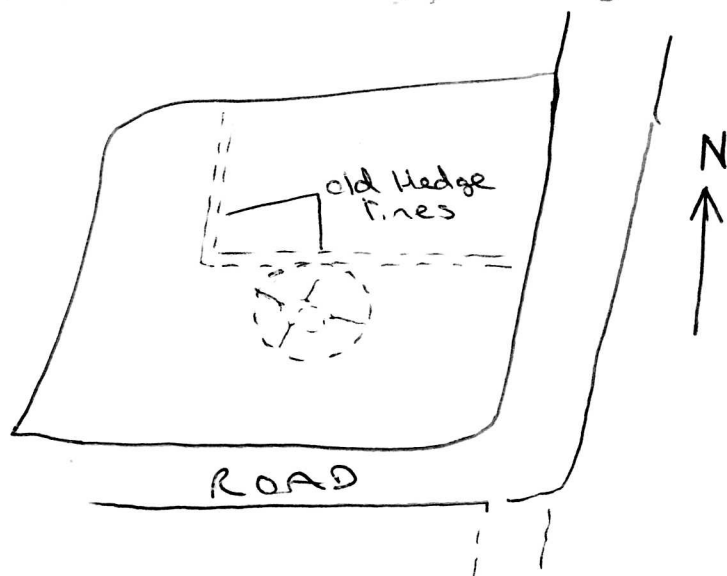
Clug Pen Uwyd. Remains of a badly ploughed down round barrow, only c. 0.3m high, 20.0m in diameter, it shows up as a slight ground swelling with a pocked surface, an old hedge line crosses it on its northern edge, running E-W.
