L. WEEKS D.A.T.  
3rd June 1985

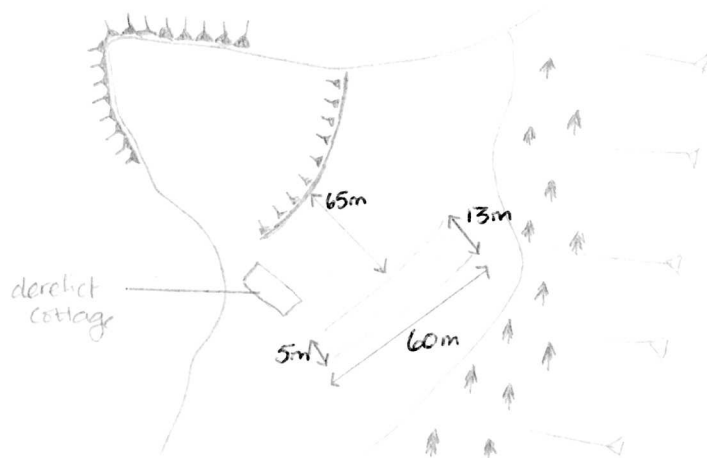
81-24 Rampart + ditch → NE

81-25 X Section Rampart  
→ ENE
