Hillfort as described by OS in 1915. Hedgebanks on ramparts overgrown but show no signs of animal erosion or other interference. Eastern curved bank is best viewed from the east side from which it stands to a height of 0.9m. A possible second bank is visible to the SE, outside the curved bank. The width of the clearer bank is 12m - spread probably due to ploughing.

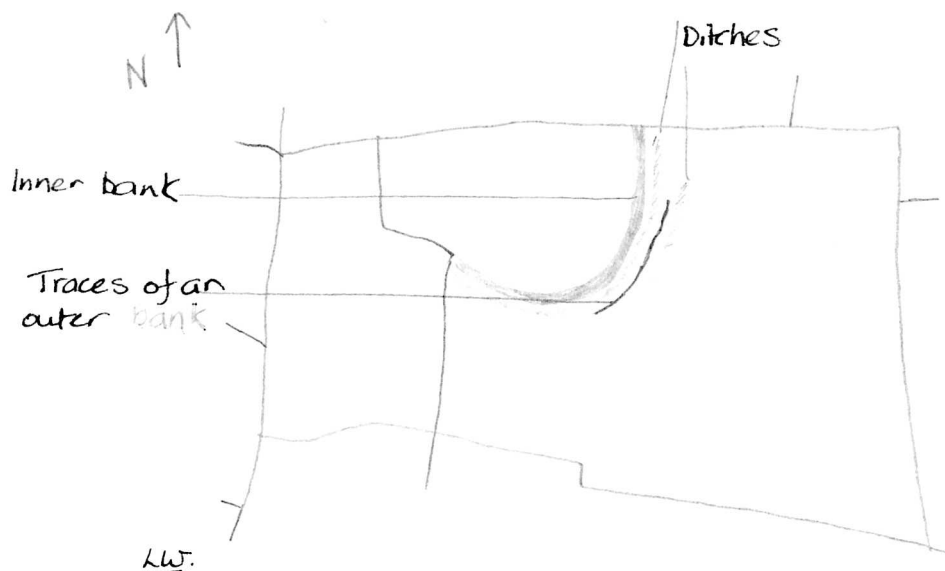
Grass in the interior of the hillfort was rather high and no features of hut circles were discernible.
