farmhouse and byre/stables:

Er Evans Dec 1983

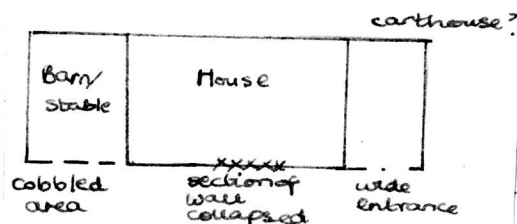
Stone built. Hse. Thatched roof now covered with corrugated iron.

Barn roof slated. A section of the front wall of the house has collapsed & the roof here has fallen in.

Cobbled area in front of the barn.

Enclosure wall visible to the back of the farmstead (N).
