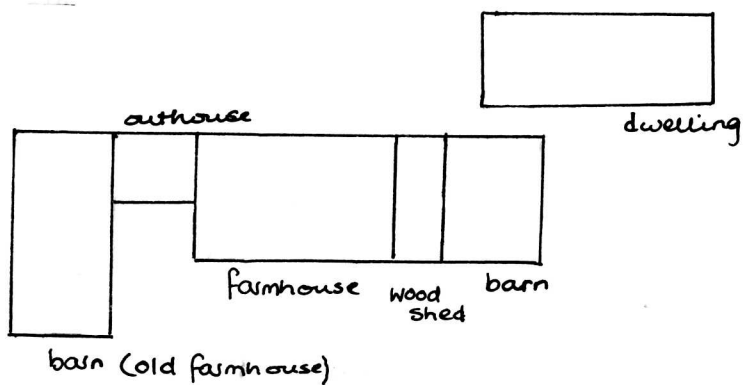
Derelict for last 3 years: now FC property  
Barn & old farmhouse: roofs thatched  
but covered over with corrugated  
iron. Latest dwelling: modern.  
Enclosure wall.
